Remediation Action Plan

Landscaped Area, Medical Gas
Loading Bay Area, West Campus of
RPA

304100230

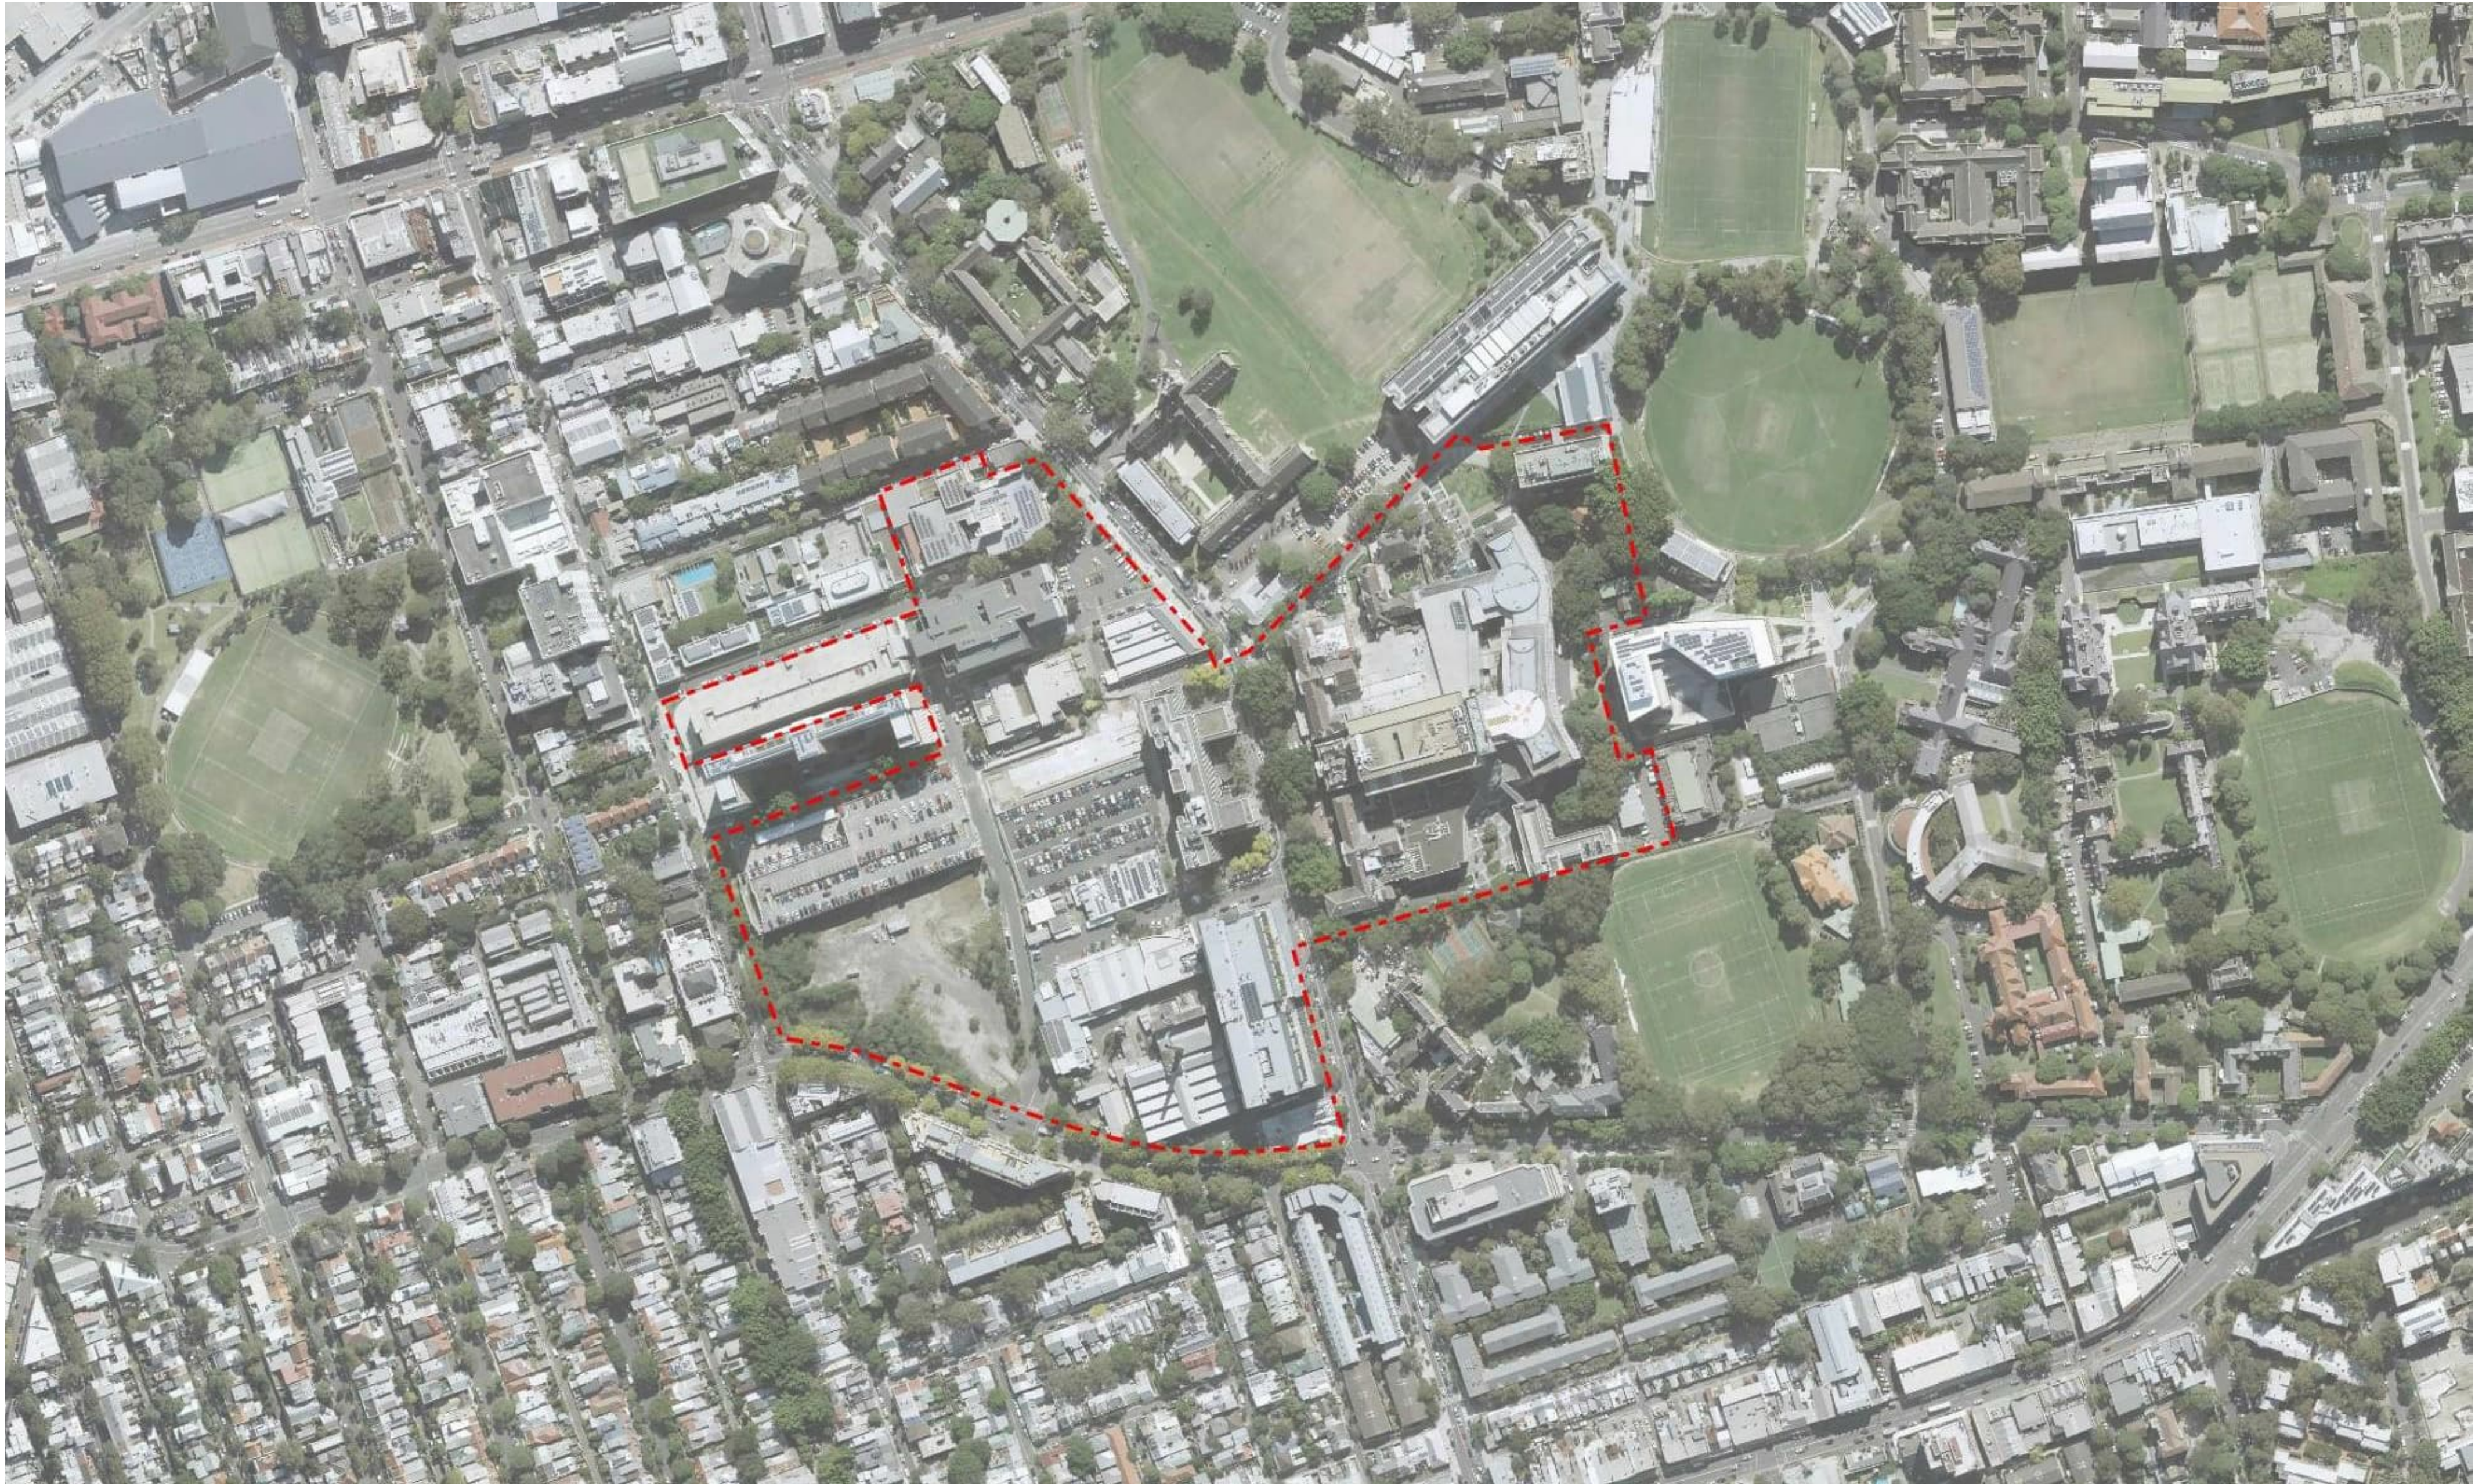
ROYAL PRINCE ALFRED HOSPITAL REDEVELOPMENT
CAMPUS INFRASTRUCTURE WORKS REF#5 PACKAGE
PROPOSED WESTERN CAMPUS MEDICAL GAS COMPOUND EXPANSION &
ASSOCIATED WORKS
