**REPORT TO  
NSW HEALTH INFRASTRUCTURE**

**ON  
DETAILED SITE INVESTIGATION**

**FOR  
PROPOSED NEW WARRAWONG COMMUNITY  
HEALTH CENTRE DEVELOPMENT**

**AT  
85-91 COWPER STREET, WARRAWONG, NSW**

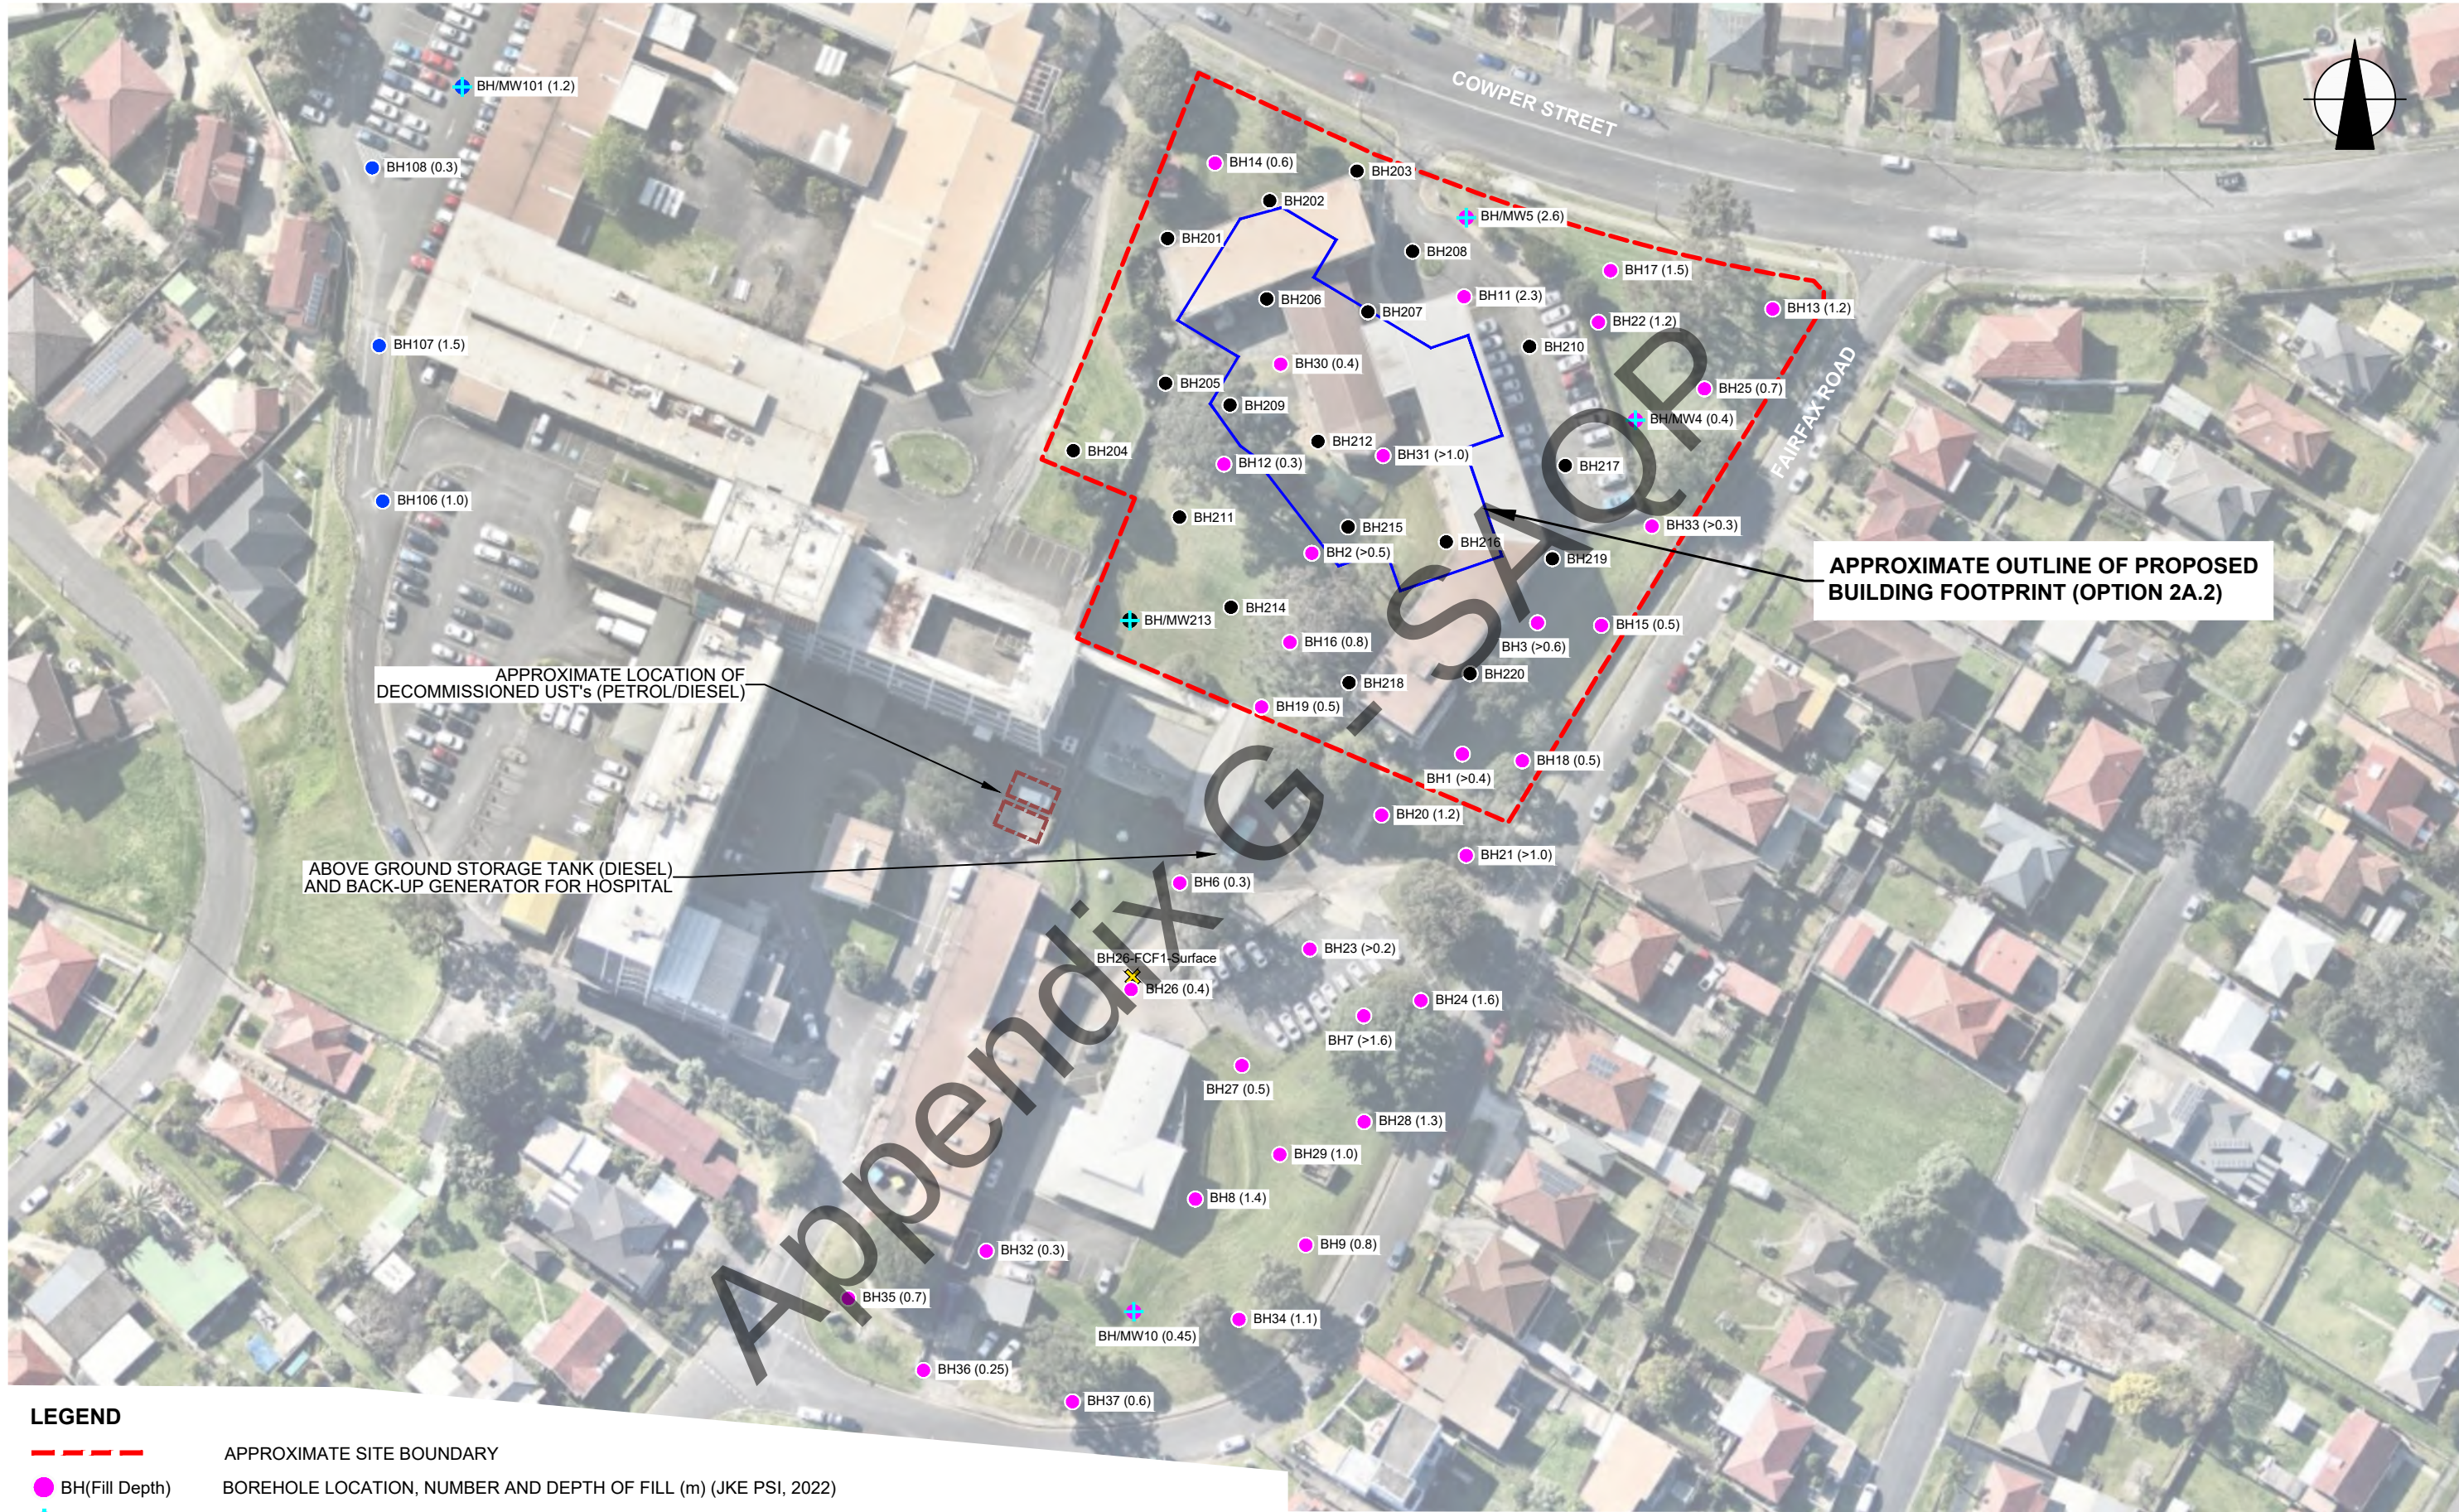
- APPROXIMATE SITE BOUNDARY
- BH(Fill Depth) BOREHOLE LOCATION, NUMBER AND DEPTH OF FILL (m) (JKE PSI, 2022)
- BH/MW(Fill Depth) BOREHOLE AND GROUNDWATER MONITORING WELL LOCATION, NUMBER AND DEPTH OF FILL (m) (JKE PSI, 2022)
- ✕ FCF(Surface) FIBRE CEMENT FRAGMENT LOCATION, NUMBER AND DEPTH (Surface/m)
- BH102 BOREHOLE LOCATION, NUMBER AND DEPTH OF FILL (m) (JKE PSI, 2023)
- BH/MW101 BOREHOLE AND GROUNDWATER MONITORING WELL LOCATION, NUMBER AND DEPTH OF FILL (m) (JKE PSI, 2023)
- BH102 PROPOSED BOREHOLE LOCATION AND NUMBER
- BH/MW213 PROPOSED BOREHOLE AND GROUNDWATER MONITORING WELL LOCATION AND NUMBER

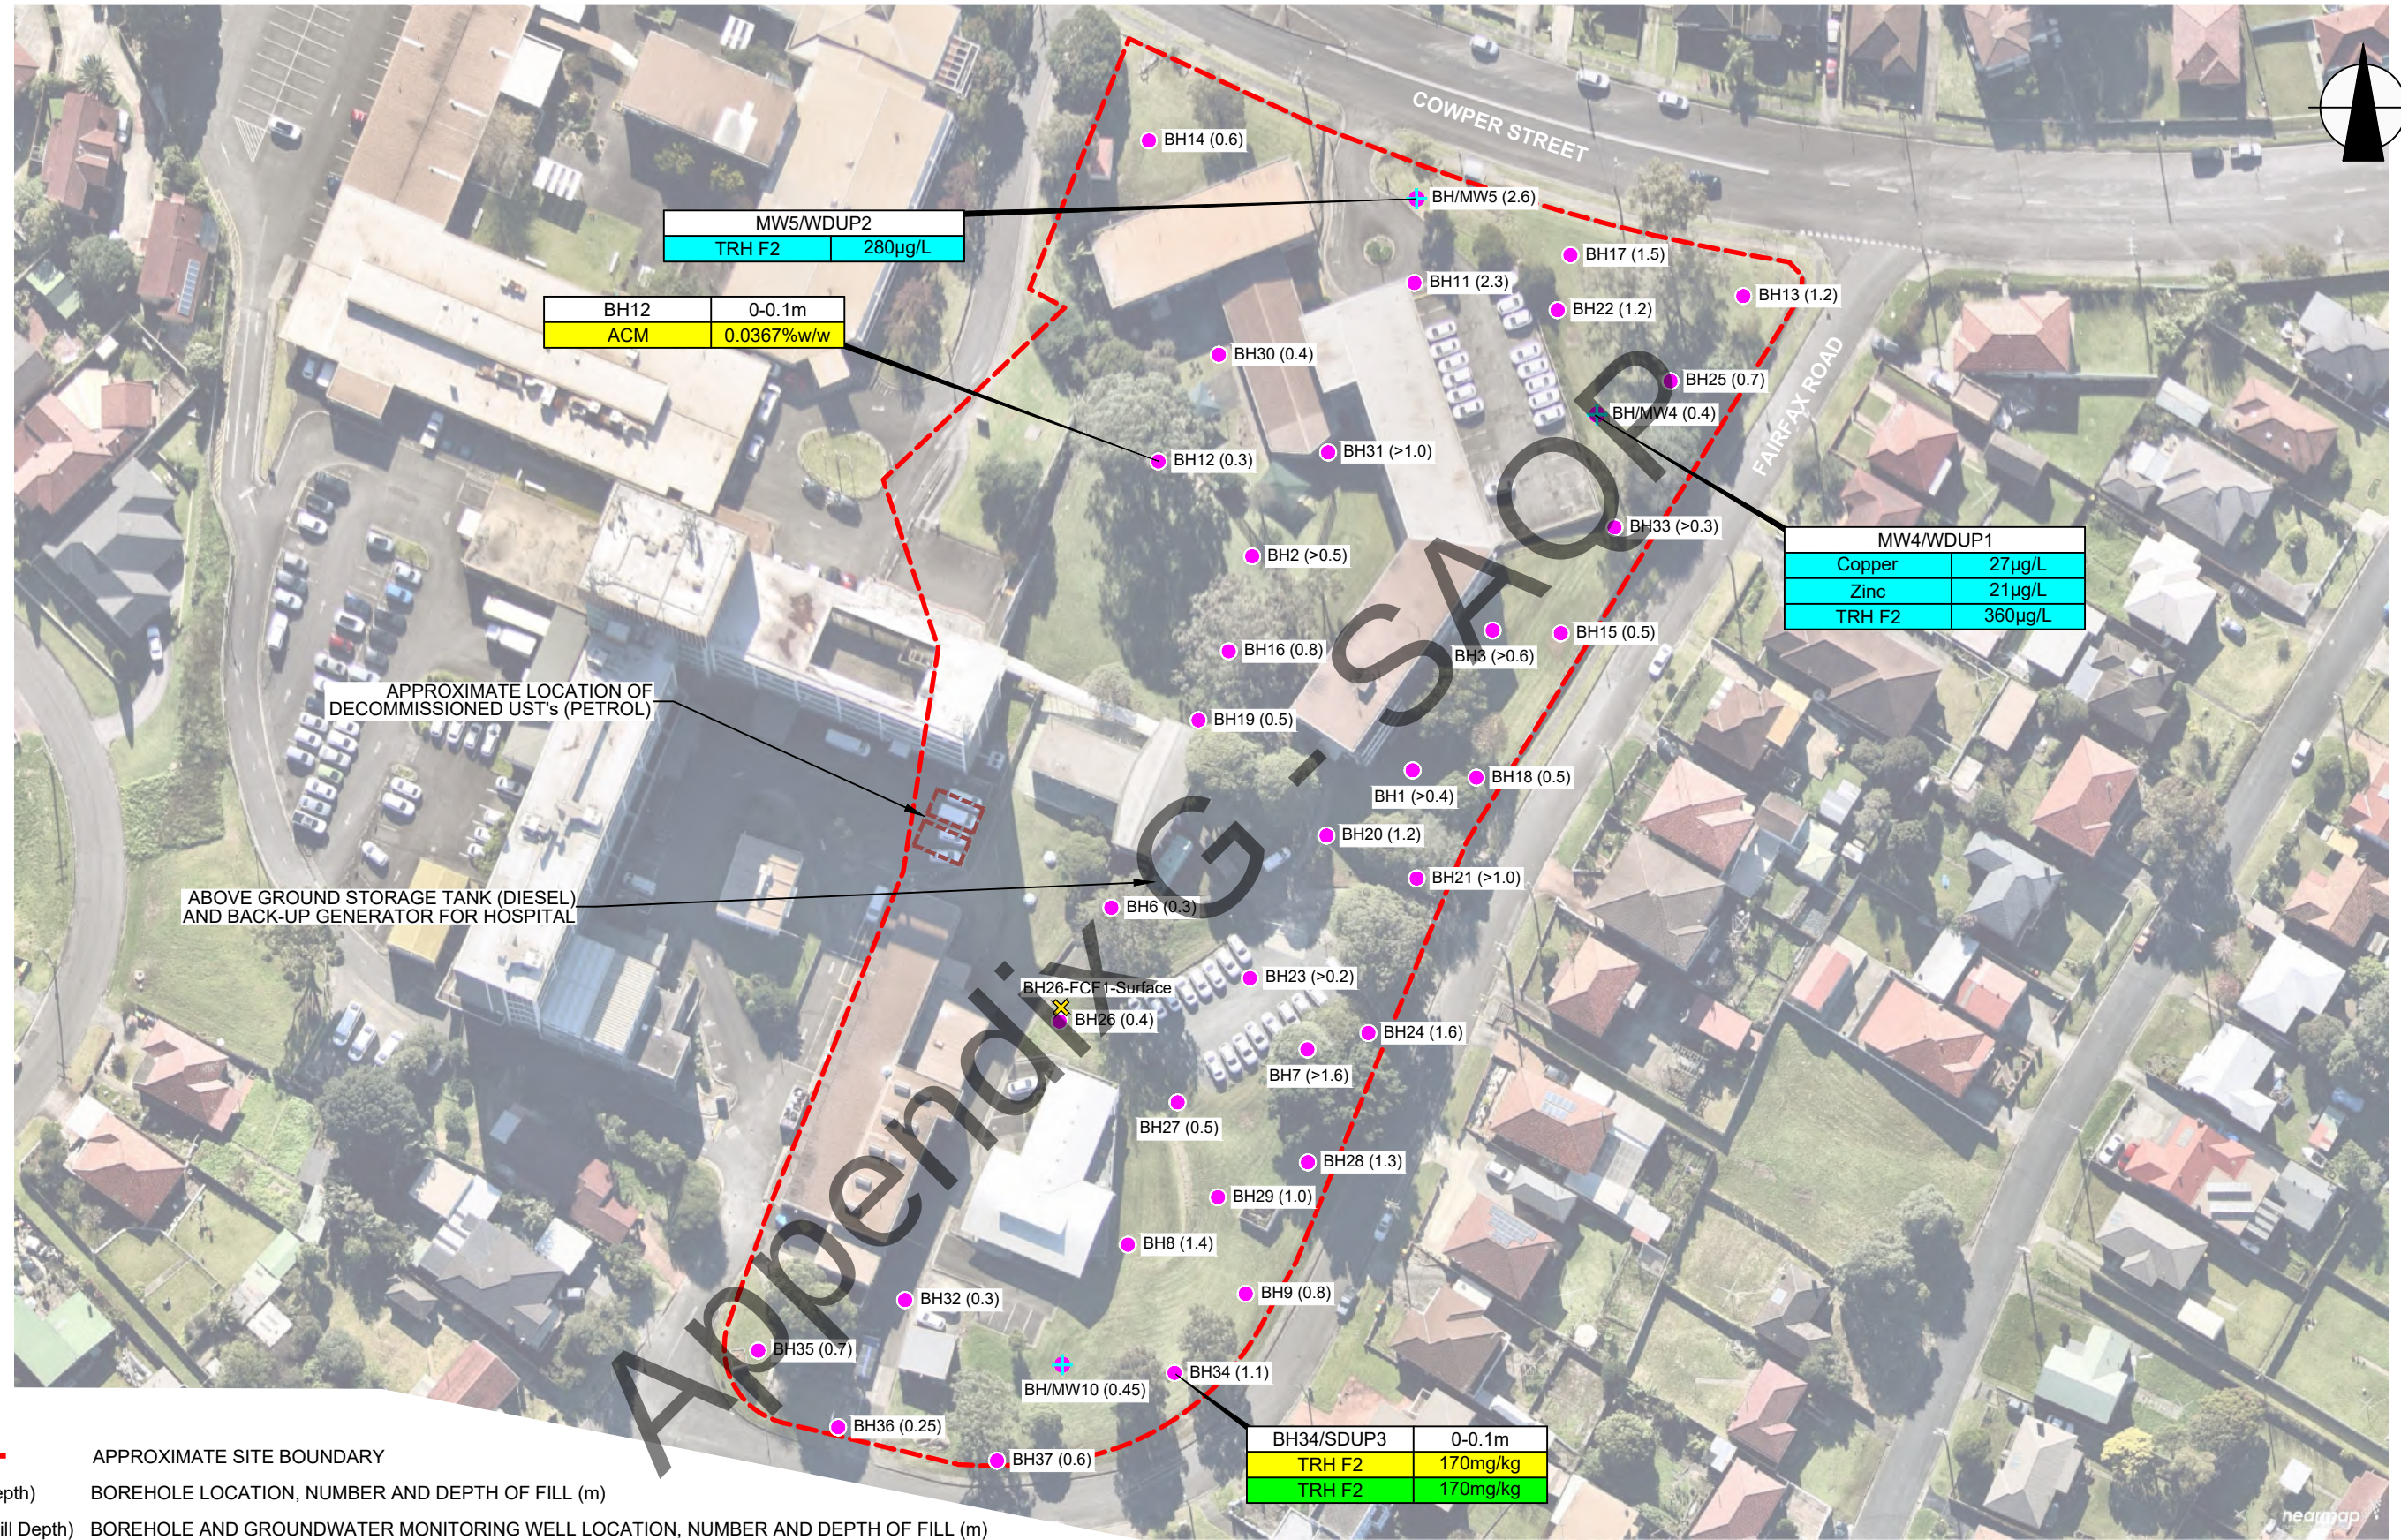
| Title: <b>SAC EXCEEDANCE PLAN</b> | |

- SOIL/SURFACE CONTAMINATION ABOVE SAC FOR HUMAN HEALTH RISK
- SOIL/SURFACE CONTAMINATION ABOVE SAC FOR ECOLOGICAL RISK
- GROUNDWATER CONTAMINATION ABOVE SAC
