REPORT TO  
**HEALTH INFRASTRUCTURE**

ON  
**STAGE 2 GEOTECHNICAL INVESTIGATION**

FOR  
**NEW COMMUNITY HEALTH CENTRE**

AT  
**89-91 COWPER STREET, WARRAWONG, NSW**

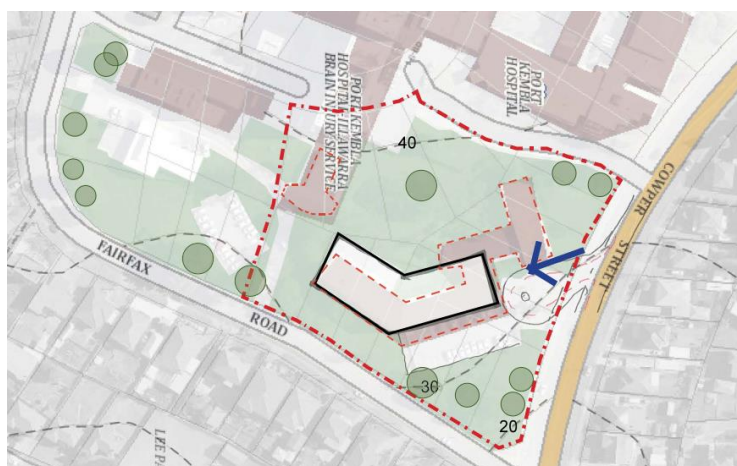
Fig. 1 – Option 2 layout (pink shaded buildings within red boundary are to be demolished)

We understand that at least three options for the design of the new WCHC building were being considered as of April 2022, all to be located within the southern portion of the Port Kembla Hospital site. Of these, Options 2 and 3 were being evaluated as preferred options. These two options are indicated in the plan excerpts from the Cox Architects plans supplied with the brief (from April 2022), shown below.

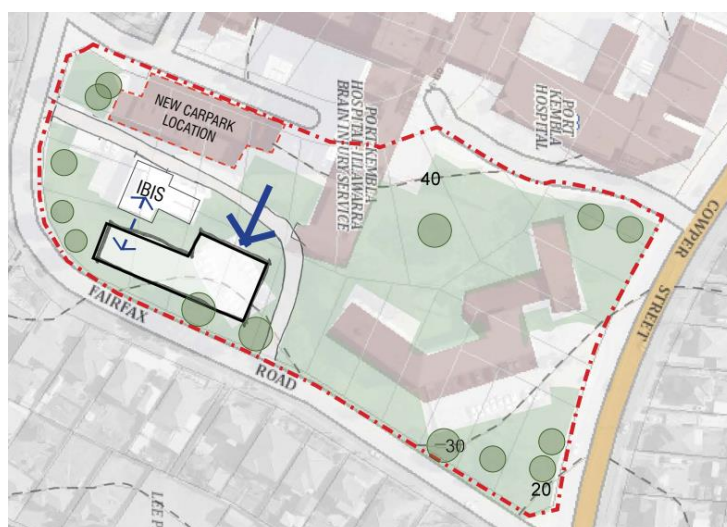
Fig. 2 – Option 3 layout, from April 2022 (pink shaded buildings within red boundary are to be demolished)

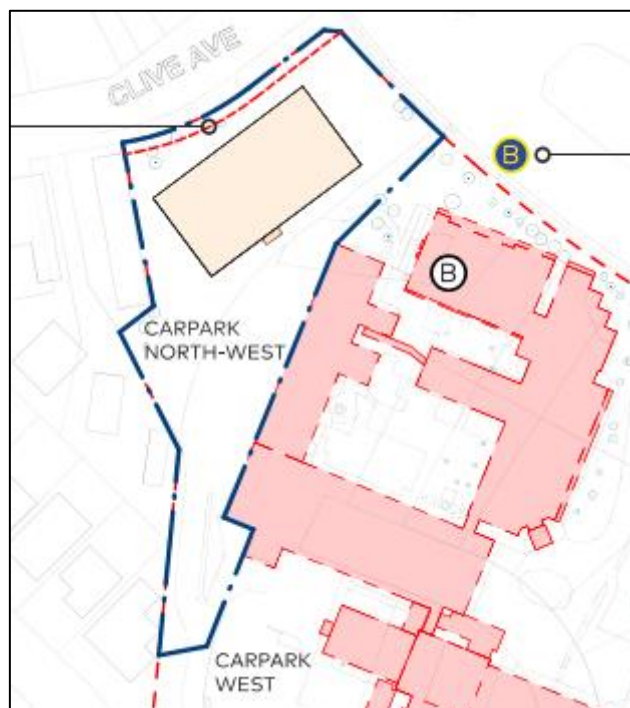
Fig. 3 – Revised Option 3 layout (December 2022)

However, Option 3 was re-evaluated in December 2022 and a new location was proposed for the WCHC building at the northwest portion of the PKH site, where there is currently a car park area. The outline of the proposed WCHC building for this revised option is shown in Figure 3 below.

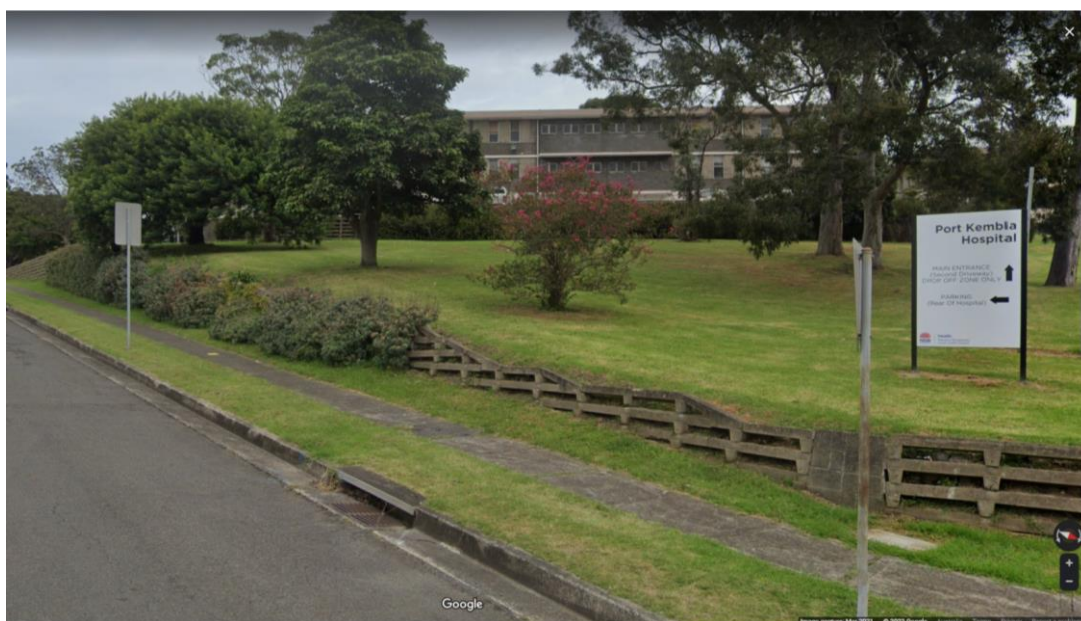
It is noted that the northeast car park and most of the boundary along Fairfax Road contains a concrete crib-type retaining wall, that varies in height from about 0.3m to about 1.5m (estimated), as shown below.

Photo 1. View from the corner of Fairfax Road and Cowper Street

The Google Earth street-view image below is from the corner of Fairfax Road and Cowper Street in the north-east corner, looking to the south-west. The area that is the subject of the investigations for the WCHC options shown in Figs. 1 and 2 is approximately 90m wide and 200m long, or about 1.7 ha across the eastern half of the hospital grounds. The northwest car park area (proposed for revised Option 3), as shown in Fig. 3, is approximately 120m in length and about 50m wide.

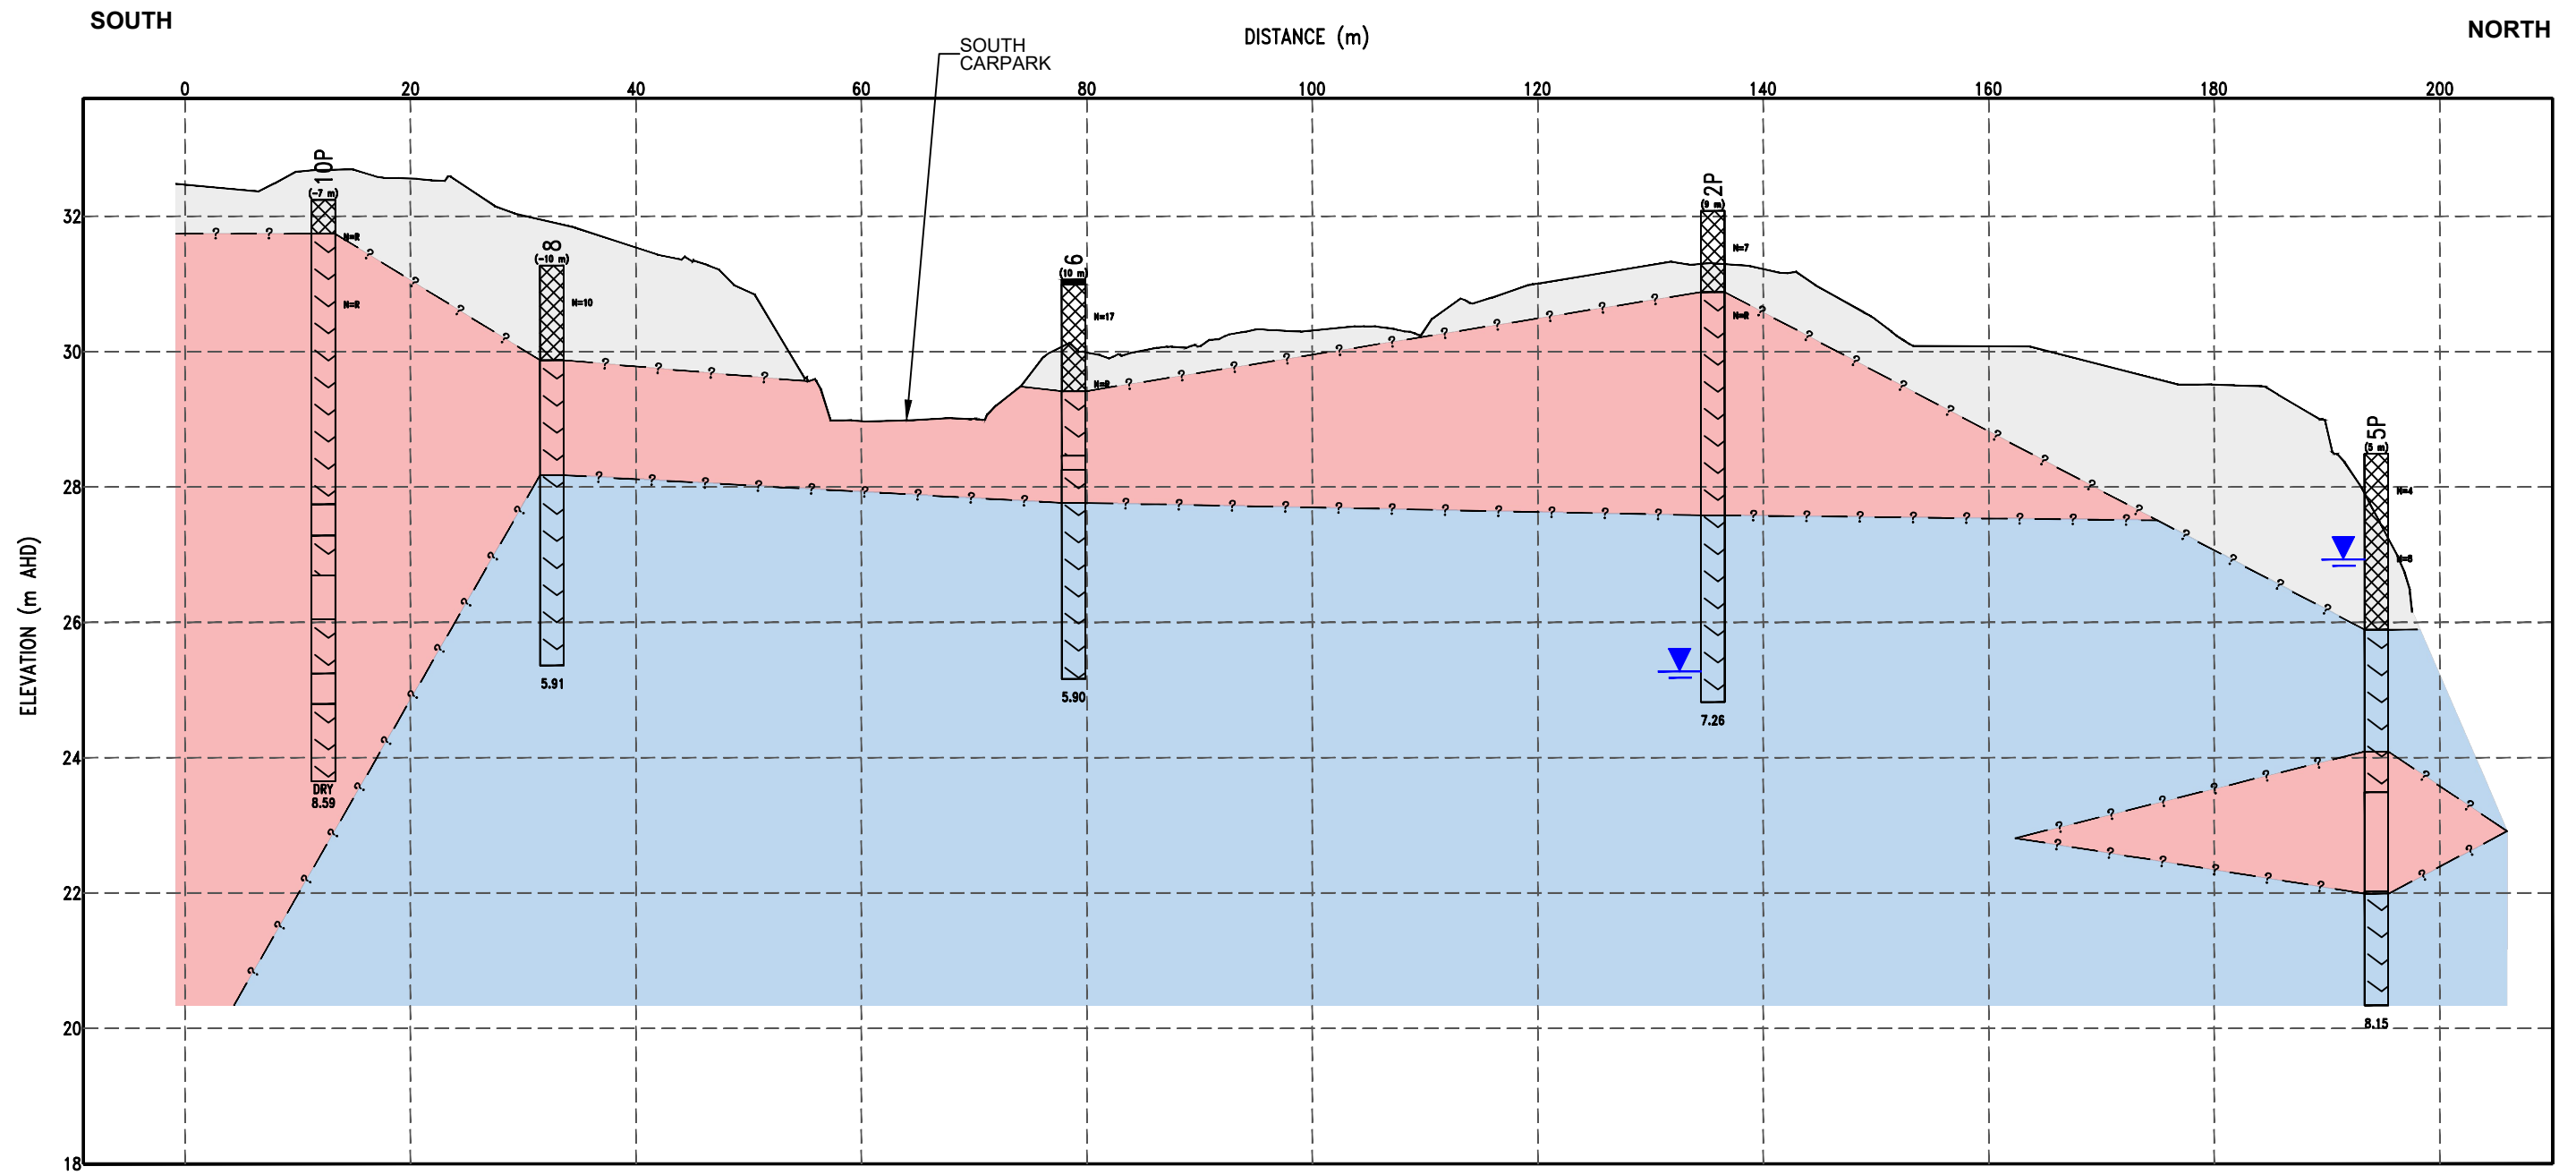
Title: <b>INFERRED GROUND PROFILE</b>		
Section: <b>SECTION A-A</b>		
Location: PORT KEMBLA HOSPITAL, WARRAWONG, NSW		
Report No: 34300LX2	Revision No: 01	Figure No: 03
<b>JKGeotechnics</b>

In boreholes BH-5P, BH-7 and BH-105P there is a more closely fractured and/or weathered section within the Lower Latite unit that has similar properties to the Upper Latite unit, even though it is shown in the cross-sections as being overlain by Lower Latite rock unit. For simplicity, these closely fractured and/or weathered sections have been described as Upper Latite in the ground model. In BH-5P it is assumed that the significant core loss between 5m and 6.45m is due to the presence of more closely fractured and/or weathered latite rock between these depths.

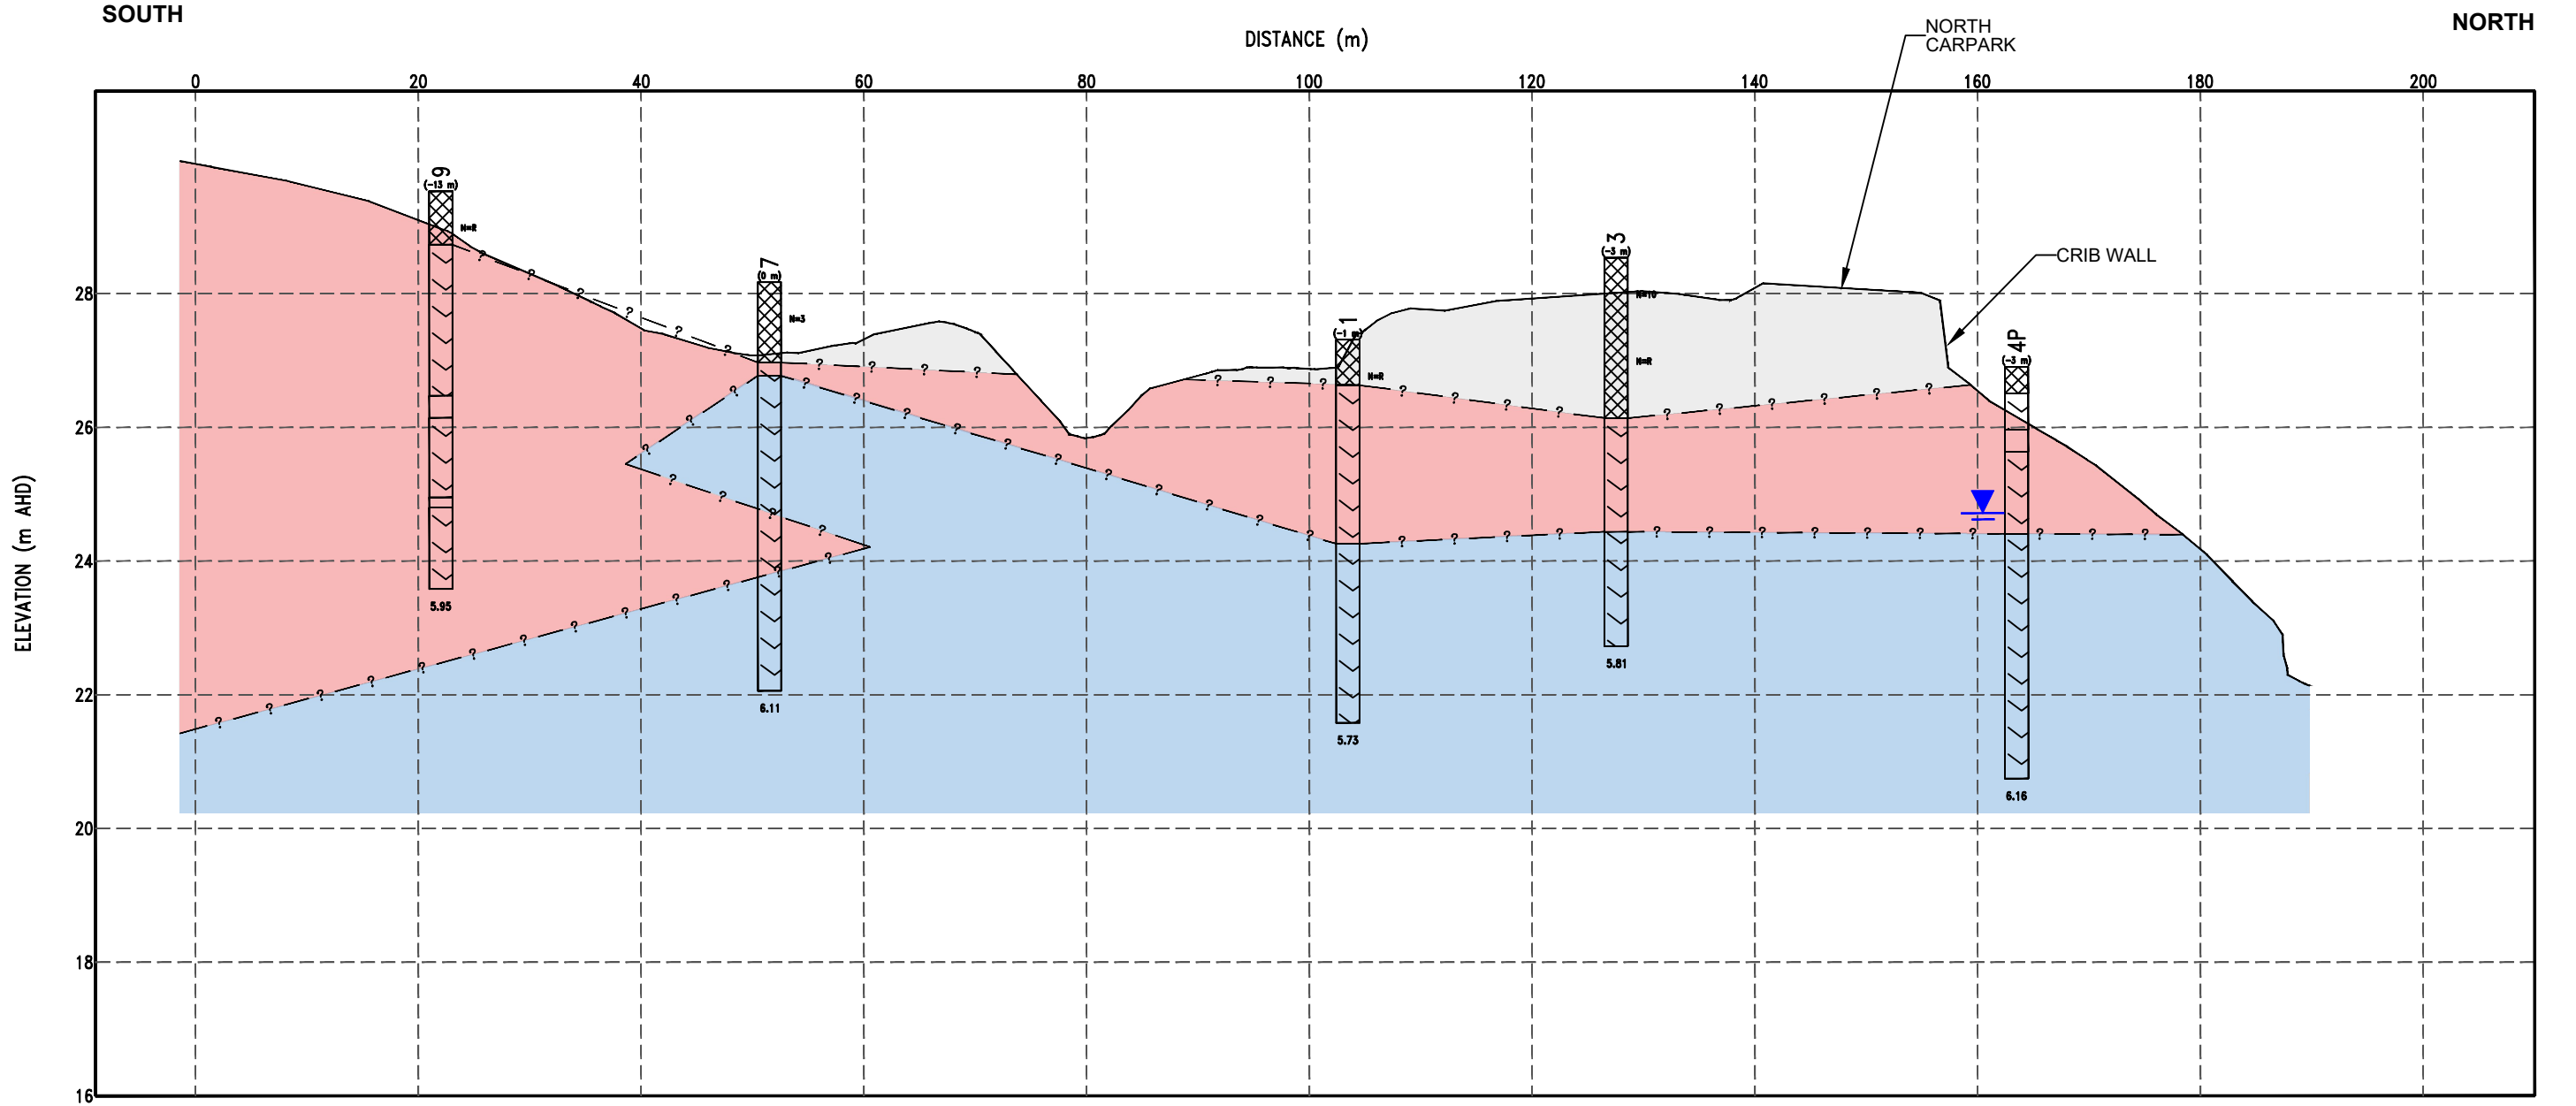
Title: <b>INFERRED GROUND PROFILE</b>		
Section: <b>SECTION B-B</b>		
Location: PORT KEMBLA HOSPITAL, WARRAWONG, NSW		
Report No: 34300LX2	Revision No: 01	Figure No: 04
<b>JKGeotechnics</b>

In boreholes BH-5P, BH-7 and BH-105P there is a more closely fractured and/or weathered section within the Lower Latite unit that has similar properties to the Upper Latite unit, even though it is shown in the cross-sections as being interbedded within the Upper Latite rock unit. In BH-5P it is assumed that the significant core loss between 5m and 6.5m is due to the presence of more closely fractured and/or weathered latite rock between these depths.

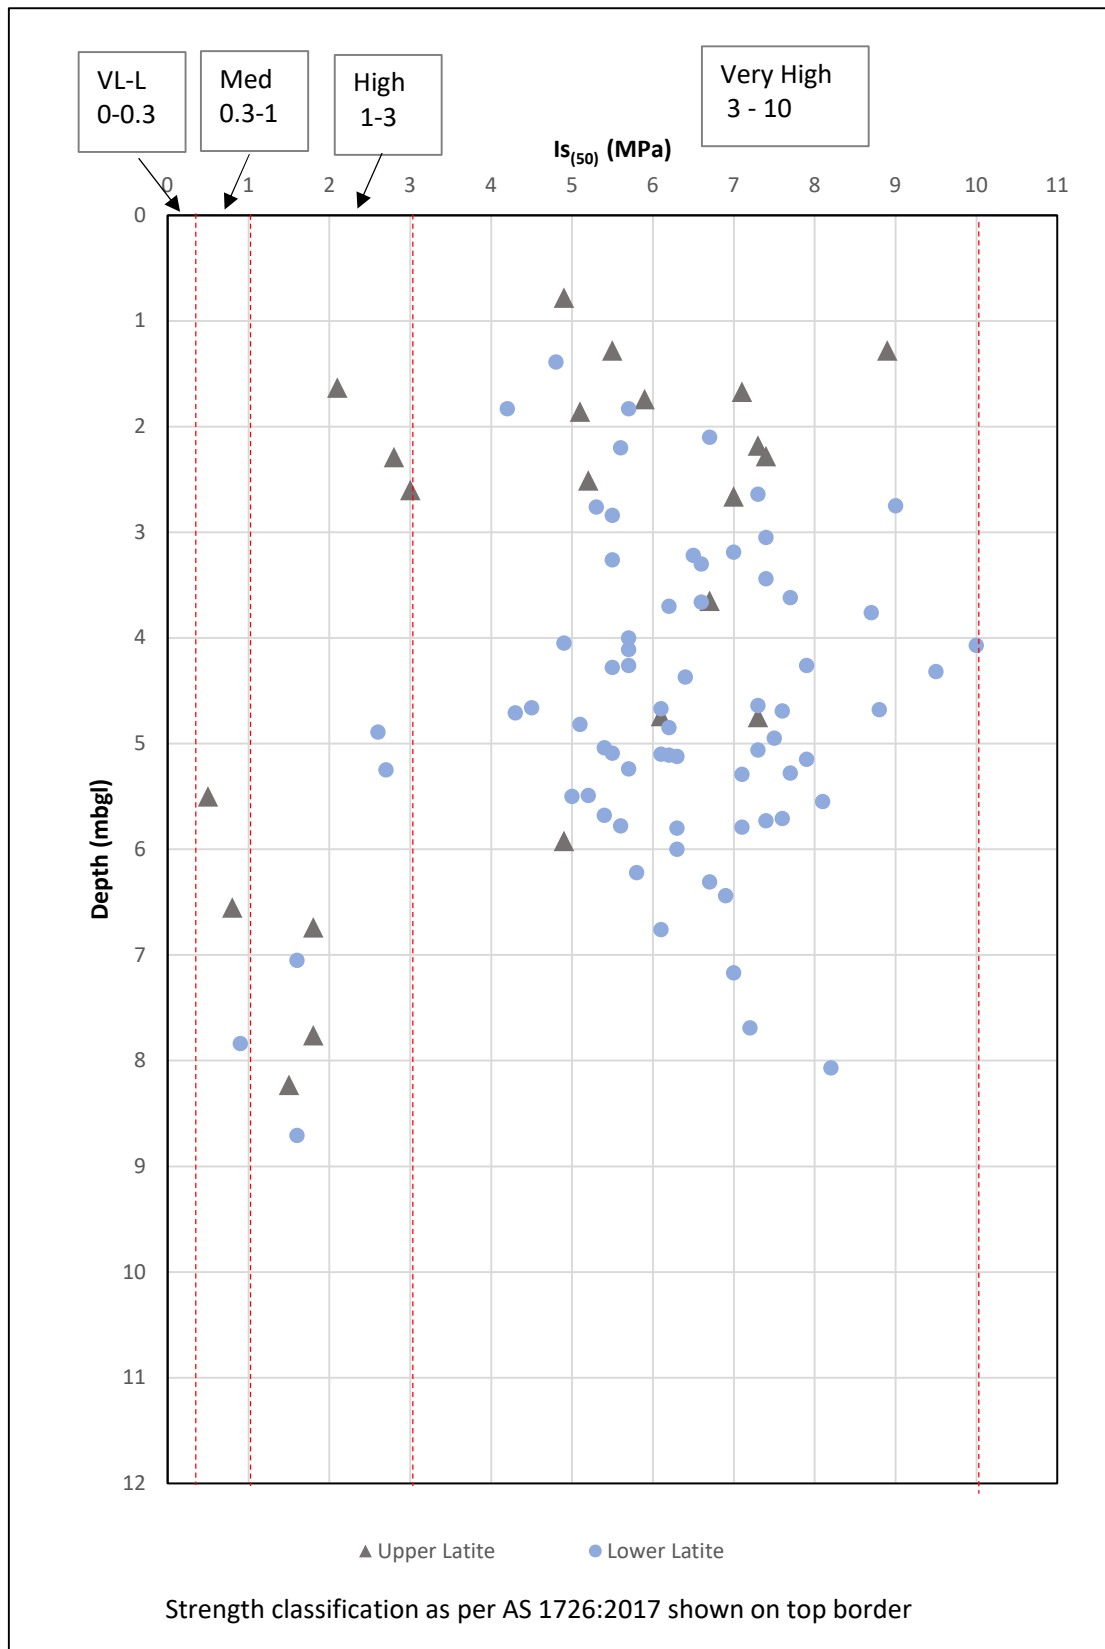
### Point Load Index Results vs Depth (WCHC Site)
