# Soil Characterisation Assessment Report

**5 Kelloway Avenue, Camden NSW 2570**

Prepared for: NSW Land and Housing Corporation

A301022.0319.11 | SCA1.V1F | Date: 06.07.2022

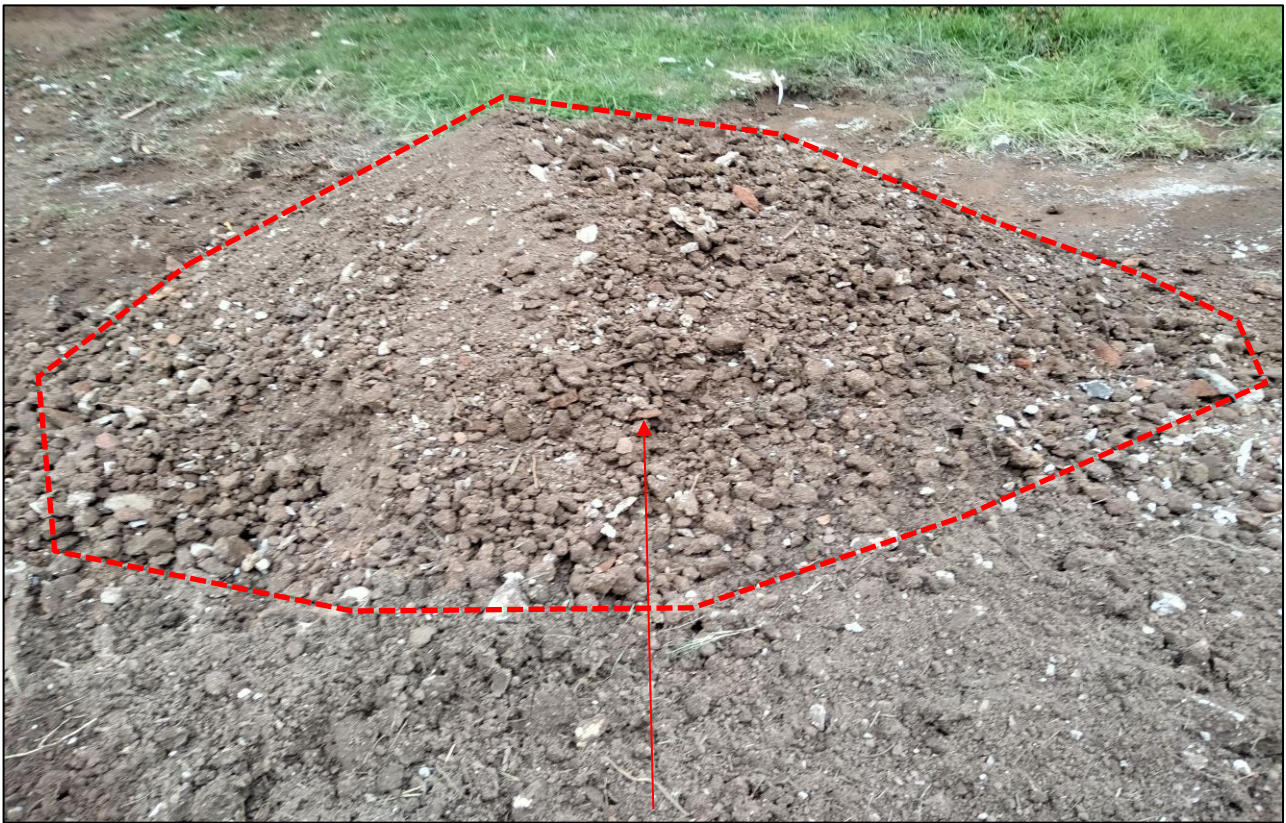
The stockpiled soil materials observed within the subject areas generally consisted of sandy CLAY (CL): medium plasticity, brown, fine to medium grained, moist. No other foreign materials, being Asbestos Containing Materials (ACM), paint chips, sulfidic ores and hydrocarbon odours / staining were observed within the soil materials inspected.

**Photograph 1.** Subject area, stockpiled soil material within residential lot located at 5 Kelloway Avenue, Camden NSW 2570, as observed on the 27.06.2022.

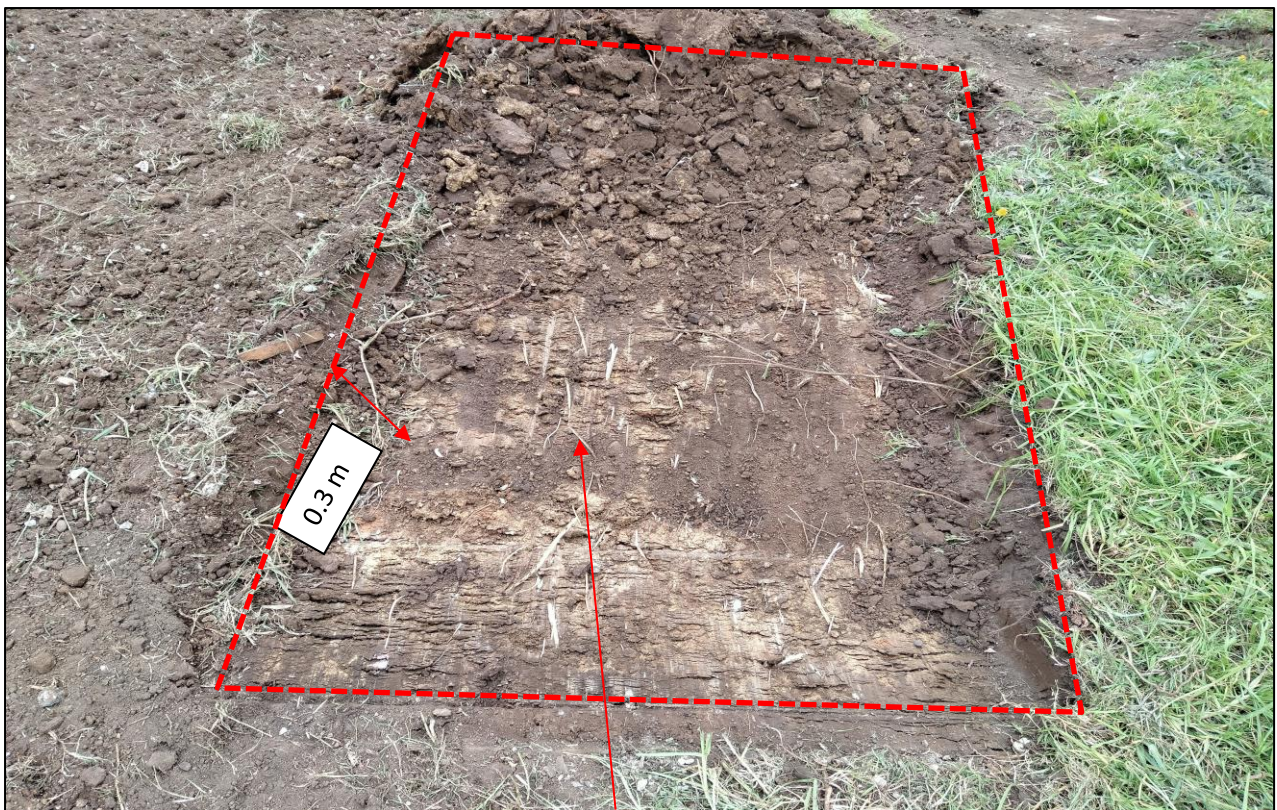
The in-situ soil materials observed within the subject areas generally consisted of sandy CLAY (CL): medium plasticity, brown mottled with red and grey patches, fine to medium grained, moist. No other foreign materials, being Asbestos Containing Materials (ACM), paint chips, sulfidic ores and hydrocarbon odours / staining were observed within the soil materials inspected.

**Photograph 2.** Subject area, in-situ (TP1) soil materials within residential lot located at 5 Kelloway Avenue, Camden NSW 2570, as observed on the 27.06.2022.

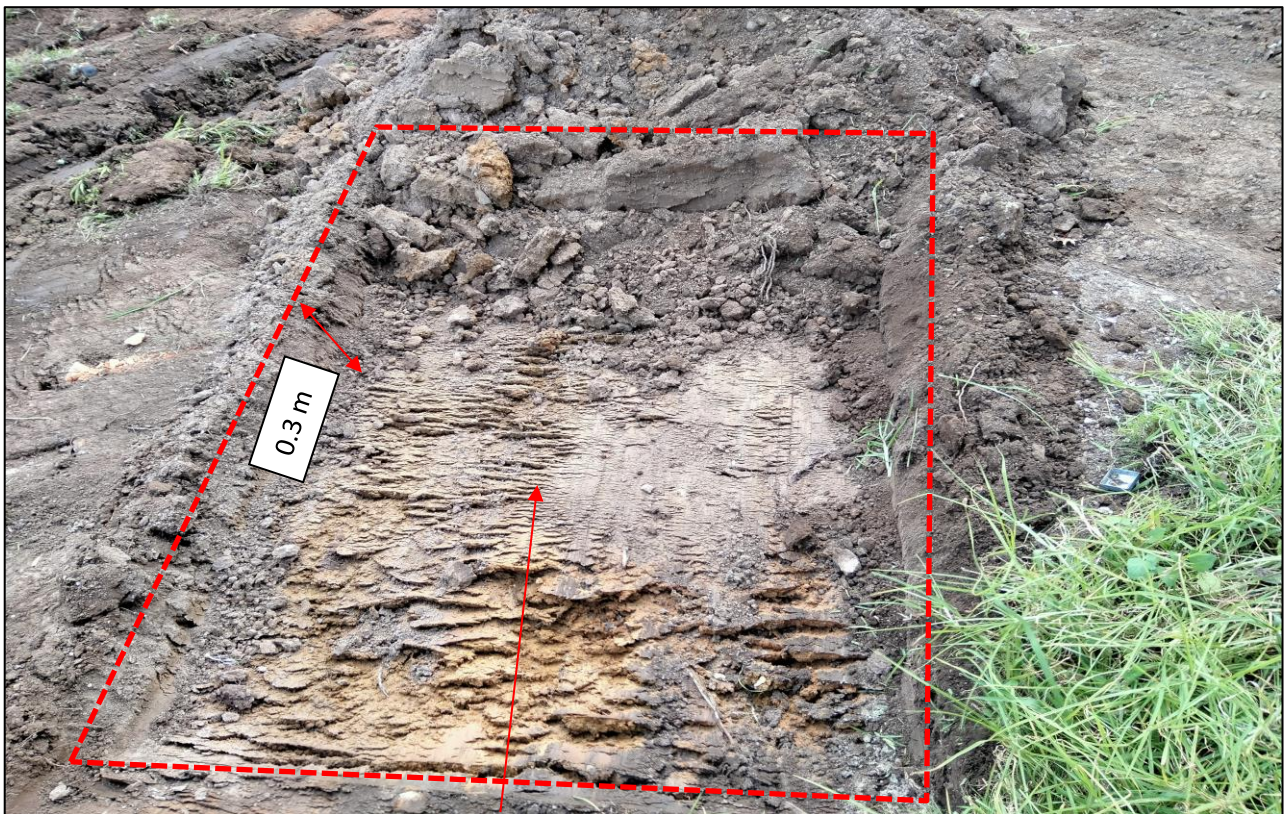
**Photograph 3.** Subject area, in-situ (TP2) soil materials within residential lot located at 5 Kelloway Avenue, Camden NSW 2570, as observed on the 27.06.2022.
