**REPORT NO:** 3230047-1

**PROJECT LOCATION:** Health Infra - Broken Hill Hospital  
BROKEN HILL

**COMMISSION:** Carry out appropriate in-situ soil tests and observations at ten locations as shown on the attached plan, to a depth of up to 6.0 metres.

## LOCATION OF TEST SITES: BROKEN HILL HOSPITAL

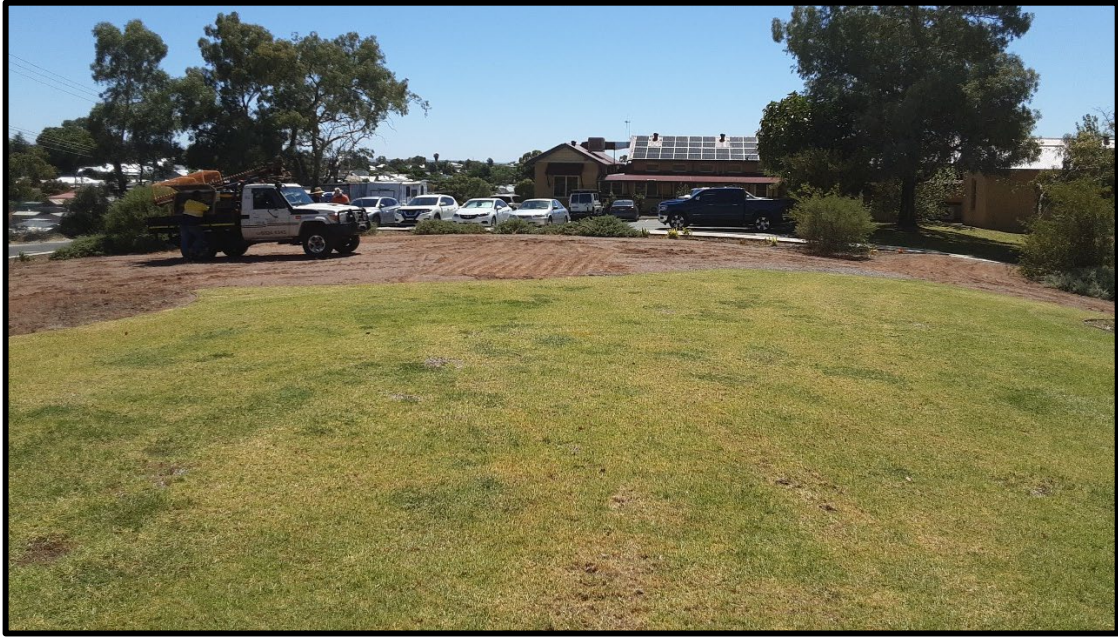
**Photograph 1:** General site condition during field investigation.

The ground surface over the site has a gentle fall to the south and north. The site around the existing double storey structure has been cleared and has remanence of natural grass regrowth. Photograph 1 shows the general site condition during the field investigation.

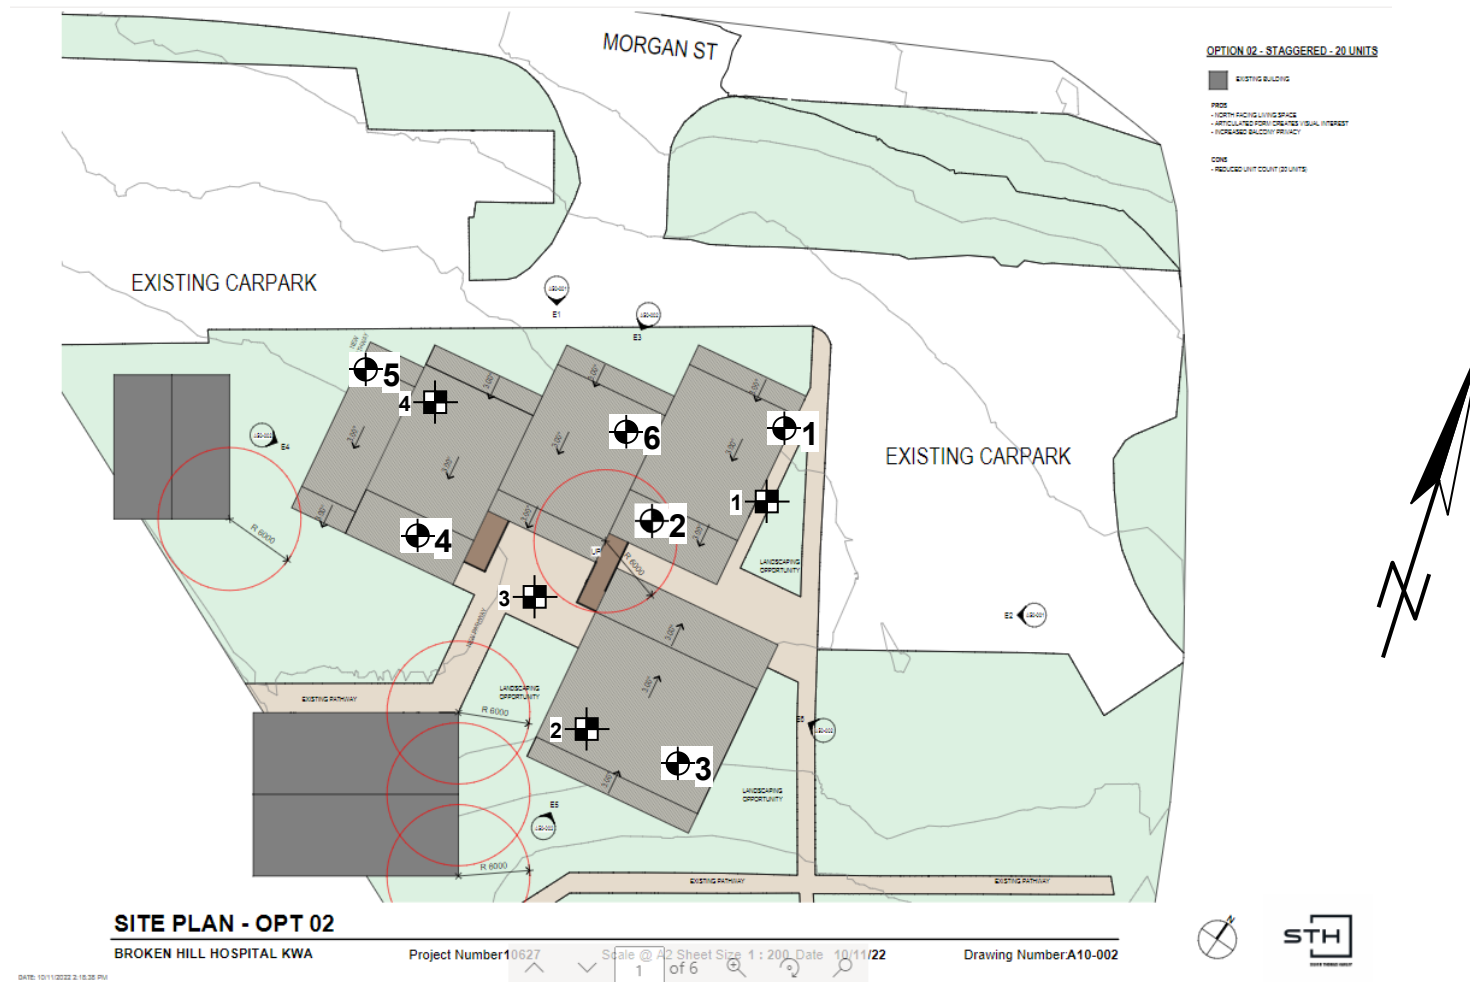
The fieldwork consisted of drilling six boreholes (BHs) up to 4.5 metres depth with a mechanical auger and excavating four test pits to refusal depth of up to 950mm. The approximate locations of the boreholes and test pits are shown on the attached plan. Subsurface materials penetrated were visually classified to AS1726: Geotechnical Site Investigation. The engineering logs of each borehole are attached showing the soil descriptions and depths, along with any cohesive strengths measured and observed densities of non-cohesive soils.

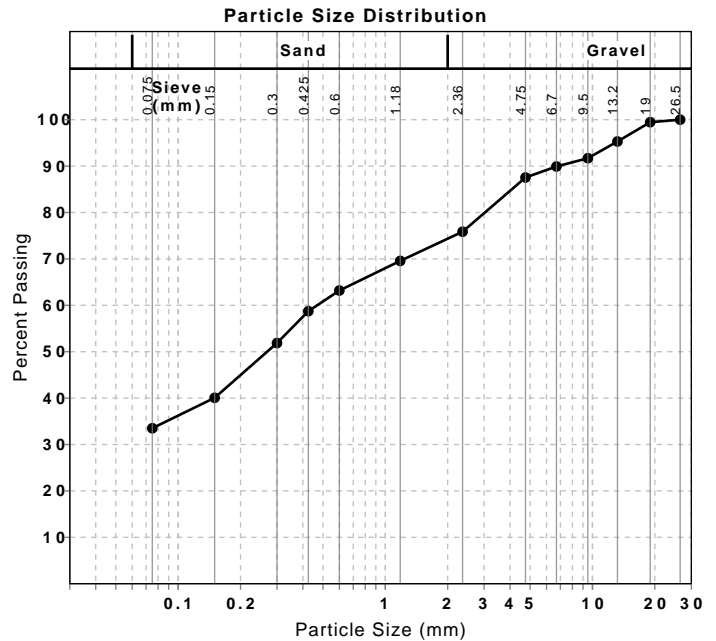
Particle Size Distribution (AS1289 3.6.1)				
Sieve	Passed %	Passing Limits	Retained %	Retained Limits
26.5 mm	100		0	
19 mm	99		1	
13.2 mm	95		4	
9.5 mm	92		4	
6.7 mm	90		2	
4.75 mm	88		2	
2.36 mm	76		12	
1.18 mm	70		6	
0.6 mm	63		6	
0.425 mm	59		4	
0.3 mm	52		7	
0.15 mm	40		12	
0.075 mm	34		7

Atterberg Limit (AS1289 3.1.2 & 3.2.1 & 3.3.1)		Min	Max
Sample History	Oven Dried		
Preparation Method	Dry Sieve		
Liquid Limit (%)	Not Obtainable		
Plastic Limit (%)	Not Obtainable		
Plasticity Index (%)	Non Plastic

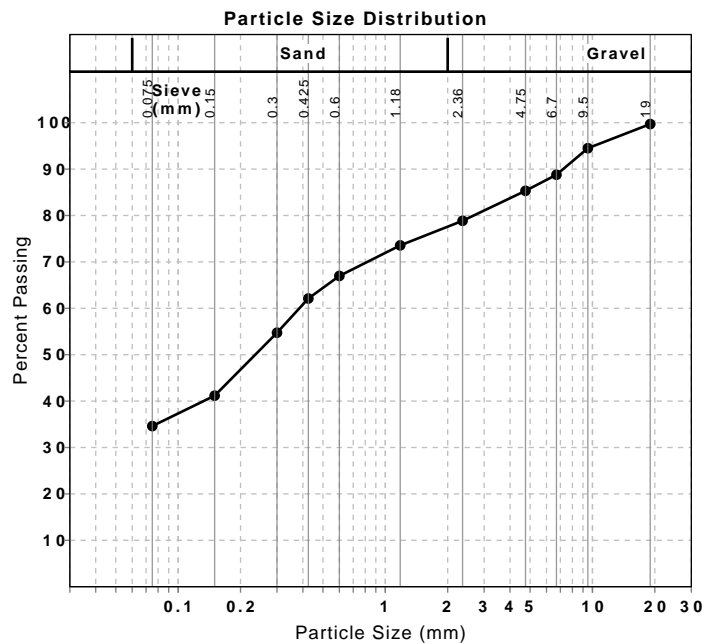
Particle Size Distribution (AS1289 3.6.1)					
Sieve	Passed %	Passing Limits	Retained %	Retained Limits	
19 mm	100		0		
9.5 mm	94		5		
6.7 mm	89		6		
4.75 mm	85		3		
2.36 mm	79		6		
1.18 mm	74		5		
0.6 mm	67		7		
0.425 mm	62		5		
0.3 mm	55		7		
0.15 mm	41		14		
0.075 mm	35		7

Atterberg Limit (AS1289 3.1.2 & 3.2.1 & 3.3.1)			Min	Max
Sample History	Oven Dried			
Preparation Method	Dry Sieve			
Liquid Limit (%)	22			
Plastic Limit (%)	15			
Plasticity Index (%)	7

Linear Shrinkage (AS1289 3.4.1)		Min	Max
Moisture Condition Determined By	AS 1289.3.1.2		
Linear Shrinkage (%)	4.0		
Cracking Crumbling Curling	Cracking

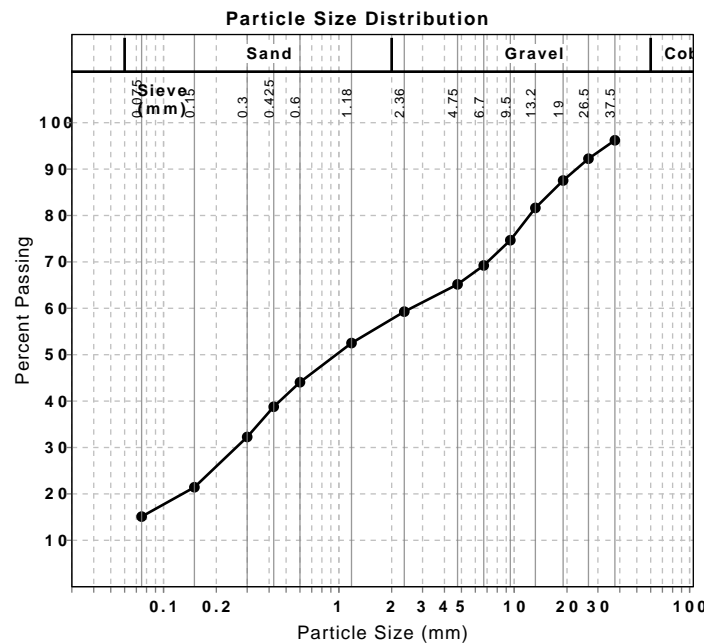
Particle Size Distribution (AS1289 3.6.1)				
Sieve	Passed %	Passing Limits	Retained %	Retained Limits
37.5 mm	96		4	
26.5 mm	92		4	
19 mm	88		5	
13.2 mm	82		6	
9.5 mm	75		7	
6.7 mm	69		5	
4.75 mm	65		4	
2.36 mm	59		6	
1.18 mm	53		7	
0.6 mm	44		8	
0.425 mm	39		5	
0.3 mm	32		7	
0.15 mm	21		11	
0.075 mm	15		6

Atterberg Limit (AS1289 3.1.2 & 3.2.1 & 3.3.1)		Min	Max
Sample History	Oven Dried		
Preparation Method	Dry Sieve		
Liquid Limit (%)	Not Obtainable		
Plastic Limit (%)	Not Obtainable		
Plasticity Index (%)	Non Plastic

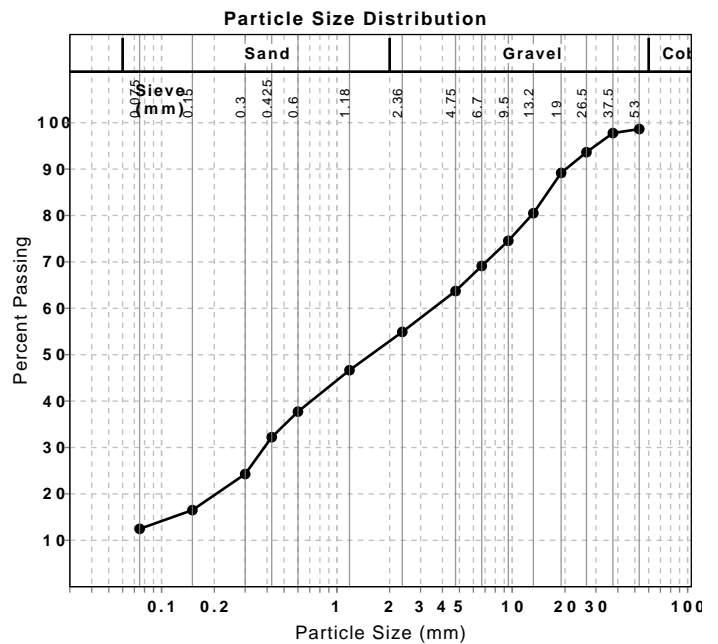
Particle Size Distribution (AS1289 3.6.1)				
Sieve	Passed %	Passing Limits	Retained %	Retained Limits
53 mm	99		1	
37.5 mm	98		1	
26.5 mm	94		4	
19 mm	89		4	
13.2 mm	80		9	
9.5 mm	75		6	
6.7 mm	69		5	
4.75 mm	64		5	
2.36 mm	55		9	
1.18 mm	47		8	
0.6 mm	38		9	
0.425 mm	32		6	
0.3 mm	24		8	
0.15 mm	17		8	
0.075 mm	12		4

Atterberg Limit (AS1289 3.1.2 & 3.2.1 & 3.3.1)		Min	Max
Sample History	Oven Dried		
Preparation Method	Dry Sieve		
Liquid Limit (%)	Not Obtainable		
Plastic Limit (%)	Not Obtainable		
Plasticity Index (%)	Non Plastic

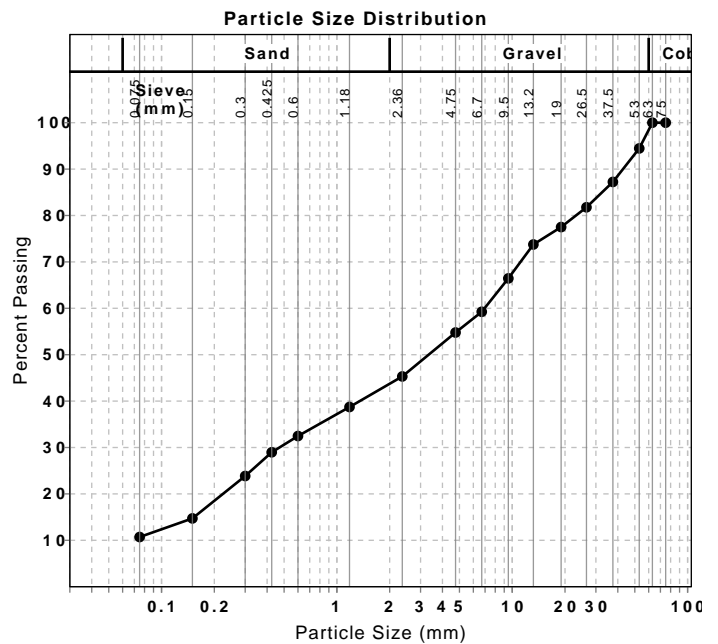
Particle Size Distribution (AS1289 3.6.1)				
Sieve	Passed %	Passing Limits	Retained %	Retained Limits
75 mm	100		0	
63 mm	100		0	
53 mm	94		6	
37.5 mm	87		7	
26.5 mm	82		5	
19 mm	78		4	
13.2 mm	74		4	
9.5 mm	66		7	
6.7 mm	59		7	
4.75 mm	55		4	
2.36 mm	45		9	
1.18 mm	39		7	
0.6 mm	32		6	
0.425 mm	29		3	
0.3 mm	24		5	
0.15 mm	15		9	
0.075 mm	11		4

Atterberg Limit (AS1289 3.1.2 & 3.2.1 & 3.3.1)		Min	Max
Sample History	Oven Dried		
Preparation Method	Wet Sieve		
Liquid Limit (%)	Not Obtainable		
Plastic Limit (%)	Not Obtainable		
Plasticity Index (%)	Non Plastic

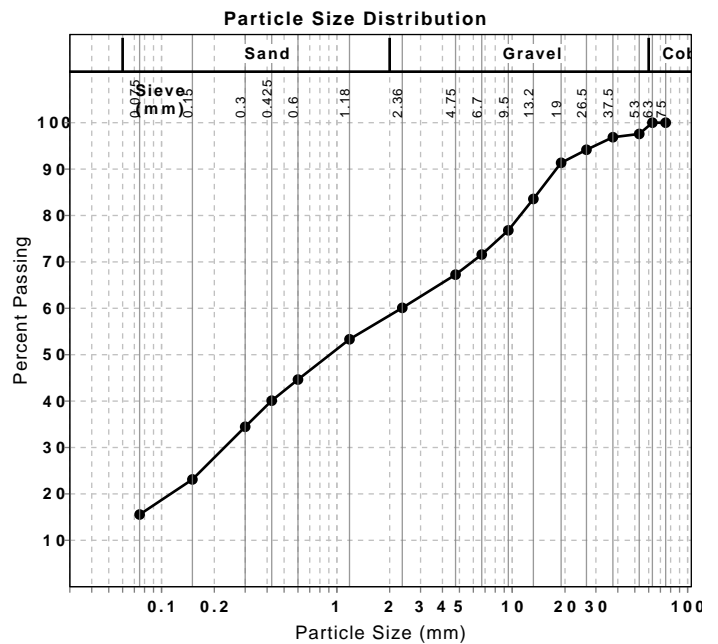
Particle Size Distribution (AS1289 3.6.1)				
Sieve	Passed %	Passing Limits	Retained %	Retained Limits
75 mm	100		0	
63 mm	100		0	
53 mm	98		2	
37.5 mm	97		1	
26.5 mm	94		3	
19 mm	91		3	
13.2 mm	84		8	
9.5 mm	77		7	
6.7 mm	72		5	
4.75 mm	67		4	
2.36 mm	60		7	
1.18 mm	53		7	
0.6 mm	45		9	
0.425 mm	40		5	
0.3 mm	34		6	
0.15 mm	23		11	
0.075 mm	16		8

Atterberg Limit (AS1289 3.1.2 & 3.2.1 & 3.3.1)		Min	Max
Sample History	Oven Dried		
Preparation Method	Dry Sieve		
Liquid Limit (%)	Not Obtainable		
Plastic Limit (%)	Not Obtainable		
Plasticity Index (%)	Non Plastic
