Remedial Action Plan (RAP)

Broken Hill Key Worker Accommodation (KWA)

Key Worker Accommodation Program, Broken Hill, NSW

JBS&G 66655 | 158125

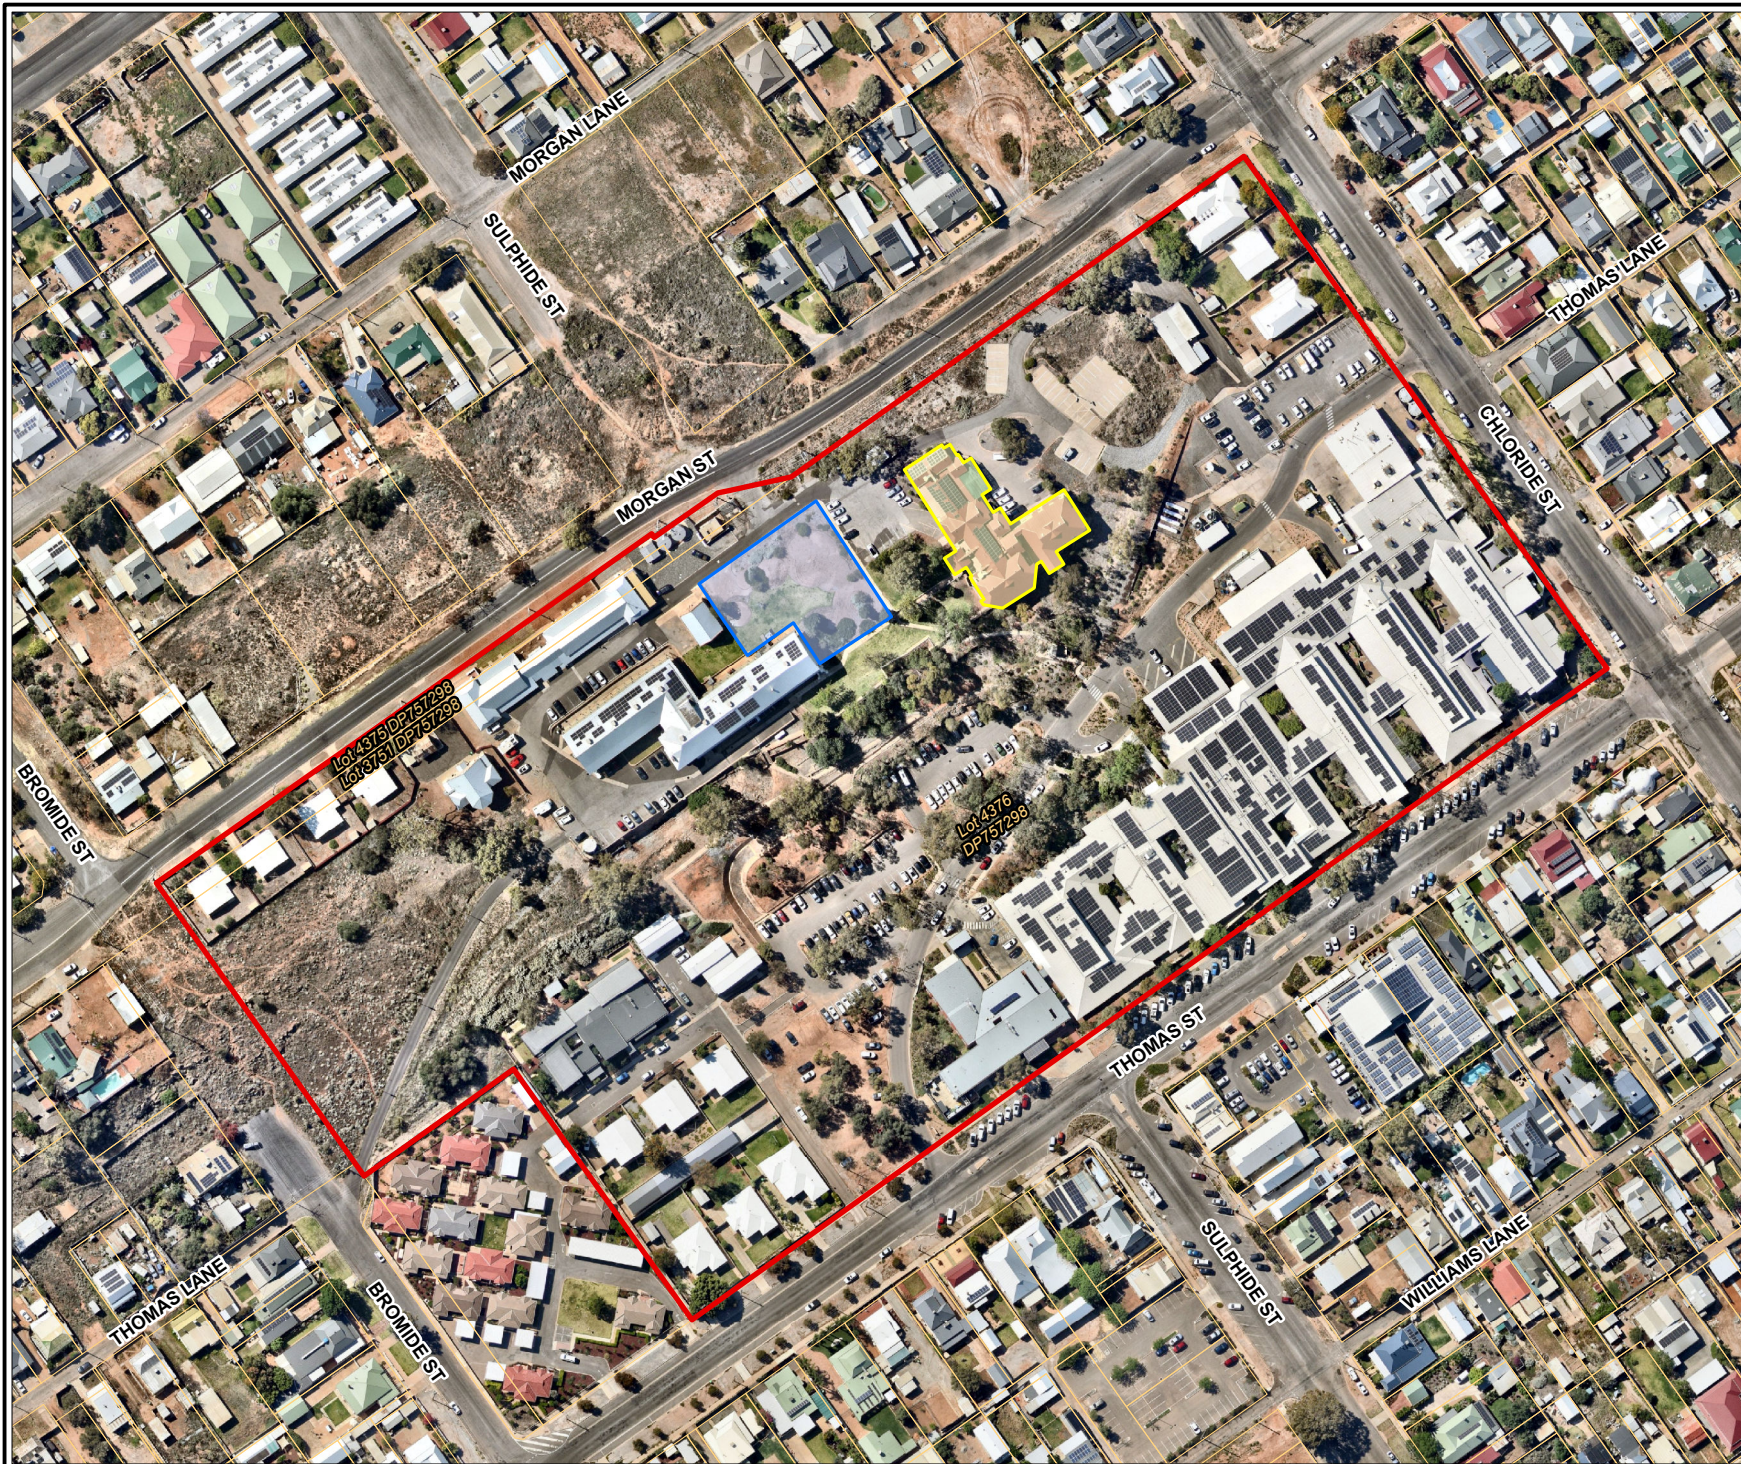
FIGURE 2

SITE LAYOUT

It is noted that Kincumber House is external to the subject site, in the central northern portion of the hospital boundary (**Figures 2 and 3**).

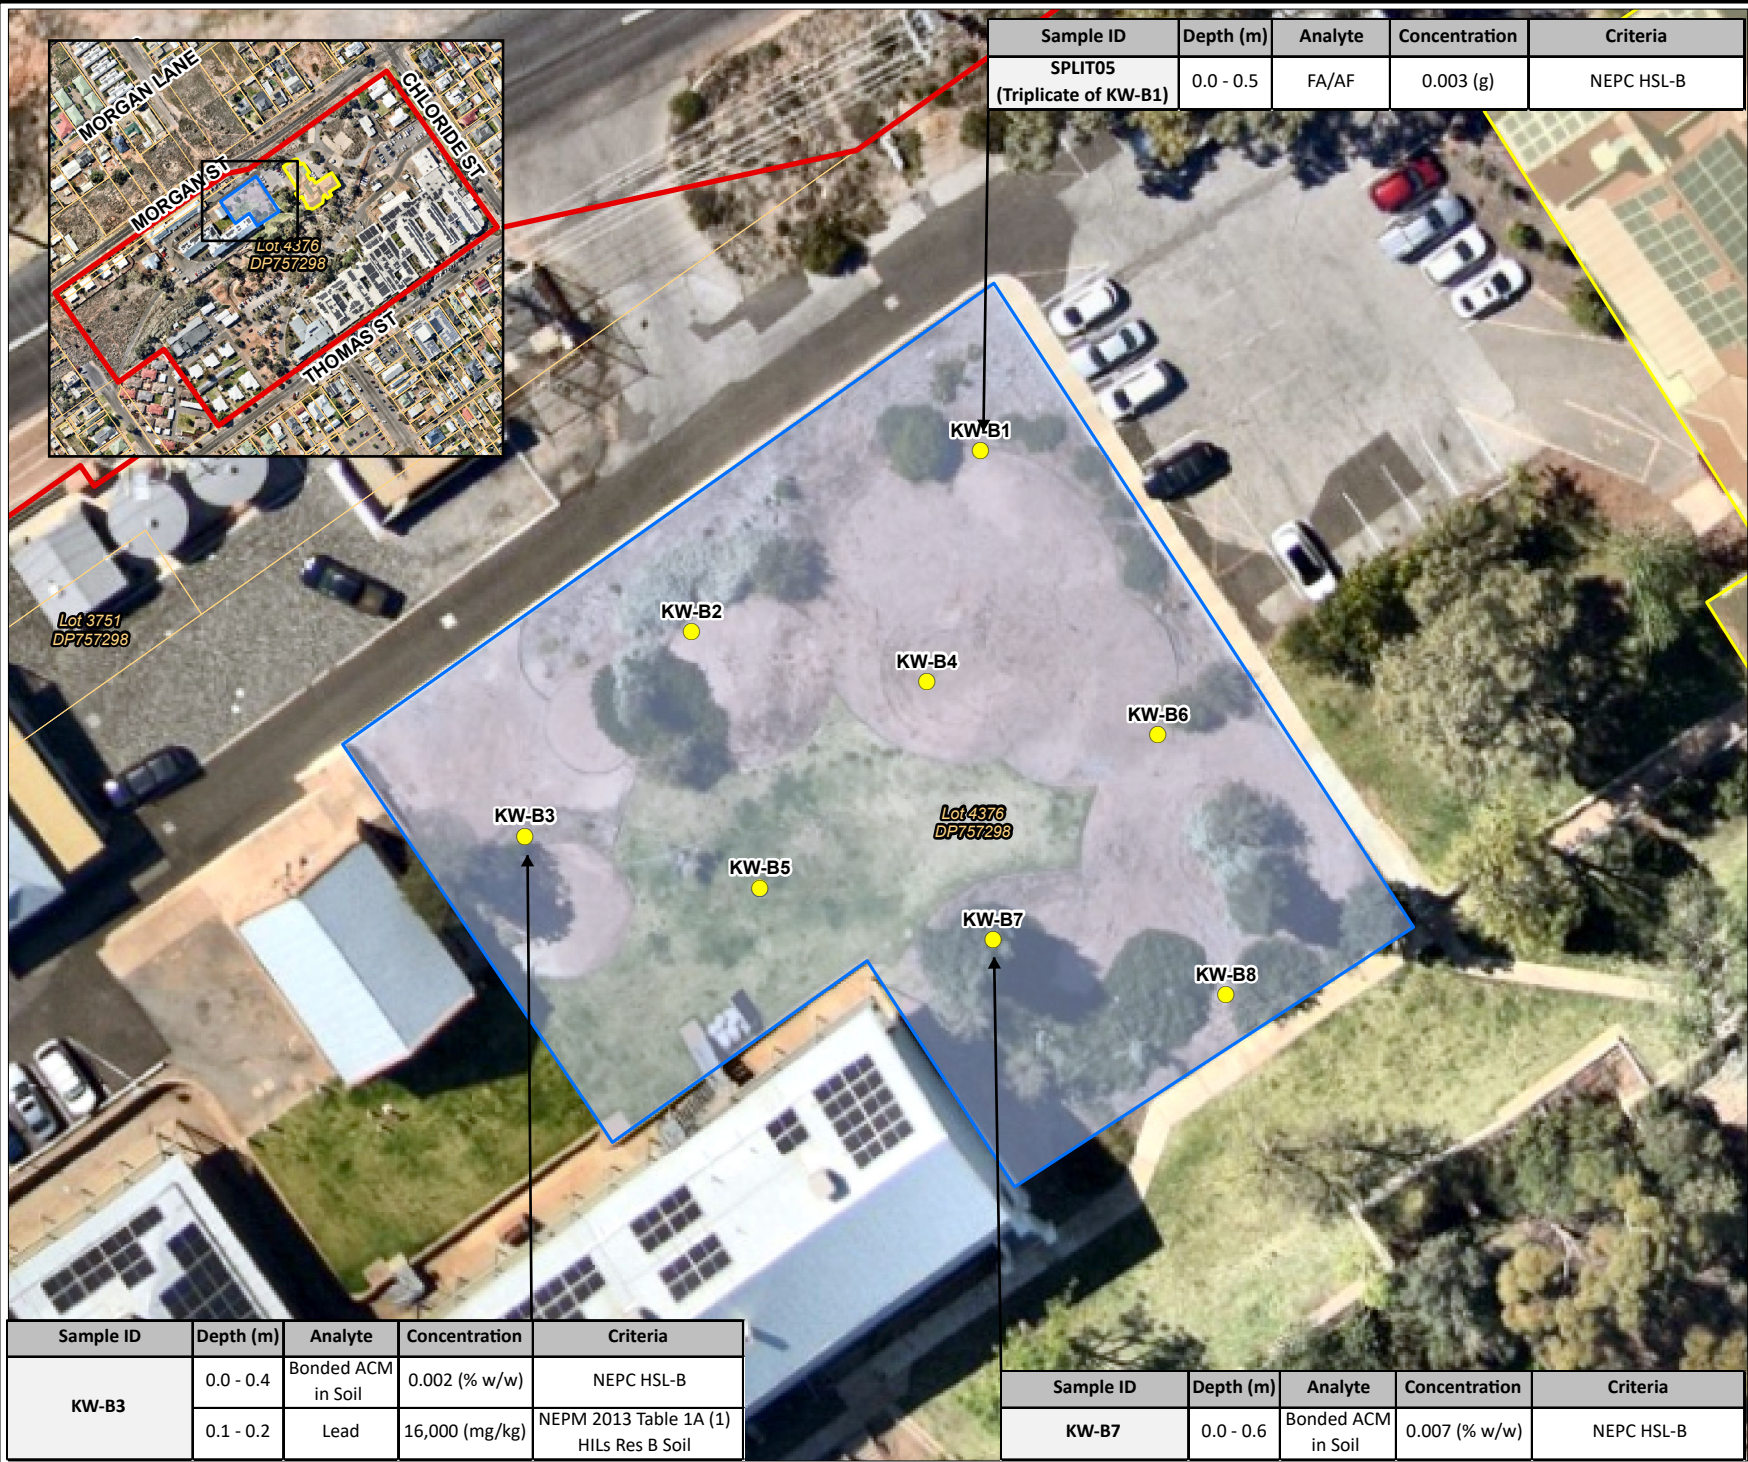
FIGURE 3

- Approximate Site Boundary
- NSW Cadastre
- Kincumber House
- KWA Proposed Location
- Sample Locations (JBS&G, 2023)

SAMPLE LOCATIONS AND EXCEEDANCES

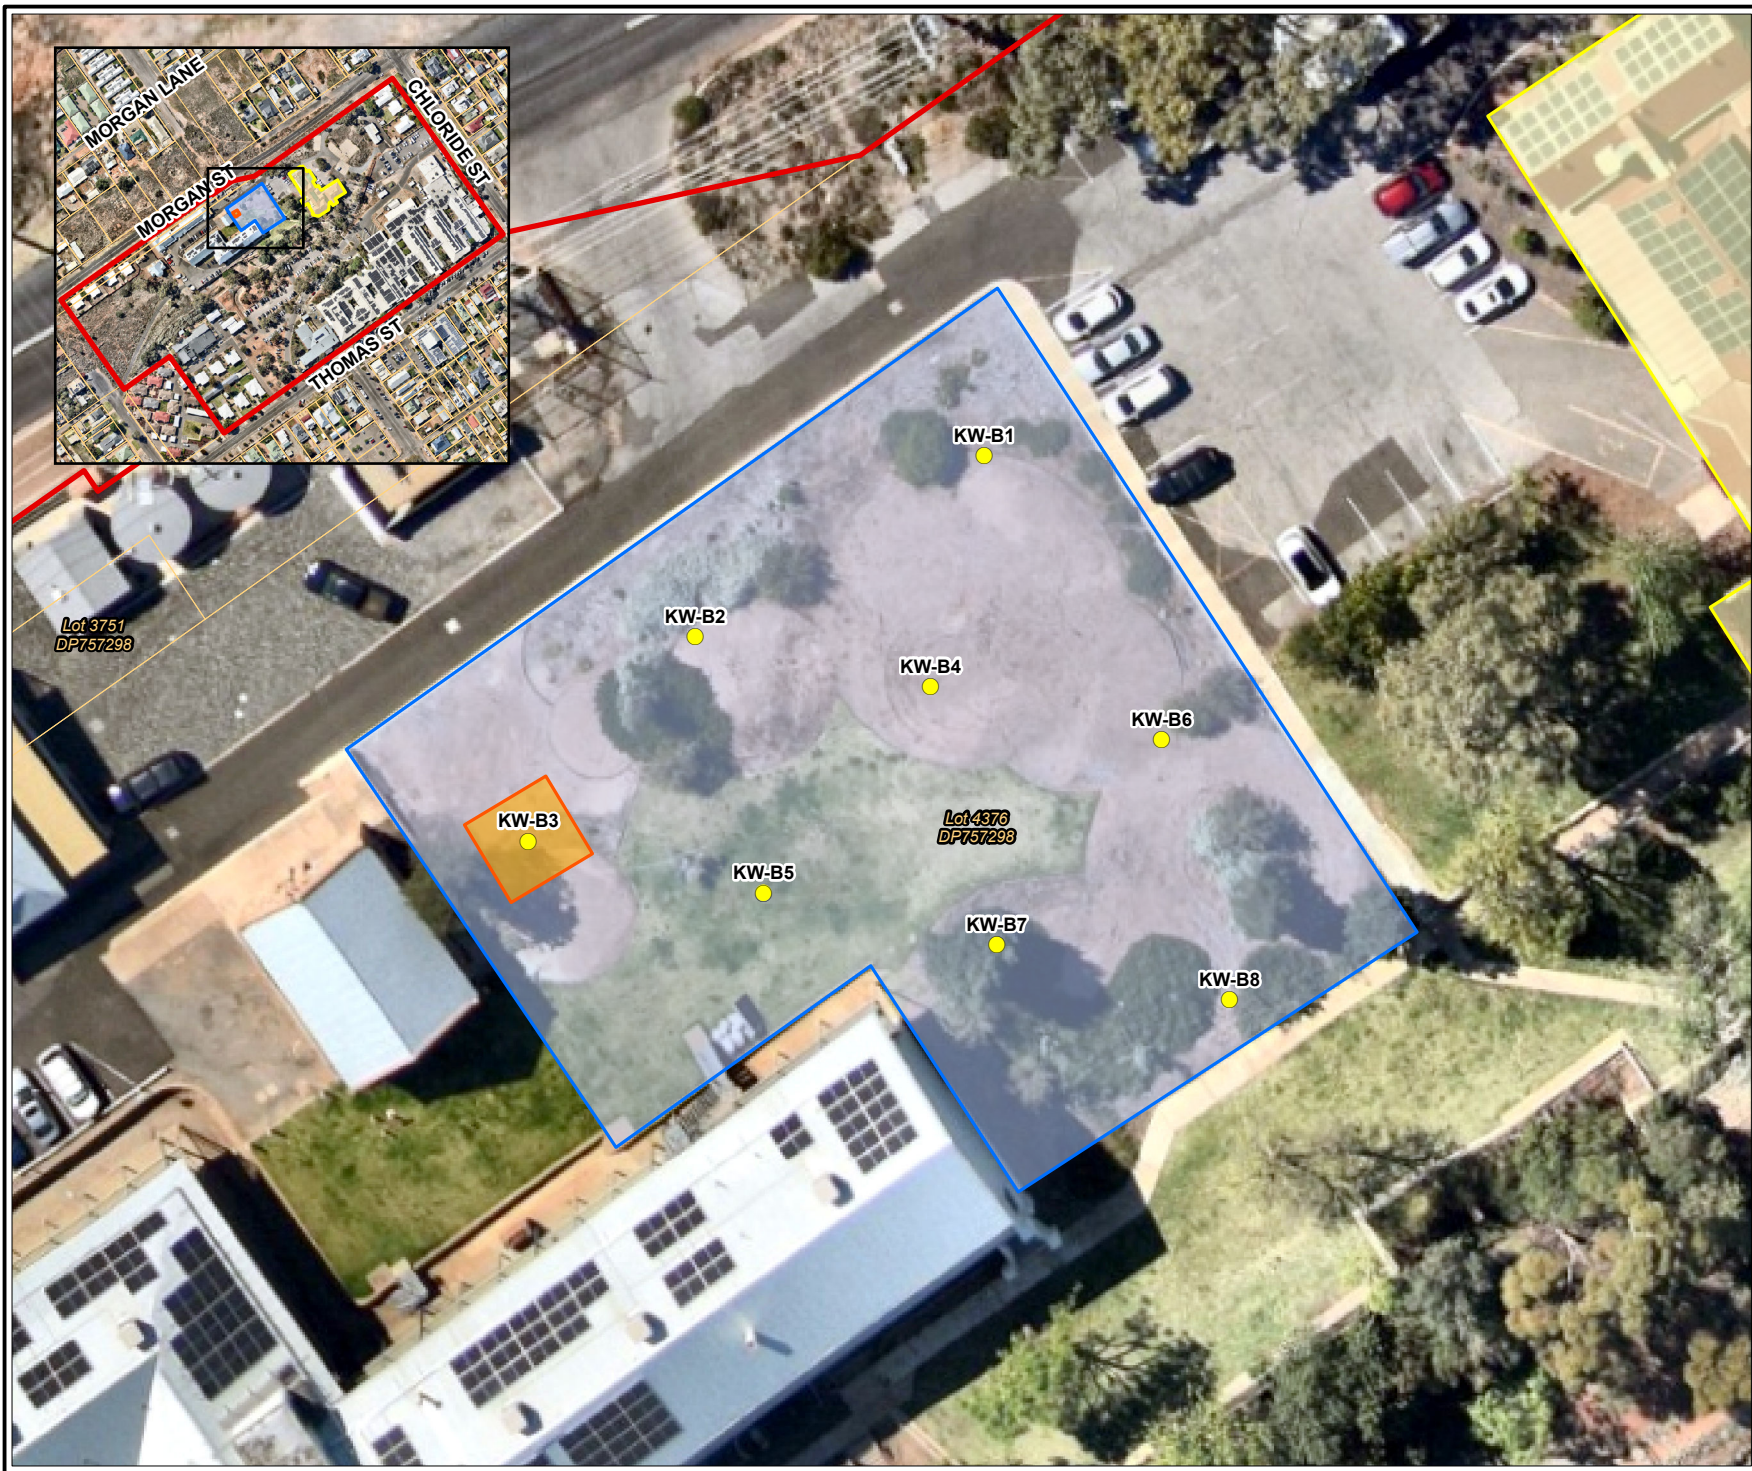
- Approximate Site Boundary
- NSW Cadastre
- KWA Proposed Location
- Kincumber House
- Remedial Extent
- Sample Locations (JBS&G, 2023)

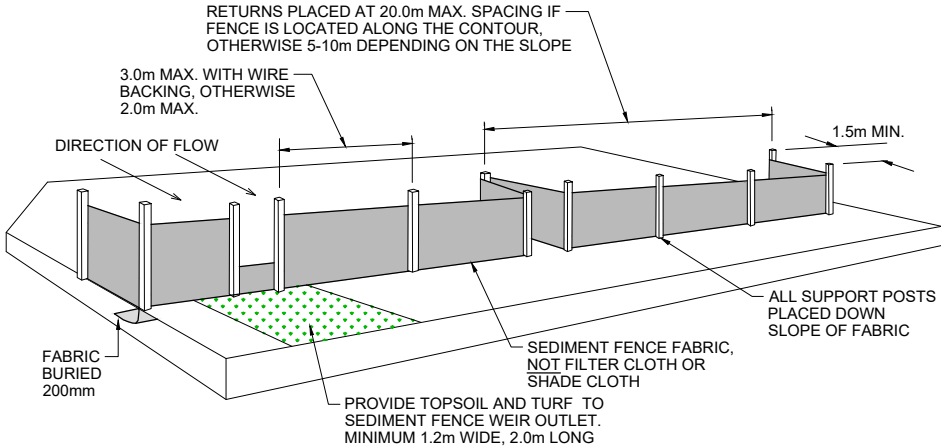
INSTALLATION OF SEDIMENT FENCE
NOT TO SCALE

1. FILTER CLOTH TO BE FASTENED SECURELY TO POSTS WITH GALVANISED WIRE TIES, STAPLES OR ATTACHMENT BELTS.
2. POSTS SHOULD NOT BE SPACED MORE THAN 2.0m APART.
3. WHEN TWO SECTIONS OF FILTER CLOTH ADJOIN EACH OTHER THEY SHALL BE OVERLAPPED BY 150mm AND FOLDED.
4. FOR EXTRA STRENGTH TO SILT FENCE, WOVEN WIRE (14mm GAUGE, 150mm MESH SPACING) TO BE FASTENED SECURELY BETWEEN FILTER CLOTH AND POSTS BY WIRE TIES OR STAPLES
5. INSPECTIONS SHALL BE PROVIDED ON A REGULAR BASIS, ESPECIALLY AFTER RAINFALL AND EXCESSIVE SILT DEPOSITS REMOVED WHEN "BULGES" DEVELOP IN SILT FENCE
6. SEDIMENT FENCES SHALL BE CONSTRUCTED WITH SEDIMENT TRAPS AND EMERGENCY SPILLWAYS AT SPACINGS NO GREATER THAN 40m ON FLAT TERRAIN DECREASING TO 20m SPACINGS ON STEEP TERRAIN.

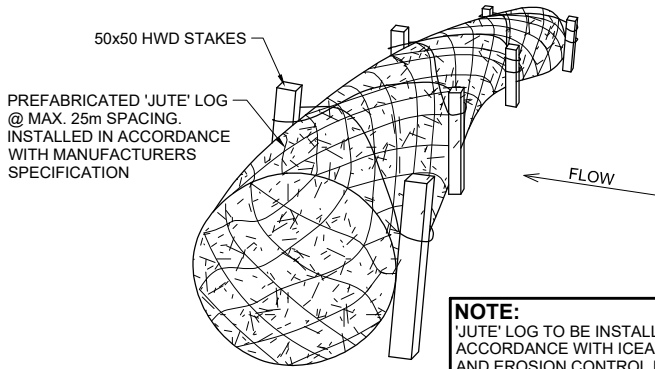
NOTE:
'JUTE' LOG TO BE INSTALLED IN ACCORDANCE WITH ICEA SEDIMENT AND EROSION CONTROL DESIGN FACT SHEET - IN-STREAM PRACTICES

ANCHORAGE OF 'JUTE' LOG

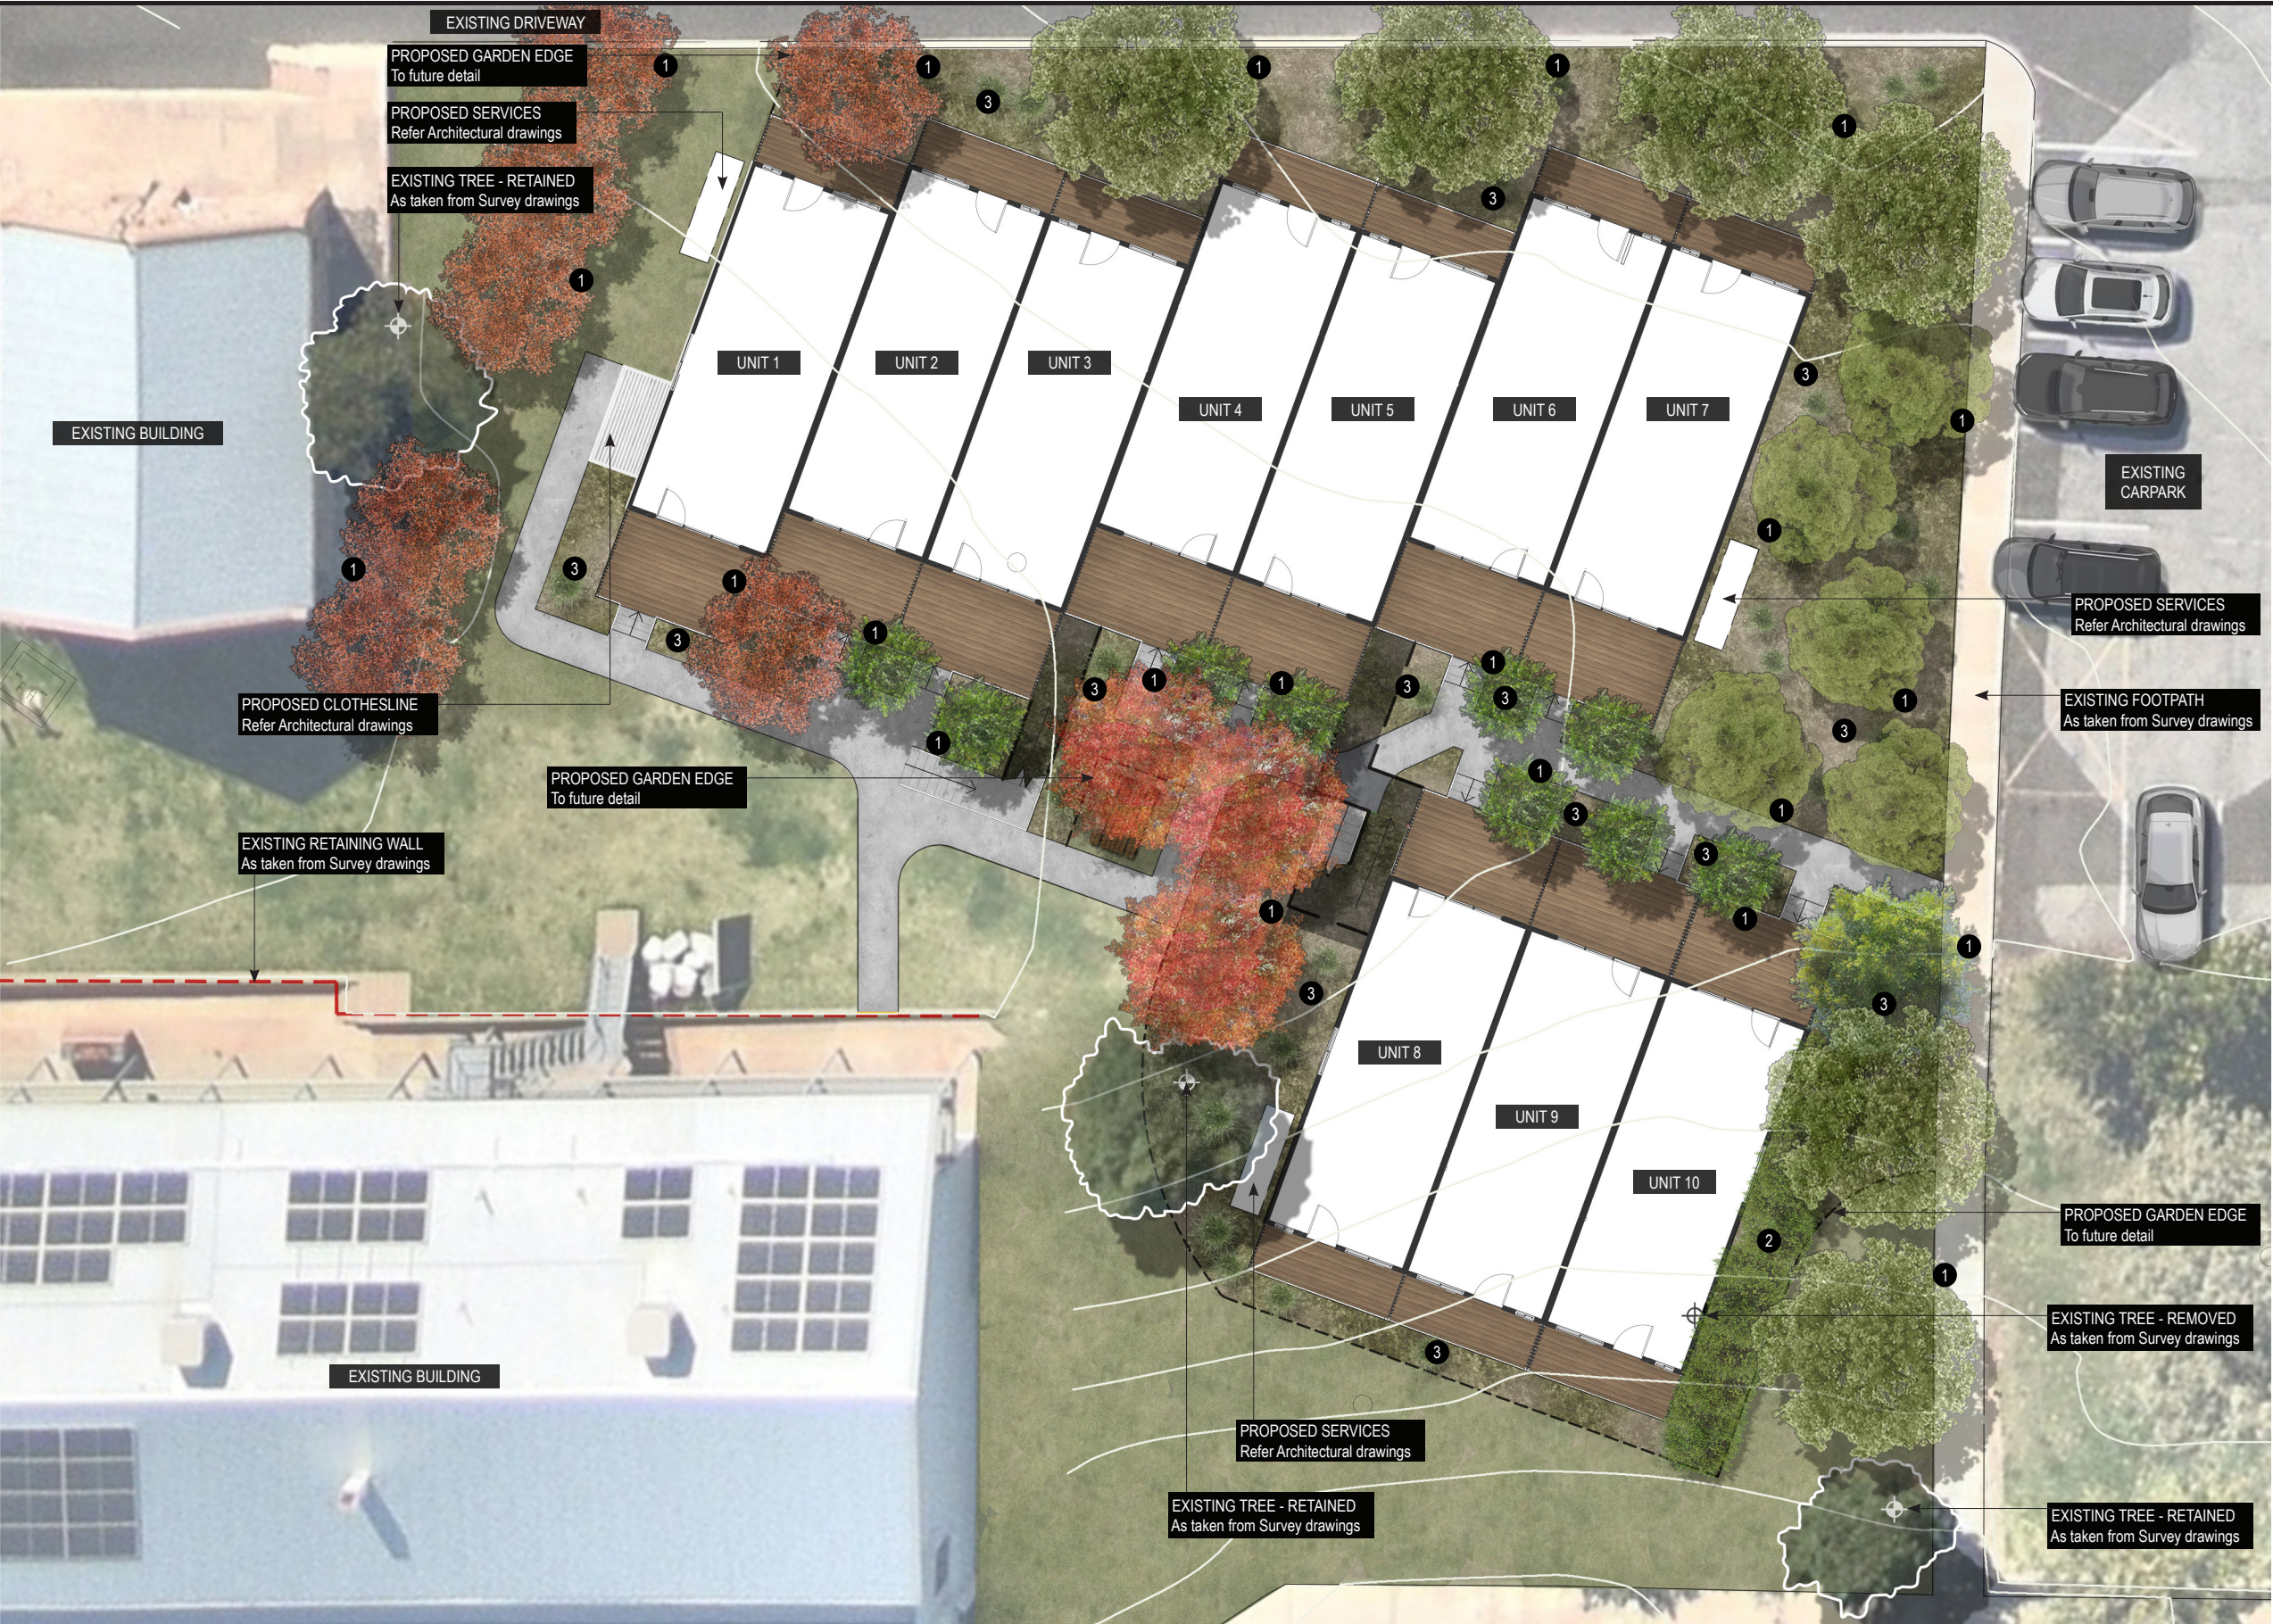
P1

LANDSCAPE CONCEPT PLAN

- 1 SHADE / SCREEN TREES**
Tree species to provide visual and climatic amenity and landscape softening of the proposed building; Refer Proposed Planting Schedule
(ie: *Brachychiton populneus*, *Brachychiton rupestris*, *Malus tschonoskii*, *Pyrus calleryana* Capital, *Pistacia chinensis*, *Tristanopsis laurina*)
- 2 SCREEN PLANTING**
Dense planting to boundaries so as to provide visual amenity and privacy screening to neighbouring properties; Refer Proposed Planting Schedule
- 3 SHRUBS AND GROUNDCOVERS**
Mass planting to large areas to assist in building presentation to the streetscape and to provide visual amenity; Refer Proposed Planting Schedule

- PROPOSED GARDEN EDGE
To future detail
- - - EXISTING RETAINING WALL
As taken from Survey drawings
- PROPOSED TURF
To future detail
- EXISTING GRASSED AREAS
Retain and protect during construction
Make good any damage. To future detail
- EXISTING TREE - RETAINED
As taken from Survey drawings
- EXISTING TREE - REMOVED
As taken from Survey drawings

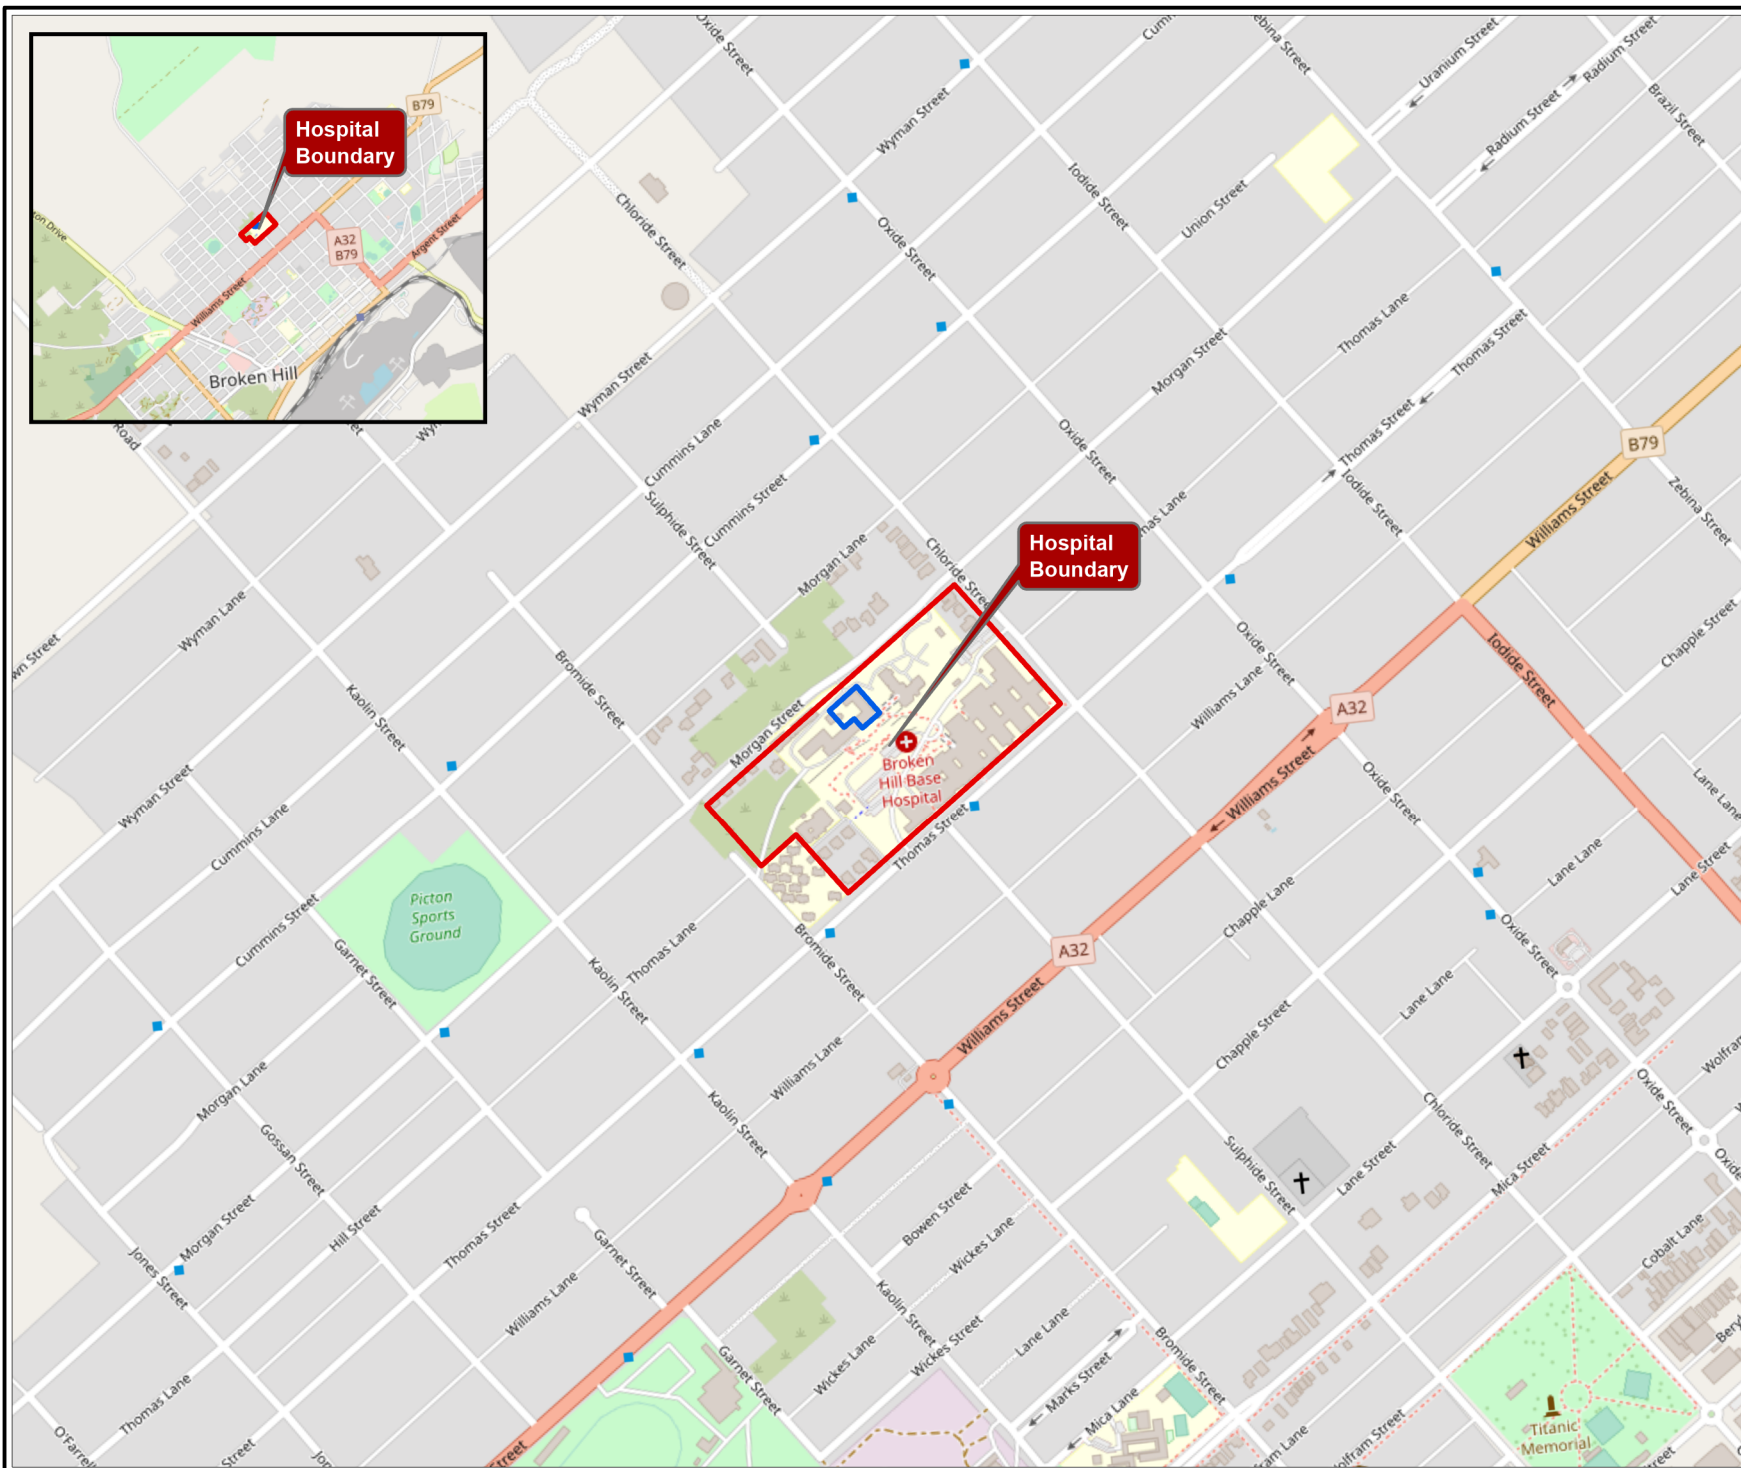
FIGURE 1

Legend:
 [Red Outline] Broken Hill Hospital Boundary
 [Blue Outline] Broken Hill Hospital Redevelopment

SITE LOCATION
