**REPORT TO
NSW HEALTH INFRASTRUCTURE**

**ON
REMEDIATION ACTION PLAN**

**FOR
PROPOSED MPS STAGE 5 DEVELOPMENT**

**AT
BLAYNEY DISTRICT HOSPITAL, 3 OSMAN STREET,
BLAYNEY, NSW**

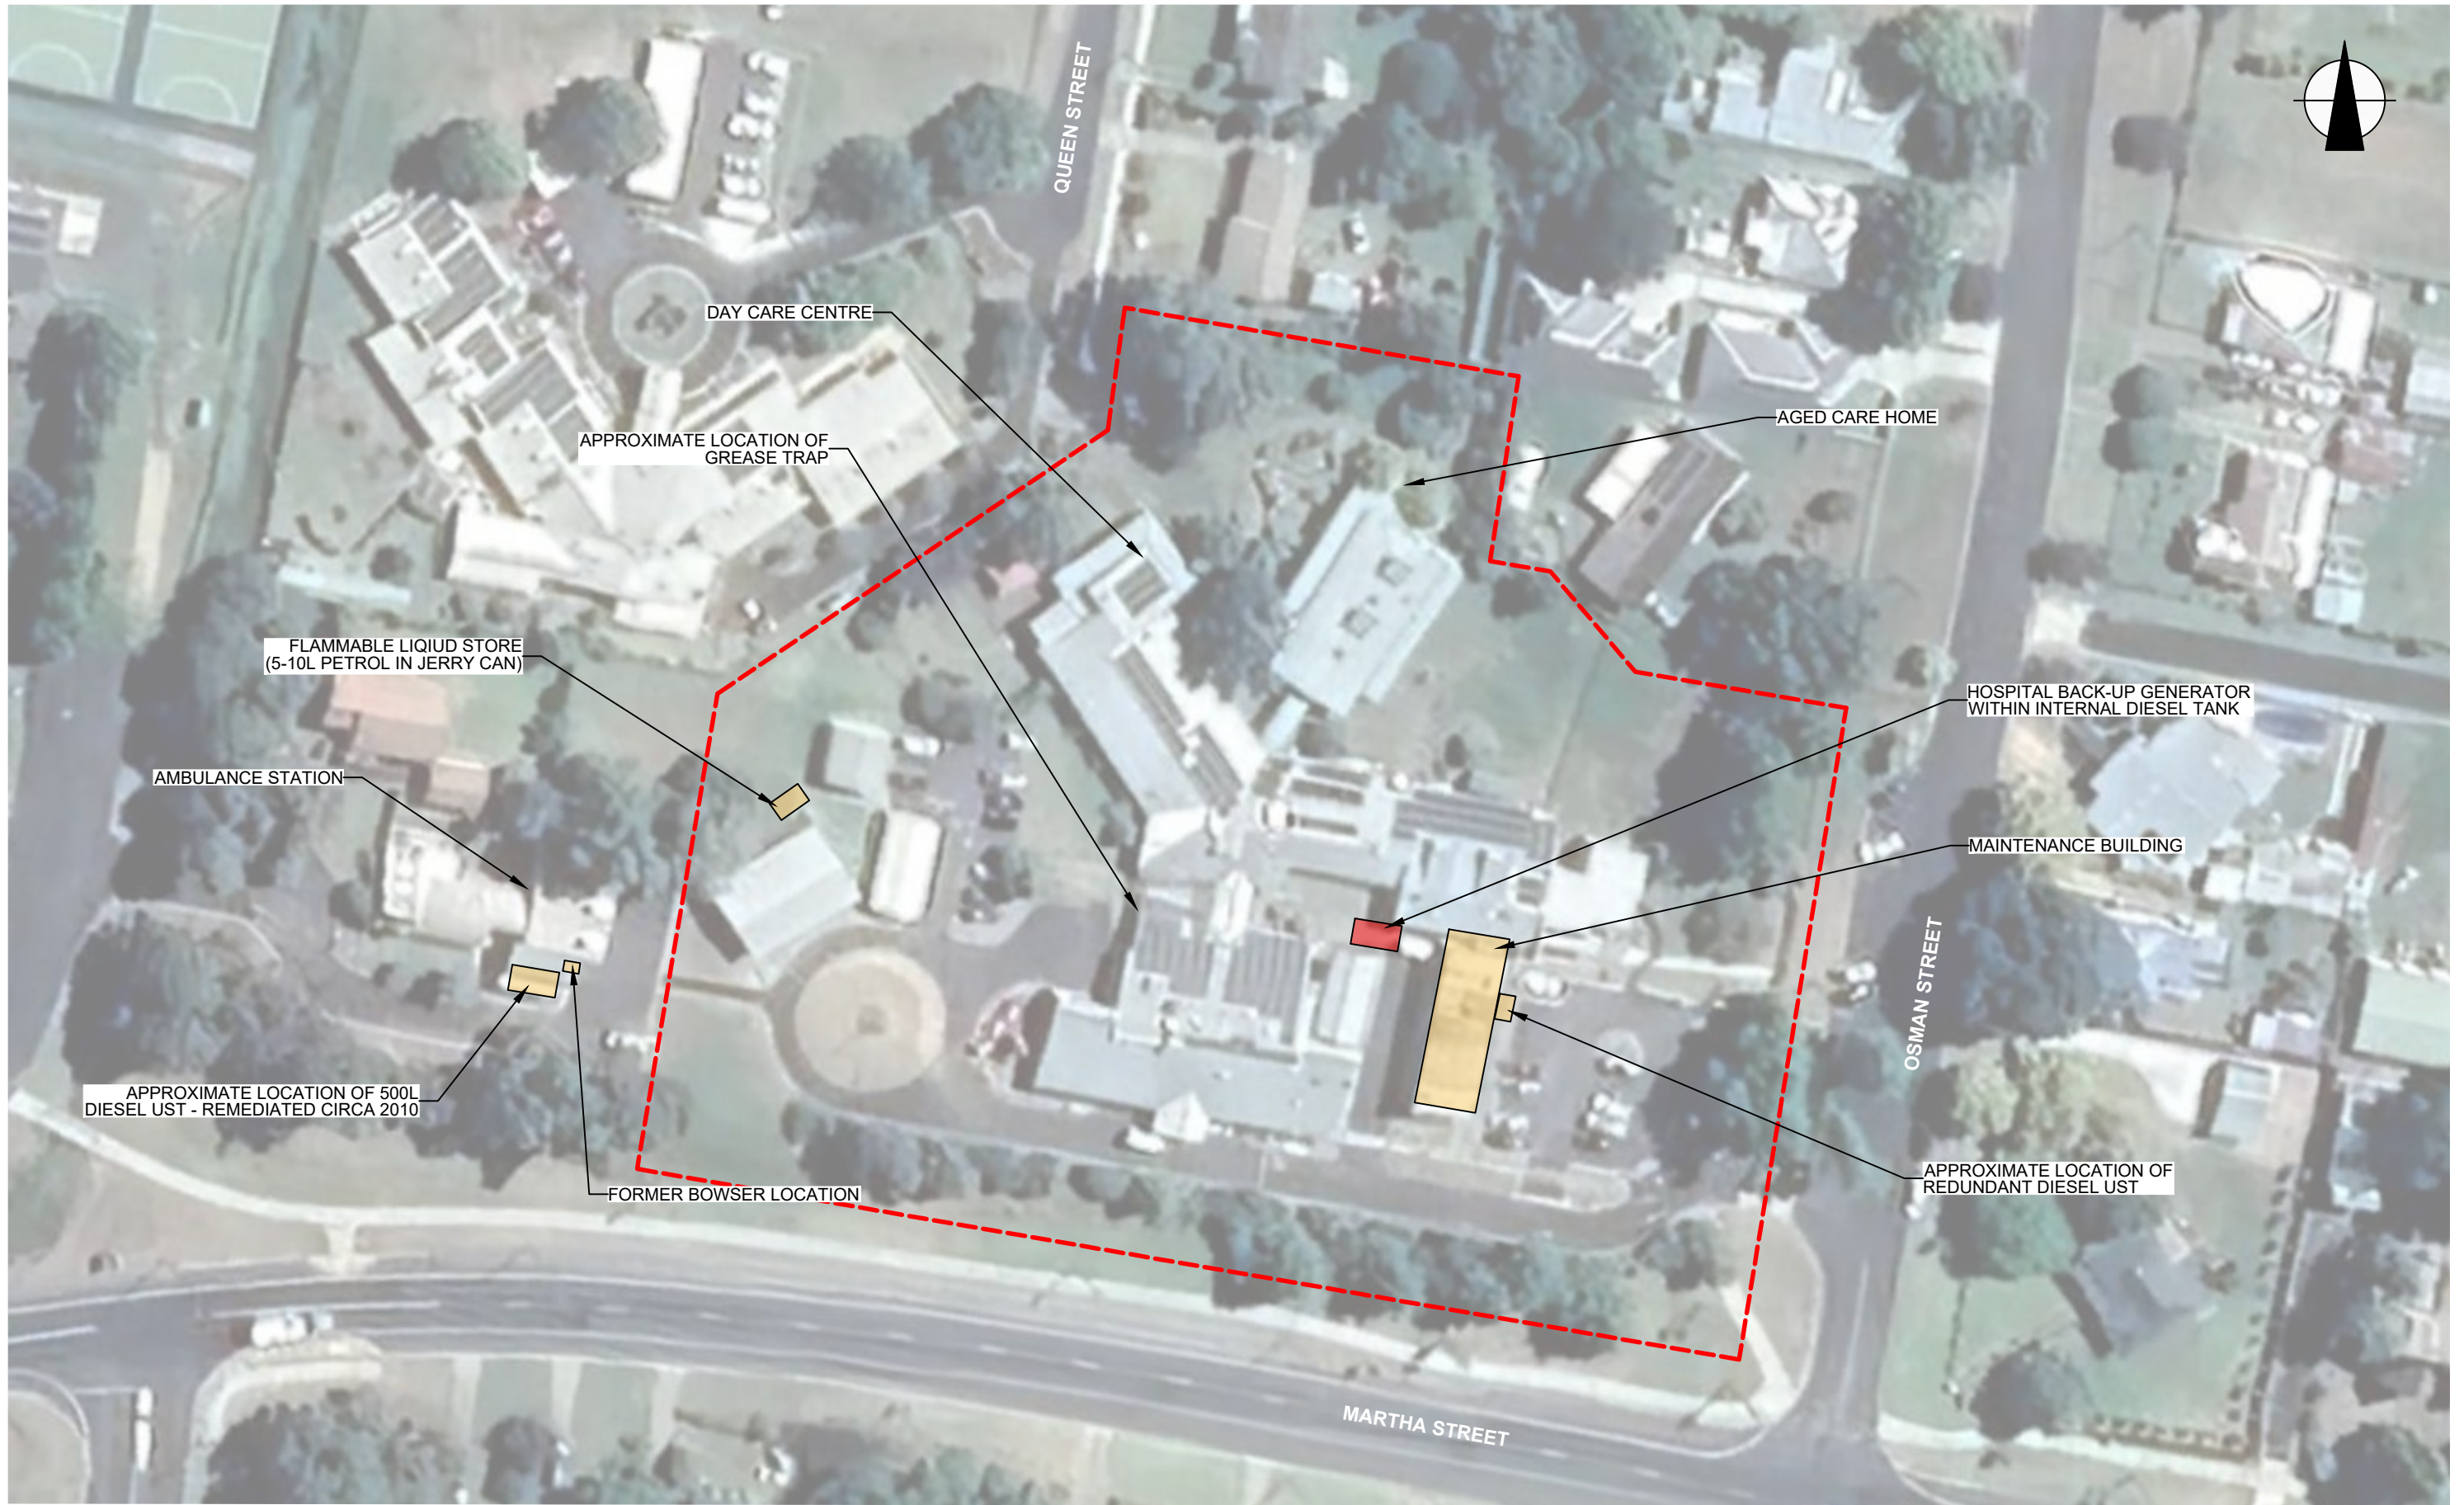
A disused diesel 500L AST was observed in the maintenance building adjacent to the former back-up generator (refer to Figure 2). A small amount of staining was observed on the surrounding concrete slab ground surface during the inspection. A grease trap was also observed at the rear of the main hospital building (refer to Figure 2).

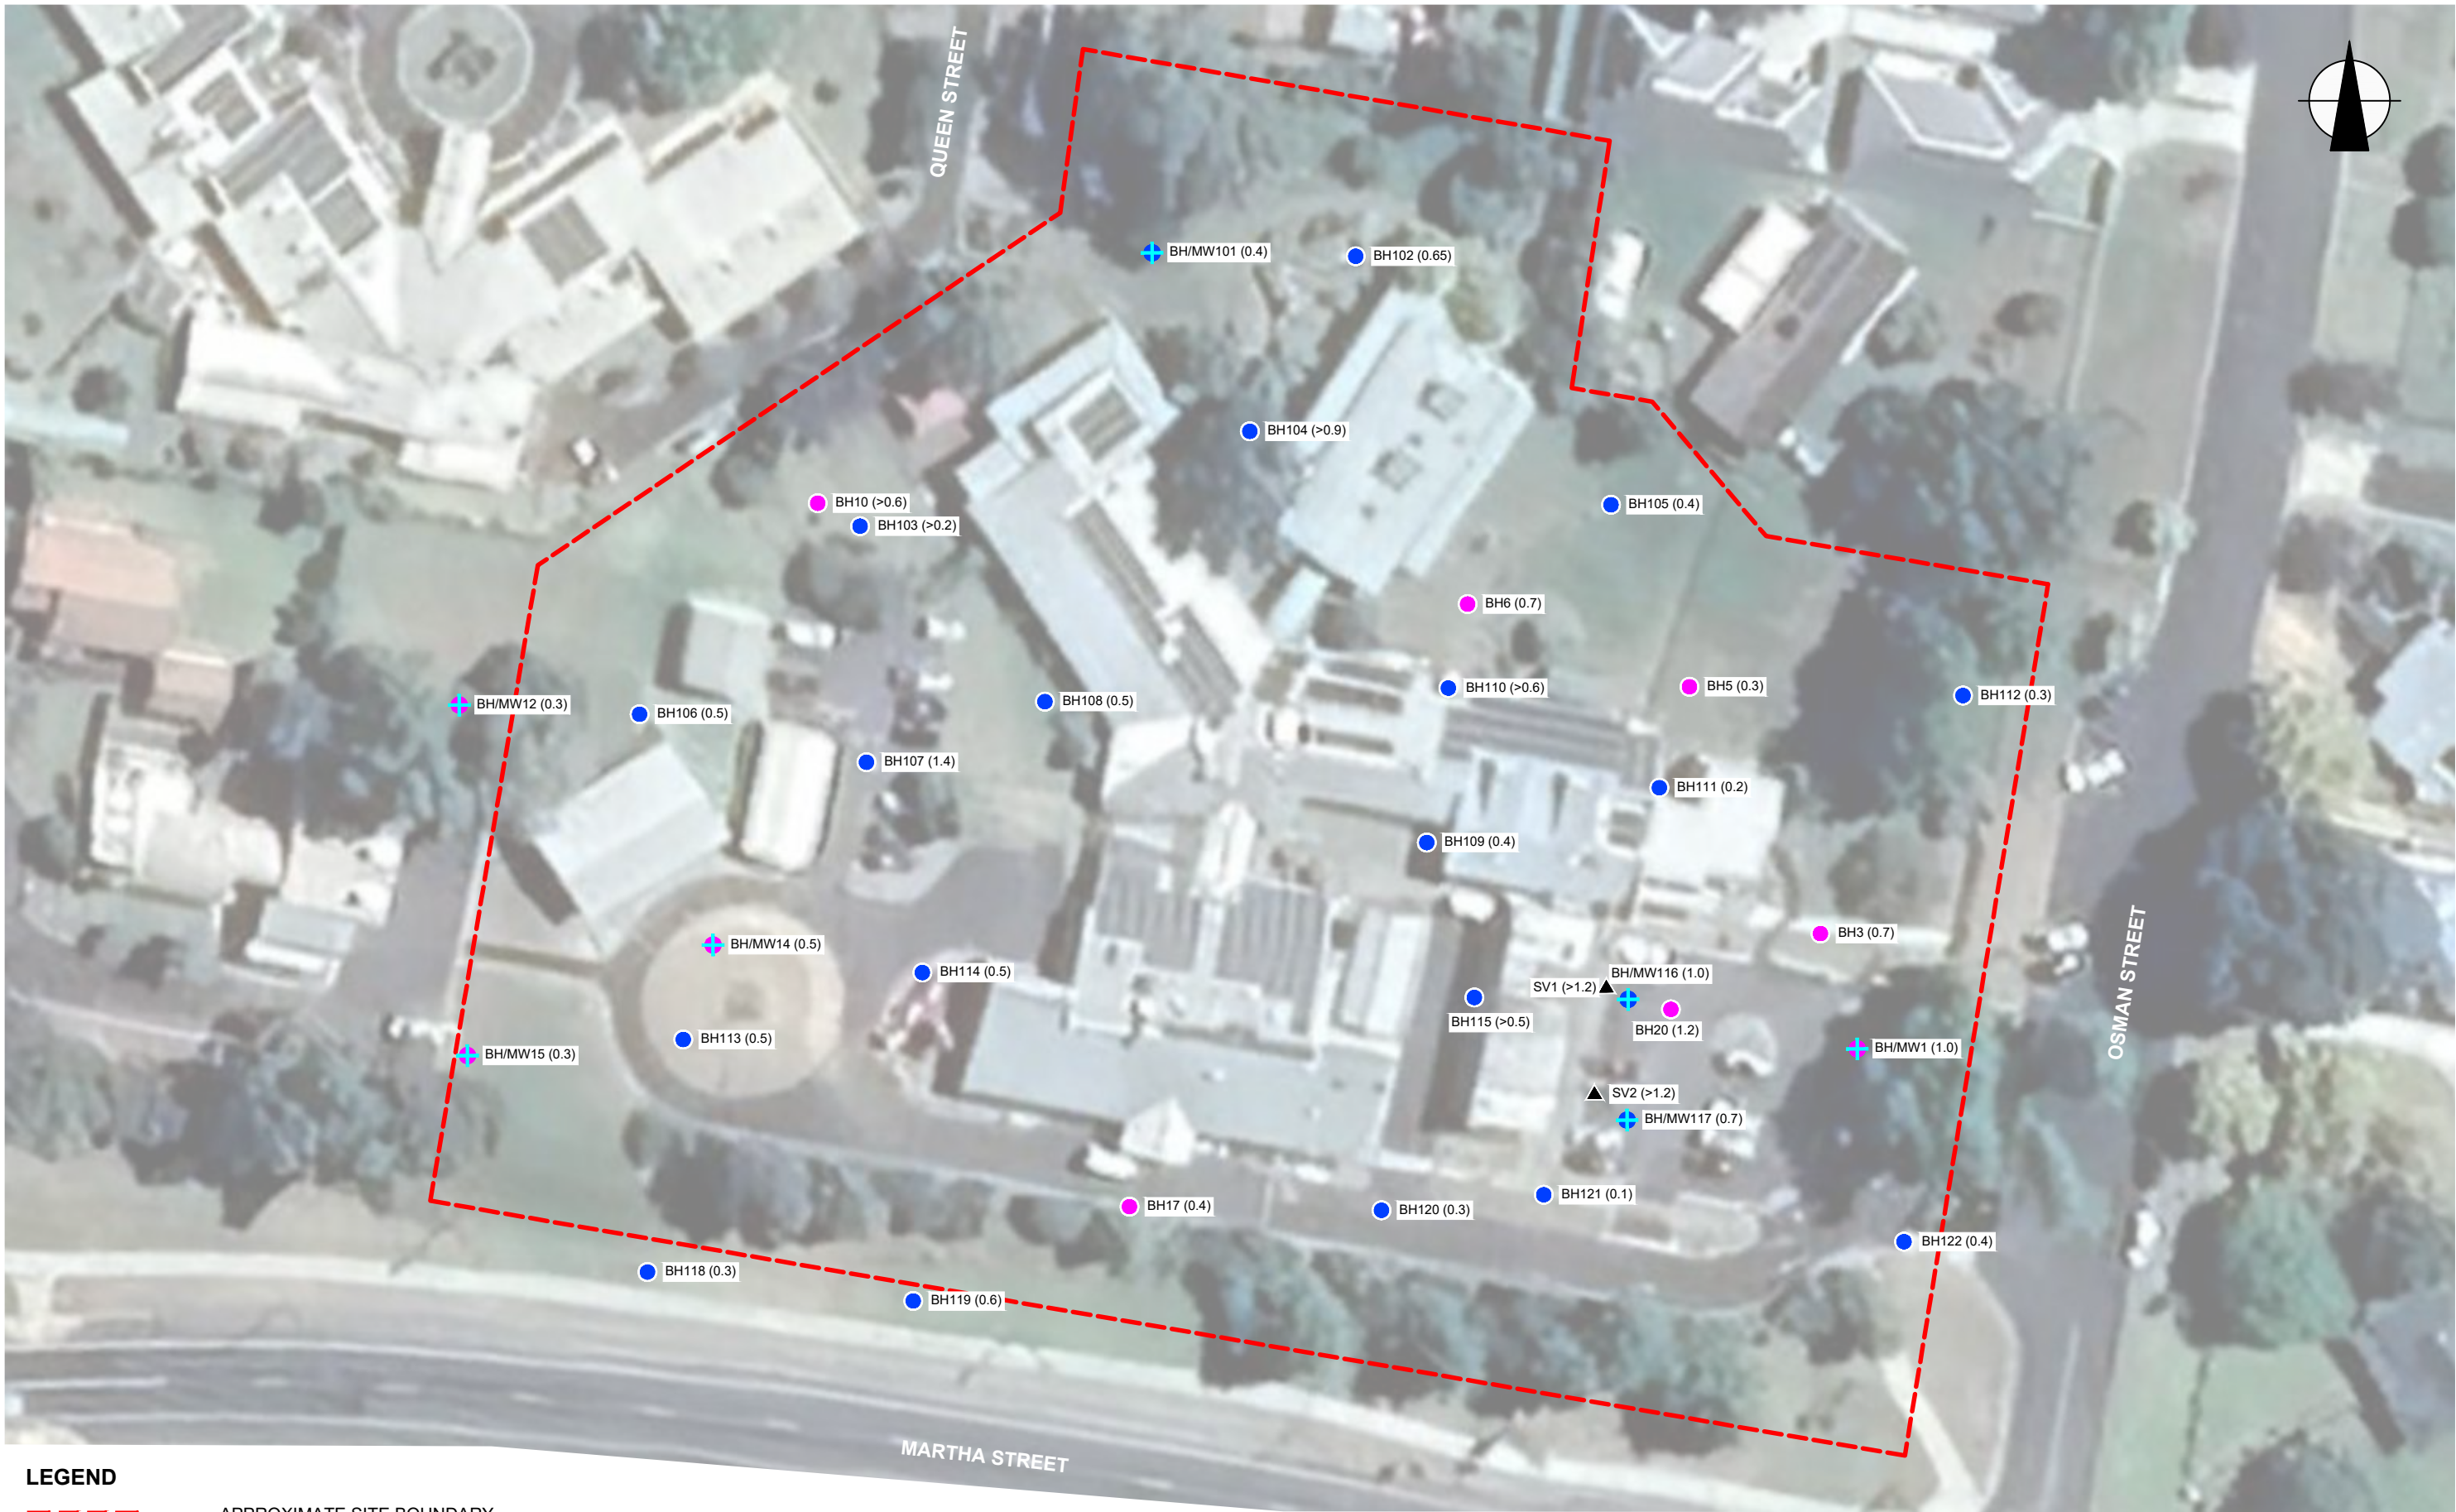
- APPROXIMATE SITE BOUNDARY
- BH(Fill Depth) BOREHOLE LOCATION, NUMBER AND DEPTH OF FILL (m) (JKE, 2022)
- BH/MW(Fill Depth) BOREHOLE AND GROUNDWATER MONITORING WELL LOCATION, NUMBER AND DEPTH OF FILL (m) (JKE, 2022)
- BH102 BOREHOLE LOCATION, NUMBER AND DEPTH OF FILL (m) (JKE, 2023)
- BH/MW101 BOREHOLE AND GROUNDWATER MONITORING WELL LOCATION, NUMBER AND DEPTH OF FILL (m) (JKE, 2023)
- ▲ SV1 SOIL VAPOUR IMPLANT AND DEPTH (m) (JKE, 2023)

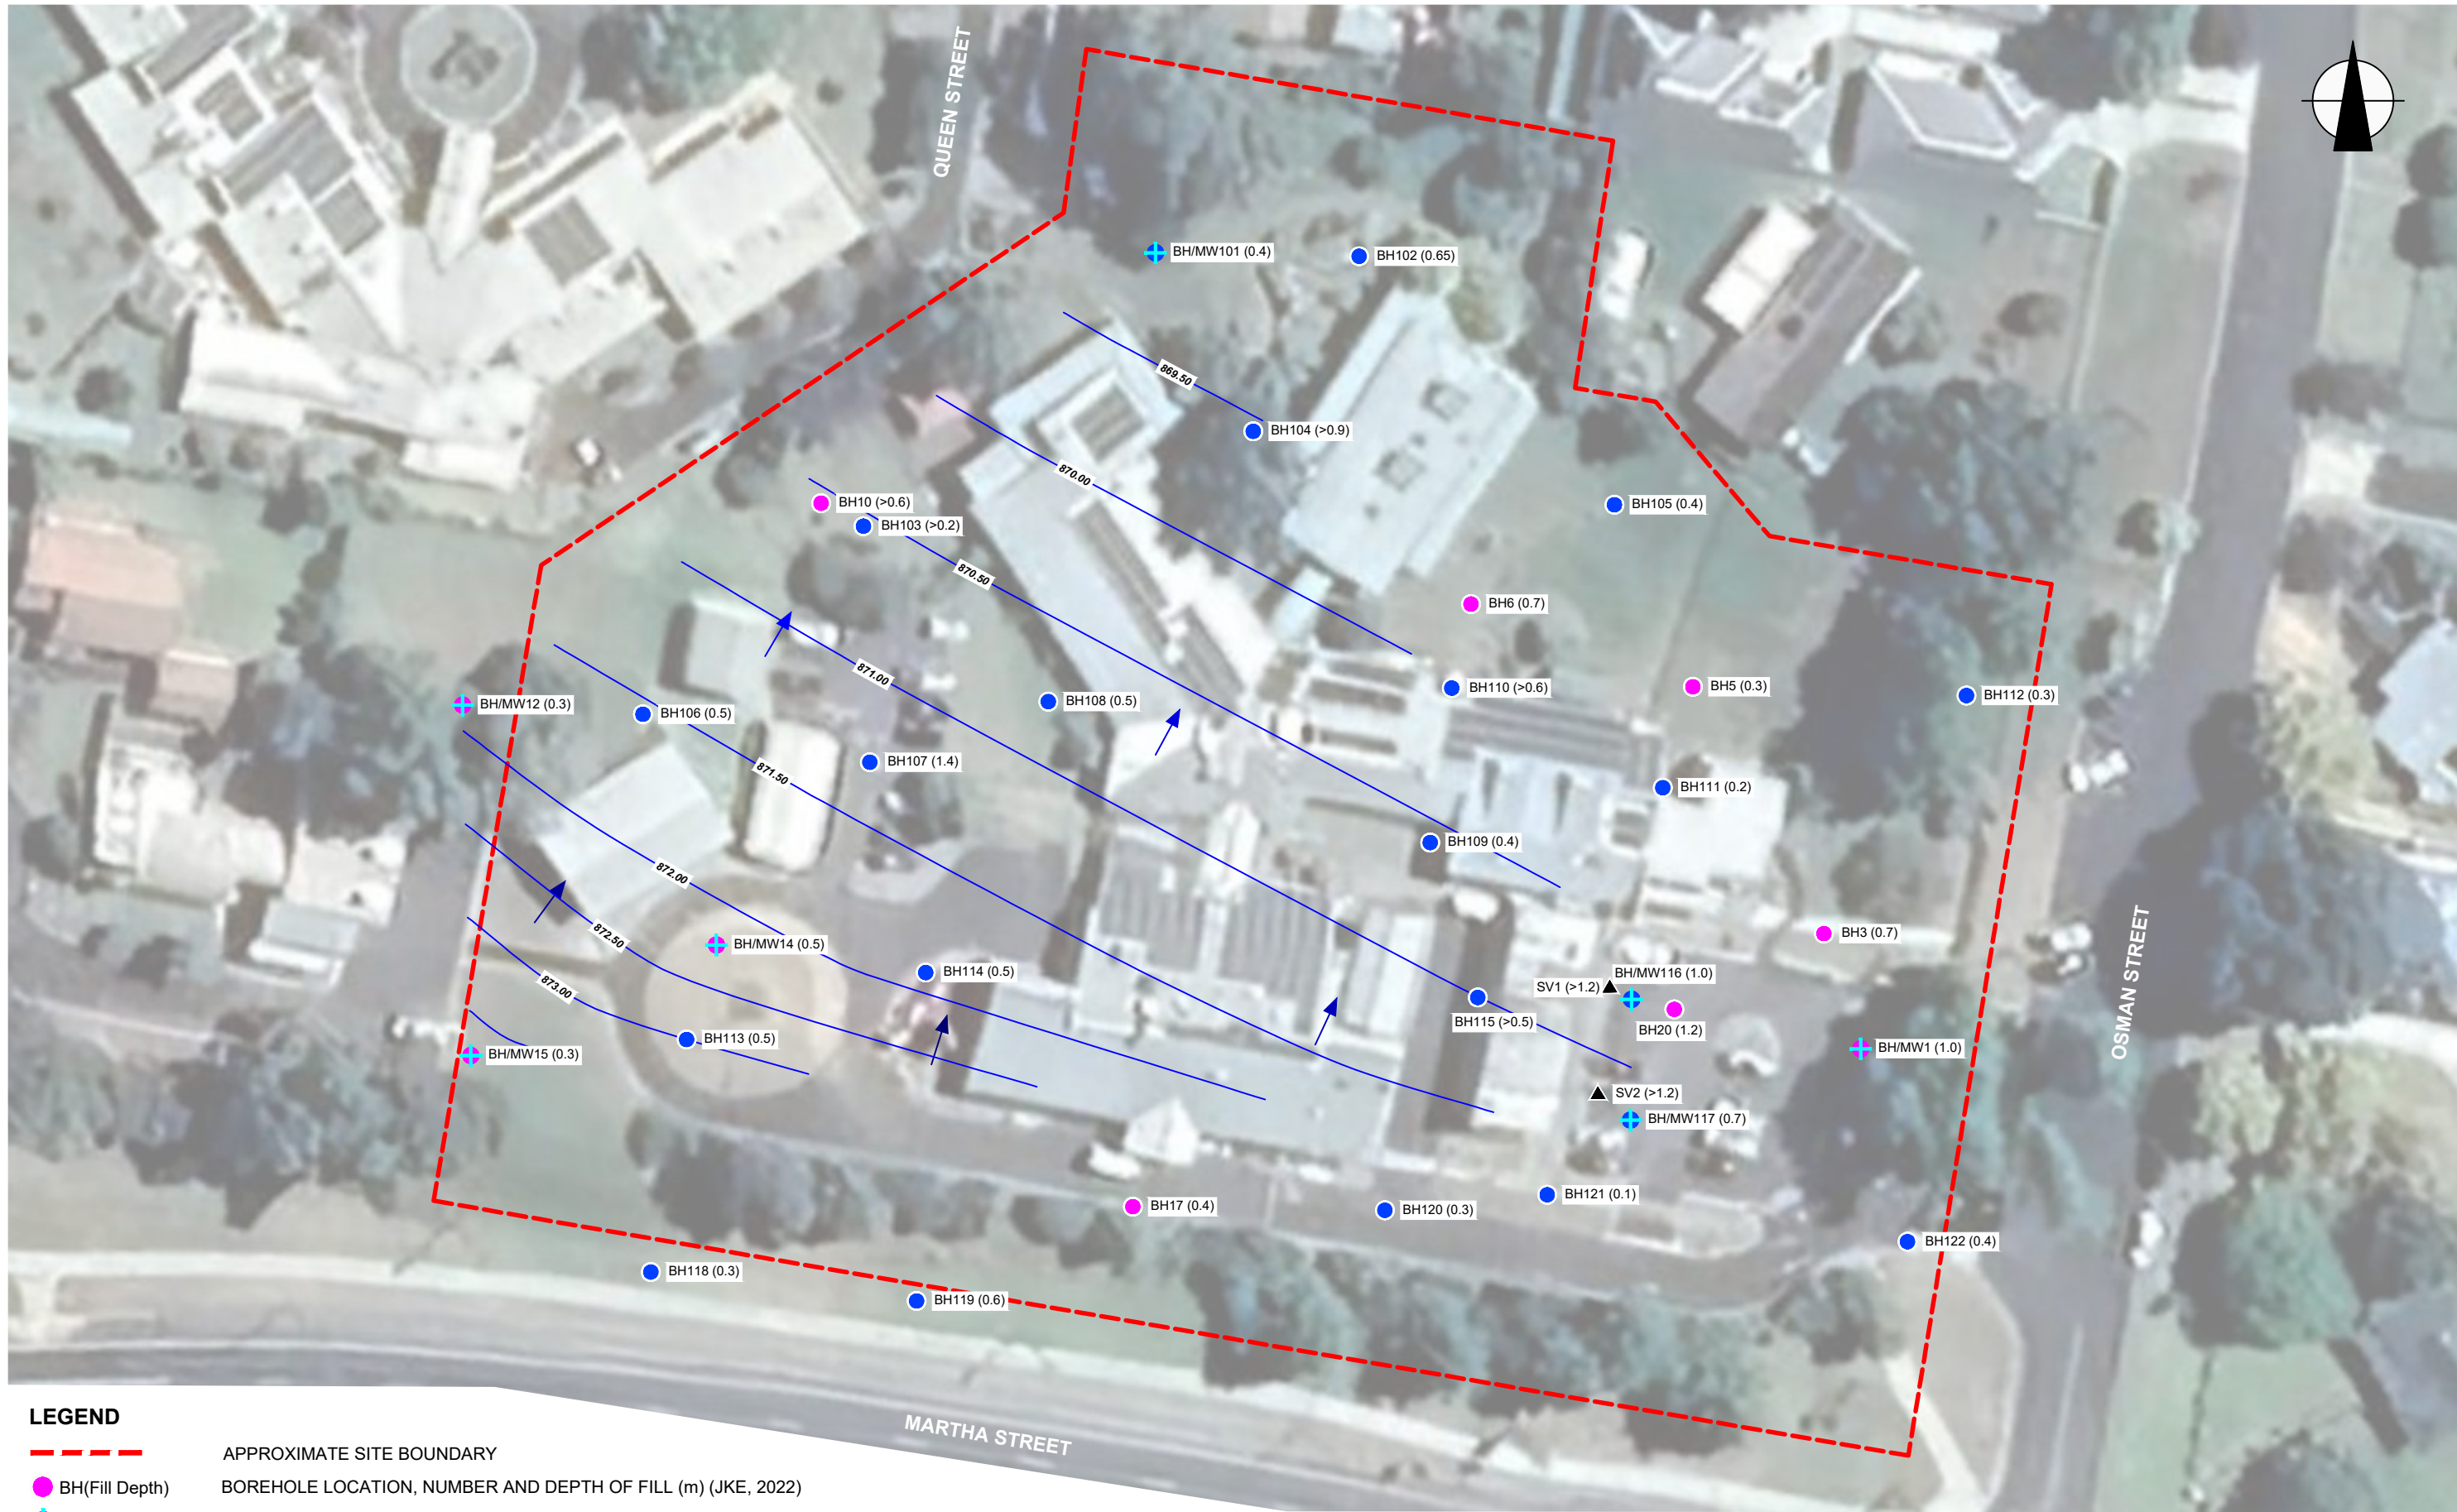
- APPROXIMATE SITE BOUNDARY
- BH(Fill Depth) BOREHOLE LOCATION, NUMBER AND DEPTH OF FILL (m) (JKE, 2022)
- + BH/MW(Fill Depth) BOREHOLE AND GROUNDWATER MONITORING WELL LOCATION, NUMBER AND DEPTH OF FILL (m) (JKE, 2022)
- BH102 BOREHOLE LOCATION, NUMBER AND DEPTH OF FILL (m) (JKE, 2023)
- + BH/MW101 BOREHOLE AND GROUNDWATER MONITORING WELL LOCATION, NUMBER AND DEPTH OF FILL (m) (JKE, 2023)
- ▲ SV1 SOIL VAPOUR IMPLANT AND DEPTH (m) (JKE, 2023)
- 871 GROUNDWATER CONTOUR INTERVALS (m)
- INFERRED GROUNDWATER FLOW DIRECTION

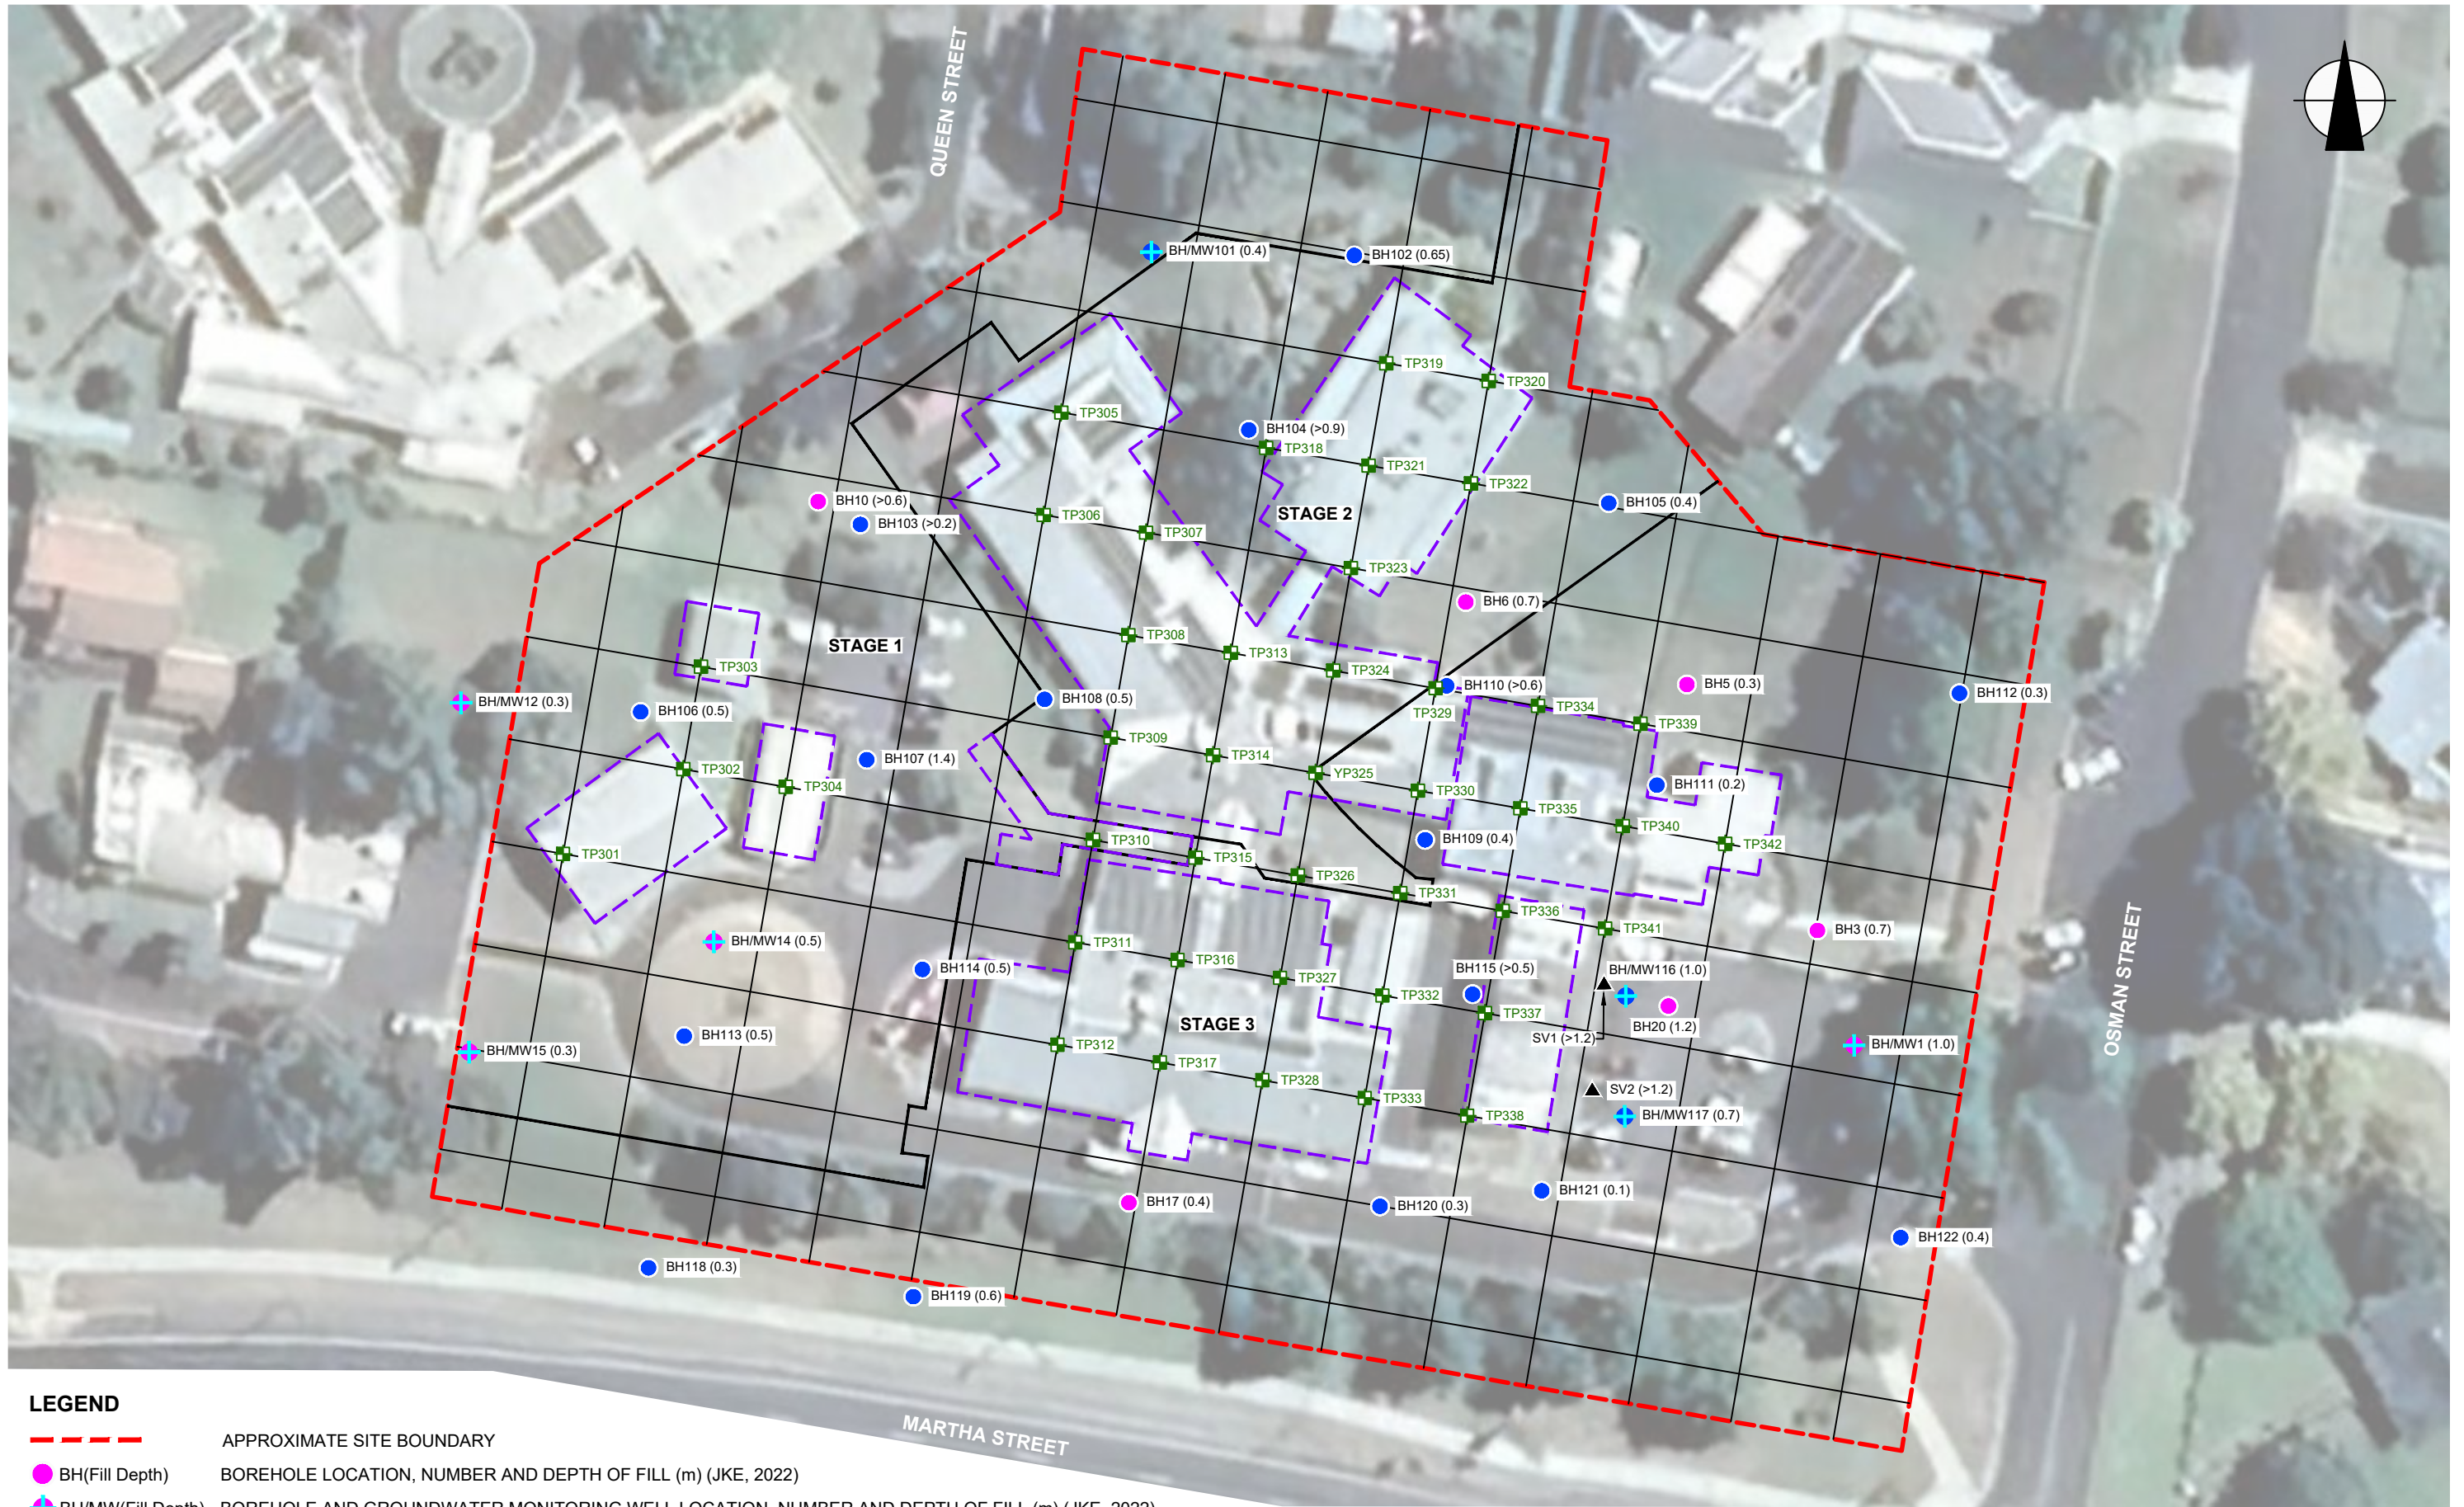
- Preparation and implementation of a suitable Work Health and Safety (WHS) plan that considers the potential for identifying asbestos during the sampling;
- Soil sampling from test pits from the proposed locations presented on Figure 6 in Appendix A. The test pits must be excavated to the base of the fill and at least 0.5m into the natural soil;
- Soil samples must be collected from each fill profile for laboratory analysis, and one sample from each location should be collected from the underlying natural soil. If there are any indicators of contamination in the natural soil (e.g. staining or odours) then deeper sampling should occur;
- Bulk (10L) field asbestos quantification must occur in accordance with the NEPM (2013) requirements;

- An additional round of soil vapour sampling/analysis for TRH/BTEX and VOCs at locations SV1 and SV2 (see Figure 6 in Appendix A). In the event that the vapour wells are damaged or cannot be located, they must be reinstalled in accordance with the specification documented in the DSI;
- A sample from each fill profile is to be analysed for the CoPC for fill as nominated in the CSM. Any FCF identified in the bulk samples are also to be analysed for asbestos;
- If there is to be a surplus of materials on the project, or if waste is to be disposed off-site, additional analysis for waste classification purposes must occur;
- Appropriate QA/QC samples are to be obtained and analysed for soil and soil vapour, with regards to the NEPM (2013) requirements; and
- Use of appropriate SAC for the Tier 1 risk assessment (note that these SAC should be established based on the outcome of the HHRA).

It is acknowledged that the site will be redeveloped in three stages. The stages are shown on the attached Figures 6 and 7 in Appendix A. The works outlined in this RAP can be tailored to align with the development stages, however, it is noted that the HHRA is an overarching process applicable to the site as a whole.

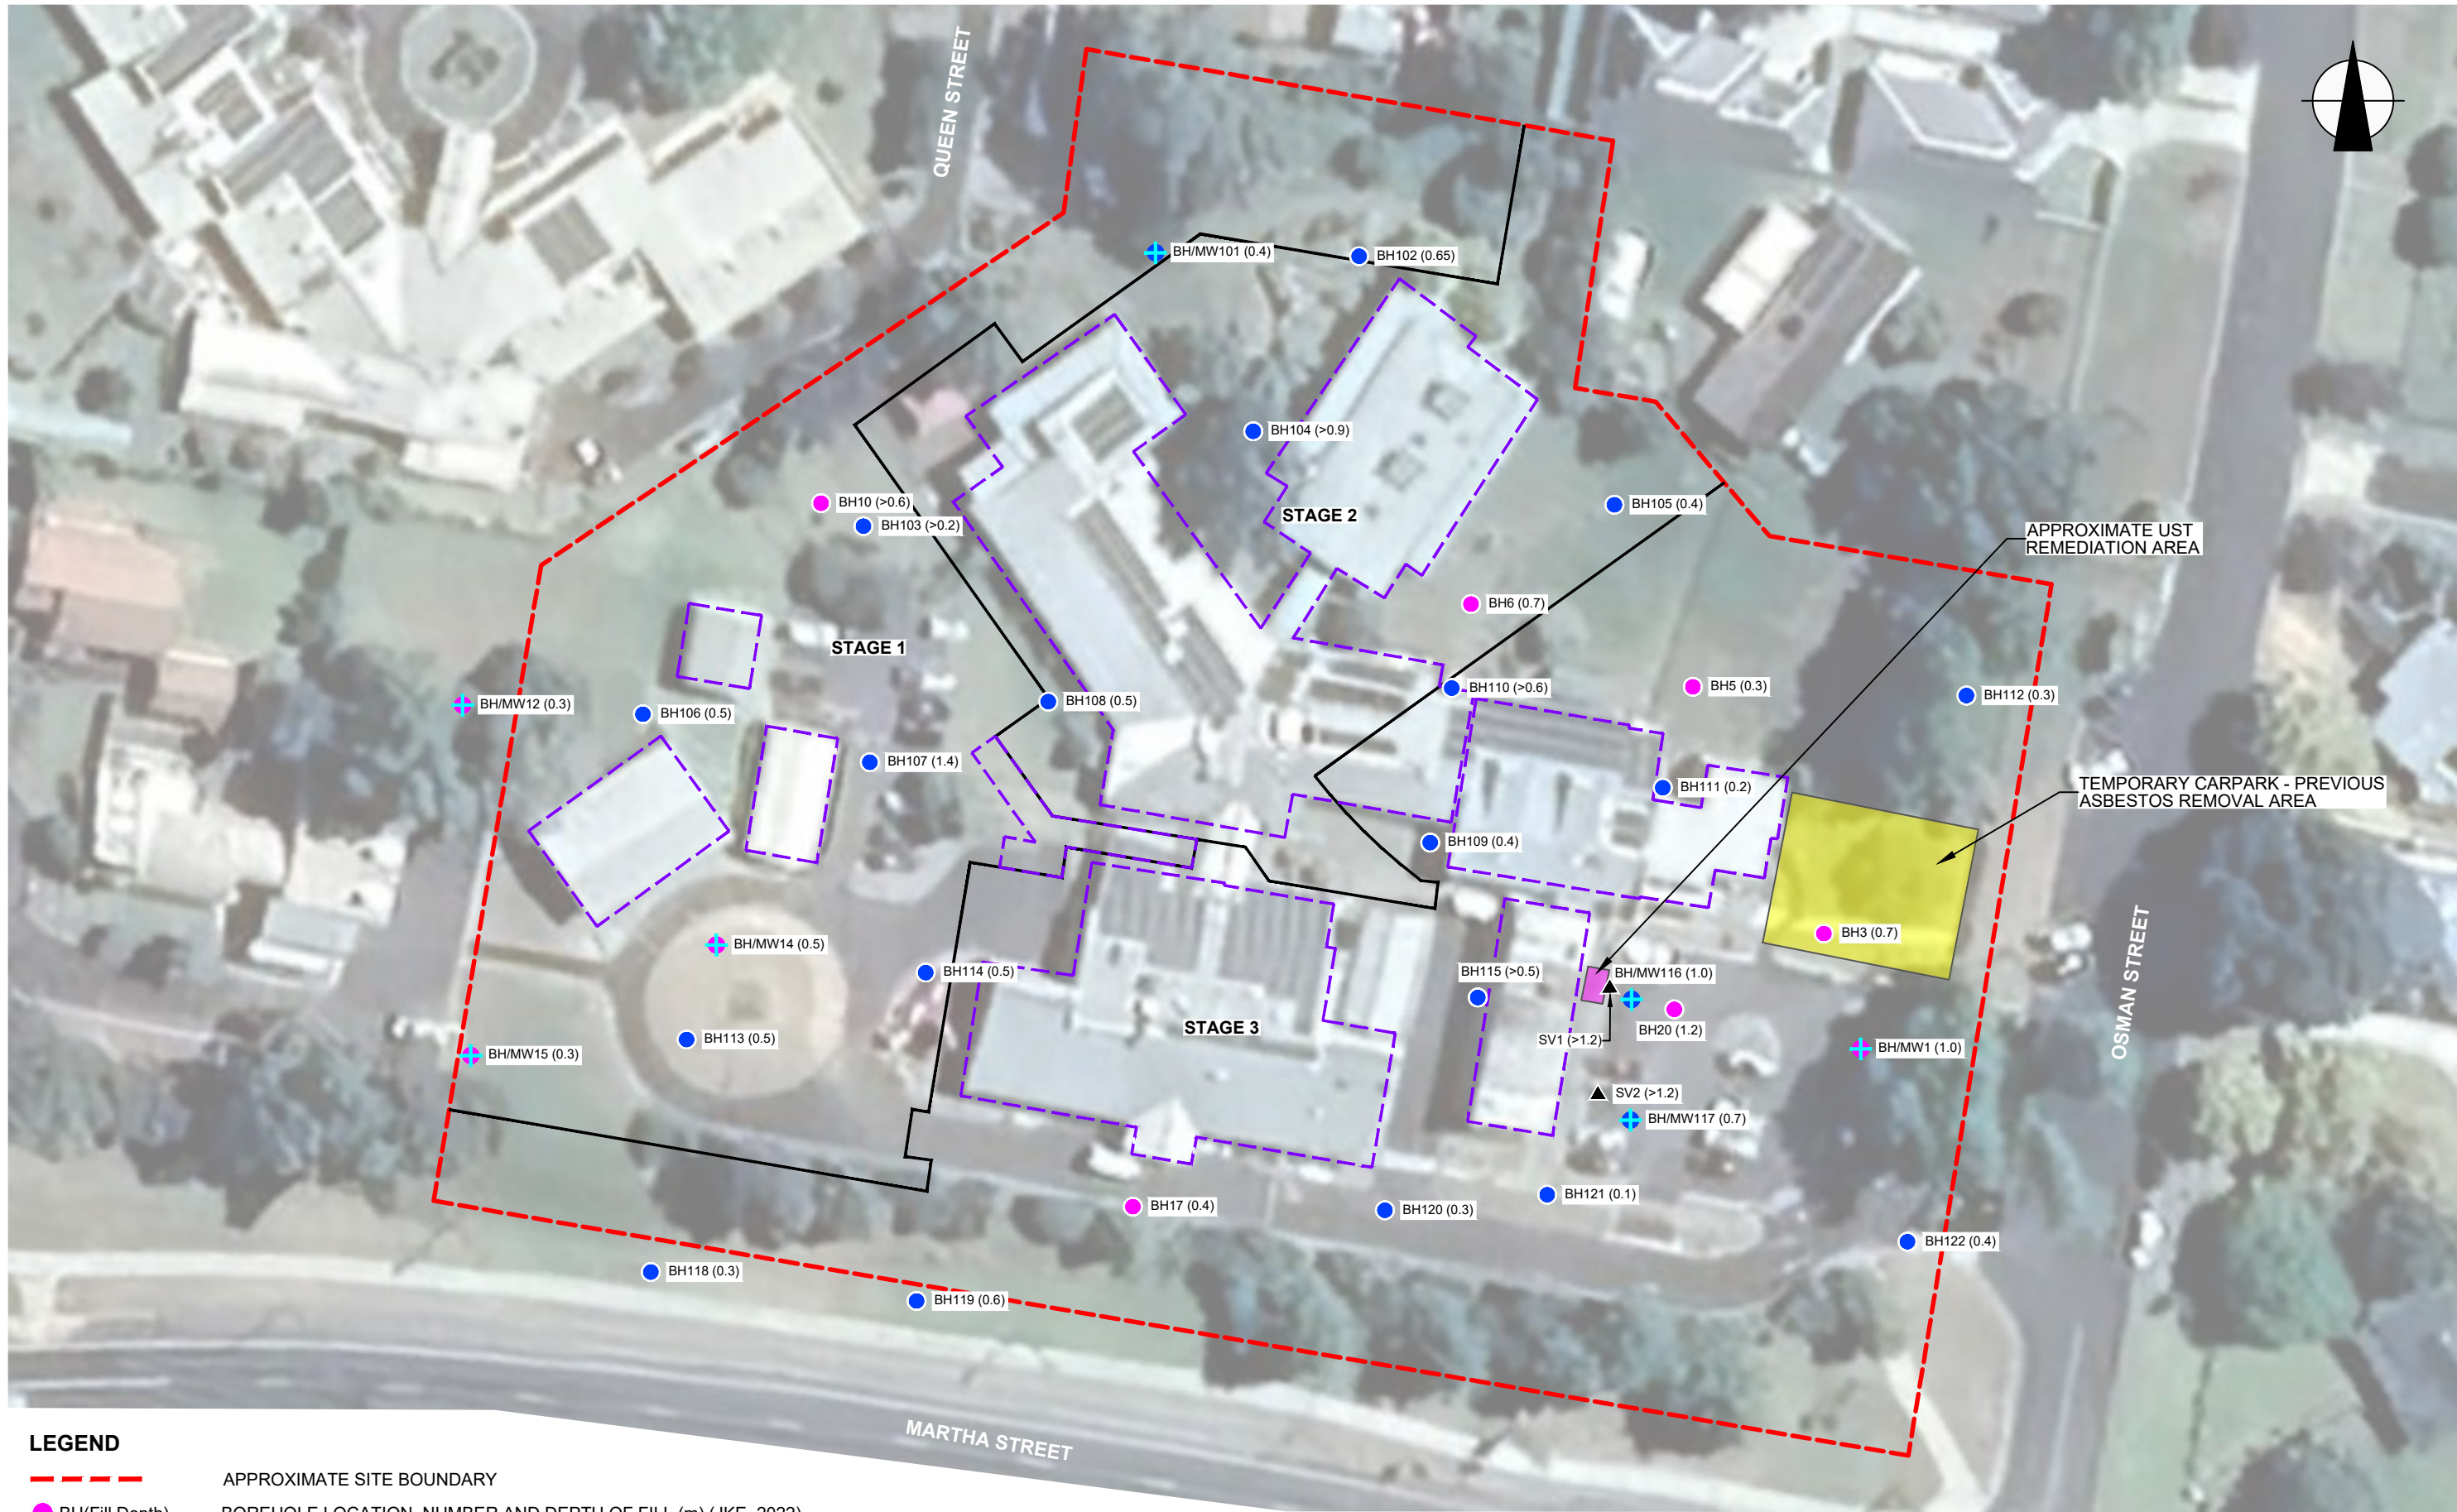
Regarding the AF/FA (asbestos) identified in BH3 during the PSI, it appears likely that this material was removed from the site during the temporary car park works (see Figure 7 in Appendix A). JKE has considered this in the context of the additional data obtained during the DSI and also by Nova Enviro. In our opinion, the occurrence of AF/FA appears to be minor and not representative of the broader soil conditions in this area of the site. The soils in this area appear to be impacted by bonded ACM and sporadic occurrences of AF/FA can often be found co-located with ACM. Asbestos as AF/FA was not identified in any other samples collected from the site, therefore, we agree with the Nova Enviro assessment that the asbestos impact at BH3/at the temporary car park area is associated with bonded (non-friable) ACM.
