**REPORT TO  
NSW HEALTH INFRASTRUCTURE**

**ON  
PRELIMINARY (STAGE 1) SITE INVESTIGATION**

**FOR  
PROPOSED MPS STAGE 5 DEVELOPMENT**

**AT  
BLAYNEY DISTRICT HOSPITAL, 3 OSMAN STREET,  
BLAYNEY, NSW**

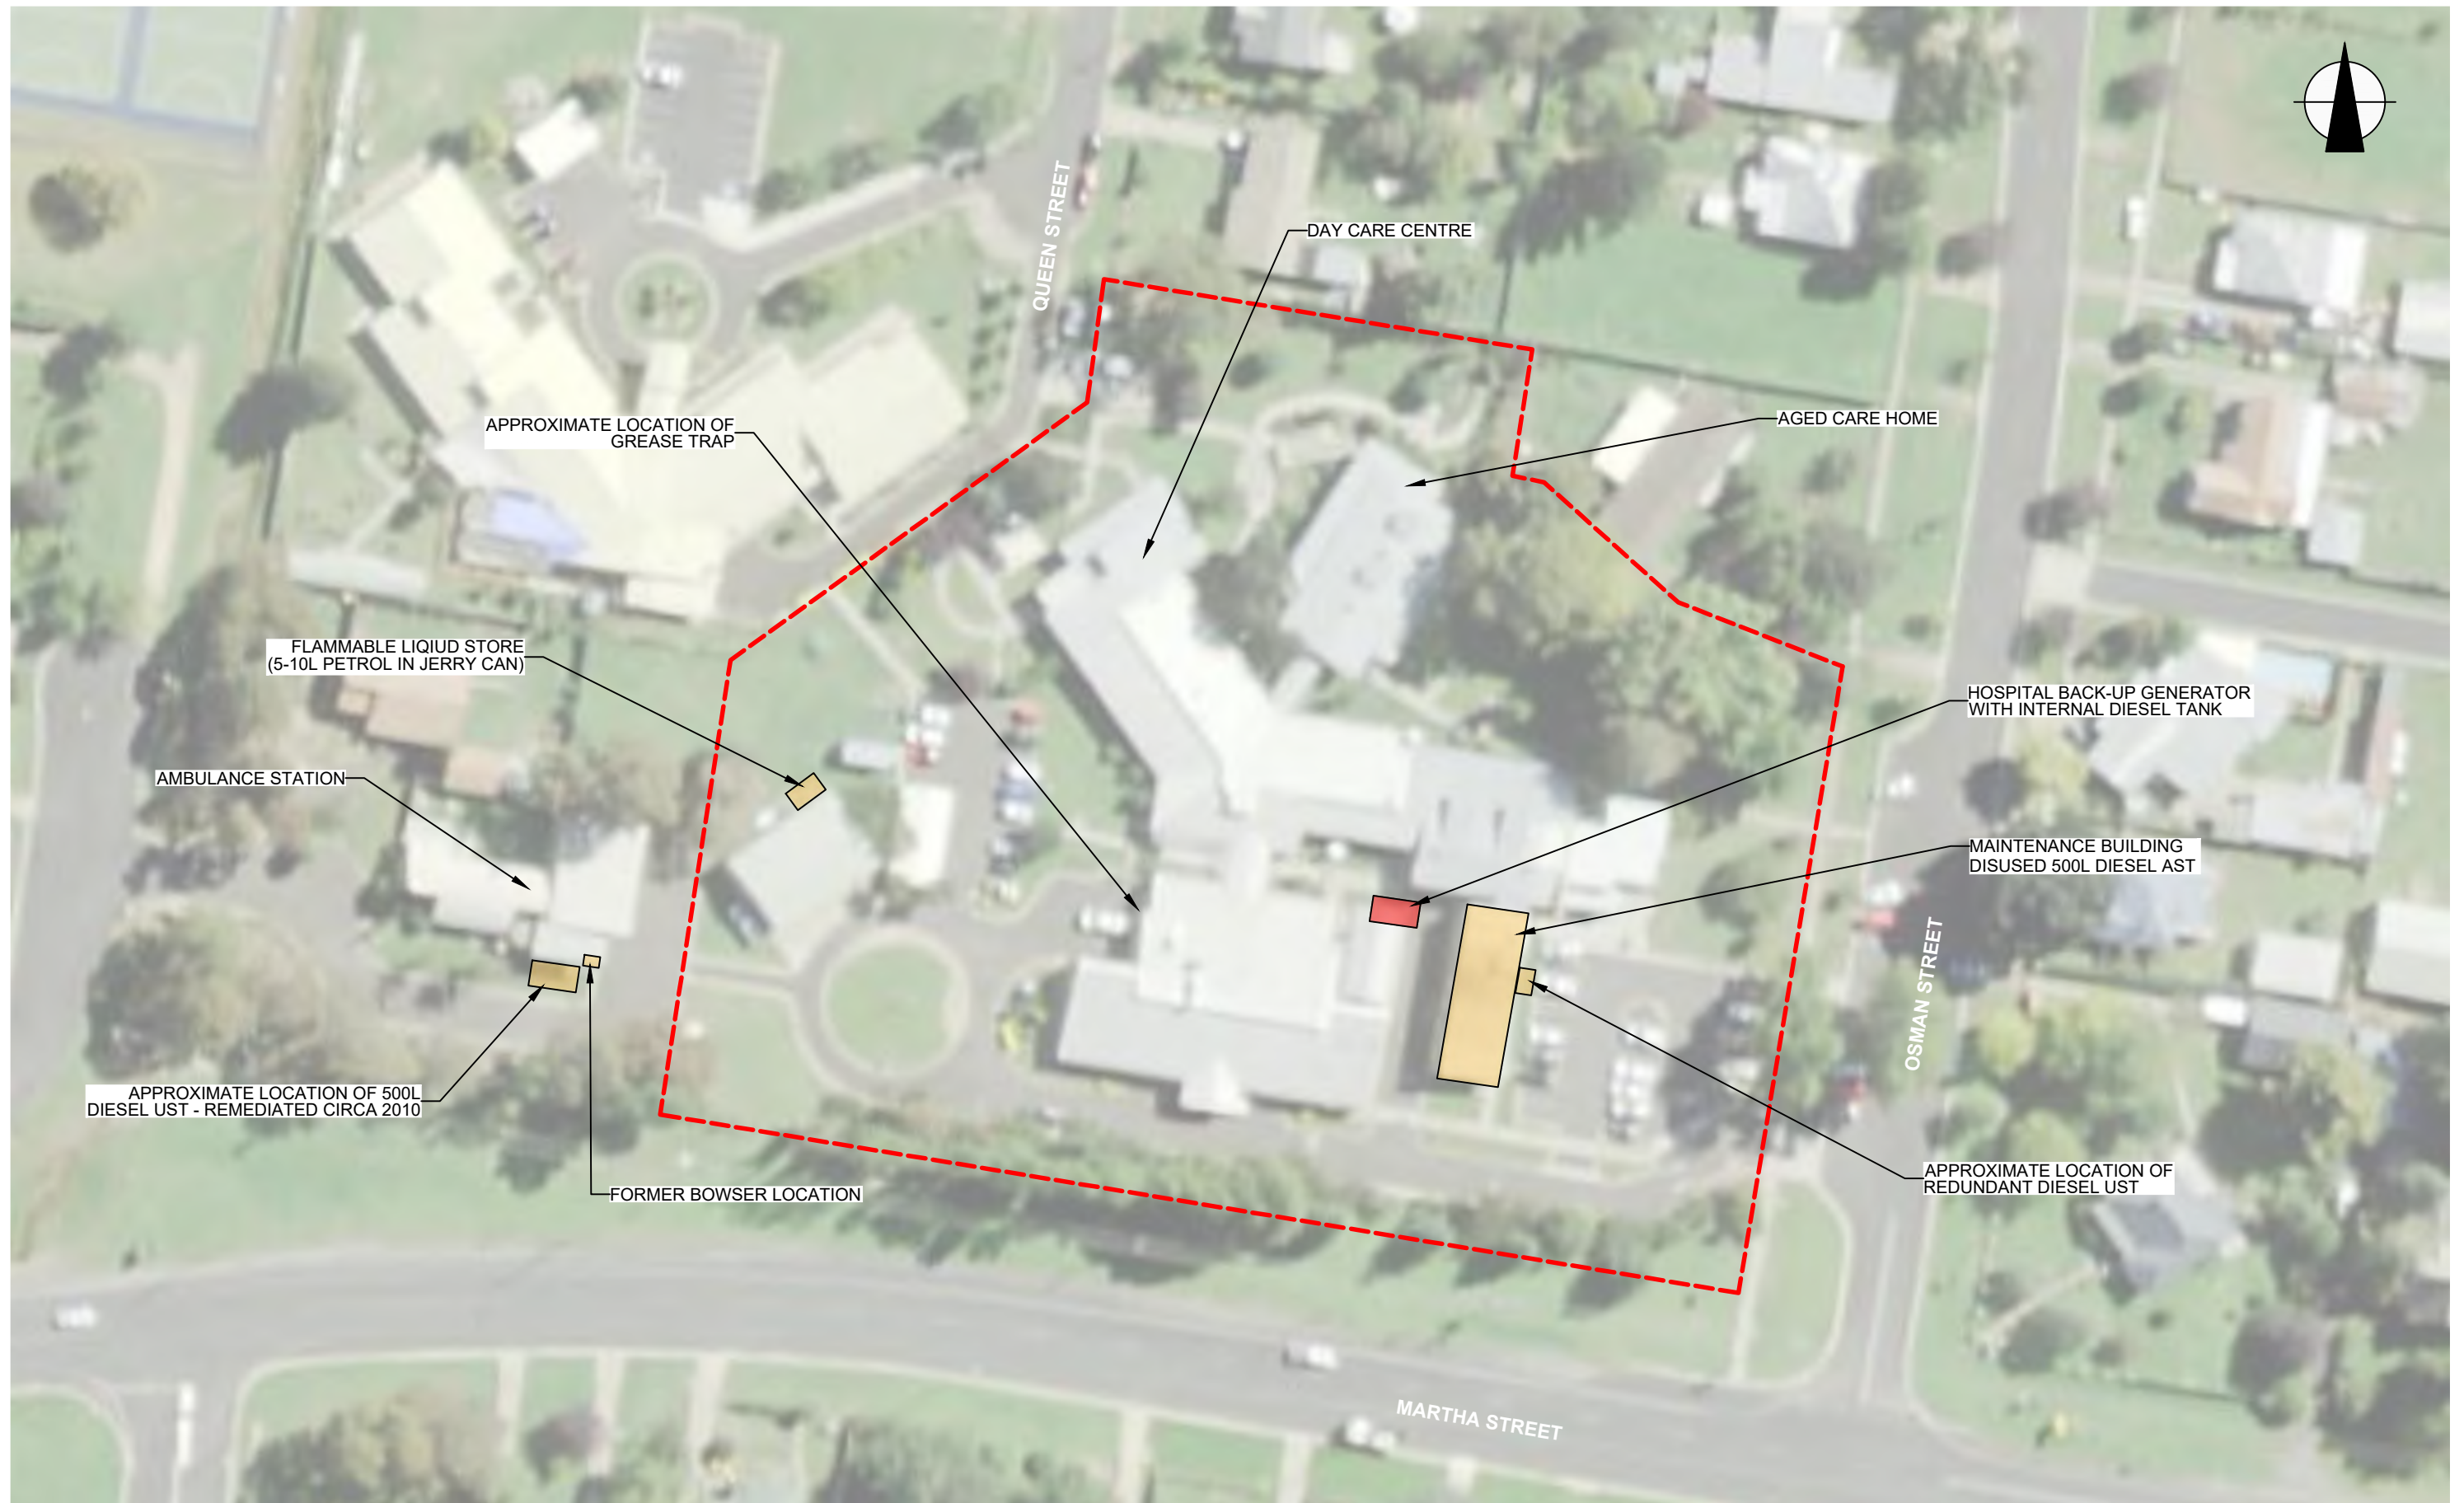
- A disused diesel 500L AST was observed in the maintenance building adjacent to the former back-up generator (refer to figure 2). A small amount of staining was observed on the surrounding concrete slab ground surface during the inspection;

- A grease trap was observed at the rear of the main hospital building (refer to figure 2);
- Surface water flows would be expected to flow to the north-east in keeping with the localised fall of the site. It is noted that several surface drains were observed in the paved sections of the site and these would be expected to drain into the regional stormwater systems; and

During installation of the wells and sampling of the groundwater, no odours or staining were encountered. It is noted that MW1 is located in close proximity to the redundant UST outside the maintenance shed (refer to Figure 2 and 3). The source of the TRH in groundwater is considered likely to be associated with the redundant UST. Further investigation is required to confirm this.

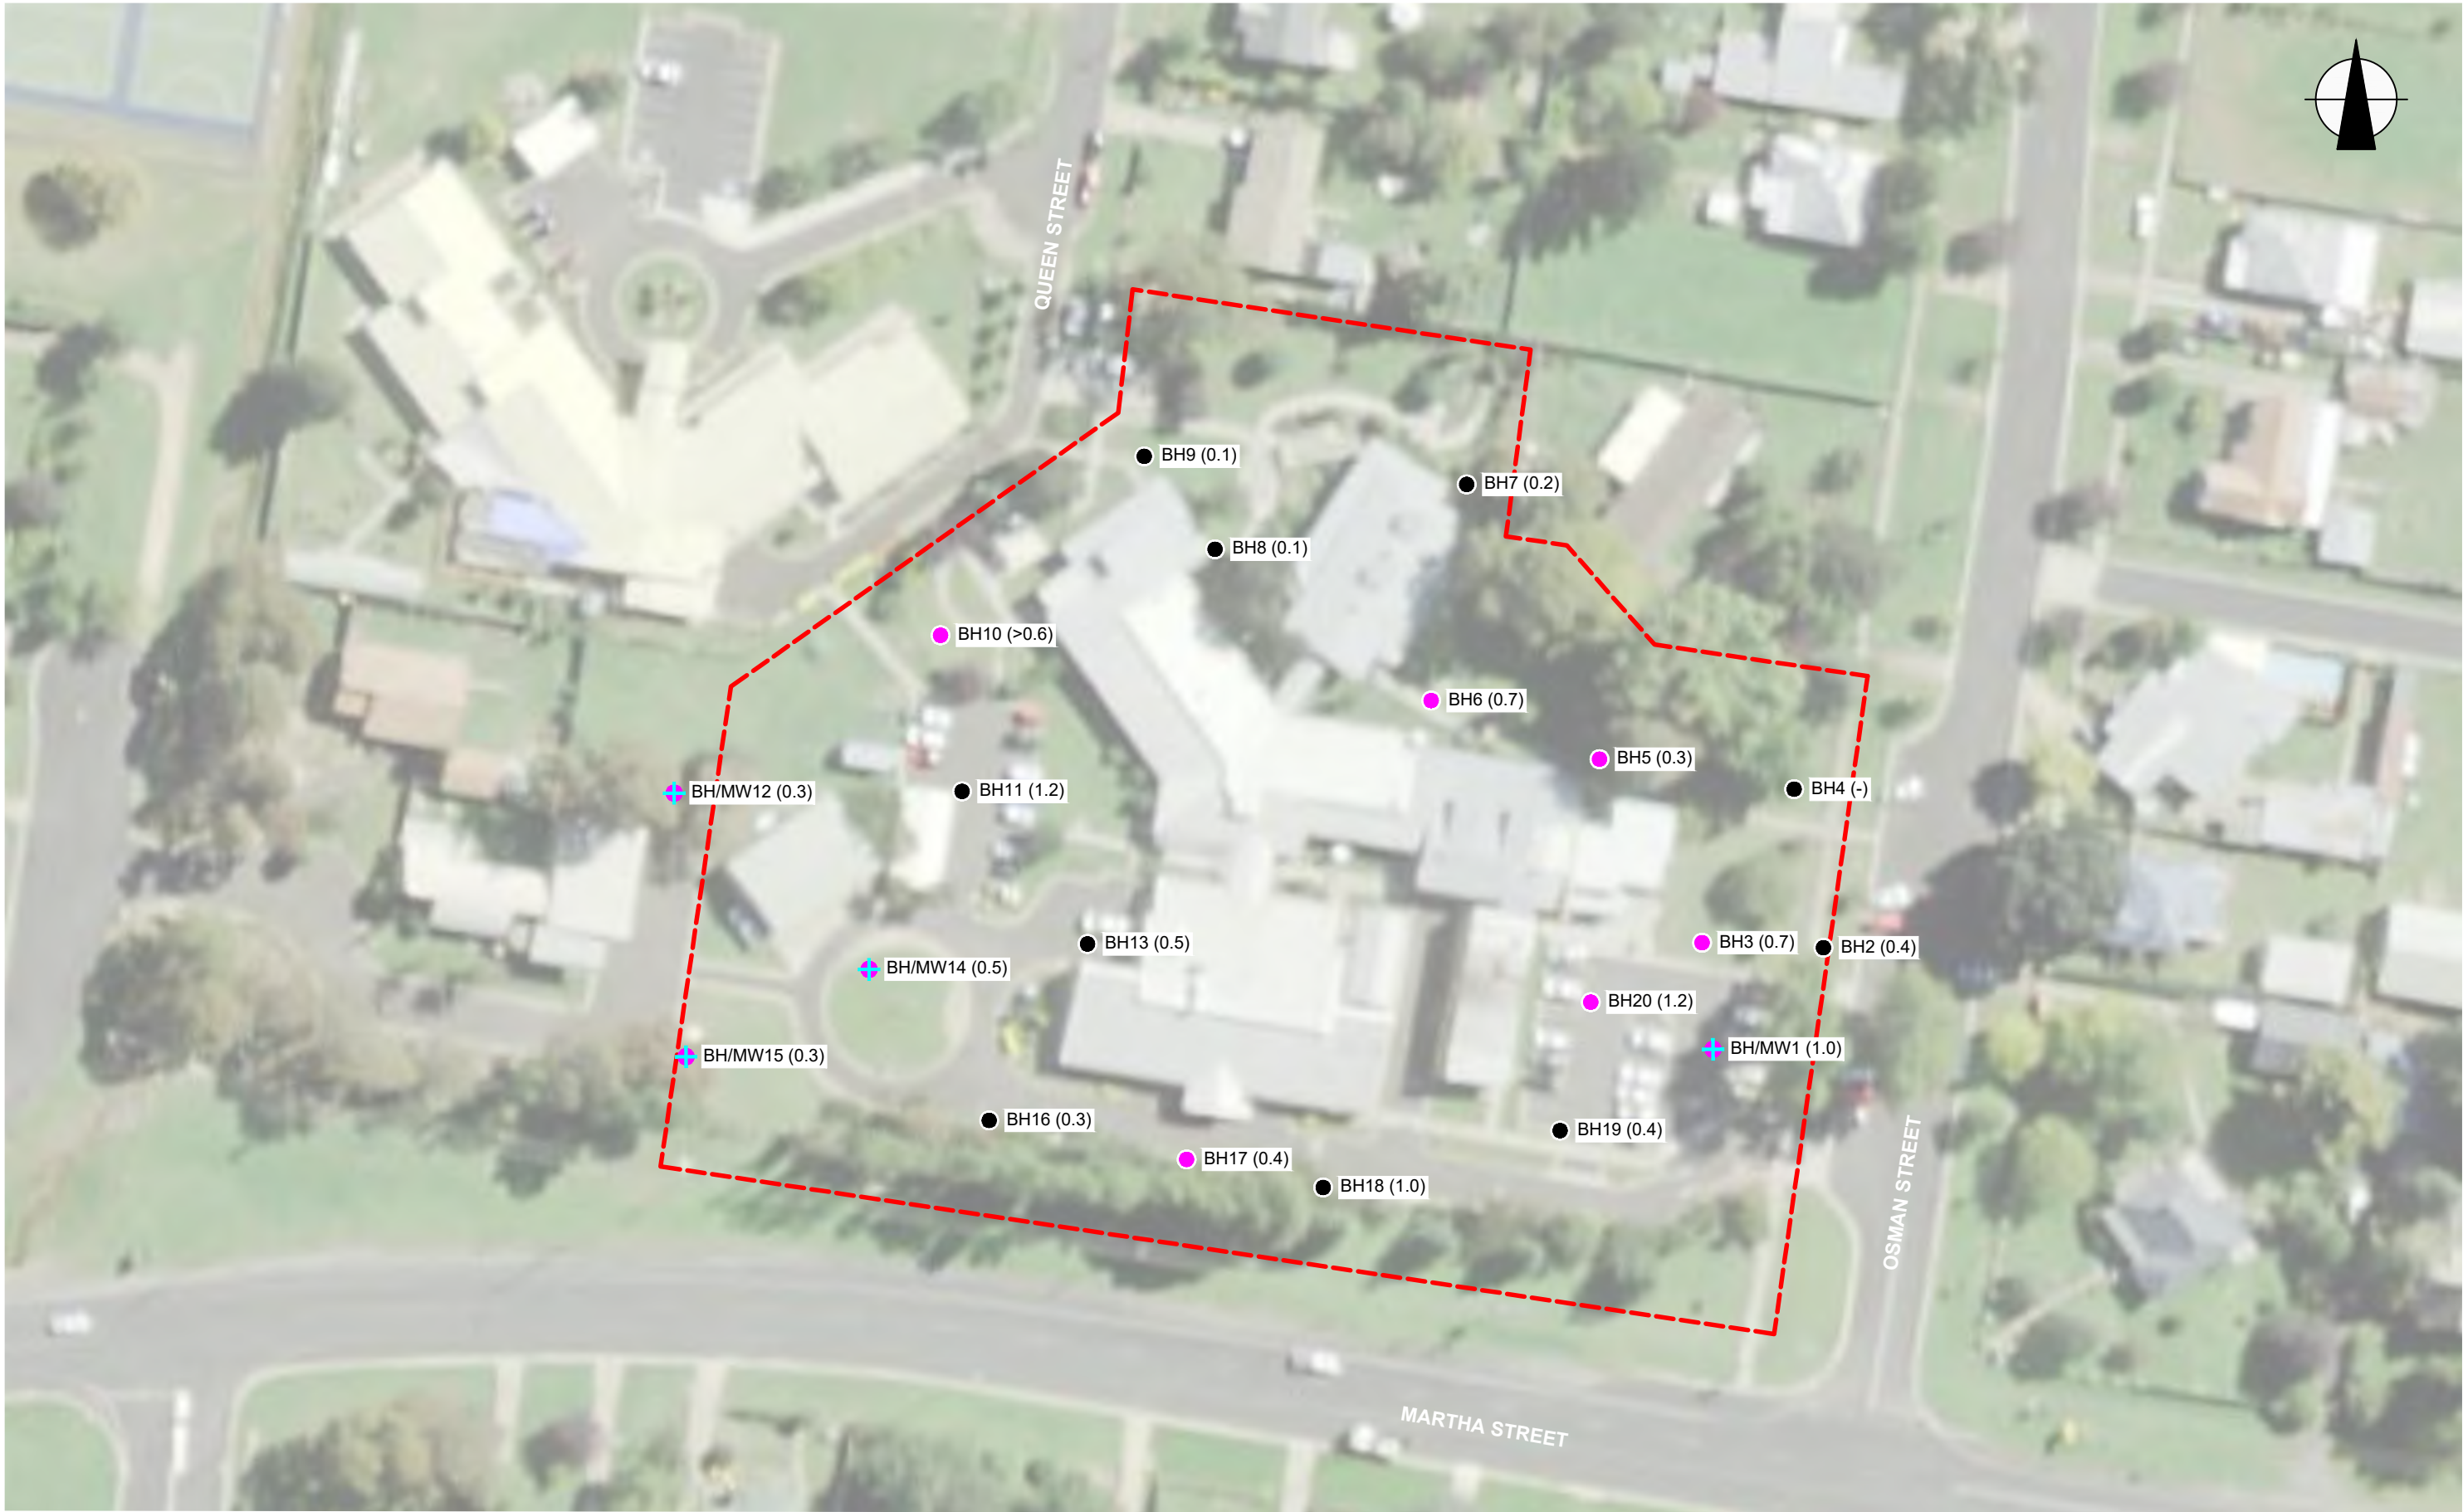
LEGEND	
	APPROXIMATE SITE BOUNDARY
	BOREHOLE LOCATION, NUMBER AND DEPTH OF FILL (m) (JKG/JKE COMBINED)
	BOREHOLE AND GROUNDWATER MONITORING WELL LOCATION, NUMBER AND DEPTH OF FILL (m) (JKG/JKE COMBINED)
	BOREHOLE LOCATION, NUMBER AND DEPTH OF FILL (m) (JKG ONLY)

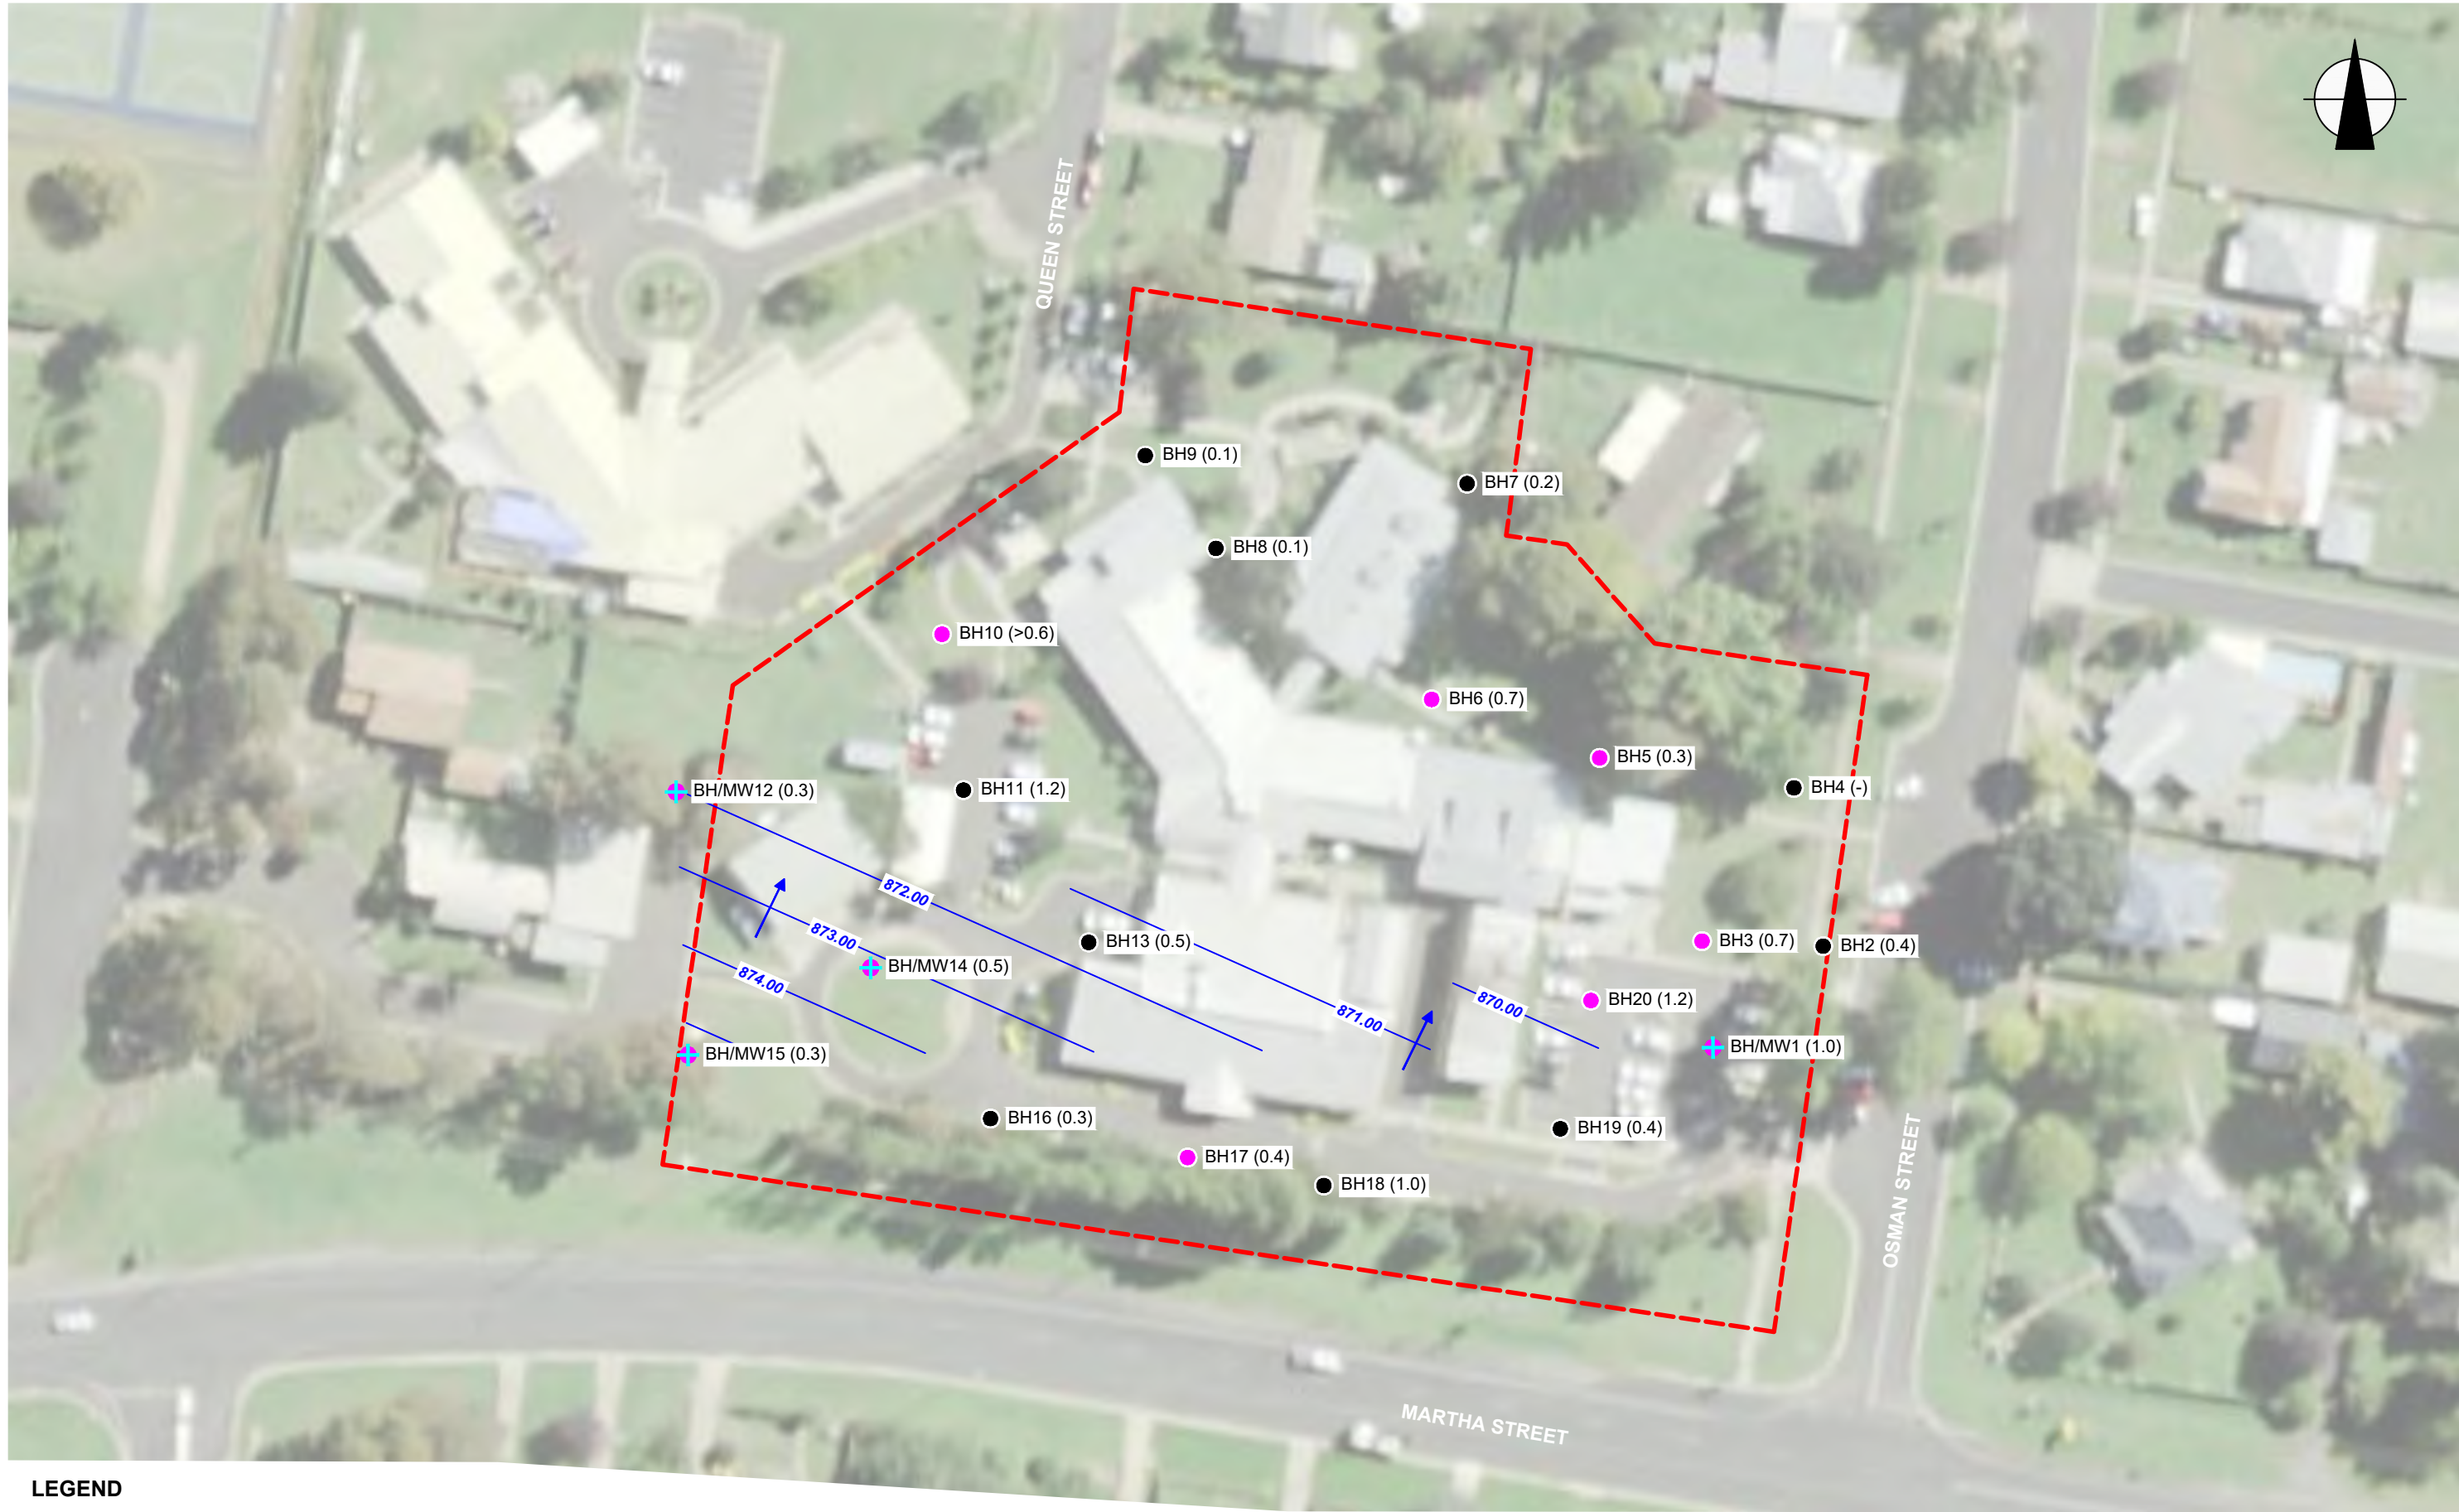
- APPROXIMATE SITE BOUNDARY
- BH(Fill Depth) BOREHOLE LOCATION, NUMBER AND DEPTH OF FILL (m) (JKG/JKE COMBINED)
- + BH/MW(Fill Depth) BOREHOLE AND GROUNDWATER MONITORING WELL LOCATION, NUMBER AND DEPTH OF FILL (m) (JKG/JKE COMBINED)
- BH(Fill Depth) BOREHOLE LOCATION, NUMBER AND DEPTH OF FILL (m) (JKG ONLY)
- 871 GROUNDWATER CONTOUR INTERVALS (m)
- INFERRED GROUNDWATER FLOW DIRECTION
