REPORT TO
NSW HEALTH INFRASTRUCTURE

ON
**DESKTOP PRELIMINARY (STAGE 1) SITE
INVESTIGATION**

FOR
PROPOSED MPS STAGE 5 DEVELOPMENT

AT
**BLAYNEY DISTRICT HOSPITAL, 3 OSMAN STREET,
BLAYNEY, NSW**

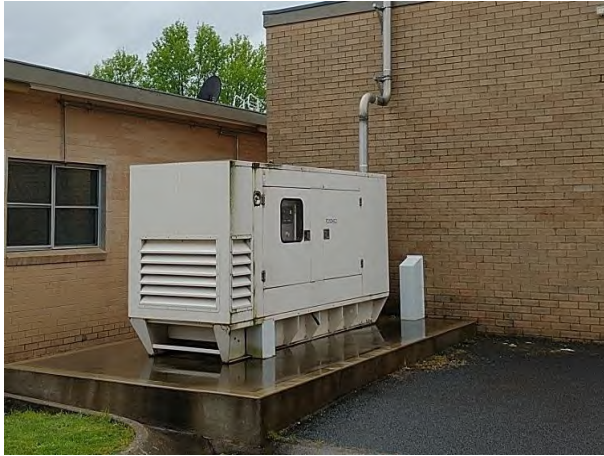
Photograph 1: Hospital back-up generator within in-built diesel tank (refer to Figure 2).

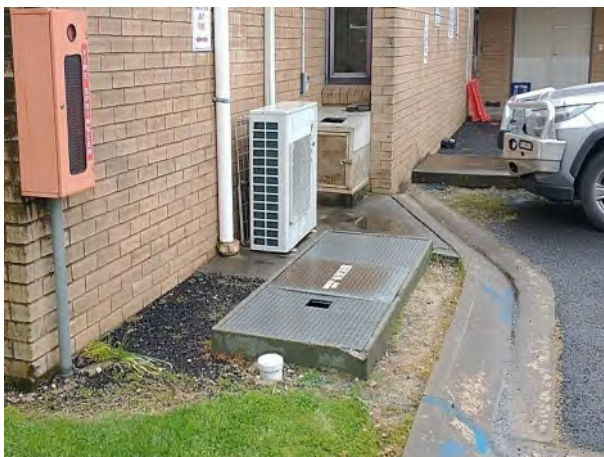
A grease pit was observed at the rear of the main hospital building (refer to figure 2 and the photograph in the appendices).

Photographs 3: Grease trap at rear of main building (west) (refer to Figure 2).

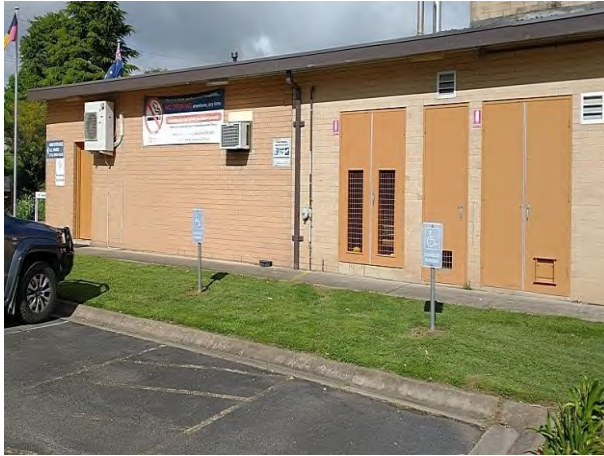
Photograph 4: Eastern frontage of maintenance building. Redundant UST indicated to be located between two signs in foreground of photograph (refer to Figure 2).

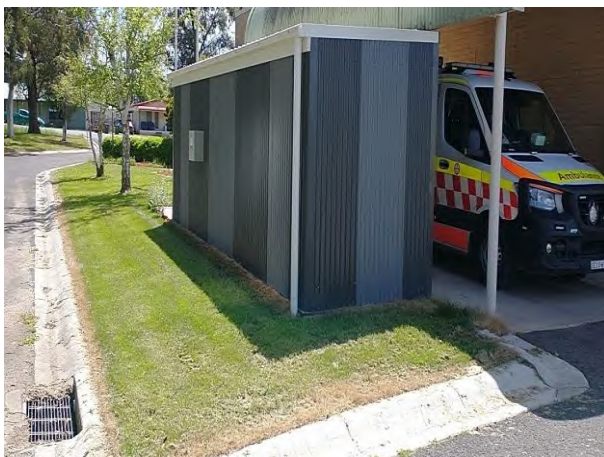
Photograph 6: Off-site adjacent Ambulance station. Approximate location of former UST (beneath shed) and bowser plinth (to right of shed).
