Shoalhaven City Council

Boondobah and Bridge Creek Bridge Renewals

Prepared By: Caitlin Battersby

Date: January 2024

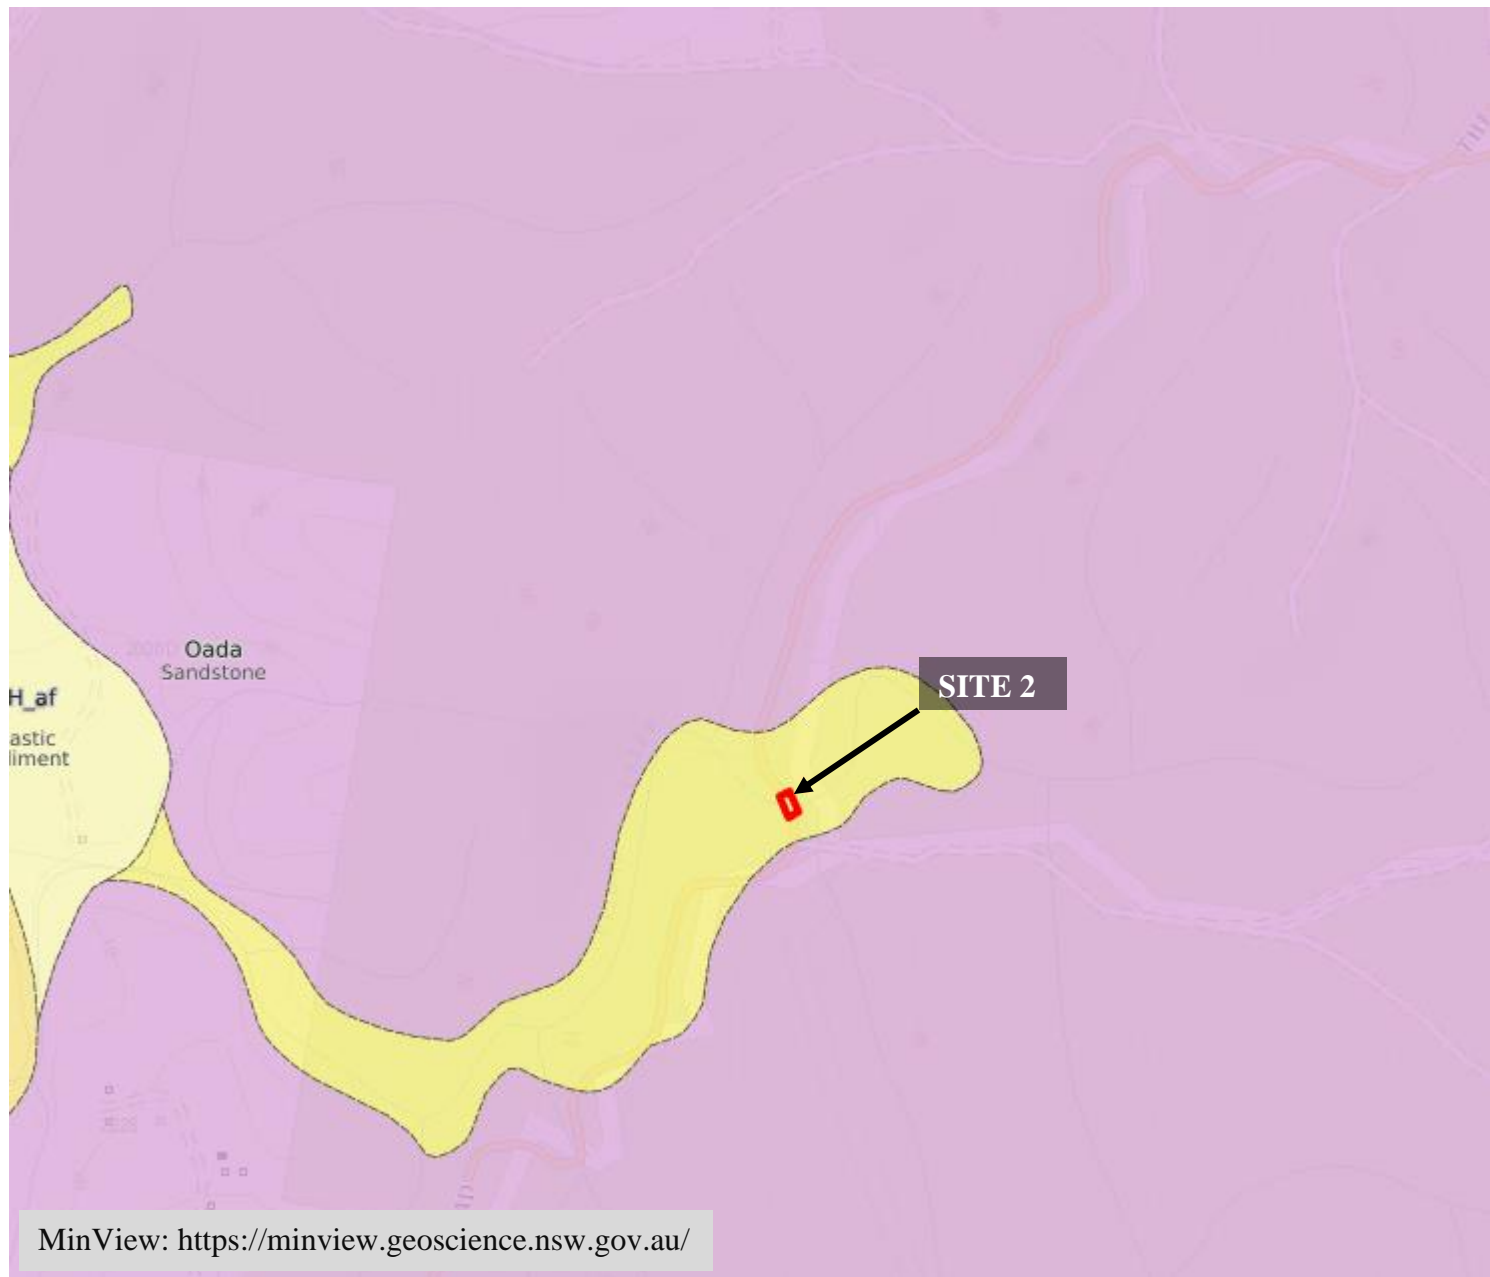
Site Geology – Site 2

Symbol	Group	Unit	Lithology
Q_av	-	Alluvial valley deposits	Silt, clay, (fluvially deposited) lithic to quartz-lithic sand, gravel.
Oada	Abercrombie Formation	-	Brown and buff to grey, thin- to thick-bedded, fine- to coarse-grained mica-quartz (\pm feldspar) sandstone, interbedded with laminated siltstone and mudstone. Sporadic chert-rich units.

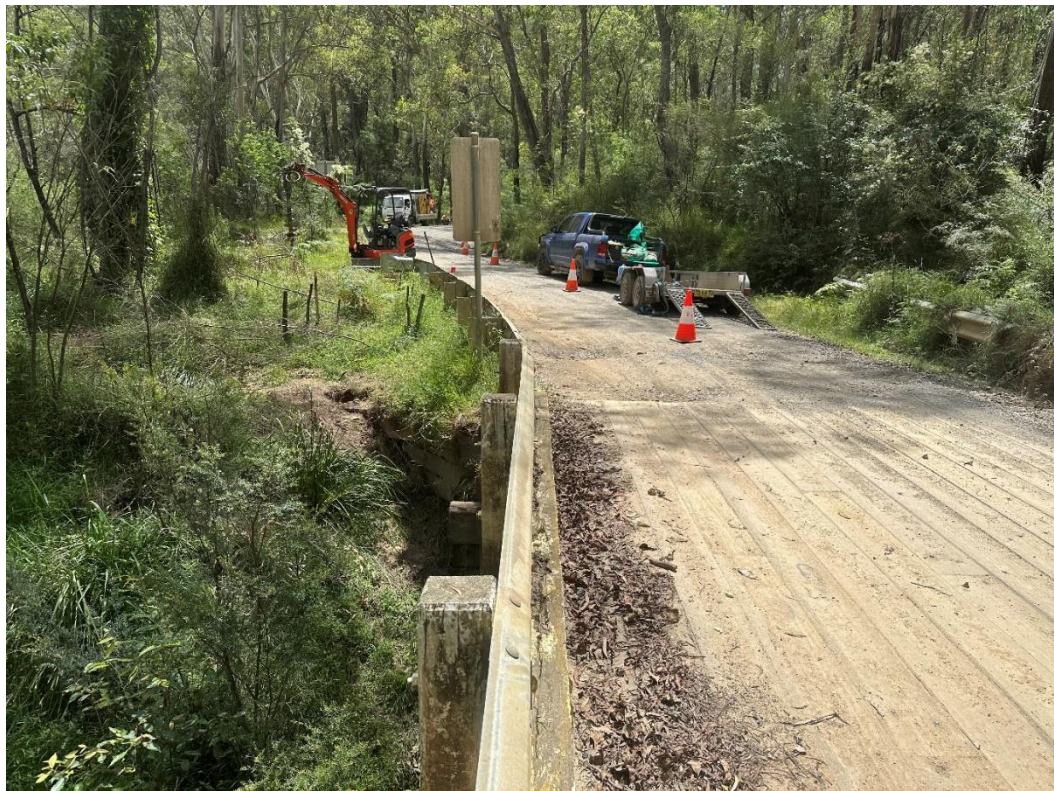
Photograph 3: Site 2 – View of northern abutment.

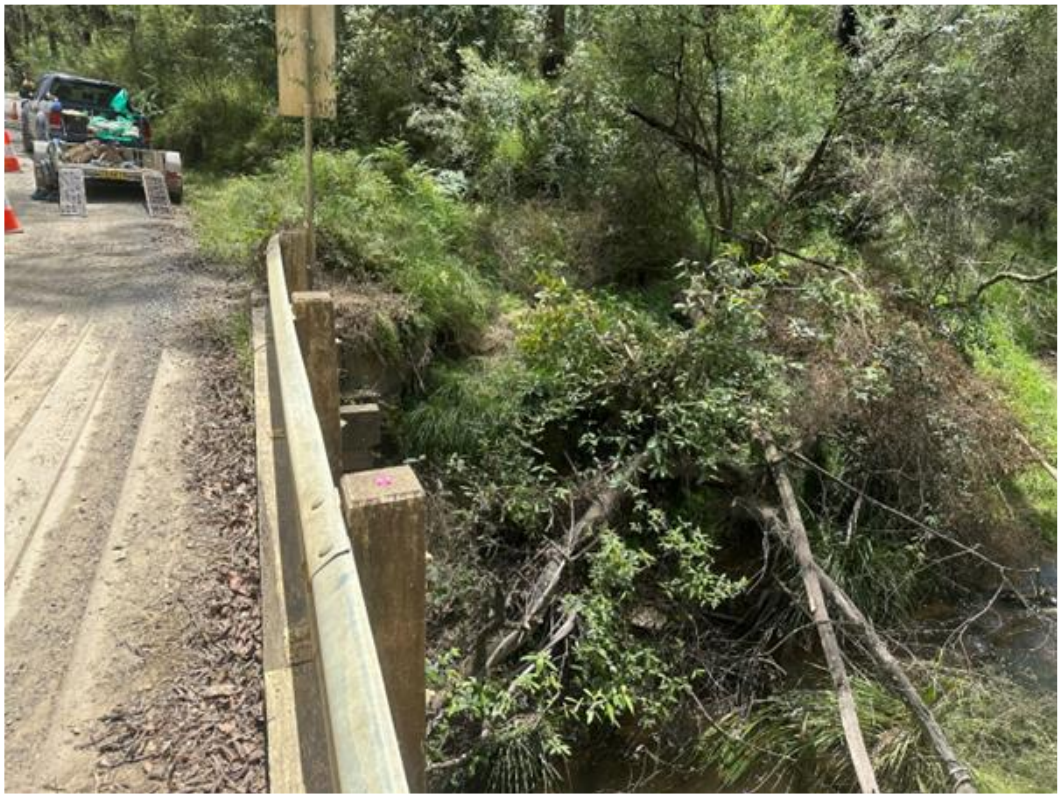
Photograph 4: Site 2 – View of northern abutment.

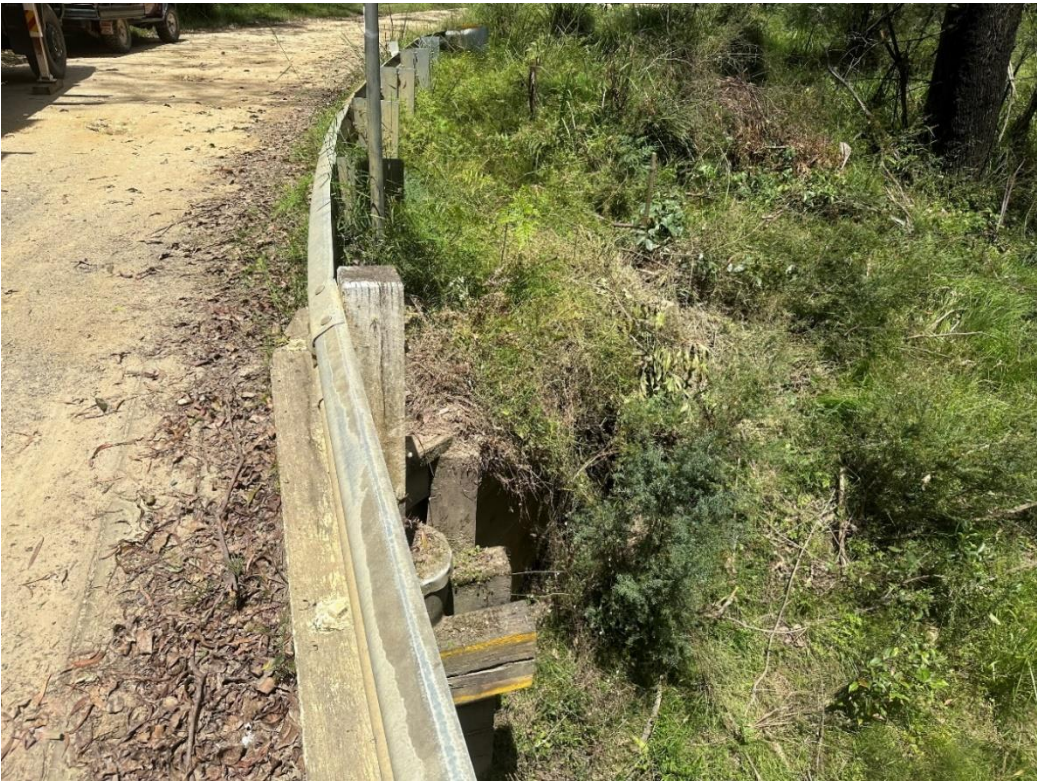
Photograph 8: Site 2 – View of southern abutment.

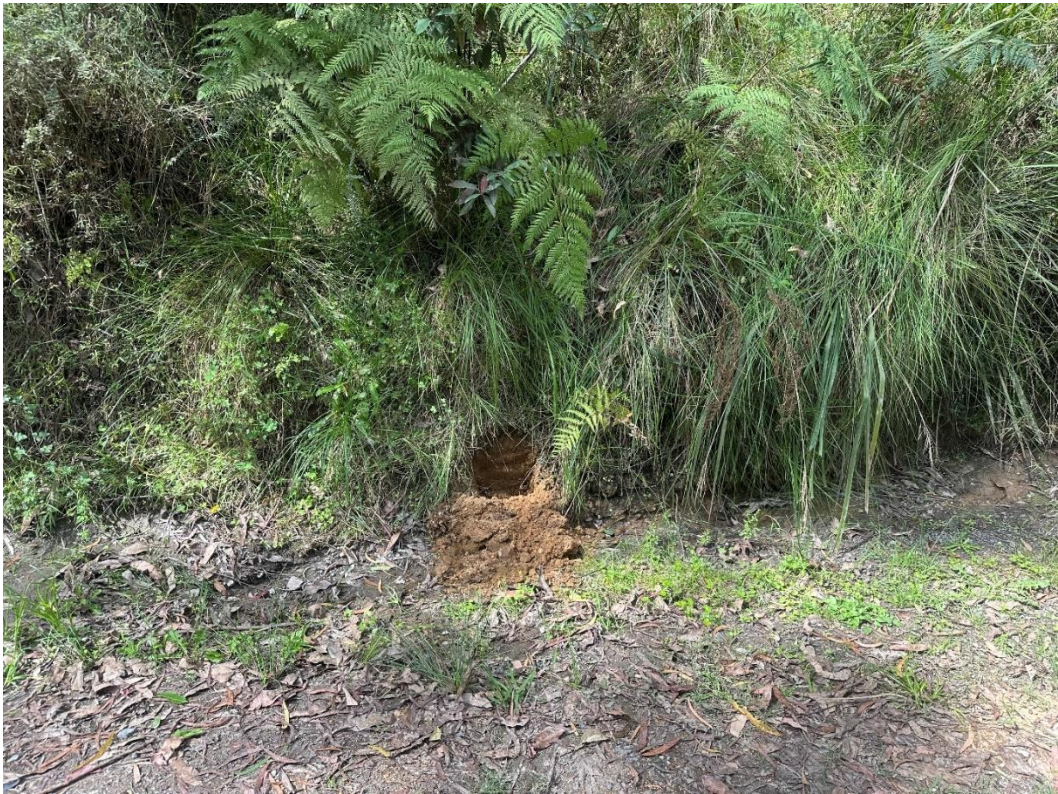
Photograph 9: Site 2 – View of EXP201 on the northern side of the bridge.

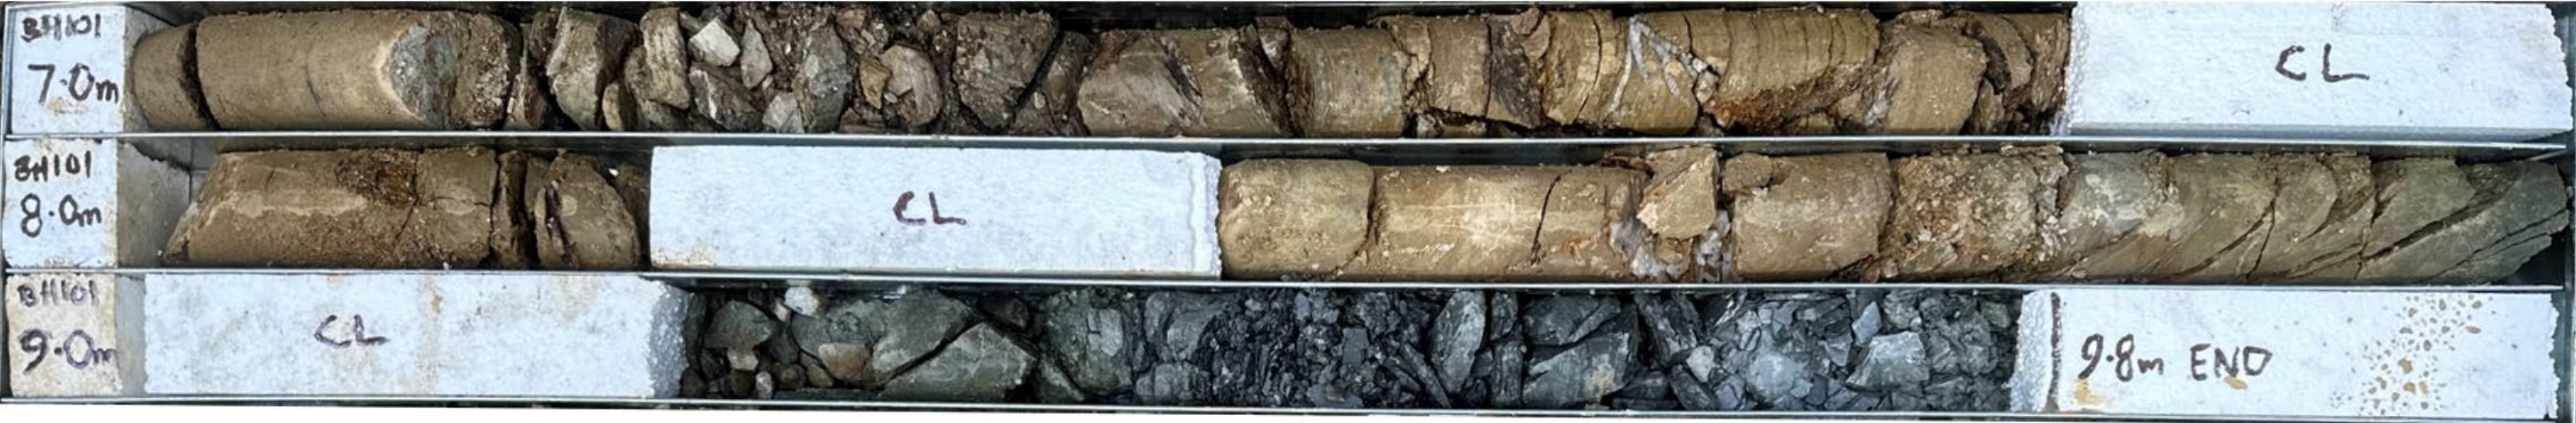
Core Recovery BH101
Start Core at 7.0m depth
EOH at 9.8m Depth

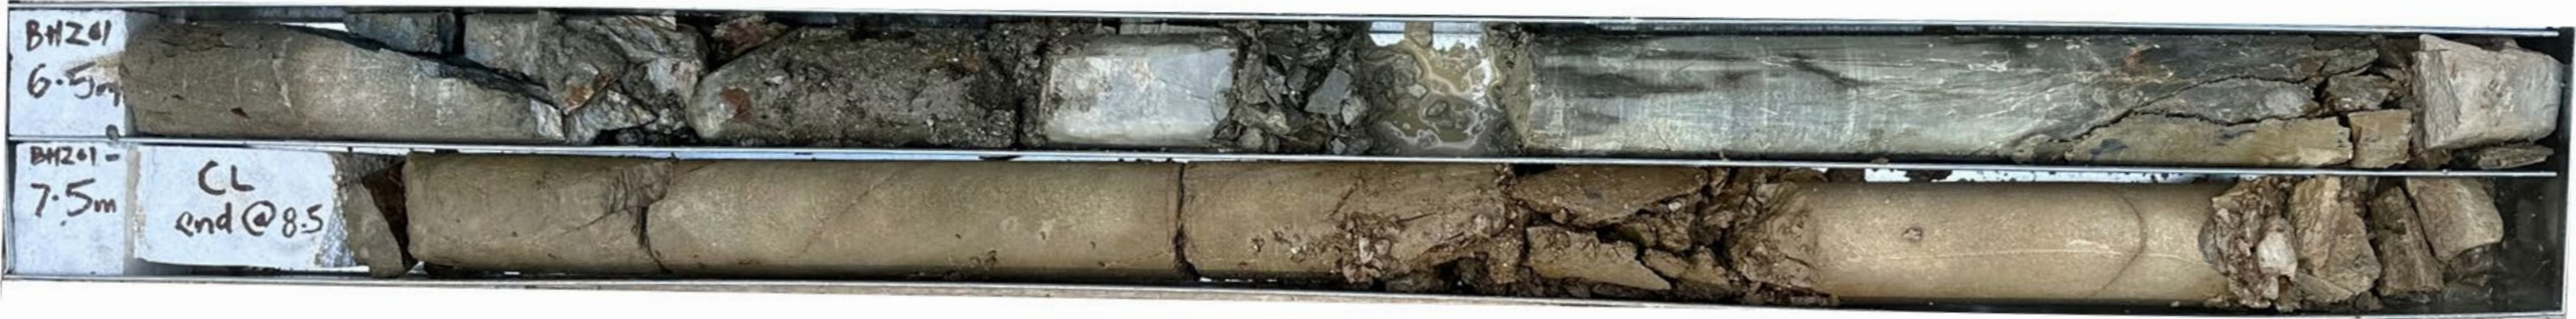
Core Recovery BH201
Start Core at 6.5m depth
EOH at 8.5m Depth
