Murrays Road Bridge, Murrays Road, Conjola

Heritage Assessment
For Shoalhaven City Council

Version 1: February 2022

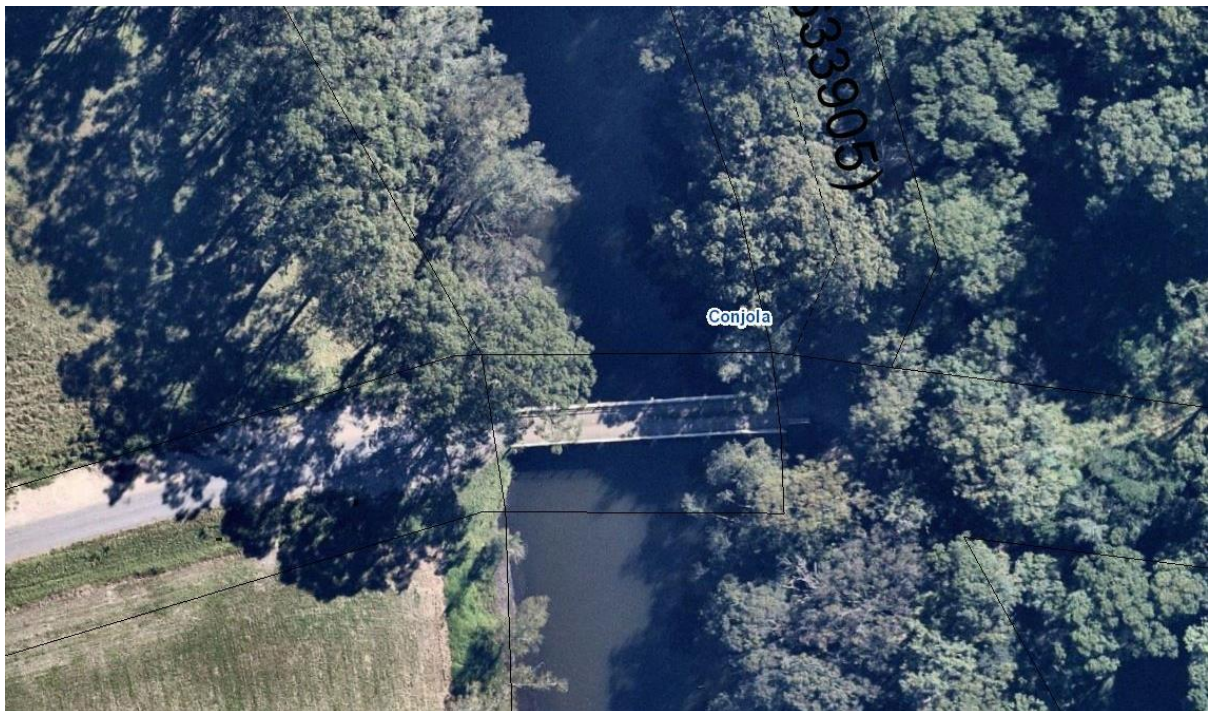
Figure 2. Aerial view of the Murrays Road Bridge. Image supplied by Shoalhaven City Council

The single lane bridge originally consisted of five spans and is 36m long. The Bridge now consists of 6 spans all with timber cross decking and running planks supported by 4 timber girders on piles. The pile sets having 3 piles braced with headstock and corbels. The western abutment consists of timber wing walls, piles and gravel boards. Handrails consist of timber post top rail and mid rail. Top rail is angled at 45 degrees. The listing includes Murrays Bridge, the roadway approaches and the Conjola Creek embankments. It is apparent that the timber bridge has been repaired on many occasions.

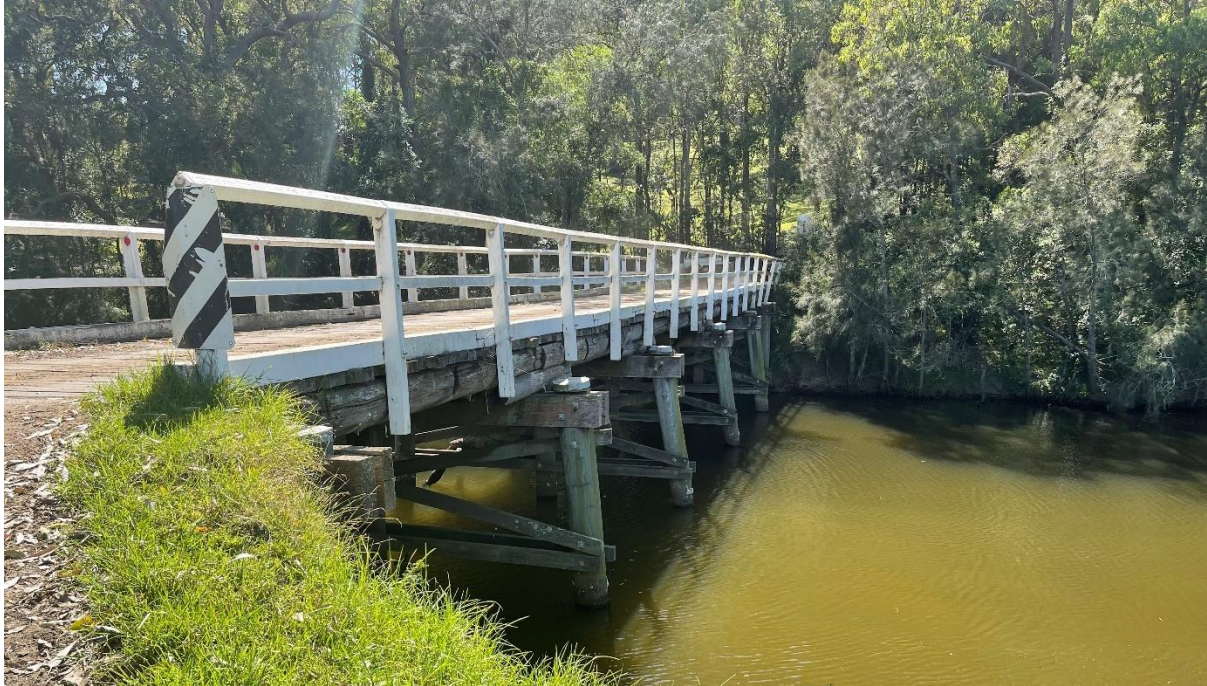
Figure 6. South side of bridge from western approach

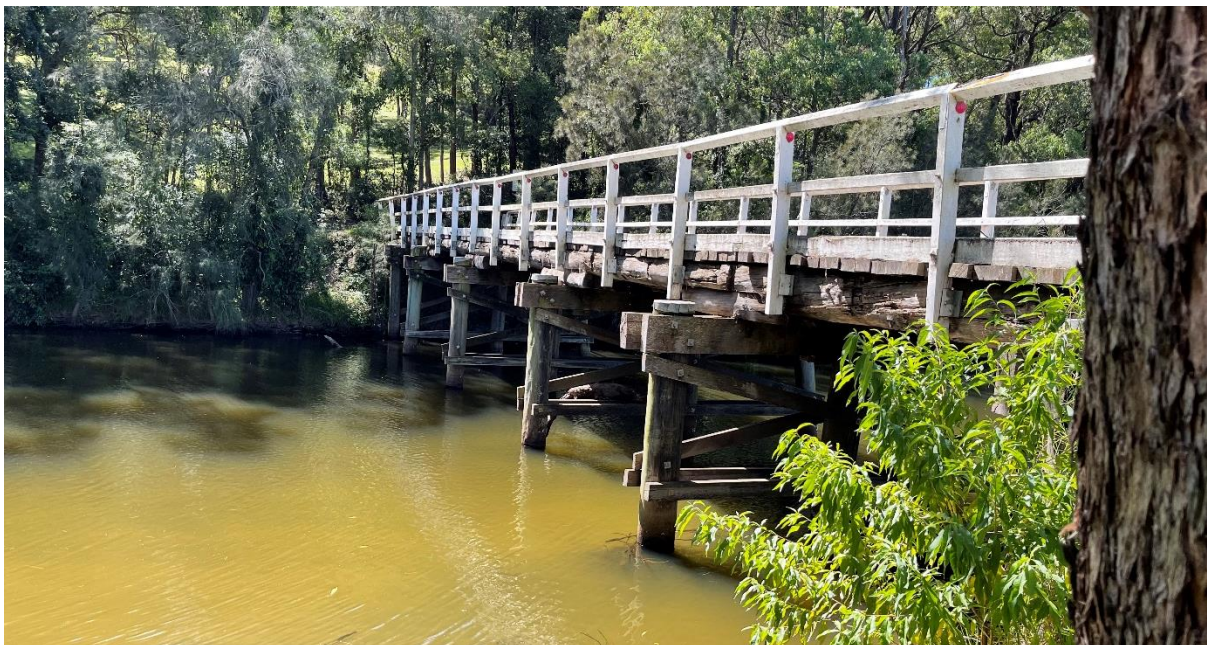
Figure 7. North side of bridge from western approach

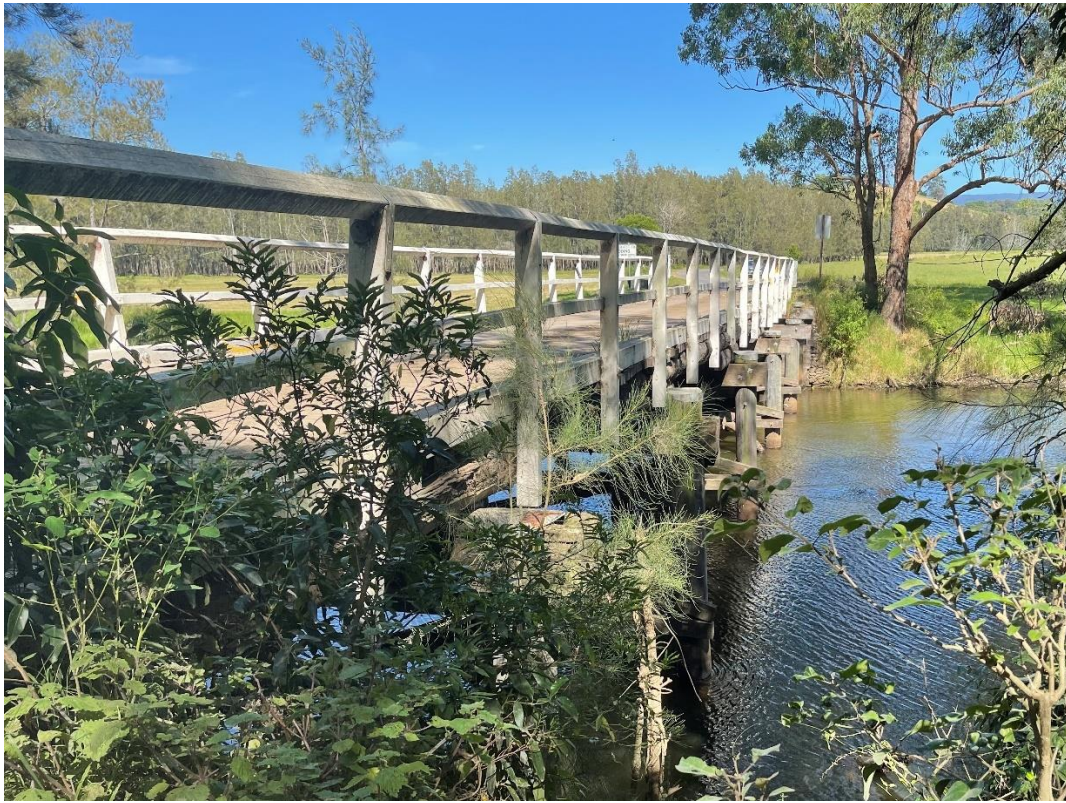
Figure 8. The bridge viewed from the eastern end looking towards Murrays Flats

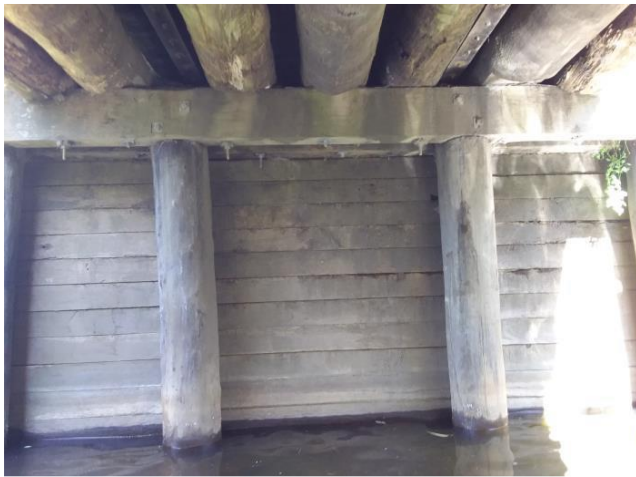
spans they are supported by timber corbels. About half the girders are redundant as they were left in-situ when new girders were installed at the last major bridge maintenance.

Figure 10. Western abutment. Note redundant girders have been left in-situ (Shoalhaven City Council,, 2021)

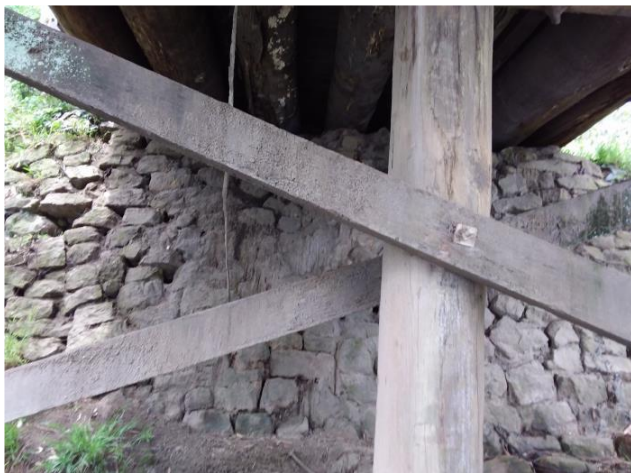
Murrays Road Bridge is supported on the eastern end by a stone abutment. The stone is stacked and without mortar and forms a retaining wall to the road at eastern end of the bridge. At the other end is a horizontally laid retaining wall of butted timber planks behind four piles.

Figure 11. Eastern abutment (Shoalhaven City Council,, 2021)

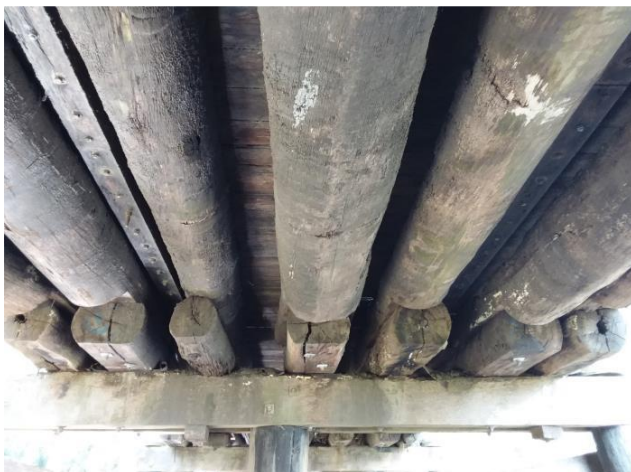
There are four trestle supports comprised of 3 round section piles each connected by diagonal sawn cross bracing and a horizontal bottom brace. A sawn stringer spans either side of the three piles supported on the outer edge by headstocks. Round section timber girders that have been made flat on the upper surface to accommodate the decking. Where the girders meet at the piers in opposing

Figure 12. Detail of girders and corbels on the first span (Shoalhaven City Council,, 2021)

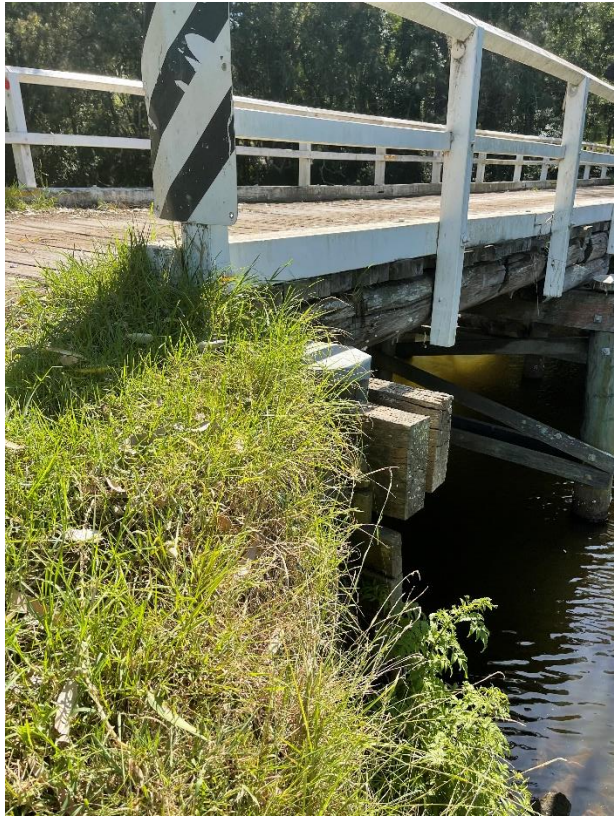
Figure 13. Southern side detail

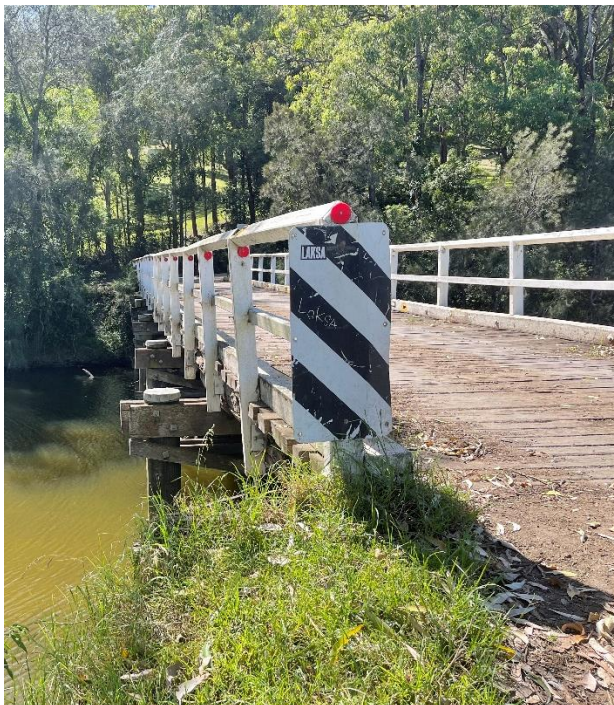
Figure 15. Top of the bridge from western approach

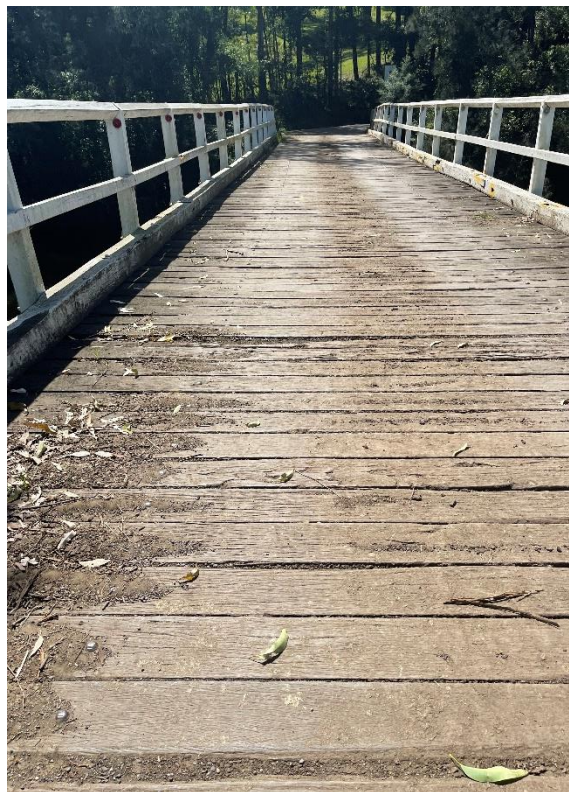
Figure 16. Decking and railings

Substructure at abutment 2 is nonvisible. All original superstructure components are defective. Strengthening components are showing signs of rotting and splitting. Kerbs and rails are rotting with section loss. Decking is loose and failing in some locations. Timber drill test is required on some

girders to determine the structural integrity of the component. Recommend assessment by a structural engineer to revise load rating. (Shoalhaven City Council,, 2021)

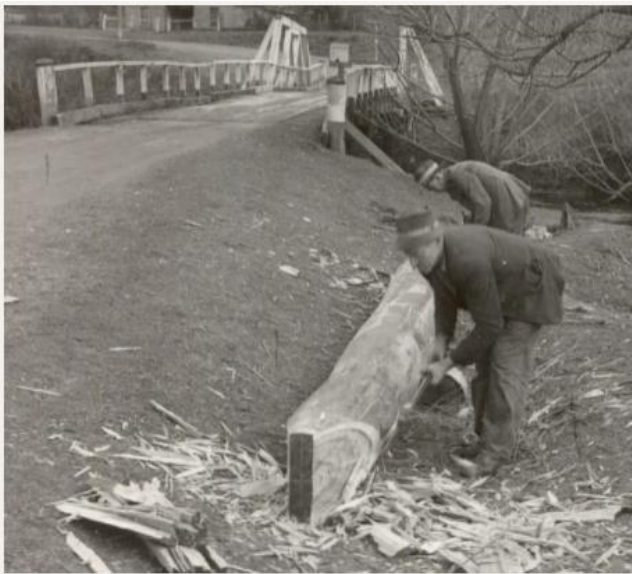
Figure 6.12: Hewing a log with a broad axe. Source: VicRoads, Roads and Maritime copy

Figure 20. Picture showing a log being hewn by hand with a broad axe. Date unknown. (Roads and Maritime Services, 2014)

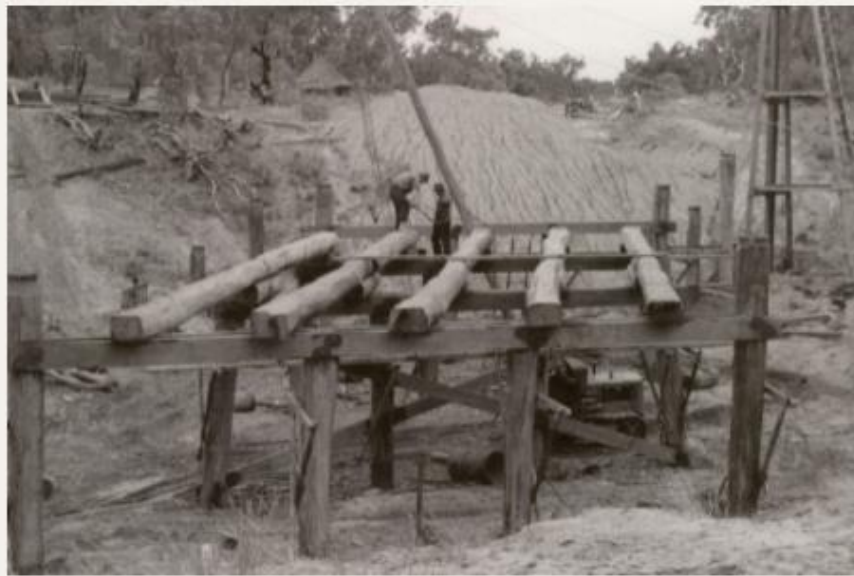
Figure 6.21: Gin pole is at rear centre with ropes extended to place a girder log, with piling derrick at rear (R). Source: Roads and Maritime

Figure 21. A timber girder bridge under construction, Date unknown. (Roads and Maritime Services, 2014)

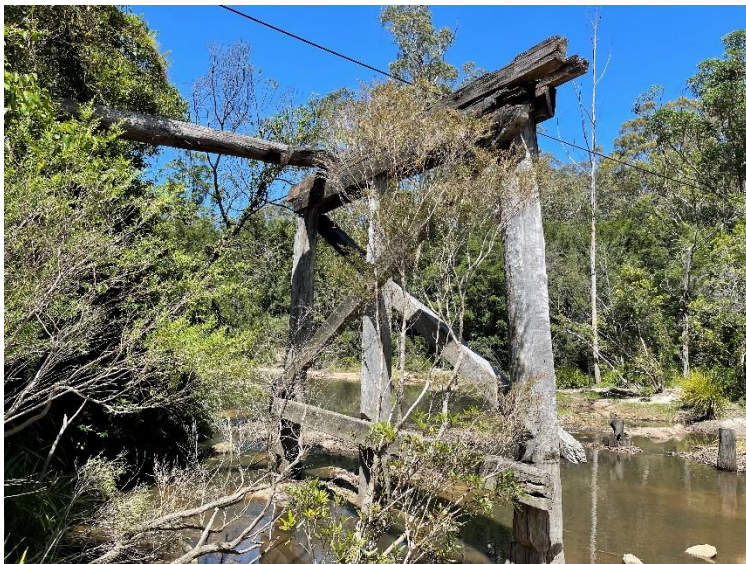
Timber beam bridges were once common in the Shoalhaven. A surviving example of a timber trestle and girder bridge can be found at Falls Creek. The bridge is now a ruin but is still in-situ crossing Currumbene Creek. It is a trestle and beam bridge of the same construction detail as the Murrays Road Bridge and was built as part of the Princes Highway.

Figure 22. Old Currumbene Creek Bridge

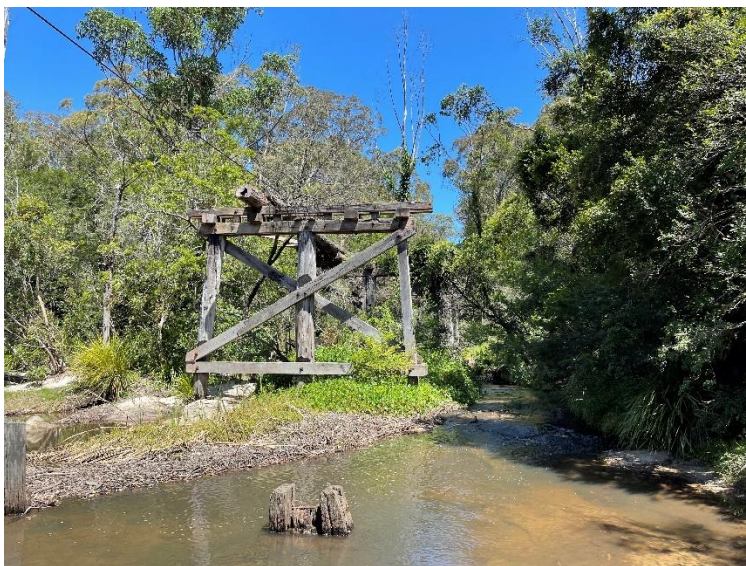
Figure 23. Old Currumbene Creek Bridge at Falls Creek

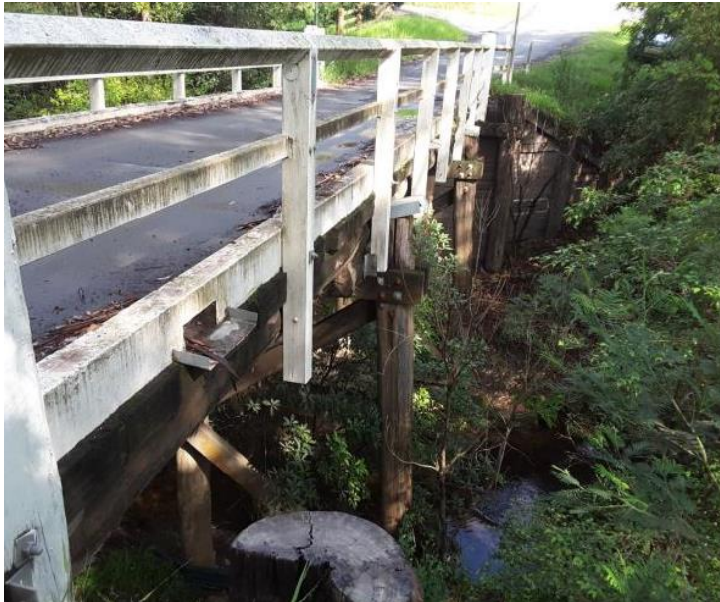
Another timber beam bridge on trestles in the Shoalhaven is Pettys bridge on Croobyar Road, Croobyar. An inspection of Pettys Bridge by Council's asset officers revealed significant structural issues requiring immediate rectification. The bridge has been assessed and is programmed for replacement with a concrete bridge.

Figure 24. Pettys Bridge, Croobyar Road in March 2020 (Manly, 2020)

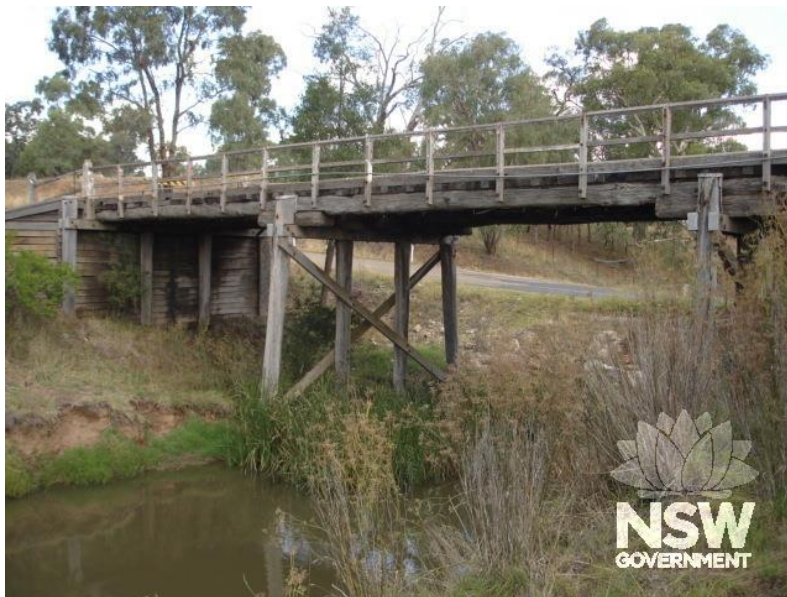
Figure 26. Clifton Bridge (NSW Heritage, 2022)

The Clifton Bridge is no longer in use, it has been fenced off at either end.

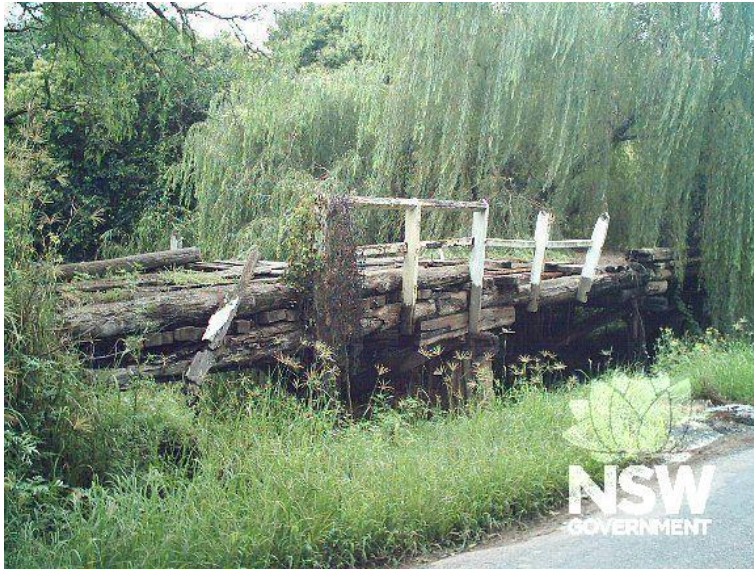
Figure 27. Brownlow Hill Road Bridge in 2006 (NSW Heritage, 2022)

The Brownlow Hill Bridge was in poor condition in 2006, it is not known if it has been conserved.

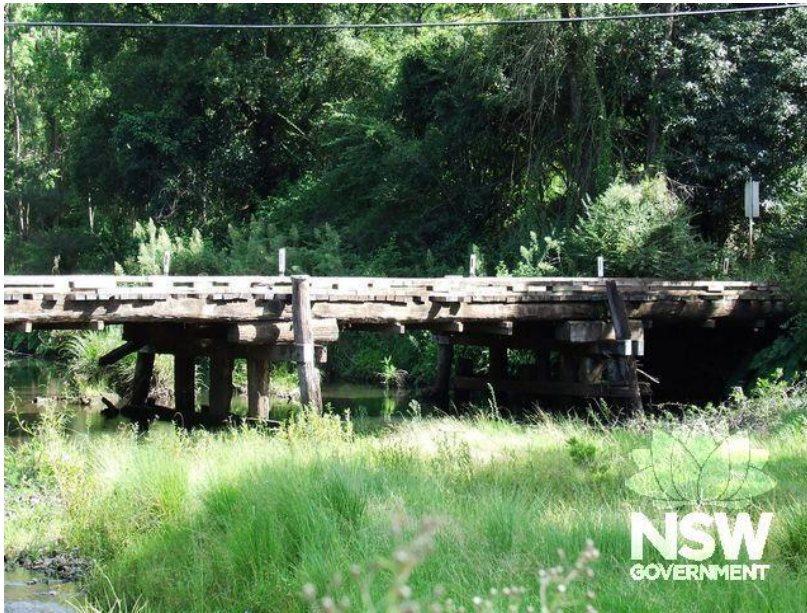
Figure 28. Green pigeon bridge in 2009 (NSW Heritage, 2022)

Photographs in the heritage database show the Green Pigeon Bridge to be still in use as a road bridge.

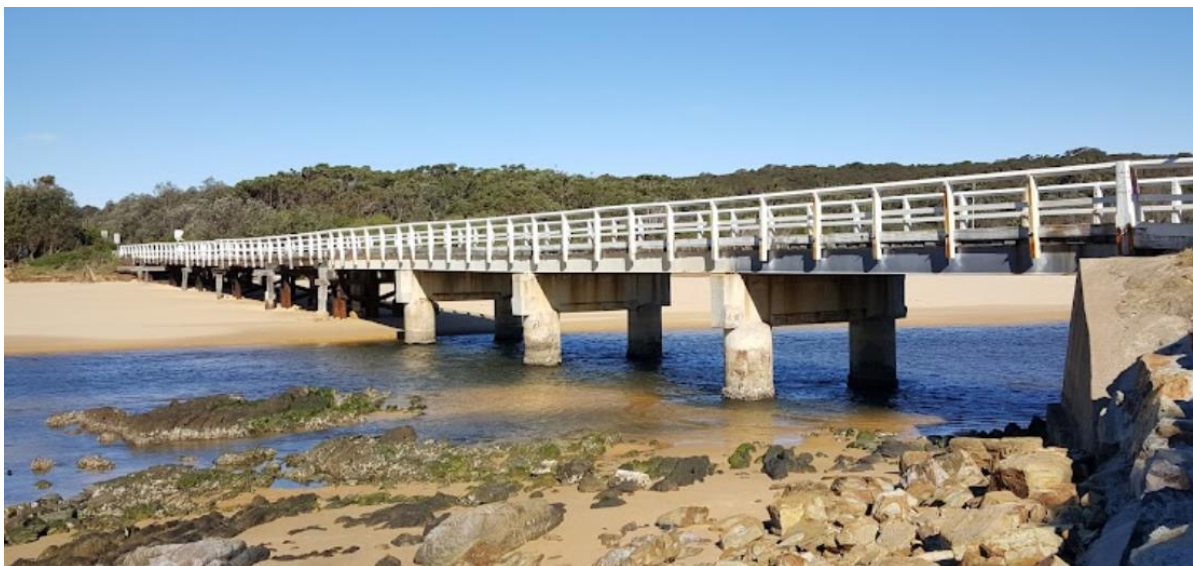
Figure 33. Cuttagee Bridge, Tathra Bermagui Road, NSW. Part of the timber bridge remains at one end.
