**REPORT TO
NSW DEPARTMENT OF EDUCATION**

**ON
GEOTECHNICAL INVESTIGATION**

**FOR
PROPOSED UPGRADE**

**AT
KOGARAH PUBLIC SCHOOL,
24B GLADSTONE STREET, KOGARAH, NSW**

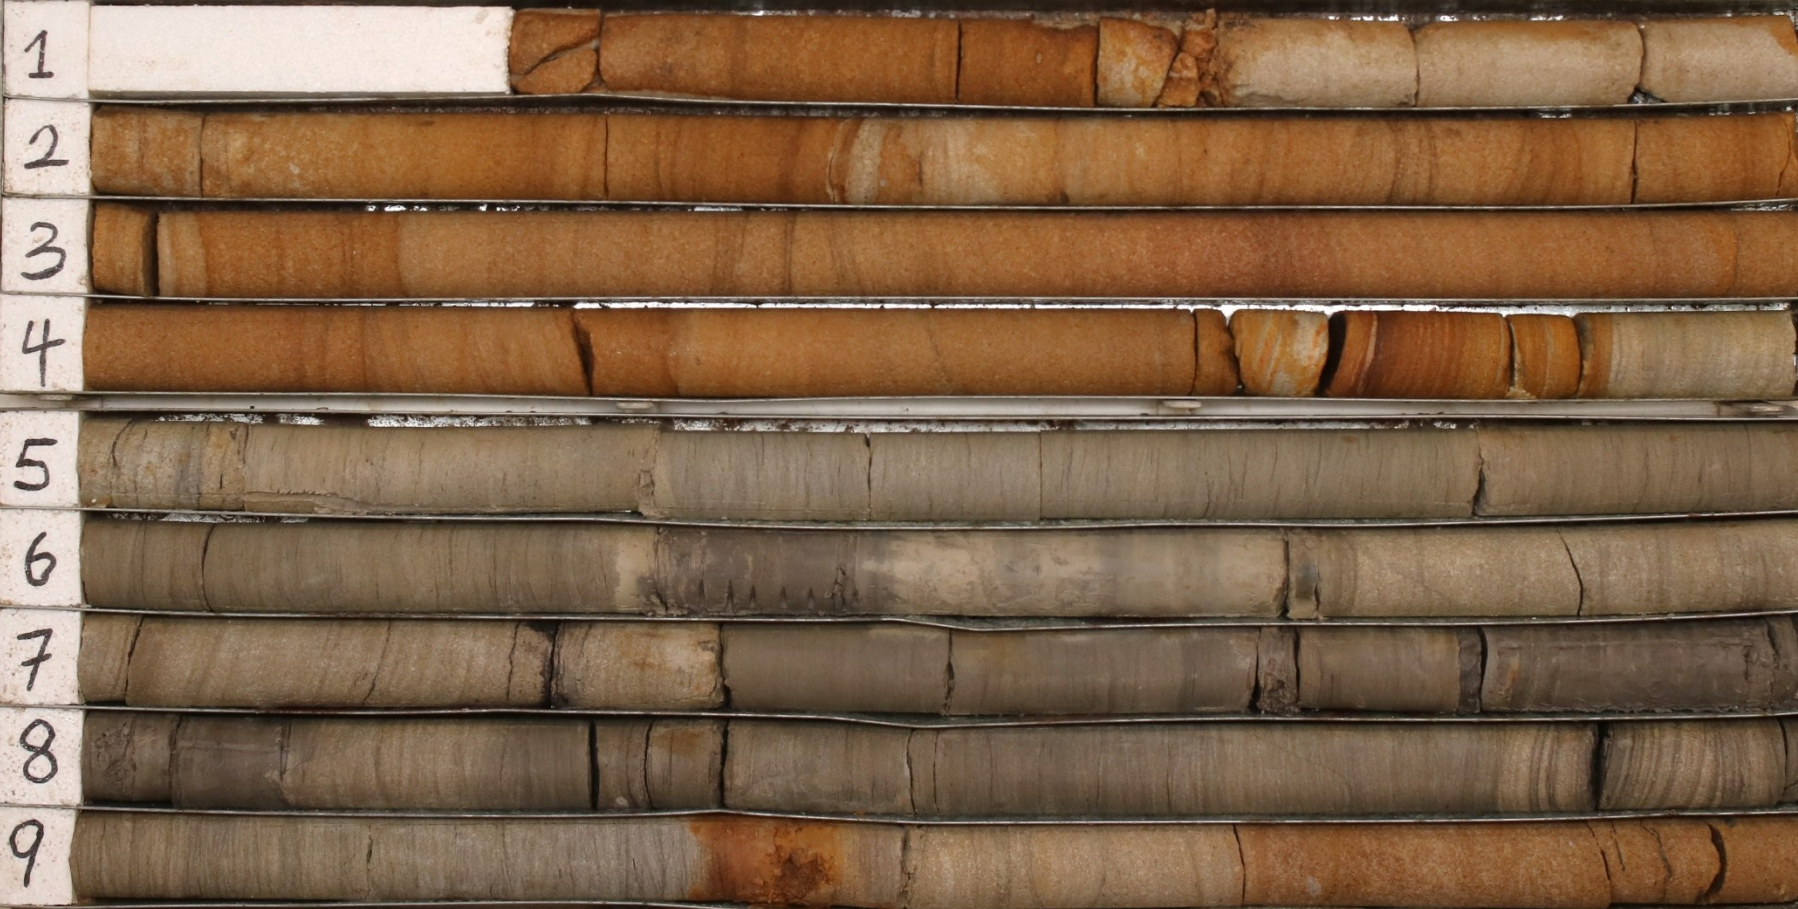
Job No: 32976LT1 32976LT1
Borehole No: BH201
Depth: 1.24m to 10.00m

32976LT1 BH201 START CORING AT 1.24 m

1. The upper bedrock in BH201 has been downgraded to Class III, due to the presence of a relatively thick extremely weathered seam towards the base of the upper bedrock profile.
2. Due to the presence of thick extremely weathered seams or 'no core' zones in the upper profile, the sandstone above the nominated depths/levels in BH202, BH204, BH206 and BH208 is not considered suitable as a founding stratum for footings.
3. The upper bedrock in BH202 and BH207 has been downgraded to Class IV, due to the presence of a thick extremely weathered seam towards the base of the upper bedrock profile.
4. The upper bedrock in BH205 and BH206 has been downgraded to Class V, due to the presence of a thick extremely weathered seam towards the base of the upper bedrock profile.

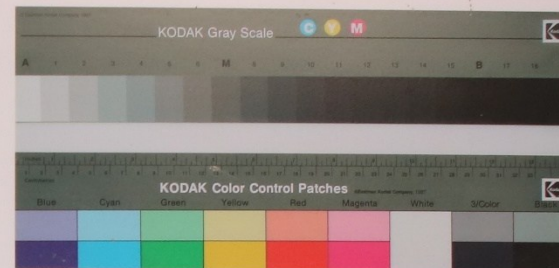
Job No: 32976LT1
Borehole No: BH202
Depth: 2.72m to 11.82m

32976LT1 BH202 START CORING AT 2.72 m

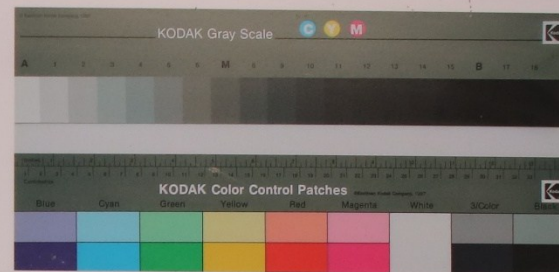
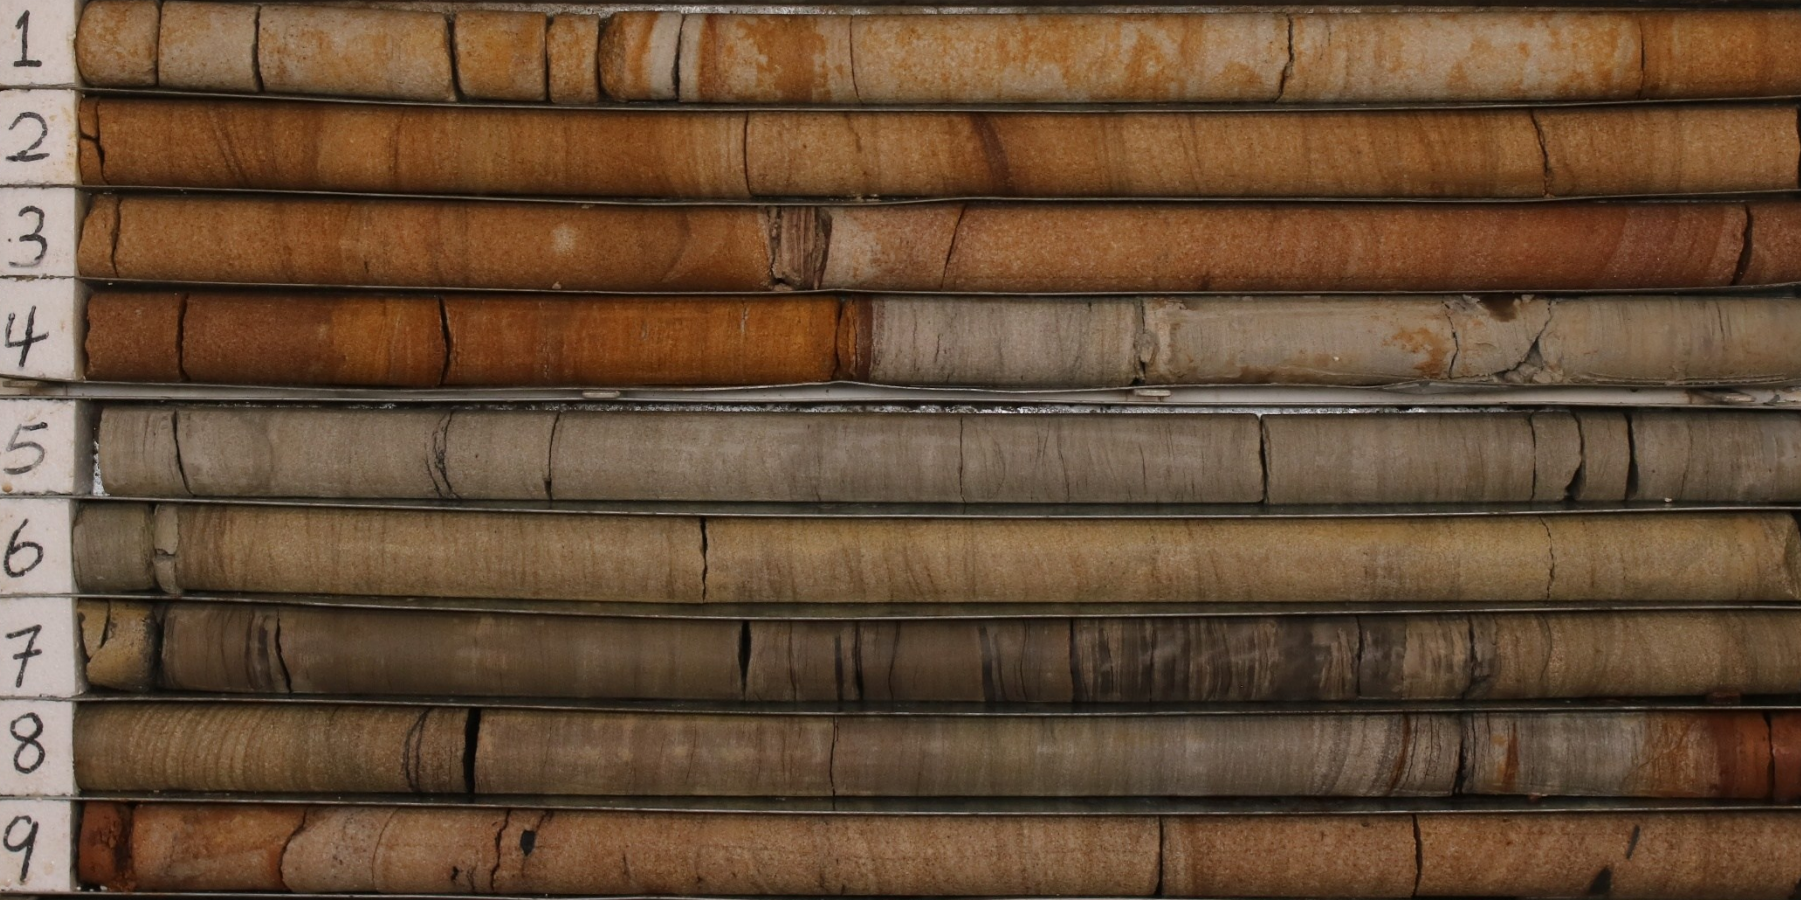
Job No: 32976LT1
Borehole No: 203
Depth: 1.00 to 10.00m

32976LT1 BH203 START CORING AT 1.00 m

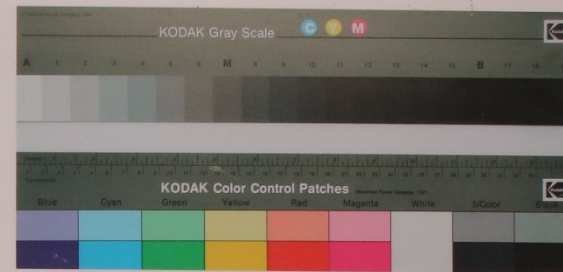
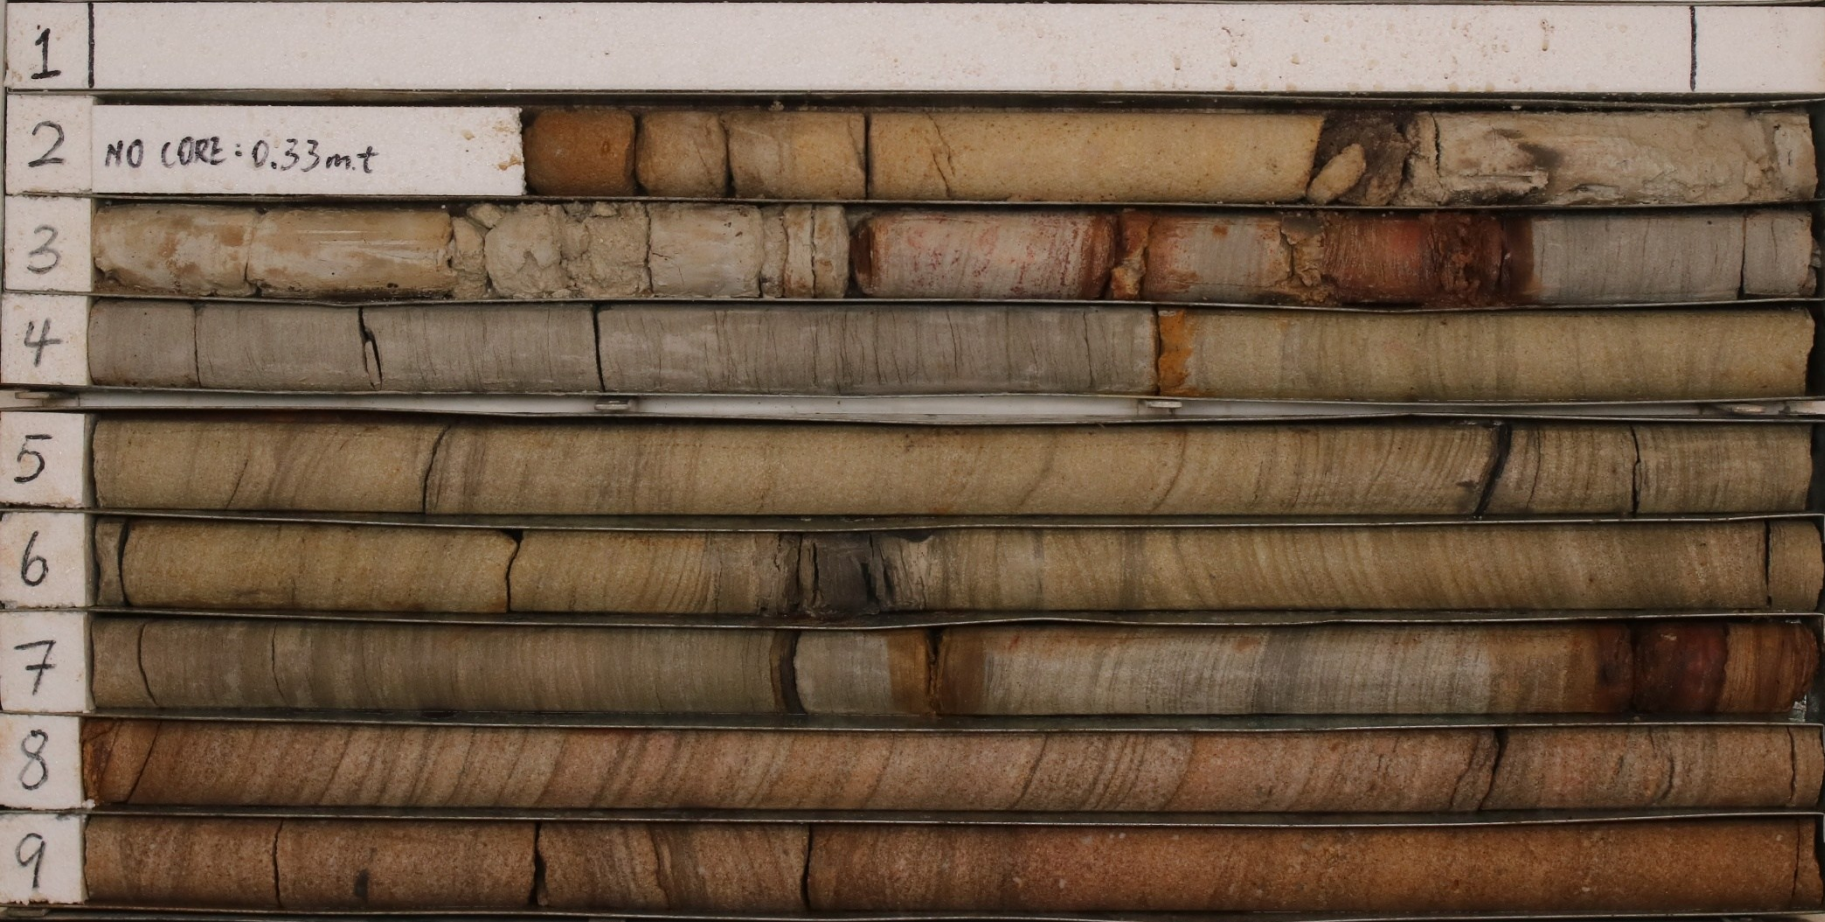
Job No: 32976LT
Borehole No: 204
Depth: 1.92 to 10.00m

32976LT1 BH204 START CORING AT 1.92 m

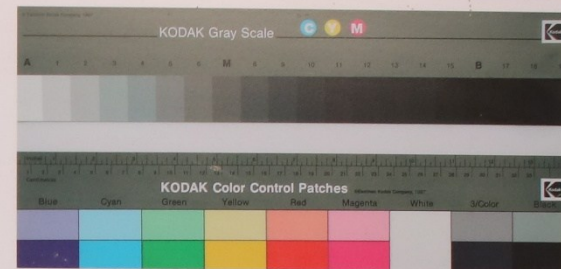
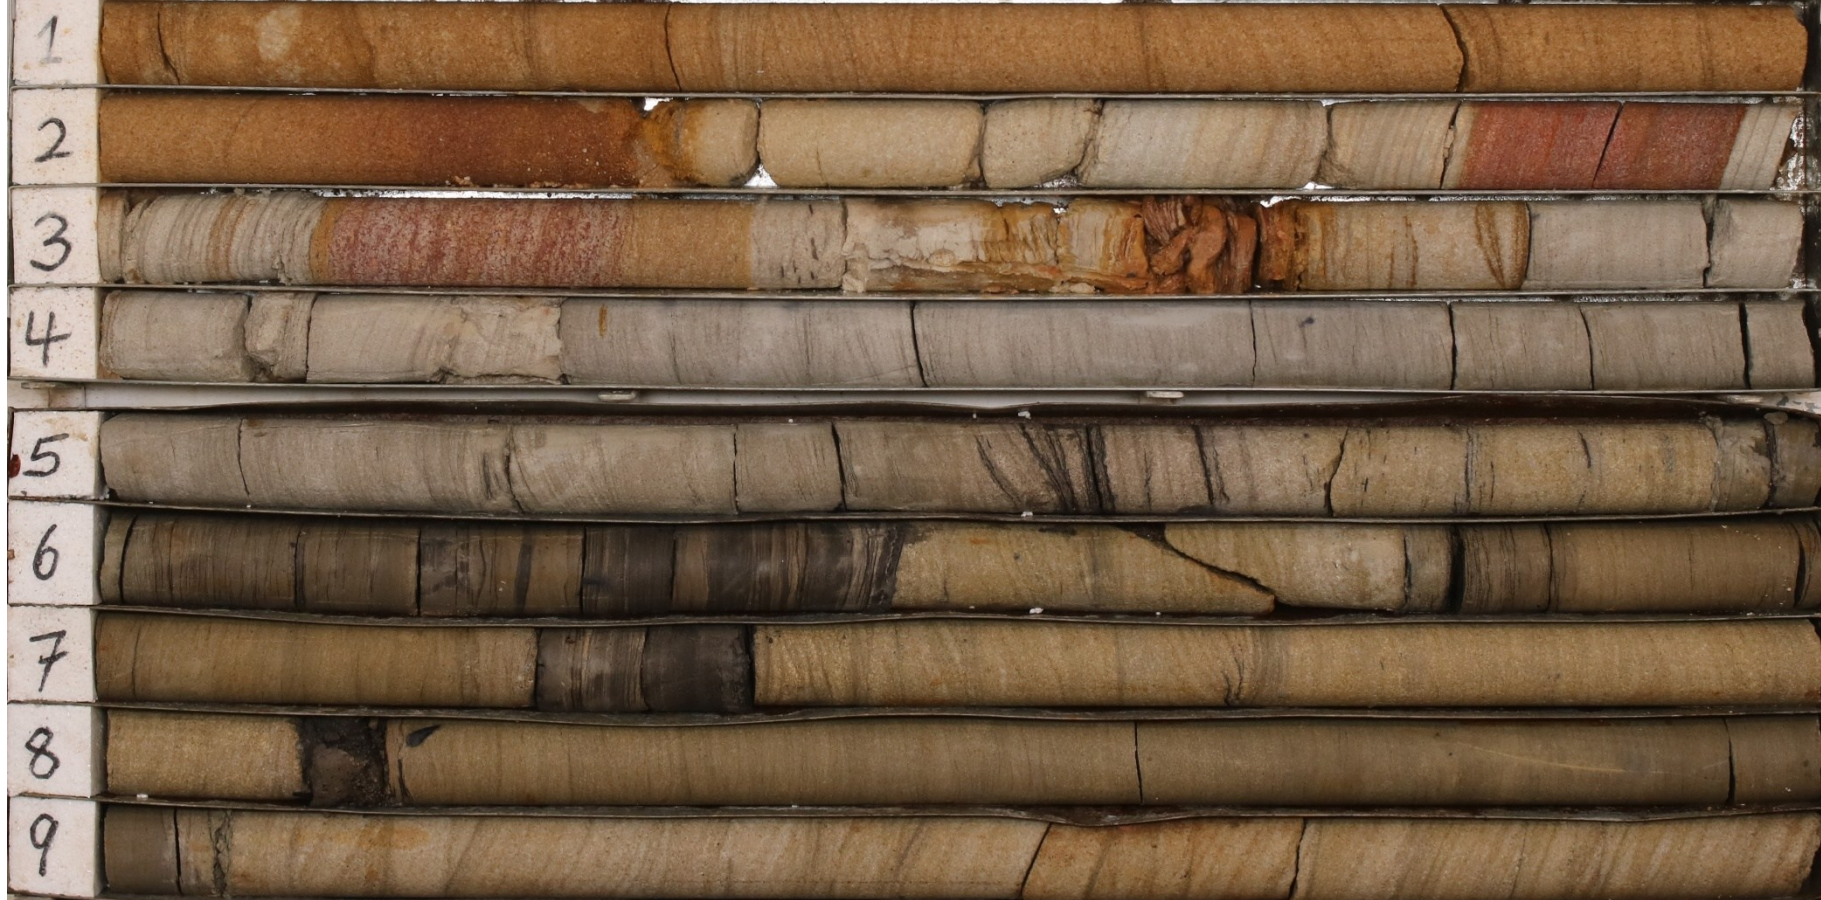
Job No: 32976LT1
Borehole No: 207
Depth: 0.68 to 10.00m

32976LT1 BH207 START CORING AT 0.68 m

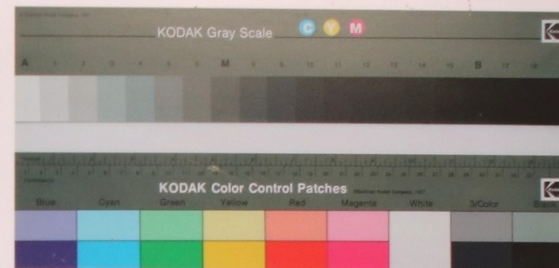
Job No: 32976LT1
Borehole No: BH208
Depth: 1.32m to 10.00m

32976LT1 BH208 START CORING AT 1.32 m
