**REPORT TO
NSW DEPARTMENT OF EDUCATION**

**ON
REMEDIATION ACTION PLAN**

**FOR
PROPOSED ALTERATIONS AND ADDITIONS**

**AT
KOGARAH PUBLIC SCHOOL, 24B GLADSTONE
STREET, KOGARAH, NSW**

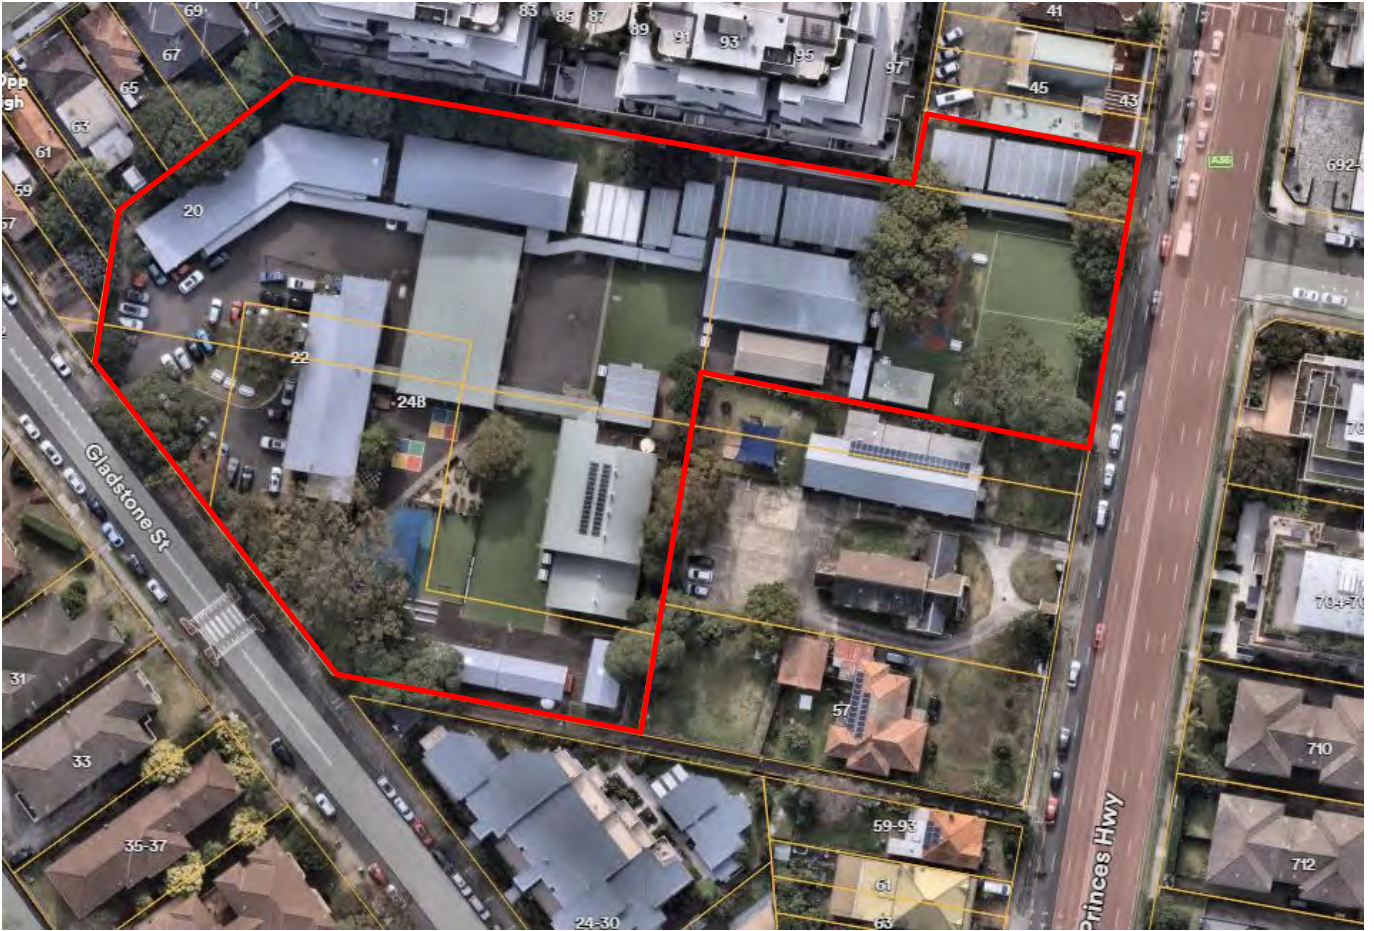
Figure 1: Aerial image of the site (Nearmap, 2024)

An aerial image of the school site is provided in Figure 1 on the next page.

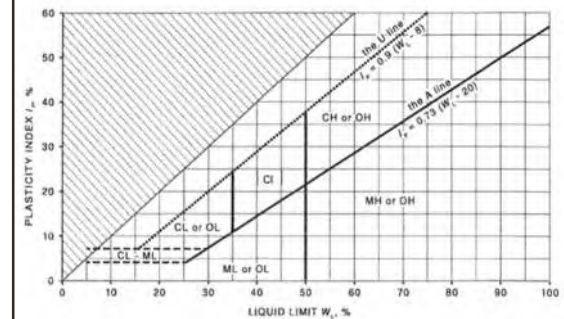
Modified Casagrande Chart for Classifying Silts and Clays according to their Behaviour

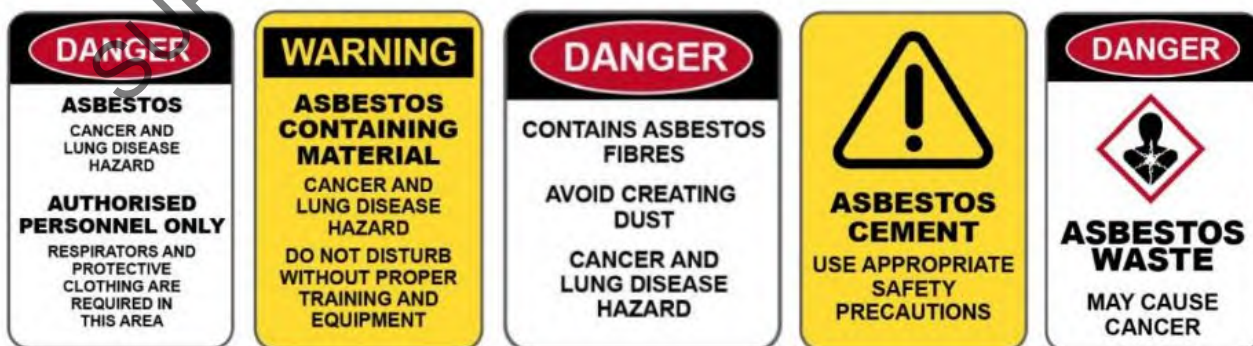
JKE is to take reasonable steps so the necessary measures are in place for the effective exclusion of unauthorised persons to asbestos work zones. The location, type and positioning of signs and labels must be decided, or authorised, by a competent person (i.e. the field scientist). Warning signs may include some of the following examples:
