# GEOTECHNICAL INVESTIGATION

## NSW LAND AND HOUSING CORPORATION

*46 Chester Avenue, Maroubra, NSW (BGZ93)*

*Report No: 22/2860*

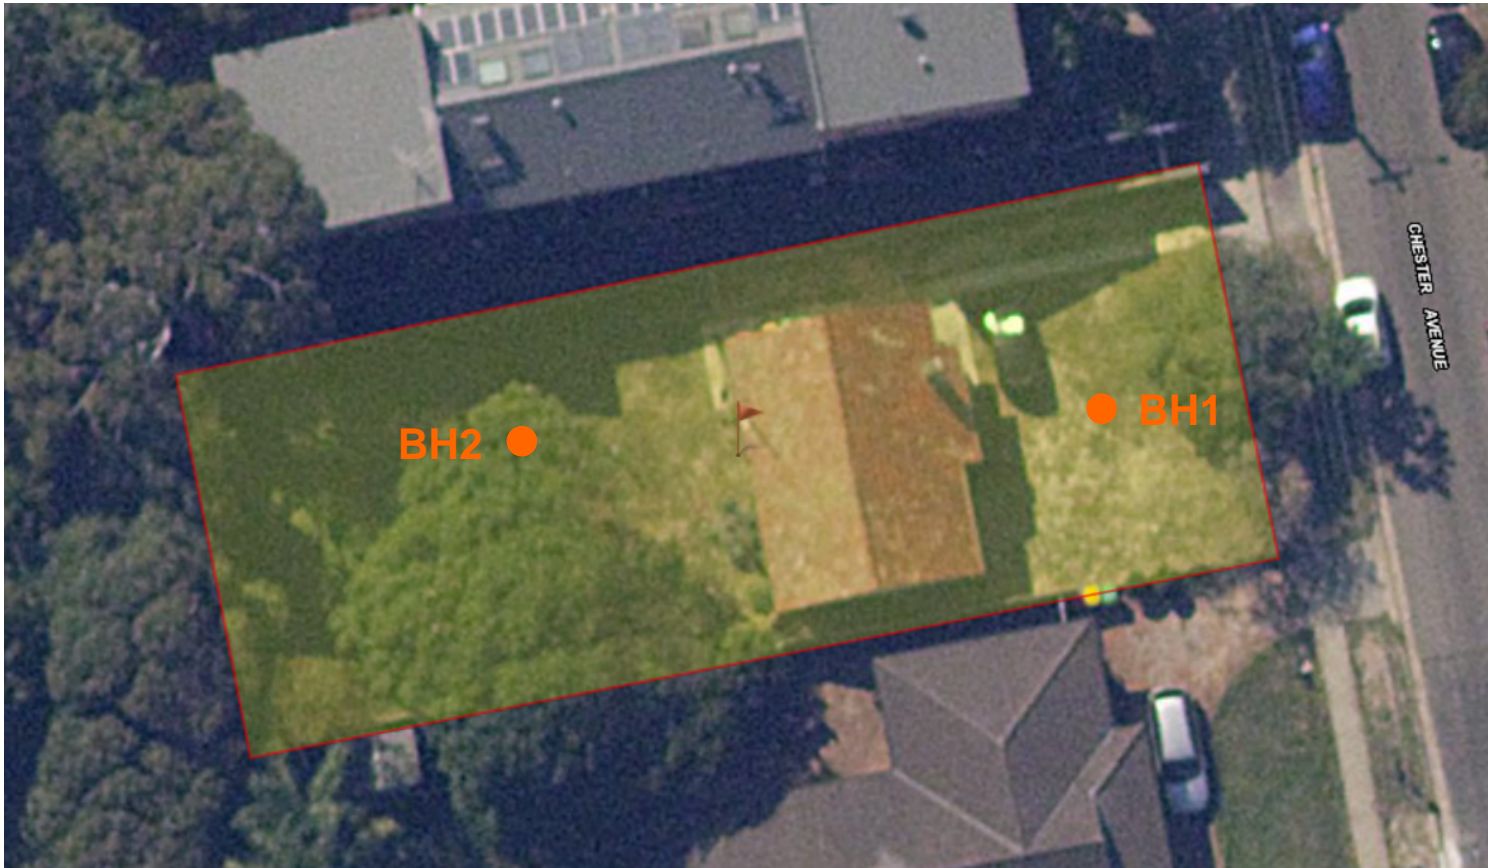
DRAWING NO. 22/2860 – BOREHOLE AND PENETROMETER LOCATIONS

The fieldwork consisted of drilling two (2) boreholes numbered BH1 and BH2, at the locations shown on Drawing No. 22/2860. Restricted site access dictated the borehole locations. The boreholes were drilled using a track mounted Commachio Geo205 drilling rig equipped with Tungsten-Carbide (T-C) bit and NMLC diamond coring equipment. The drilling rig is owned and operated by GeoSense Drilling.

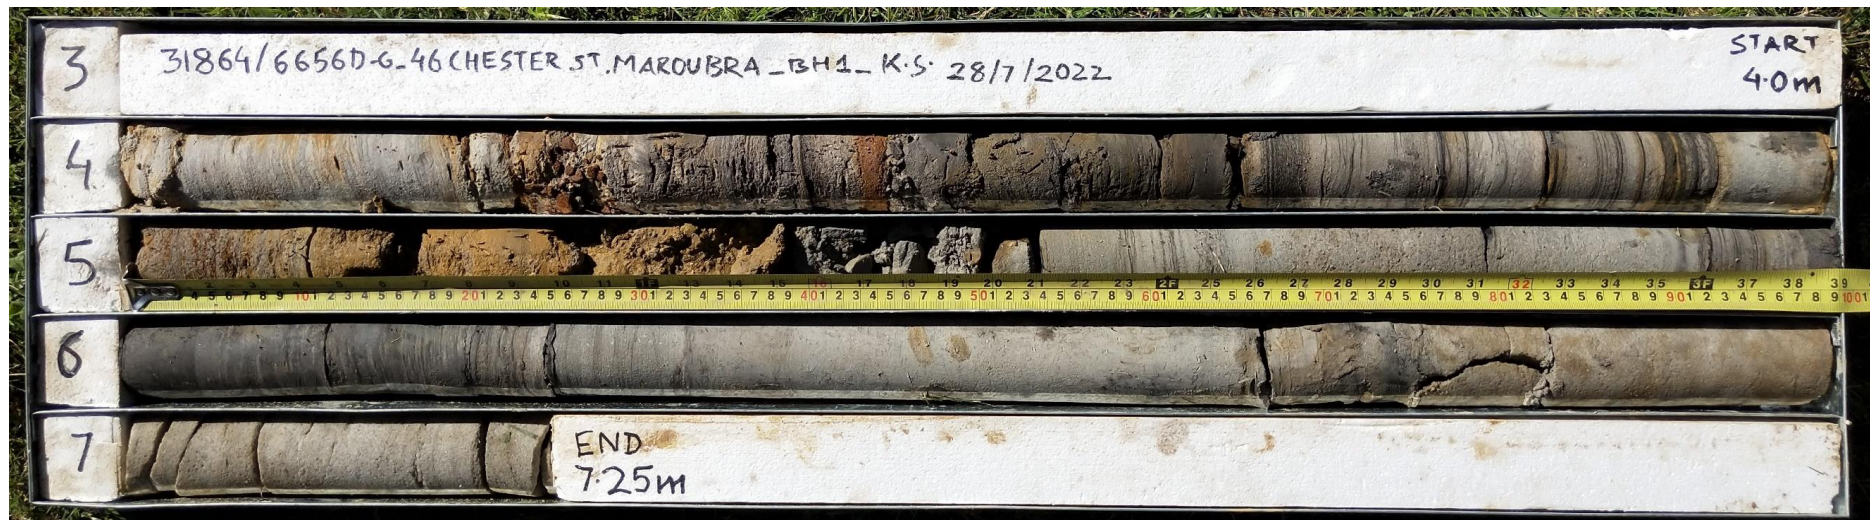
**PROJECT: 46 CHESTER AVENUE, MAROUBRA**  
**PROJECT NO. 31864/6656D-G**  
**CLIENT: NSW LAND & HOUSING CORPORATION**  
**BOREHOLE NUMBER: BH1**  
**DEPTH (m) START 4.0m - 7.25m END**

STS Geotechnics Pty Ltd										GEOTECHNICAL LOG - CORED BOREHOLE									
Client: NSW Land & Housing Corporation					Project / STS No. 31864/6656D-G					BOREHOLE NO.: BH 1									
Project: 46 Chester Avenue, Maroubra					Date: July 28, 2022					Sheet 2 of 3									
Location: Refer to Drawing No. 22/2860					Logged: KS					Checked By: IW									
DRILLING				Depth (m)	MATERIAL STRENGTH						DISCONTINUITIES								
Method	Water	RQD (SCR)	Recovery / TCR		Rock Type (Colour, Grain Size, Structure & Minor Components)	Weathering	Estimated Rock Strength						Average Defect Spacing (mm)					Visual	Additional Data (Joints, partings, seams, zones etc. Description, orientation, infilling, or coating, shape, roughness, thickness, other)
							Extremely Low	Very Low	Low	Medium	High	Very High	Extremely High	20	40	100	300

The subsurface conditions observed are recorded on the borehole logs given in Appendix A together with photographs of the recovered rock core and results of the point load testing. An explanation of the terms used on the logs is also given in Appendix A. Notes relating to geotechnical reports are also given in Appendix A.
