GEOTECHNICAL INVESTIGATION AND ACID SULFATE SOIL ASSESSMENT

NSW LAND & HOUSING CORPORATION

18 – 28 Simpson Street, Dundas Valley, New South Wales (BGYJW)

Report No: 21/3669

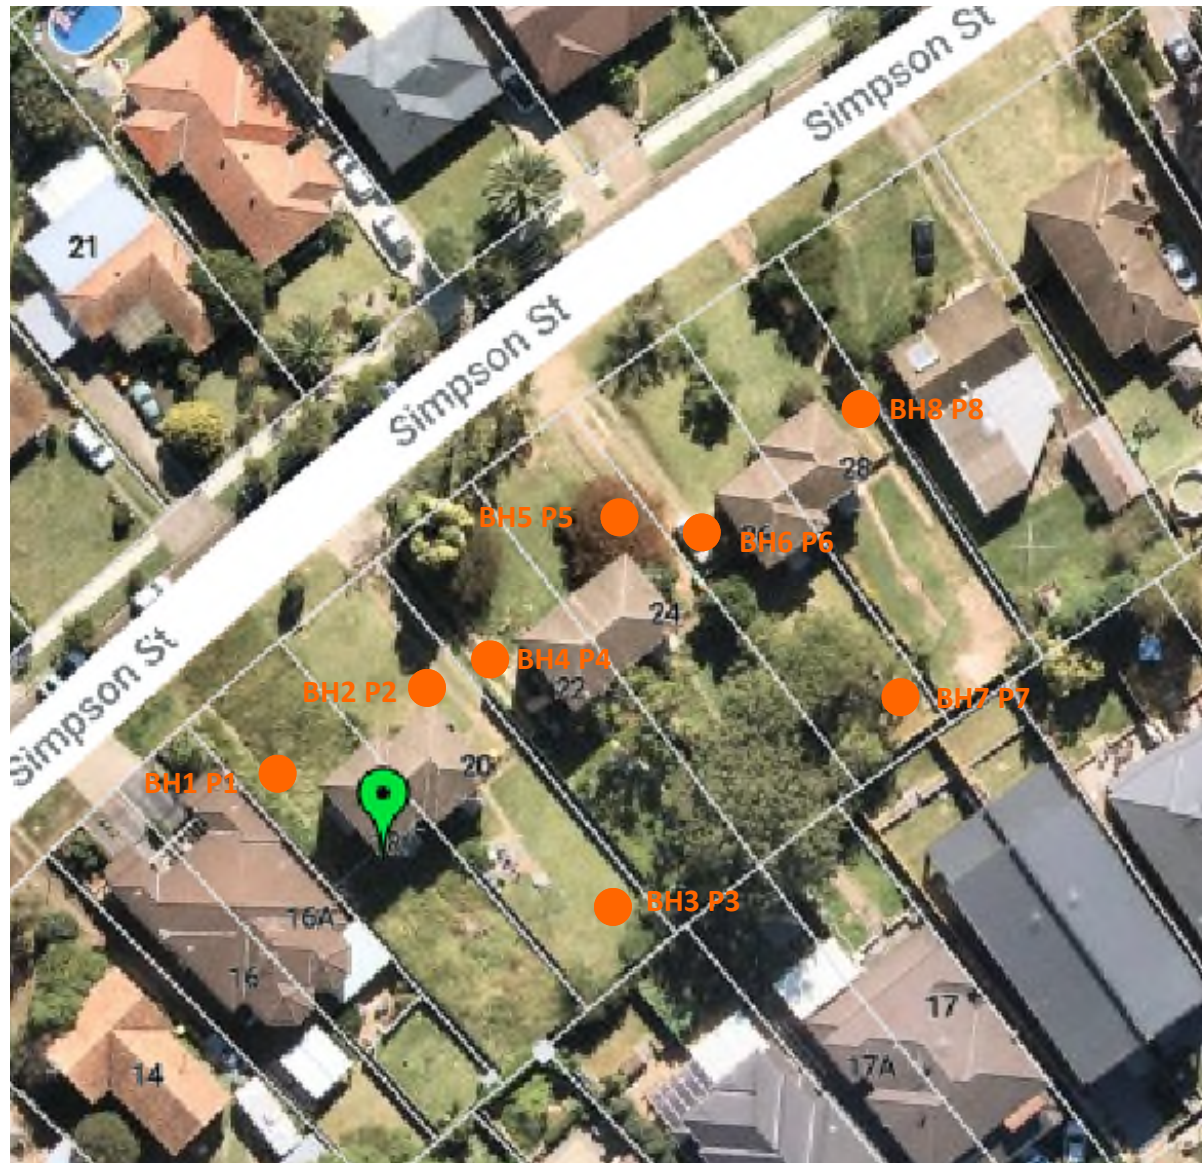
Drawing No: 21/3669

**GEOTECHNICAL INVESTIGATION
18-28 SIMPSON STREET, DUNDAS VALLEY
BOREHOLE AND PENETROMETER LOCATIONS**

The fieldwork consisted of drilling eight (5) boreholes numbered BH1 to BH8, inclusive, at the locations shown on Drawing No. 21/3668. Restricted site access dictated the borehole locations. The boreholes were drilled using a track mounted Christie drilling rig owned and operated by STS. Soils and weathered rock were drilled using rotary solid flight augers. Soil strengths were determined by undertaking Dynamic Cone Penetrometer (DCP) tests at each borehole location. Drilling operations were undertaken by one of STS’s technical officers who also logged the subsurface conditions encountered.
