# **GEOTECHNICAL INVESTIGATION**

# **NSW Land & Housing Corporation**

1 – 7 Fergerson Avenue, Fairfield, New South Wales

Report No: 20/1821

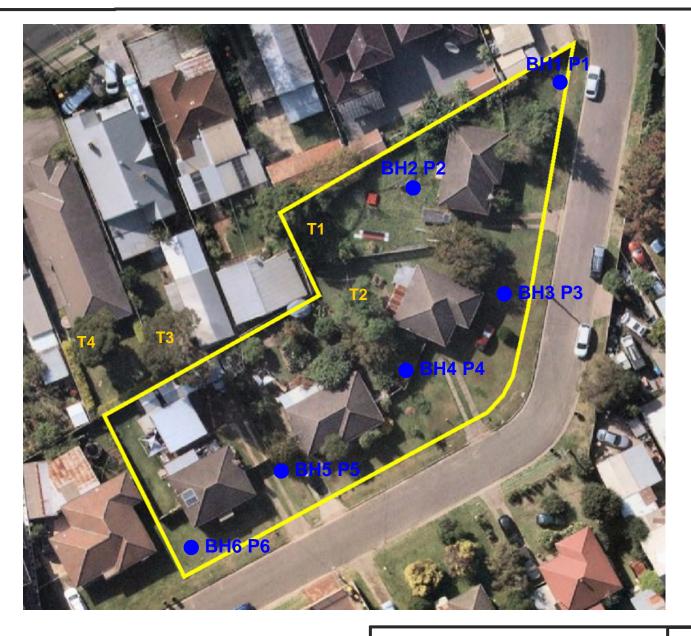
Drawing No: 20/1821

GEOTECHNICAL INVESTIGATION
1-7 FERGERSON AVENUE, FAIRFIELD
BOREHOLE AND PENETROMETER LOCATIONS

The fieldwork consisted of drilling six (6) boreholes numbered BH1 to BH6, at the locations shown on Drawing No. 20/1821. The boreholes were drilled using an Edson RP70 utility mounted drilling rig owned and operated by STS. Soils were drilled using rotary solid flight augers. Soil strengths were determined by undertaking Dynamic Cone Penetrometer (DCP) tests at each borehole location.
