Report on
Geotechnical and Salinity Assessment

Stage 2A
Bradfield City Centre
215 Badgerys Creek Road, Bradfield

Prepared for
Western Parkland City Authority

Project 222630.00
January 2024

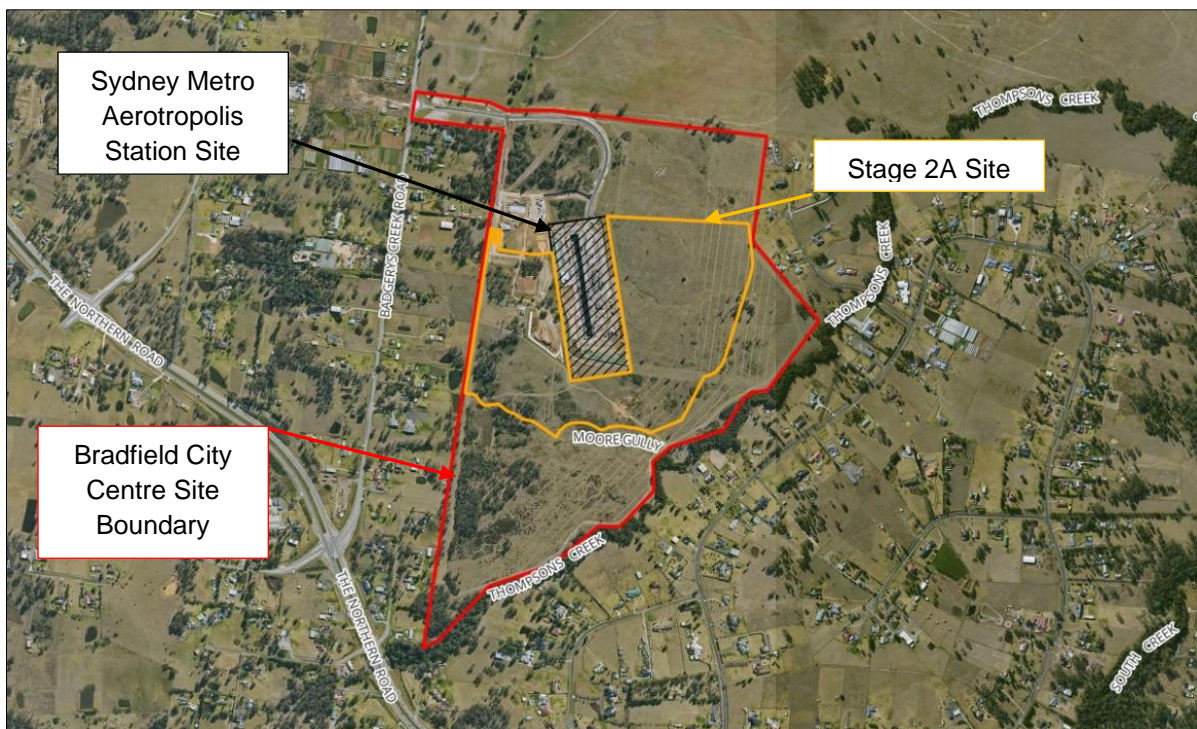
Figure 1: Site Location

Bradfield City Centre is located to the south-east of the new Western Sydney International (Nancy-Bird Walton) Airport at the intersection of Badgerys Creek Road and The Northern Road in Bradfield (formerly Bringelly, refer Figure 1). Stage 2A is located in the central portion of the Bradfield City Centre Site. The site location and layout are shown on Drawing 1 (Appendix B) and Figure 1.

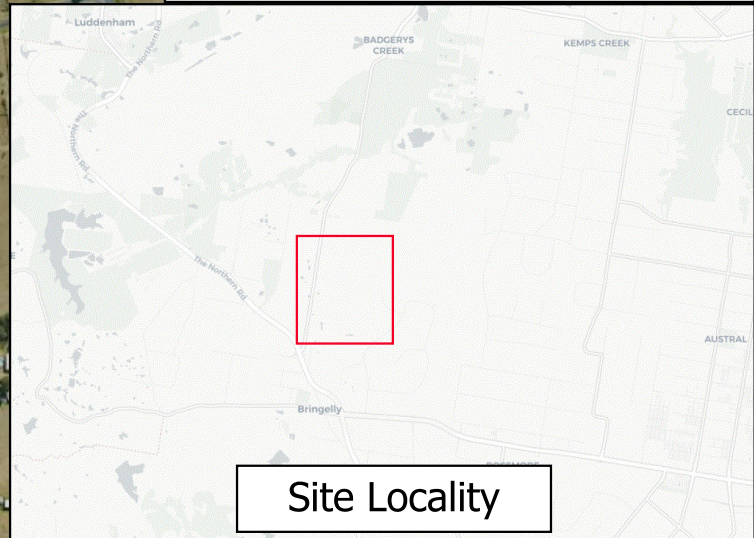
Douglas Partners <i>Geotechnics Environment Groundwater</i>	Site Location Plan Proposed Urban Development Stage 2A, Bradfield City Centre Badgerys Creek Road, Bringelly

- Bradfield City Centre Site Boundary
- Stage 2A Boundary
- Metro Station Site

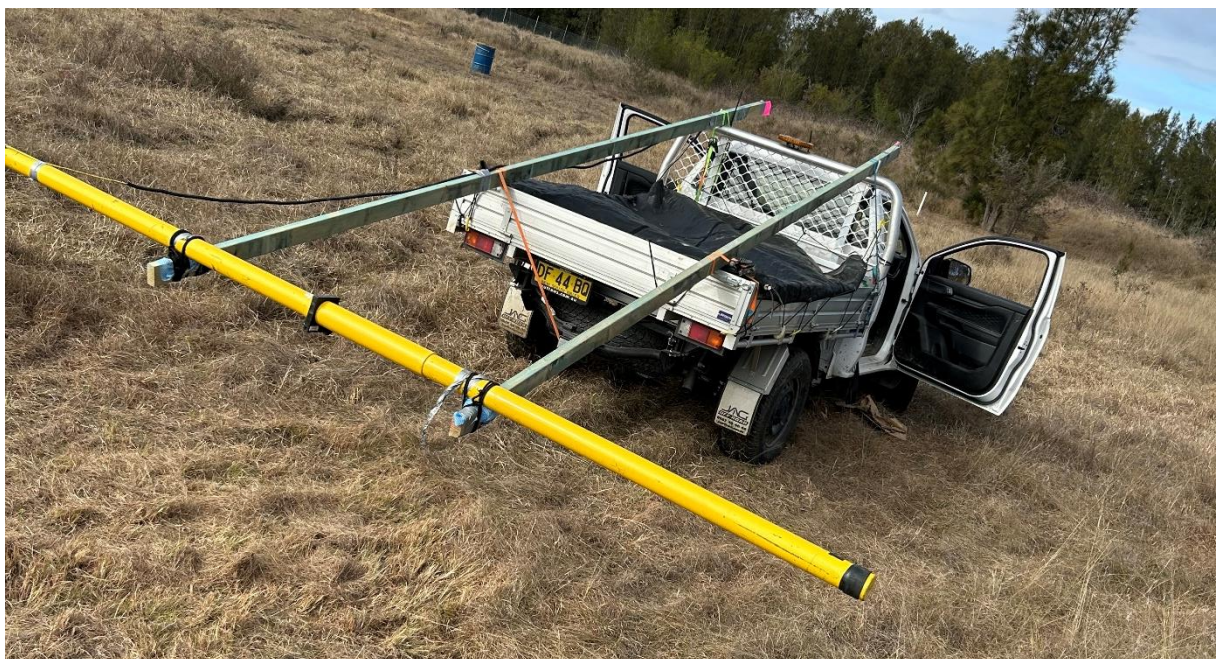
The survey instrument employed was the Dualem 42s, mounted on extensions behind a 4wd vehicle. The instrument (Figure 4) recorded data using 2.0 m and 4.0 m transmitter - receiver coil separations (horizontal co-planar coils configuration), and 2.1 m and 4.1 m transmitter - receiver coil separations (non-co-planar coils configuration, having vertical receiver coils). The instrument has a fixed transmitter frequency of 9k Hz and produces four quadrature (out-of-phase) and four in-phase data-streams for theoretical or nominal depths of investigation (response to ground conductors) of up to approximately 6 m below the coils, however this is dependent on actual soil conductivities (and sensor height above the ground) and most of the conductivity response was expected to be in the depth range of approximately 0 m - 4.0 m below the ground surface at this site.

Figure 4: Dualem 42s extended behind 4WD vehicle.

ECa data were acquired at 1 second intervals during slow continuous driving along on a grid of survey lines spaced approximately 25 m apart. Slashing of survey lines where necessary/possible was provided by the client. It is noted that not all areas of the site were accessible. Inaccessible areas included the thick vegetated area to the southwest of the site and the active construction areas. It is noted that the equipment is highly sensitive to interference from metallic objects such as construction fences and vehicles/plant etc. The approximate area covered by the survey was 71.5 Ha.

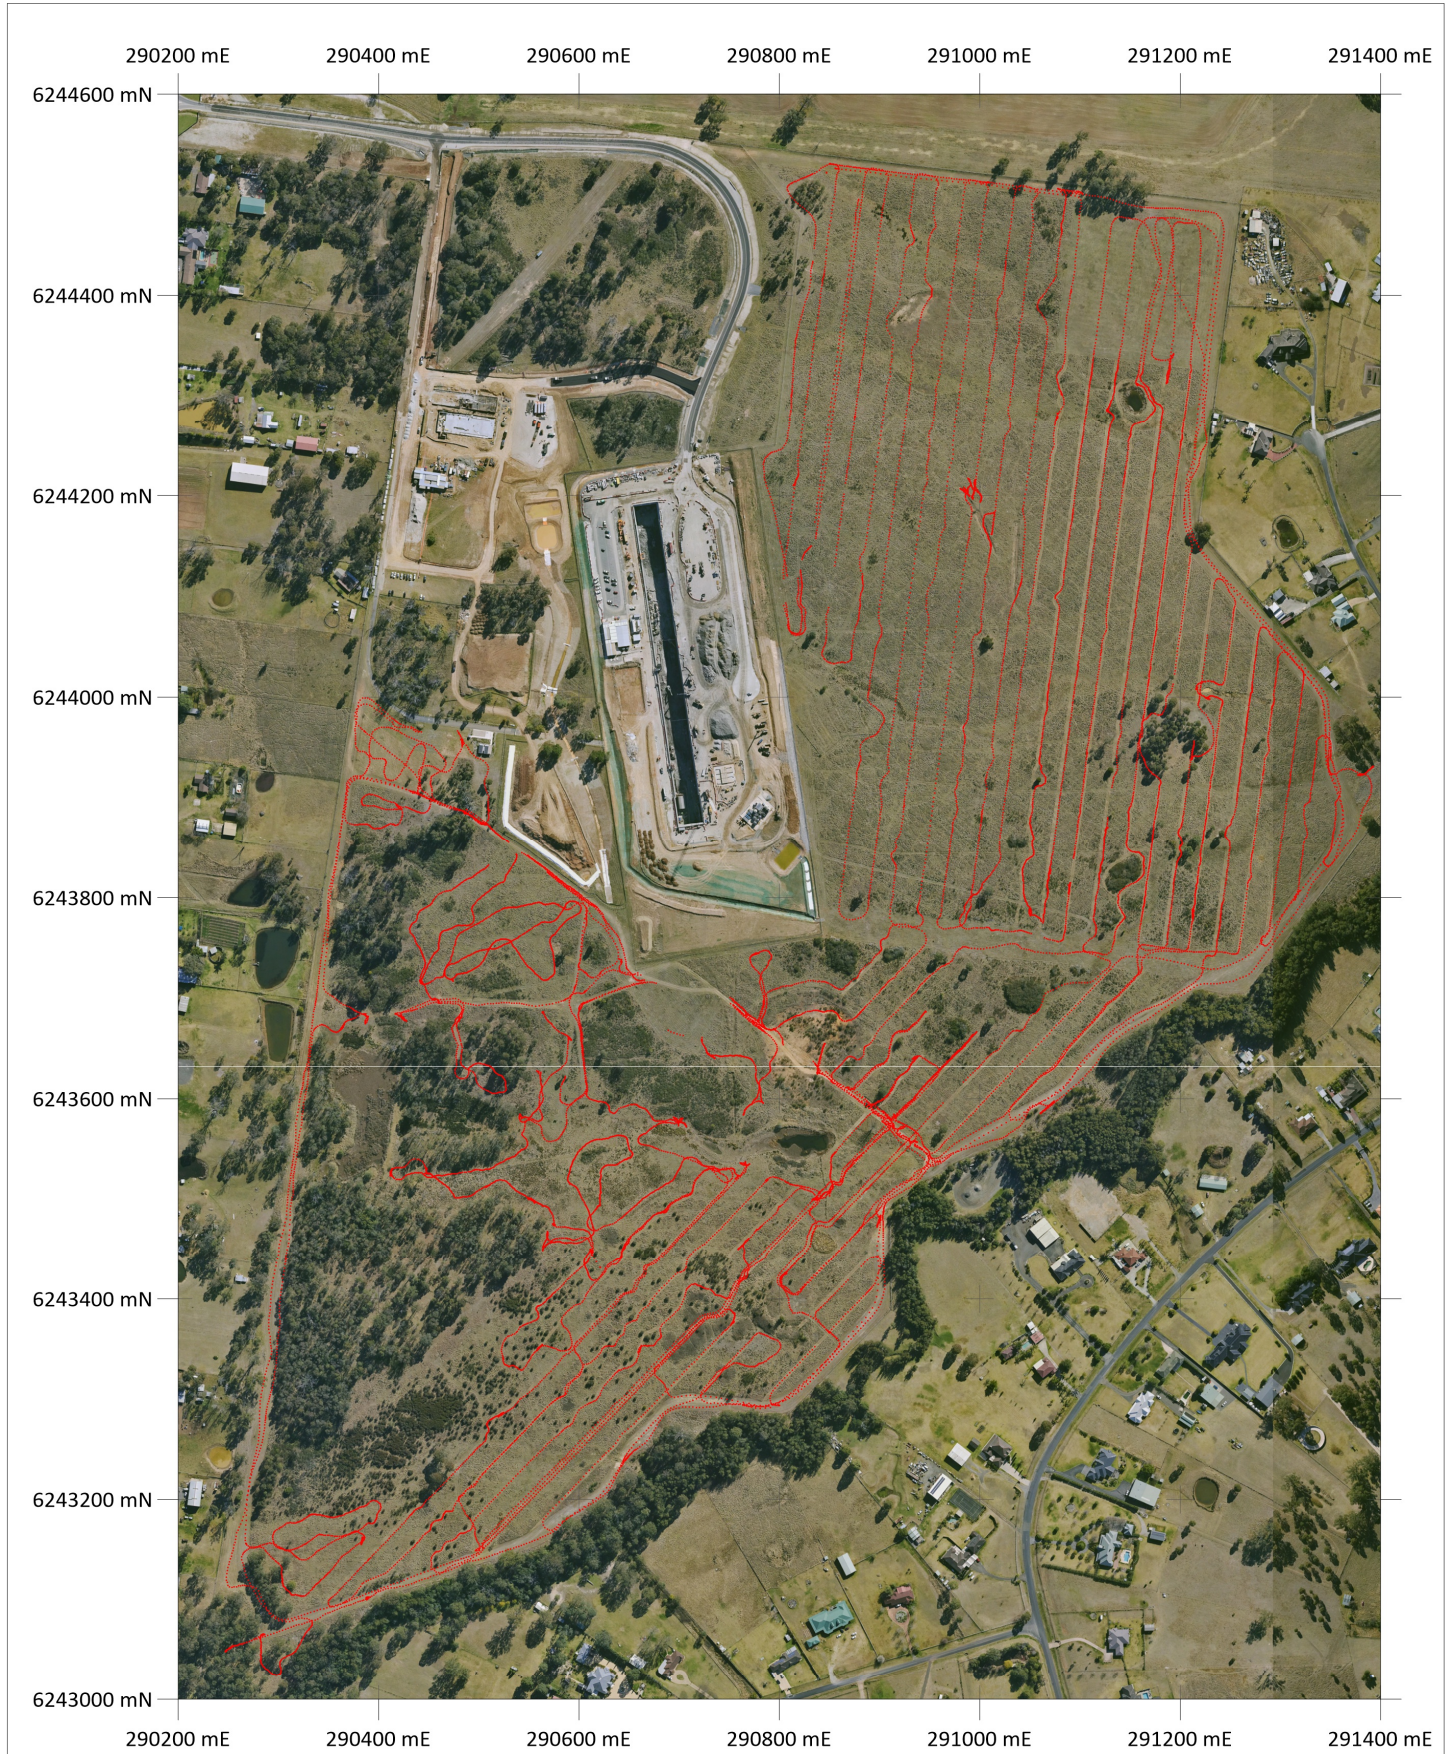
DRAWING No: 5

..... EM-induction conductivity instrument
Data Coverage (post filtering)

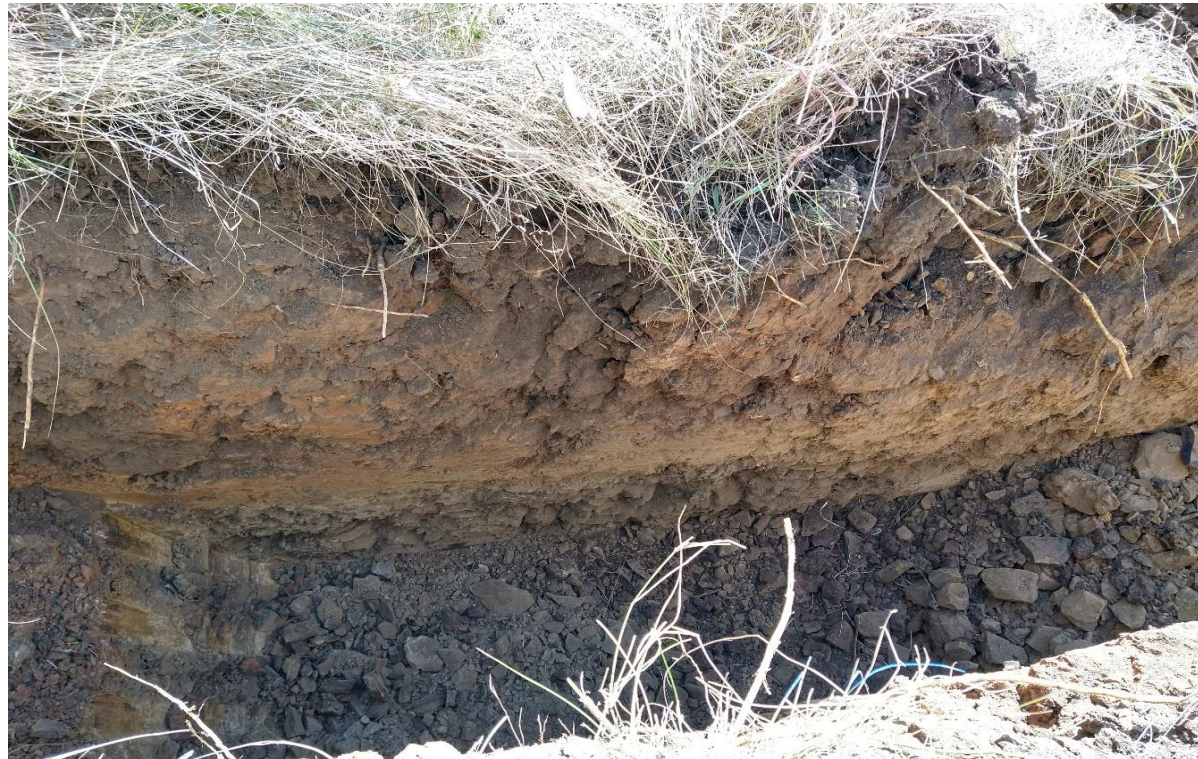
Photo 5: Test Pit 107 profile (refusal at 1.1m)
Typical of northern part of Stage 2

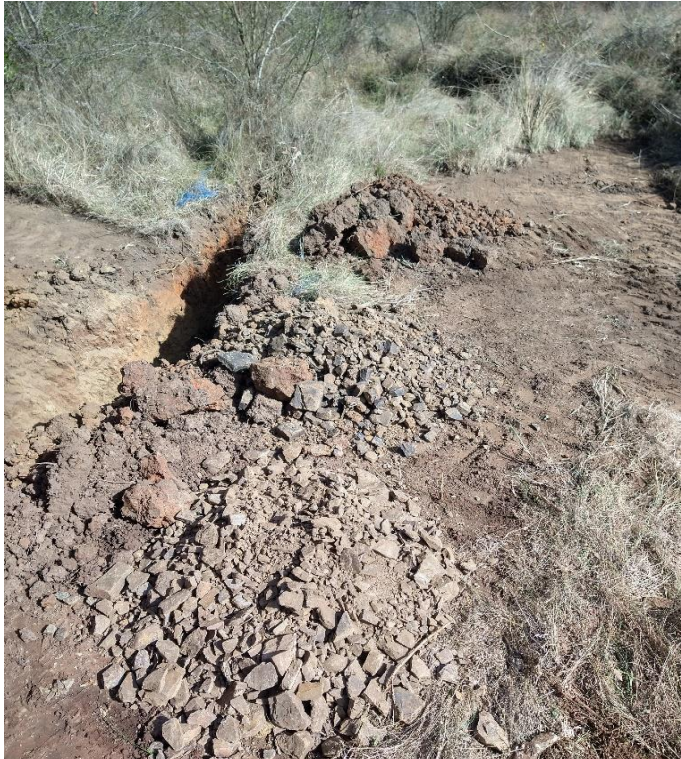
Photo 6: Spoil from Test Pit 107

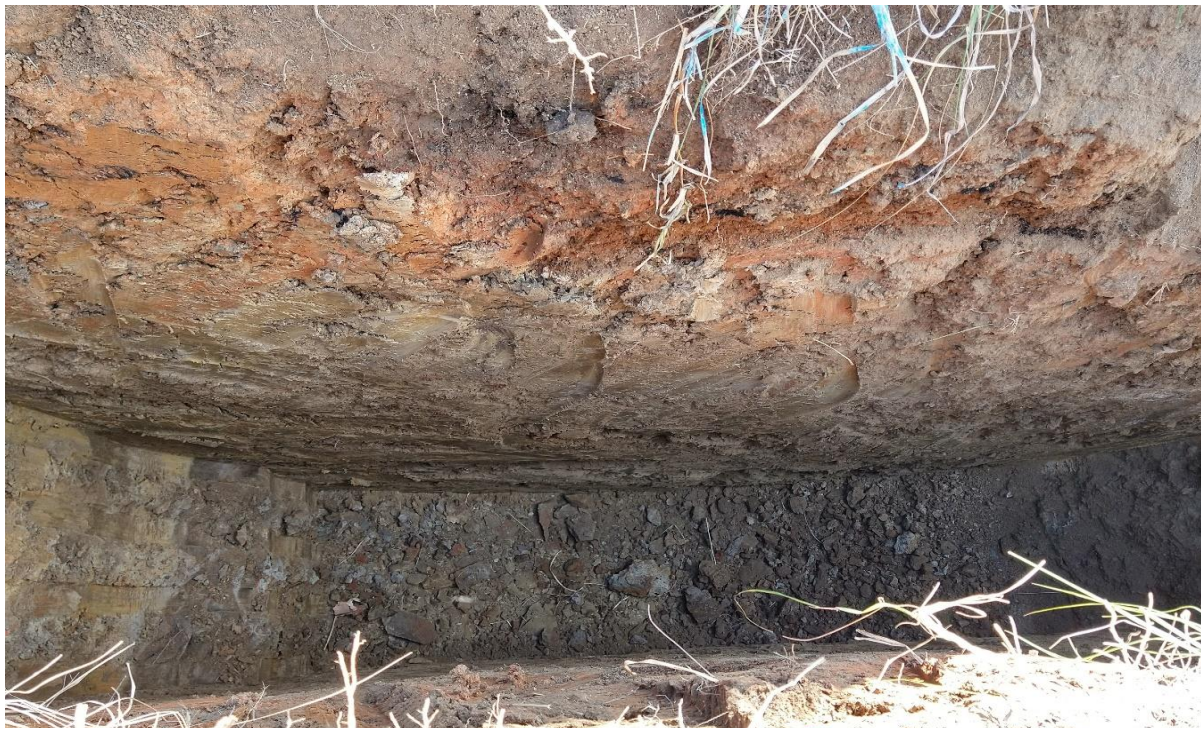
Photo 7: Test Pit 117 profile (Refusal at 2.2m)
Typical of central and southern parts of Stage 2

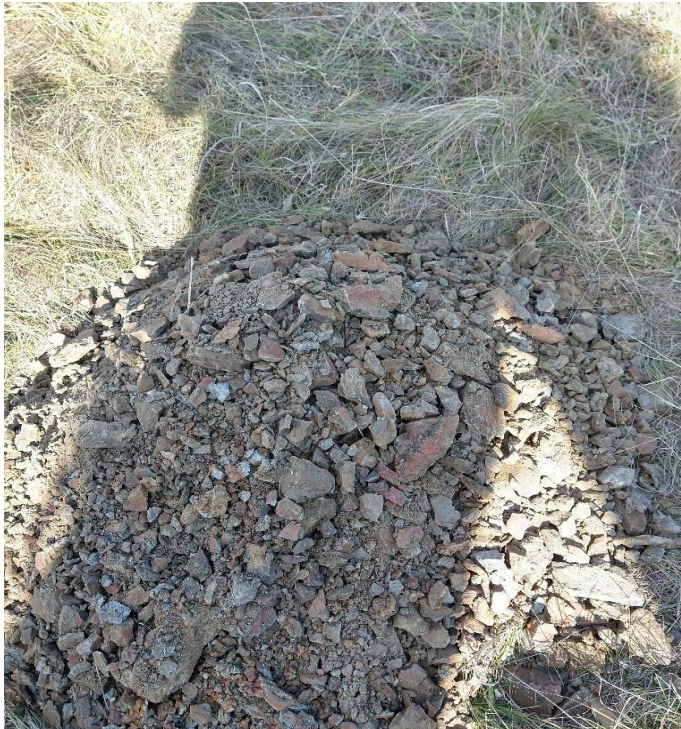
Photo 8: Medium to low strength shale from base of Pit 117

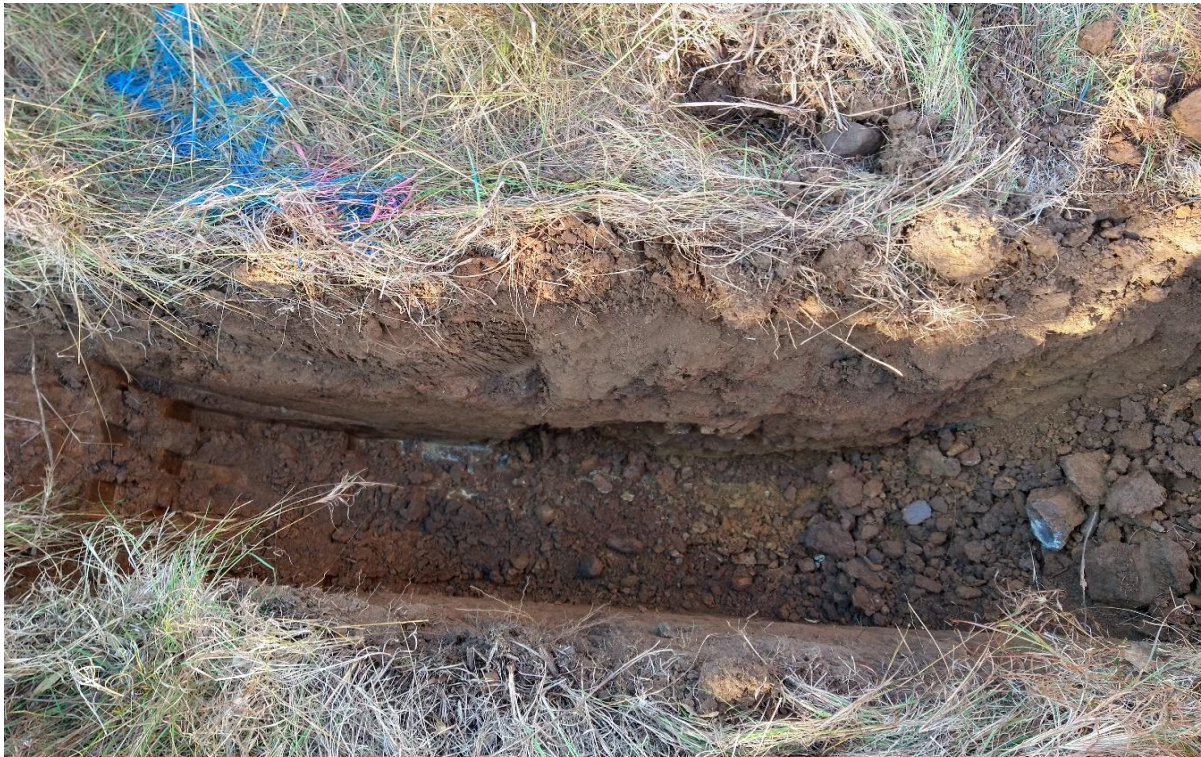
Photo 9: Test Pit 123 showing profile where the Luddenham Dyke was encountered (Refusal at 0.9m)

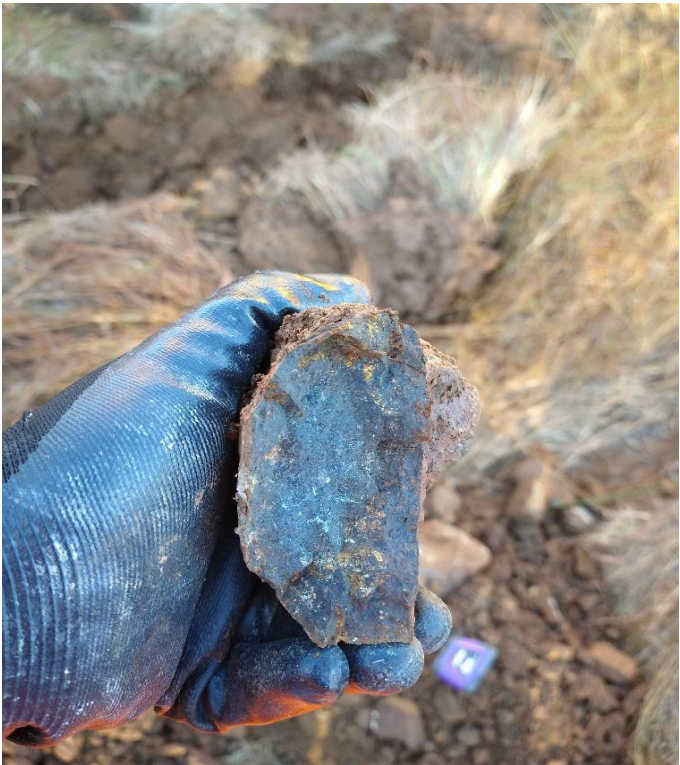
Photo 10: Basaltic material from base of Test Pit 123 - high strength

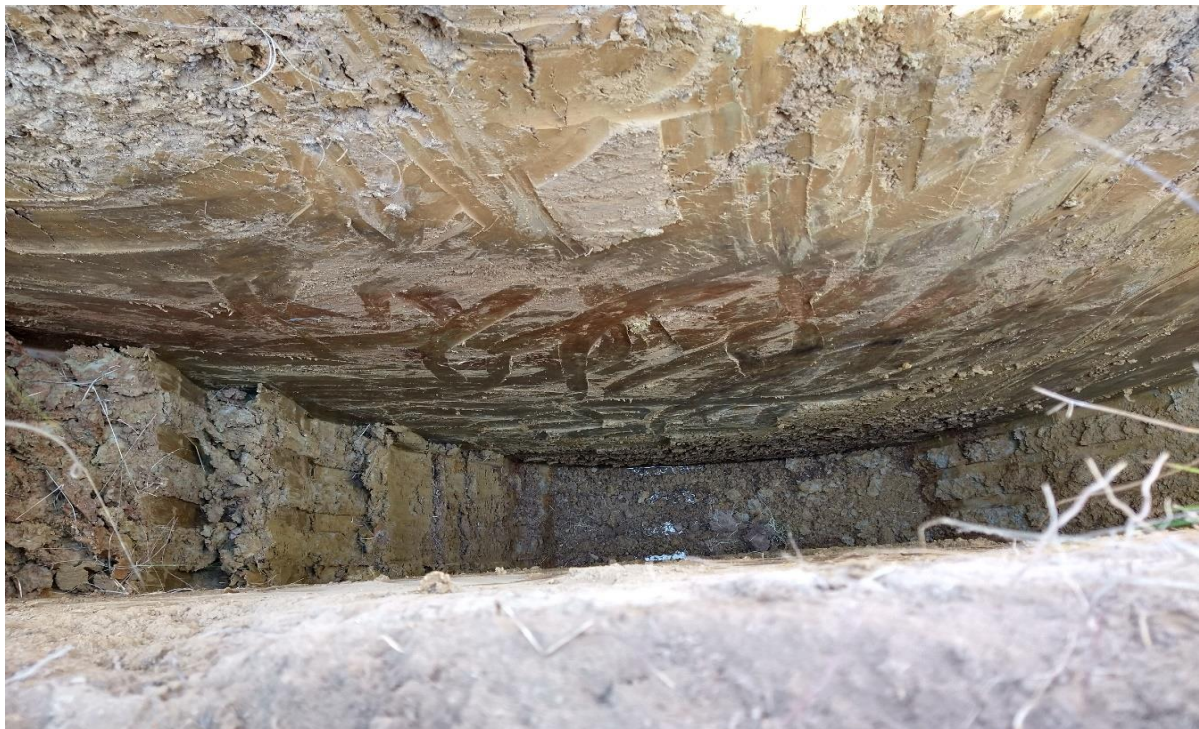
Photo 11: Test Pit 205 in stormwater corridor showing typical alluvial soil profile

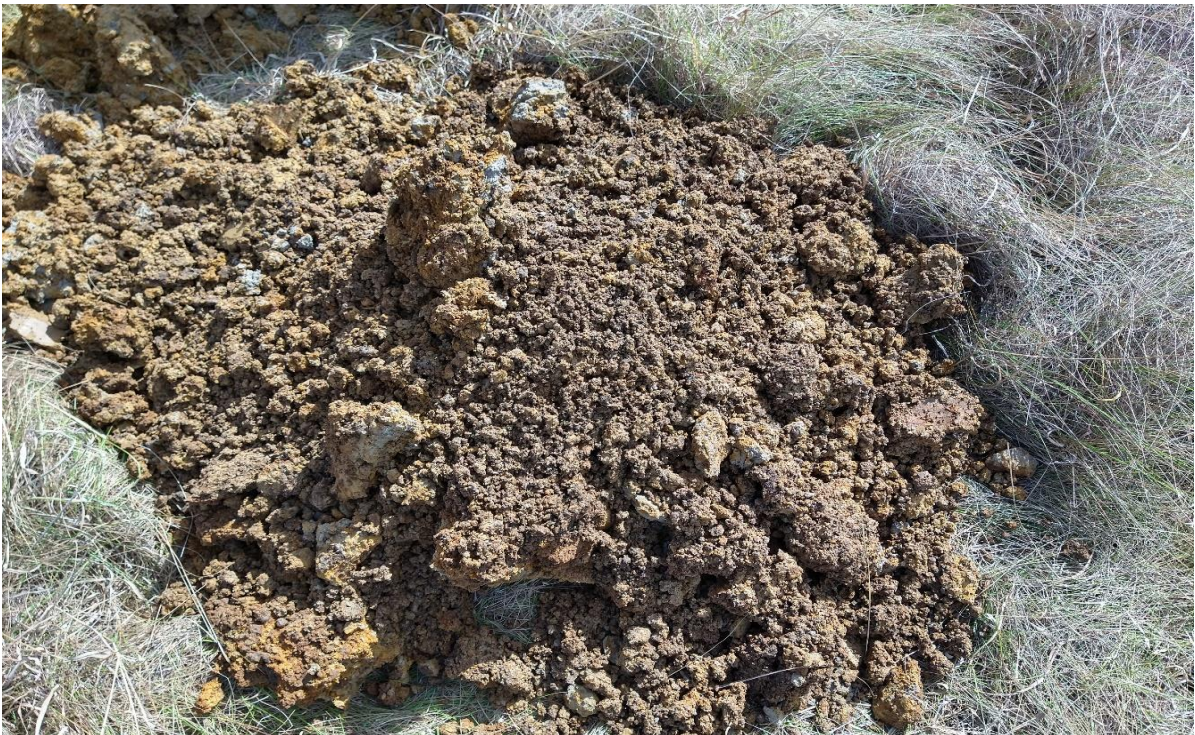
Photo 12: Alluvial soil from Pit 205
