**MILTON PUBLIC SCHOOL UPDATE  
INTRUSIVE GEOTECHNICAL  
INVESTIGATION REPORT**

Prepared for:  
NSW Department of Education (DoE)

Prepared by:  
Stantec Australia Pty Ltd

Project Number:  
305001663

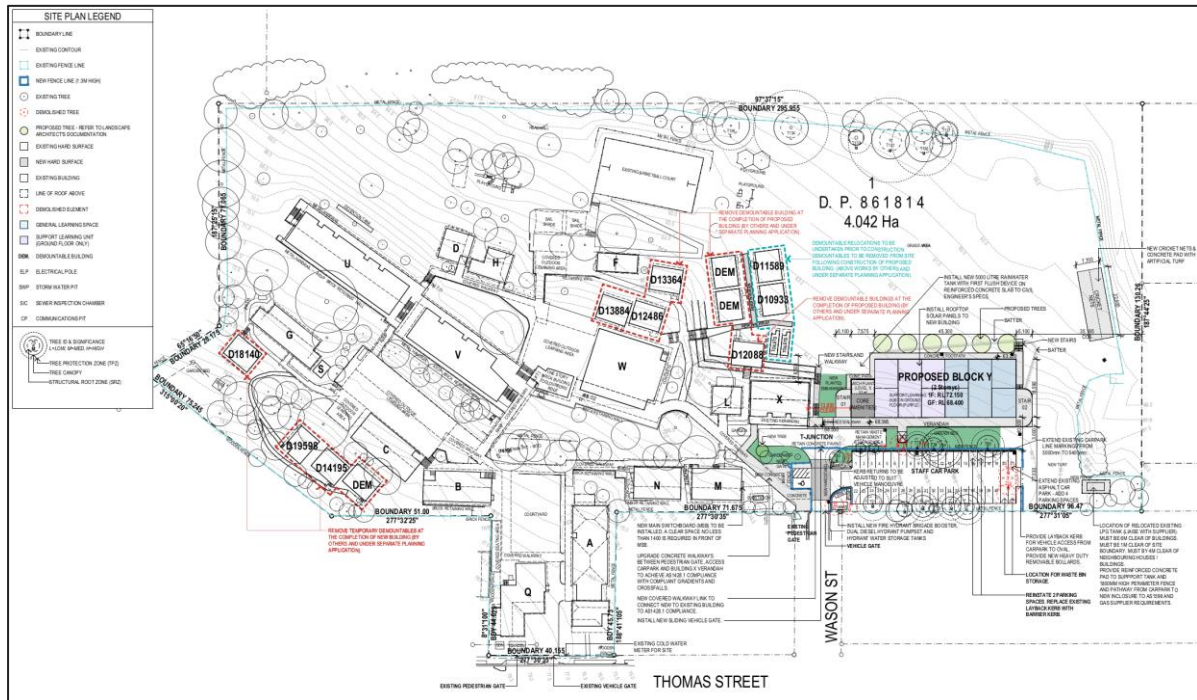
### Figure 1-2 Site Plan

The proposed activity relates to upgrades to Milton Public School. Specifically, the proposed activity comprises the following:

- > Construction of a new two-storey home base building.
- > Installation of additional solar panels.
- > Relocation of existing cricket nets to the eastern boundary of site.
- > Construction of new stairs and covered walkways linking the new building to the existing school.
- > Construction of new fencing.
- > Construction of new hardstand area.
- > Minor alterations to the existing staff car park.
- > Disconnection and relocation of existing LPG tank.
- > Tree removal.
- > External landscape works.

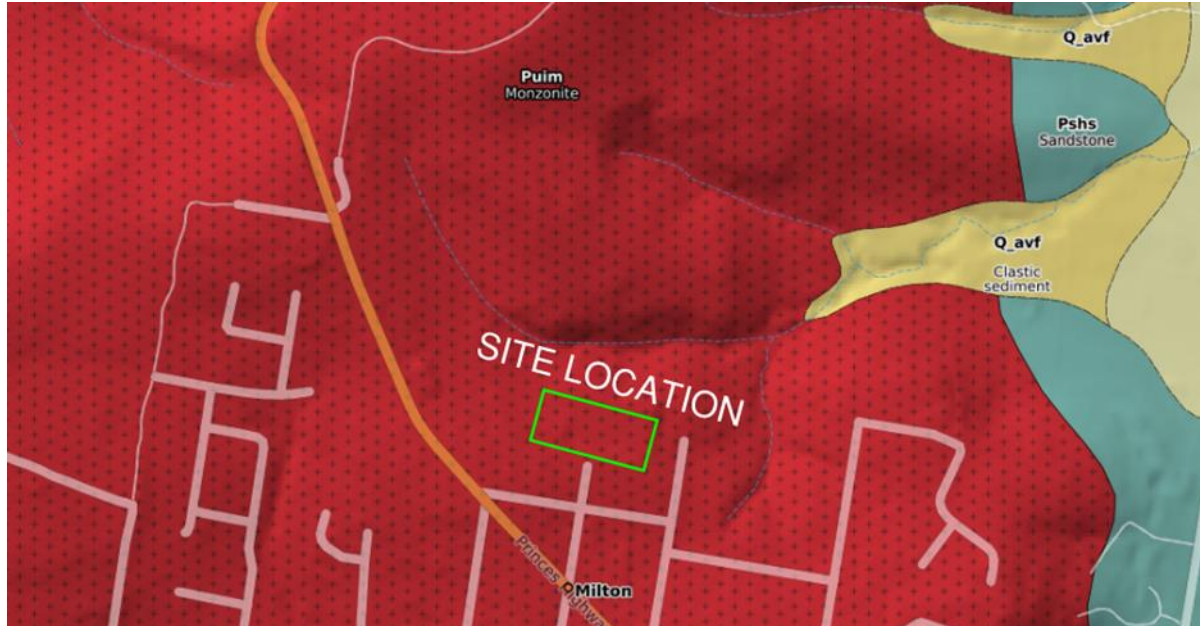
Figure 2-2 Regional Geology

An assessment of the regional geology has been undertaken through review of MinView spatial geology website (NSW Department of Planning, Industry and Environment, 2023) which indicated the site is underlain by the following geological units as shown in Error! Reference source not found. below.

- Puim – Milton Monzonite – Porphyritic monzonite with phenocrysts of glassy plagioclase in a black fine-grained matrix; variable to monzonite-porphyry; weather to a light colour; small zones of olivine basalt dyke material.
- Pshs – Snapper Point Formation – fine to medium grained sandstone, pebbly sandstone and polymictic pebble conglomerate, medium to coarse grained sandstone with lithic pebbles and fragments, minor siltstone.
- Q\_avf – Alluvial fan deposits – Fluvially-deposited quartz-lithic sand, silt, gravel and clay.
