# TREE SURVEY

**ARBORICULTURAL IMPACT ASSESSMENT & TREE PROTECTION PLAN**

**Batemans Bay Community Health**  
**7 Pacific Street, Batemans Bay**  
Version 3

10 June 2024

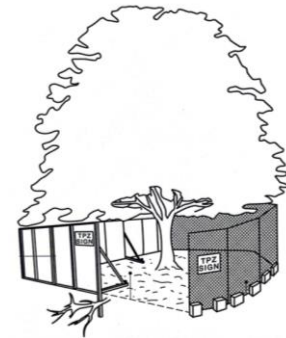
Tree protection fencing must be established at the locations shown in the TPP. Existing fencing, site hoarding, or structures (such as a wall or building) may be used as tree protection fencing, providing the TPZ remains isolated from the construction footprint. Tree protection fencing must be installed prior to site establishment and remain intact until the completion of works. Once erected, protective fencing must not be removed or altered without the approval of the project arborist. Specifications for the tree protection fencing are as follows:

- Temporary mesh panel fencing (minimum height of 1.8m).
- Installed prior to site establishment and remain intact until the completion of works.
- Protective fencing must not be removed or altered without the approval of the project arborist.
- Prominently signposted with 300mm x 450mm boards stating, "NO ACCESS - TREE PROTECTION ZONE."
- Certified and inspected by the project arborist.
