PHASE 1 PRELIMINARY SITE CONTAMINATION INVESTIGATION

**Batemans Bay Hospital
7 Pacific Street, BATEMANS BAY NSW
2536**

REPORT NUMBER: 12740.01.PSCA

DATE OF REPORT: 6 May 2024

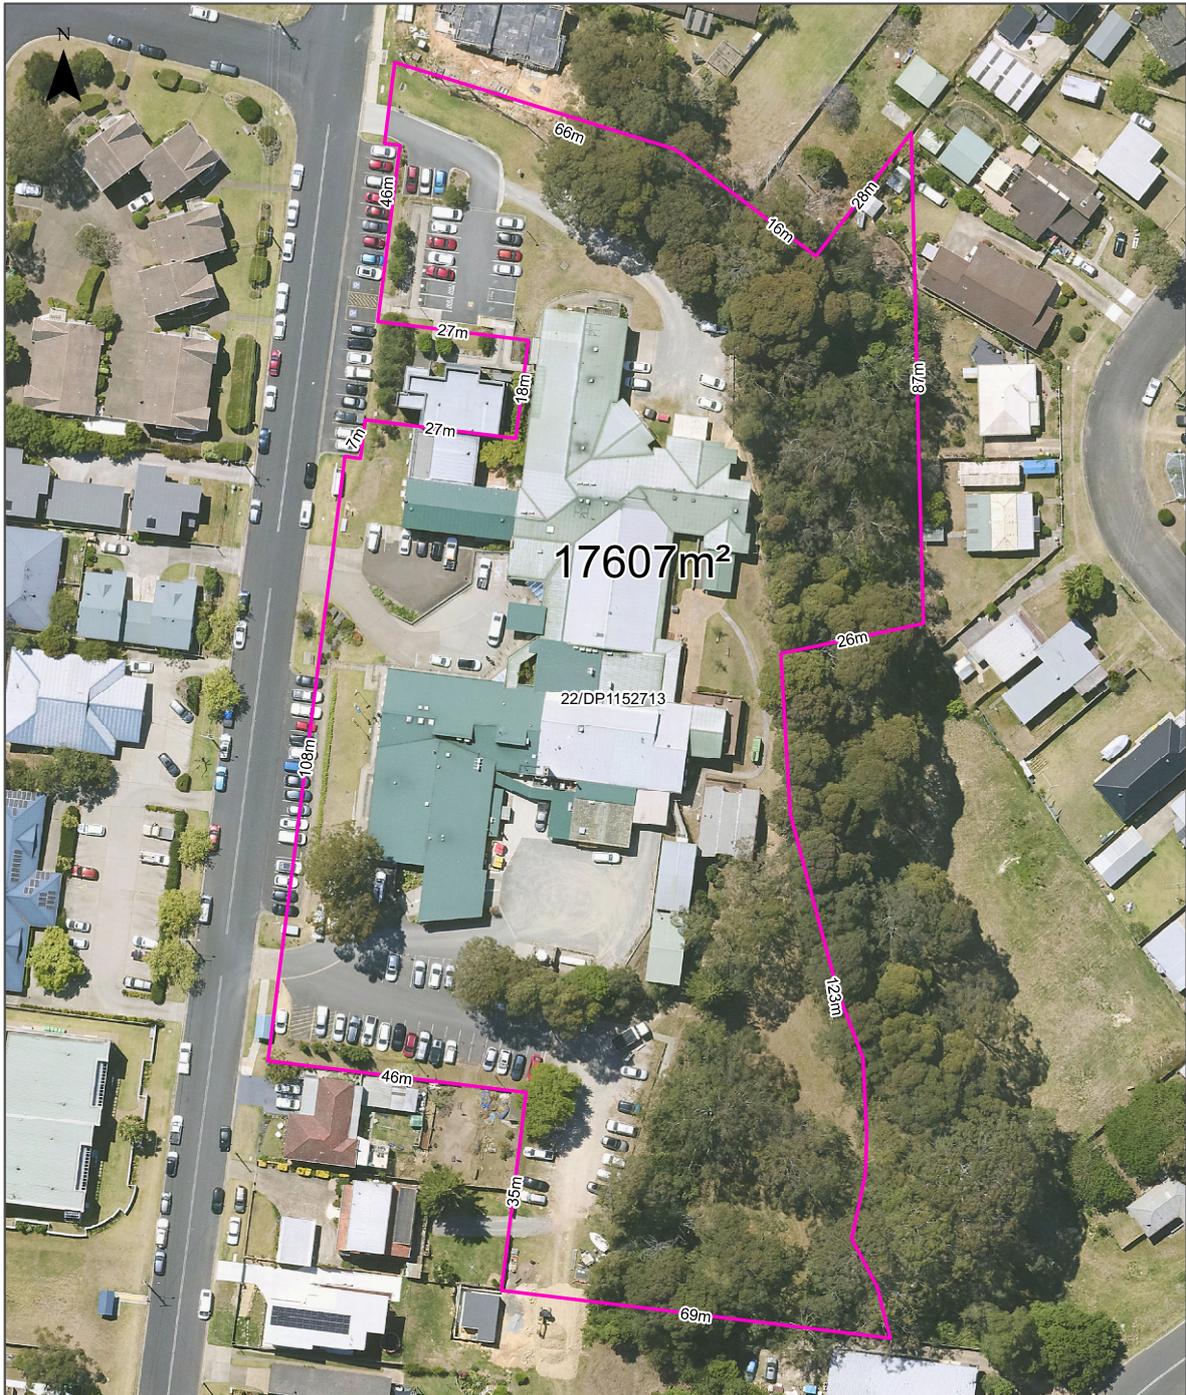
Site Diagram

<p>Legend</p> <ul style="list-style-type: none"> Site Boundary Internal Parcel Boundaries 	<p>Total Area: 17607m²</p> <p>Total Perimeter: 734m</p> <p><small>Disclaimers:</small></p> <p><small>Measurements are approximate only and may have been simplified or smaller lengths removed for readability.</small></p> <p><small>Parcels that make up a small percentage of the total site area have not been labelled for increased legibility.</small></p>	<p><small>Scale:</small></p>
<p><small>Data Source Aerial Imagery:</small> © Aerometrex Pty Ltd</p>		<p><small>Coordinate System:</small> GDA 1994 MGA Zone 56</p>
<p><small>Date:</small> 19 April 2024</p>

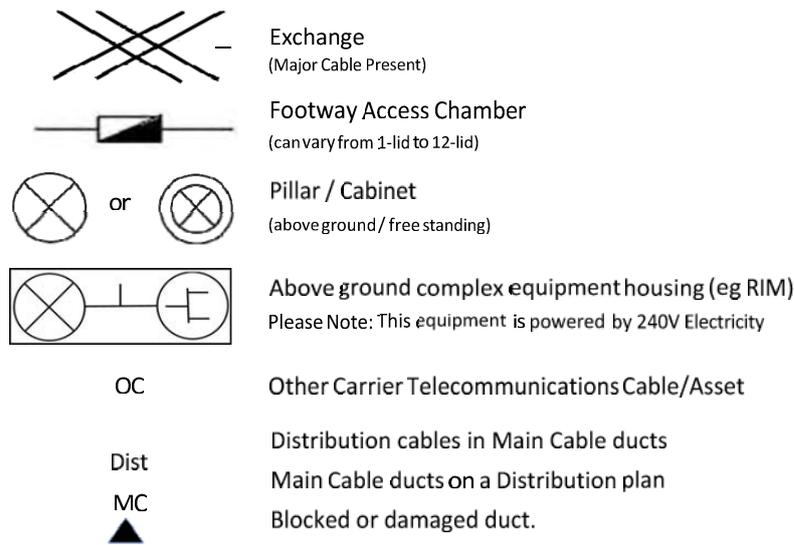
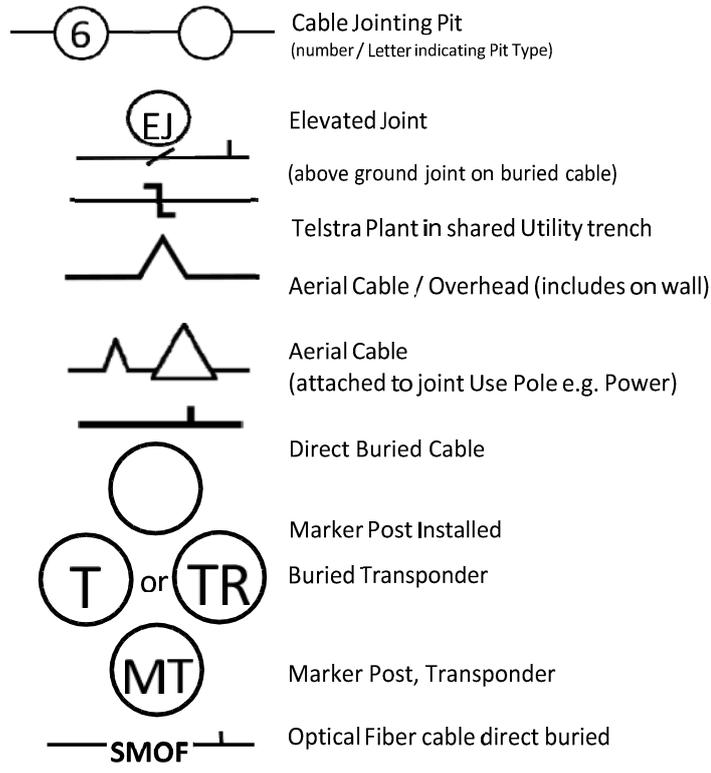
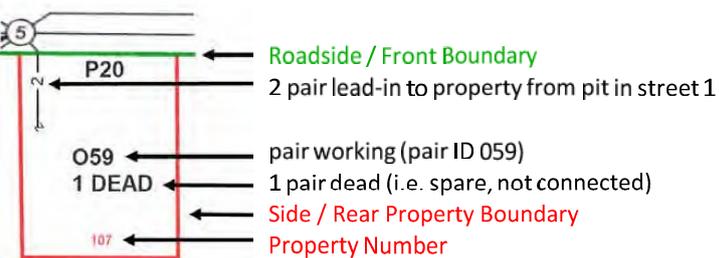
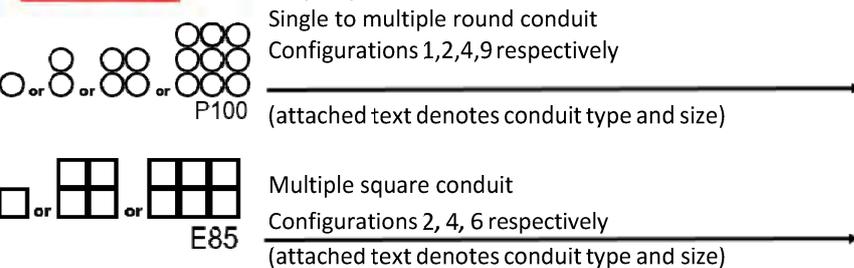
Some examples of conduit type and size:

A - Asbestos cement, P - PVC / Plastic, C - Concrete,
GI - Galvanised iron, E - Earthenware
Conduit sizes *nominally* range from 20mm to 100mm
P50 50mm PVC conduit
P100 100mm PVC conduit
A100 100mm asbestos cement conduit

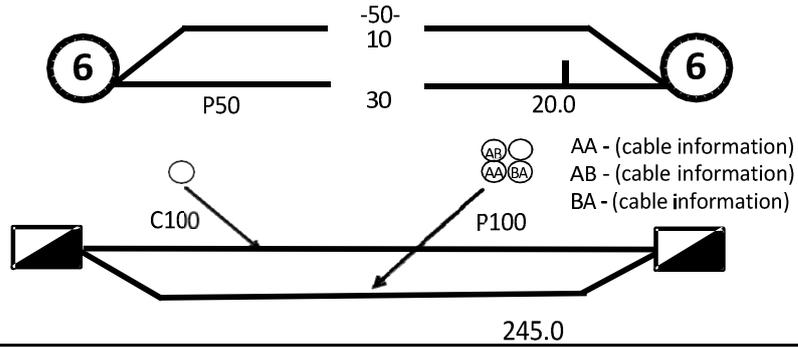
Some Examples of how to read Telstra Plans

One 50mm PVC conduit (P50) containing a 50-pair and a 10-pair cable between two 6-pits. approximately 20.0m apart, with a direct buried 30-pair cable along the same route

Two separate conduit runs between two footway access chambers (manholes) approximately 245m apart A nest of four 100mm PVC conduits (P100) containing assorted cables in three ducts (one being empty) and one empty 100mm concrete duct (C100)
