## **ADDITIONAL DETAILED SITE INVESTIGATION**

### **PROPOSED UPGRADES TO NORTHMEAD PUBLIC SCHOOL**

**52A MOXHAMS ROAD, NORTHMEAD**

**REPORT NO 20429/10-AA**

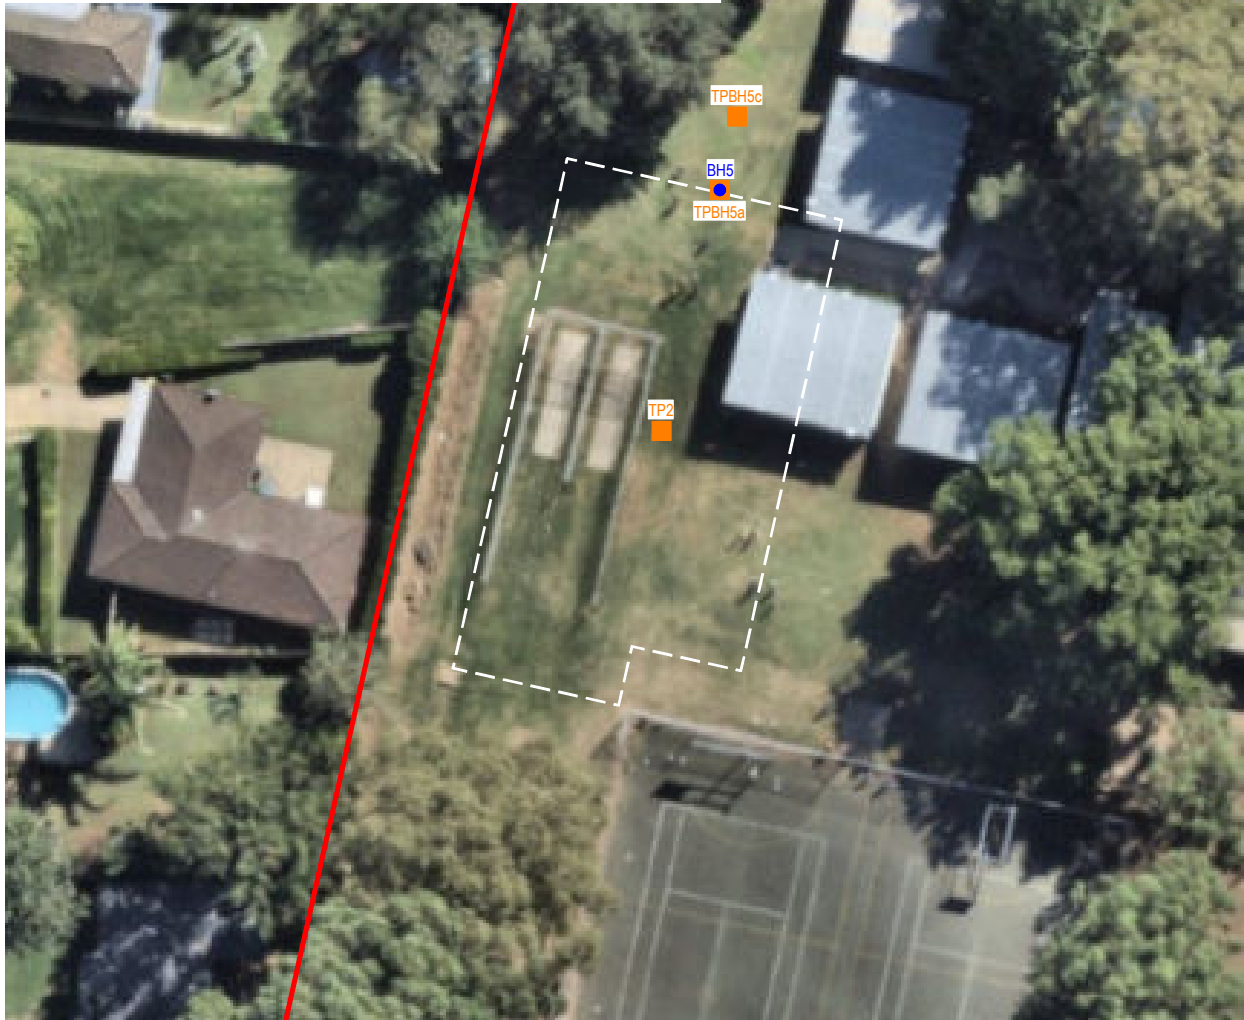
*Drawing No 20429/10-AA2 – Locations of Contamination*

As indicated in Table I, with the exception of samples TP2 (0.5-0.8m), no ACM (>7mm) was found at the LOR of 0.01% w/w for the remaining samples analysed. ACM (>7mm) in excess of the SAC (0.01% w/w) was detected in sample TP2 (0.5-0.8m).

As shown in Table I, with the exception of samples TPBH5a (0.0-0.15m) and TP2 (0.0-0.15), no AF or FA was found at the LOR of 0.001% w/w for the all the samples analysed. AF (<7mm) in excess of the SAC (0.001% w/w) was detected in sample TPBH5a (0.0-0.15m) and TP2 (0.0-0.15).

Based on the previous DSI and current ADSI, most of the laboratory test results satisfied the criteria for stating that the analytes selected are either not present (i.e. concentrations less than laboratory LOR), or present in the sampled soils at concentrations that do not pose a risk of hazard to human health or the environment, environment under the condition for the proposed school upgrade, with the exception of asbestos. The identified contaminant being bonded ACM and friable asbestos in a number of test pit locations, as indicated and tabulated on Drawing No 20429/10-AA2 in Appendix A.

Based on asbestos contamination at the proposed development site, it is our assessment that the potential impacts of the proposed upgrade work or activity can be appropriately mitigated or managed by excavating and disposing asbestos contaminated fill material in an EPA licensed landfill facility in accordance with the recommended mitigation measures presented in Table 12. Excavation and disposal of soil is a common practice in construction works. Hence, the required mitigation measures will not have a significant effect on the environment.
