## **REMEDIAL ACTION PLAN**

**PROPOSED UPGRADES TO NORTHMEAD PUBLIC SCHOOL**

**52A MOXHAMS ROAD, NORTHMEAD**

**REPORT NO 20429/13-AA     19 MARCH 2025**

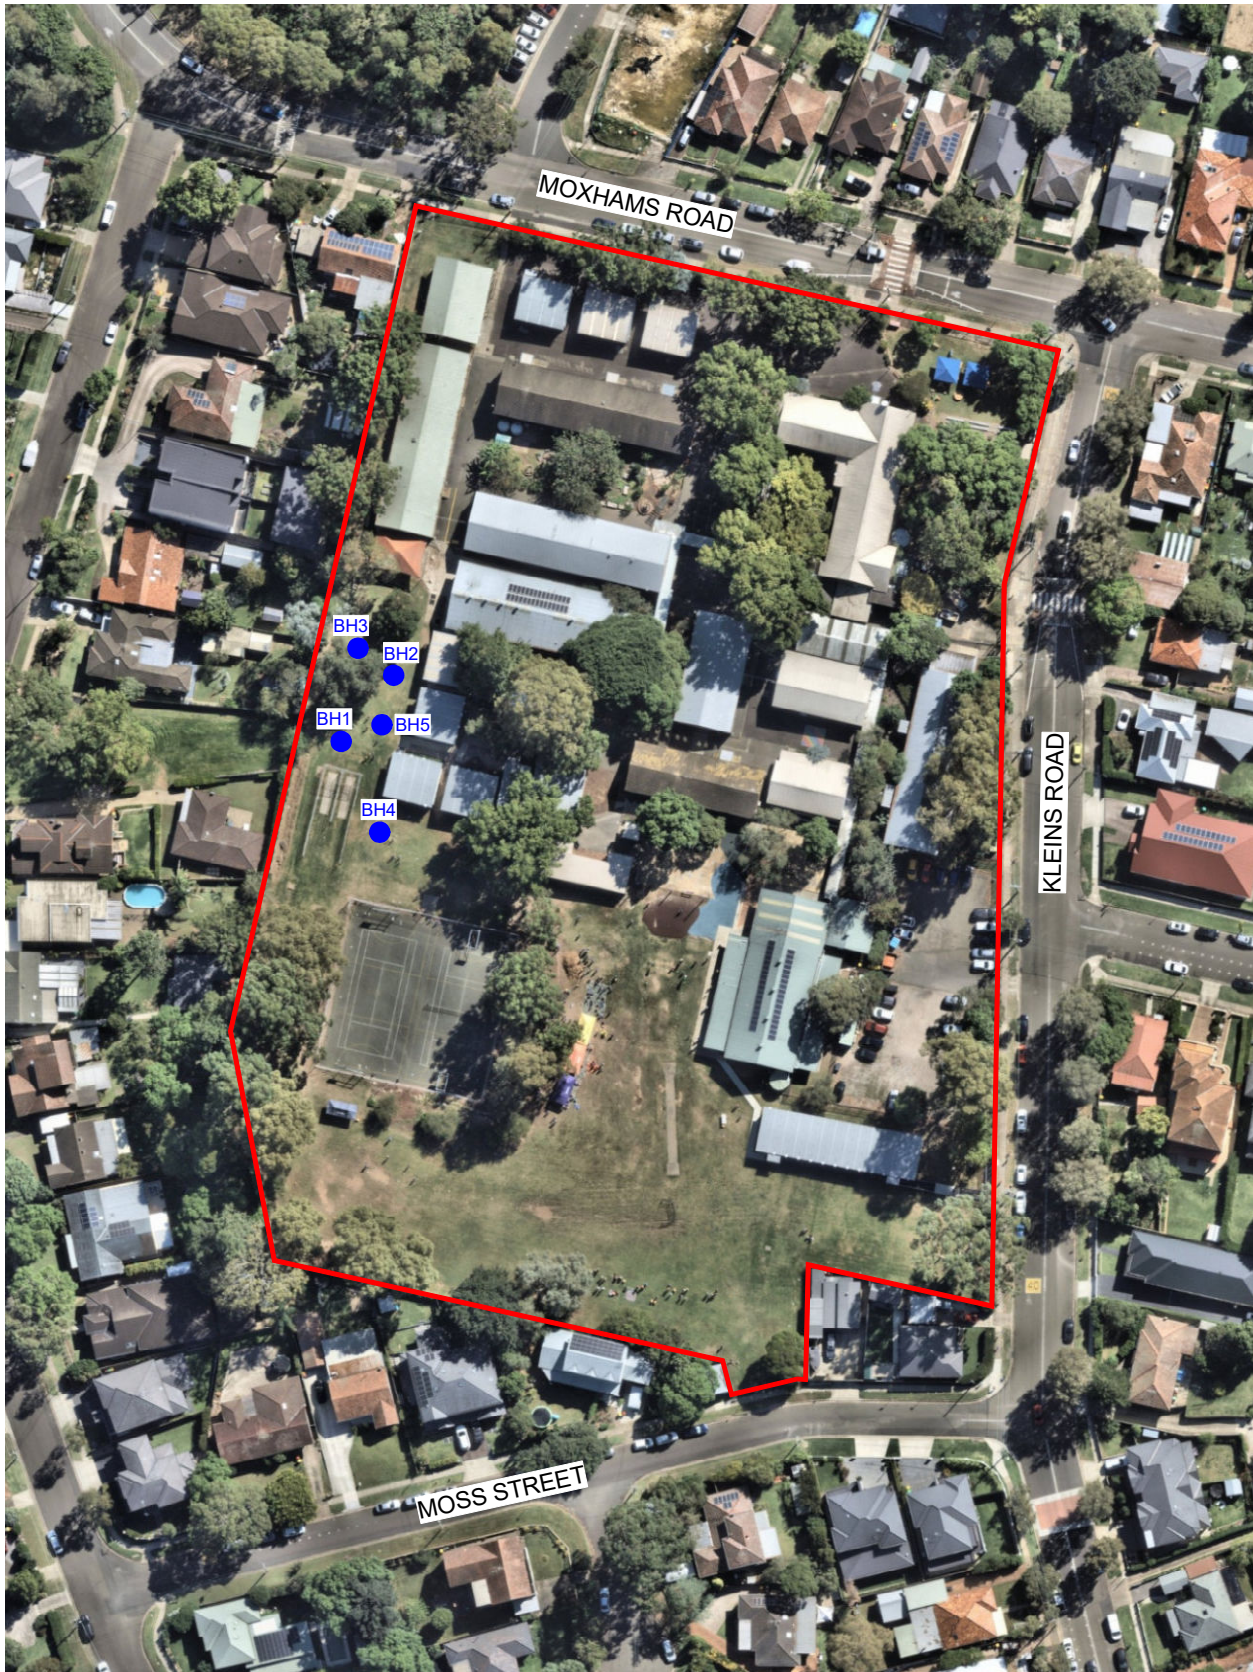
Drawing No: 20429/6-AA1  
Job No: 20429/6  
Drawn By: MH  
Date: 3 October 2023  
Checked By: JH/JX/IJ

- Five boreholes BH1 to BH5 (refer to Drawing No 20429/6-AA1) were drilled nominated for geotechnical investigation at and in the vicinity of the investigation area determined by SINSW.
- Fibro cement pieces (FCPs) were noted within the fill in BH5. One FCP sample was collected.

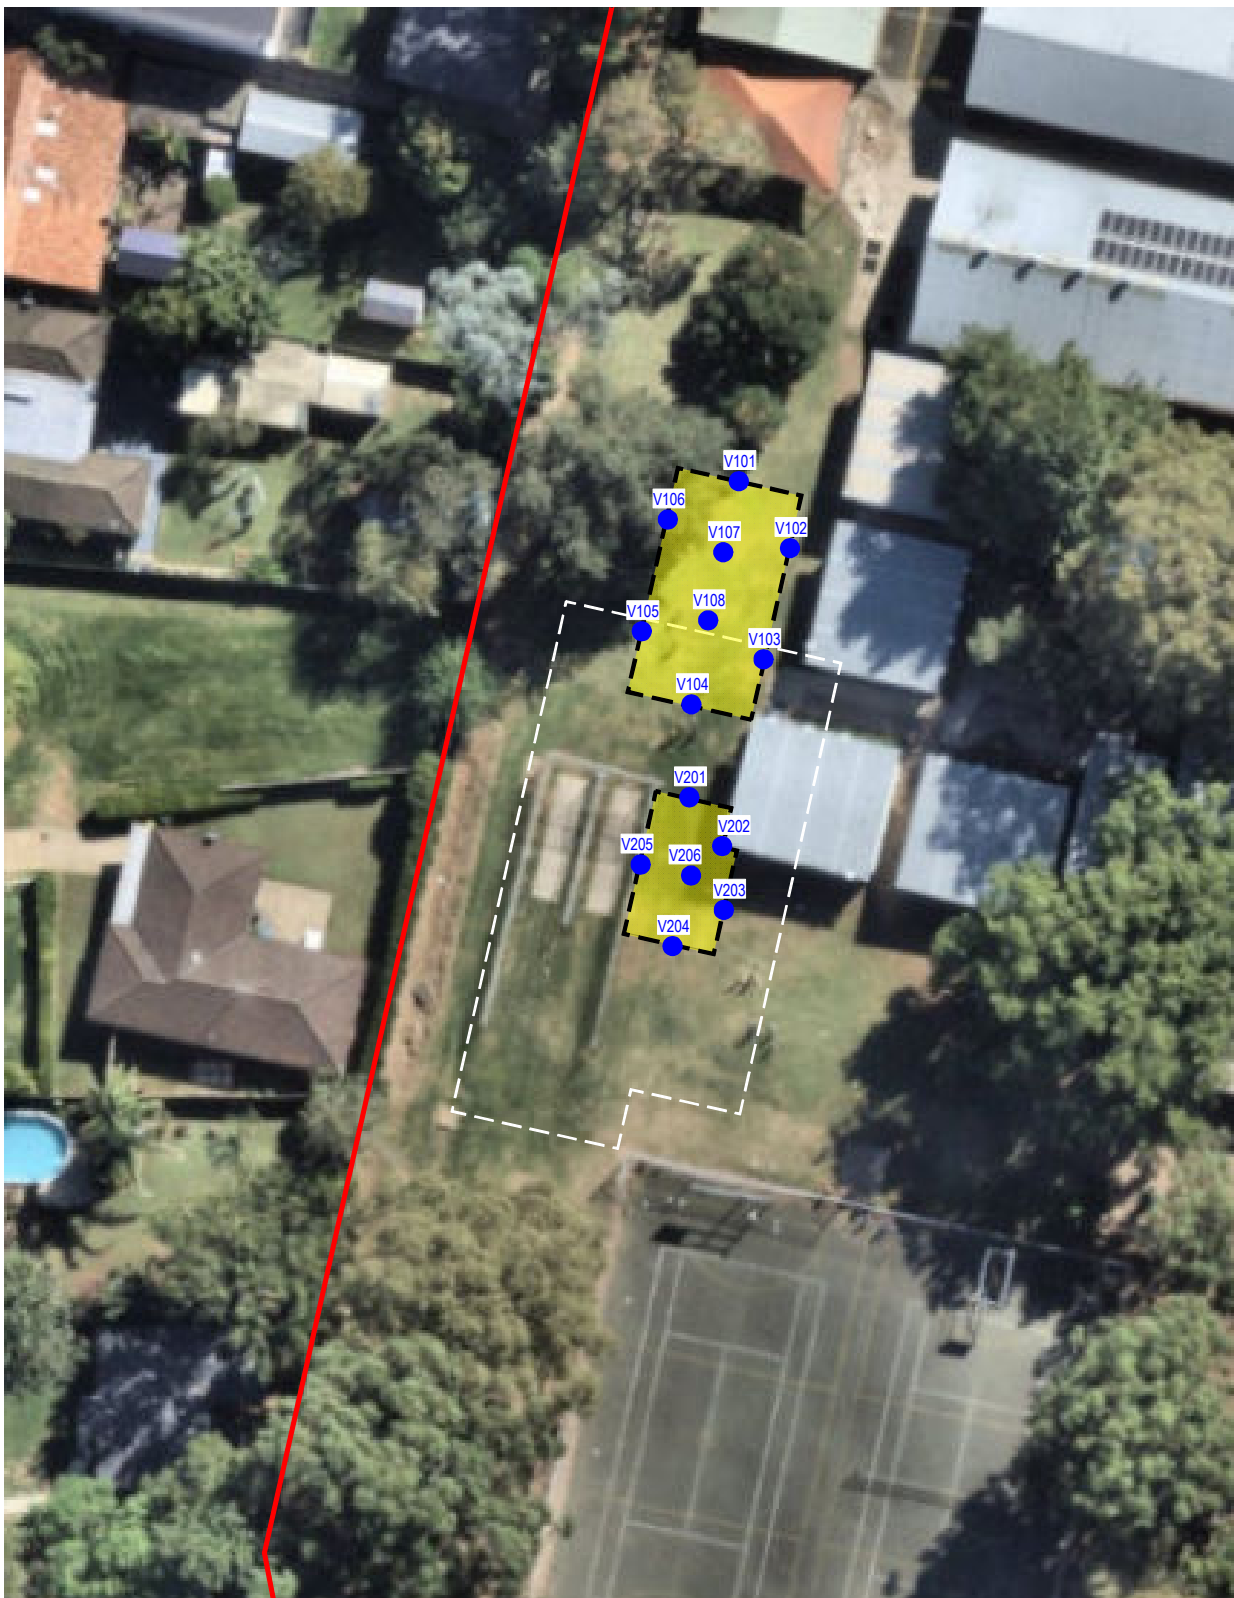
20429/13-AA2

*Proposed Validation Sample Locations*
