# Supplementary Geotechnical Investigation Report

## Upgrade to Dundas Public School

85 Kissing Point Road, Dundas, NSW 2117

A201023.0722.03\_C\_v1f | Date: 11 March 2025

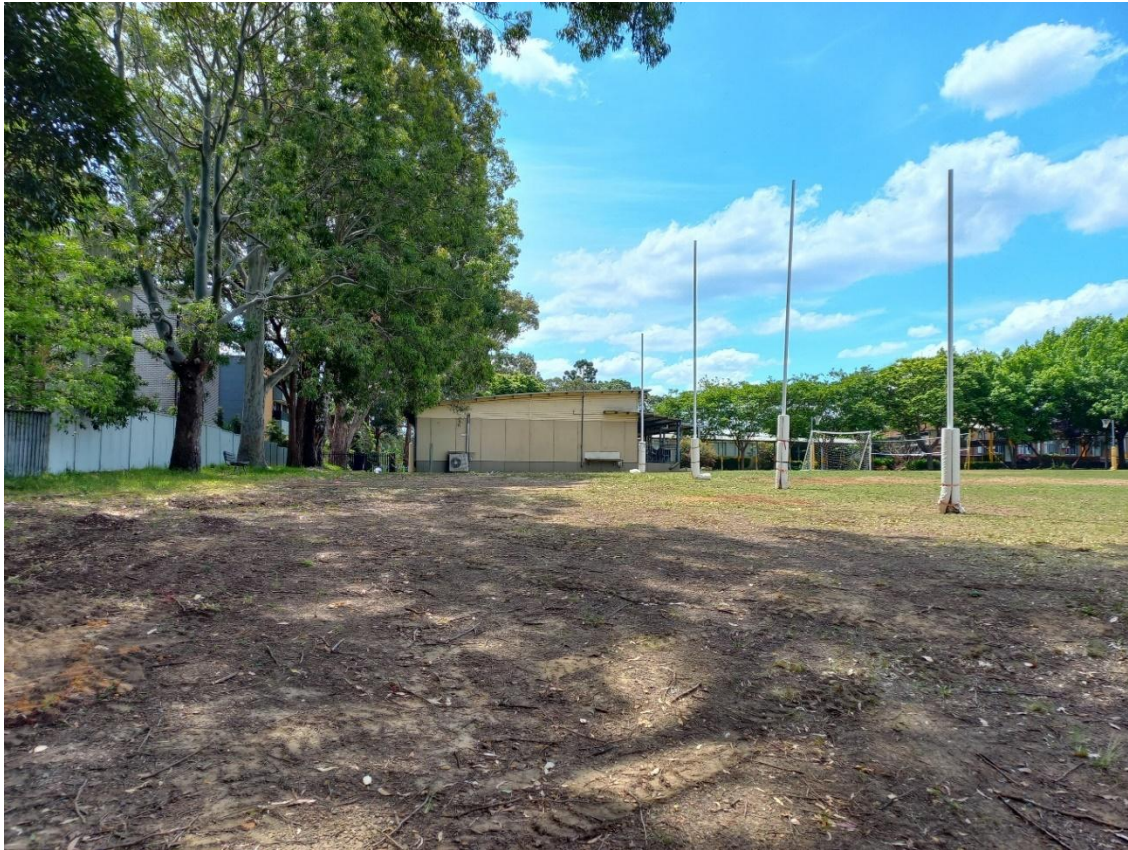
Figure 3 below shows the proposed building footprint, with the school's current oval on the right. Figure 4 shows more of the school's ovals.

*Figure 3: View of the proposed new building footprint looking north*

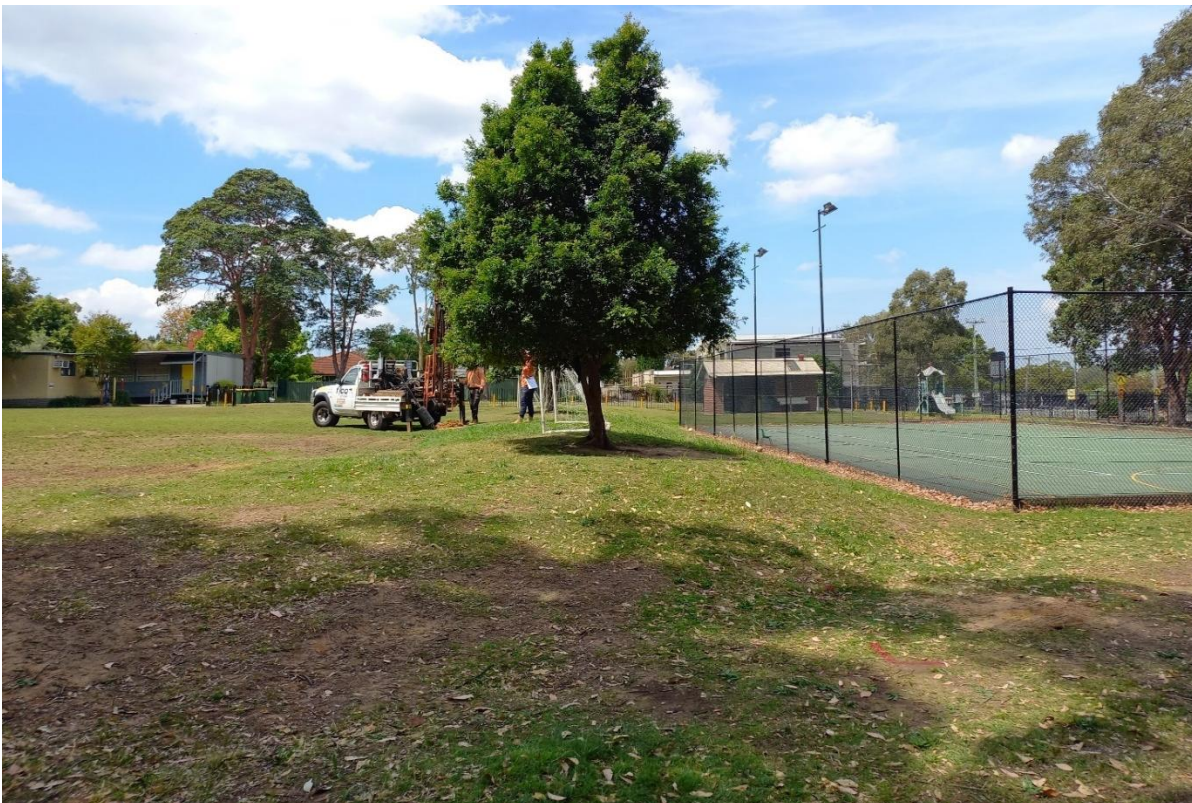
*Figure 4: Site photo looking east towards BH104 and the school's basketball courts and oval*

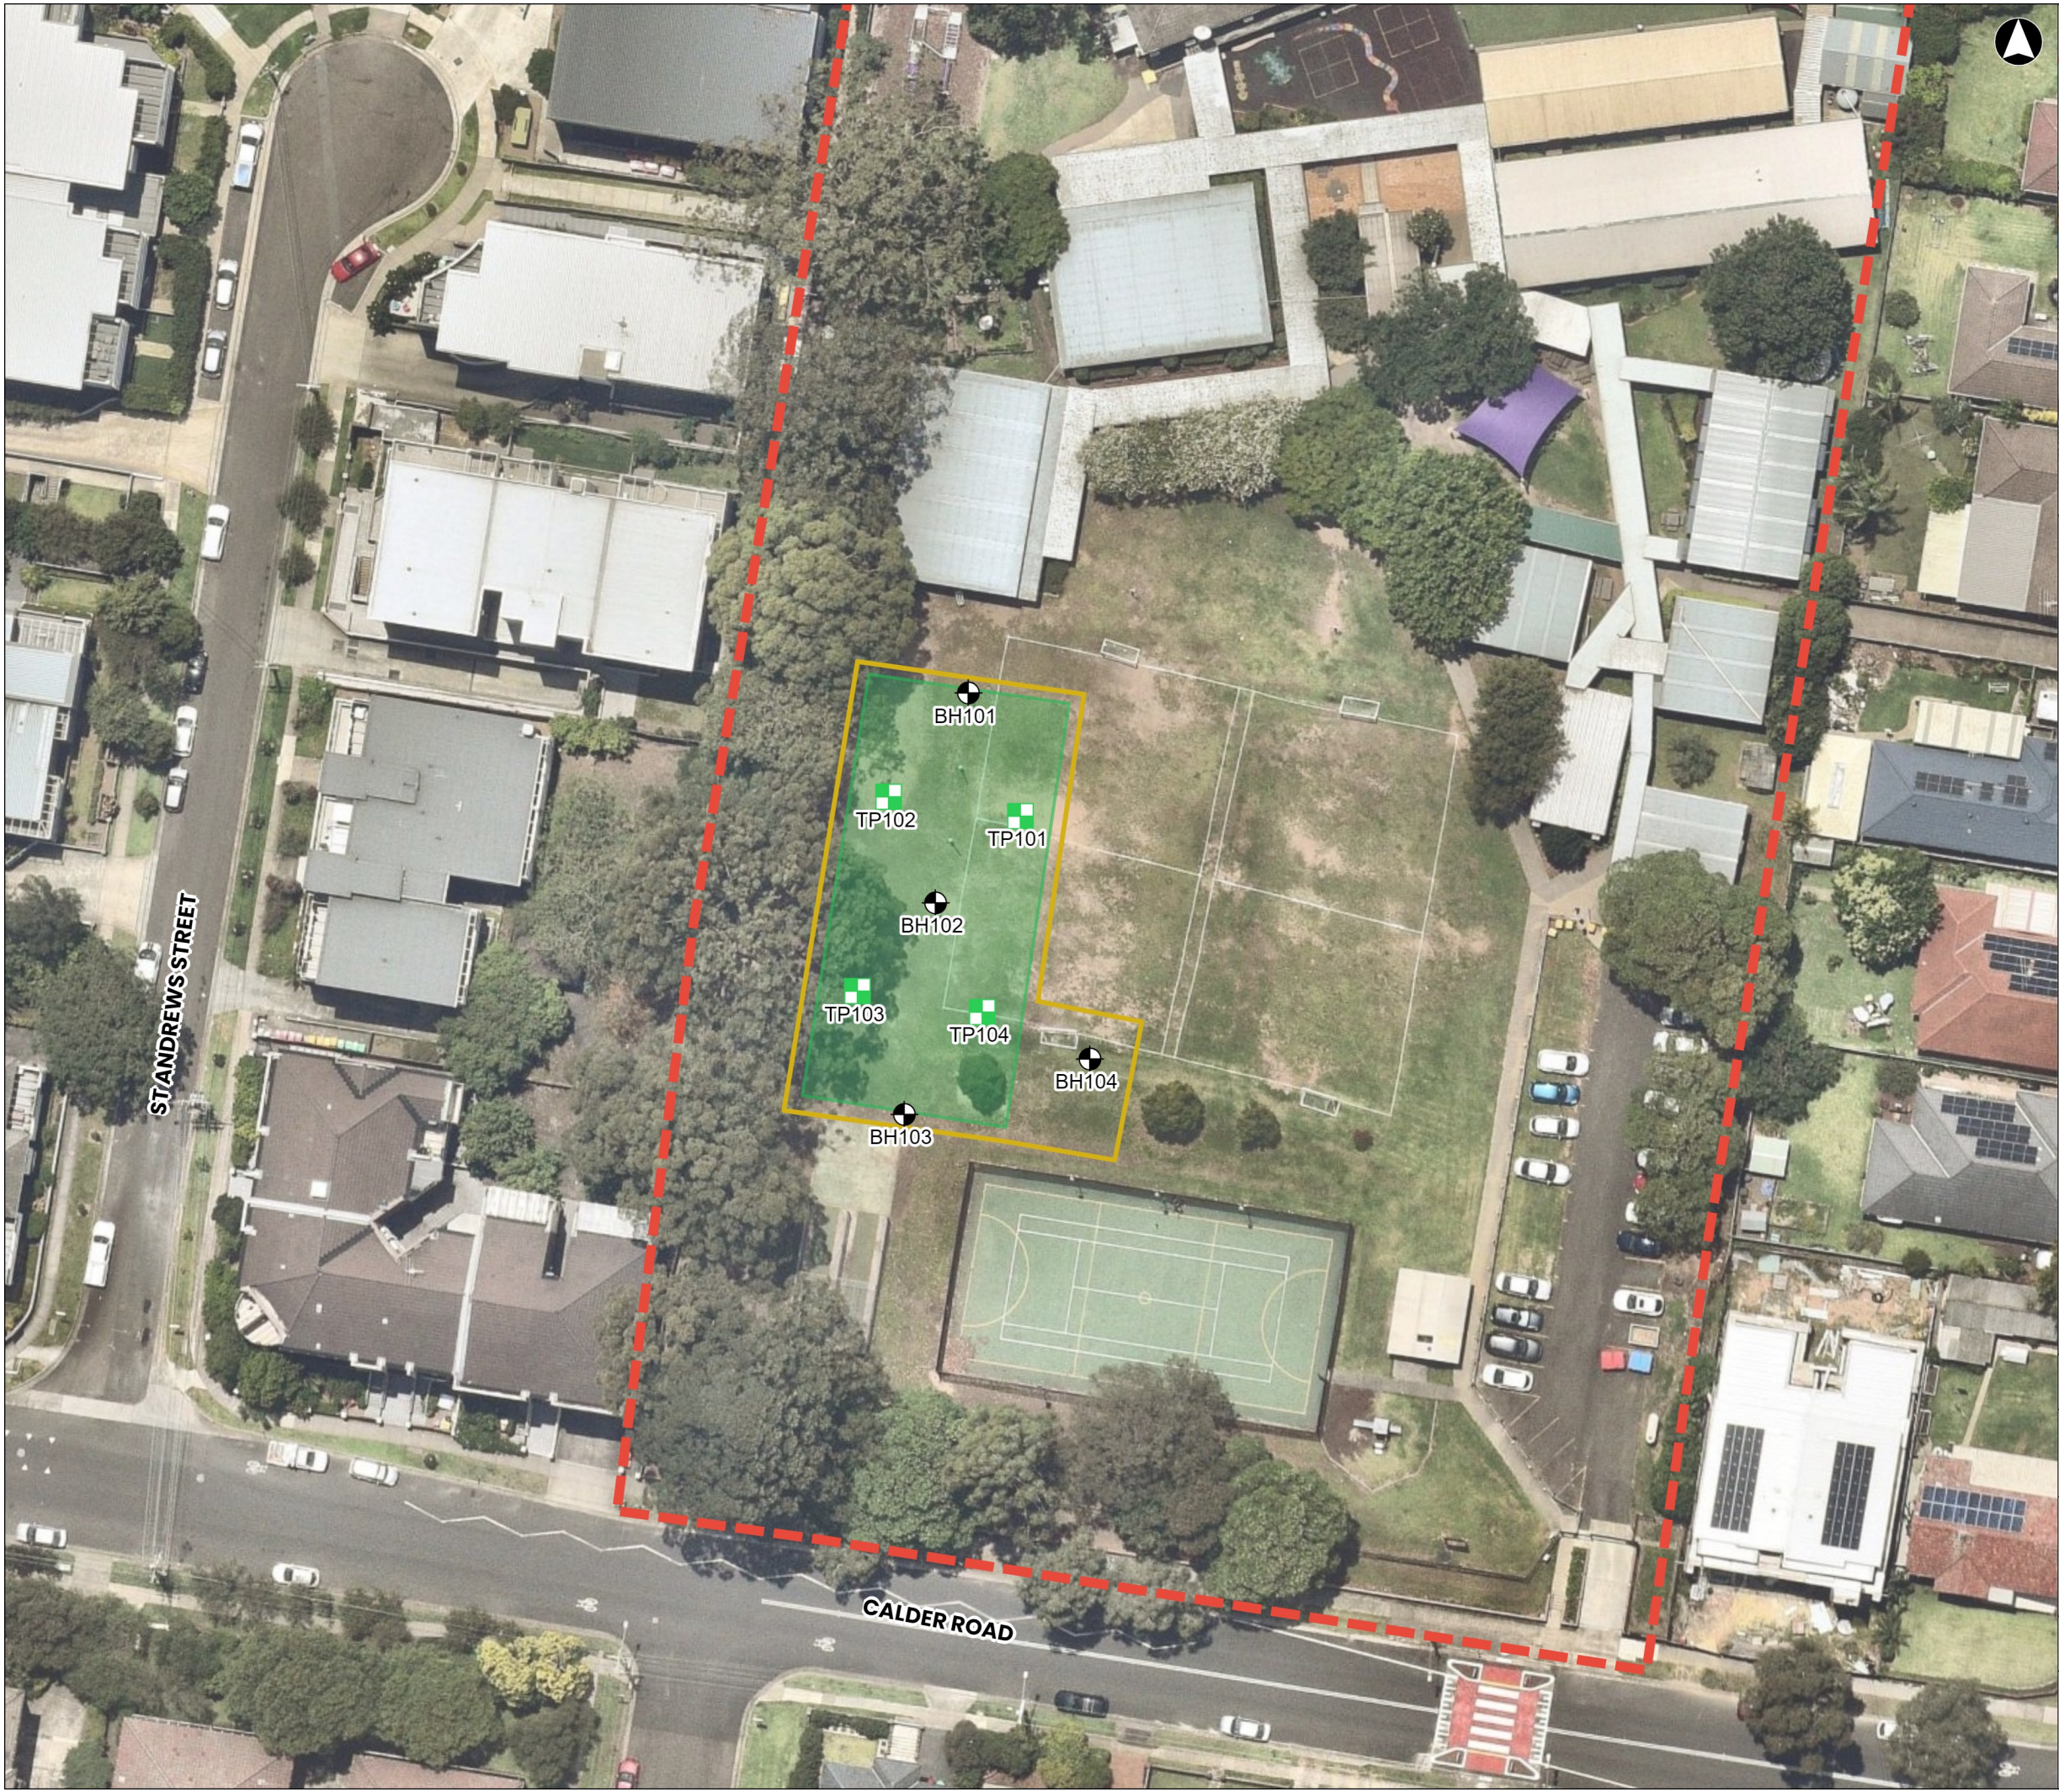
## **Appendix I – Borehole Location Plan**

- Legend**
- Test pit locations
  - Borehole locations
  - Investigation area
  - Footprint of proposed school building
  - Dundas Public School - Boundary

A site plan showing the proposed building footprint and borehole locations is presented in **Appendix I**.
