Additional Geotechnical Investigation Report

Upgrades to Melrose Park Public School

110 Wharf Road, Melrose Park NSW 2114

A201023.0436.01_C_v2f | Date: 2 April 2025

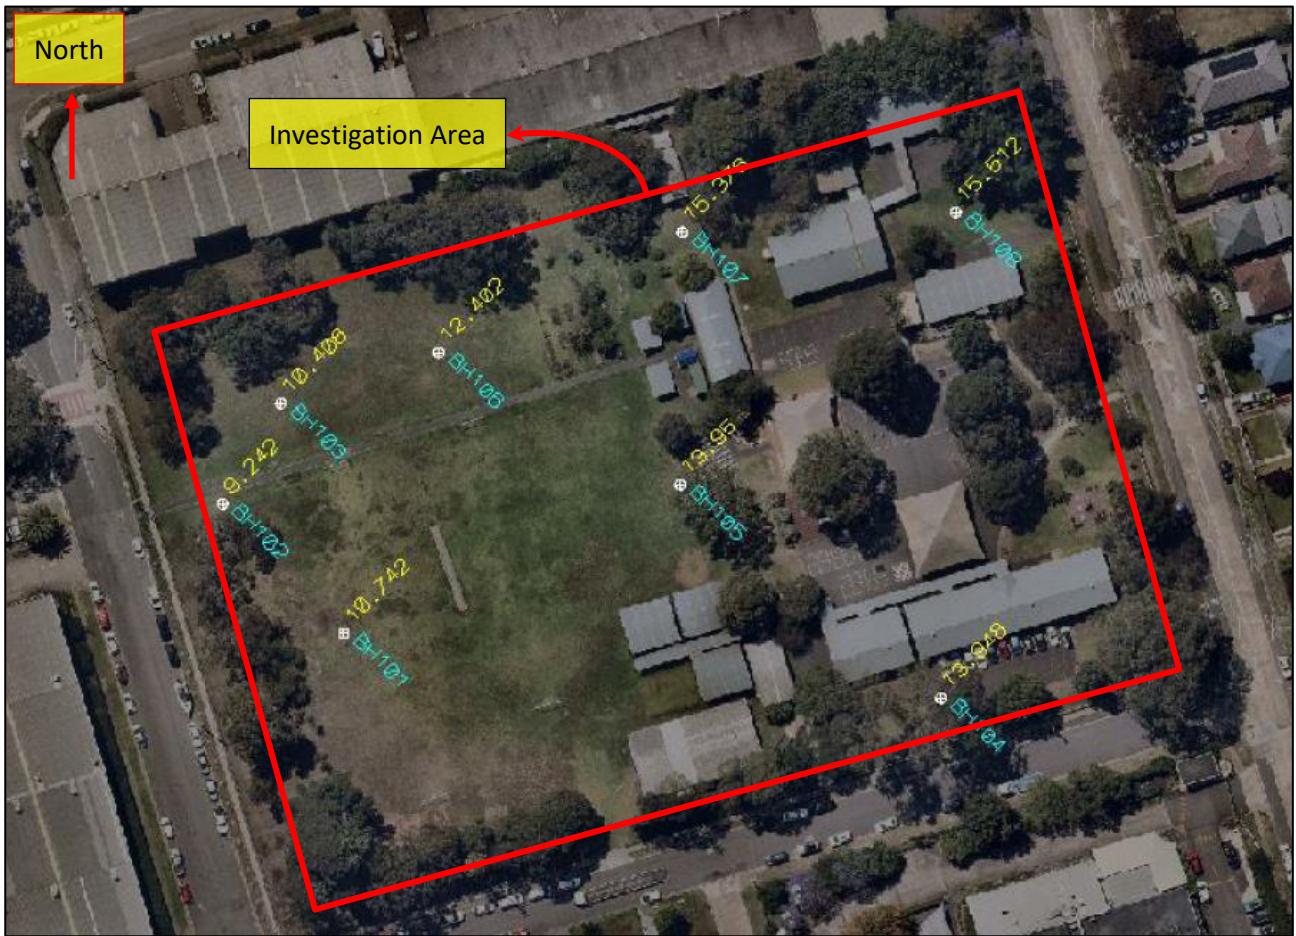
Figure 2: Aerial View of the Site Showing Boundaries and Existing Structures, (Astrea, 2025).

Figure 2 below shows the approximate location of MPPS site boundaries, existing structures, and the borehole locations from this round of investigation.

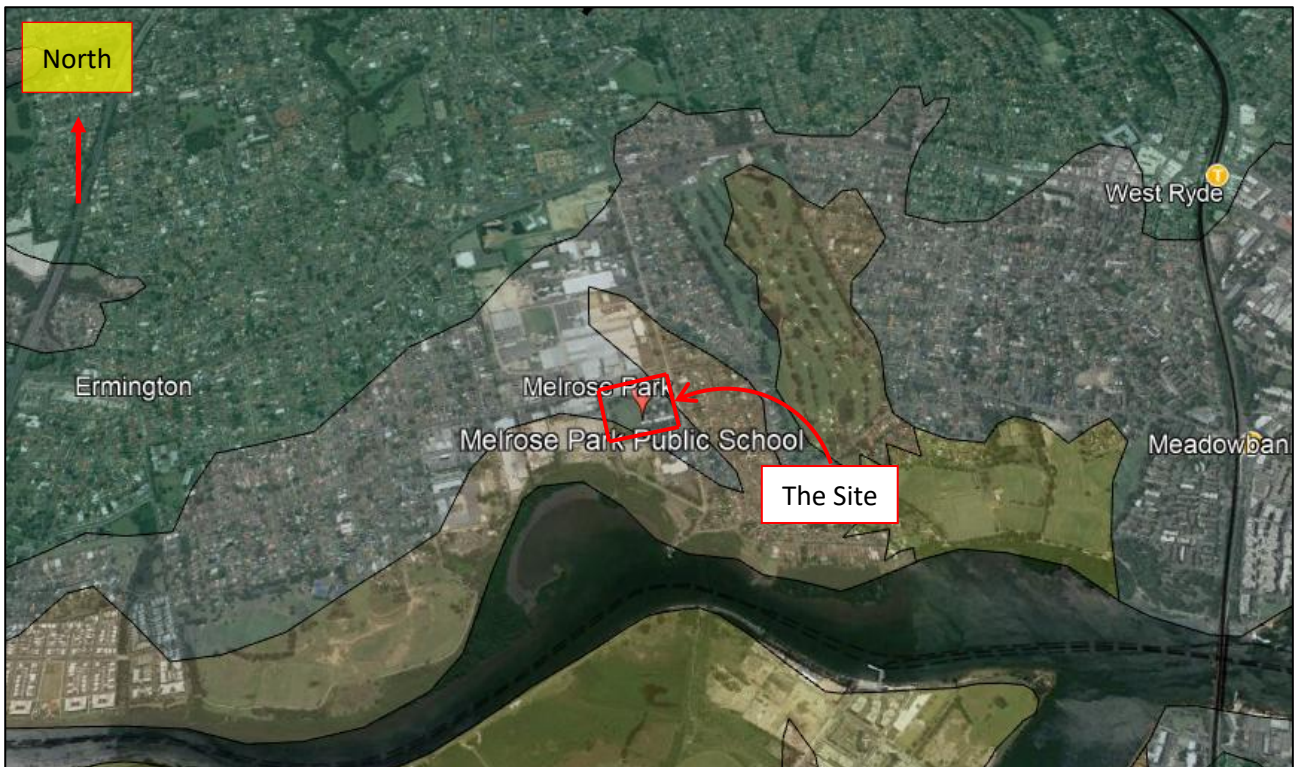
Figure 5: Excerpt of the Sydney Geological Map showing the Site Location

Geological Survey of NSW (1983) indicates that the site is underlain by Hawkesbury Sandstone (Rh) and Alluvial soil (Qha) geologies. Hawkesbury Sandstone is part of Wianamatta Group, Triassic aged and described as *“medium to coarse-grained quartz sandstone, very minor shale and laminate lenses”*. Alluvial soils mapped to the south and east of the site are Quaternary aged and described as *“Silty to peaty quartz sand, silt, and clay. Ferruginous and humic cementation in places. Common shell layers”*.

Figure 5 shows the excerpt of the local geology from the Sydney Geological Map.

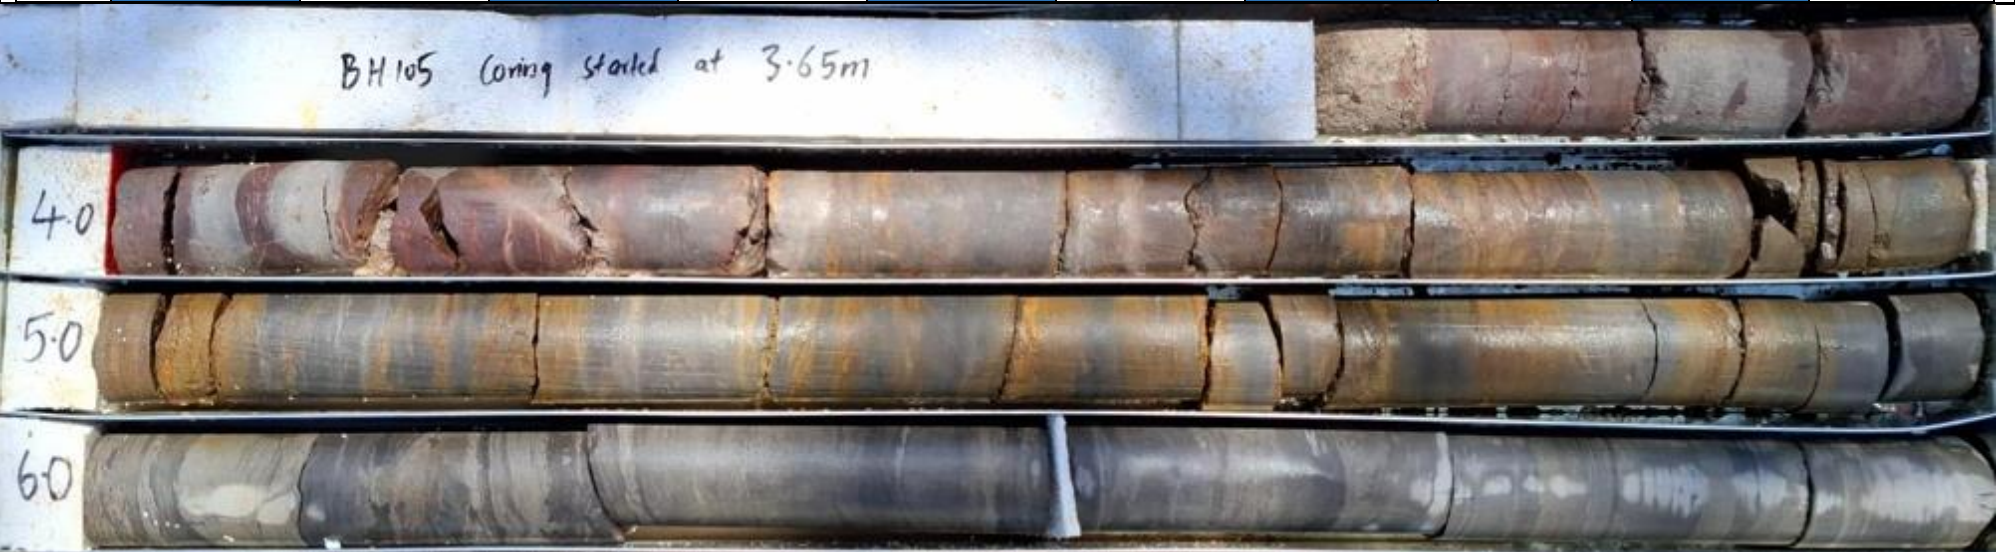
Core Photo : No. 1

ADECONSULTINGGROUP SOLUTIONS THROUGH INNOVATION	Client:	SINSW	Borehole No:	BH 105
	Project:	Geotechnical Investigation	Depth:	3.65 m – 7.00 m
	Title:	Core Photograph	Photograph By:	GL
	Location:	110 Wharf Road, Ermington NSW 2114	Date:	06.01.2025

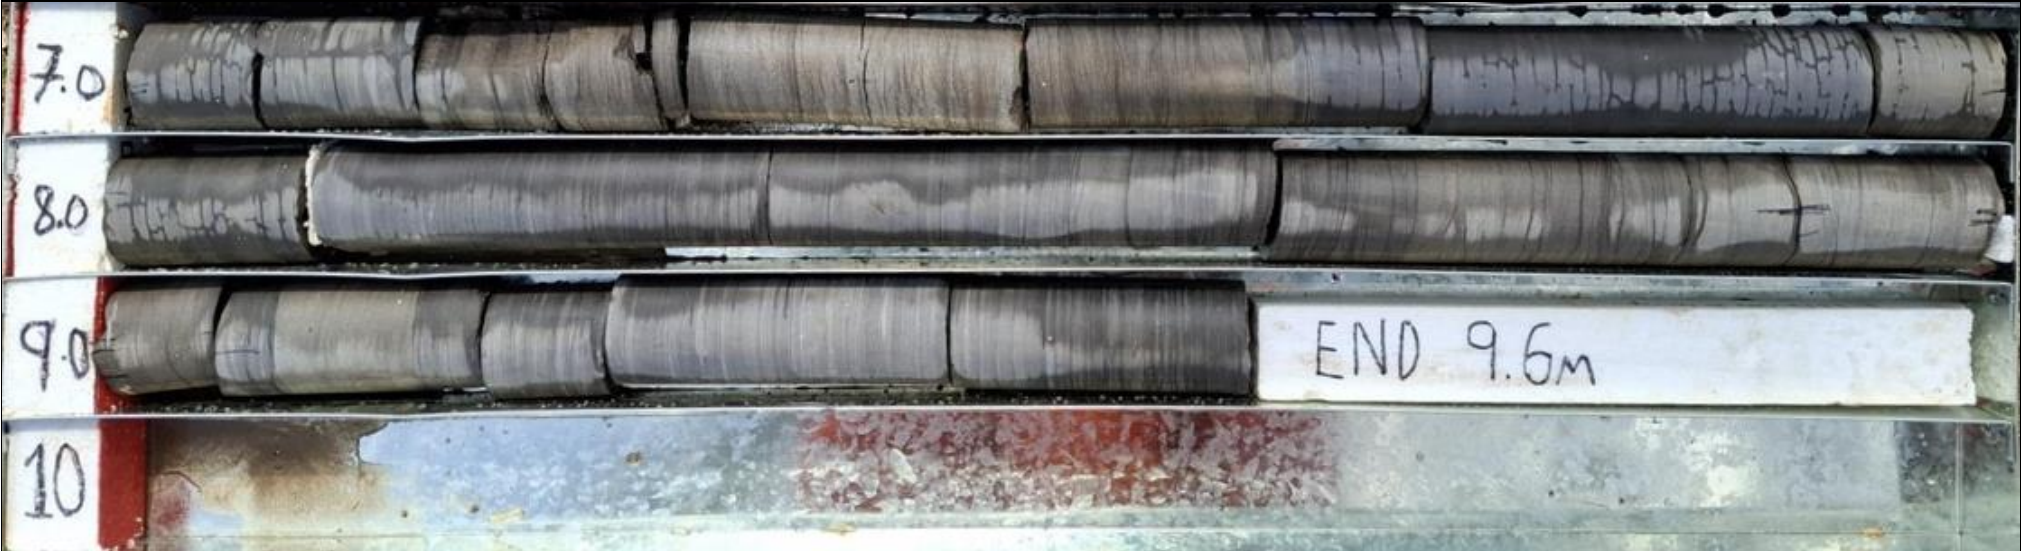
Core Photo : No. 2

Client:	SINSW	Borehole No:	BH 105
	Project:	Geotechnical Investigation	Depth:	7.00 m – 9.60 m
	Title:	Core Photograph	Photograph By:	GL
	Location:	110 Wharf Road, Ermington NSW 2114	Date:	06.01.2025

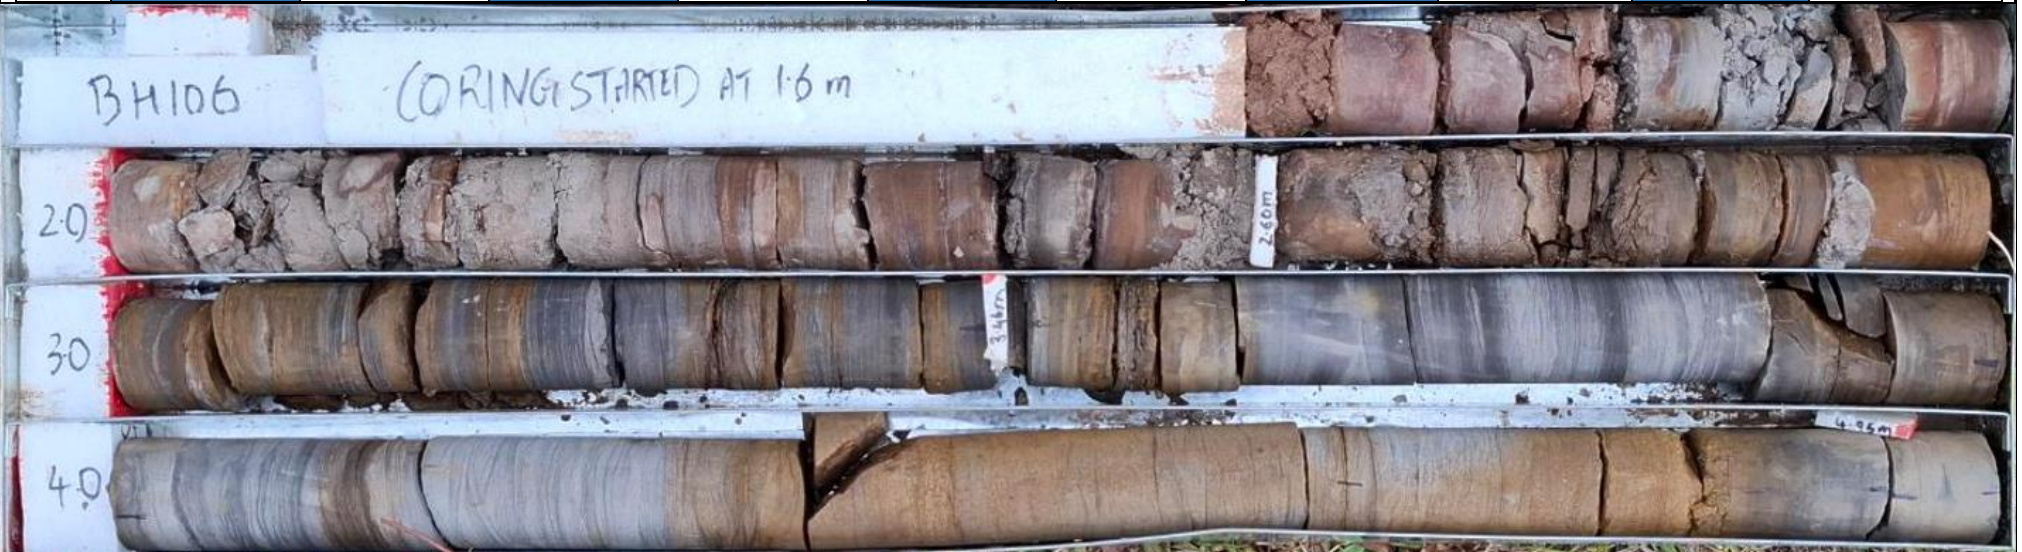
Core Photo : No. 1

ADECONSULTINGGROUP SOLUTIONS THROUGH INNOVATION	Client:	SINSW	Borehole No:	BH 106
	Project:	Geotechnical Investigation	Depth:	1.60 m – 5.00 m
	Title:	Core Photograph	Photograph By:	GL
	Location:	110 Wharf Road, Ermington NSW 2114	Date:	10.01.2025

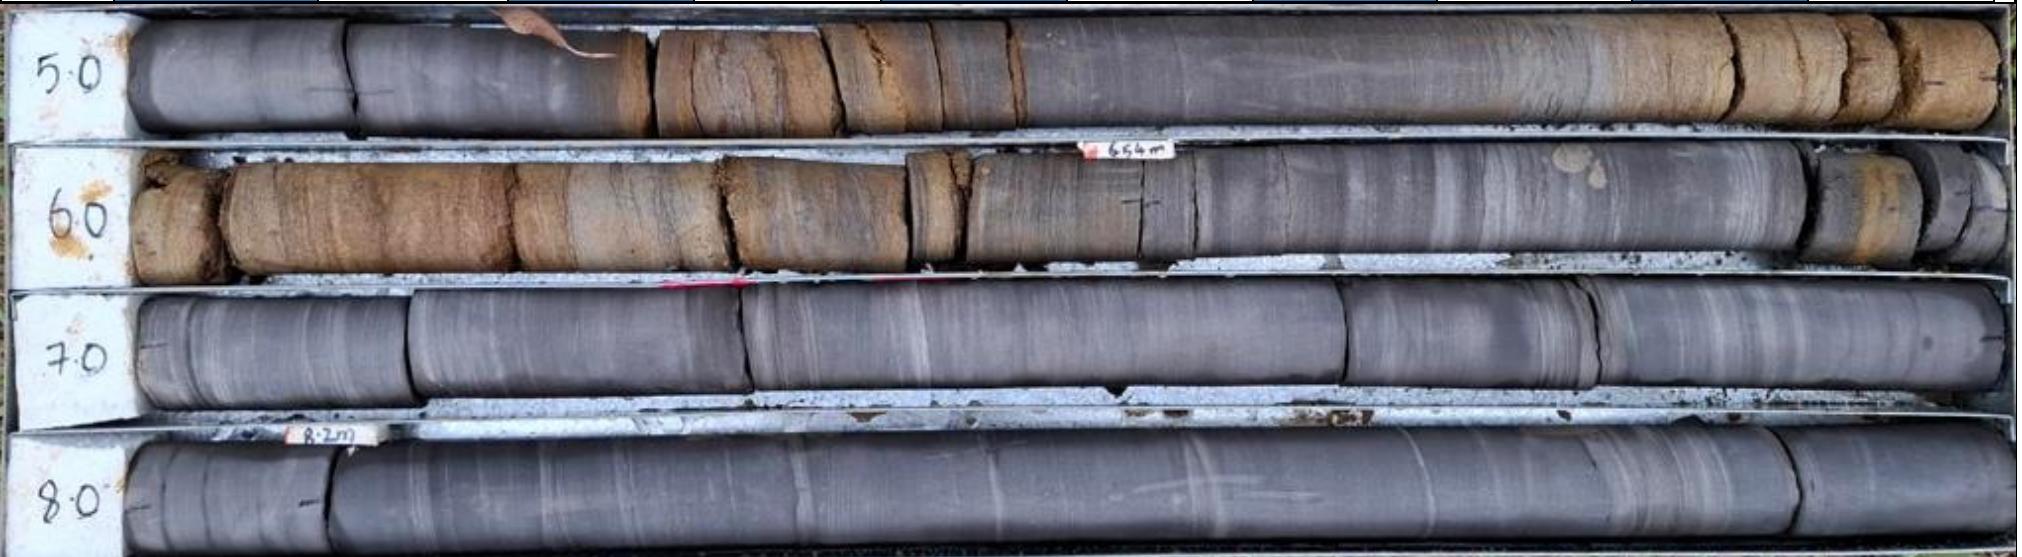
Core Photo : No. 2

Client:	SINSW	Borehole No:	BH 106
	Project:	Geotechnical Investigation	Depth:	5.00 m – 9.60 m
	Title:	Core Photograph	Photograph By:	GL
	Location:	110 Wharf Road, Ermington NSW 2114	Date:	10.01.2025

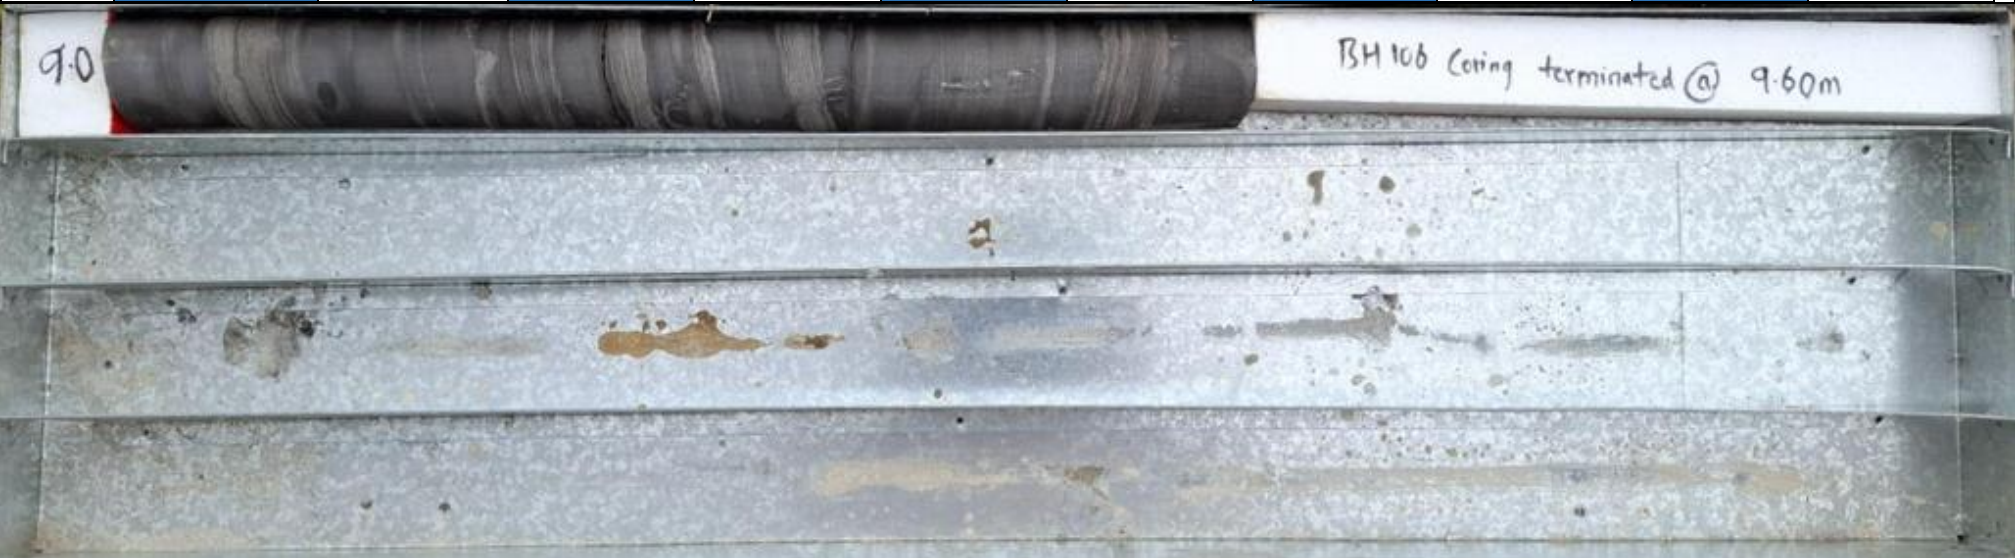
Core Photo : No. 3

Client:	SINSW	Borehole No:	BH 106
	Project:	Geotechnical Investigation	Depth:	9.00 m – 9.60 m
	Title:	Core Photograph	Photograph By:	GL
	Location:	110 Wharf Road, Ermington NSW 2114	Date:	10.01.2025

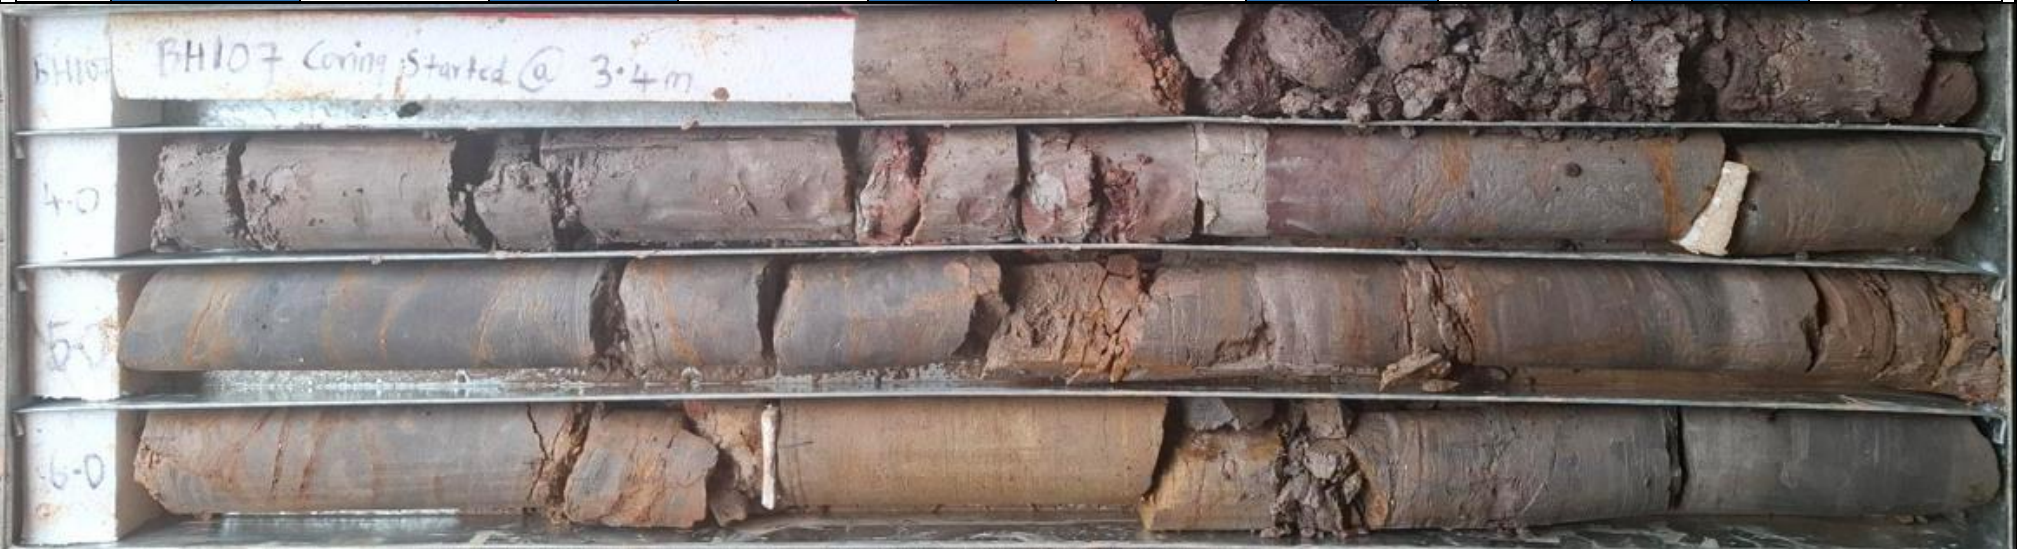
Core Photo : No. 1

ADECONSULTINGGROUP SOLUTIONS THROUGH INNOVATION	Client:	SINSW	Borehole No:	BH 107
	Project:	Geotechnical Investigation	Depth:	3.40 m – 7.00 m
	Title:	Core Photograph	Photograph By:	GL
	Location:	110 Wharf Road, Ermington NSW 2114	Date:	9.01.2025

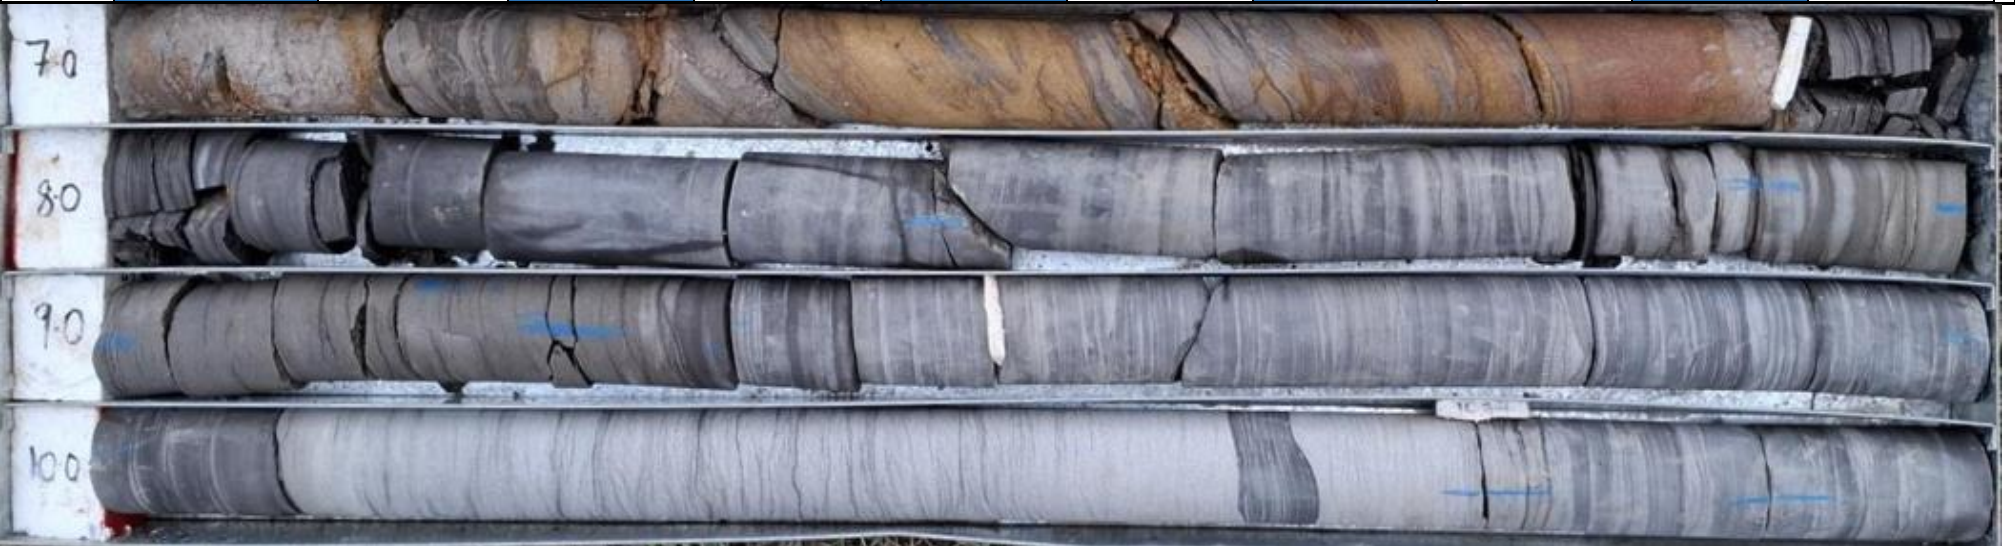
Core Photo : No. 2

Client:	SINSW	Borehole No:	BH 107
	Project:	Geotechnical Investigation	Depth:	7.00 m – 11.00 m
	Title:	Core Photograph	Photograph By:	GL
	Location:	110 Wharf Road, Ermington NSW 2114	Date:	9.01.2025

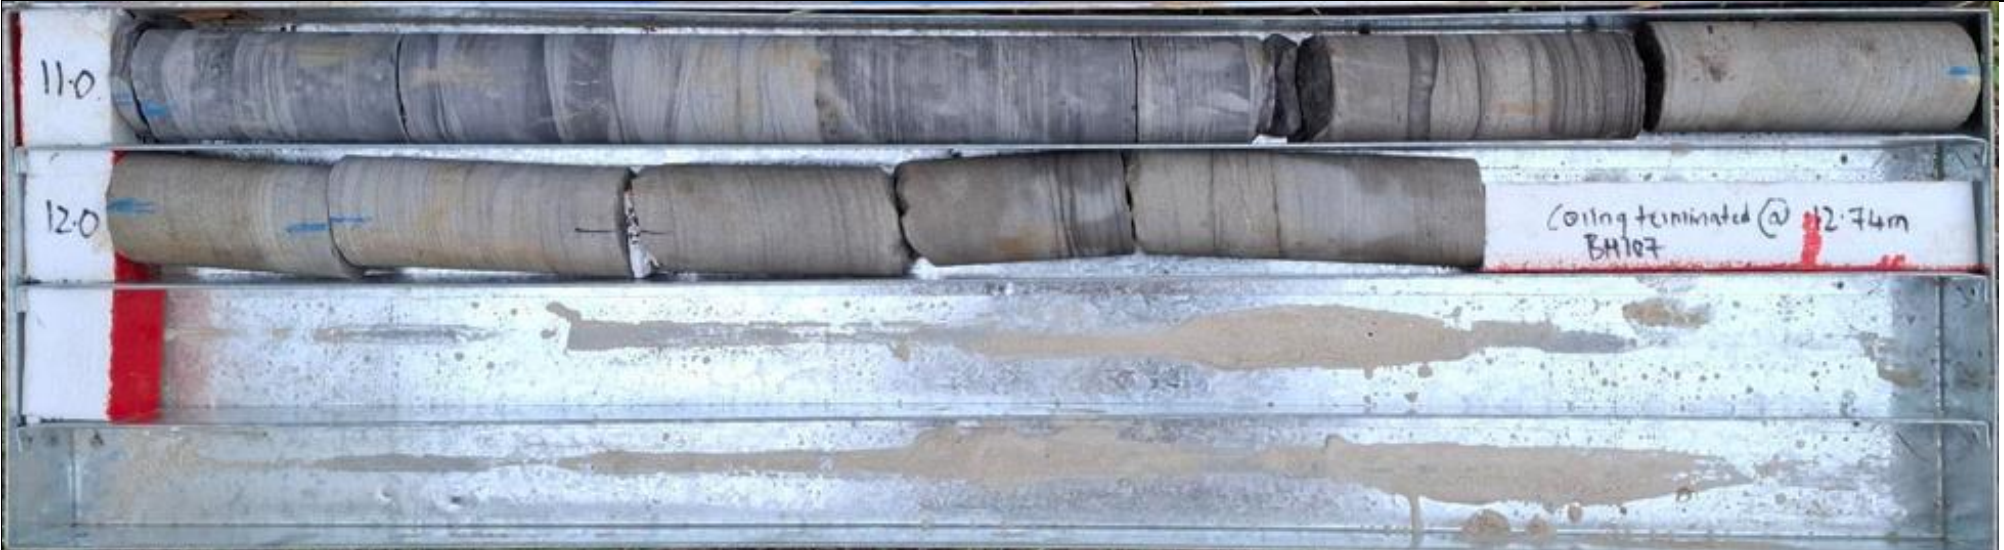
Core Photo : No. 3

Client:	SINSW	Borehole No:	BH 107
	Project:	Geotechnical Investigation	Depth:	11.00 m – 12.74 m
	Title:	Core Photograph	Photograph By:	GL
	Location:	110 Wharf Road, Ermington NSW 2114	Date:	09.01.2025

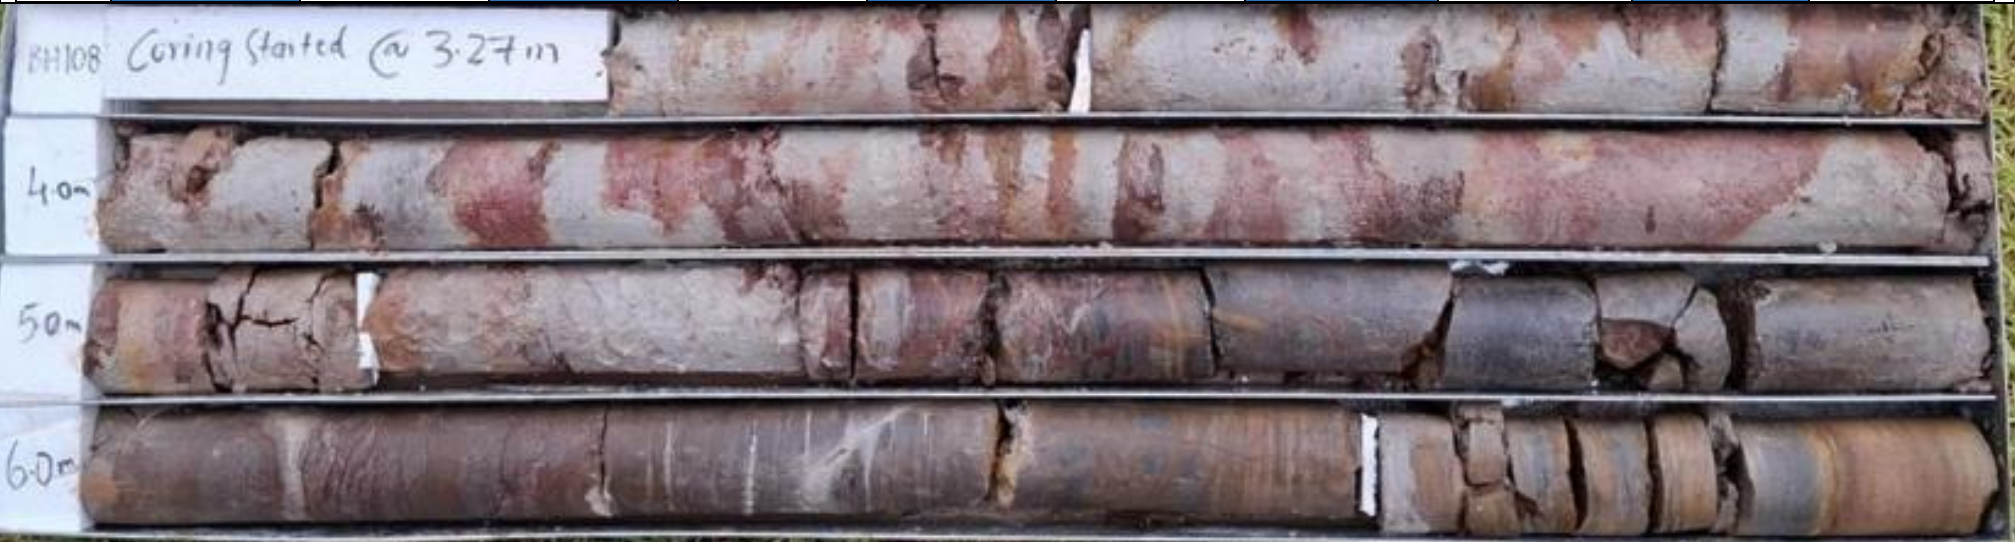
Core Photo : No. 1

ADE CONSULTING GROUP SOLUTIONS THROUGH INNOVATION	Client:	SINSW	Borehole No:	BH 108
	Project:	Geotechnical Investigation	Depth:	3.27 m – 7.00 m
	Title:	Core Photograph	Photograph By:	GL
	Location:	110 Wharf Road, Ermington NSW 2114	Date:	07.01.2025

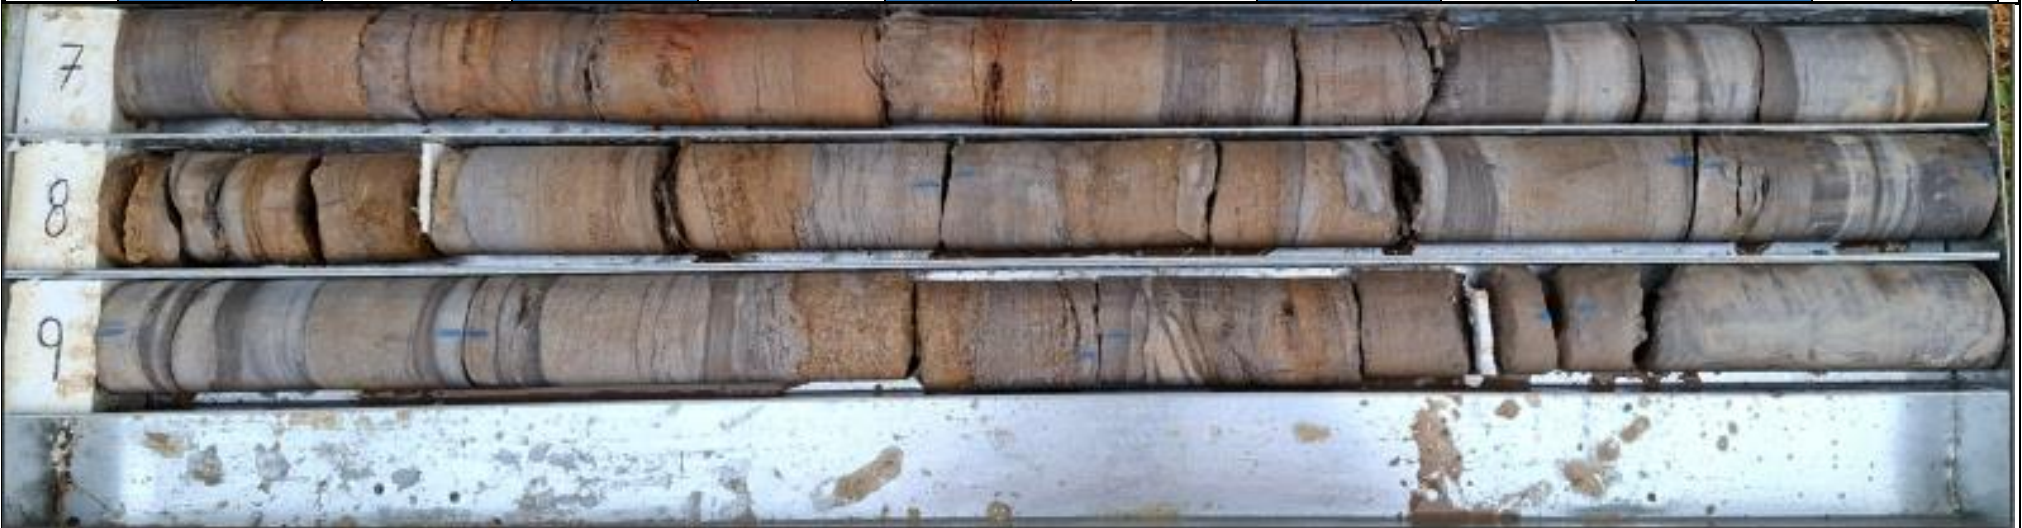
Core Photo : No. 2

Client:	SINSW	Borehole No:	BH 108
	Project:	Geotechnical Investigation	Depth:	7.00 m – 10.00 m
	Title:	Core Photograph	Photograph By:	GL
	Location:	110 Wharf Road, Ermington NSW 2114	Date:	07.01.2025

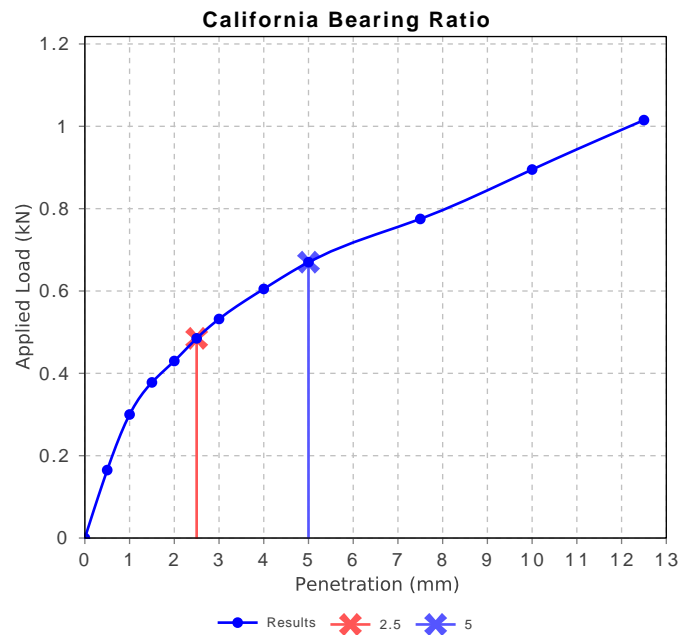
California Bearing Ratio (AS 1289 6.1.1 & 2.1.1)		Min	Max
CBR taken at	2.5 mm		
CBR %	3.5		
Method of Compactive Effort	Standard		
Method used to Determine MDD	AS1289.5.1.1 & 2.1.1		
Method used to Determine Plasticity	Visual/ Tactile		
Maximum Dry Density (t/m ³)	1.74		
Optimum Moisture Content (%)	15.5		
Laboratory Density Ratio (%)	100.0		
Laboratory Moisture Ratio (%)	100.0		
Dry Density after Soaking (t/m ³)	1.70		
Field Moisture Content (%)	11.9		
Moisture Content at Placement (%)	15.5		
Moisture Content Top 30mm (%)	20.2		
Moisture Content Rest of Sample (%)	19.6		
Mass Surcharge (kg)	9		
Soaking Period (days)	4		
Curing Hours (h)	24.0		
Swell (%)	2.0		
Oversize Material (mm)	19		
Oversize Material Included	Excluded		
Oversize Material (%)	2.4

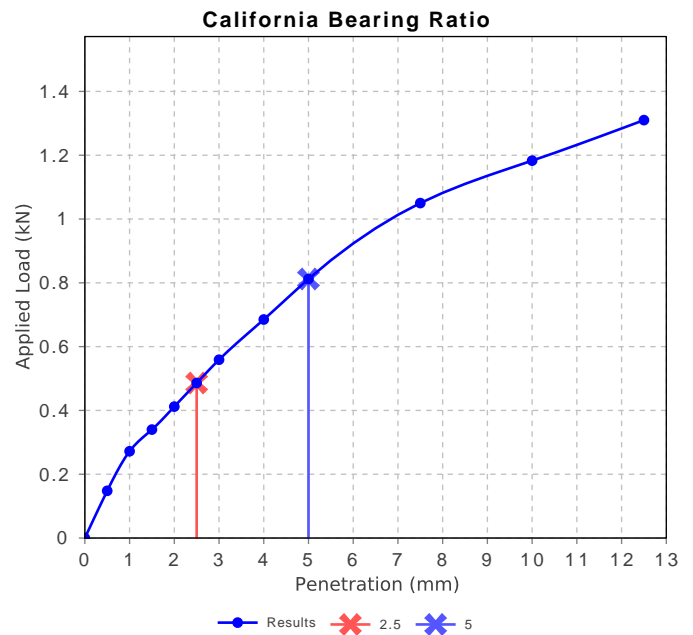
California Bearing Ratio (AS 1289 6.1.1 & 2.1.1)		Min	Max
CBR taken at	5 mm		
CBR %	4.0		
Method of Compactive Effort	Standard		
Method used to Determine MDD	AS1289.5.1.1 & 2.1.1		
Method used to Determine Plasticity	Visual/ Tactile		
Maximum Dry Density (t/m ³)	1.67		
Optimum Moisture Content (%)	18.5		
Laboratory Density Ratio (%)	101.0		
Laboratory Moisture Ratio (%)	94.0		
Dry Density after Soaking (t/m ³)	1.66		
Field Moisture Content (%)	14.9		
Moisture Content at Placement (%)	17.4		
Moisture Content Top 30mm (%)	25.8		
Moisture Content Rest of Sample (%)	22.7		
Mass Surcharge (kg)	9		
Soaking Period (days)	4		
Curing Hours (h)	24.0		
Swell (%)	1.5		
Oversize Material (mm)	19		
Oversize Material Included	Excluded		
Oversize Material (%)

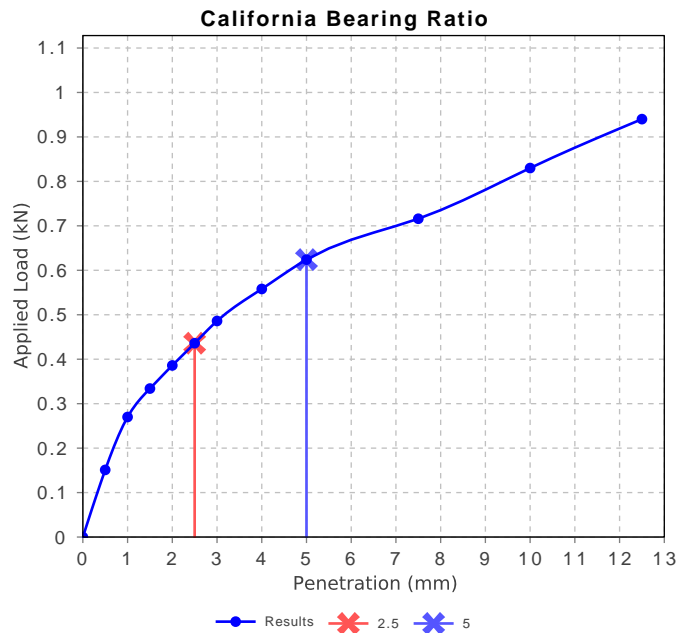
Preparation Method: AS 1289.1.1 - Sampling and Preparation of Soils
Remarks: Reference: A201023.0436.01 4*CBR tests (5 samples)
Sample Location: Melrose Park Public School, Depth: 0.7-1m
Material: Silty CLAY, pale BROWN

California Bearing Ratio (AS 1289 6.1.1 & 2.1.1)		Min	Max
CBR taken at	2.5 mm		
CBR %	3.5		
Method of Compactive Effort	Standard		
Method used to Determine MDD	AS1289.5.1.1 & 2.1.1		
Method used to Determine Plasticity	Visual/ Tactile		
Maximum Dry Density (t/m ³)	1.64		
Optimum Moisture Content (%)	16.0		
Laboratory Density Ratio (%)	99.5		
Laboratory Moisture Ratio (%)	102.5		
Dry Density after Soaking (t/m ³)	1.58		
Field Moisture Content (%)	13.8		
Moisture Content at Placement (%)	16.4		
Moisture Content Top 30mm (%)	23.3		
Moisture Content Rest of Sample (%)	22.1		
Mass Surcharge (kg)	9		
Soaking Period (days)	4		
Curing Hours (h)	24.0		
Swell (%)	3.5		
Oversize Material (mm)	19		
Oversize Material Included	Excluded		
Oversize Material (%)	1

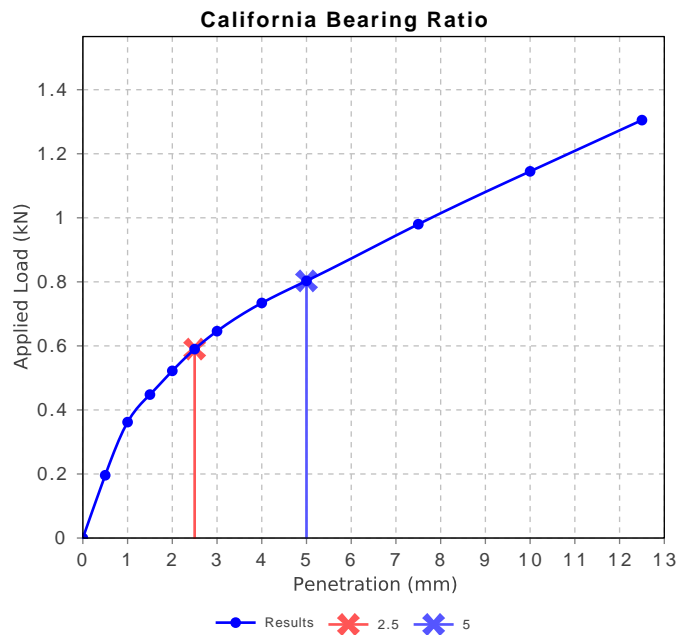
California Bearing Ratio (AS 1289 6.1.1 & 2.1.1)		Min	Max
CBR taken at	2.5 mm		
CBR %	4.5		
Method of Compactive Effort	Standard		
Method used to Determine MDD	AS1289.5.1.1 & 2.1.1		
Method used to Determine Plasticity	Visual/ Tactile		
Maximum Dry Density (t/m ³)	1.64		
Optimum Moisture Content (%)	19.0		
Laboratory Density Ratio (%)	100.0		
Laboratory Moisture Ratio (%)	101.0		
Dry Density after Soaking (t/m ³)	1.61		
Field Moisture Content (%)			
Moisture Content at Placement (%)	19.2		
Moisture Content Top 30mm (%)	29.0		
Moisture Content Rest of Sample (%)	22.6		
Mass Surcharge (kg)	9		
Soaking Period (days)	4		
Curing Hours (h)	24.0		
Swell (%)	2.0		
Oversize Material (mm)	19		
Oversize Material Included	Excluded		
Oversize Material (%)	0

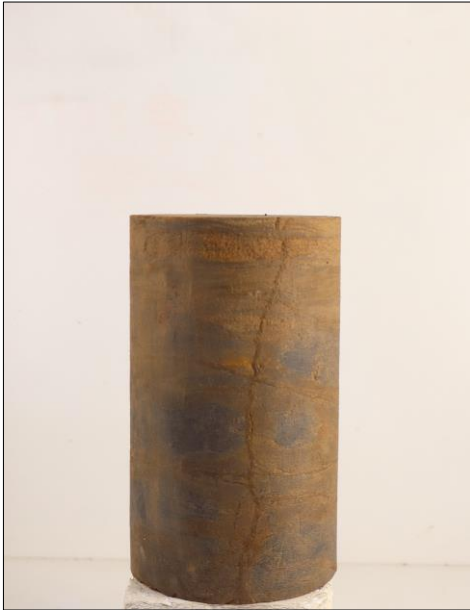
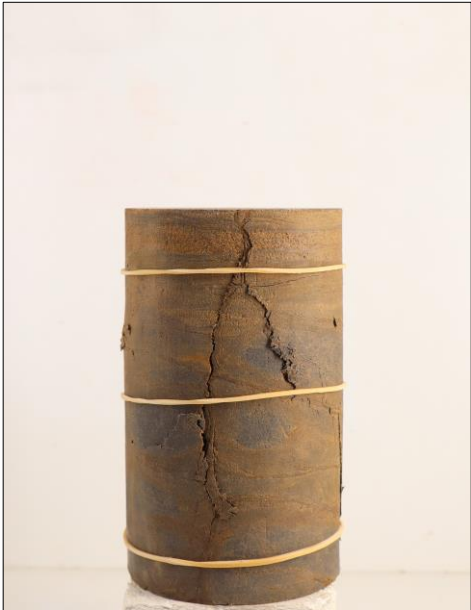
Unconfined Compressive Strength			
Client Address Project Job No.	ADE Consulting Group	Sample Source	BH108 6.52-6.68m
	6/7 Millennium Ct, Silverwater 2128 NSW	Sample Description	Shale
	Proposed Extension (A201023 0436 01)	Report No.	S102926-UCS
	S25017-1	Lab No.	S102926
Test Procedure	RMS T229 Unconfined compressive strength of rock core to 50 MPa strength		
Test Condition	Unsoaked	Specimen Curing	-
Sampling Method	Sampled by Client - results apply to the sample as received	Date Sampled	7/01/2025
<div>

</div>			
Corrected Compressive Strength		5.36 MPa	Corrected due to sample length
Specimen Length:	117.6 mm	Original Moisture Content:	N/A %
Average Specimen Diameter:	60.8 mm	After Test Moisture Content:	7.4 %
Length to Diameter Ratio:	1.9	Dry Density:	2.26 t/m ³
Failure Type:	Failure influenced by defect	Date Tested:	21/01/2025
Comments:			
Deviation from Standard:	Test specimen length to diameter ratio falls outside of standard limitations of 2.0-2.5.

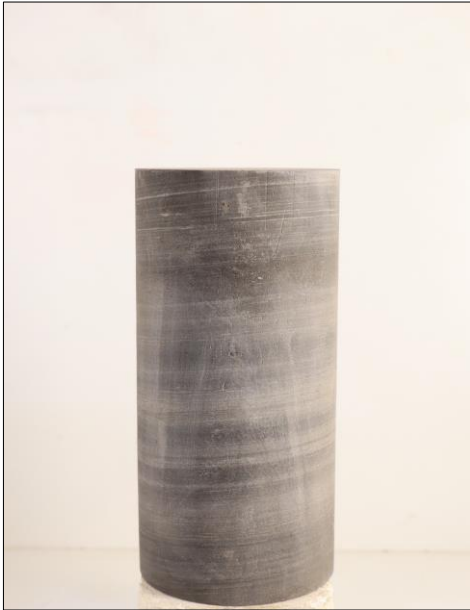
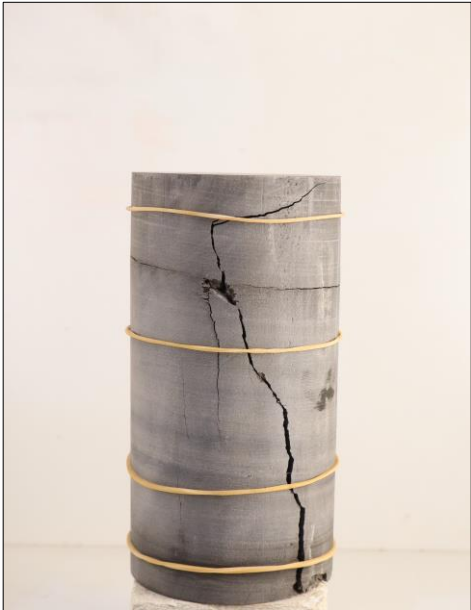
Unconfined Compressive Strength			
Client Address Project Job No.	ADE Consulting Group	Sample Source	BH108 9.81-10.00m
	6/7 Millennium Ct, Silverwater 2128 NSW	Sample Description	Shale
	Proposed Extension (A201023 0436 01)	Report No.	S102927-UCS
	S25017-1	Lab No.	S102927
Test Procedure	RMS T229 Unconfined compressive strength of rock core to 50 MPa strength		
Test Condition	Unsoaked	Specimen Curing	-
Sampling Method	Sampled by Client - results apply to the sample as received	Date Sampled	7/01/2025
<div>

</div>			
Unconfined Compressive Strength 20.3 MPa			
Specimen Length: 143.0 mm		Original Moisture Content: 3.9 %	
Average Specimen Diameter: 60.8 mm		After Test Moisture Content: 2.7 %	
Length to Diameter Ratio: 2.4		Dry Density: 2.53 t/m ³	
Failure Type: Axial Single		Date Tested: 21/01/2025	
Comments:			
Notes			
<div>

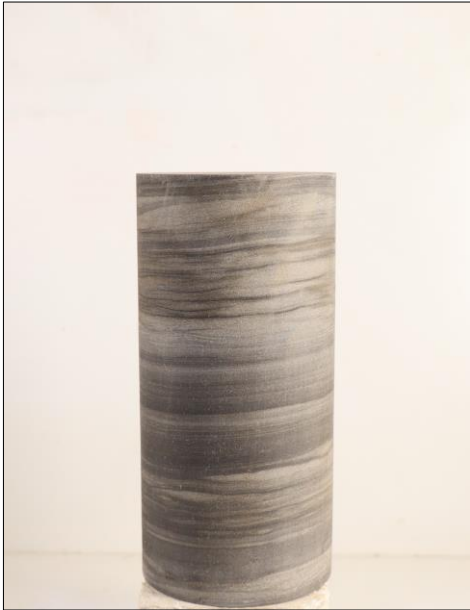
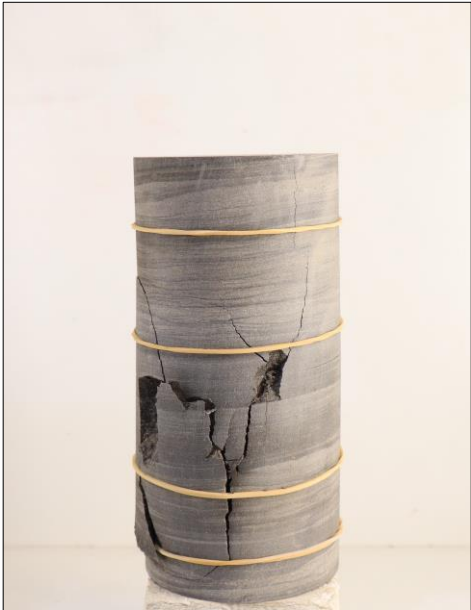
Unconfined Compressive Strength			
Client Address Project Job No.	ADE Consulting Group	Sample Source	BH107 9.59-9.79m
	6/7 Millennium Ct, Silverwater 2128 NSW	Sample Description	Shale
	Proposed Extension (A201023 0436 01)	Report No.	S102928-UCS
	S25017-1	Lab No.	S102928
Test Procedure	RMS T229 Unconfined compressive strength of rock core to 50 MPa strength		
Test Condition	Unsoaked	Specimen Curing	-
Sampling Method	Sampled by Client - results apply to the sample as received	Date Sampled	9/01/2025
<div>

</div>			
Unconfined Compressive Strength 24 MPa			
Specimen Length: 142.8 mm		Original Moisture Content: 2.3 %	
Average Specimen Diameter: 60.8 mm		After Test Moisture Content: 2.0 %	
Length to Diameter Ratio: 2.3		Dry Density: 2.57 t/m ³	
Failure Type: Axial Multiple		Date Tested: 21/01/2025	
Comments:			
Notes			
<div>

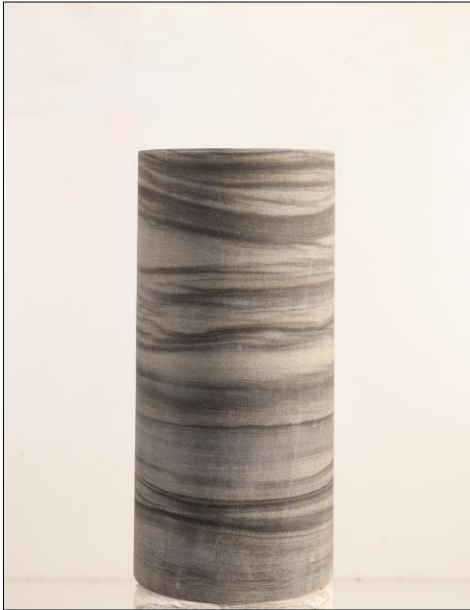
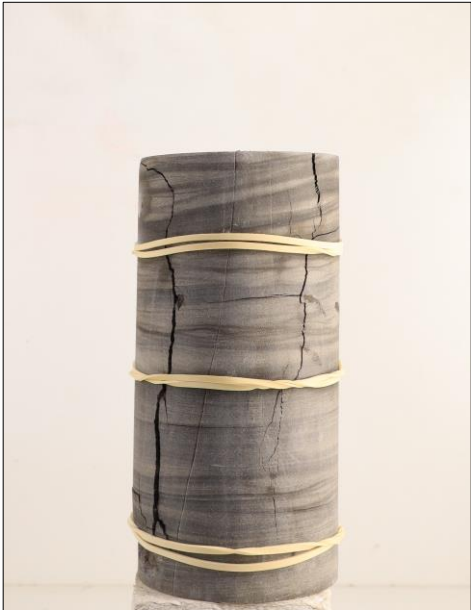
Unconfined Compressive Strength			
Client Address Project Job No.	ADE Consulting Group	Sample Source	BH107 8.59-8.79m
	6/7 Millennium Ct, Silverwater 2128 NSW	Sample Description	Shale
	Proposed Extension (A201023 0436 01)	Report No.	S102929-UCS
	S25017-1	Lab No.	S102929
Test Procedure	RMS T229 Unconfined compressive strength of rock core to 50 MPa strength		
Test Condition	Unsoaked	Specimen Curing	-
Sampling Method	Sampled by Client - results apply to the sample as received	Date Sampled	9/01/2025
<div>

</div>			
Unconfined Compressive Strength 29.9 MPa			
Specimen Length: 143.5 mm		Original Moisture Content: 2.2 %	
Average Specimen Diameter: 60.9 mm		After Test Moisture Content: 2.1 %	
Length to Diameter Ratio: 2.4		Dry Density: 2.56 t/m ³	
Failure Type: Axial Multiple		Date Tested: 21/01/2025	
Comments:			
Notes			
<div>

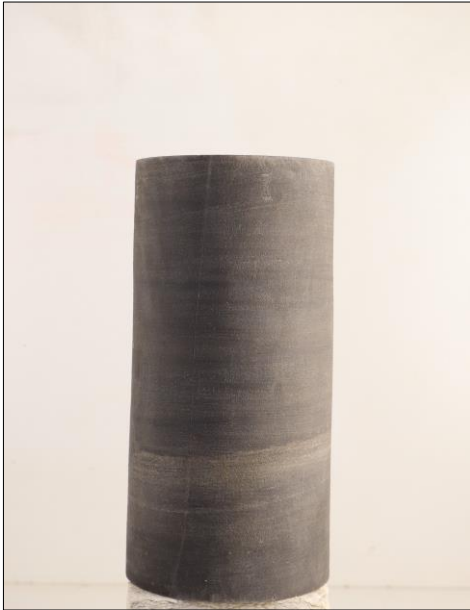
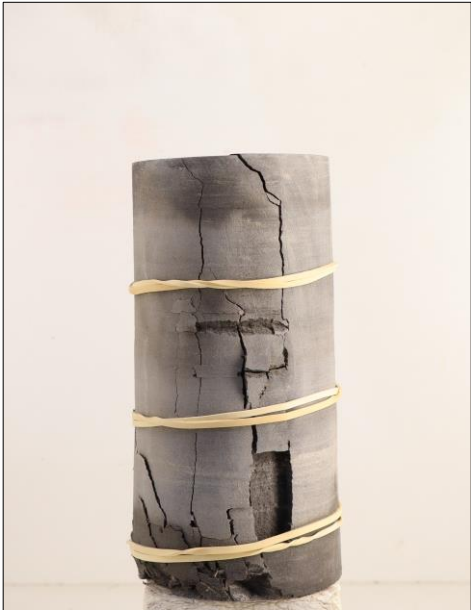
Unconfined Compressive Strength			
Client	ADE Consulting Group	Sample Source	BH106 7.33-7.56m
	6/7 Millennium Ct, Silverwater 2128 NSW	Sample Description	Shale
	Proposed Extension (A201023 0436 01)	Report No.	S102930-UCS
	Job No.	S25017-1	Lab No.
Test Procedure	RMS T229 Unconfined compressive strength of rock core to 50 MPa strength		
Test Condition	Unsoaked	Specimen Curing	-
Sampling Method	Sampled by Client - results apply to the sample as received	Date Sampled	10/01/2025
<div>

</div>			
Unconfined Compressive Strength 22.1 MPa			
Specimen Length: 141.6 mm		Original Moisture Content: 3.1 %	
Average Specimen Diameter: 60.7 mm		After Test Moisture Content: 2.6 %	
Length to Diameter Ratio: 2.3		Dry Density: 2.53 t/m ³	
Failure Type: Axial Multiple		Date Tested: 21/01/2025	
Comments:			
Notes			
<div>

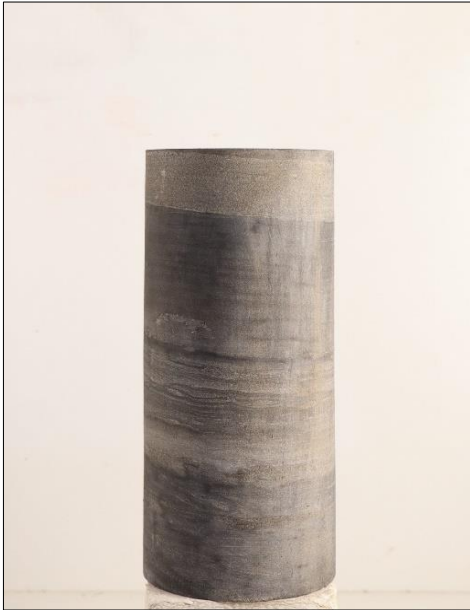
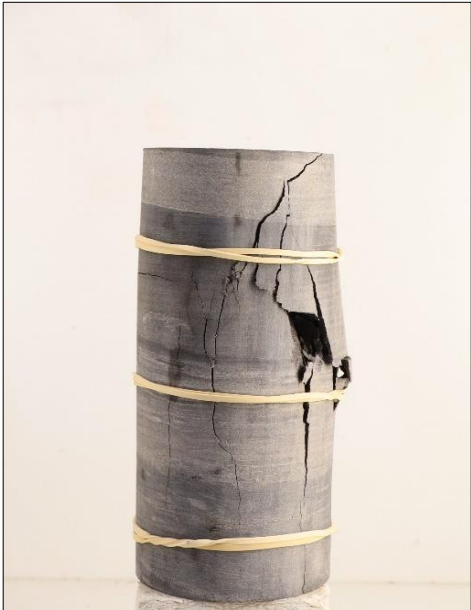
Unconfined Compressive Strength			
Client Address Project Job No.	ADE Consulting Group	Sample Source	BH105 6.70-6.89m
	6/7 Millennium Ct, Silverwater 2128 NSW	Sample Description	Shale
	Proposed Extension (A201023 0436 01)	Report No.	S102932-UCS
	S25017-1	Lab No.	S102932
Test Procedure	RMS T229 Unconfined compressive strength of rock core to 50 MPa strength		
Test Condition	Unsoaked	Specimen Curing	-
Sampling Method	Sampled by Client - results apply to the sample as received	Date Sampled	6/01/2025
<div>

</div>			
Unconfined Compressive Strength 22 MPa			
Specimen Length: 142.8 mm		Original Moisture Content: 2.1 %	
Average Specimen Diameter: 60.7 mm		After Test Moisture Content: 2.2 %	
Length to Diameter Ratio: 2.4		Dry Density: 2.56 t/m ³	
Failure Type: Axial Multiple		Date Tested: 21/01/2025	
Comments:			
Notes			
<div>

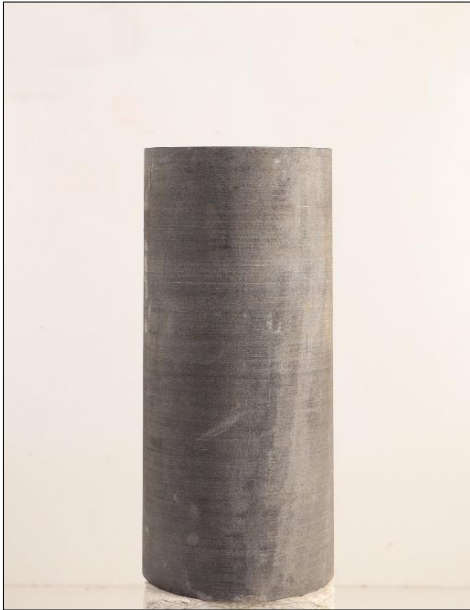
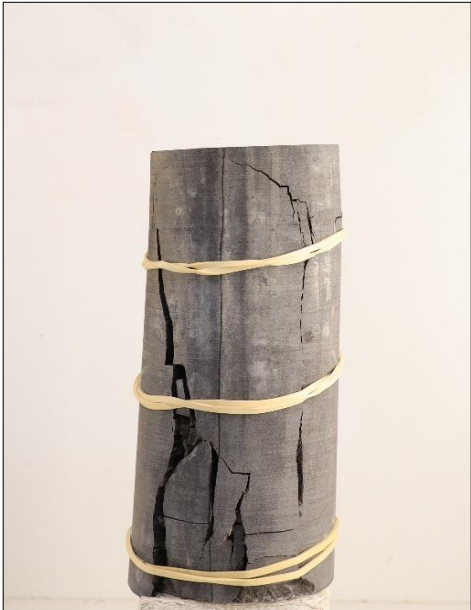
Unconfined Compressive Strength			
Client Address Project Job No.	ADE Consulting Group	Sample Source	BH105 7.71-7.93m
	6/7 Millennium Ct, Silverwater 2128 NSW	Sample Description	Shale
	Proposed Extension (A201023 0436 01)	Report No.	S102933-UCS
	S25017-1	Lab No.	S102933
Test Procedure	RMS T229 Unconfined compressive strength of rock core to 50 MPa strength		
Test Condition	Unsoaked	Specimen Curing	-
Sampling Method	Sampled by Client - results apply to the sample as received	Date Sampled	6/01/2025
<div>

</div>			
Unconfined Compressive Strength 32 MPa			
Specimen Length: 142.3 mm		Original Moisture Content: 1.9 %	
Average Specimen Diameter: 60.7 mm		After Test Moisture Content: 2.0 %	
Length to Diameter Ratio: 2.3		Dry Density: 2.57 t/m ³	
Failure Type: Axial Multiple		Date Tested: 21/01/2025	
Comments:			
Notes			
<div>
