Geotechnical Investigation and Geotechnical Design Advice

Western Sydney University Richmond
Agricultural Centre - NEW SITE

PSM5353-006R REV2 23 April 2025

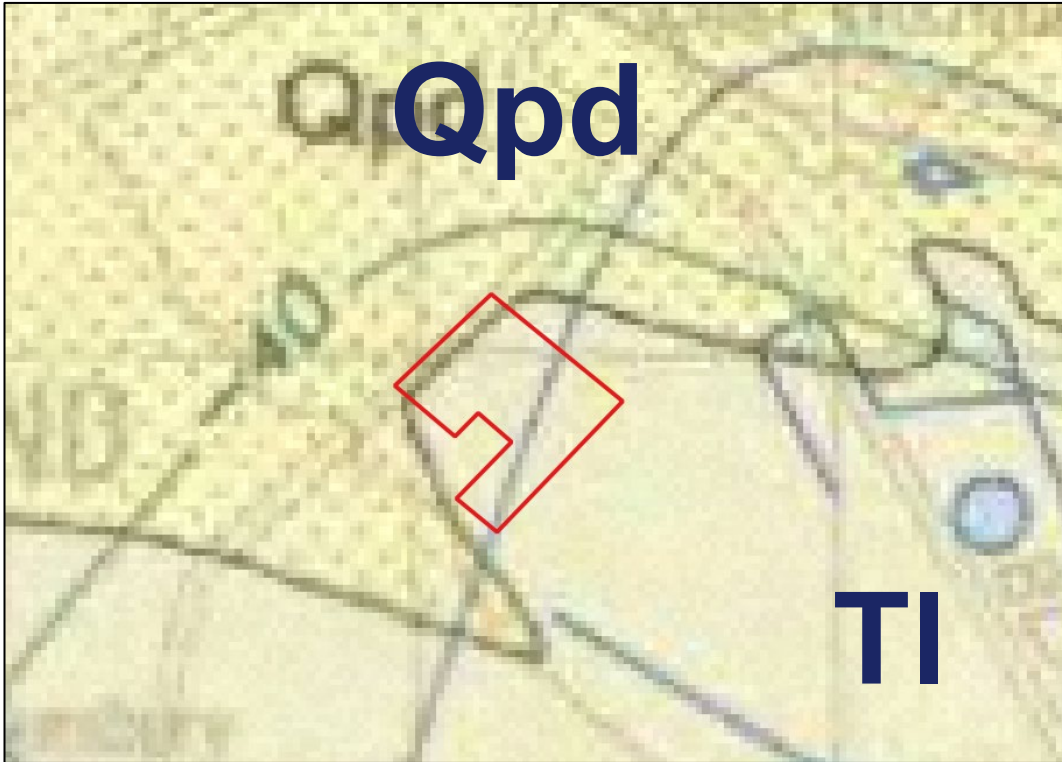
Inset 4: Penrith 1:100,000 geological map (site boundary in red)

- (TI) Londonderry Clay comprising medium to high plasticity clay with patches of consolidated sand:
- (Qpd) Clarendon Formation comprising of fine to coarse grain, pale brown to red-brown clayey sand or clayey silt overlying a grey mottled brown plastic clay.

Inset 4 presents the site location with regards to the geological settings.

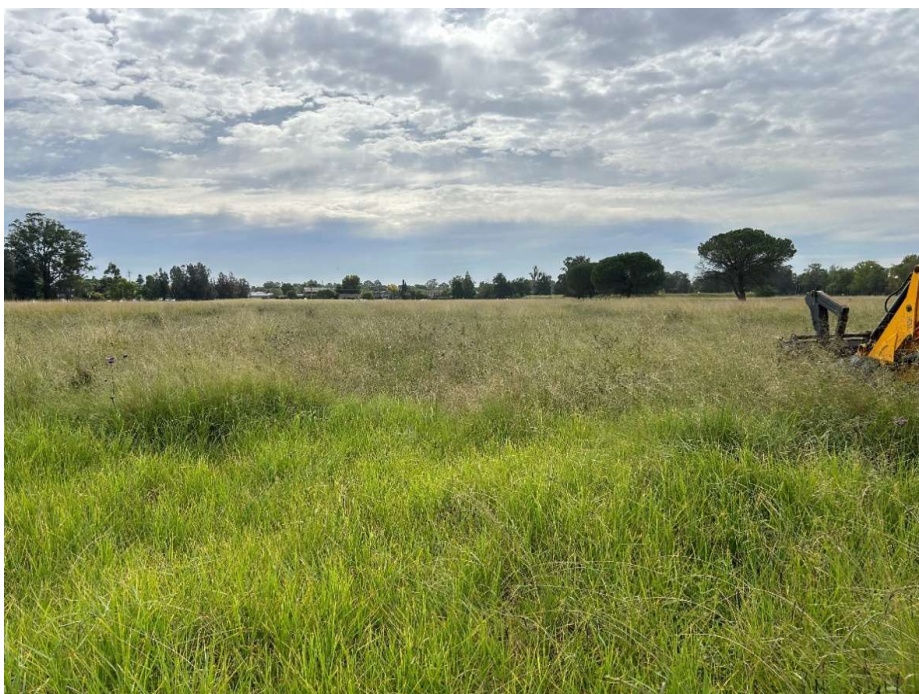
Photo 1 - General Site Photo facing North

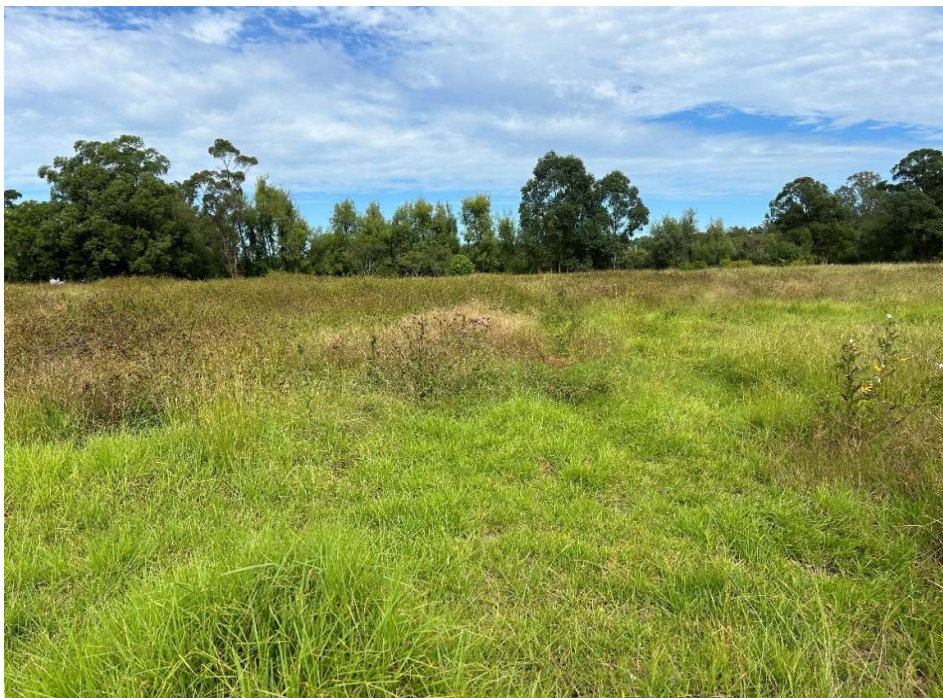
Photo 2 - General Site Photo facing South

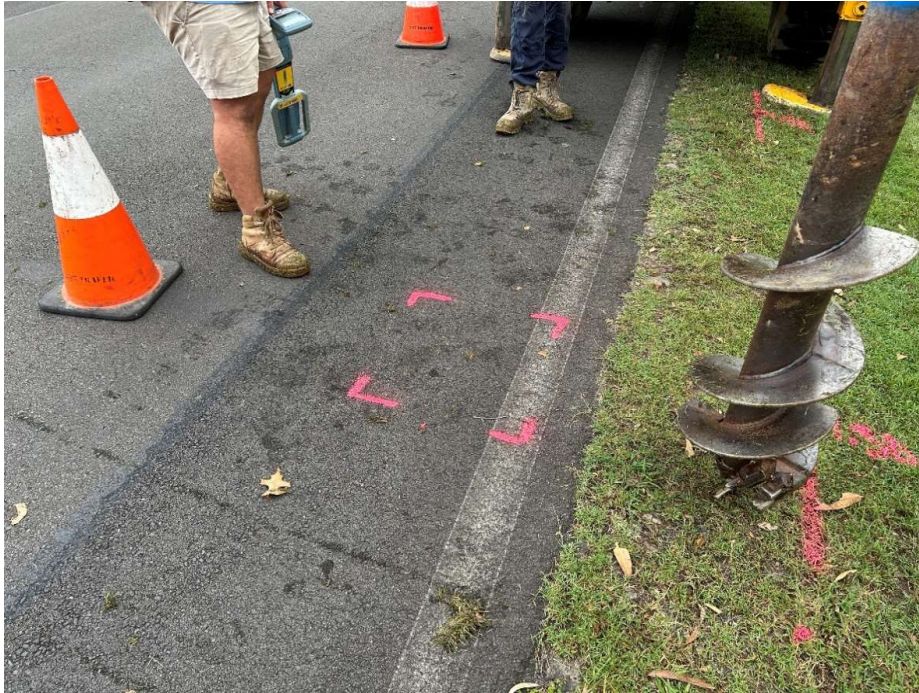
Photo 3 - Typical Surface Conditions near CBR A

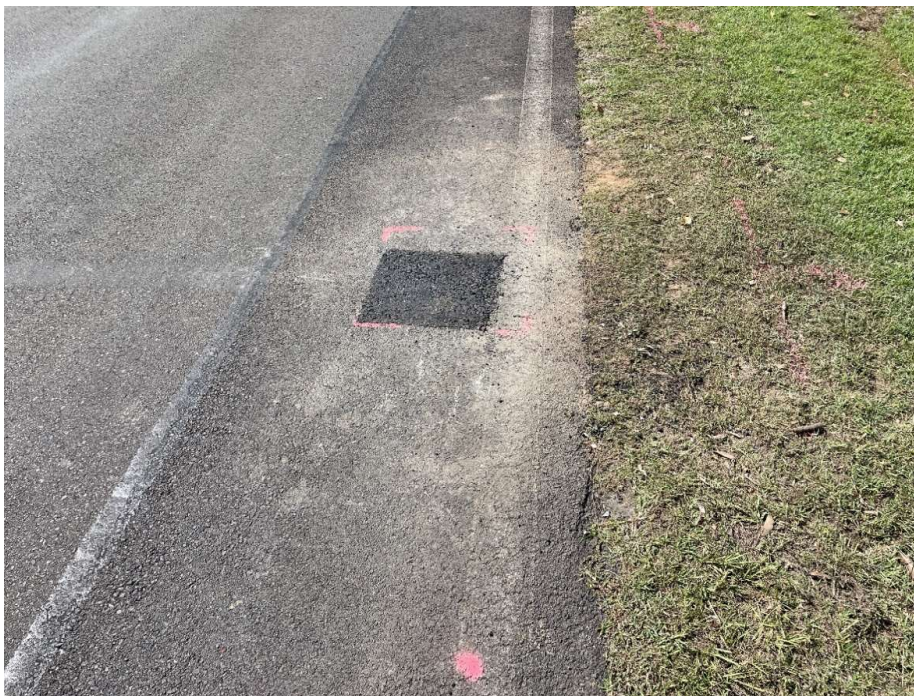
Photo 4 - Completion of Backfill (CBR A)

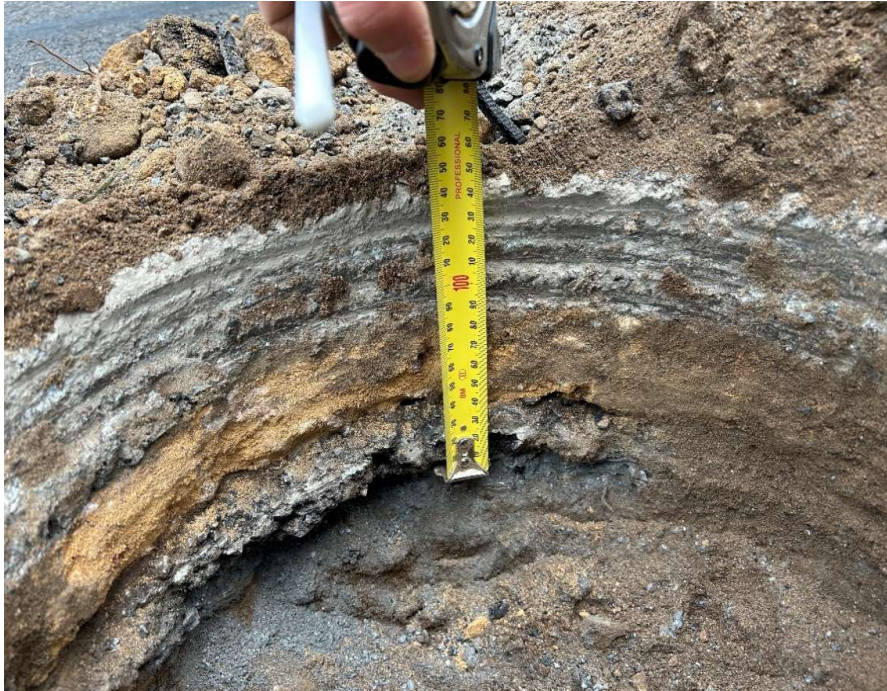
Photo 5 - Pavement Profile Encountered in CBR B

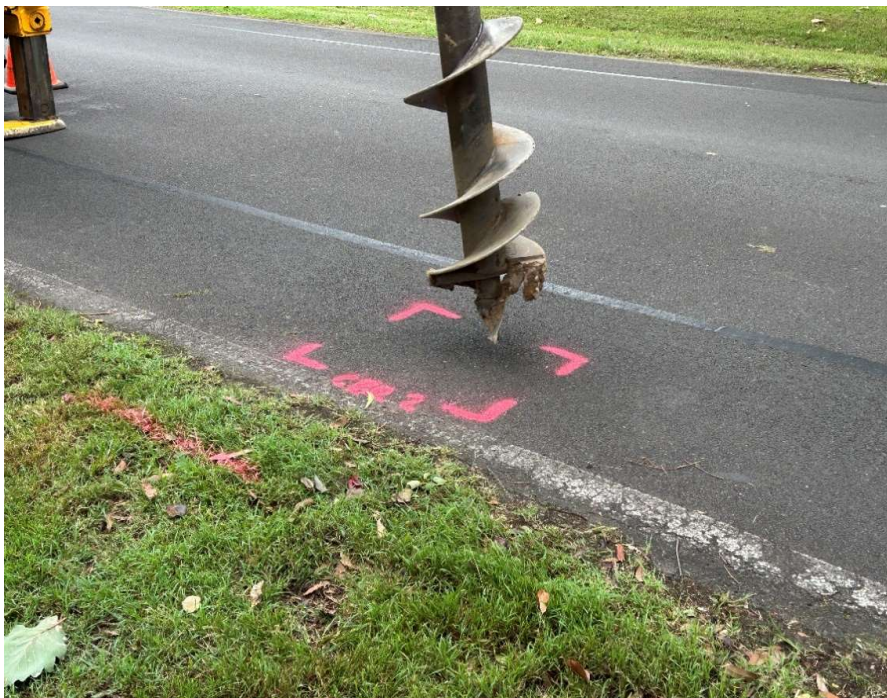
Photo 6 - Typical Surface Conditions near CBR B

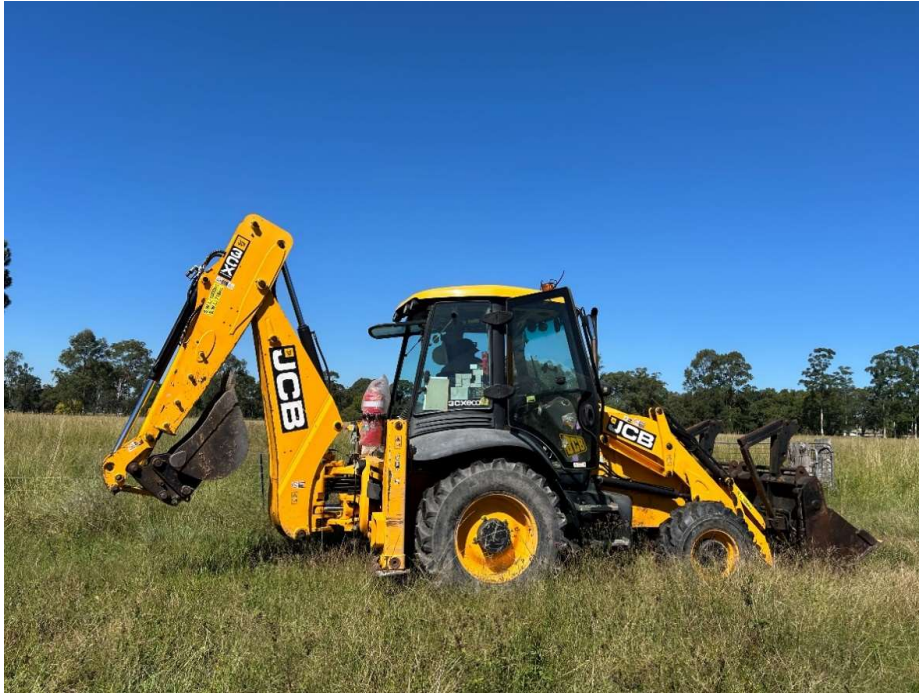
Photo 7 - 10t Excavator used to Excavate Test Pits

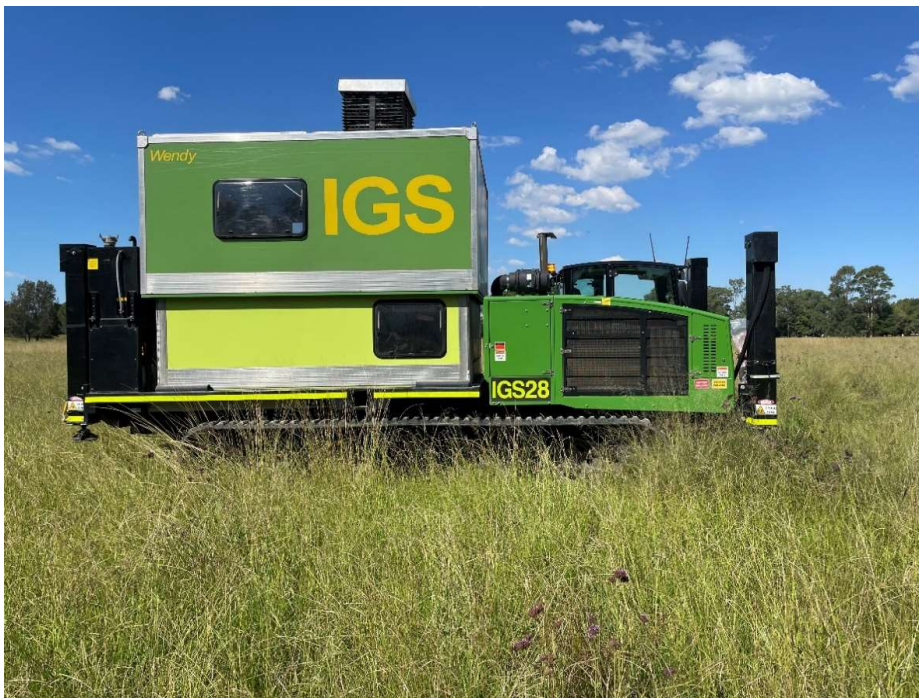
Photo 8 - CPT Rig

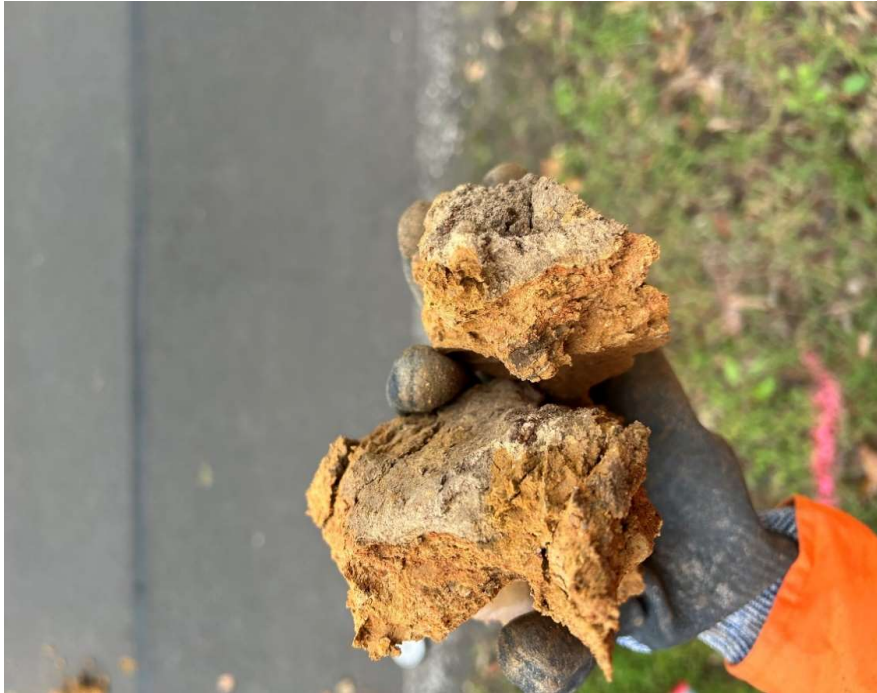
Photo 9 - CLAY unit encountered under the pavement -CBR B

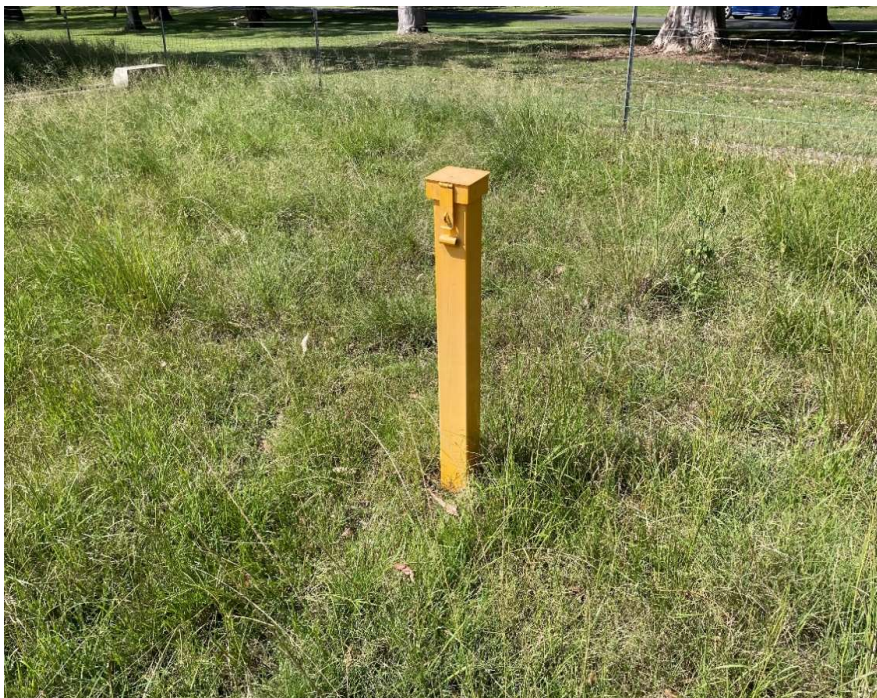
Photo 10 - Typical Ground Monitoring Well

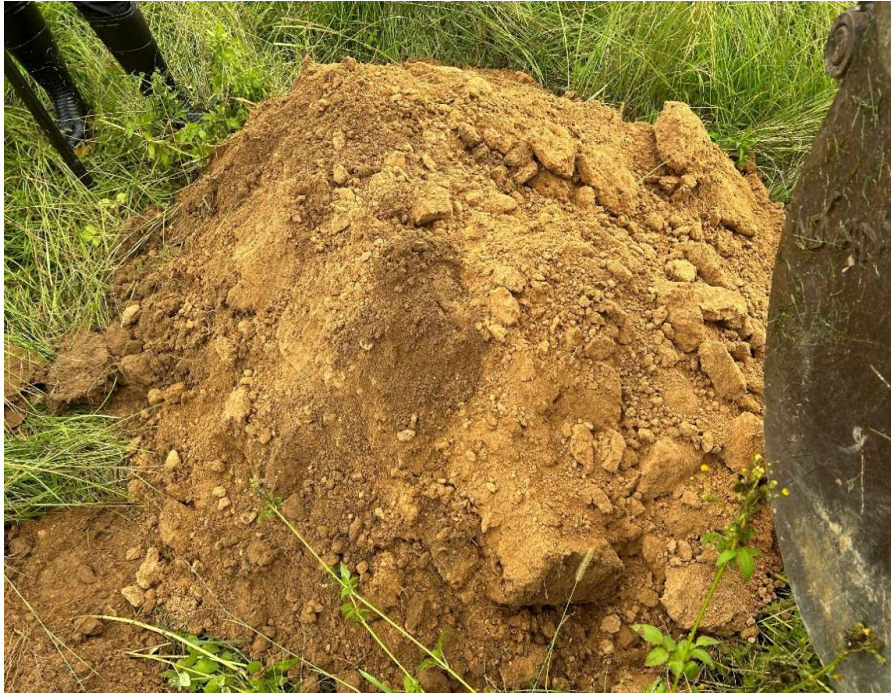
Photo 11 - Typical TOPSOIL unit - brown Silty SAND (TP I)

| Unit Name | Approximate Depth to Top of Unit (m) | Description |
|---|---|--|
| TOPSOIL | 0 | Silty SAND: brown, fine to medium-grained, low plasticity silt, loose, moist, rootlets observed. |

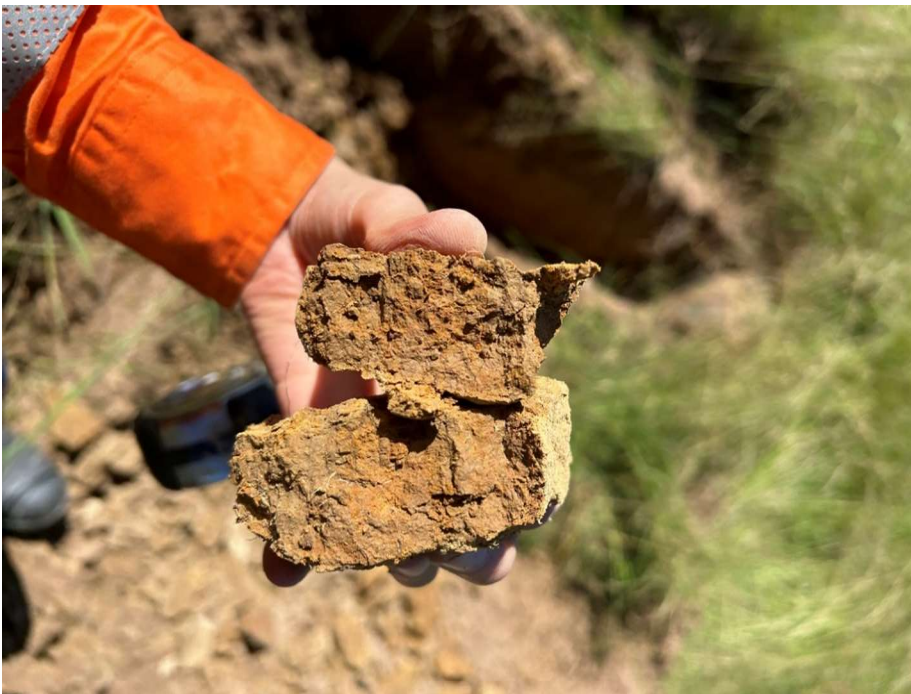
Photo 12 - Typical SURFICAL MATERIAL unit - Yellow Brown CLAY (TP E)

| Unit Name | Approximate Depth to Top of Unit (m) | Description |
|---|---|--|
| SURFICIAL MATERIAL | 0.18 – 0.3 | Sandy CLAY to CLAY: yellow-brown to yellow-brown mottled grey, medium plasticity, fine to medium-grained sand, stiff to very stiff, moist. |

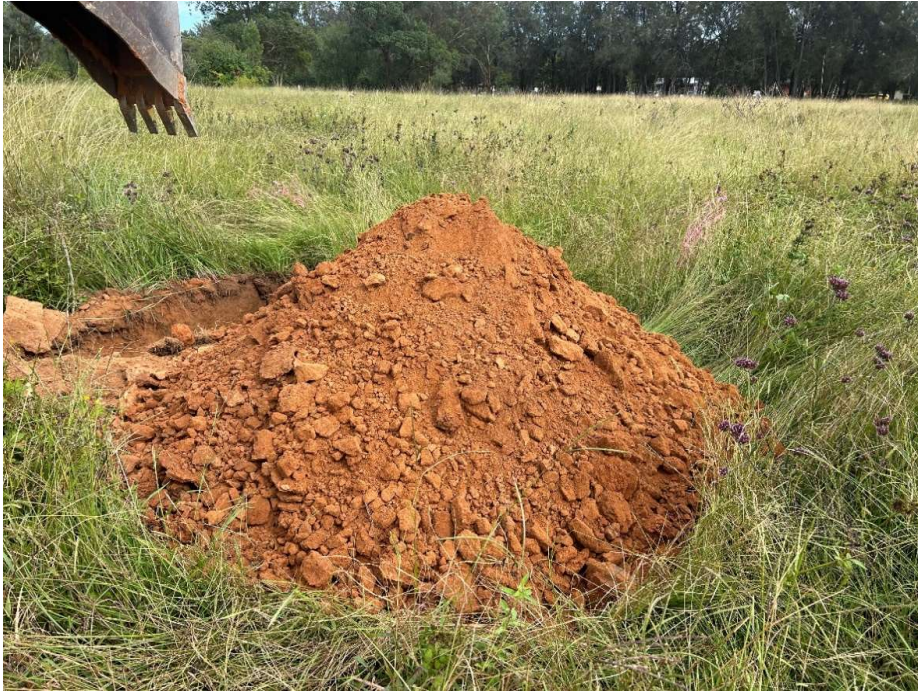
Photo 13 - Typical UPPER INTERBEDDED CLAY unit - Red Brown mottled Grey CLAY (TP H)

| Unit Name | Approximate Depth to Top of Unit (m) | Description |
|---|---|--|
| UPPER INTERBEDDED SAND/CLAY LAYER | 0.7 – 1.9 | Sandy CLAY to CLAY: yellow-brown mottled grey to red-brown mottled grey, medium plasticity, fine to medium-grained sand, very stiff to hard, moist to dry. |

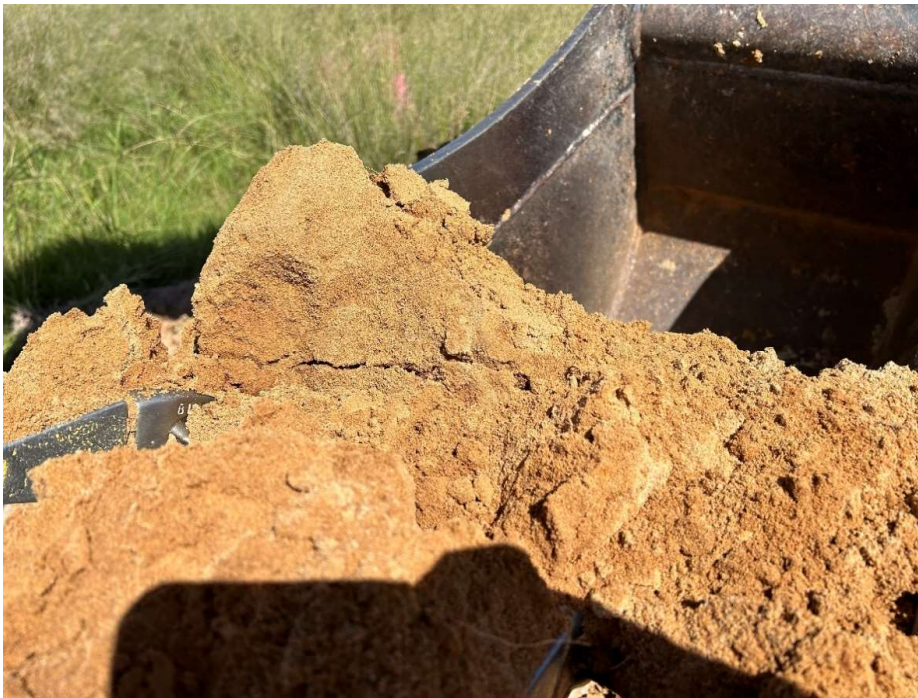
Photo 14 - Clayey SAND observed 2.2m below ground surface (TP E)

| Test Pit ID (Easting, Northing) | Approximate Depth (m) | Material Encountered | Notes |
|---|---|---|---|
| | 2.2 – 2.3 | Clayey SAND: yellow brown, fine to medium grained, dense, medium plasticity, moist. | NATURAL SOIL |

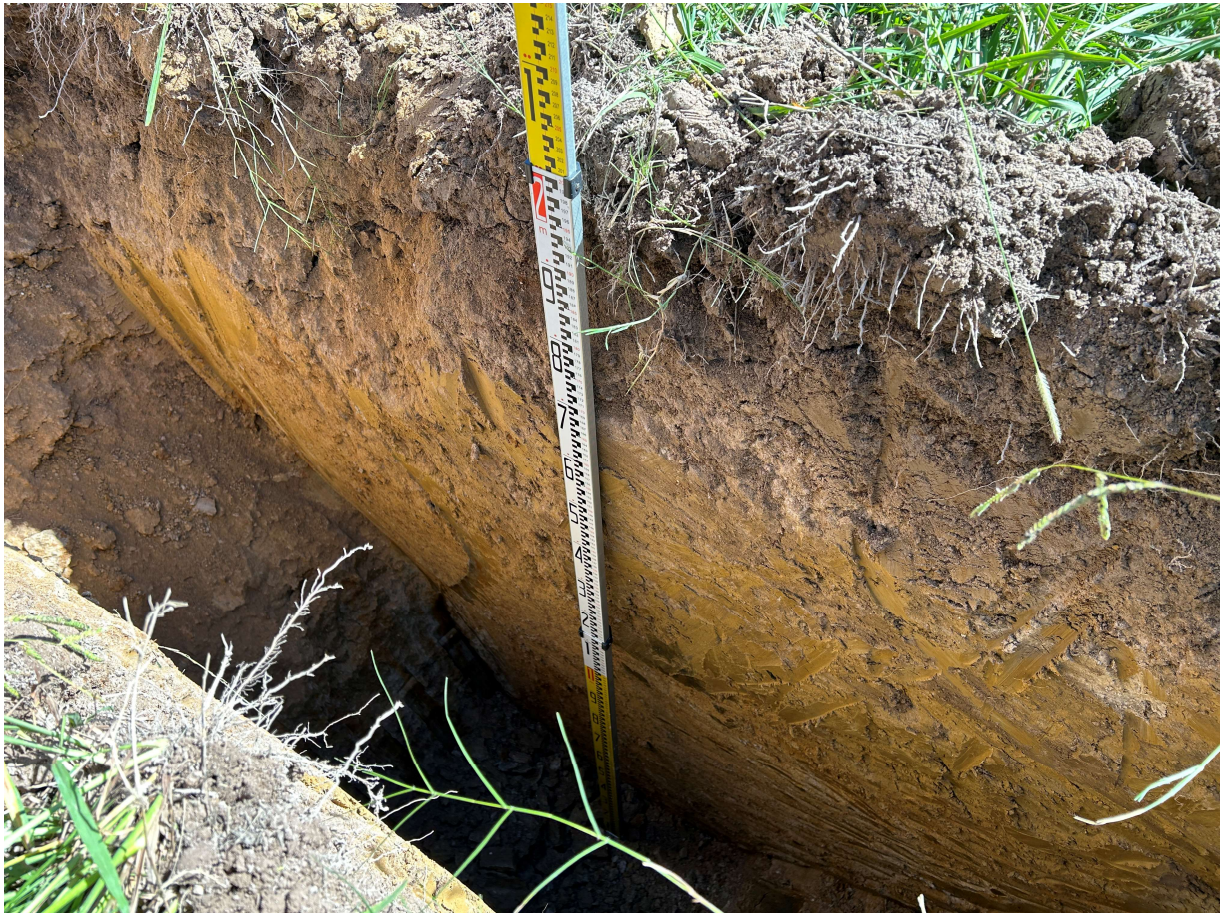
| Test Pit ID (Easting, Northing) | Approximate Depth (m) | Material Encountered | Notes |
|---|---|---|---|
| TP A (291388.4, 6279057.8) | 0.0 – 0.2 | Silty SAND: brown, fine to medium grained, loose, low plasticity, moist; rootlets observed. | TOPSOIL |
| | 0.2 – 0.4 | Sandy CLAY: pale grey mottled yellow brown, medium plasticity, fine to medium grained, stiff, moist (W < PL). | Inferred NATURAL SOIL |
| | 0.4 – 1.0 | CLAY: yellow brown mottled grey, medium plasticity, stiff to very stiff, moist (W > PL). | NATURAL SOIL |
| | 1.5 – 2.1 | CLAY: red brown mottled grey, medium plasticity, very stiff, dry (W < PL). | NATURAL SOIL |
| | 2.1 | Test pit terminated. | Target Depth |

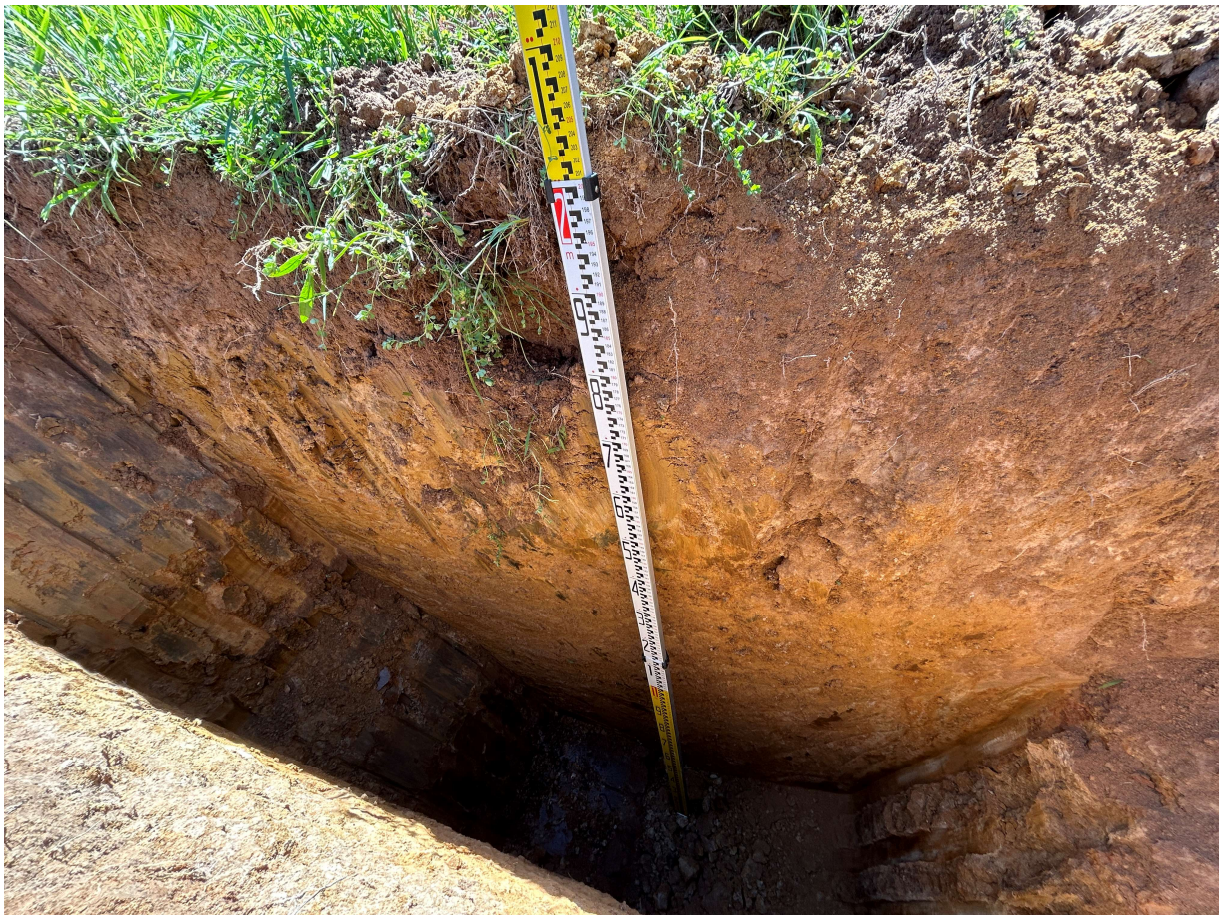
| Test Pit ID (Easting, Northing) | Approximate Depth (m) | Material Encountered | Notes |
|---|---|---|---|
| TP B (291344.9, 6279174.6) | 0.0 – 0.3 | Silty SAND: brown, fine to medium grained, loose, low plasticity, moist; rootlets observed. | TOPSOIL |

| Test Pit ID (Easting, Northing) | Approximate Depth (m) | Material Encountered | Notes |
|---|---|---|---|
| | 1.5 – 2.1 | CLAY: red brown mottled grey, medium plasticity, very stiff, dry (W < PL). | Aggressivity Testing @1.5m NATURAL SOIL |
| | 2.1 | Test pit terminated. | Target Depth |

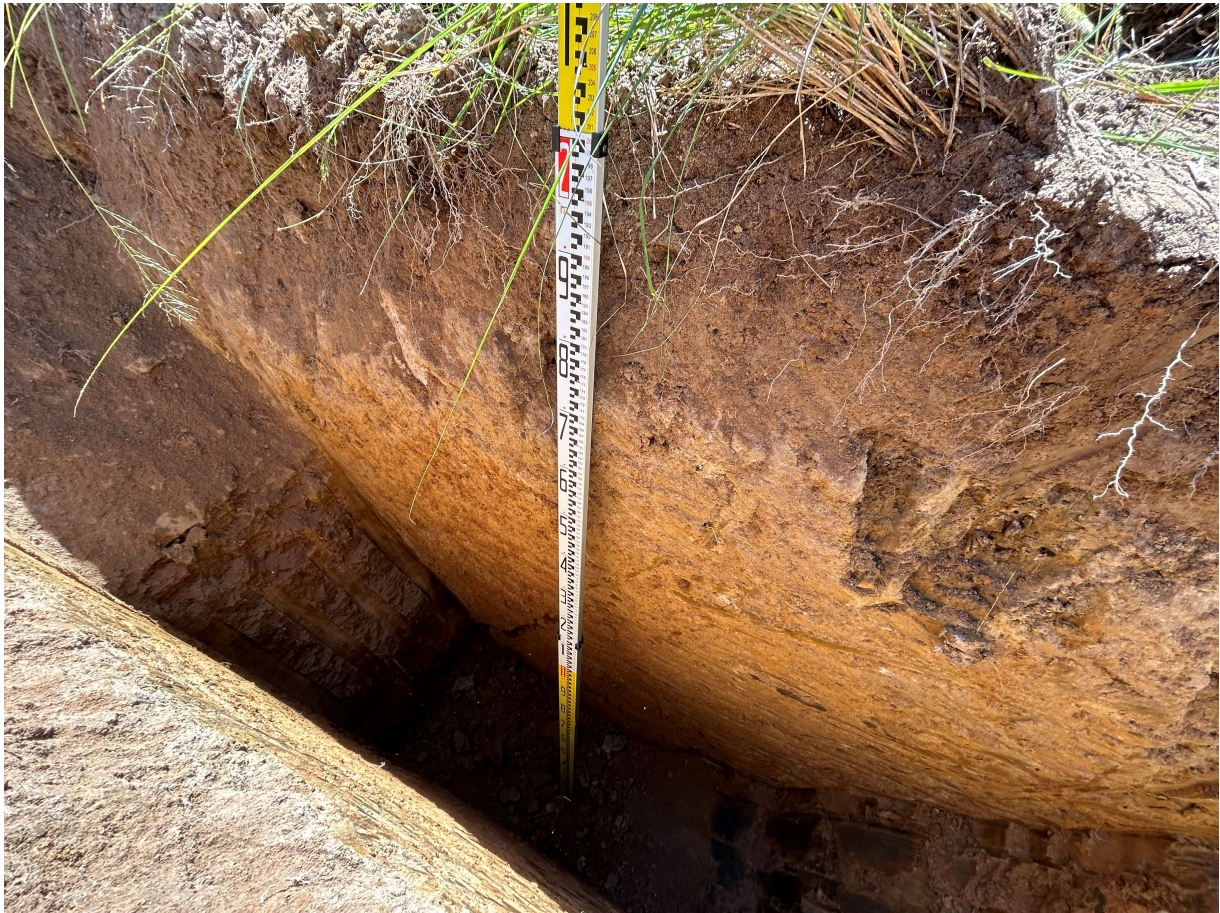
| Test Pit ID (Easting, Northing) | Approximate Depth (m) | Material Encountered | Notes |
|---|---|---|---|
| TP D (291236.8, 6279166.9) | 0.0 – 0.2 | Silty SAND: brown, fine to medium grained, loose, low plasticity, moist; rootlets observed. | TOPSOIL |
| | 1.5 – 2.0 | CLAY: red brown mottled grey, medium plasticity, very stiff, dry (W < PL). | NATURAL SOIL |
| | 2.0 | Test pit terminated. | Target Depth |

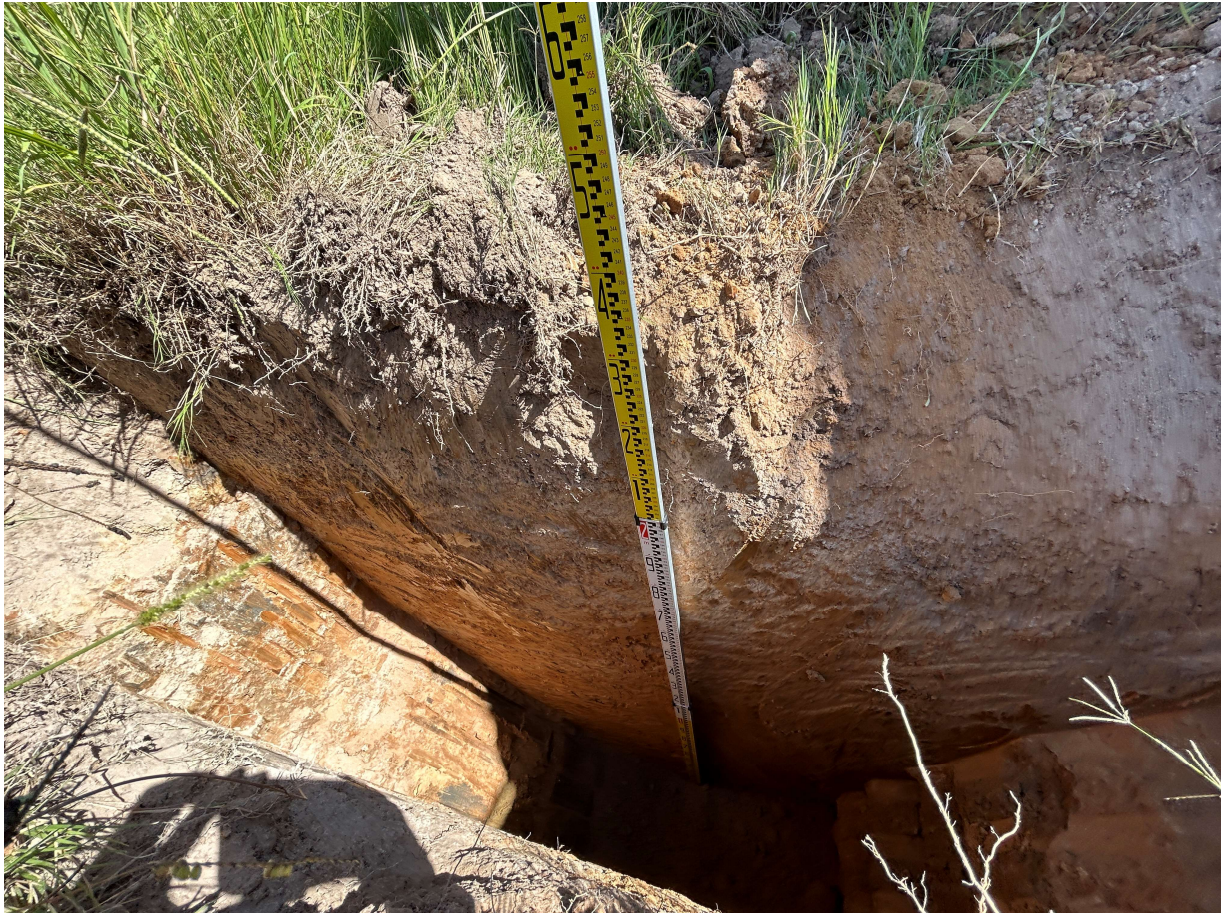
| Test Pit ID (Easting, Northing) | Approximate Depth (m) | Material Encountered | Notes |
|---|---|---|---|
| TP E (291205.3, 6279123.9) | 0.0 – 0.25 | Silty SAND: brown, fine to medium grained, loose, low plasticity, moist; rootlets observed. | TOPSOIL |
| | 2.3 | Test pit terminated. | Target depth |

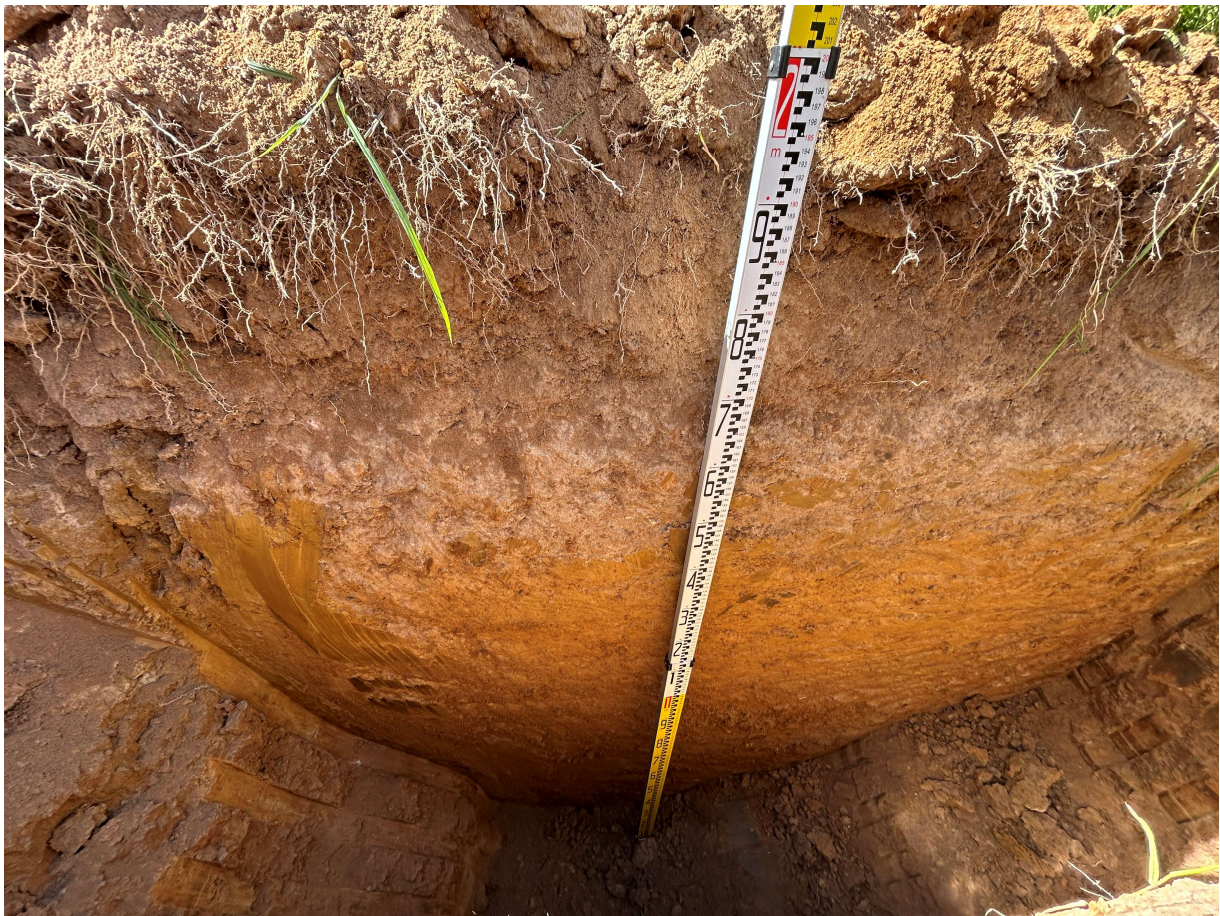
| Test Pit ID (Easting, Northing) | Approximate Depth (m) | Material Encountered | Notes |
|---|---|---|---|
| TP F (291228.7, 6279114.4) | 0.0 – 0.2 | Silty SAND: brown, fine to medium grained, loose, low plasticity, moist; rootlets observed. | TOPSOIL |
| | 1.5 – 2.0 | CLAY: red brown mottled grey, medium plasticity, stiff to hard, dry (W < PL). | NATURAL SOIL |
| | 2.0 | Test pit terminated. | Target Depth |

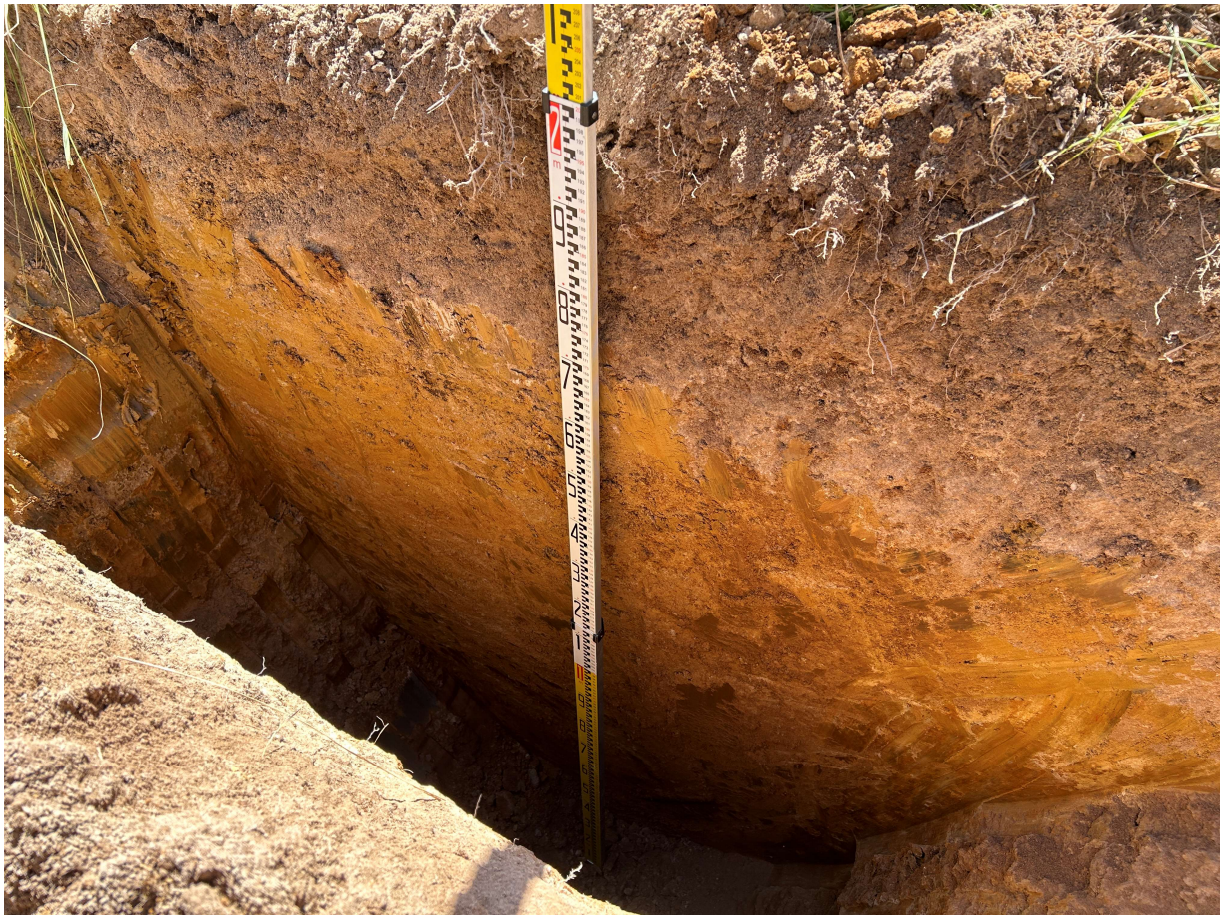
| Test Pit ID (Easting, Northing) | Approximate Depth (m) | Material Encountered | Notes |
|---|---|--|---|
| TP G (291258.6, 6279124.0) | 0.0 – 0.18 | Silty SAND: brown, fine to medium grained, loose, low plasticity, moist; rootlets observed. | TOPSOIL |
| | 1.5 – 2.0 | CLAY: red brown mottled grey, medium plasticity, very stiff, dry (W < PL). | NATURAL SOIL |
| | 2.0 | Test pit terminated. | Target Depth |

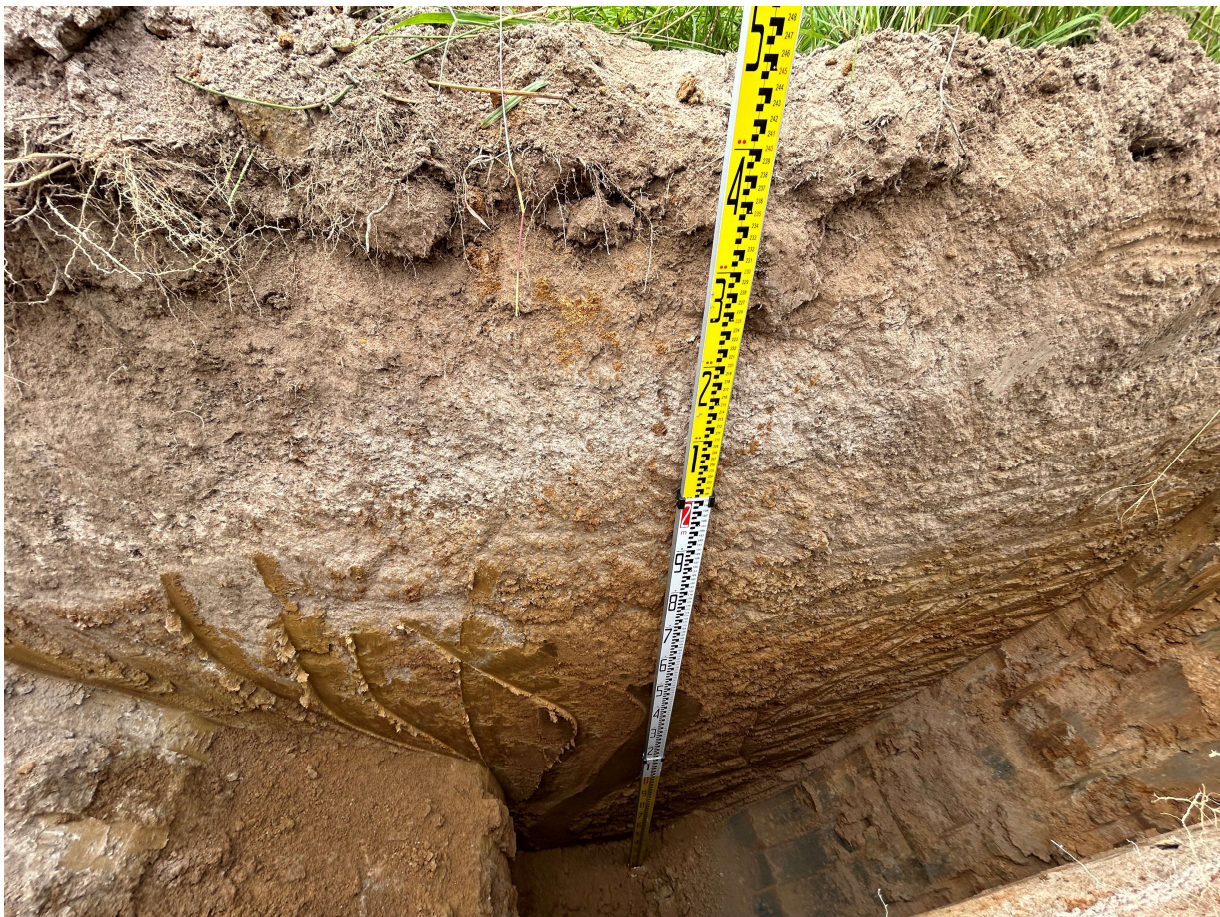
| Test Pit ID (Easting, Northing) | Approximate Depth (m) | Material Encountered | Notes |
|---|---|---|---|
| TP H (291215.0, 6279087.0) | 0.0 – 0.2 | Silty SAND: brown, fine to medium grained, loose, low plasticity, moist; rootlets observed. | TOPSOIL |
| | 1.4 – 2.4 | CLAY: red brown mottled grey, medium plasticity, very stiff to hard, dry (W < PL). | NATURAL SOIL |
| | 2.4 | Test pit terminated. | Target Depth |

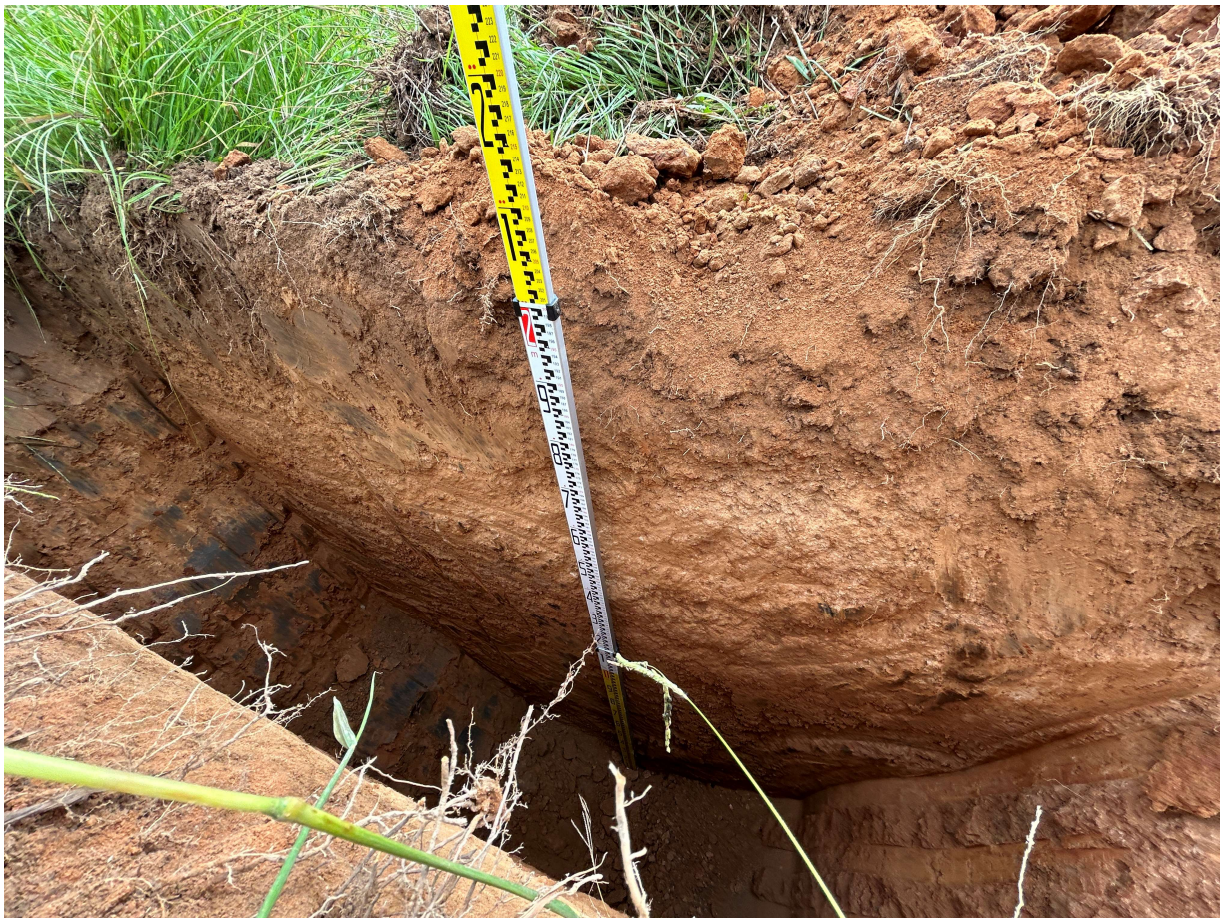
| Test Pit ID (Easting, Northing) | Approximate Depth (m) | Material Encountered | Notes |
|---|---|--|--|
| TP I (291162.4, 6279060.8) | 0.0 – 0.2 | Silty SAND: brown, fine to medium grained, loose, low plasticity, moist; rootlets observed. | TOPSOIL |
| | 1.4 – 2.0 | CLAY: red brown mottled grey, medium plasticity, very stiff, dry (W < PL). | NATURAL SOIL |
| | 2.0 | Test pit terminated. | Target Depth |

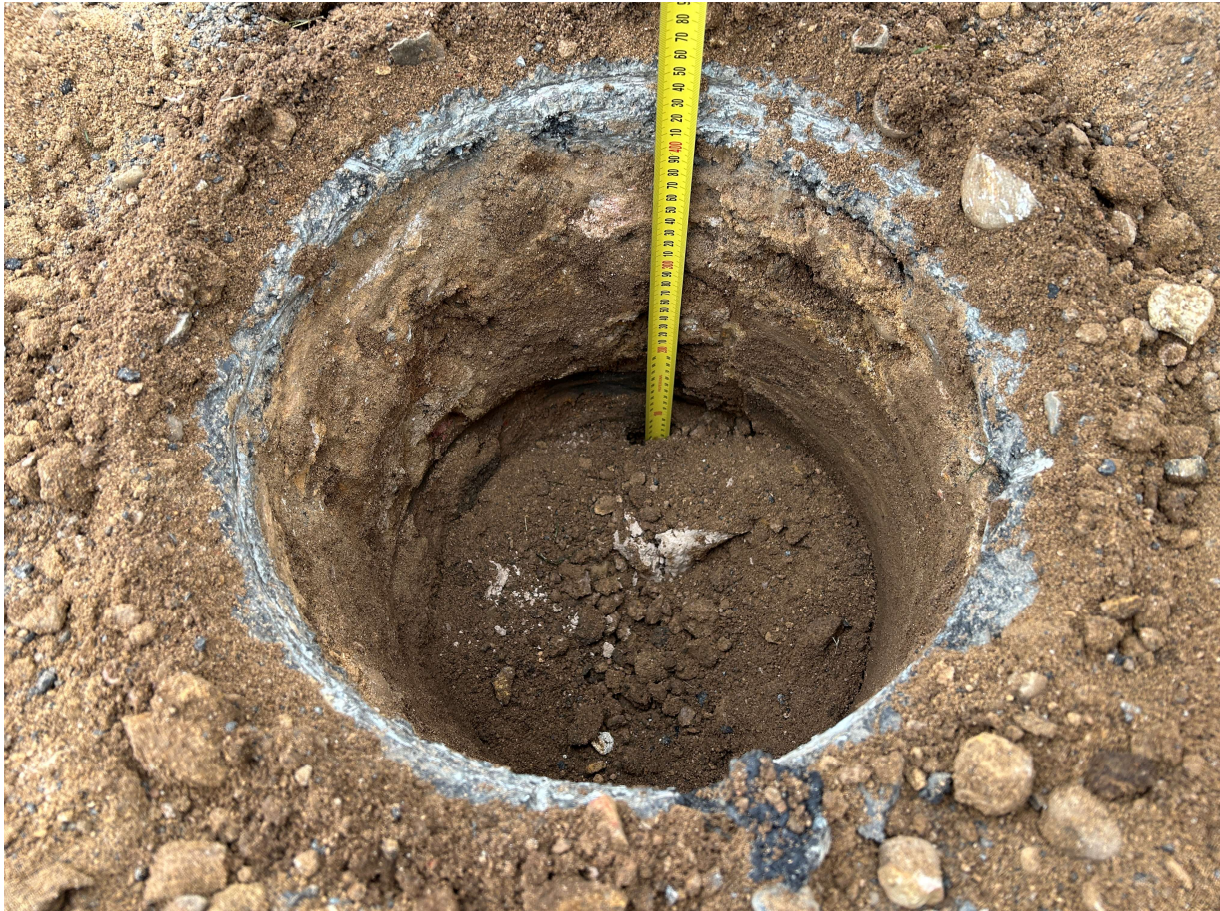
| Borehole ID (Easting, Northing) | Approximate Depth (m) | Material Encountered | Notes |
|--|---|--|---|
| CBR A (291536.7, 6278998.3) College Drive (Pavement Shoulder) | 0.0 – 0.05 | ASPHALT: 50mm thick. | WEARING COURSE |
| | 0.05 – 0.45 | Sandy CLAY trace gravel: brown, low to medium plasticity, fine grained sand, gravel sub-angular up to 8mm, moist; some crushed sandstone pieces up to 20mm observed. | CBR sample @0.05 – 0.45 m FILL |
| | 0.45 | Borehole terminated. | Target depth |

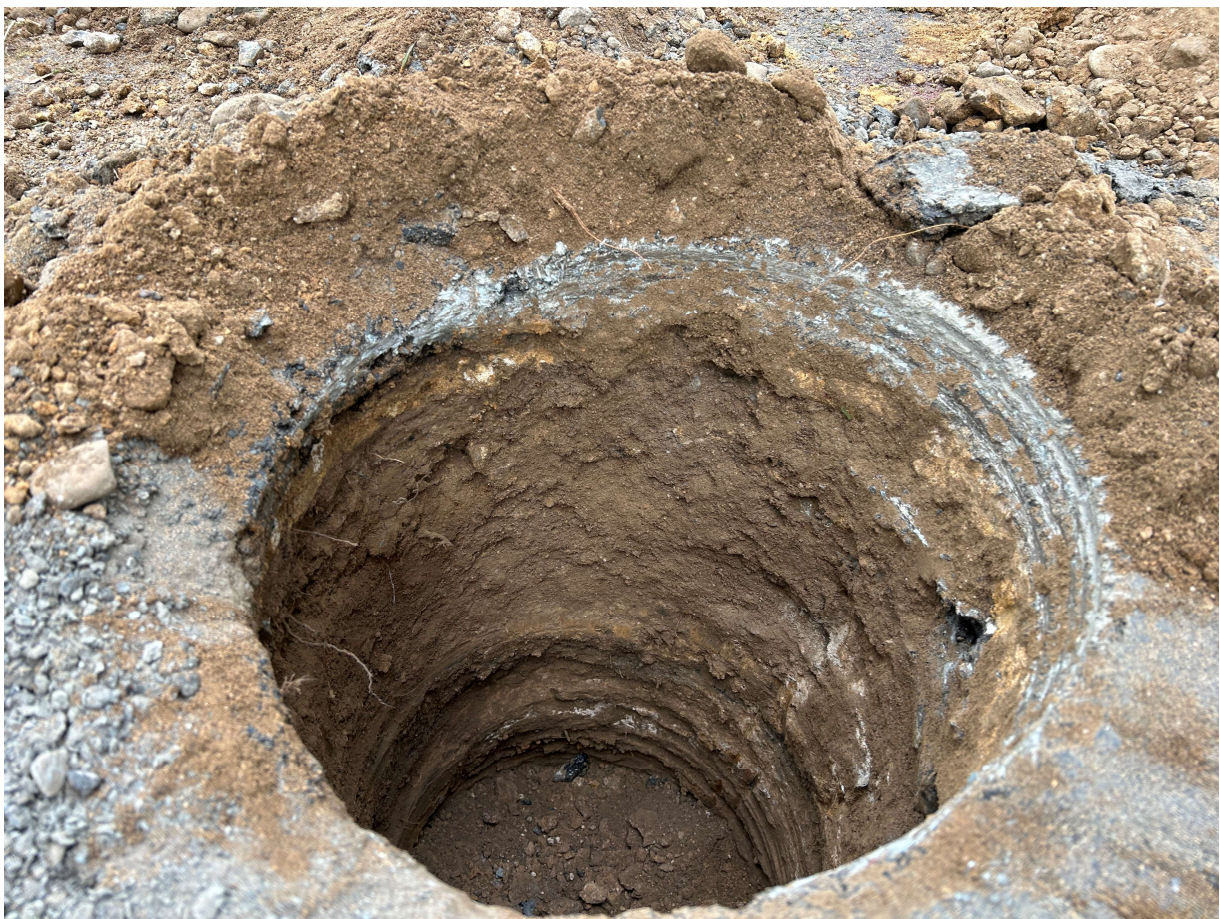
| Borehole ID (Easting, Northing) | Approximate Depth (m) | Material Encountered | Notes |
|--|---|---|---|
| CBR B (291437.7, 6278897.5) College Drive Pavement | 0.0 – 0.14 | ASPHALT: 140 mm thick. | WEARING COURSE |
| | 0.65 – 0.7 | CLAY: yellowish brown, medium plasticity, moist | |
| | 0.7 | Borehole terminated. | Target depth |
