## **Remediation Action Plan**

**Randwick High School Upgrade**

**Avoca Street, Randwick**

**Project 224455.00**

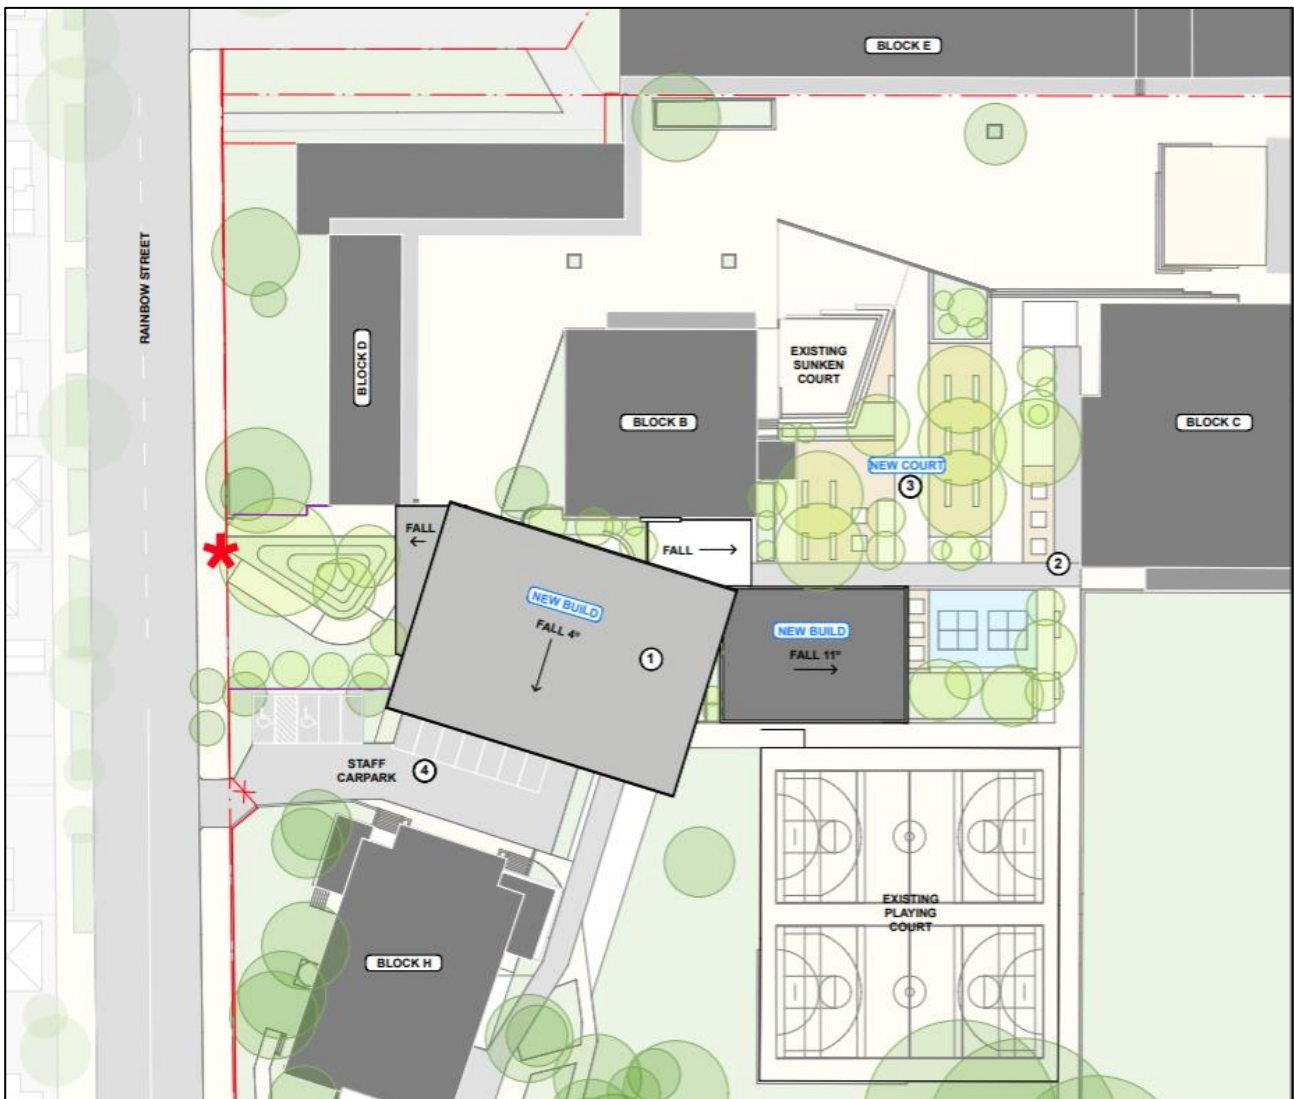
**Figure 1: Extract of proposed Site Plan (Bennett and Trimble, 2025)**

An extract of the proposed Site Plan is provided at Figure 1.

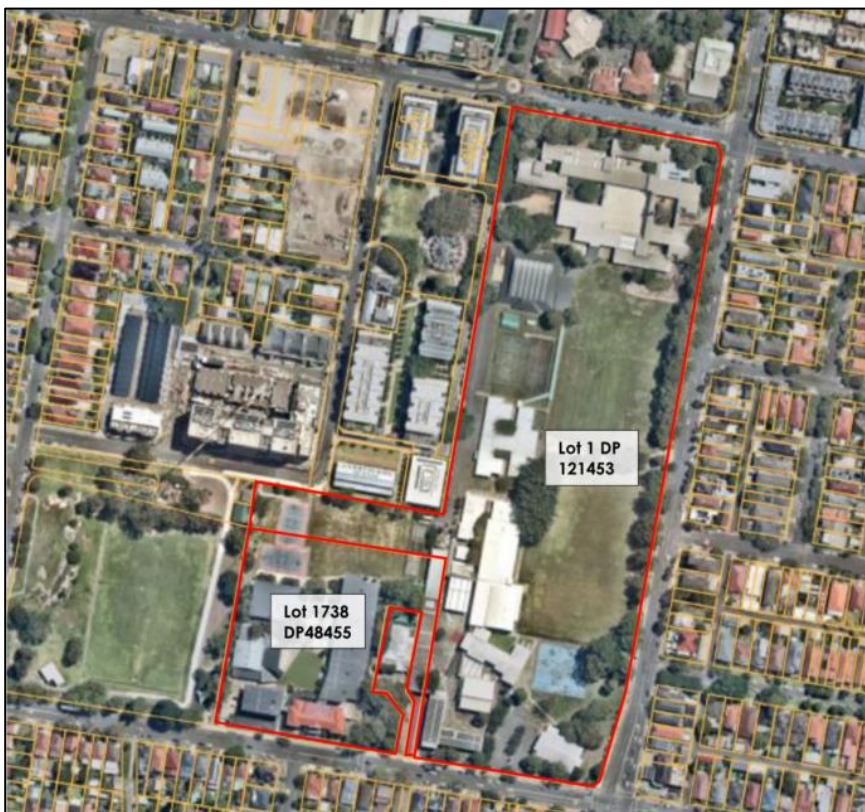
**Figure 2: Aerial image of the School site (Randwick High School – REF Preamble, 2025)**

An aerial image of the school site is provided in Figure 2.

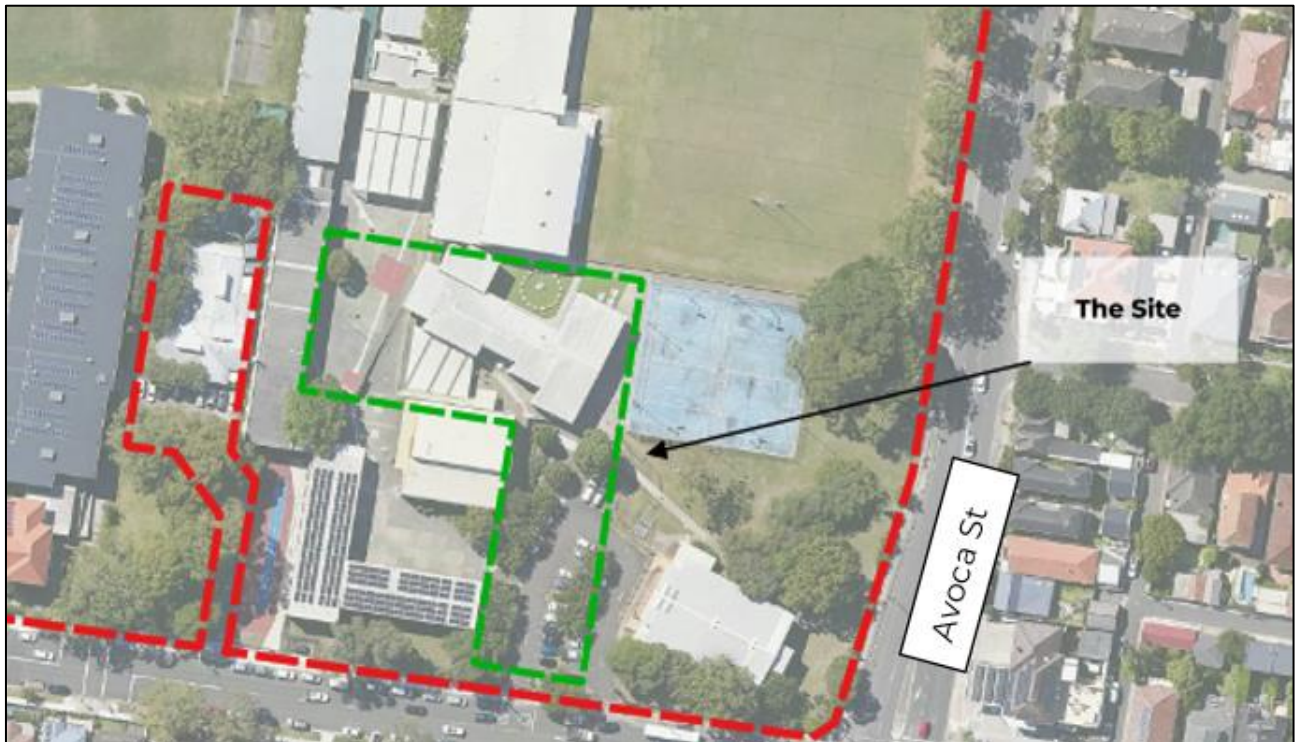
**Figure 3: The site (Area B) (in dotted green line, refer to Drawing R.003.D.001 for full legends)**

The boundary of the site (labelled as Area B) for the purpose of this RAP is shown on Drawing R.003.D.001, Appendix A and Figure 3 below.

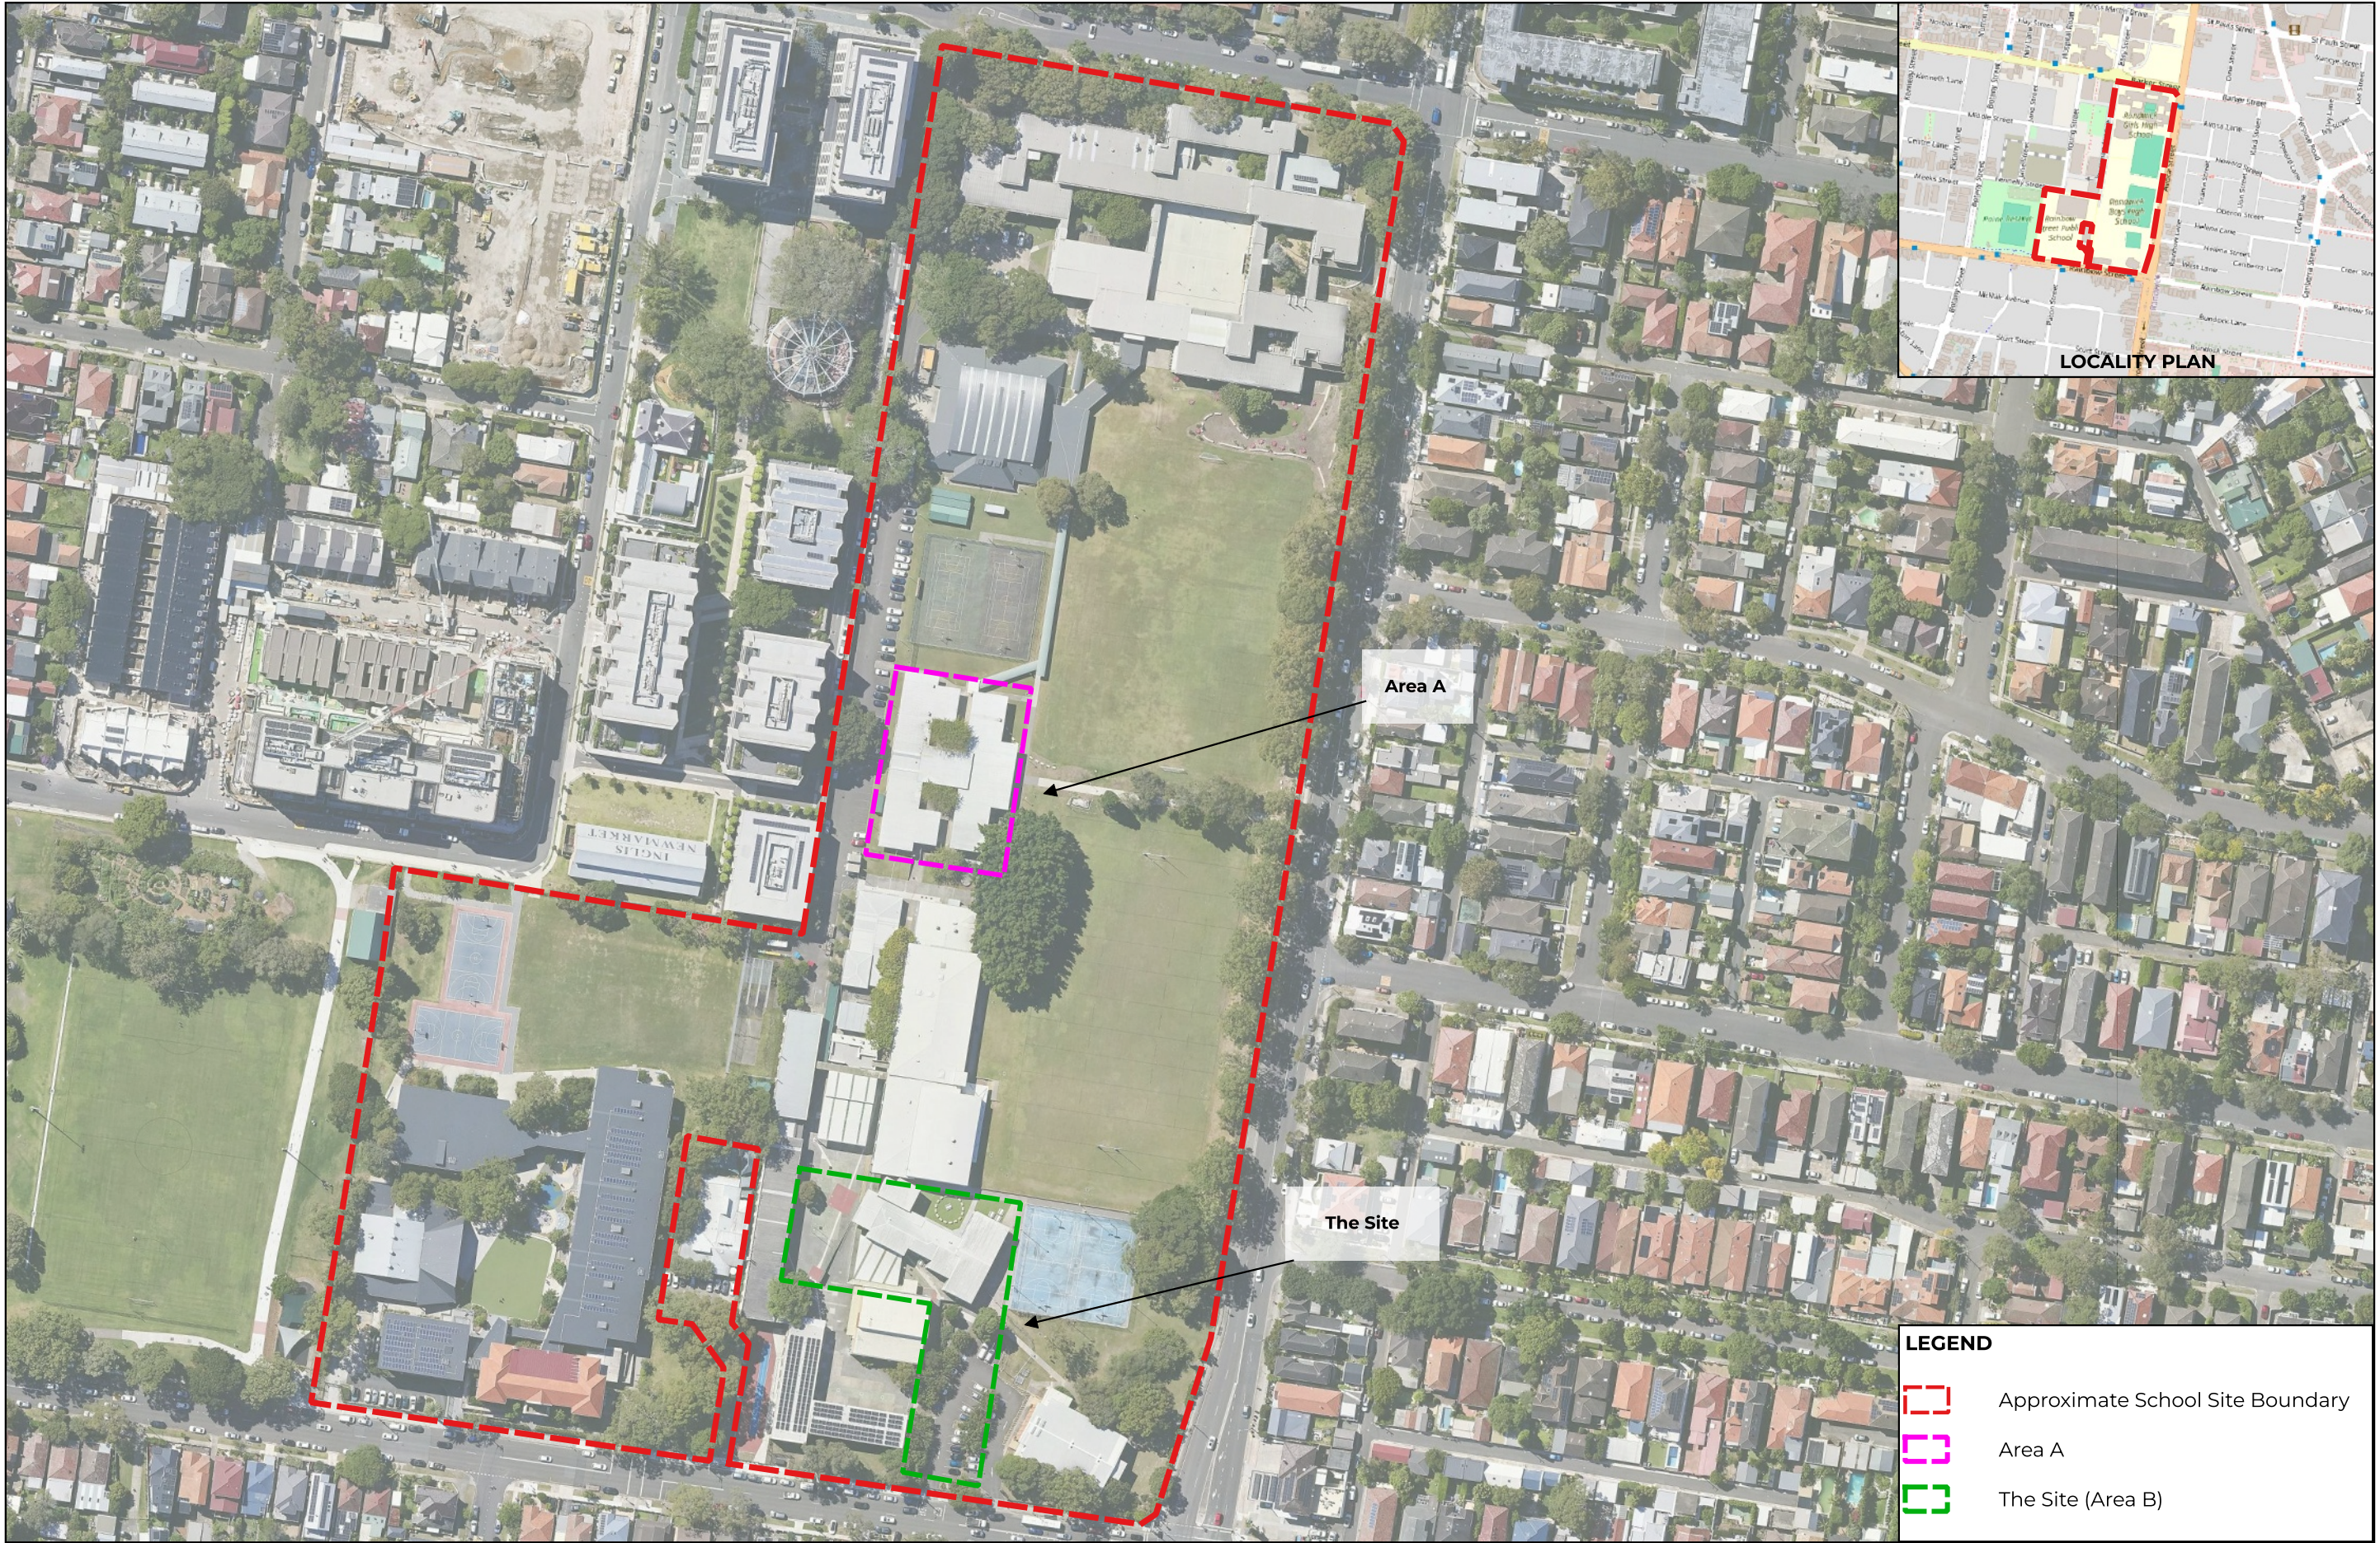
DRAWING NO:  
**R.003.D.001**

- Approximate School Site Boundary
- Area A
- The Site (Area B)

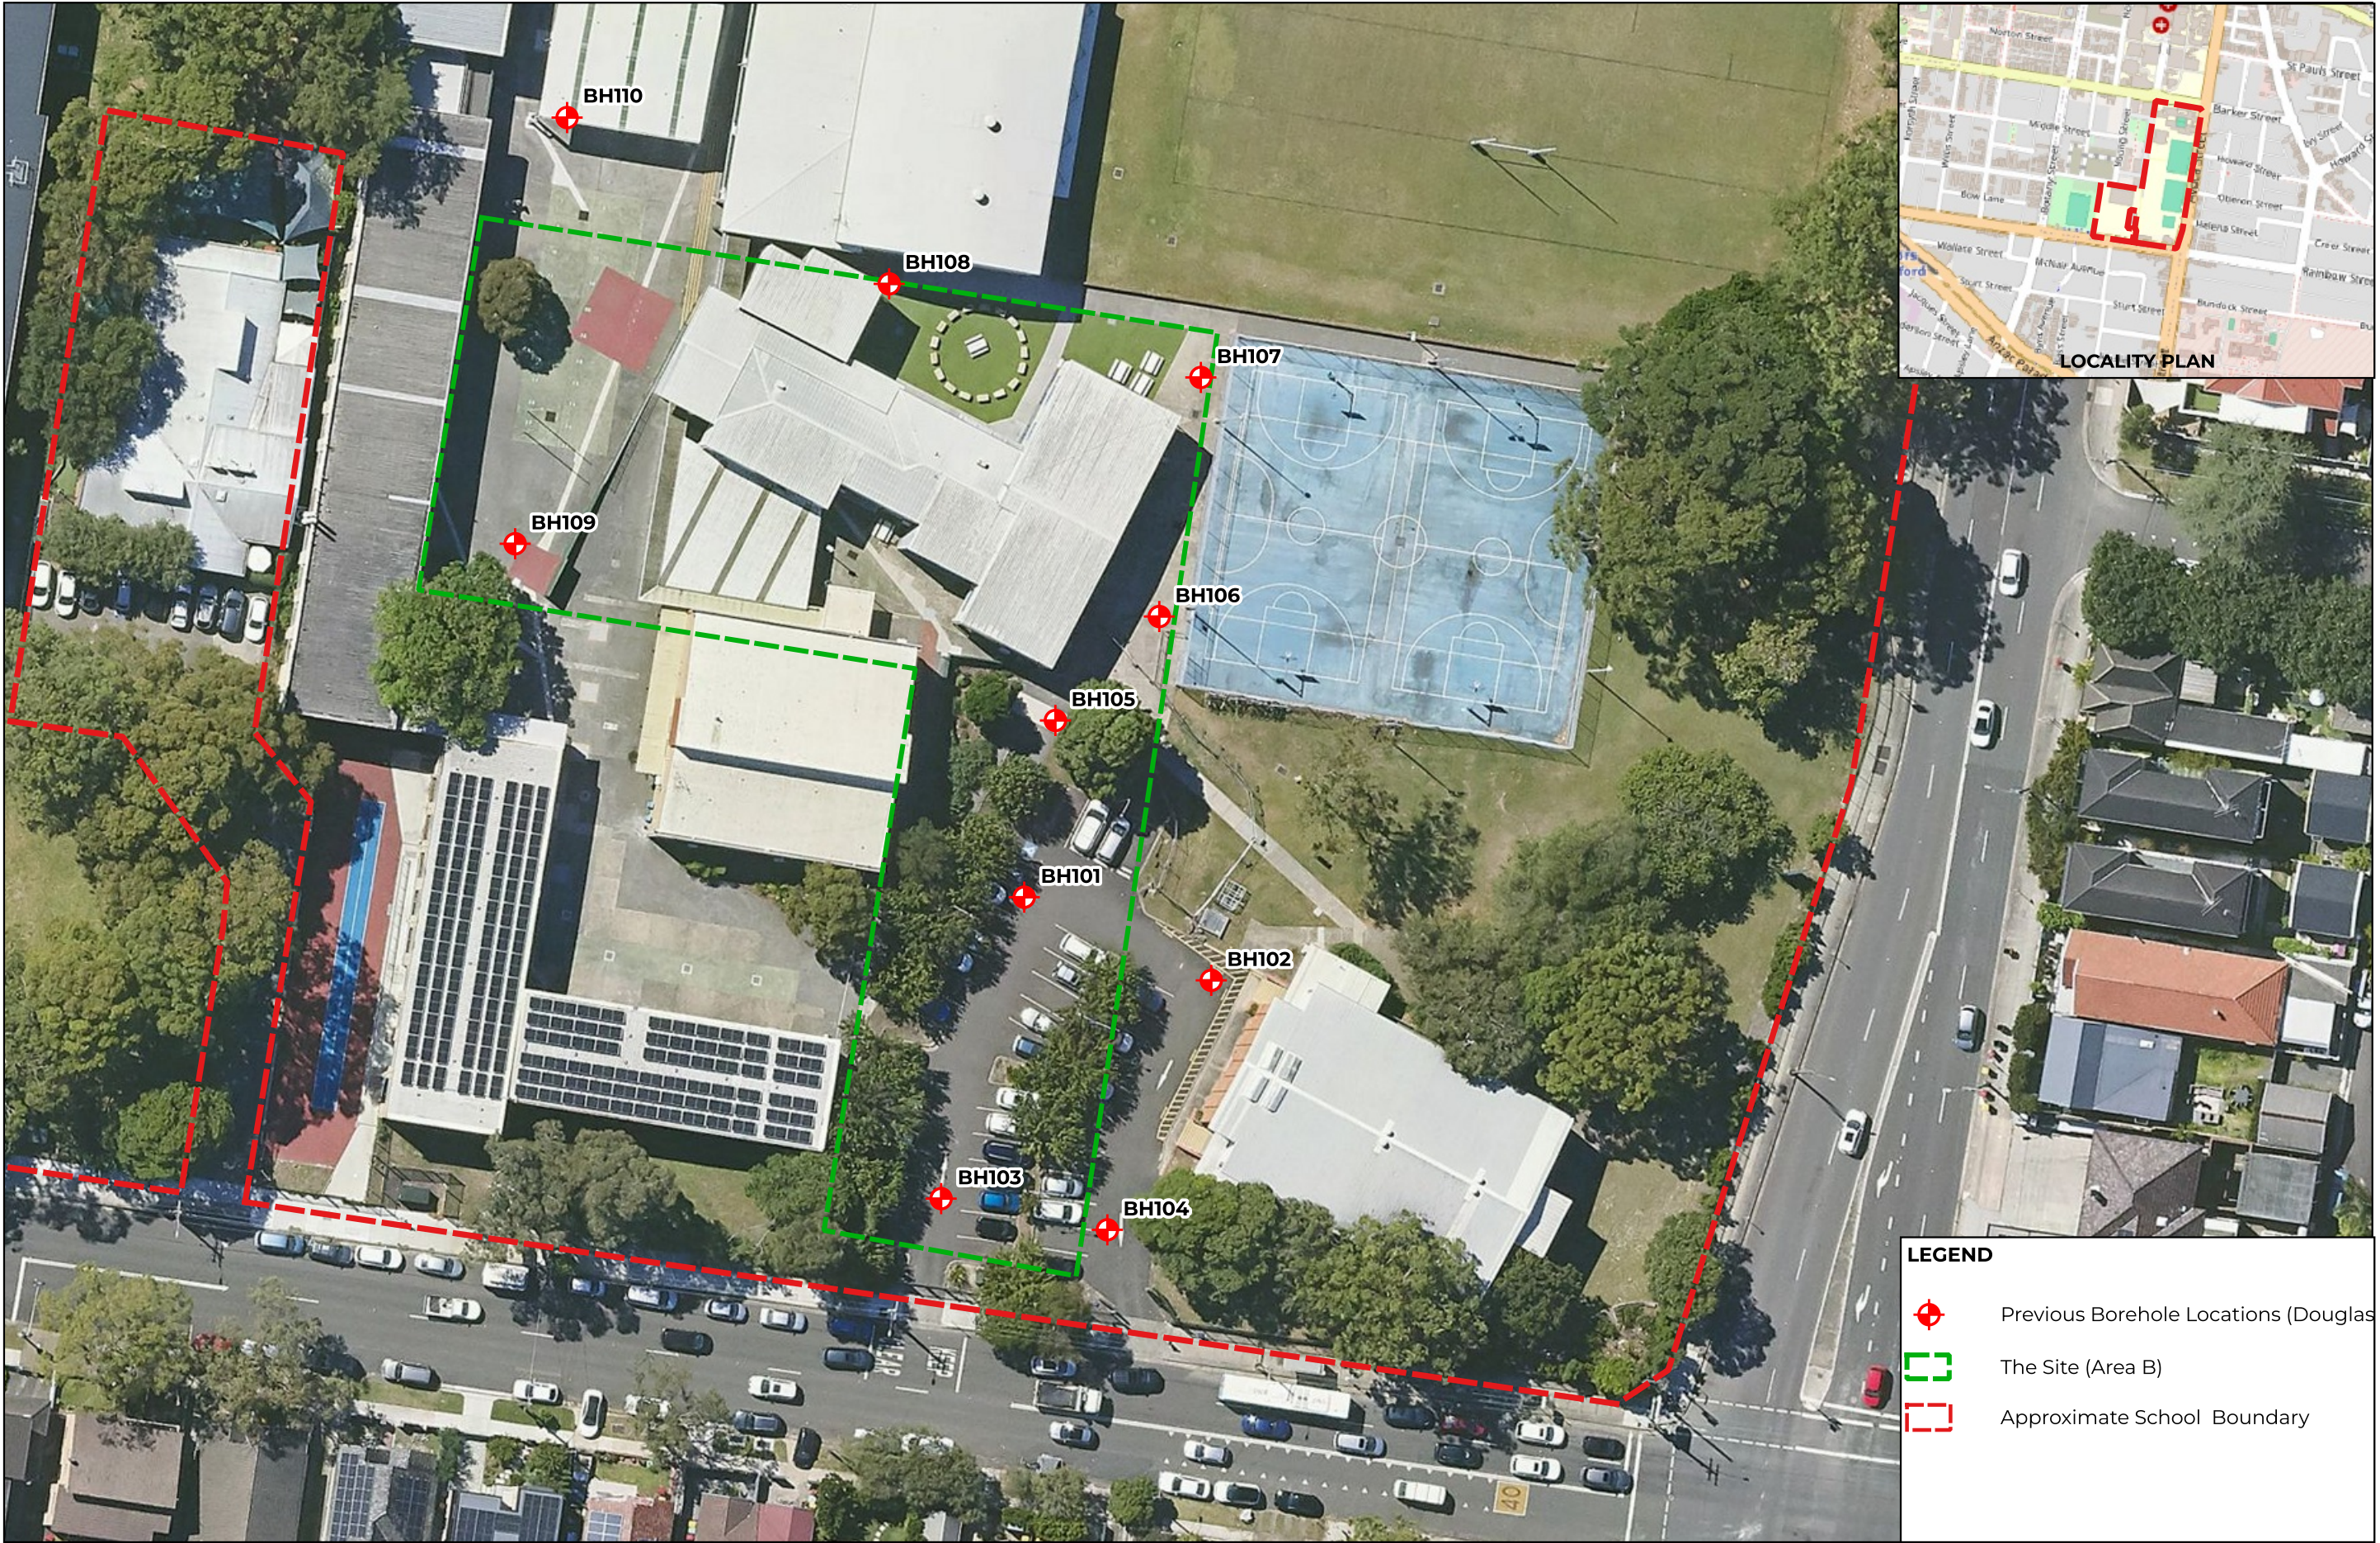
PROJECT NO:  
**224455.00**  
DRAWING NO:  
**R.003.D.002**  
REVISION:  
**0**

DRAWING TITLE:  
**Previous Test Locations At The Site**

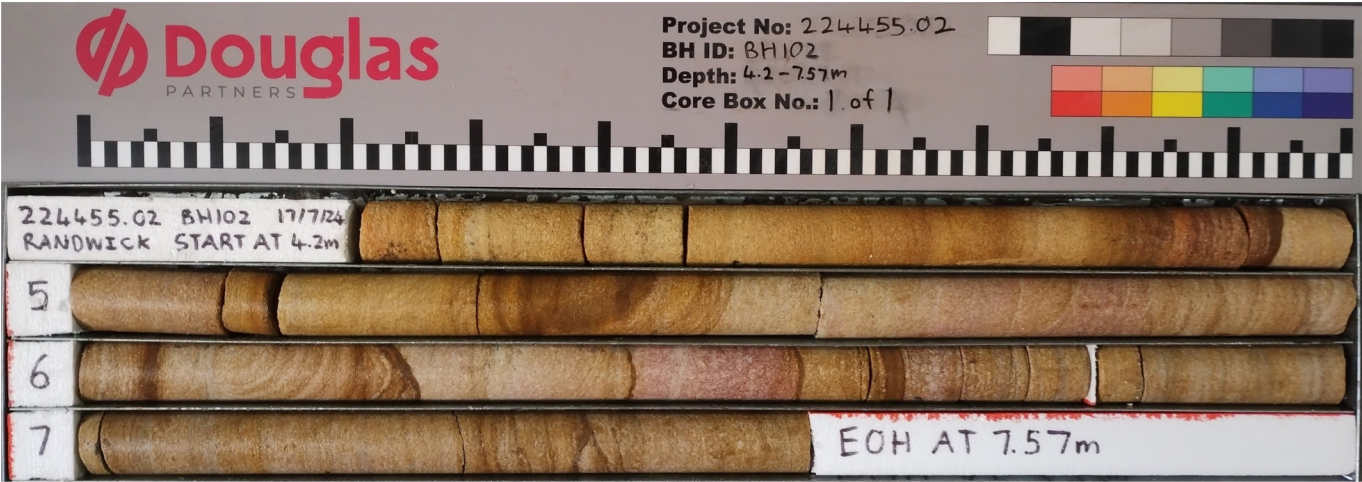
**LOCATION ID:** BH102  
**PROJECT No:** 224455.02  
**DATE:** 17/07/24  
**SHEET:** 1 of 1

4.20-7.57 m depth

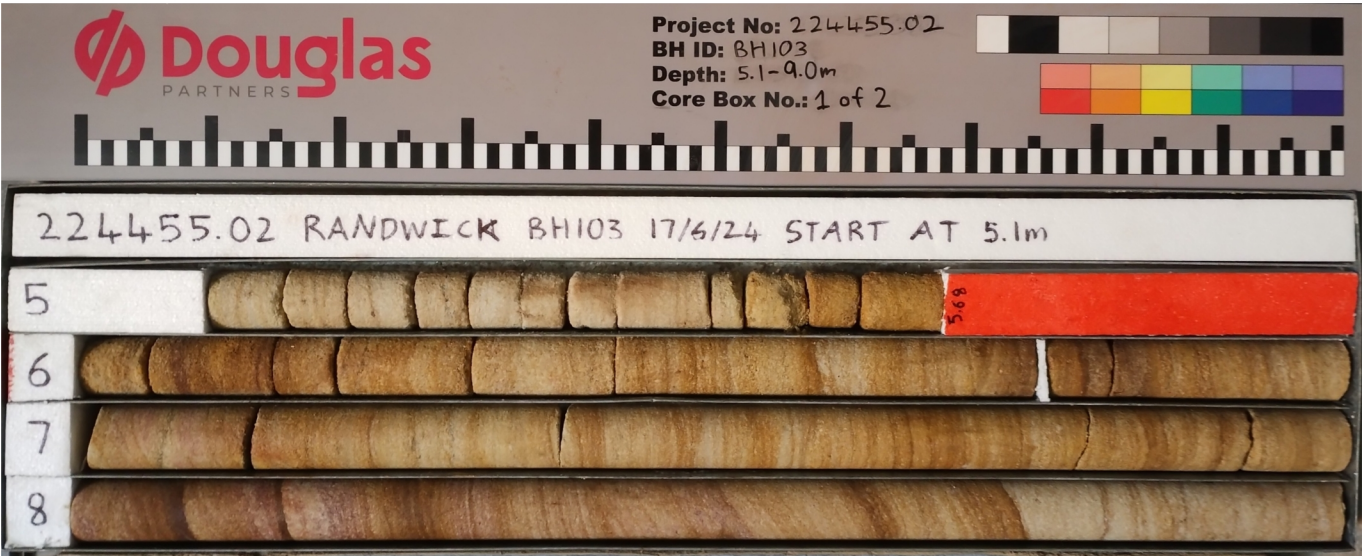
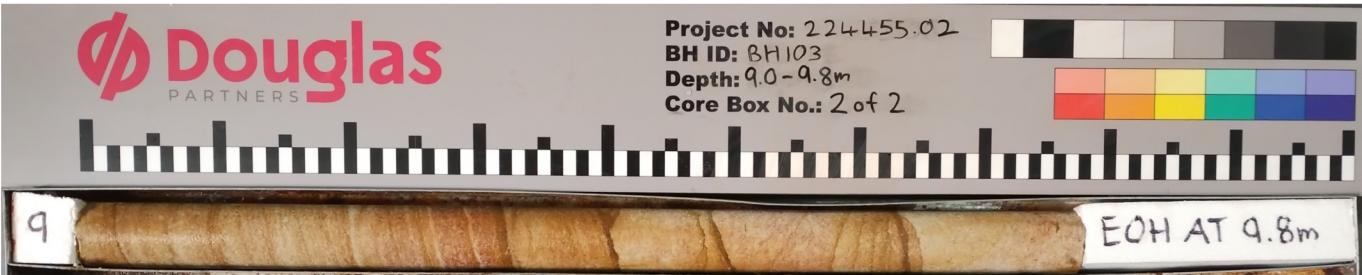
**LOCATION ID:** BH103  
**PROJECT No:** 224455.02  
**DATE:** 17/06/24  
**SHEET:** 1 of 1

5.10-9.00 m depth

9.00-9.80 m depth
