**Report on Detailed Site Investigation  
Contamination**

**Randwick Boys and Girls School Upgrade**

**Rainbow Street, Randwick NSW**

**Project 224455.00**

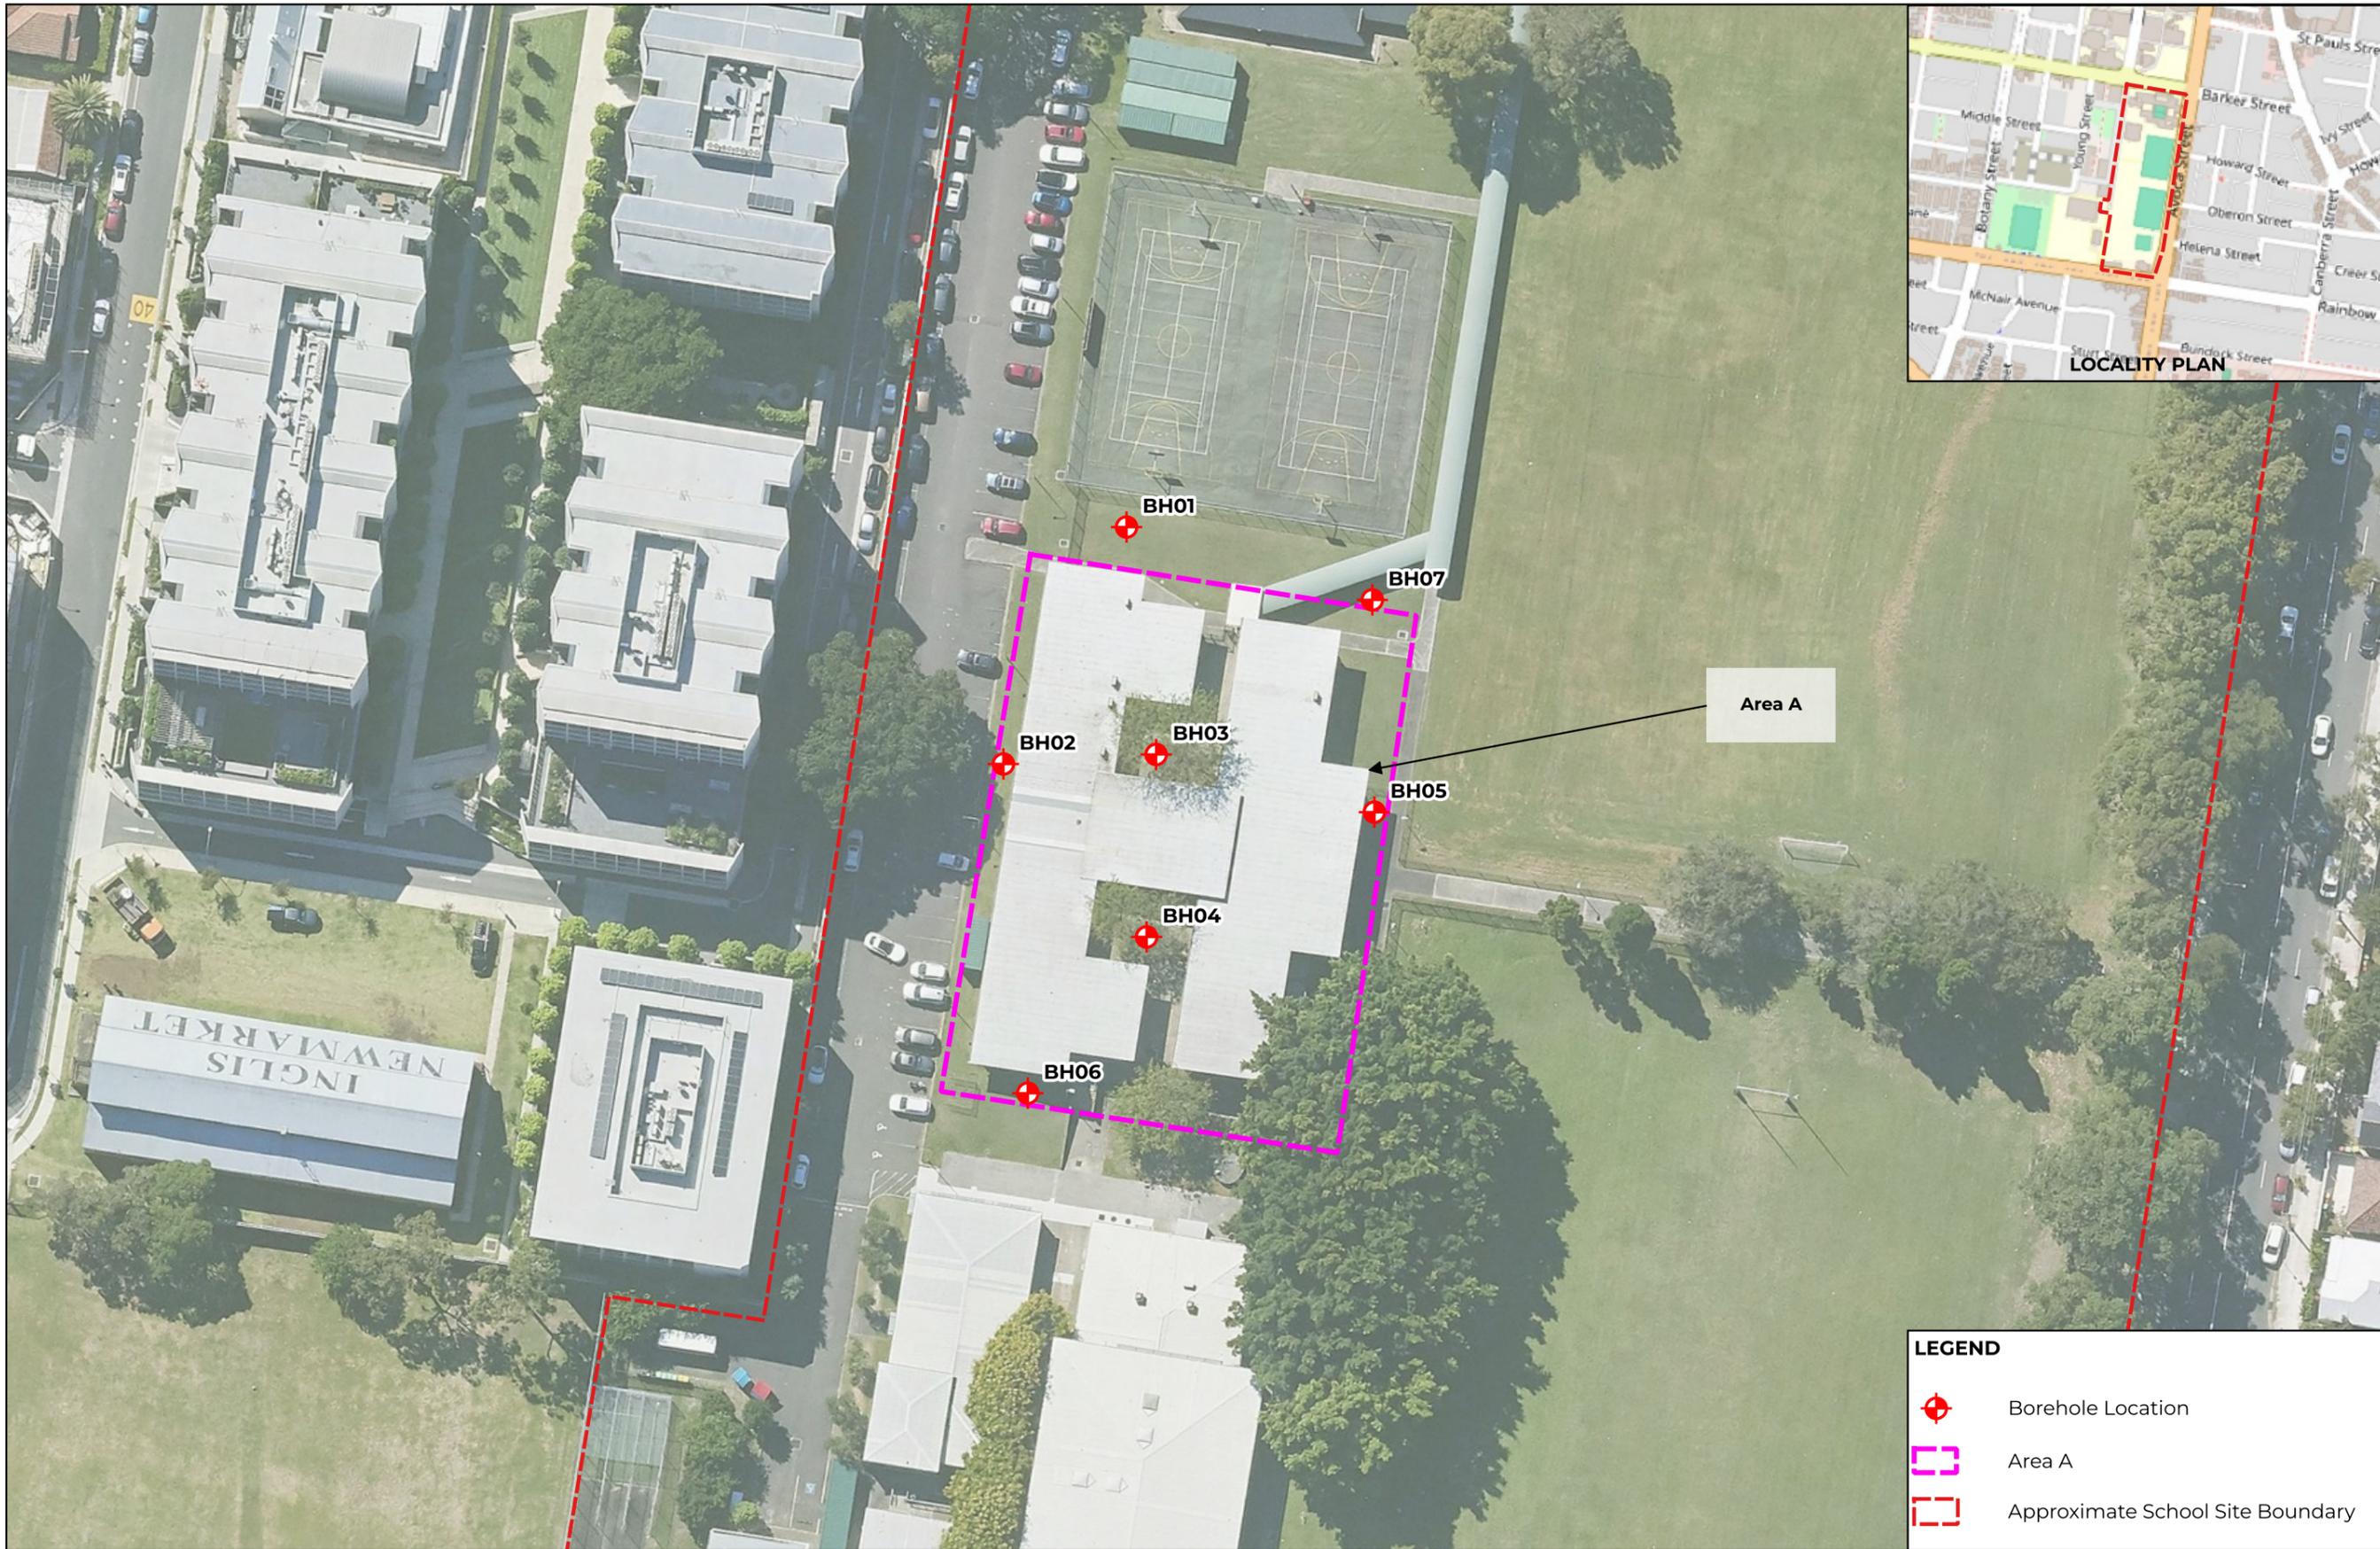
DRAWING NO:  
**R.002.D.003**

LEGEND	
	Borehole Location
	Area A
	Approximate School Site Boundary

During the geotechnical investigations undertaken in conjunction with the DSIC, seven boreholes (BH01 to BH07) were drilled across Area A, and 10 boreholes (BH101 to BH110) across Area B. Details of the investigation methodologies and subsurface conditions encountered are presented in later sections of this DSIC report.

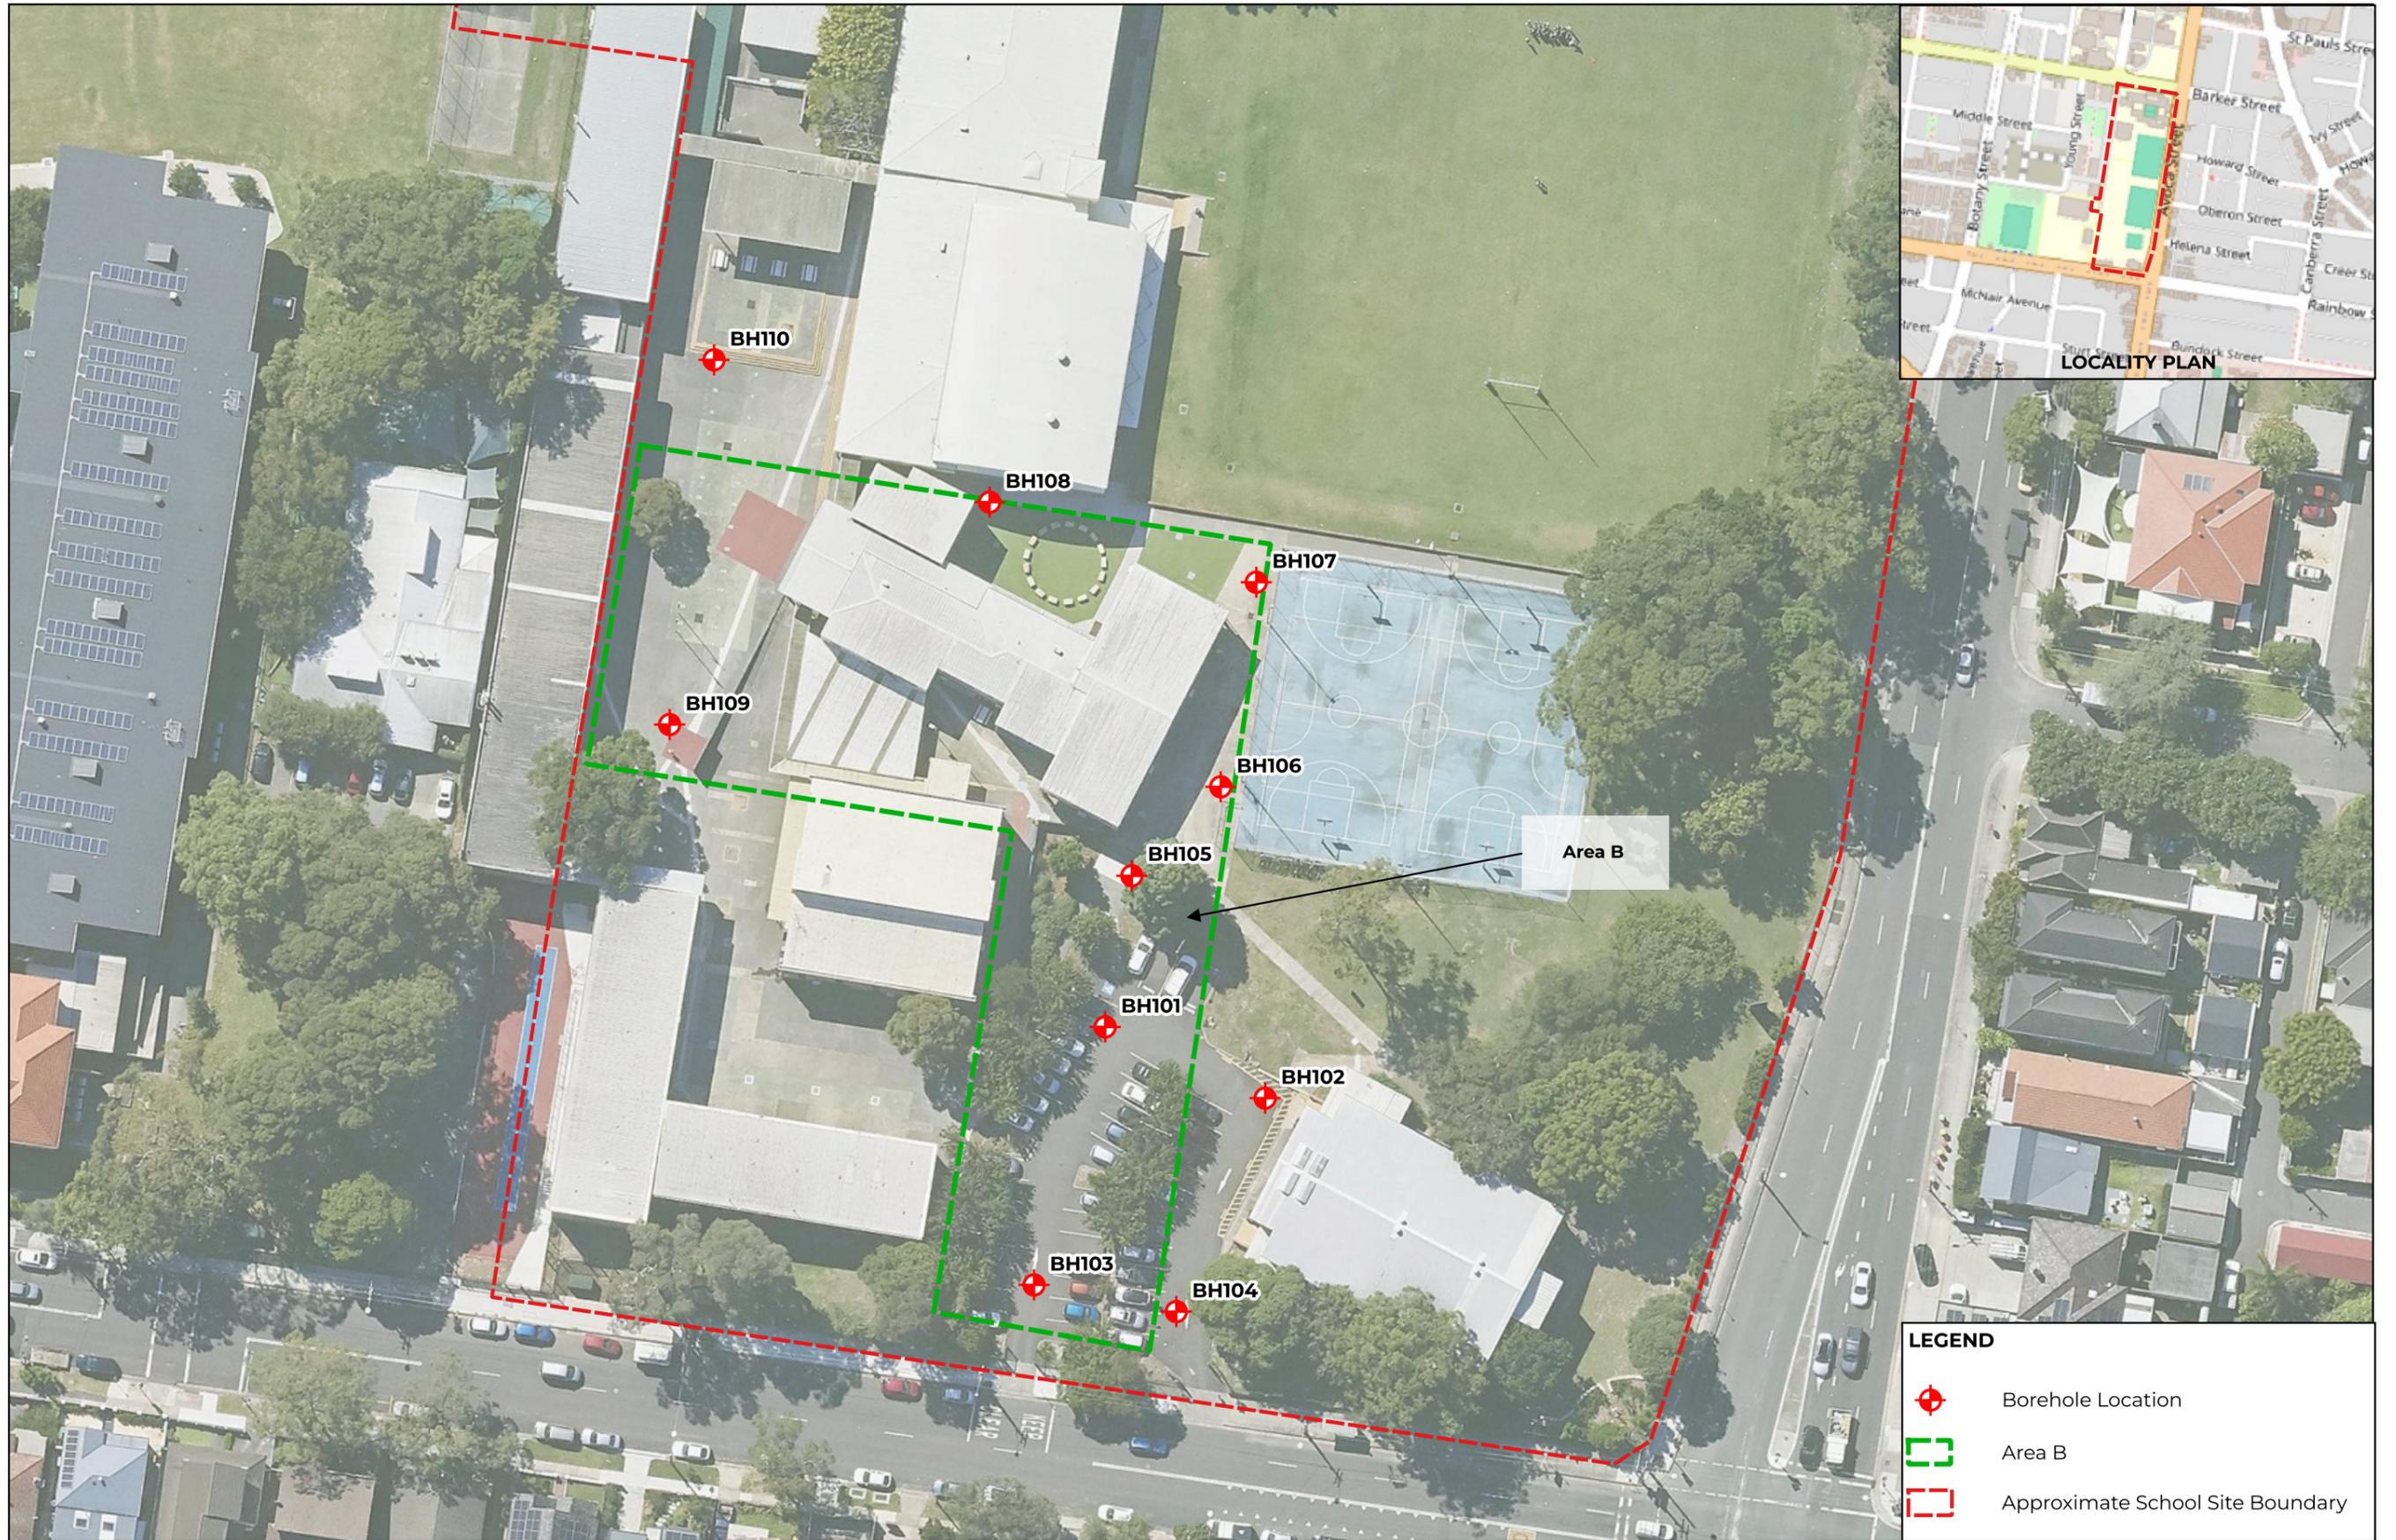
Borehole Location
	Area B
	Approximate School Site Boundary

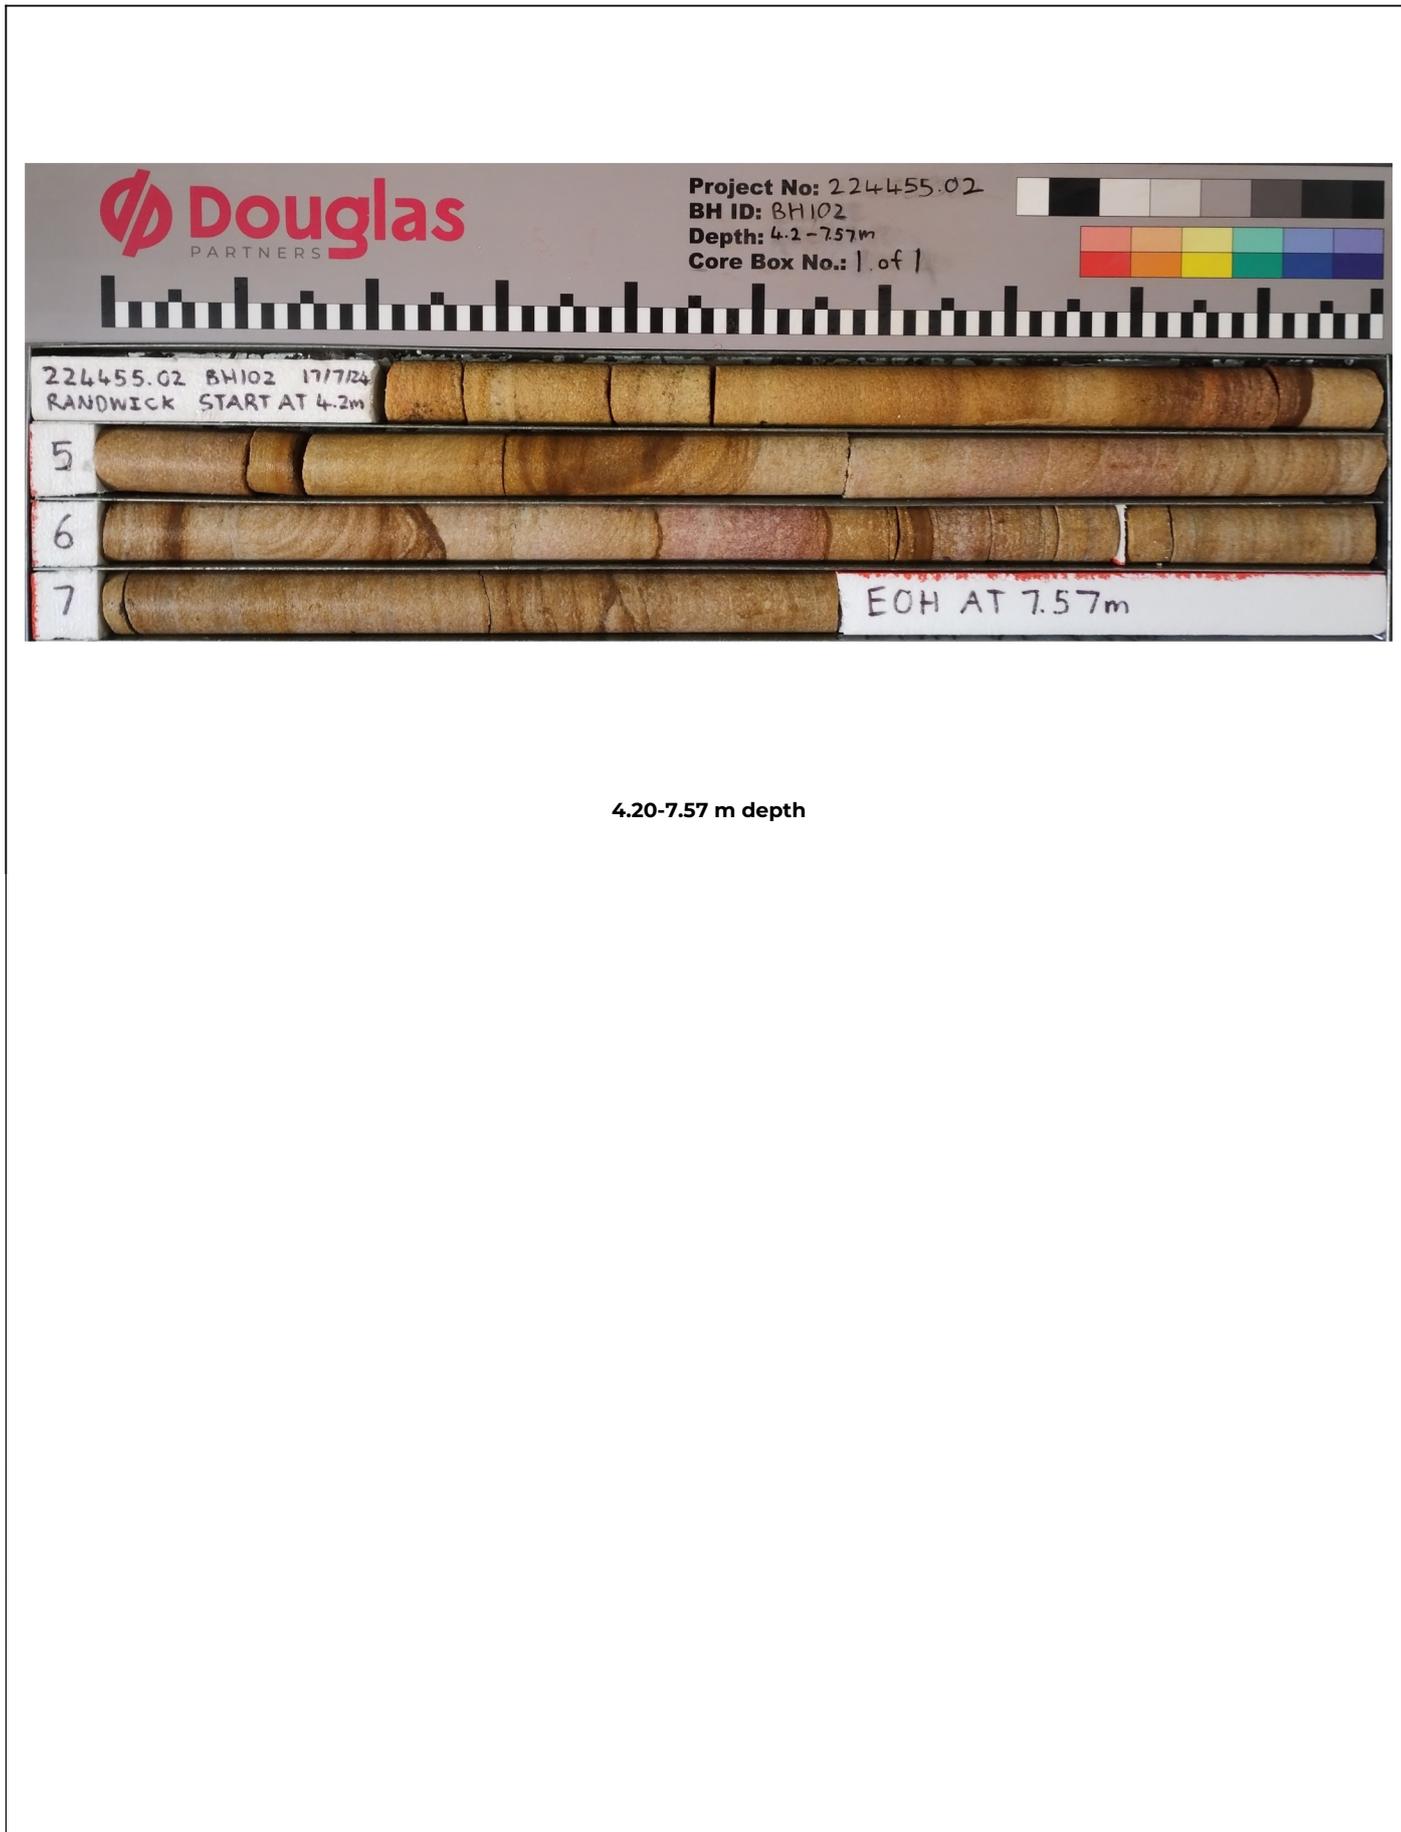
**LOCATION ID:** BH102  
**PROJECT No:** 224455.02  
**DATE:** 17/07/24  
**SHEET:** 1 of 1

4.20-7.57 m depth

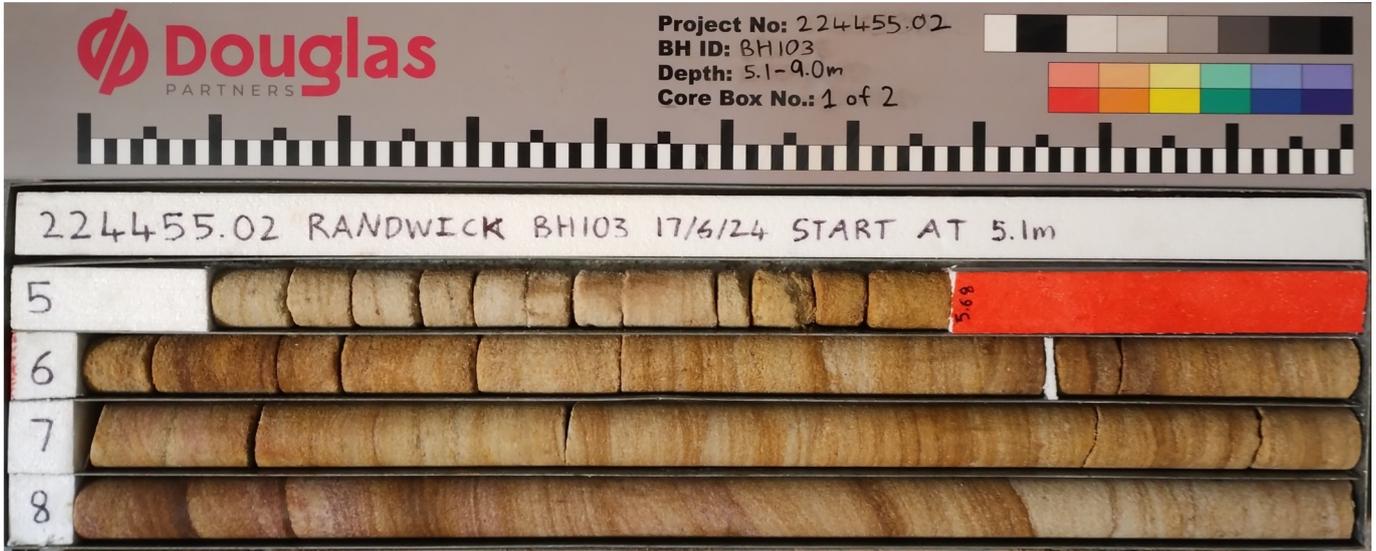
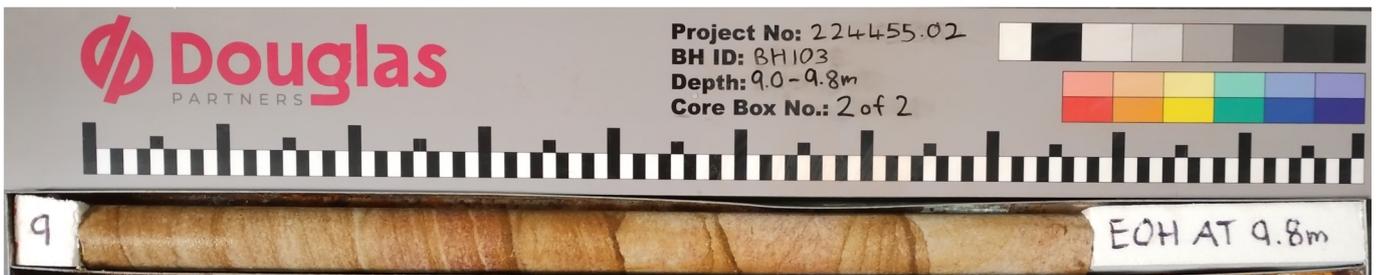
**LOCATION ID:** BH103  
**PROJECT No:** 224455.02  
**DATE:** 17/06/24  
**SHEET:** 1 of 1

5.10-9.00 m depth

9.00-9.80 m depth
