Upgrade to Cammeray Public School Geotechnical Investigation Report

68 Palmer Street, Cammeray NSW 2062

Prepared for: NSW Department of Education

A201023.0772.01_A_v3f | Date: 28 February 2025

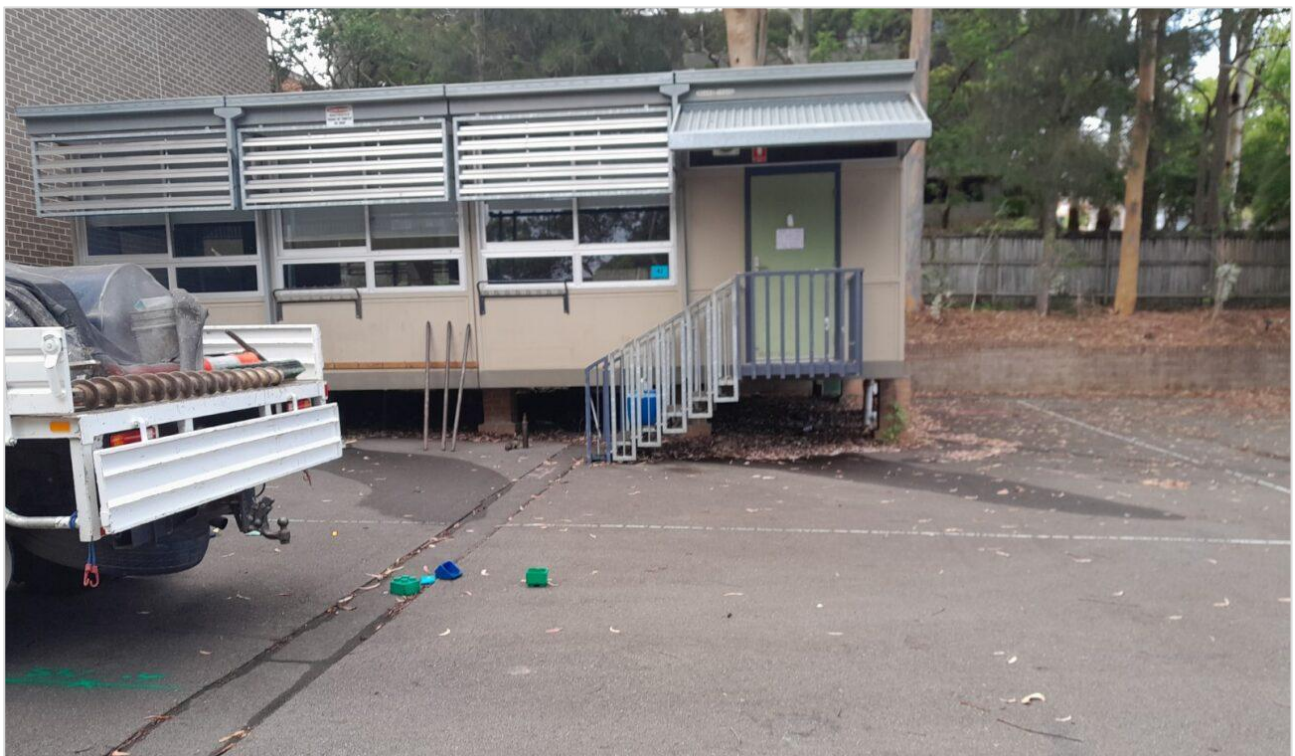
Figure 2: View of an existing demountable at the proposed development

The site is an irregularly shape land that encompasses a total area of approximately 1.3 ha. The main administration block is located most southernly to the site near the car park and a gate along Palmer Street. A row of demountable buildings and a busway are on the eastern side along Bellevue Street. **Figure 1** presents the current demountable structure, while **Figures 2 and 3** delineate the areas marked for proposed borehole drilling.

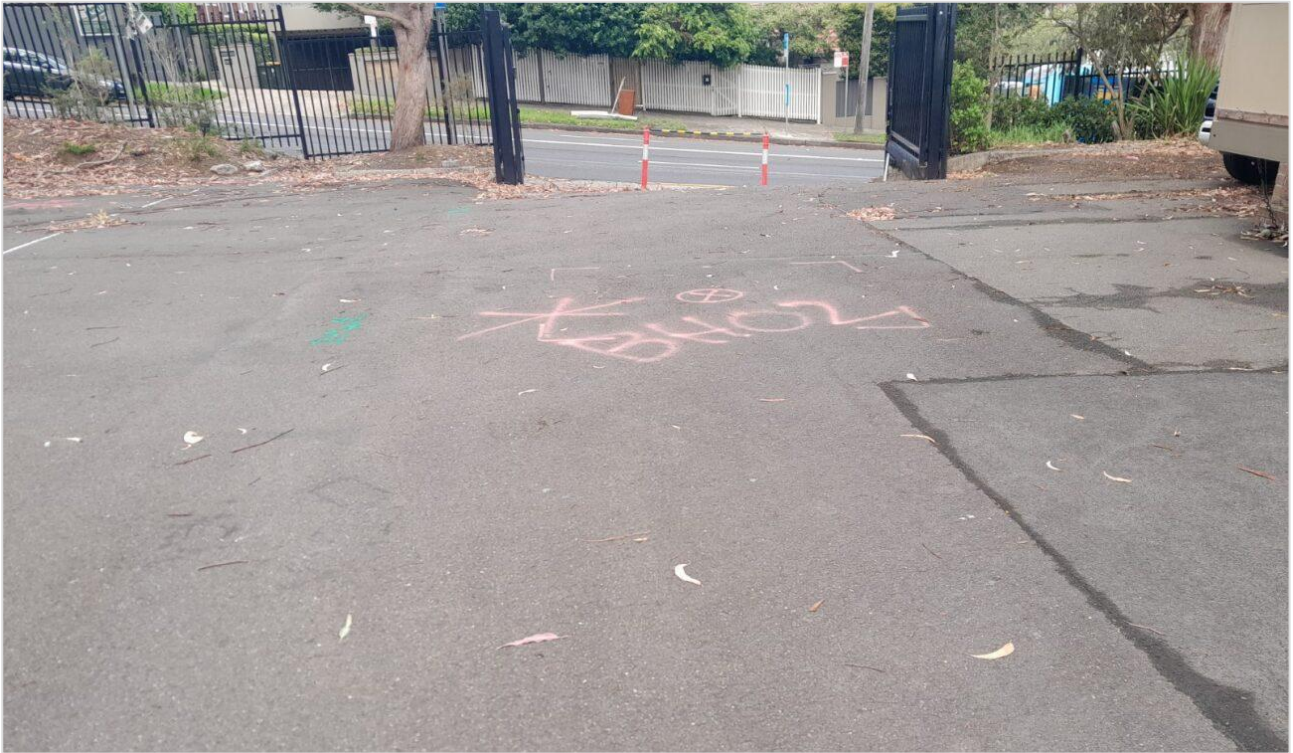
Figure 3: View of existing gate to carpark entry from Miller Street

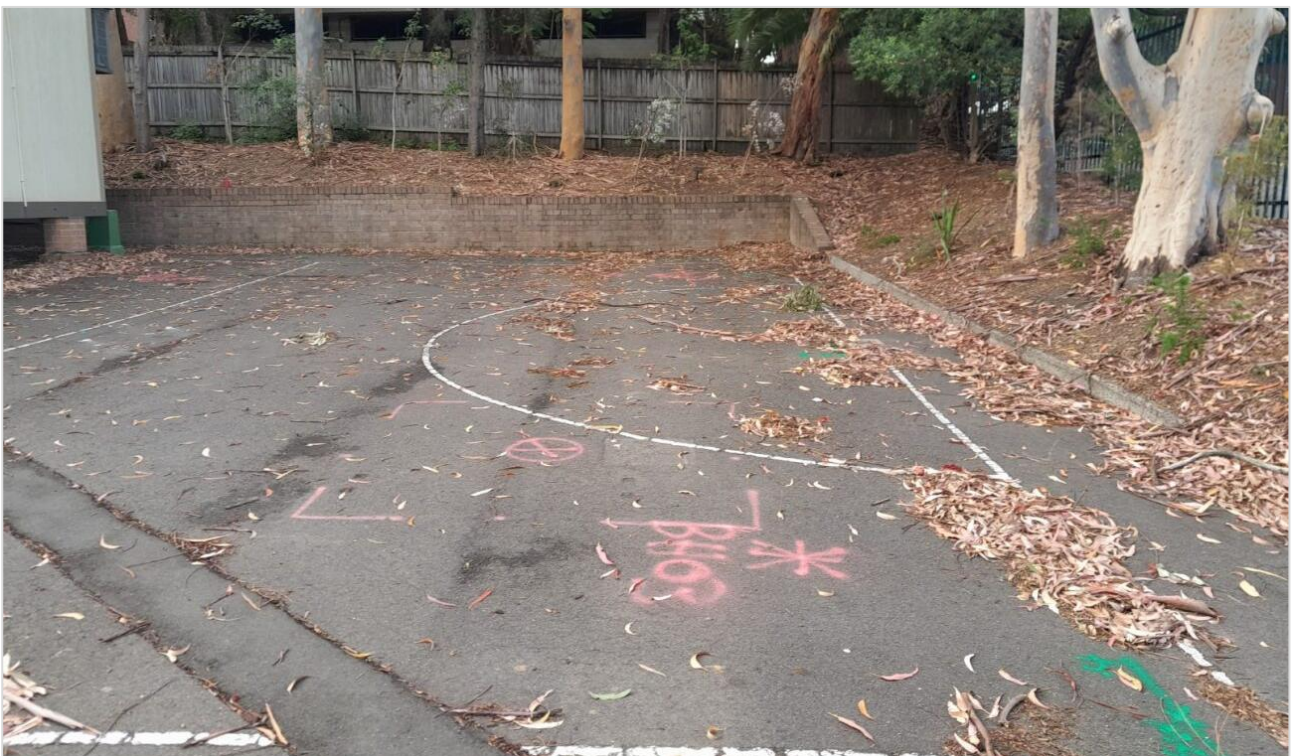
Figure 4: View of marked borehole locations marked within the proposed development area

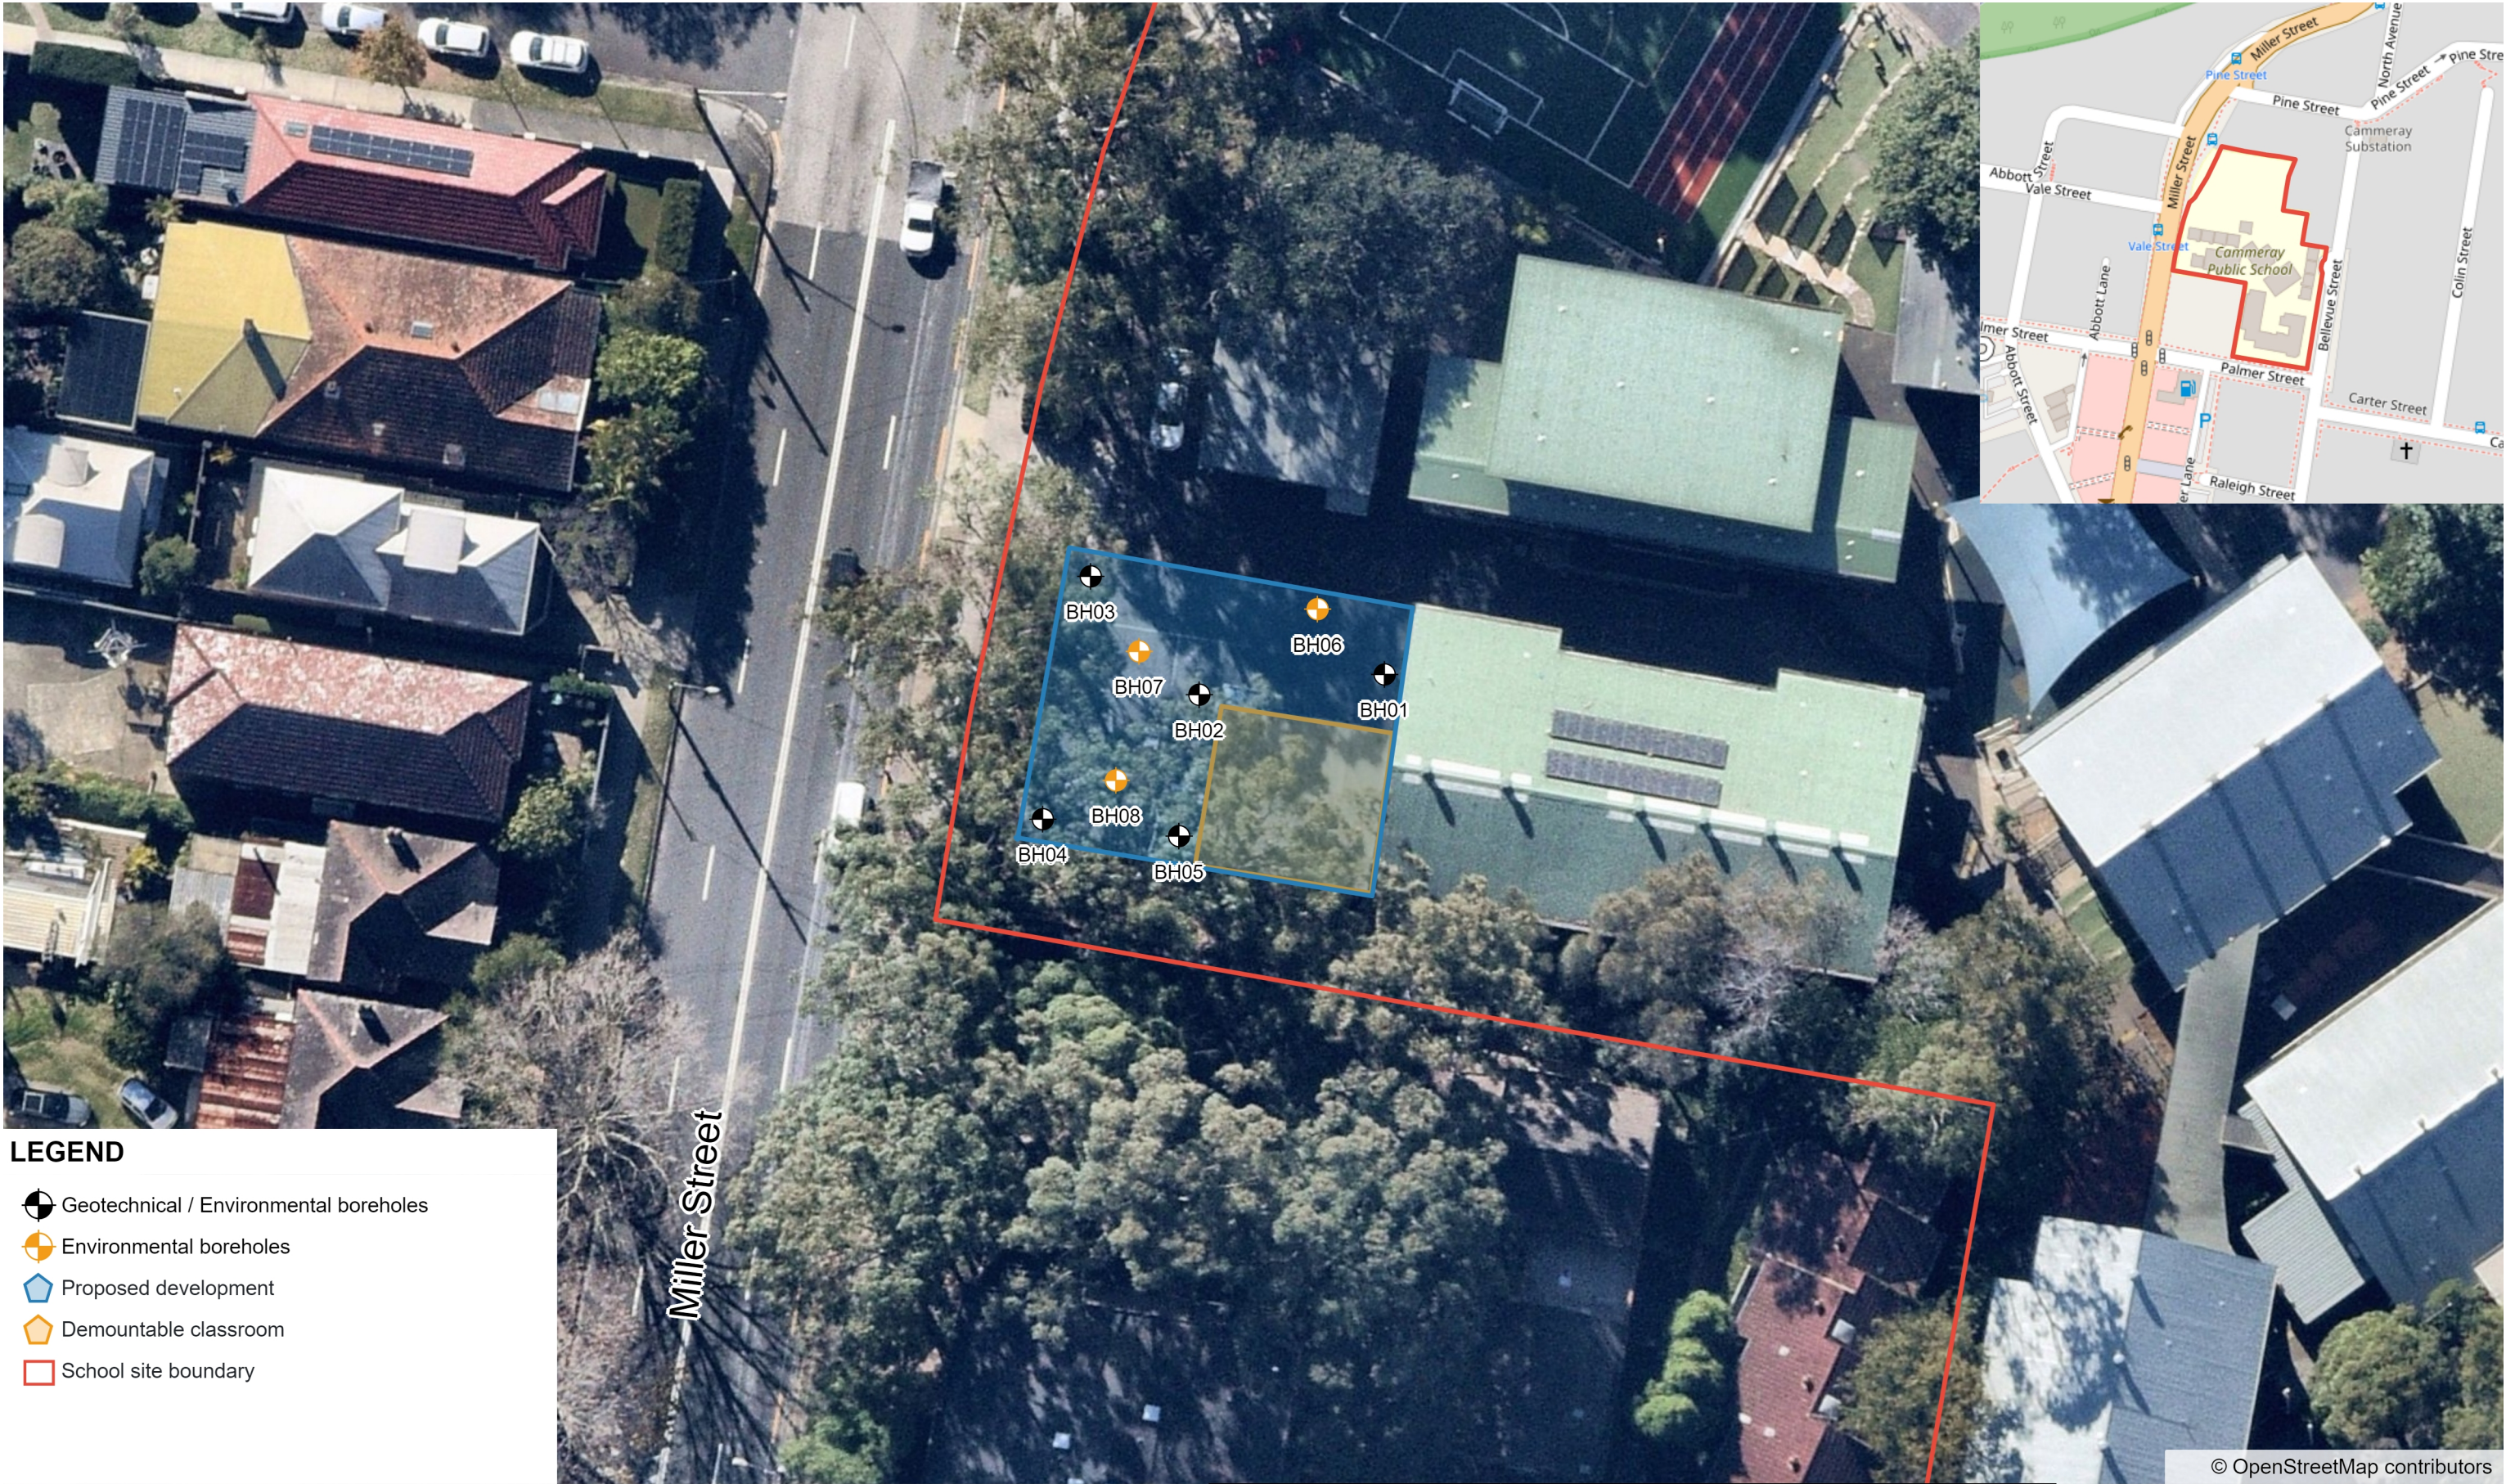
Appendix I – Borehole Location Plan

Geotechnical / Environmental boreholes

The purpose of this report is to preliminarily assess the subsurface conditions of the proposed work area to support the design layout development only. The school is located at 68 Palmer Street, Cammeray NSW 2062. A Site Plan showing the proposed building footprint and borehole locations is presented in **Appendix I**.
