## PART 1 - PRELIMINARY INDIGENOUS HERITAGE IMPACT

### Report for *Cammeray Public School*

<b>Project Name</b>	Cammeray Public School Upgrade		
<b>Report Title</b>	Preliminary Indigenous Heritage Assessment and Impact Report		
<b>File Name</b>	Aboriginal Due Diligence-Cammeray Public School - AMAC-Aegis Pty Ltd-DDWO05118-23		
<b>School Name:</b>	Cammeray Public School	<b>Company Name:</b>	AMAC-AEGIS PTY LTD
<b>School Address:</b>	68 Palmer Street, Cammeray, NSW 2062	<b>Report Date:</b>	09/11/2023
<b>School Region:</b>	North Sydney, NSW	<b>Contract Number:</b>	DDWO05118-23

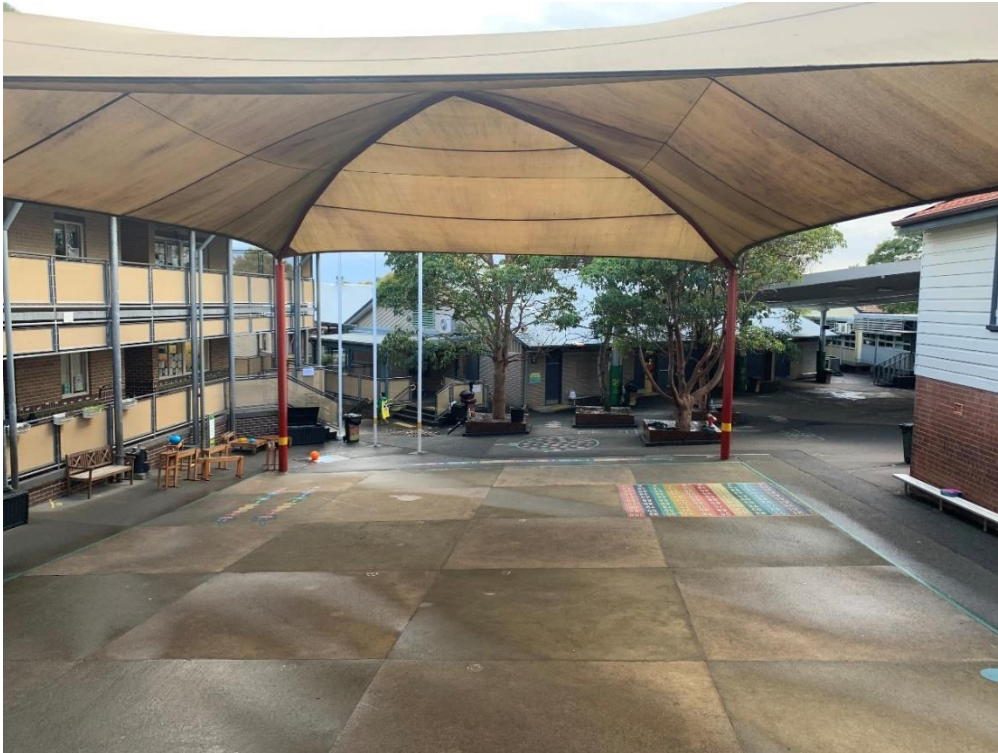
**Figure 4.11 School play area with enclosed surfaces, view to north.**  
Located on the upper slope.  
AMAC Group, IMG 5852 (18/08/2023).

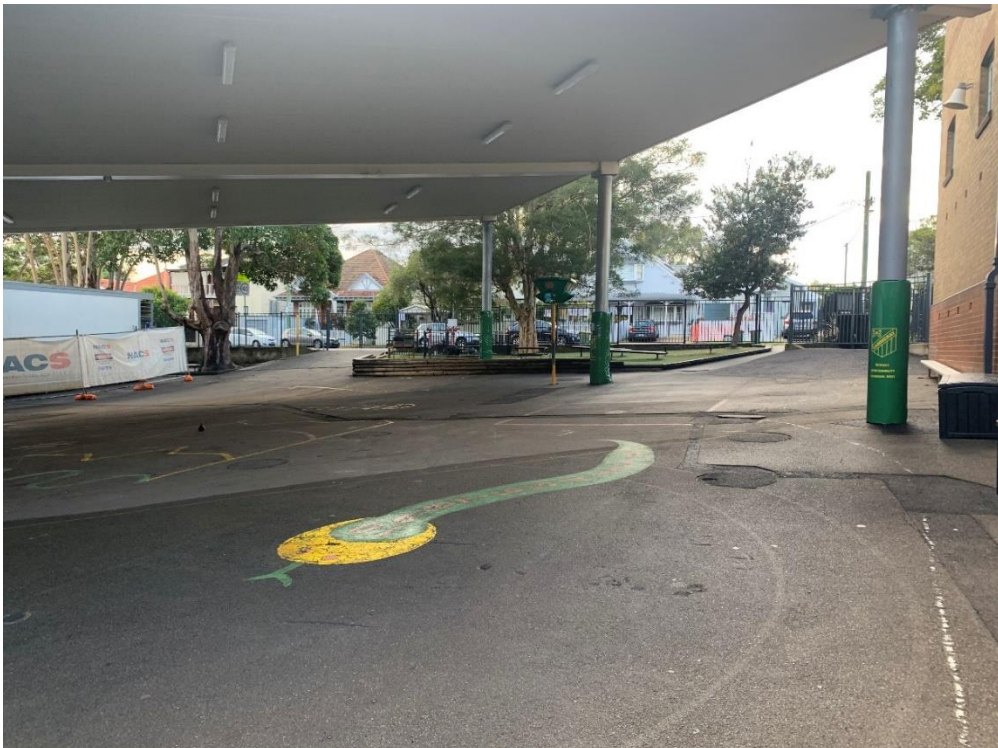
**Figure 4.12 School play area with enclosed surfaces and garden beds, view to northeast.**  
Located on the upper slope.  
AMAC Group, IMG 5855 (18/08/2023).

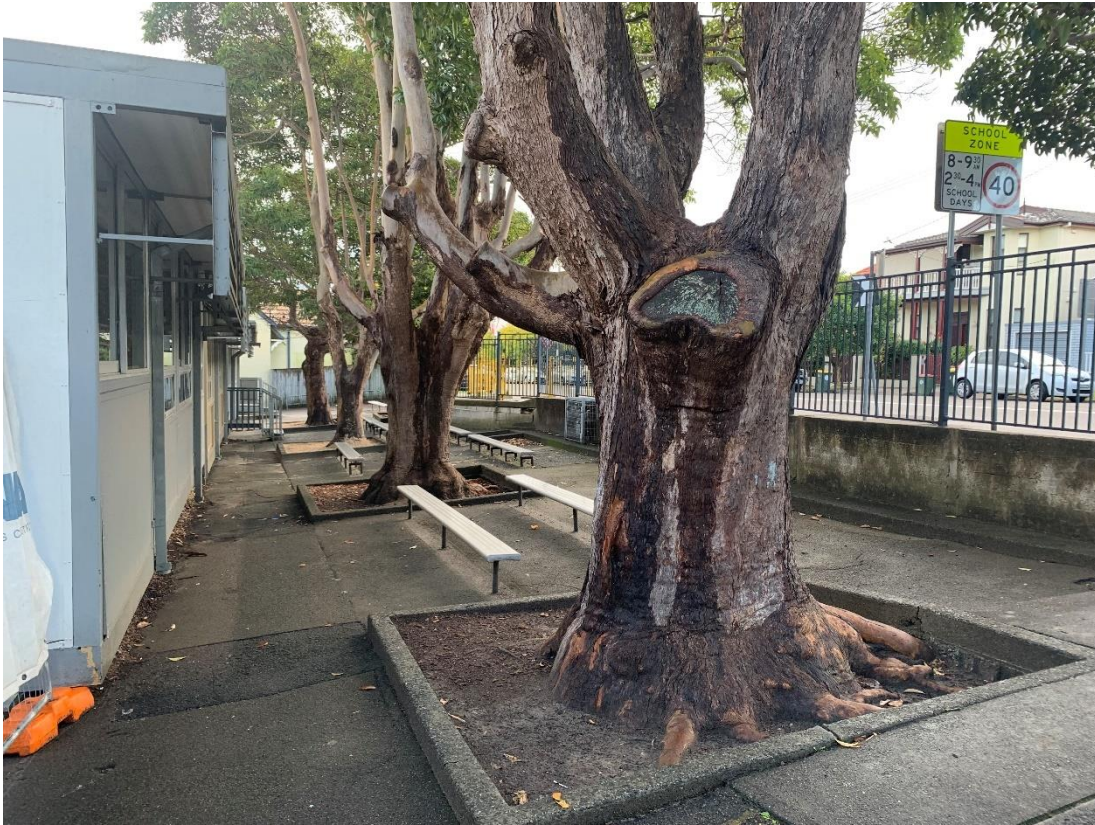
**Figure 4.13** Seated area along Bellevue Street with trees, view to northeast.  
Located on the upper slope.  
AMAC Group, IMG 5859 (18/08/2023).

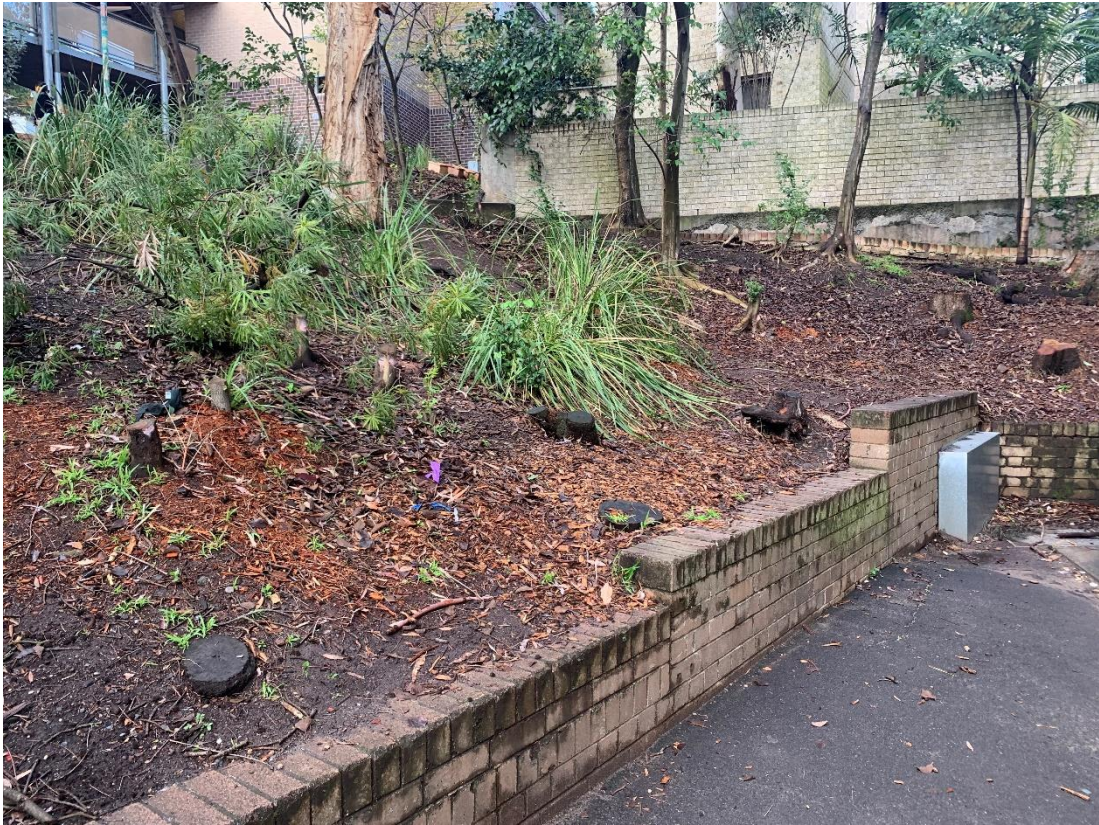
**Figure 4.15** Terraced garden bed on the upper slope.  
AMAC Group, IMG 5893 (18/08/2023).

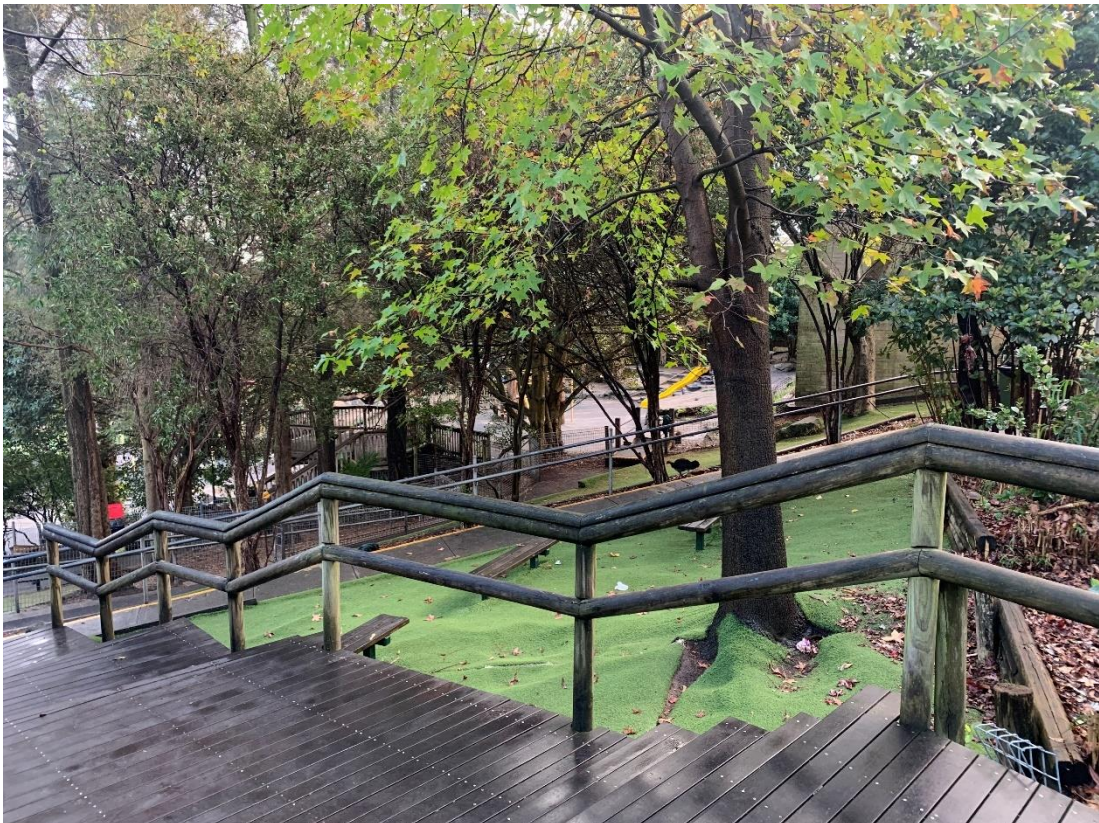
**Figure 4.16** Stairs and Astro turf showing steep topography, view to north.  
Located on the upper slope.  
AMAC Group, IMG 5861 (18/08/2023).

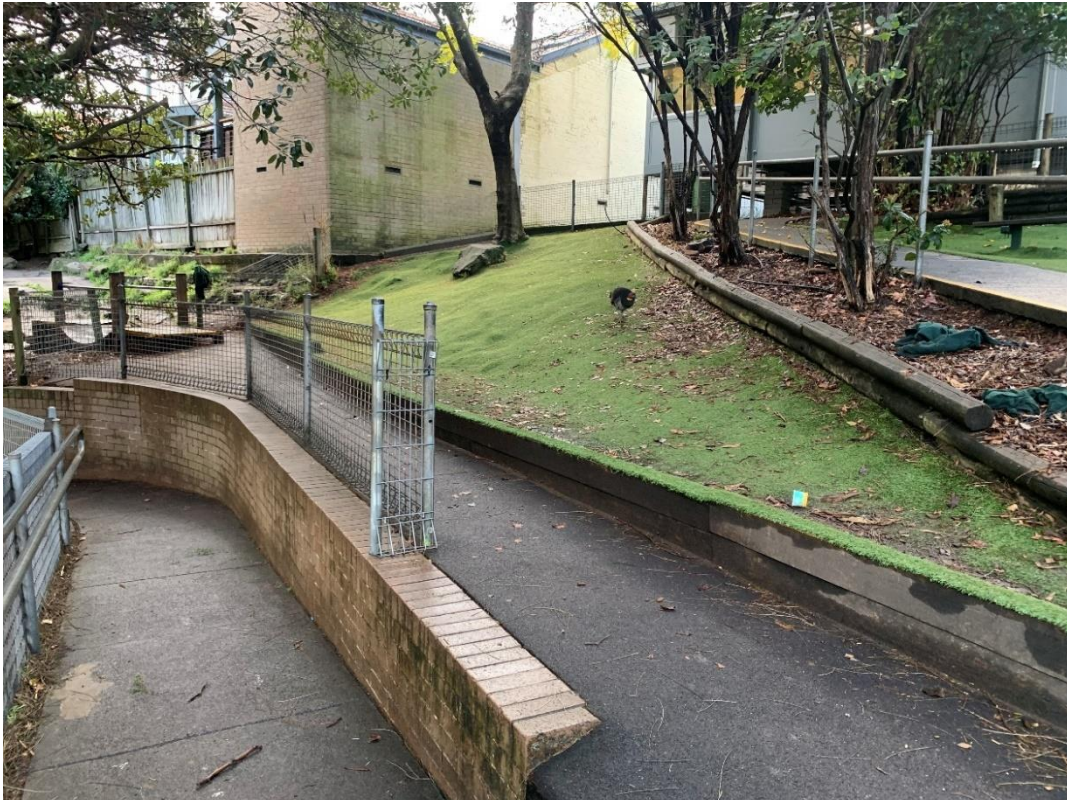
**Figure 4.17 Ramps, Astro turf and garden beds, view to southeast.**  
Located on the upper slope.  
AMAC Group, IMG 5862 (18/08/2023).

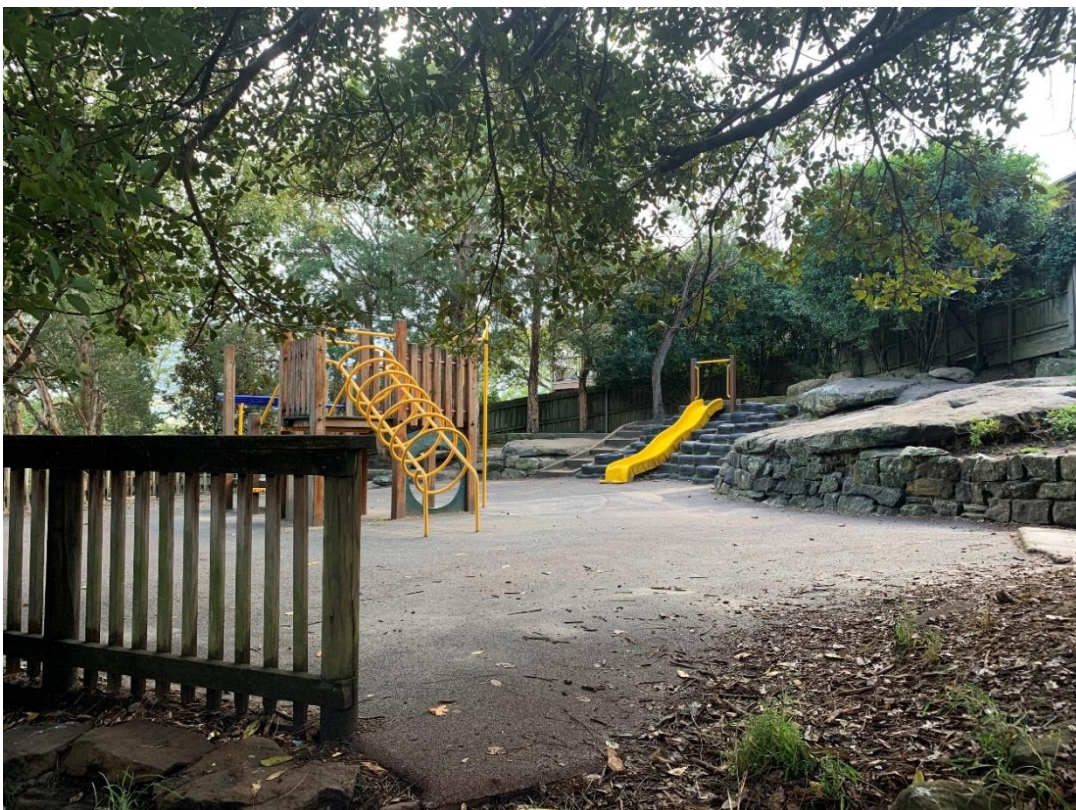
**Figure 4.18 Play area showing enclosed surfaces and natural sandstone rock, view to southeast.**  
Located on the lower slope.  
AMAC Group, IMG 5863 (18/08/2023).

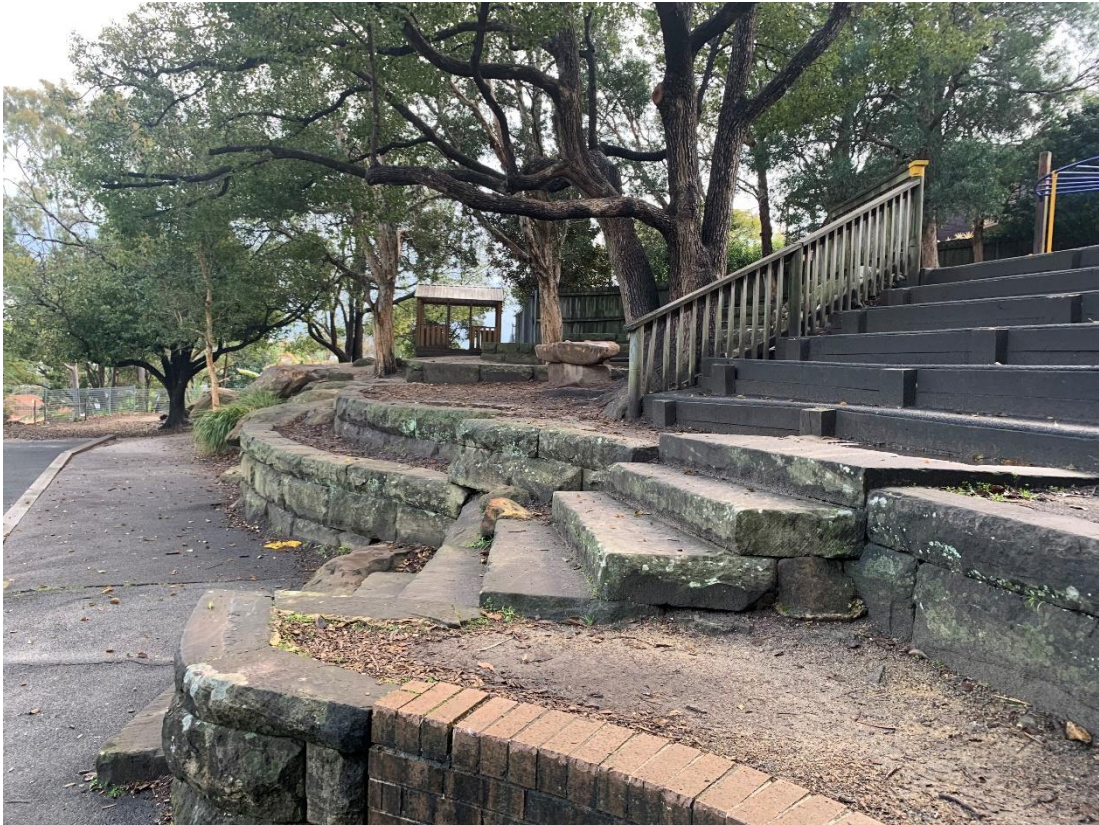
**Figure 4.19** Stairs and enclosed surfaces showing sloping topography, view to east.

Located on the lower slope.

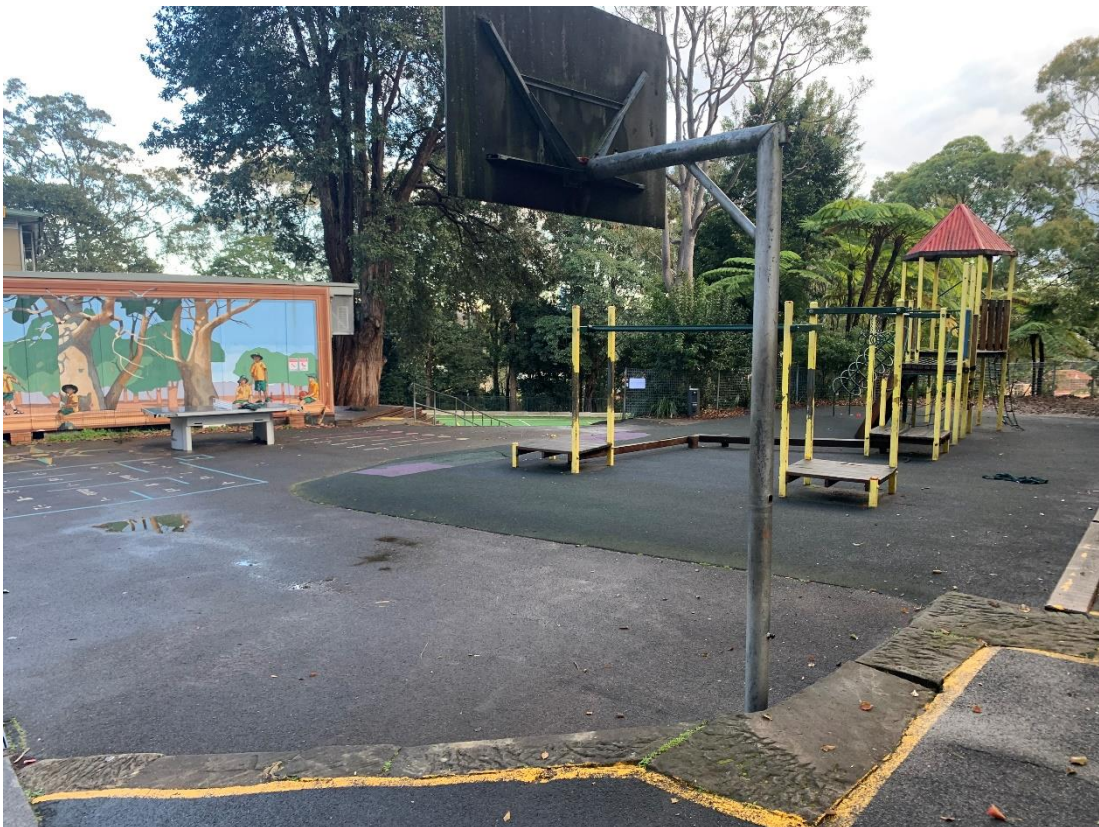
**Figure 4.20** Play area showing enclosed surfaces on the lower slope.

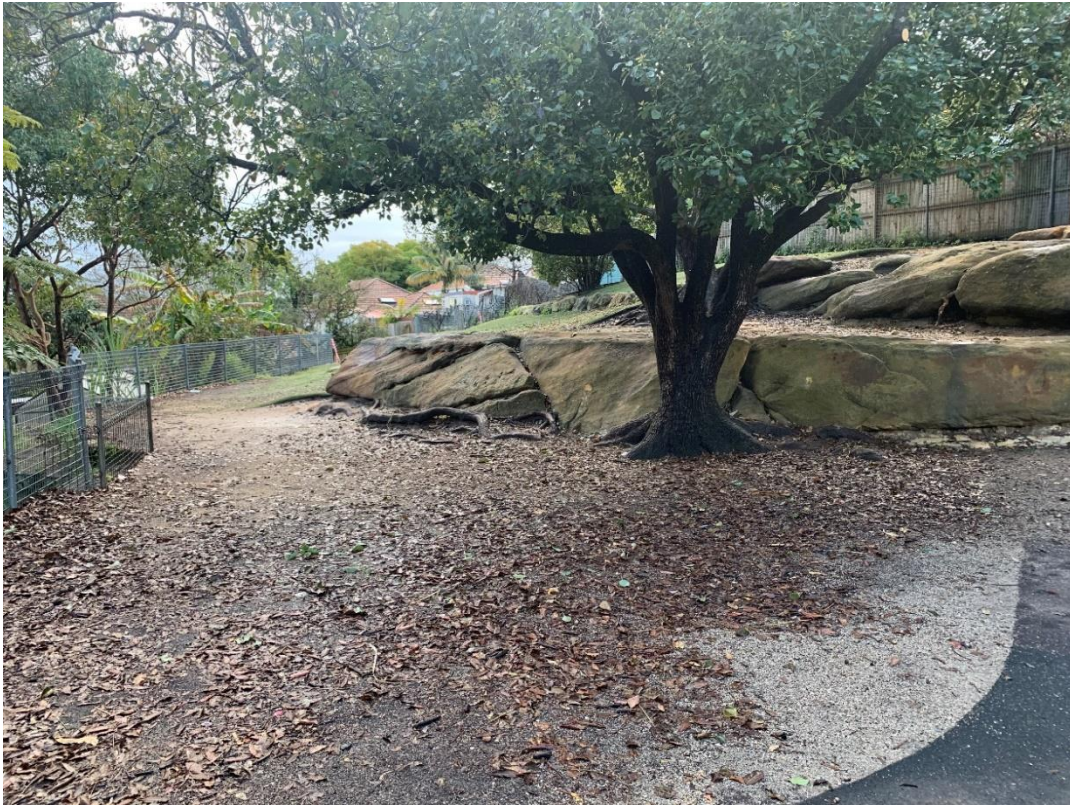
**Figure 4.21** Play area with soil landscape and natural outcropping of sandstone rock, view to east.

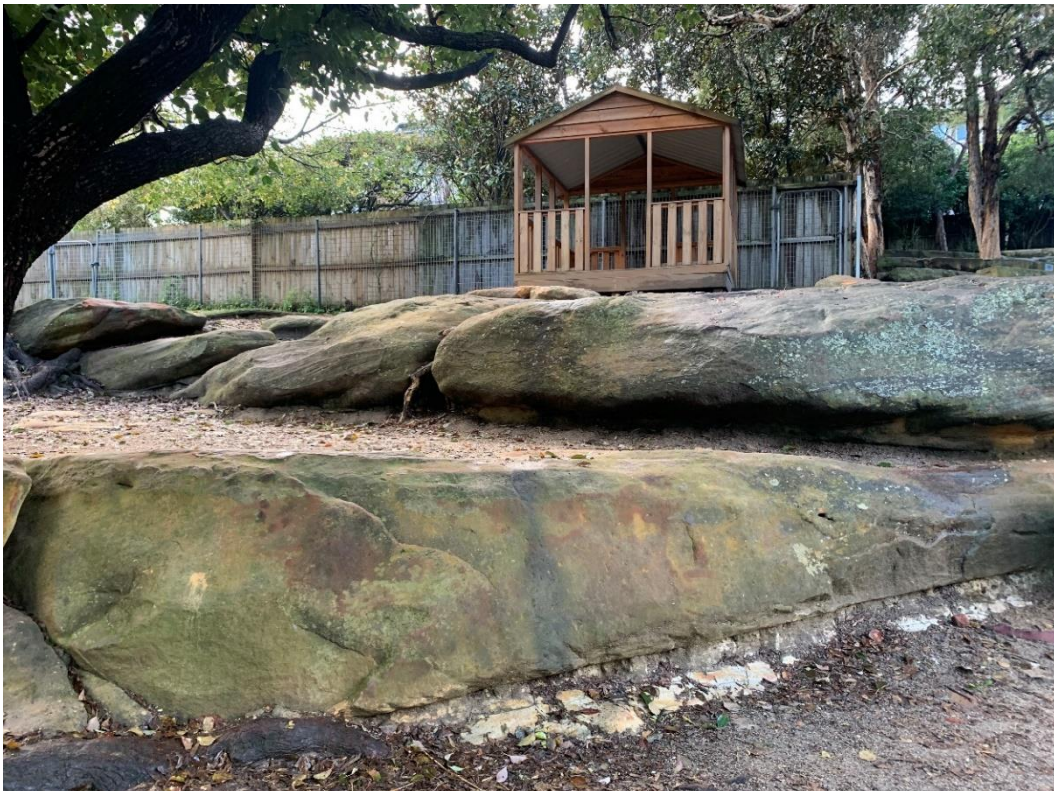
**Figure 4.22** Section of outcropping of natural sandstone rock, view to south.

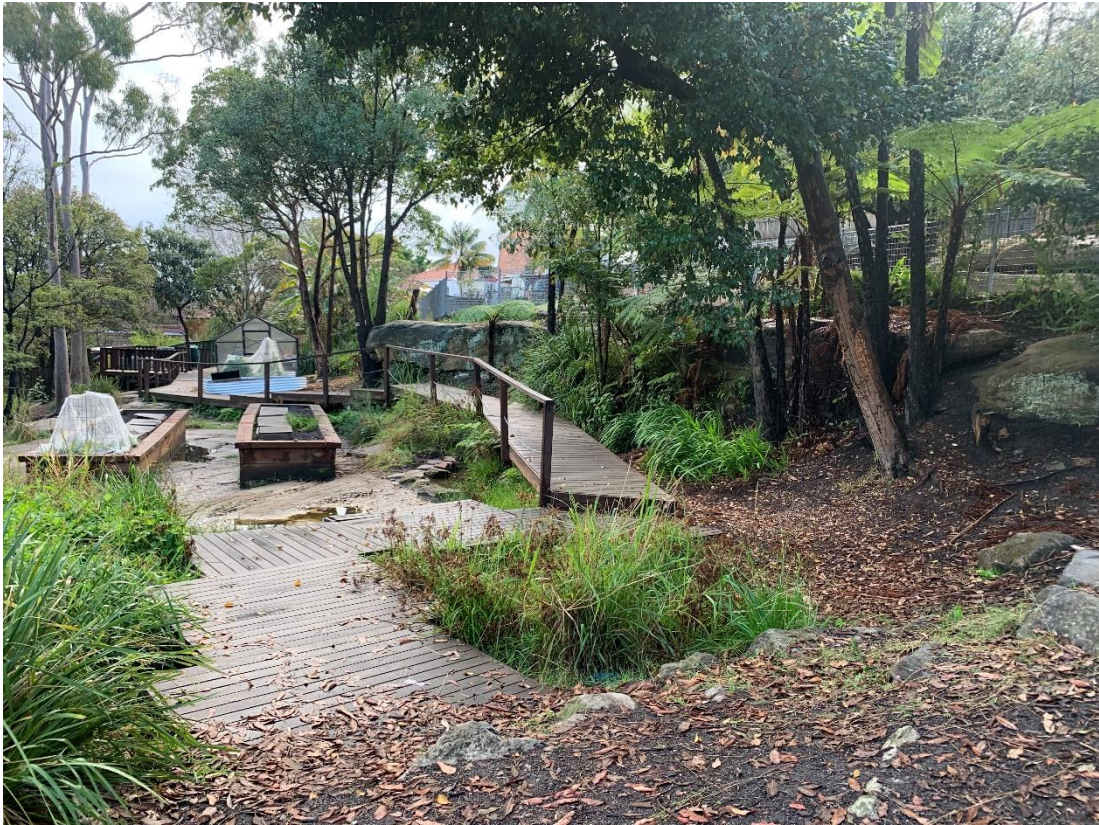
**Figure 4.23** Landscaped vegetable garden, view to northeast.  
Located on the lower slope.  
AMAC Group, IMG 5871 (18/08/2023).

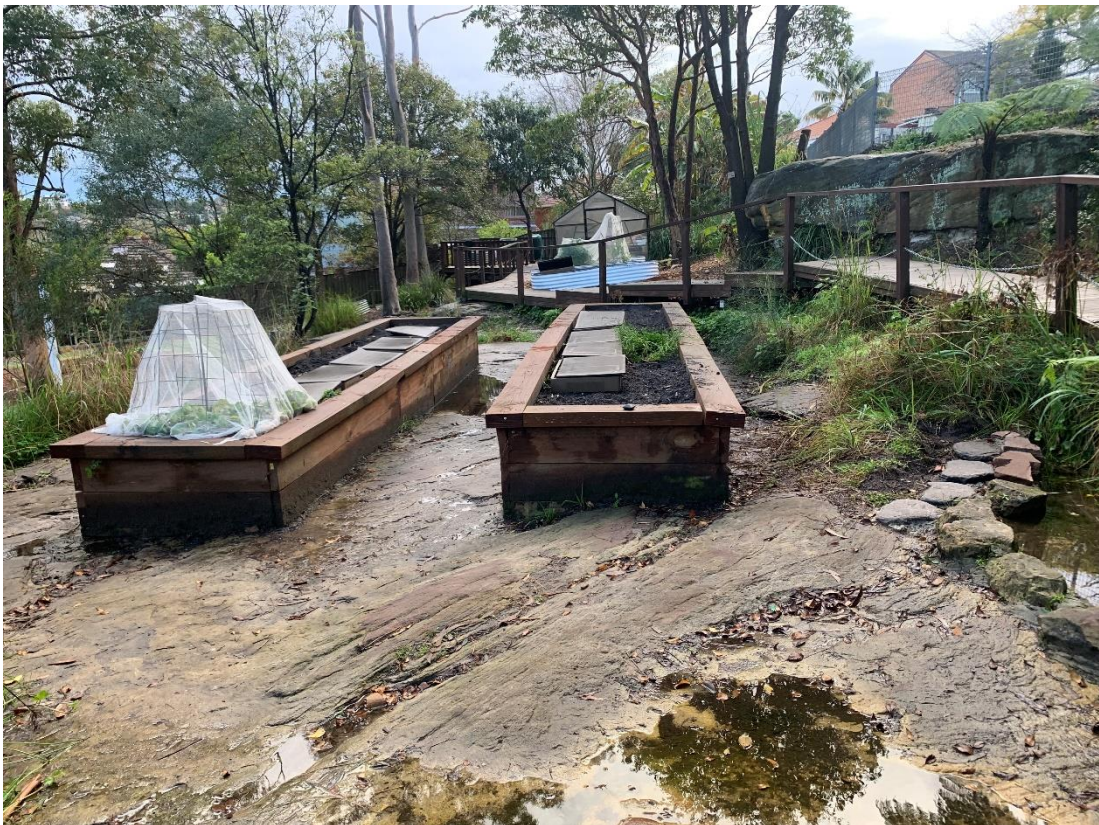
**Figure 4.24** Vegetable planter boxes on natural sandstone bedrock, view to northeast.  
AMAC Group, IMG 5872 (18/08/2023).

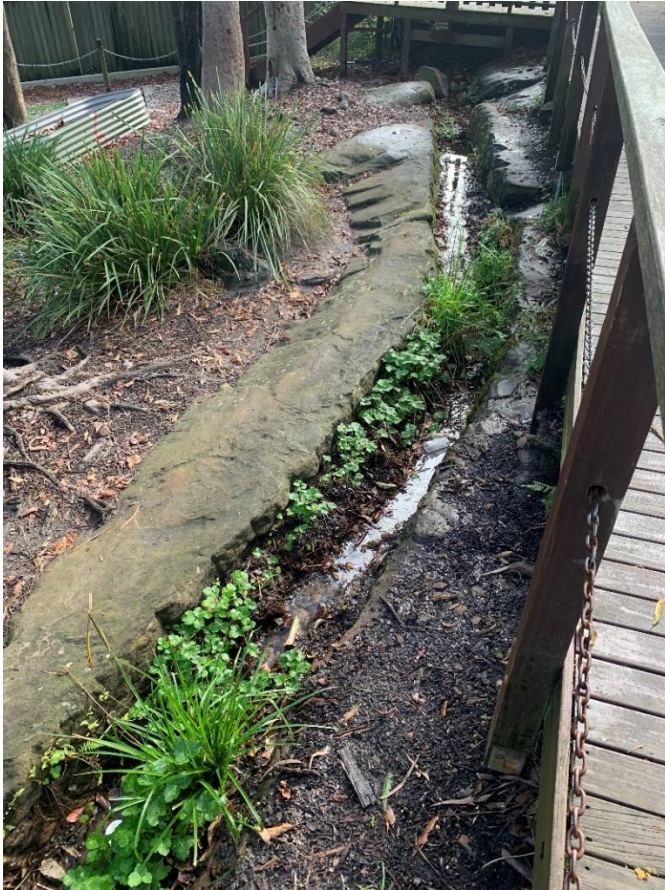
**Figure 4.25** Water source and natural sandstone rock, view to northeast.  
Located on the lower slope.  
AMAC Group, IMG 5990 (18/08/2023).

(southeast approx. 470m). During the site inspection (see Section 4.5) a natural water source that has been diverted into a stormwater drain was observed within the natural sandstone rock in the north portion of the site. The study site also lies 680m west of Long Bay.

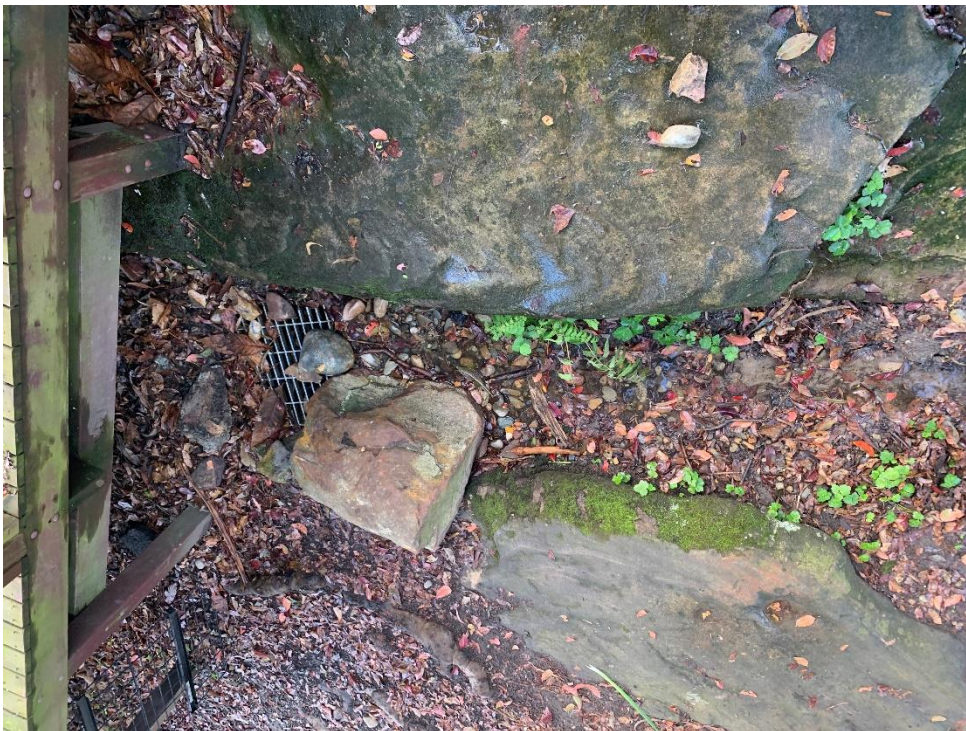
**Figure 4.26** Water source diverted to stormwater drain.  
Located on the lower slope.  
AMAC Group, IMG 5903 (18/08/2023).

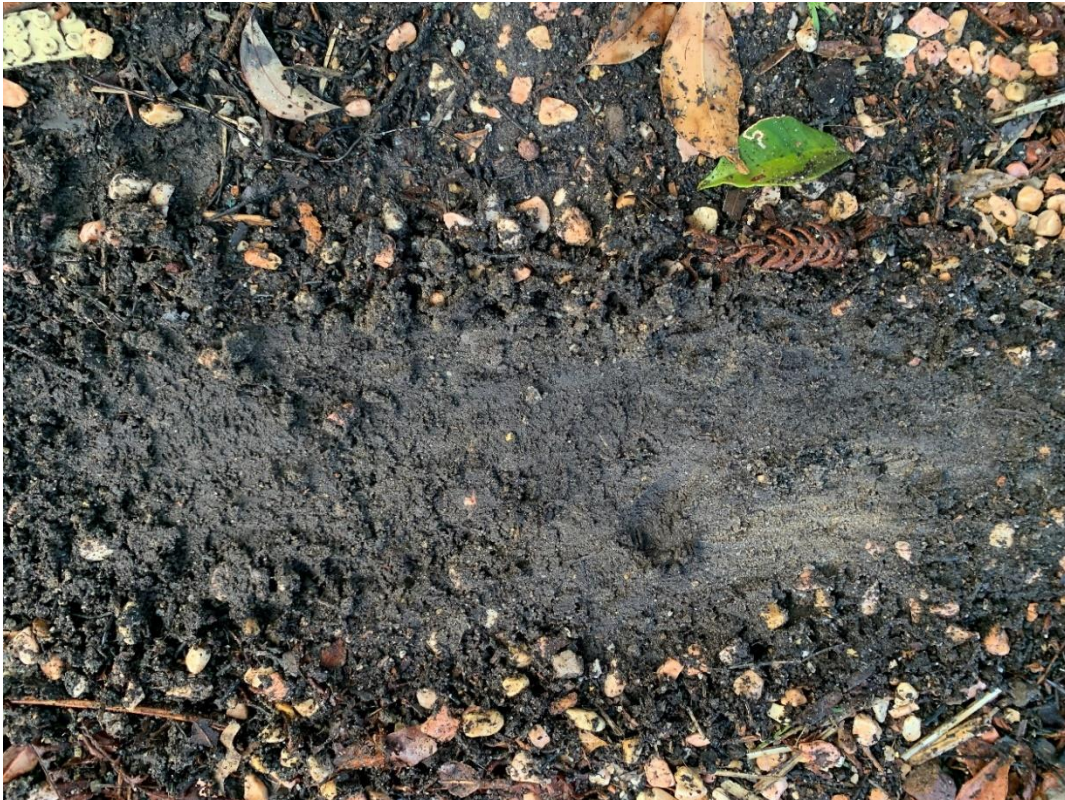
**Figure 4.27** Exposure of natural soil consisting of brown sandy loam (natural A1 horizon).  
Located on the lower slope.  
AMAC Group, IMG 5873 (18/08/2023).

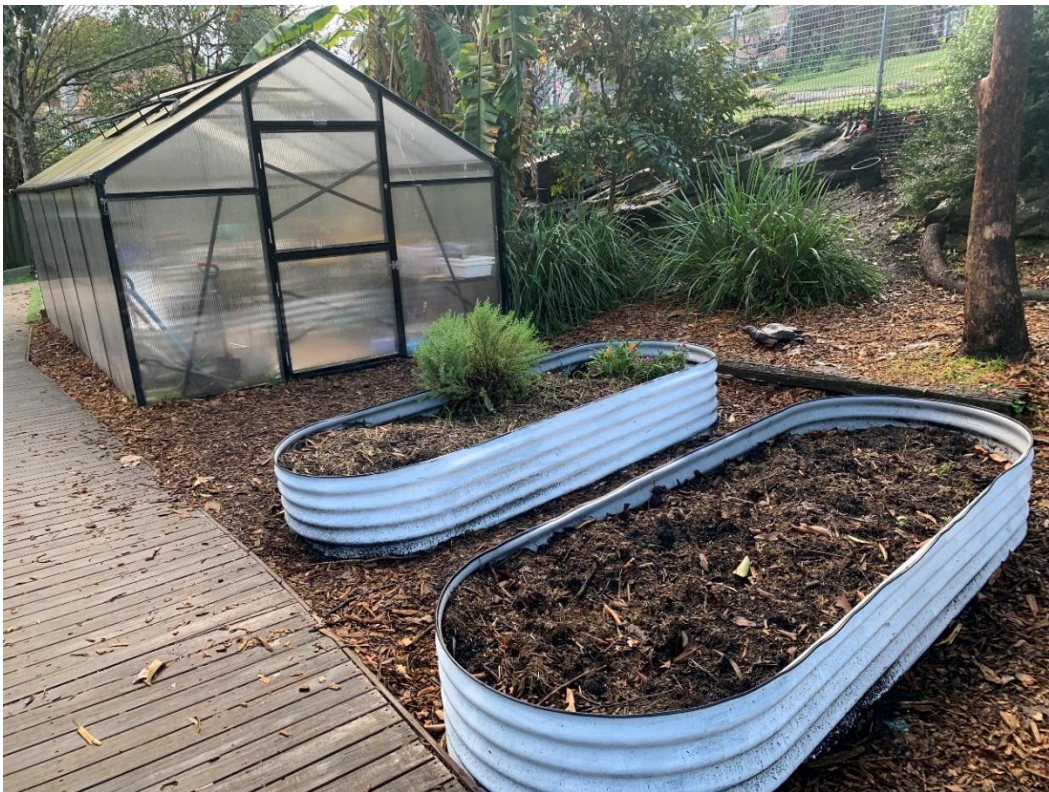
**Figure 4.28** Greenhouse and planter boxes on soil landscape, view to southeast.  
Located on the lower slope.  
AMAC Group, IMG 5876 (18/08/2023).

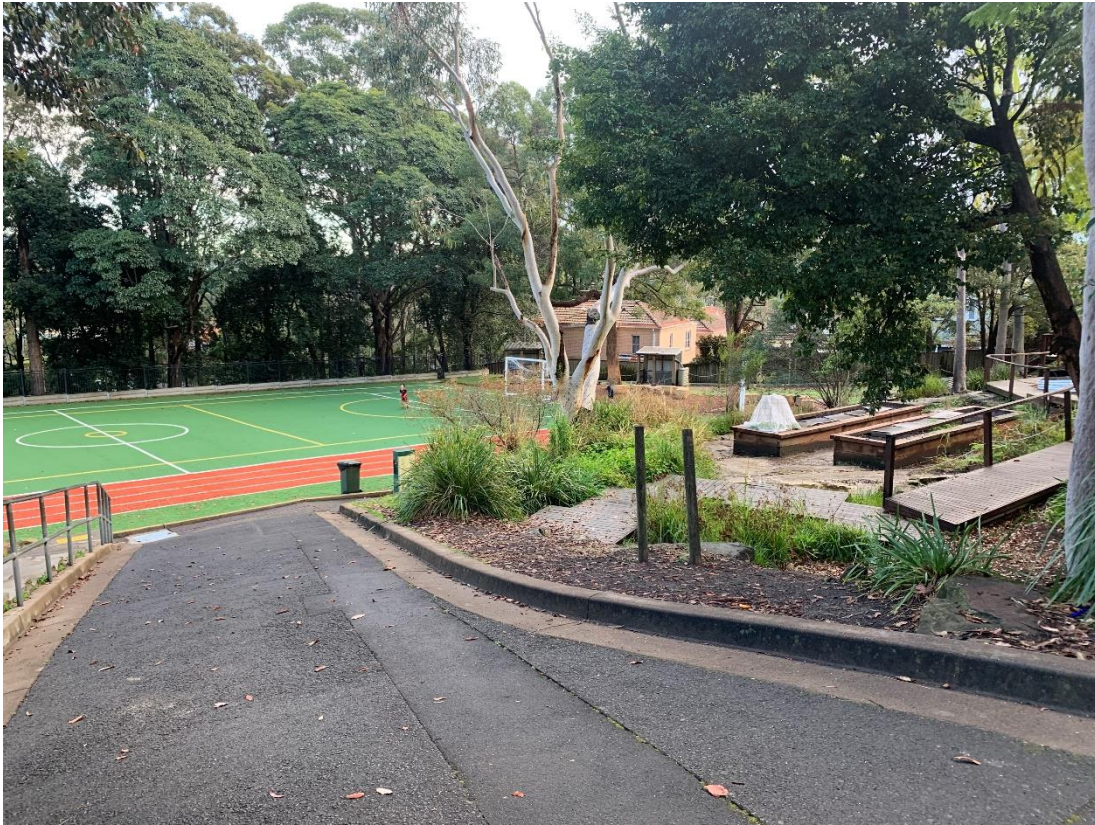
**Figure 4.29** View of sport court and vegetable garden, view to north.  
Located on the lower slope.  
AMAC Group, IMG 5870 (18/08/2023).

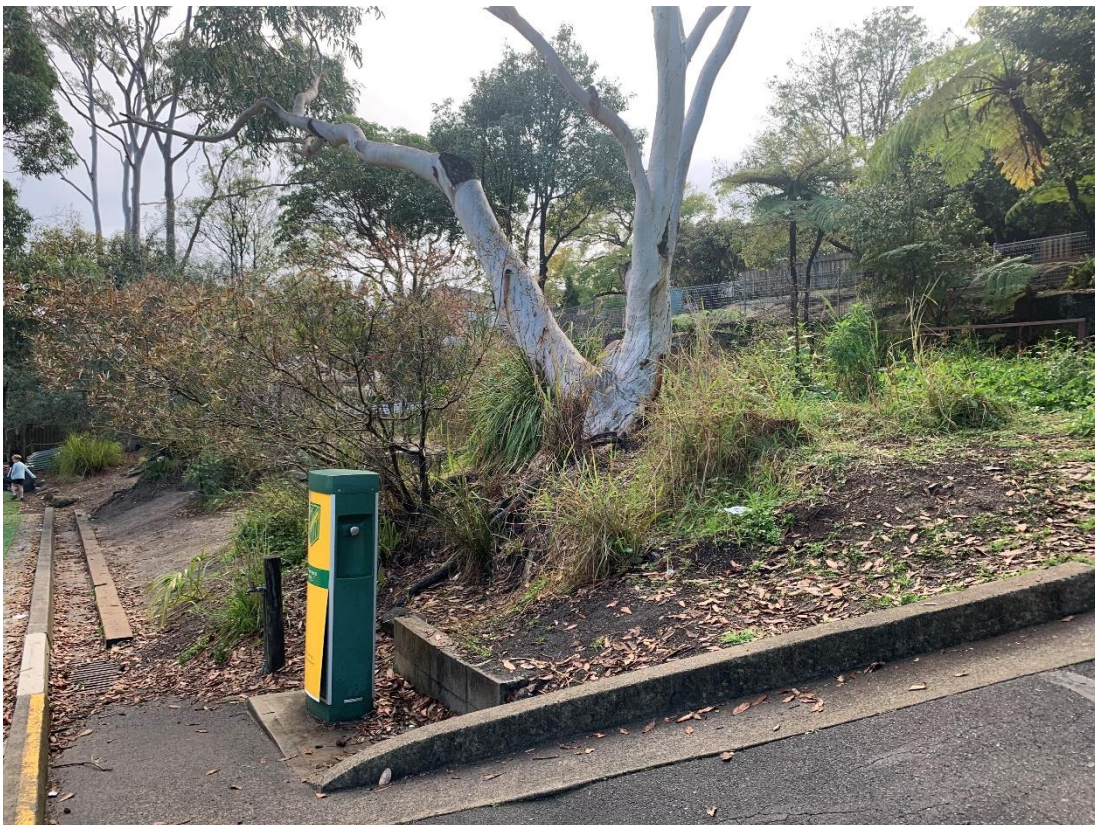
**Figure 4.30** Landscaped area, view to east.  
AMAC Group, IMG 5880 (18/08/2023).

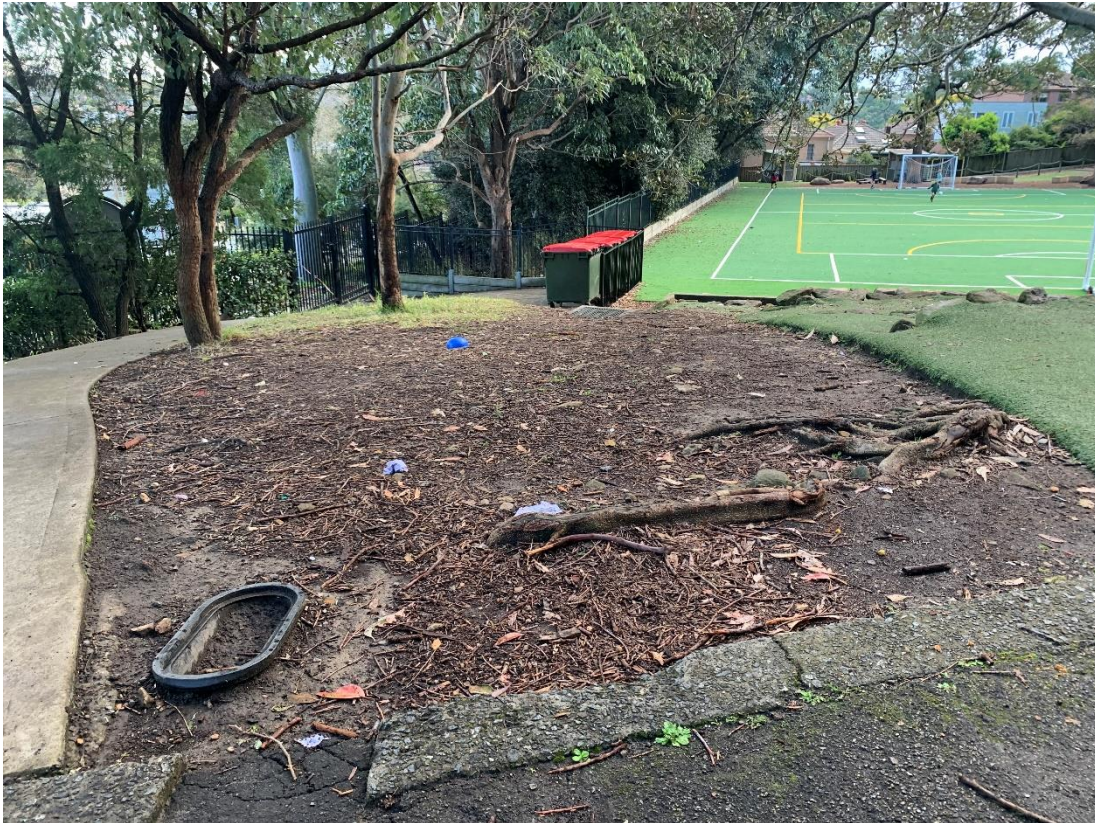
**Figure 4.31** Area of exposed soil and enclosed surfaces, view to northeast.  
AMAC Group, IMG 5880 (18/08/2023).

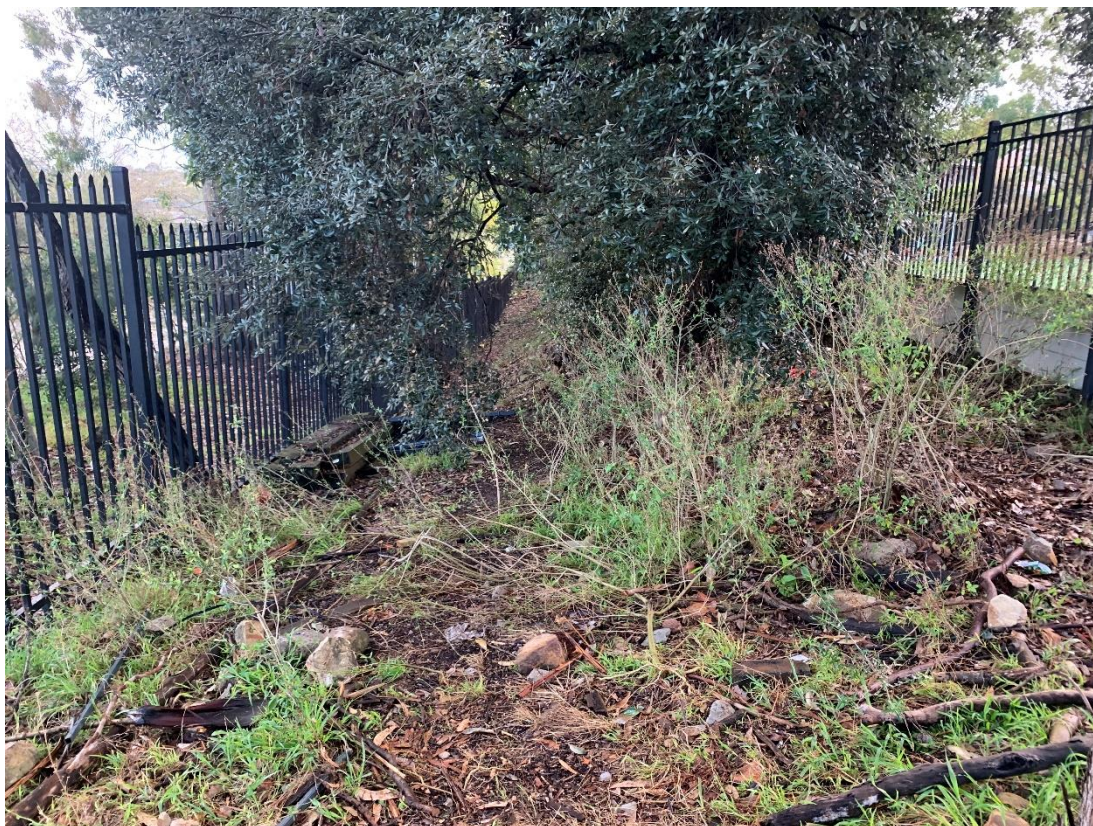
**Figure 4.33** Biodiversity area showing dense vegetation and trees, view to east.  
AMAC Group, IMG 5882 (18/08/2023).

The natural topography of the study site slopes steeply down to the northwest and as discussed in Section 4.5 the site was divided into three zones: The upper slope, lower slope, and biodiversity area. The upper slope was located in the south portion of the site and has low visibility (5%) due to containing majority of the education buildings, concrete surfaces and accessways (Figure 4.11 and Figure 4.17). The lower slope was located in the north portion of the site and has moderate visibility (60%) as it used the natural sandstone outcrops for benching and terracing play areas with areas of grass and Astro turf, vegetable garden on sandstone and soil, a natural water source that has been diverted into a stormwater drain, and a substantial number of garden beds with trees and vegetation (Figure 4.18 and Figure 4.31). The biodiversity area was fenced off and is on the boundary of Miller Street in the north portion and had low visibility (5%) as it contained trees and vegetation that appear to be unmodified and a natural soil landscape with minimal exposure (Figure 4.32 and Figure 4.33).

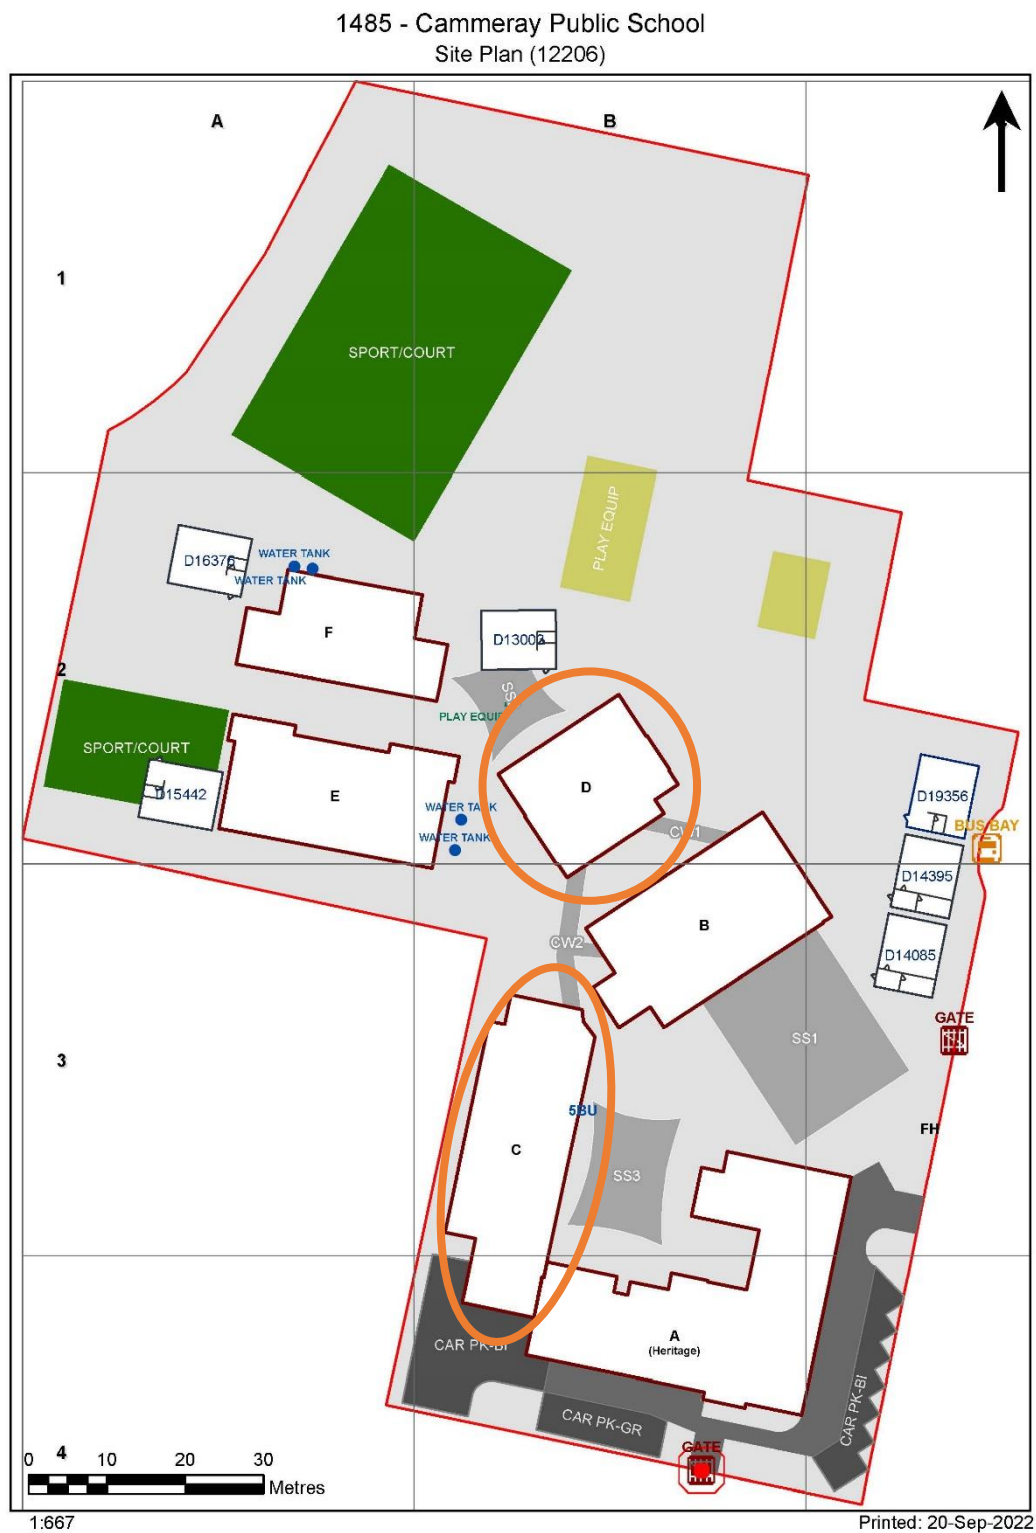
**Figure 4.34** Existing Site Plan – Cammeray Public School, showing general 2001 borehole testing locations circled in orange. Plans supplied by SINSW (August 2023).

Geotechnical borehole testing was undertaken on part of the study site in 2001.<sup>1</sup> This work was associated with construction works for current Block C and Block D, located on the southern half of the site (Figure 4.34), within areas assessed as having high disturbance (Figure 4.10). Review of the 2001 report show that boreholes 1 and 2 form the two northernmost boreholes, situated within the footprint of Block D. Both boreholes were recorded as containing fill (brown-grey, loose sand with silt and trace gravel) to a depth of 50-60cm and overlying weathered sandstone.<sup>2</sup> No evidence of the natural soil profile was identified among the boreholes.

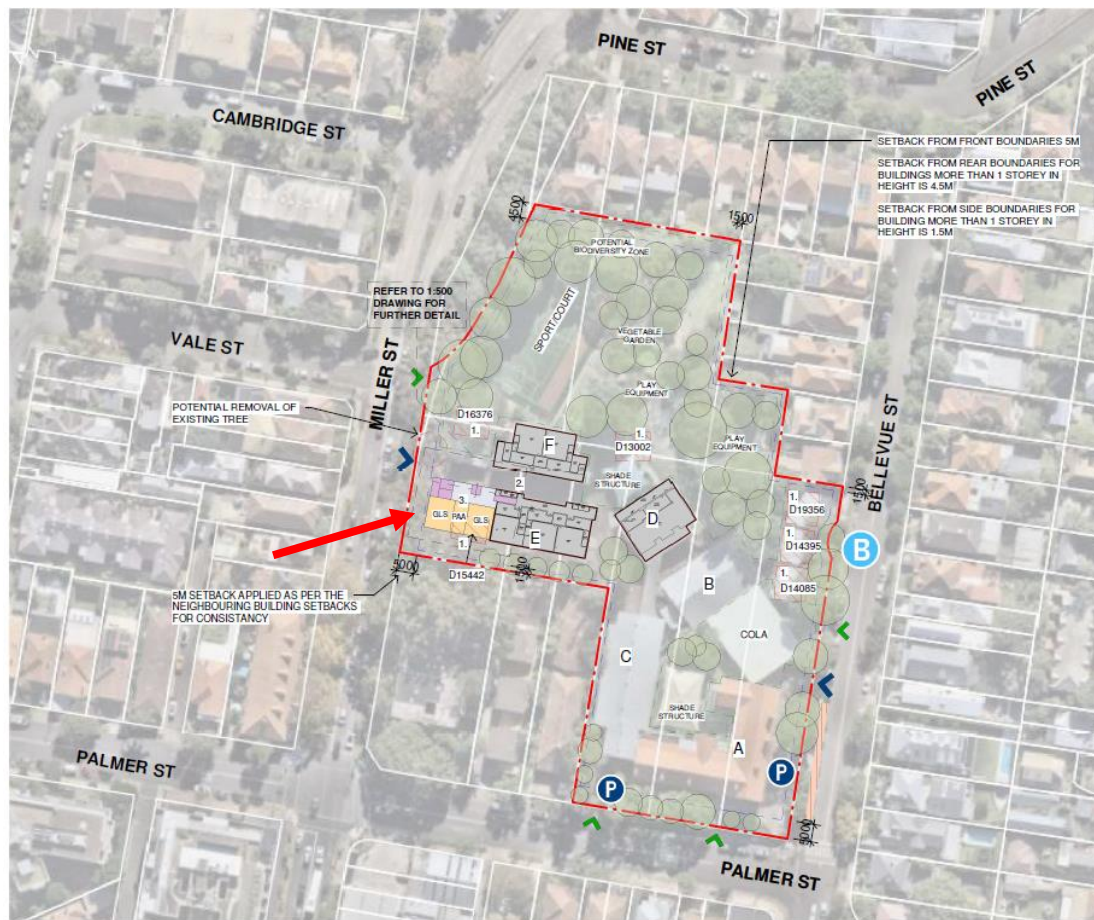
**Figure 4.35** Indicative plan – Cammeray Public School, showing proposed construction of additional classrooms near Miller Street boundary (red arrow). Plans supplied by SINSW, August 2023.

The current plan for upgrades is at masterplan phase only, therefore specific subsurface impacts or proposed development plans are undetermined at this stage. SINSW have identified the need for upgrades at Cammeray Public School, primarily related to meeting the current demand and overutilisation at the school and overcome the current reliance on demountables to accommodate student demand. Upgrades may include the replacement of demountables with permanent classrooms which will require both demolition and construction as part of these works. Per the current indicative plan, construction works are proposed to replace an existing sports courts and demountable with new classroom spaces. Per Figure 4.35, this work would occur along the Miller Street site boundary.

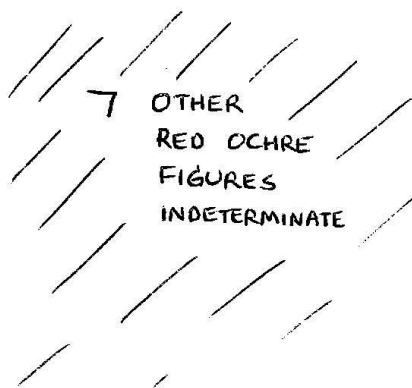
9 Figures in Red Ochres all in eastern end of cave on wall

2 RED OCHRE  
BOOMERANGS  
INFILLED

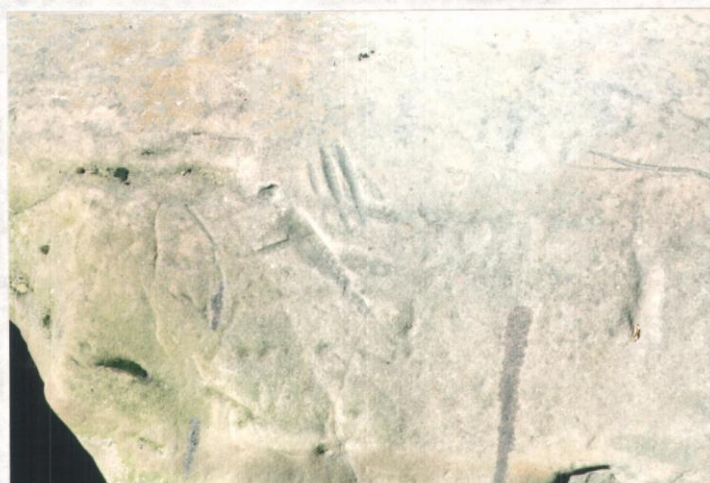
16 MUNRO PARK AXE-GRINDING GROOVES, CLOSE UP OF ABOVE
