## PART 1 - PRELIMINARY INDIGENOUS HERITAGE IMPACT

### Report for *Cammeray Public School*

<b>Project Name</b>	Cammeray Public School Upgrade		
<b>Report Title</b>	Preliminary Indigenous Heritage Assessment and Impact Report		
<b>File Name</b>	Aboriginal Due Diligence-Cammeray Public School - AMAC-Aegis Pty Ltd-DDWO05118-23		
<b>School Name:</b>	Cammeray Public School	<b>Company Name:</b>	AMAC-AEGIS PTY LTD
<b>School Address:</b>	68 Palmer Street, Cammeray, NSW 2062	<b>Report Date:</b>	09/11/2023
<b>School Region:</b>	North Sydney, NSW	<b>Contract Number:</b>	DDWO05118-23

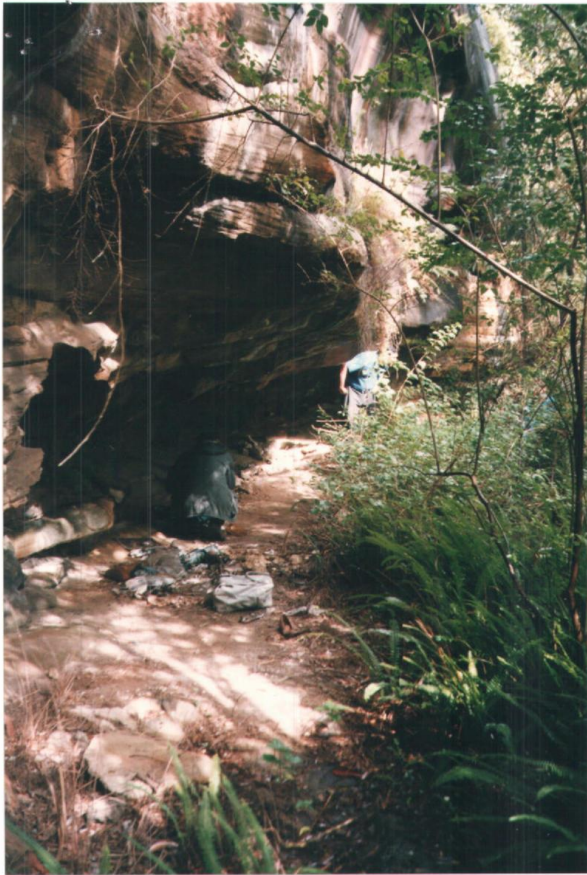
← PHOTO 1 ROCK SHELTER (FACING WEST) MIDDEN VISIBLE IN FOREGROUND ALTHOUGH PARTLY OBSCURED BY SUNLIGHT. DARKER DEPOSIT TO THE LEFT OF CROUCHING SUBJECT

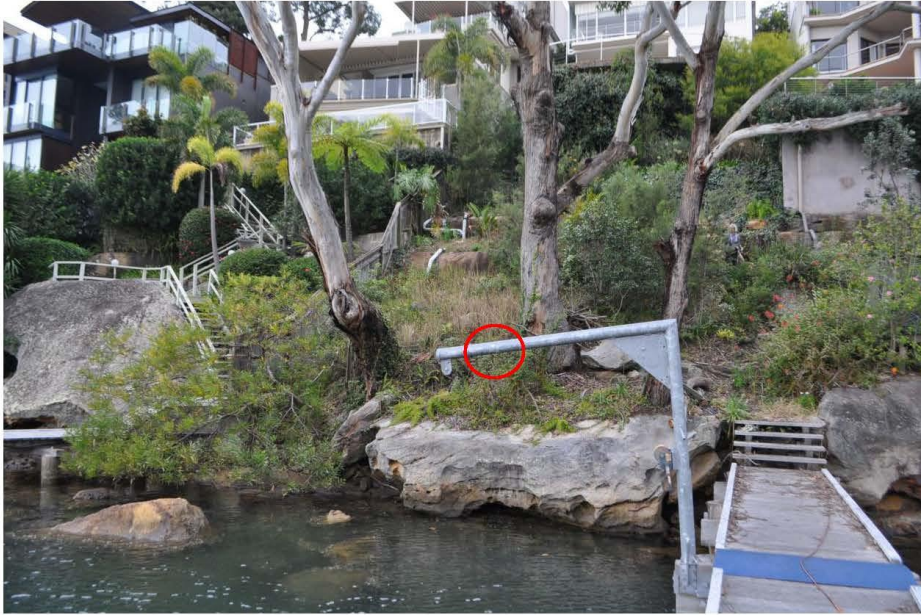
DSC-6339 foreshore and area of shell (circled), looking south-easterly

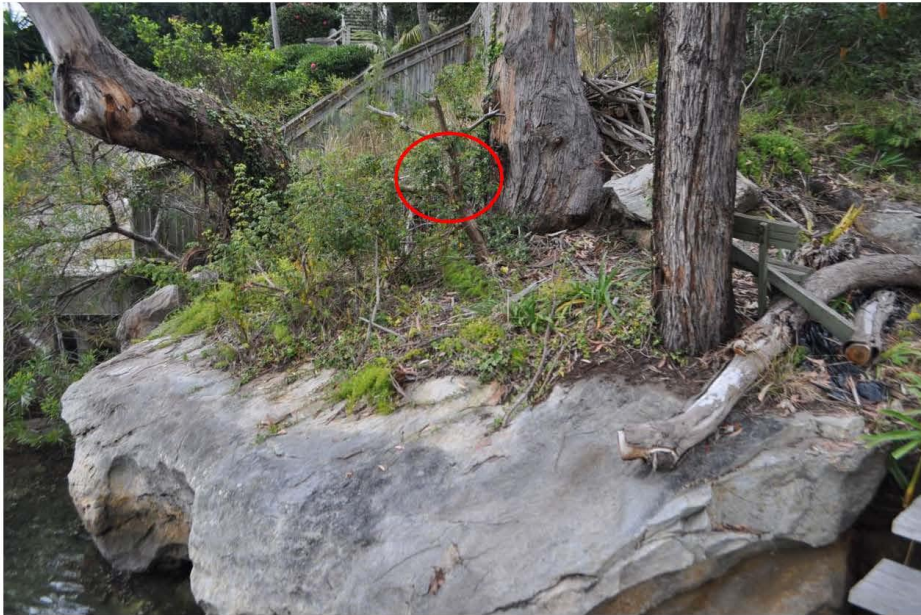
DSC-6338 midden area, looking W.

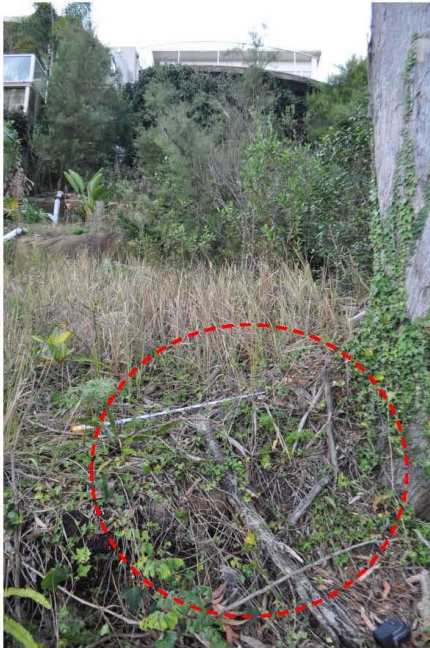
DSC\_6334 area of shell, looking S

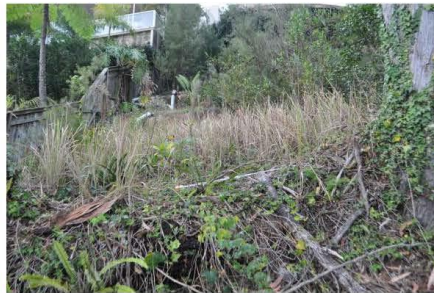
DSC\_6335 area of shell, looking SE

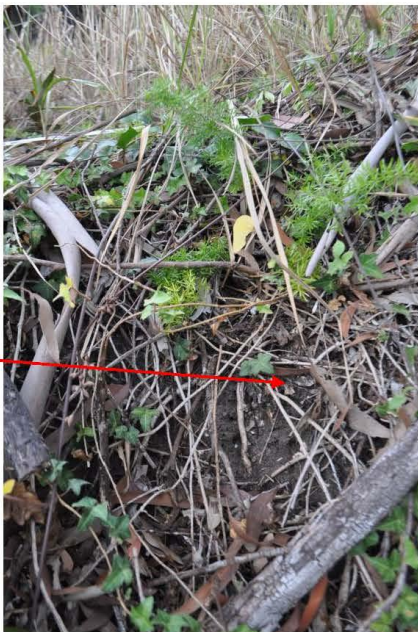
DSC\_6336 shell exposed in eroding vertical face (looking SE)

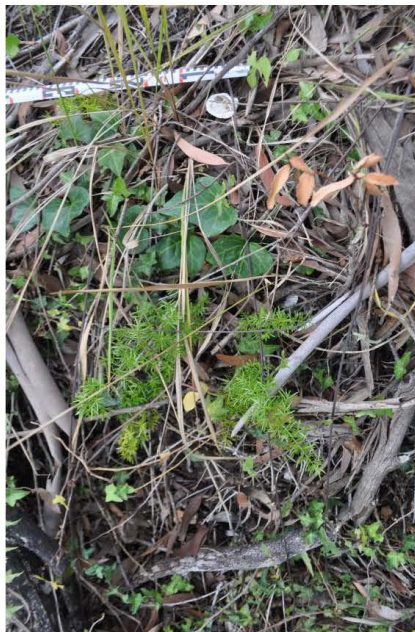
DSC\_6337 shell on terrace surface.
