Review of Environmental Factors

Currowan Creek Crossing Upgrade

Shoalhaven City Council

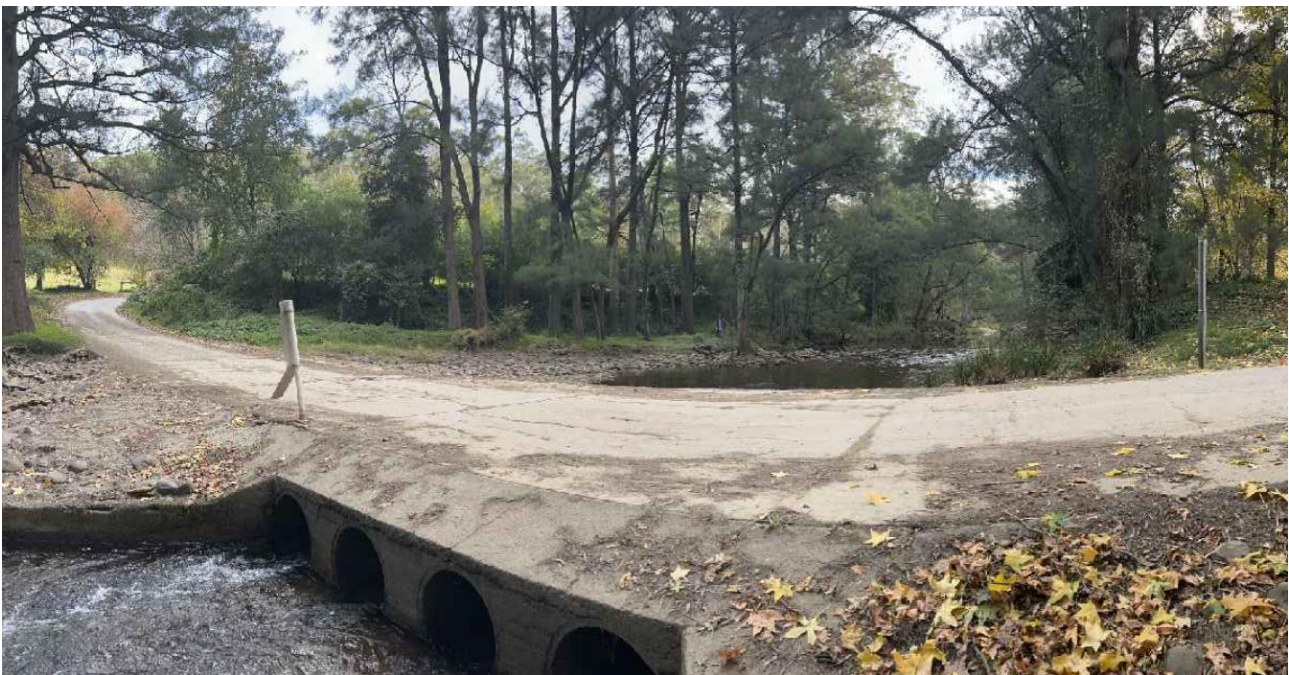
Figure 1. Site image – view up stream

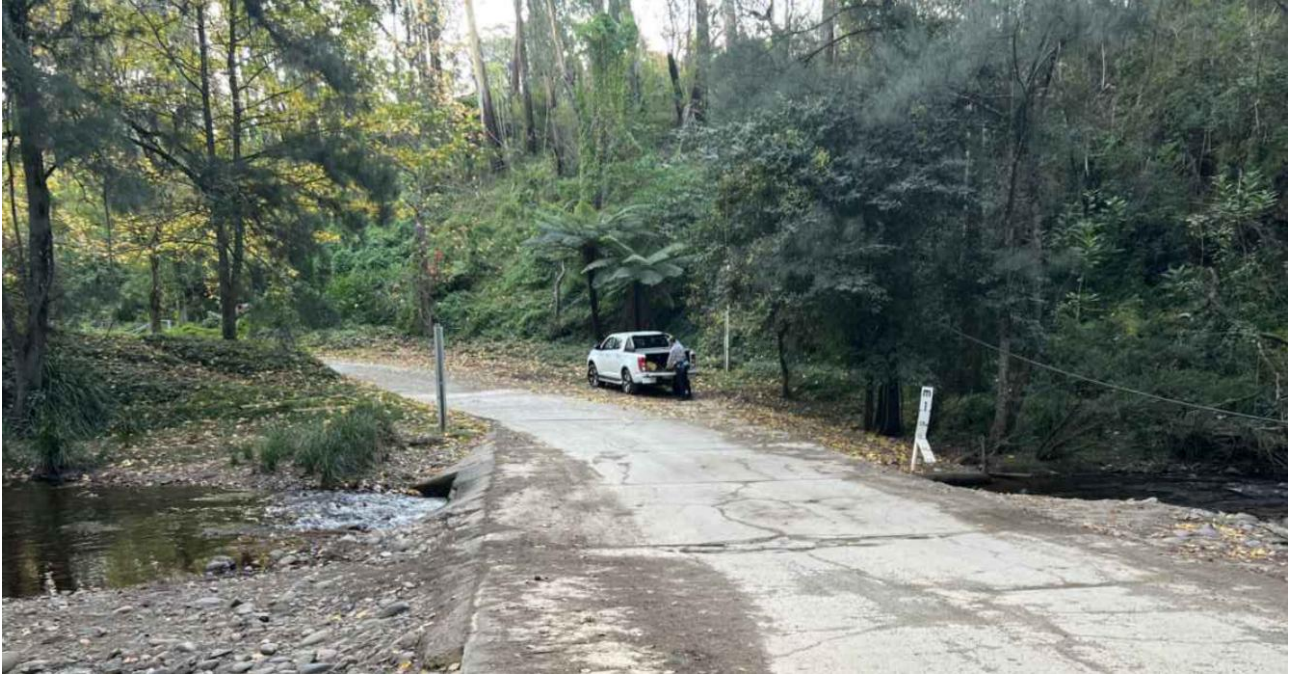
Figure 2. Site image – view west

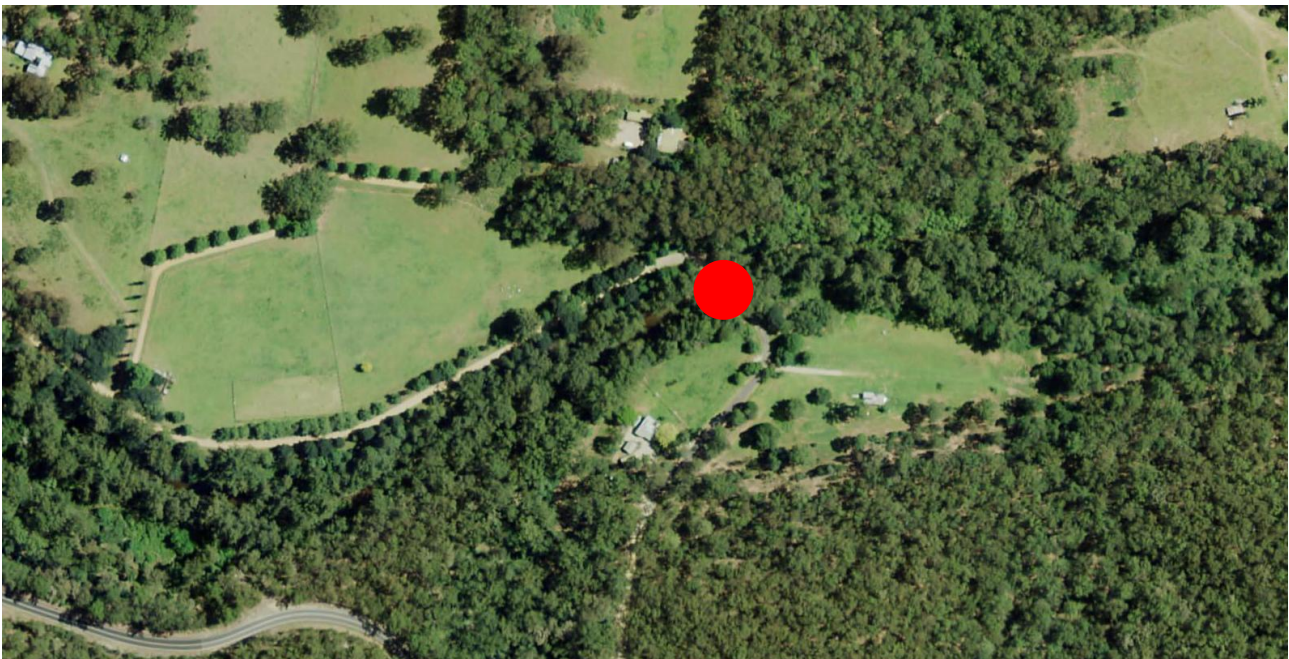
Westen Distributor Road at Currowan Creek is located approximately 300m north-east of the Kings Highway in Currowan and can be accessed from a junction on the Kings Highway. The existing piped culvert is comprised of a low-level concrete piped culvert which channels creek flow through four x 600 mm diameter pipes.

Figure 9. Subject Site

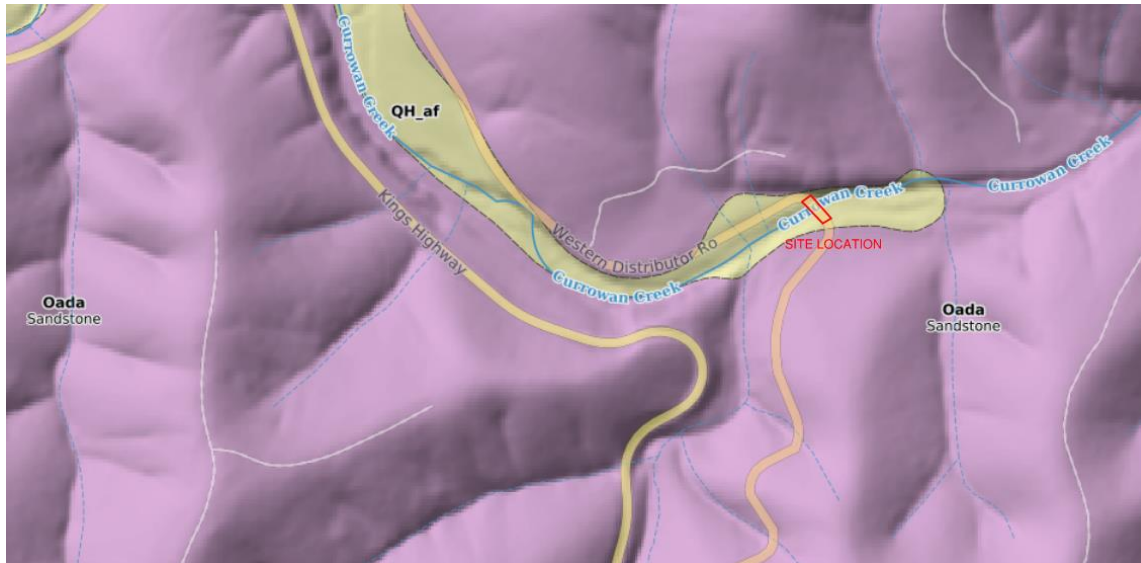
Figure 2-3 Regional Geology

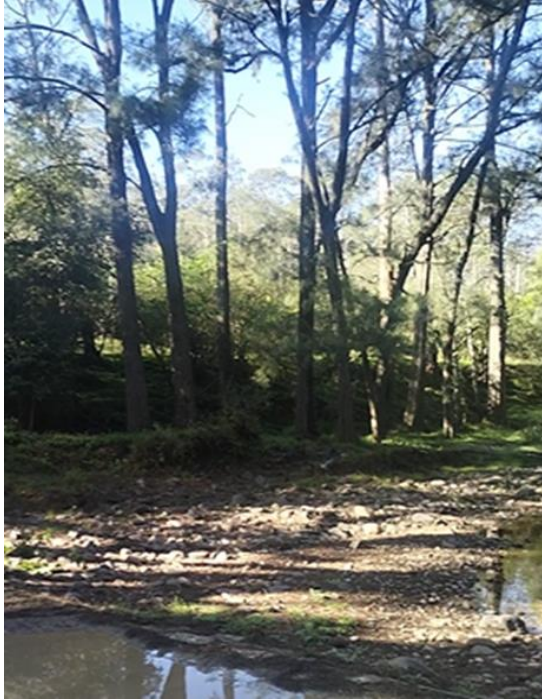
Figure 3-1 Eastern side of crossing

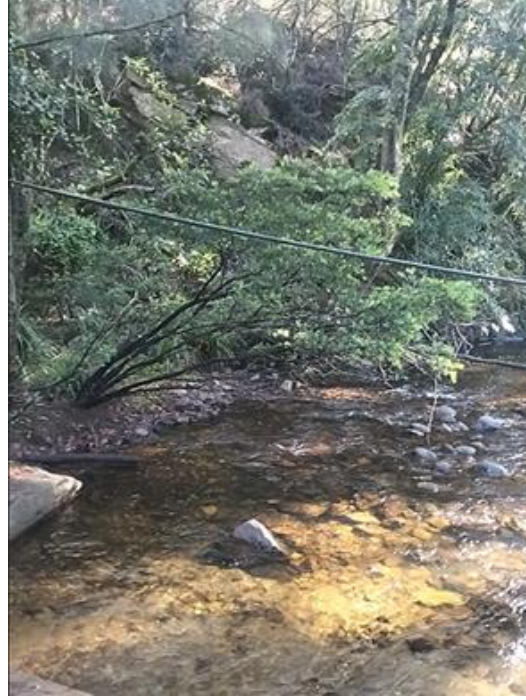
Figure 3-2 Western side of crossing

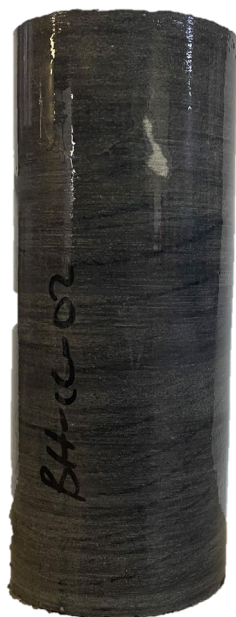
Specimen - Before Testing

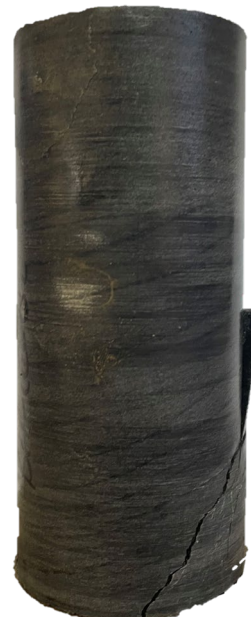
Specimen - After Testing

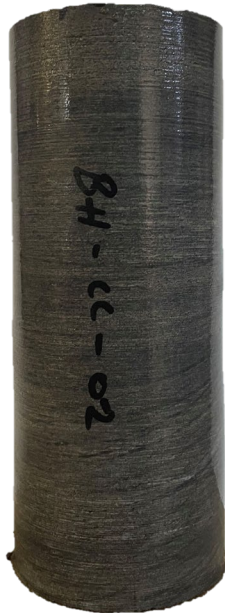
Specimen - Before Testing

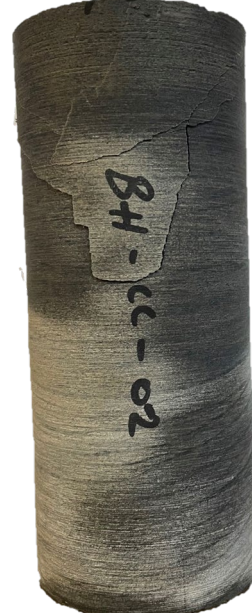
Specimen - After Testing
