Report on
Geotechnical Investigation

Stage 2 Civil Works and Regional Stormwater
Infrastructure Works

Bradfield City Centre
Badgerys Creek Road, Bringelly

Project 222630.00
November 2023

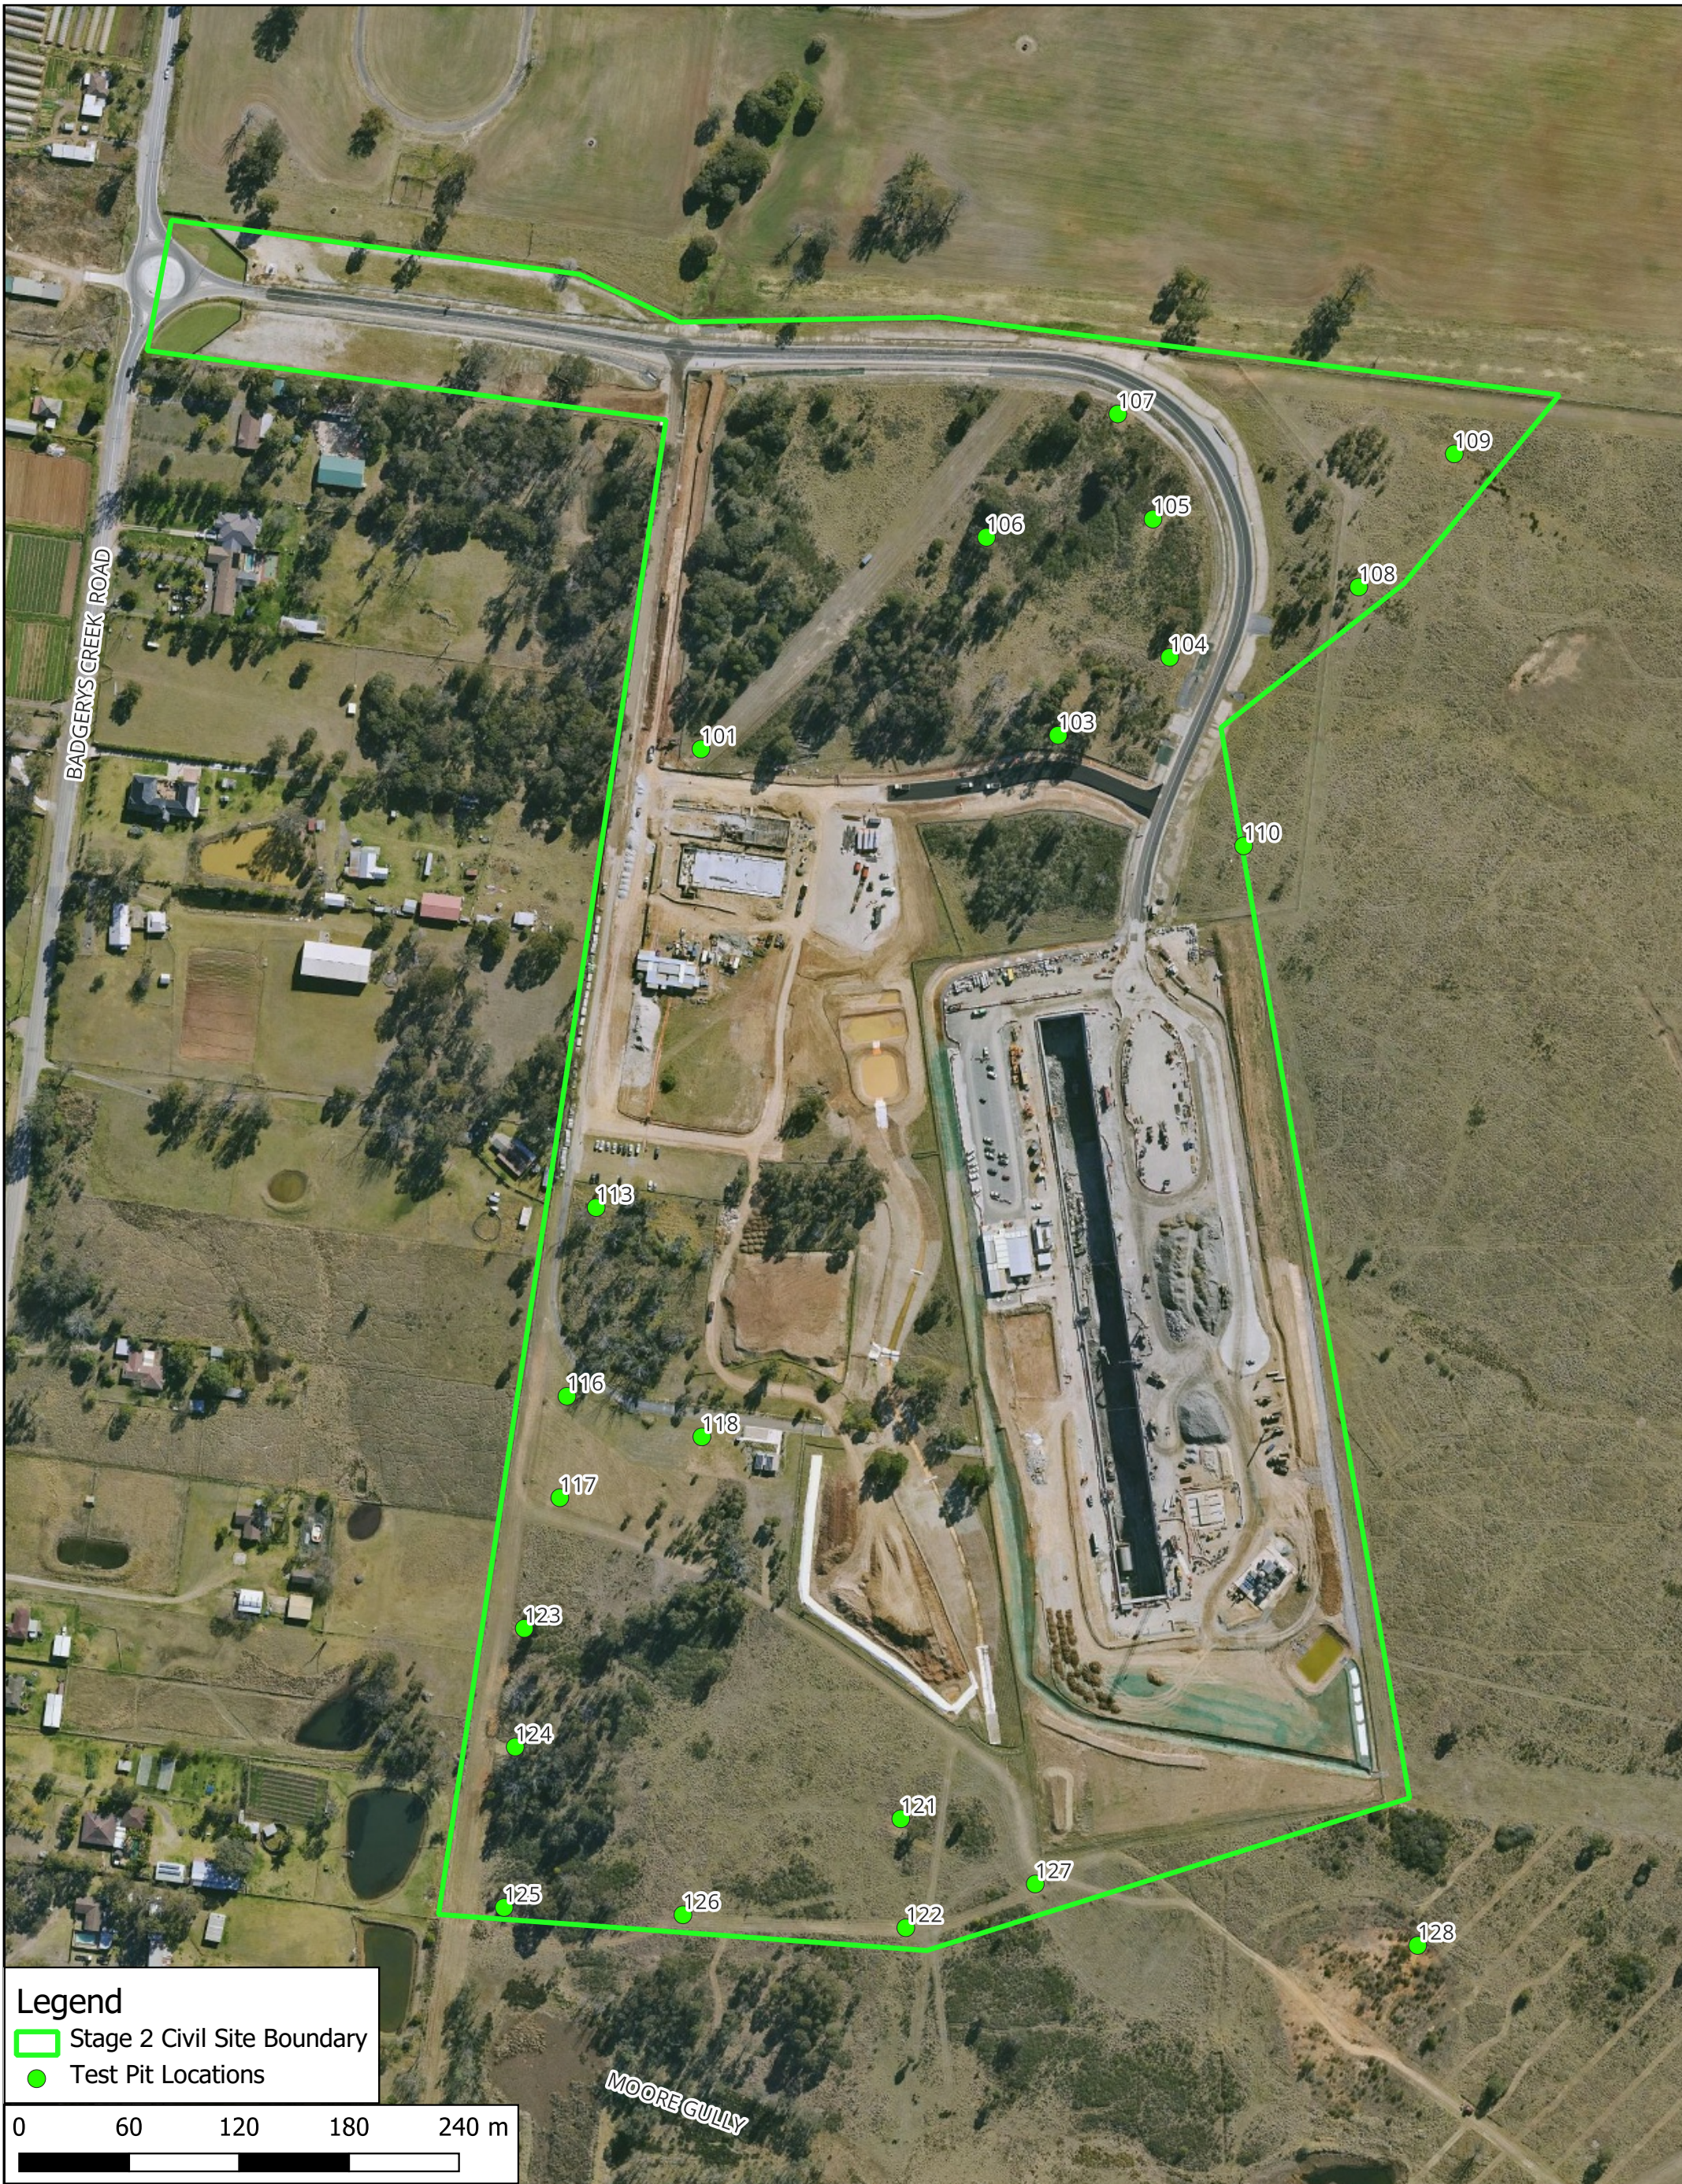
- Stage 2 Civil Site Boundary
- Test Pit Locations

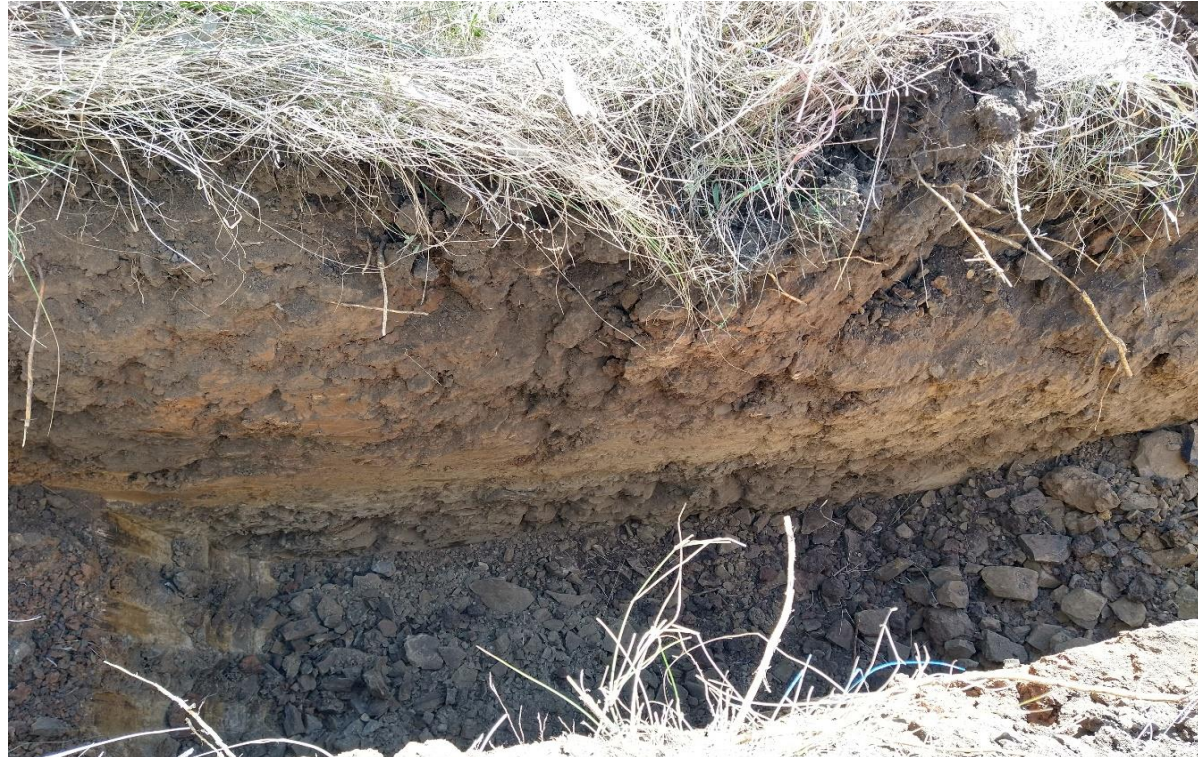
Photo 5: Test Pit 107 profile (refusal at 1.1m)
Typical of northern part of Stage 1

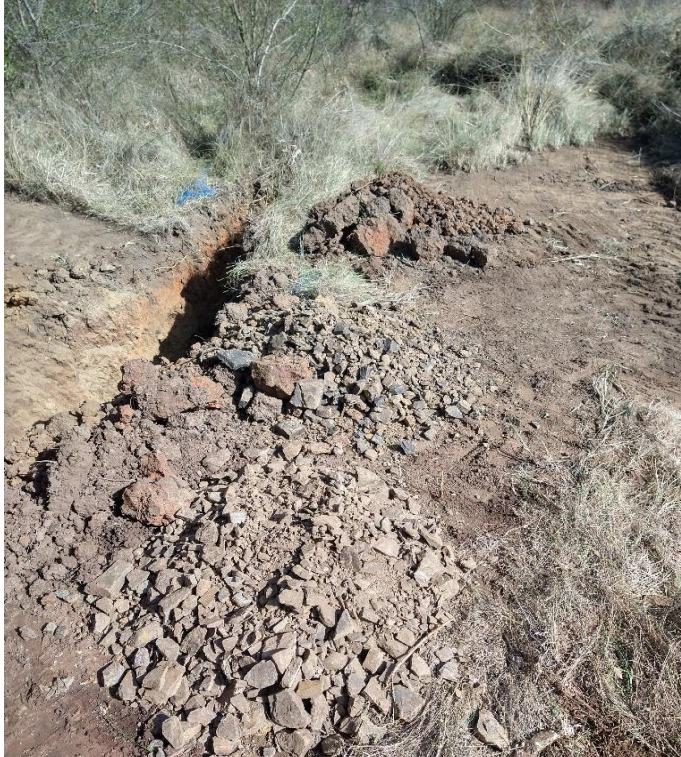
Photo 6: Spoil from Test Pit 107

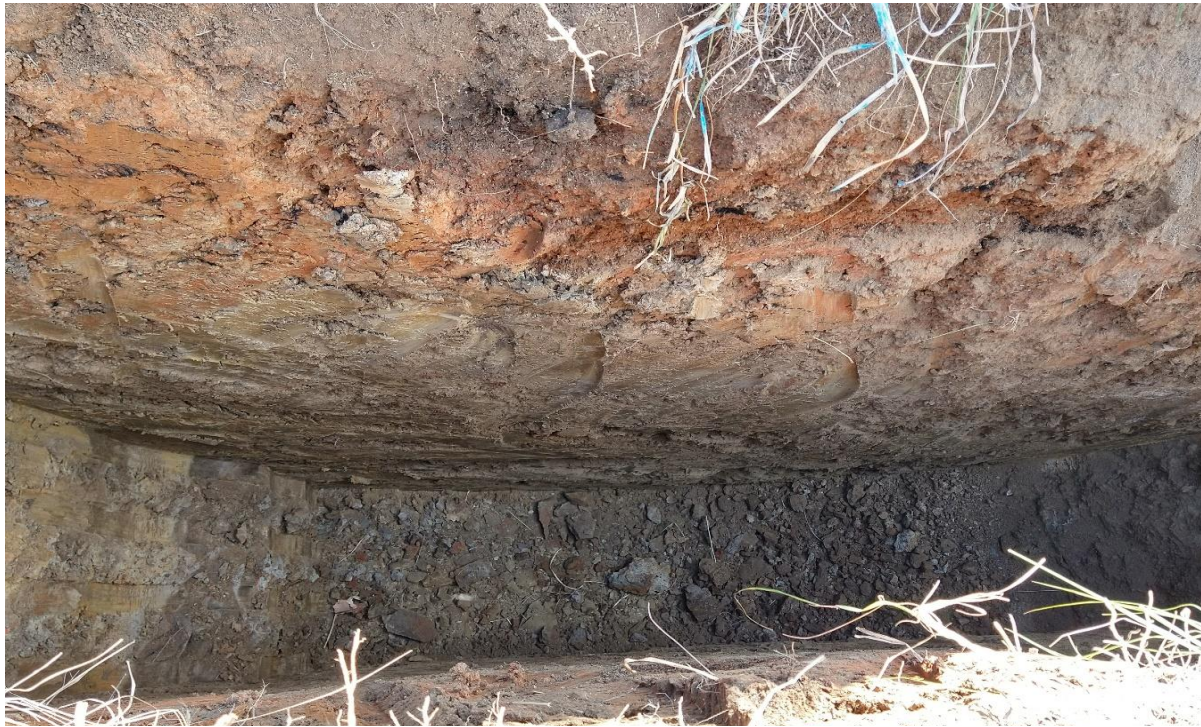
Photo 7: Test Pit 117 profile (Refusal at 2.2m)
Typical of central and southern parts of Stage 1

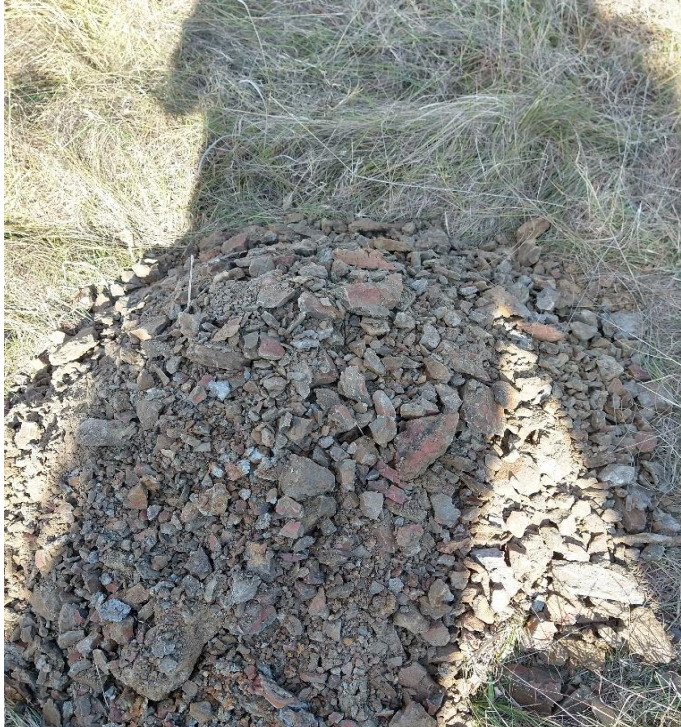
Photo 8: Medium to low strength shale from base of Pit 117

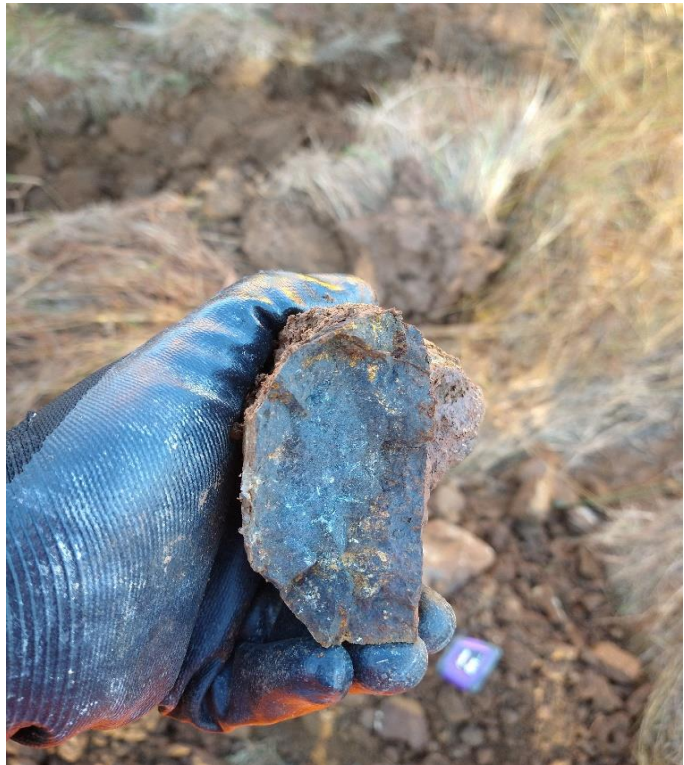
Photo 10: Basaltic material from base of Test Pit 123 - high strength

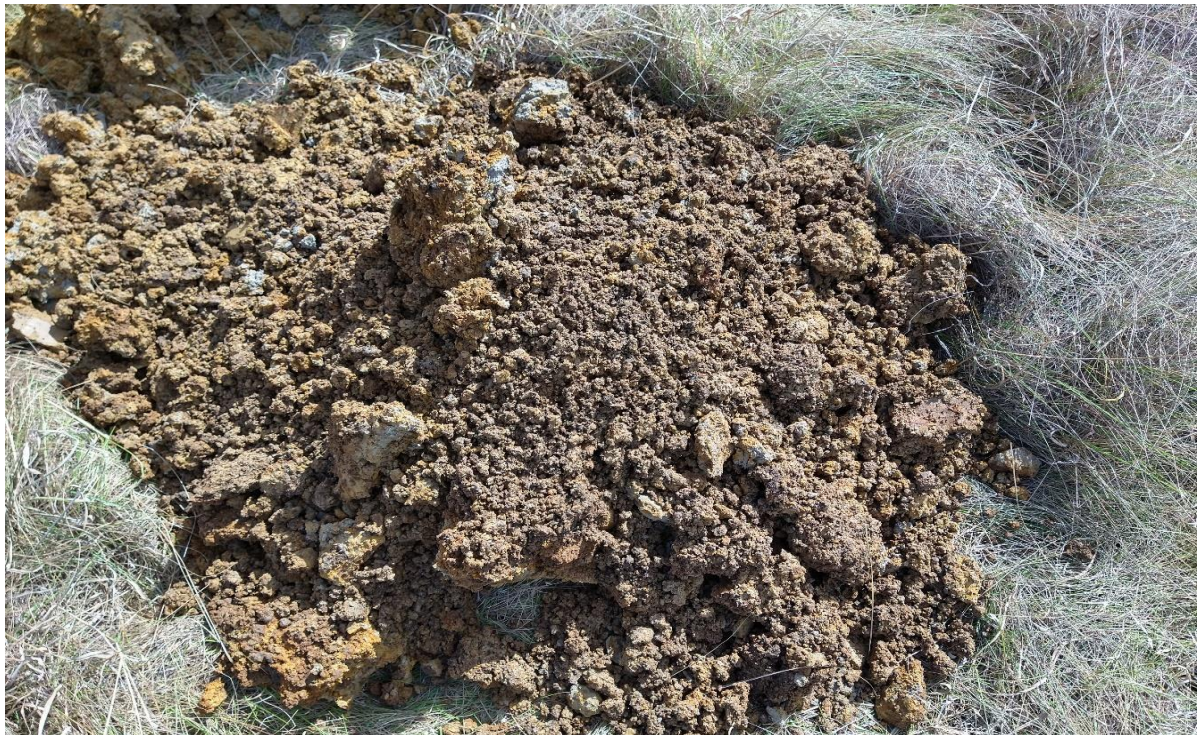
Photo 12: Alluvial soil from Pit 205
