ARBORICULTURAL IMPACT ASSESSMENT & TREE PROTECTION MANAGEMENT PLAN

Trunk Stormwater Drainage Project v.2

Bradfield City Centre Development, Bringelly, NSW 2556

May 2023

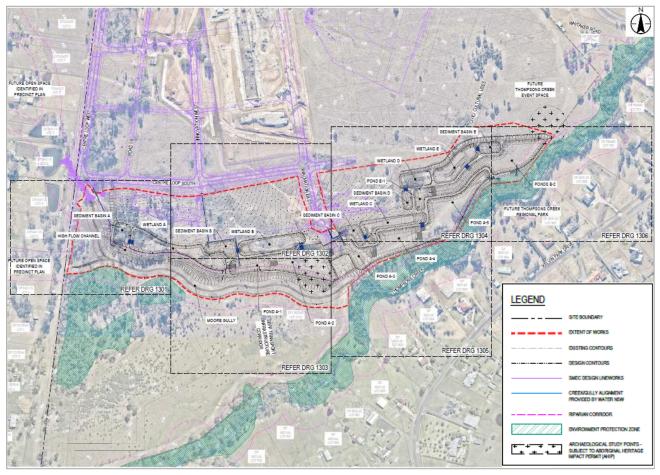
Stormwater Trunk Infrastructure, Sediment Basins, Wetlands & Ponds Design (courtesy of Stantec)

i. A Stormwater drainage installation is proposed for the Bradfield City Centre development per the below design plan supplied by WPCA. A full set of Design Concept Plans can be made available upon request from their design team.

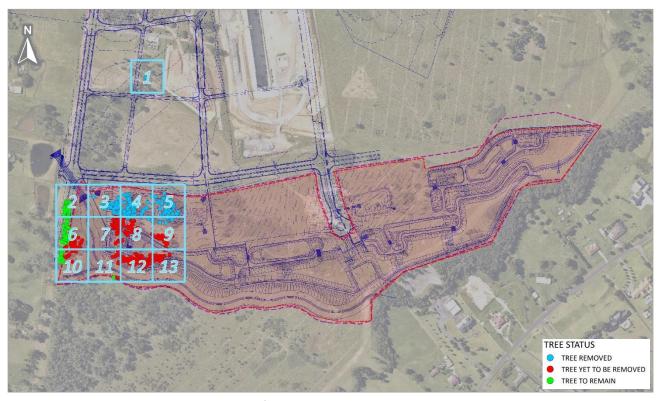
Trunk Stormwater Project: Master-Map

iii. Please see below the Mastermap. Thirteen (13) satellite sub-maps with the locations of the assessed trees follow. These sub-maps indicatively show the proposed infrastructure and whether on the balance of probabilities a subject tree will remain viable under the proposed design. (I.e., Non-Viable = Remove & Compensatory Replanting or Viable = Retain & Protect per the accompanying TPMP).

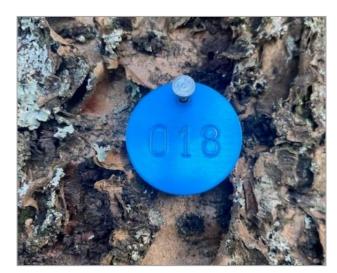
Indicative aluminum Tree Tag Installation

i. For convenience all of the subject trees have been individually tree tagged at approximately 1.5m. On this tree tag is an engraved number that corresponds to the above maps and Visual Tree Assessment Data tables. Thus, the subject tree can be physically identified, and any recommended arboricultural works and/or tree protection installation carried out.

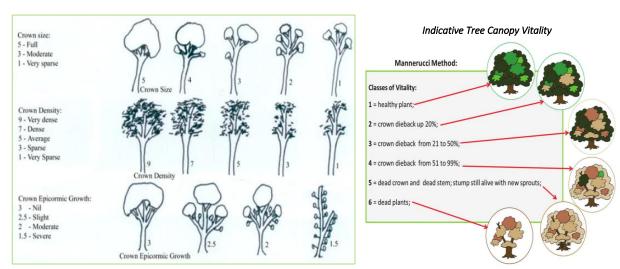
Visual vitality index for mature trees (Callow, 2018)

- leaf, twig or needle size, shape, and colour
- seasonal growth rates
- reaction wood development
- foliage density & foliage coverage throughout the crown
- branch architecture & ecophysiology
- species specific traits & biomechanics
- branch-tip dieback
- typical branch senescence.

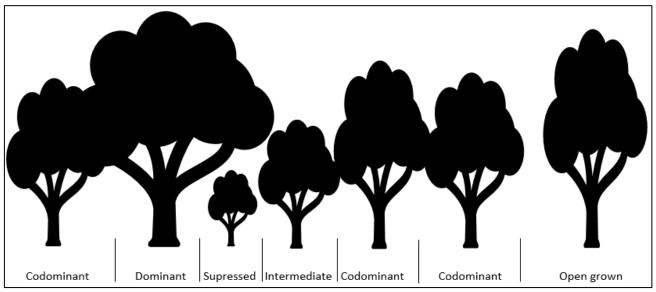
Indicative Crown Class (International Society of Arboriculture)

Crown Class: this rating provides an indication on the tree's relationship with other trees in the subject environment. The categories used include Dominant, Codominant, Intermediate, Suppressed and Open grown, as shown in the below diagram.

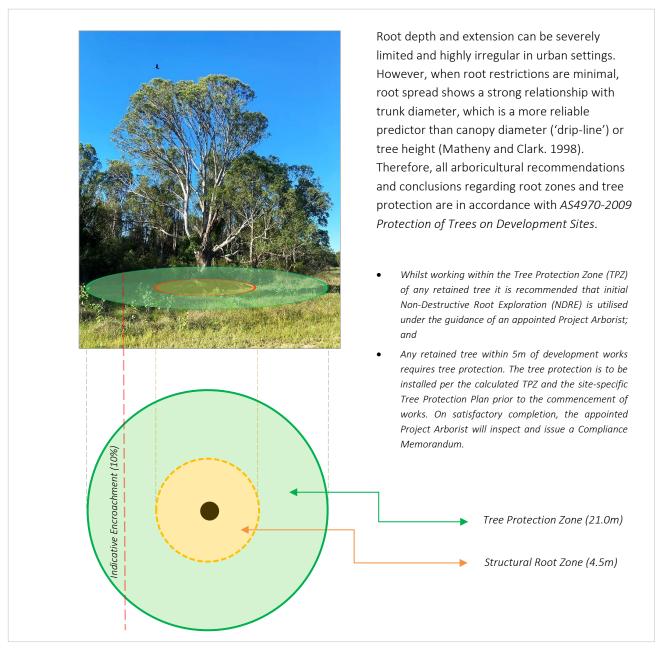
Root Zones: An infographic indicative of a calculated Tree Protection Zone (TPZ), Structural Root Zone (SRZ) and Encroachment level per *AS4970-2009 Protection of trees on development sites* is included below to aid in the visualisation of the 'No-Dig' zones; and where initial Non-Destructive Root Exploration (NDRE) must be carried out under the direct supervision of the Project Arborist. In addition, the formula's provided can be used in combination with the recommended 'stair-step' Construction Encroachment Descriptors & Stair-step Approach table to indicatively calculate impact levels.

- AS4970-2009 Protection of trees on development site s3: The radius of the TPZ is calculated for each tree by multiplying its Diameter @ Breast Height measured @ 1.4m from ground level (DBH \times 12 = TPZ). (DBH = Trunk Girth @ 1.4m \div π).
- To calculate the SRZ: Radius SRZ = Diameter bove Root Crown ($DRC \times 50$) ^ 0.42 x 0.64. If the DRC is less than 0.15m the SRZ will be 1.5m.

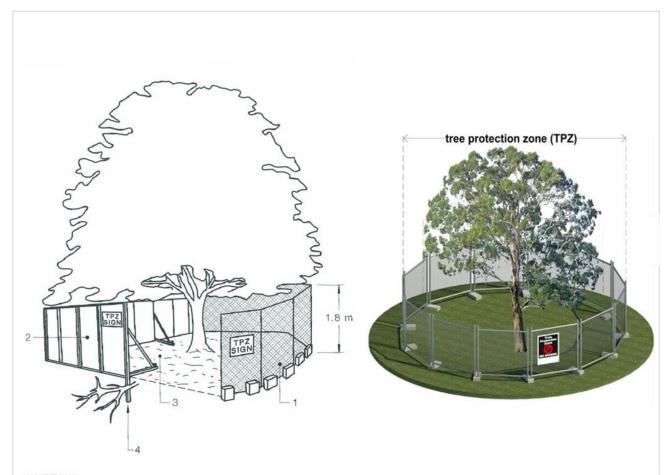
- 1 Chain wire mesh panels with shade cloth (if required) attached, held in place with concrete feet.
- 2 Alternative plywood or wooden paling fence panels. This fencing material also prevents building materials or soil entering the TPZ.
- 3 Mulch installation across surface of TPZ (at the discretion of the project arborist). No excavation, construction activity, grade changes, surface treatment or storage of materials of any kind is permitted within the TPZ.
- 4 Bracing is permissible within the TPZ. Installation of supports should avoid damaging roots.

i. Tree Protection is to be erected around any tree within five (5) metres of development per *AS4970-2009 Protection of trees on development sites*.

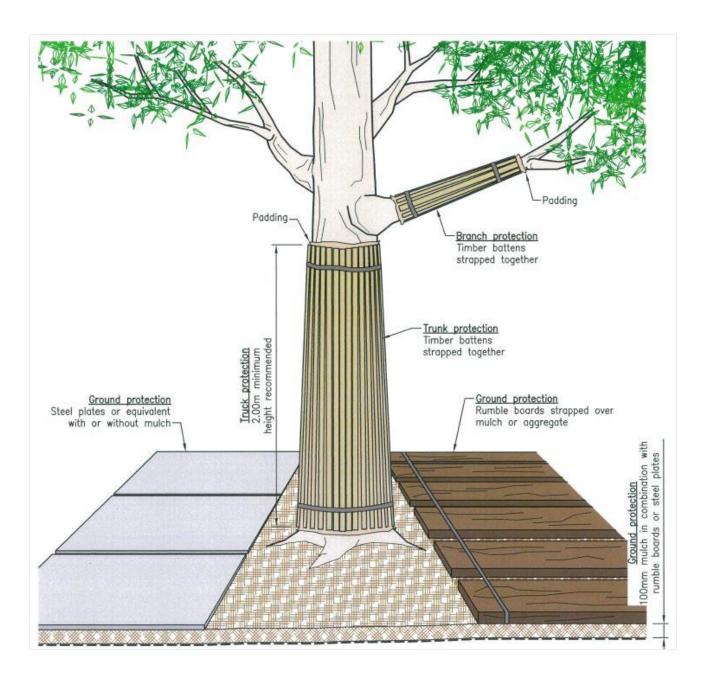
- i. When tree protection fencing cannot be installed or requires temporary removal, other tree protection measures should be used. Where necessary, install protection to the trunk and branches of trees as pictured below.
- ii. The materials and positioning of protection are to be specified by the Project Arborist and are to include:
 - For the trunk and branch protection use boards and padding that will prevent damage to the bark.
 For the trunk boards a minimum height of two (2) metres is recommended. Boards are to be strapped to trees, not nailed or screwed.

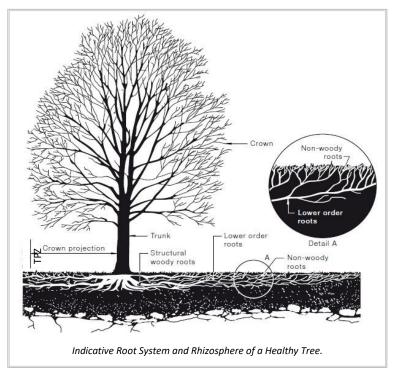
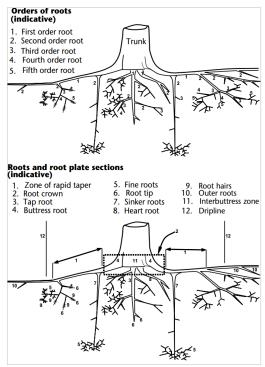
Image credit: AS4970-2009 Protection of trees on developmnet sites

Image credit: Perry. 1992

- i. The main functions of roots include the uptake of water and nutrients, anchorage, storage of sugar reserves and the production of some plant hormones required by the shoots. For roots to function, they must be supplied with oxygen from the soil. The root system of trees consists of several 'types' of roots found in different parts of the soil and is generally much more extensive than commonly thought. The importance of roots is easily overlooked because they are not visible, that is 'out of sight, out of mind'. Damage to the root system is a common cause of tree decline and death and is the most common form of damage associated with development sites (Matheny et. al, 1998).

- Non-woody roots (absorption of water and nutrients, extension, synthesis of amino acids and growth regulators) (please refer to Drawing above).
- iii. In addition to lateral root spread being underestimated, root depth in trees has also been grossly exaggerated. Deep root systems or taproots are the exception rather than the rule. Most roots of most trees are found in the very top of the soil. The vast majority of these roots are small non-woody absorbing roots which grow upward into the very surface layers of the soil and leaf litter. This delicate, non-woody system, because of its proximity to the surface, is very vulnerable to injury (Watson et. al, 2014).

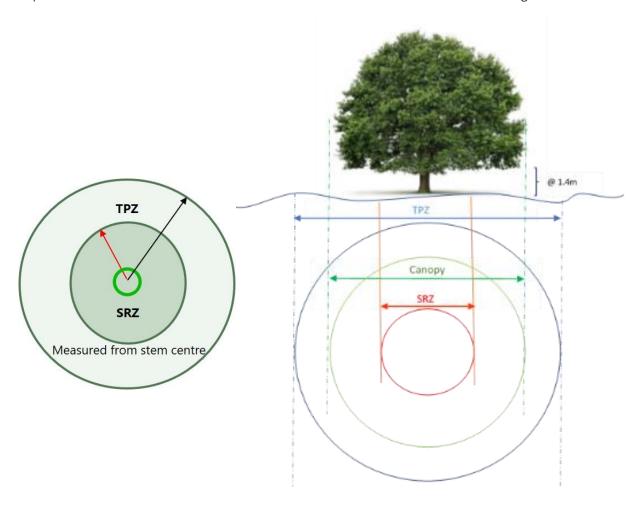
i. The Australian Standard *AS 4970-2009 - Protection of trees on development sites* is used for the allocation of tree protection zones. This method provides a TPZ that addresses both tree stability and growth requirements. TPZ distances are measured as a radius from the centre of the trunk at ground level.

- ii. As per AS4970-2009 Protection of trees on development sites the following calculations are to be used:
 - s3: The radius of the TPZ is calculated for each tree by multiplying its Diameter @ Breast Height measured @ 1.4m from ground level (DBH \times 12 = TPZ). (DBH = Trunk Girth @ 1.4m \div π).
 - To calculate the SRZ: Radius SRZ = **D**iameter above **R**oot **C**rown (**DRC** x 50) ^ 0.42 x 0.64. If the DRC is less than 0.15m the SRZ will be 1.5m.
 - Note: A TPZ should not be less than 2m or more than 15m from the tree stem.

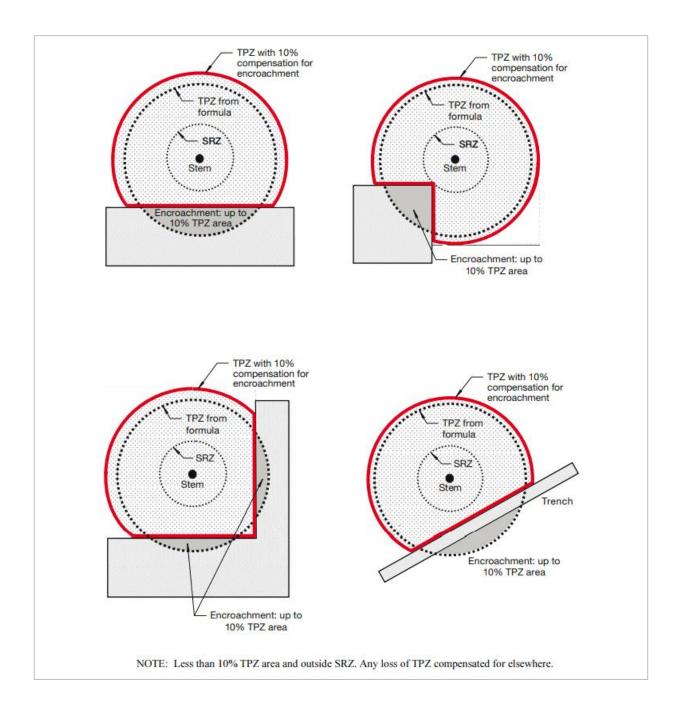
i. Encroachment into the Tree Protection Zone (TPZ) is sometimes unavoidable. The images above are analogous to the abovementioned works scenario and indicate how encroachment within the tree protection zone can be compensated for elsewhere per *AS4970-2009 Protection of Trees on Development Sites*.
