Report on  
Salinity Investigation

Proposed Urban Development  
Bradfield City Centre  
215 Badgerys Creek Road, Bradfield

Prepared for  
Western Parkland City Authority

Project 222630.00  
April 2024

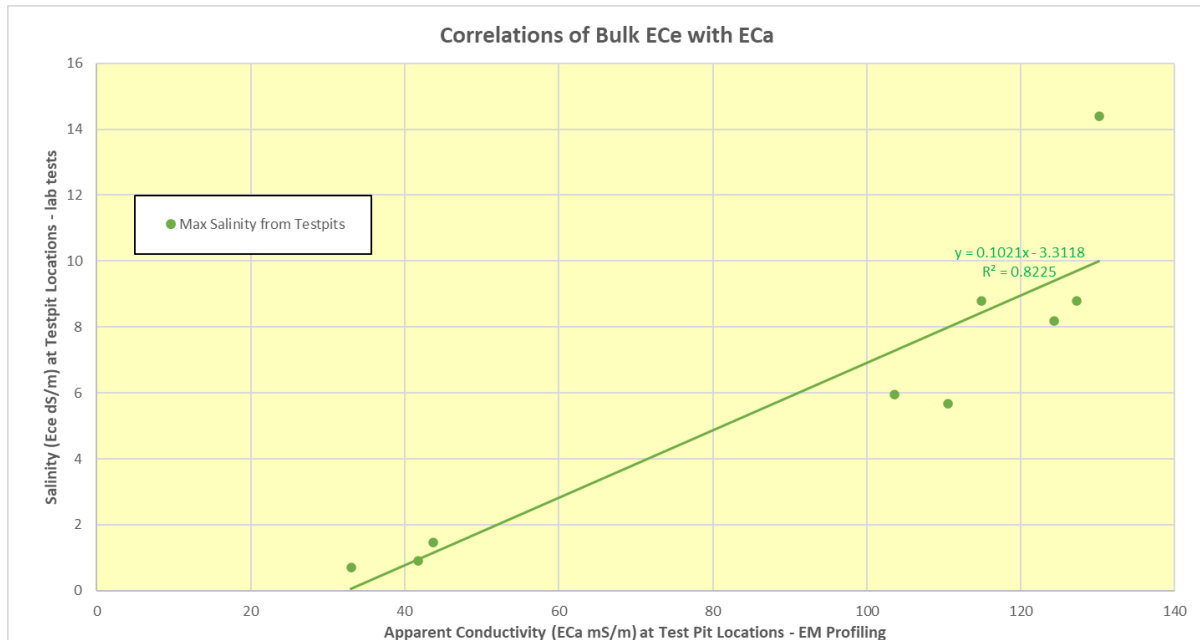
**Figure 7: Correlation of apparent conductivity (E<sub>Ca</sub> from EM profiling) with maximum salinity E<sub>Ce</sub> from Testpits 302 – 310.**

The line of best fit defines the E<sub>Ce</sub>/E<sub>Ca</sub> trend and provides an equation by which to convert apparent conductivities (E<sub>Ca</sub> in mS/m), to estimate apparent maximum salinities (E<sub>Ce</sub> in dS/m) throughout the data set.

The correlation equation (of linear form:  $E_{Ce} = \text{gradient} \times E_{Ca} - C$ ) shown in Figure 7 above was applied to apparent conductivity gridded data for presentation as E<sub>Ce</sub> salinity maps (Drawing 4, Appendix B) with continuous colour spectral scales in dS/m and at key depth ranges. The 2D-images were also contoured at 2 dS/m and 4 dS/m, and 8 dS/m, corresponding to boundaries of the salinity classes of Richards 1954, providing a direct subdivision of the study area into non-saline (< 2 dS/m), slightly saline (2 - 4 dS/m), moderately saline (4 - 8 dS/m) and very saline shown in yellow-red-white (8 - 16 dS/m) classes.

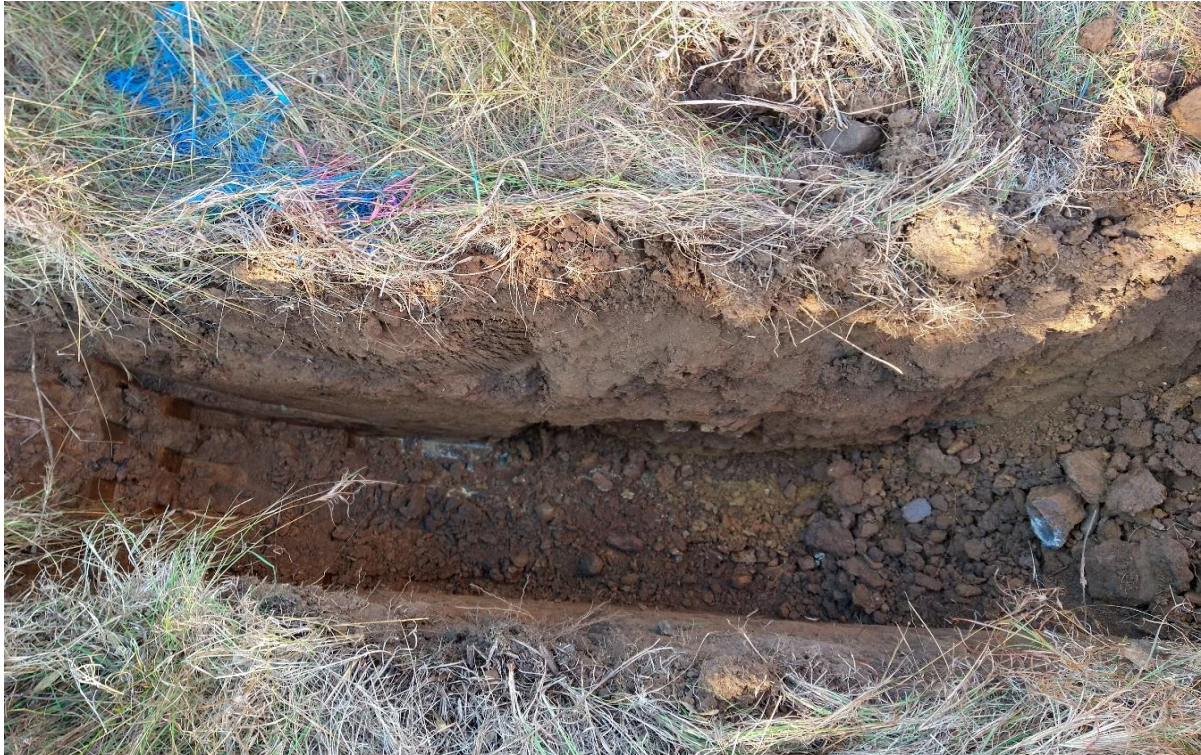
Photo 9: Test Pit 123 showing profile where the Luddenham Dyke was encountered (Refusal at 0.9m)

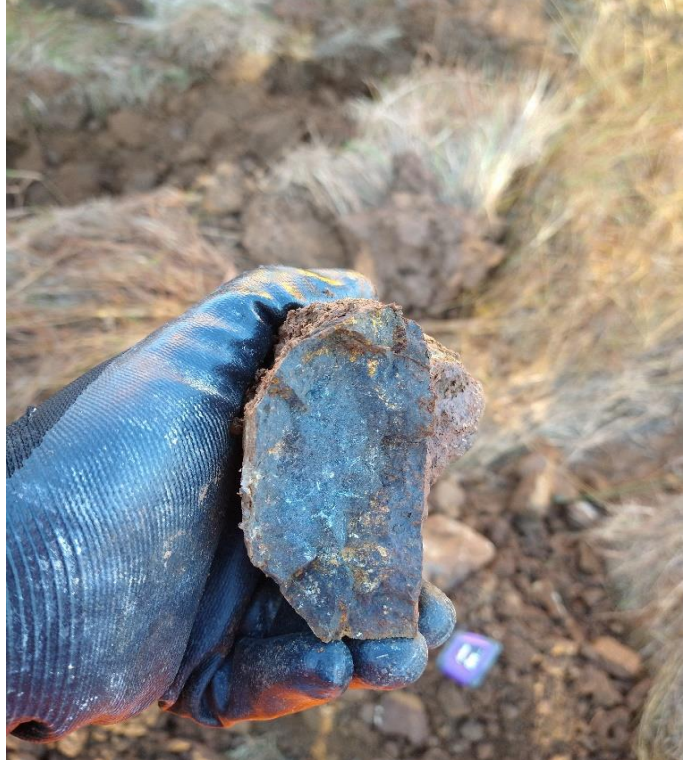
Photo 10: Basaltic material from base of Test Pit 123 - high strength

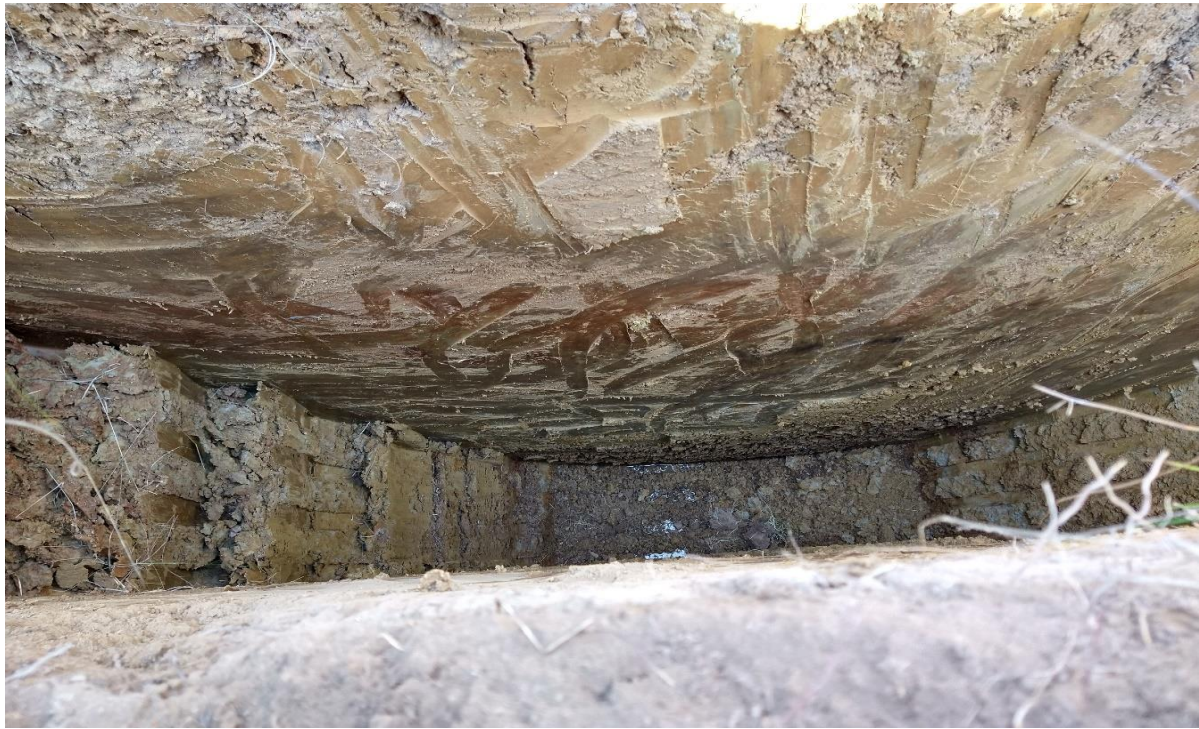
Photo 11: Test Pit 205 in stormwater corridor showing typical alluvial soil profile

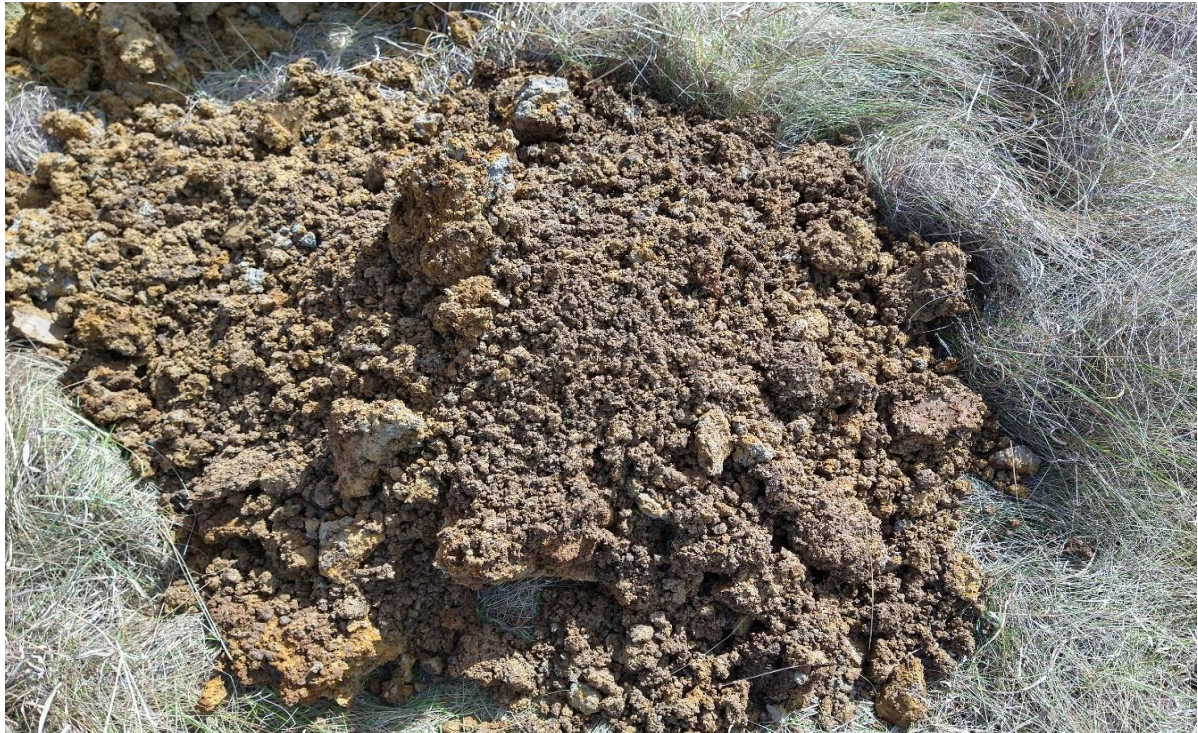
Photo 12: Alluvial soil from Pit 205
