# Groundwater Impact Assessment

Department of Education – Geotechnical, Groundwater & Contamination  
Assessment – New High School for Jordan Springs

19 December 2024

Prepared by:  
Stantec Australia

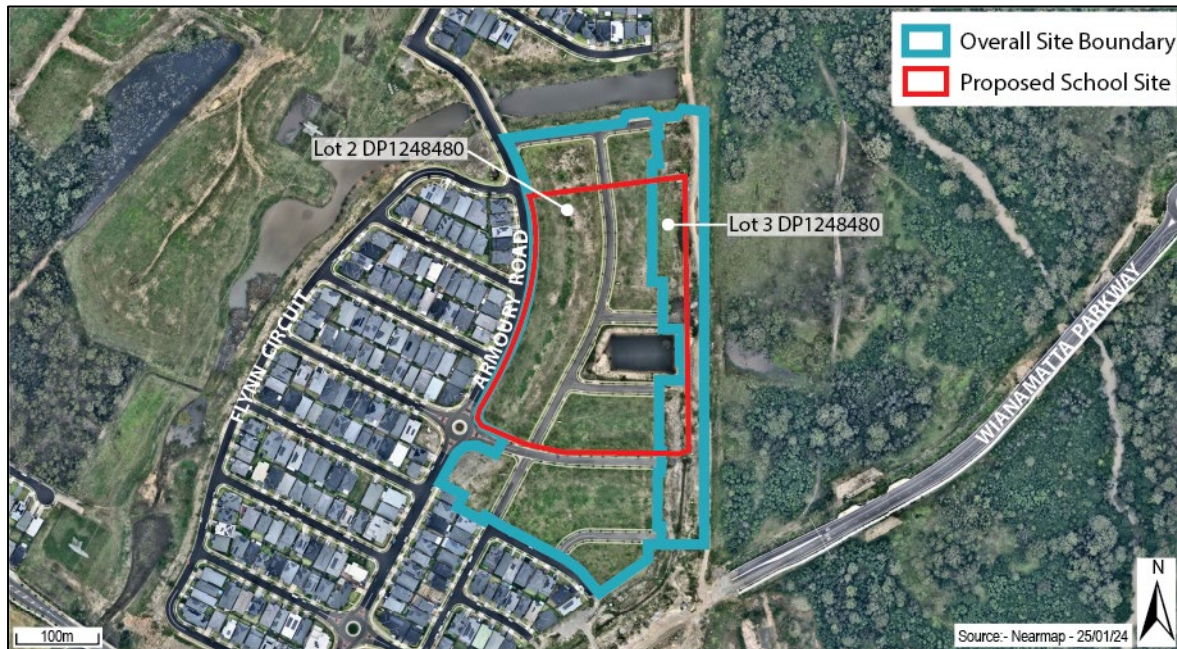
*Figure 2-1 Aerial Photograph showing the proposed school boundary*

**Figure 2-1** provides an aerial photograph of the project site, outlines the boundaries of the project site (in red) and the boundaries of Lots 2 and 3 in DP 1248480 (in blue).

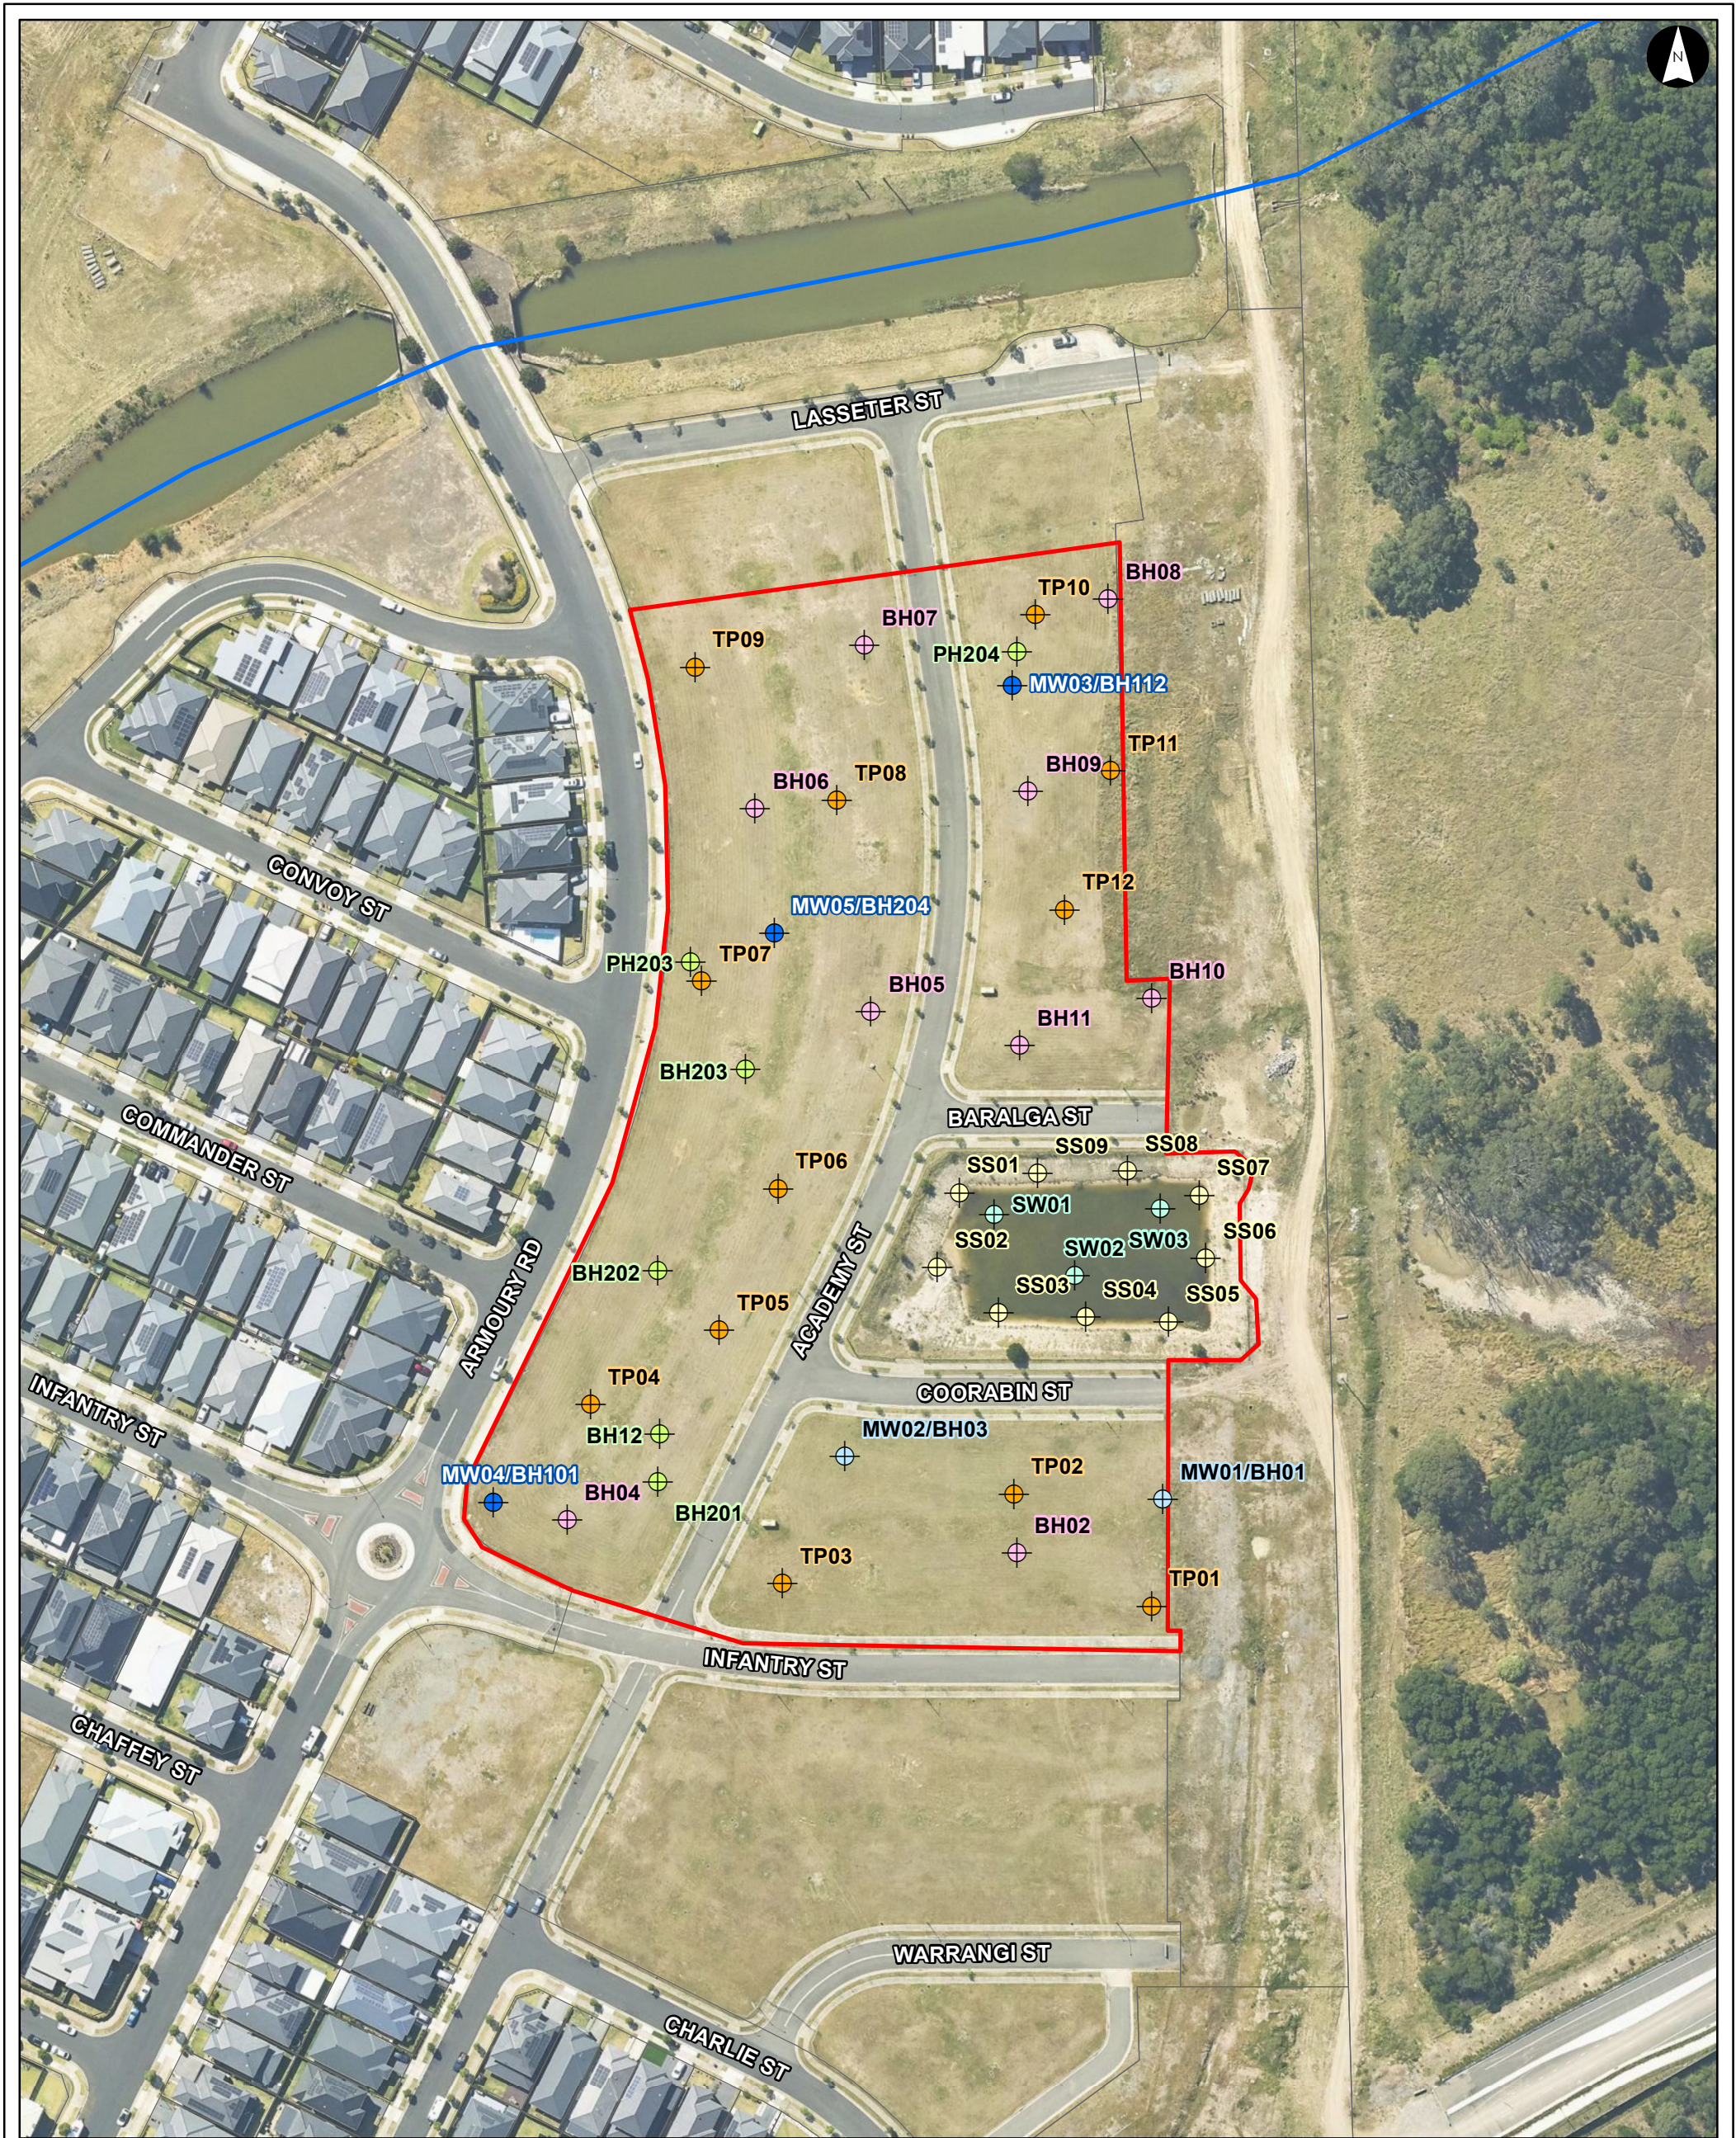
## Sample Plan

Groundwater wells were sampled utilising low-flow sampling techniques, in which wells were purged until groundwater field parameters were stabilised before collecting a sample. Groundwater field parameters and observations noted during the groundwater sampling event are shown below in **Table 8-2**, with the locations of groundwater wells indicated on **Figure 2, Appendix A**.
