Proposed Construction of a New High School at Jordan Springs East, Penrith City Council, NSW

Preliminary Indigenous Heritage Assessment and Impact Report

Prepared for School Infrastructure NSW on behalf of the NSW Department of Education

December 2024

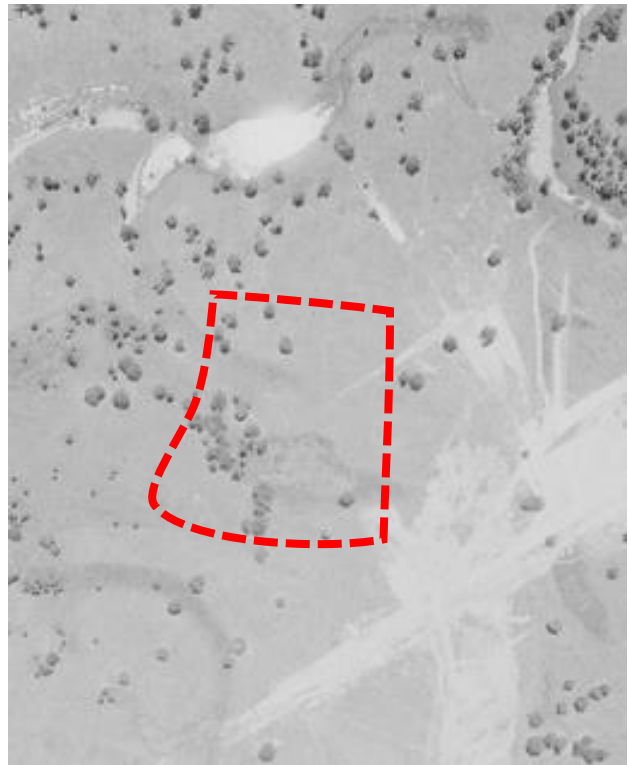
Plate 2: 1955 Aerial Photograph (source: NSW Historical Imagery Viewer)

In addition, historic aerials and satellite images dating from between 1947-2021 were reviewed as part of preparing this PIHA (see Plate 1 to Plate 8). These aerials provide a summary of development at the site and within the surrounding area (refer to Table 3).

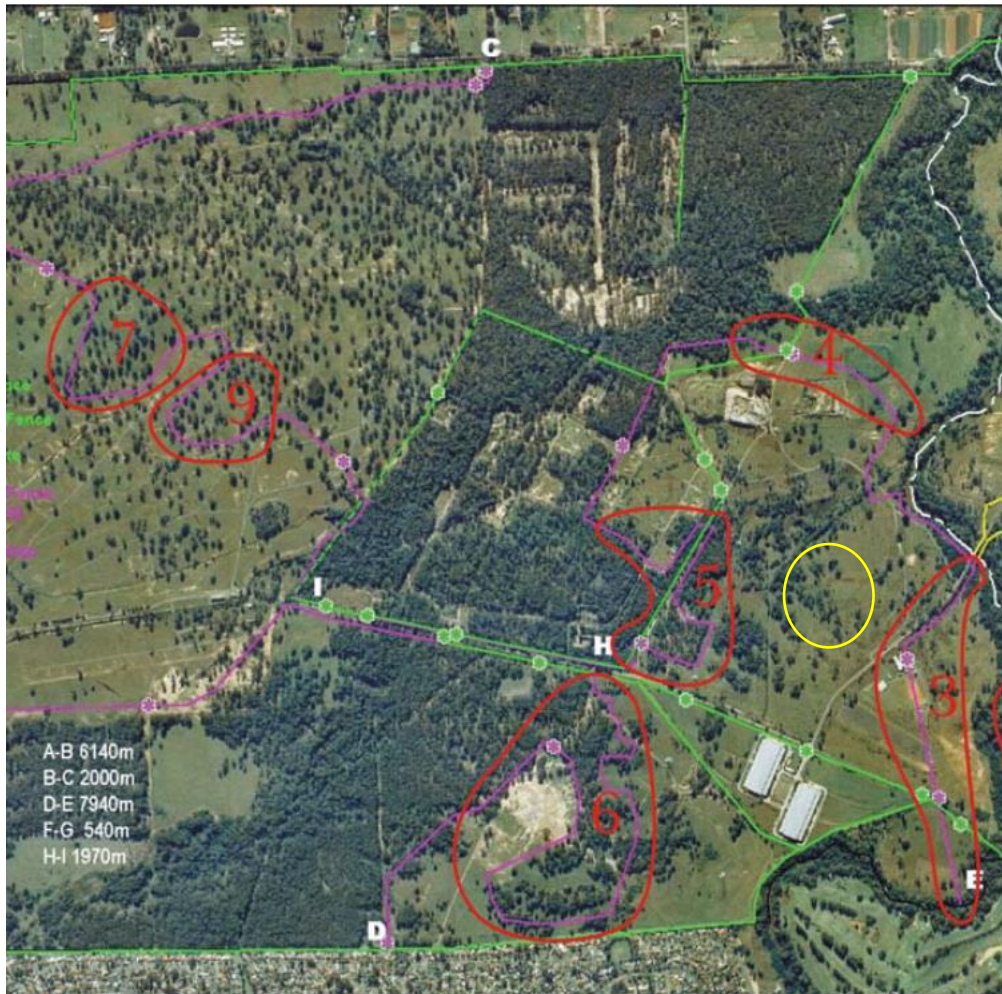
Figure 6: Approximate location of the Jo McDonald (1997) Sample Areas (source: Jo McDonald CHM (2009, p. 33)). The approximate location of the Subject Area is identified by the yellow circle

While the current Subject Area is situated between Sample Areas 3 (SA3), SA4 and SA5 (Jo McDonald CHM, 1997b, p. 81 & 82), it is closest to SA3 (see Figure 6).

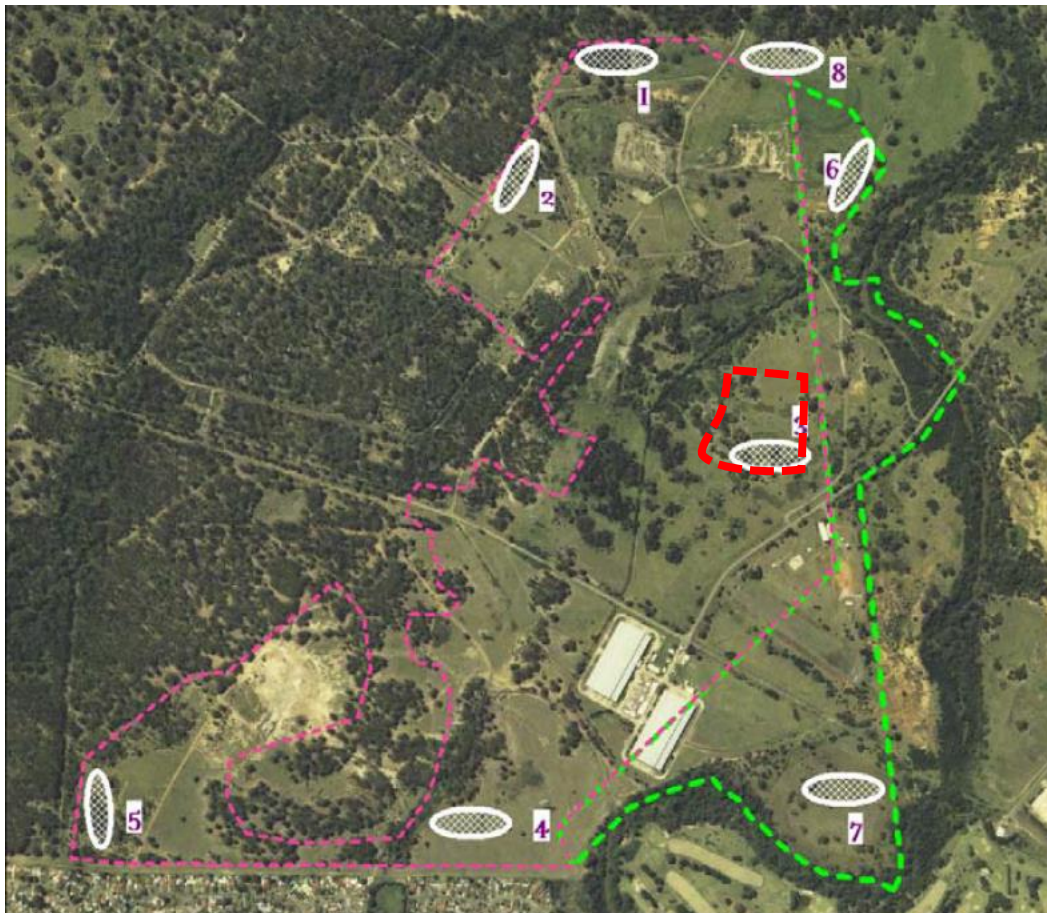
Figure 7: Aerial photo of Central Precinct showing locations of suggested salvage locations (source: Jo McDonald CHM (2009, p. 51)). Subject Area outlined in red

It was proposed that open area salvage excavation be undertaken in eight target areas. These locations were intended to be a representative sample of the landforms within the precinct. Area 3 was located in the southeast portion of the current Subject Area (refer to Figure 7).

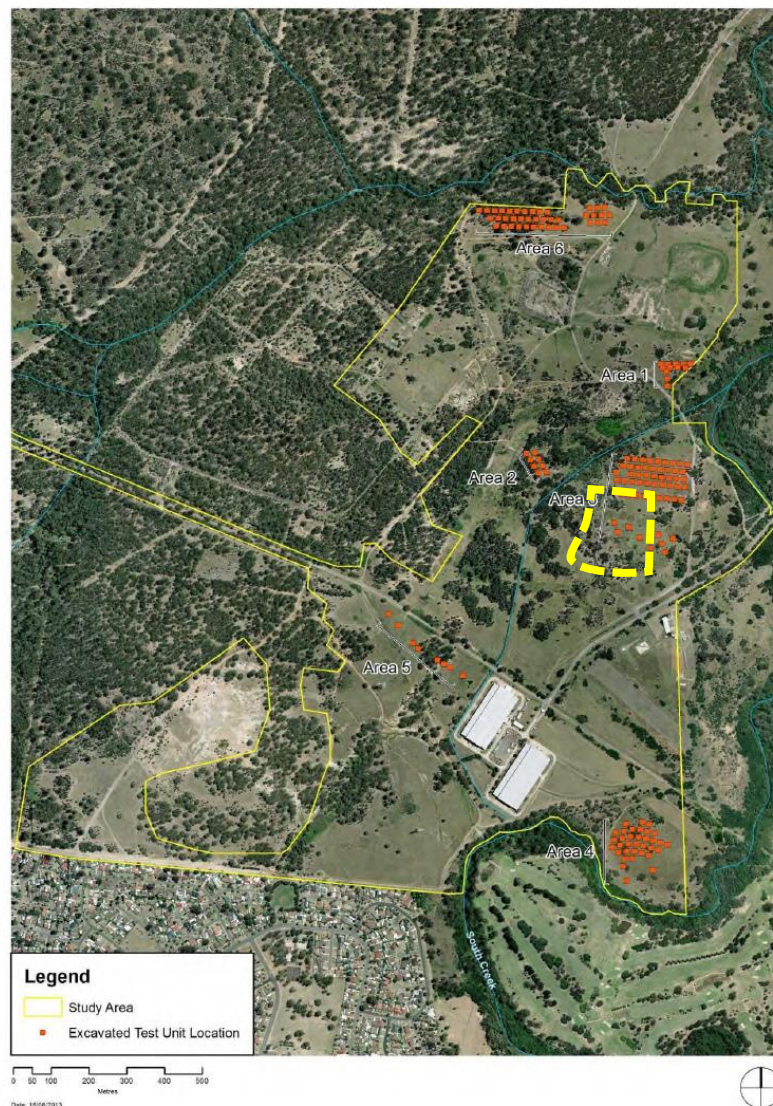
Figure 3.10 General location of 2013 test excavation areas. (Source: GML + JMcDCHM 2013)

Figure 8: General location of the 2013 test excavation areas (source: Godden Mackay Logan and Jo McDonald CHM (2013, p. 46)). Subject Area outlined in yellow

Following the survey, six areas were identified for the archaeological excavation program – Area 3 included portions of the central eastern part of the Subject Area (refer to Figure 8). A total of 157 test units were excavated across the 6 areas, with six being expanded into 1m x 1m squares. A total of 432 cultural lithics of which 266 were identified as being stone artefacts were recovered from the Central Precinct.

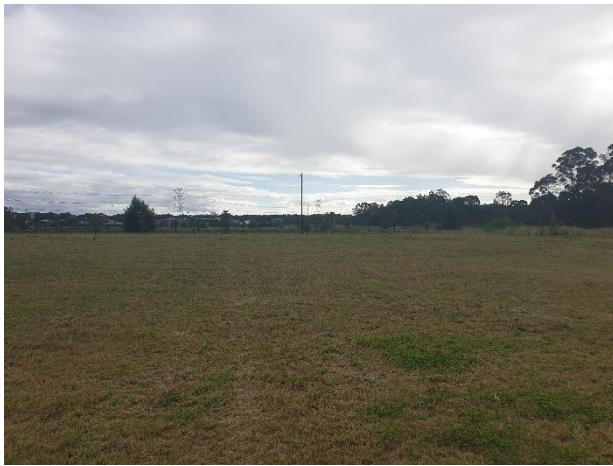
Plate 9: Looking north across the Subject Area

Ground Surface Visibility (GSV) was low across the majority of the Subject Area, as much of the Subject Area was grassed with areas of asphalt (refer to Plate 9 to Plate 21).

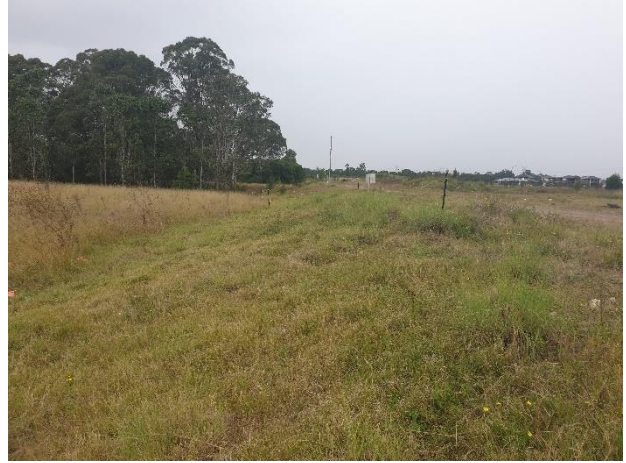
Plate 20: Looking south along the edge of the emplaced fill

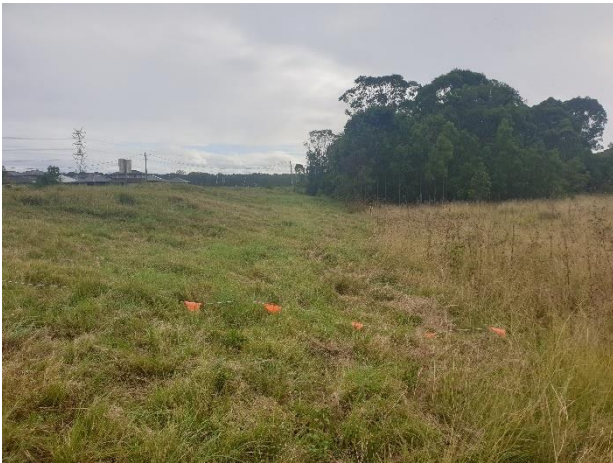
Plate 21: Looking north along the edge of the emplaced fill
