**INTRUSIVE GEOTECHNICAL  
INVESTIGATION REPORT**

New High School for Jordan Springs

16 December 2024

Prepared by:  
Stantec Australia Pty Ltd

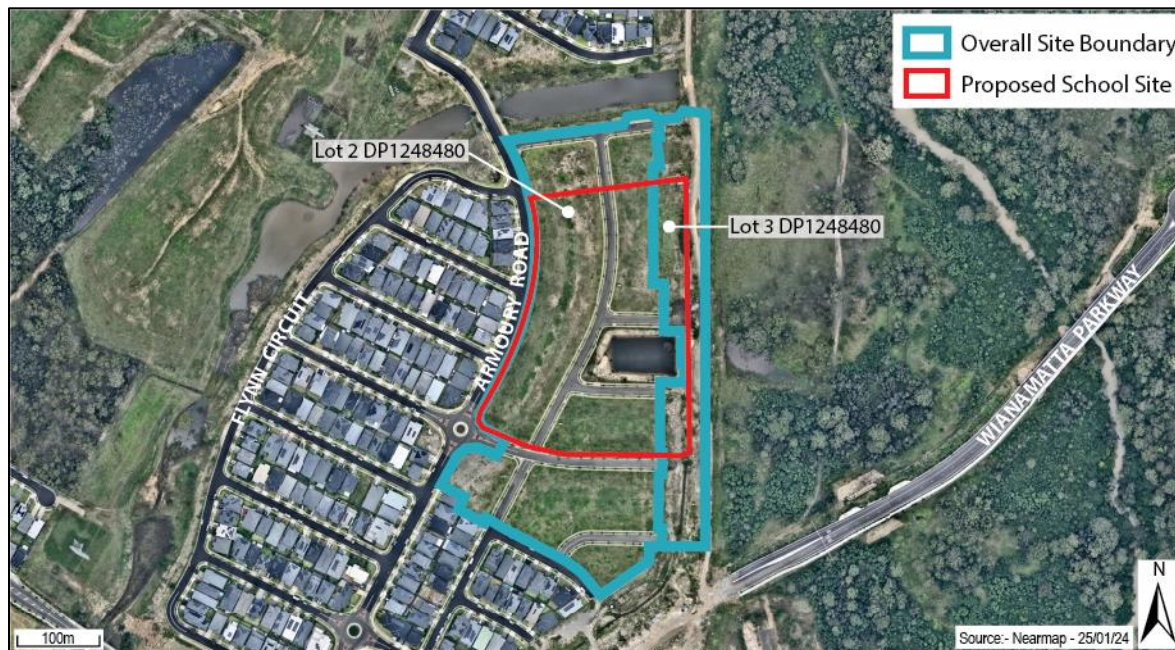
**Figure 1.1 Proposed Activity Site**

Based on the review of available information, it is understood that the proposed activity will include the construction of multi-storey school buildings with a hall, carpark and sport field facilities. The proposed activity footprint is shown in **Figure 1.1** below:

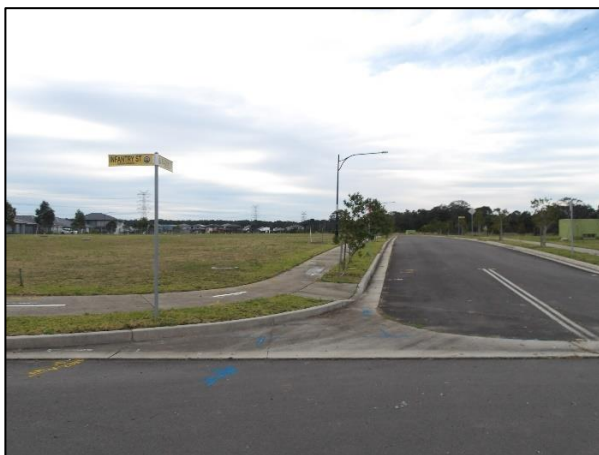
**Photo 1 Site View**  
(From the south side, looking at northwest direction)

The site is irregular in shape, with its western side attaching to Armoury Road, and southern side attaching to Infantry Street. The area is surrounded by existing low density residential properties. The present site surface comprises grass topsoil, and recently built roads. Site photos are shown below.

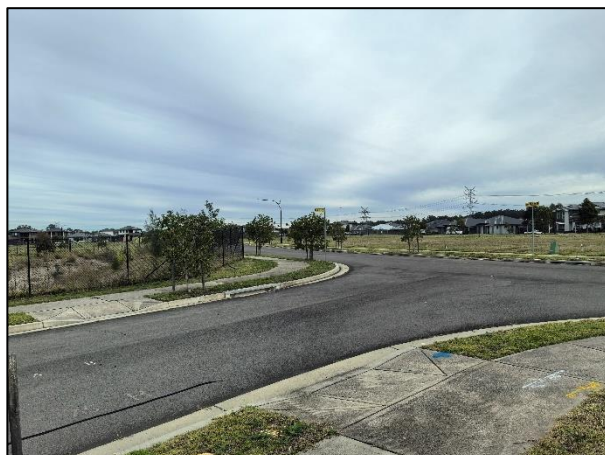
**Photo 2 Site View**  
(From the east side, looking at southwest direction)

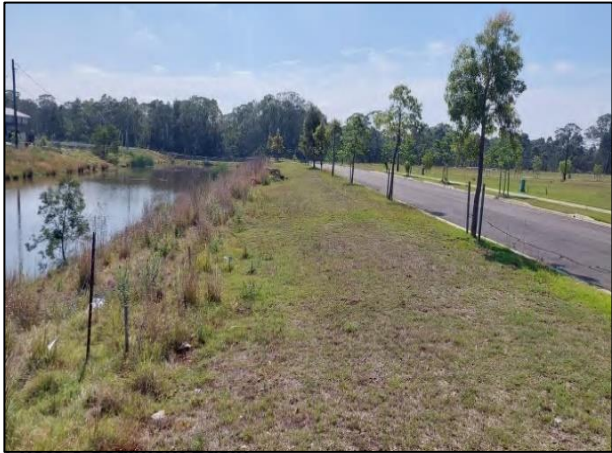
**Photo 3 Site View**  
(From the west side, looking at east direction)

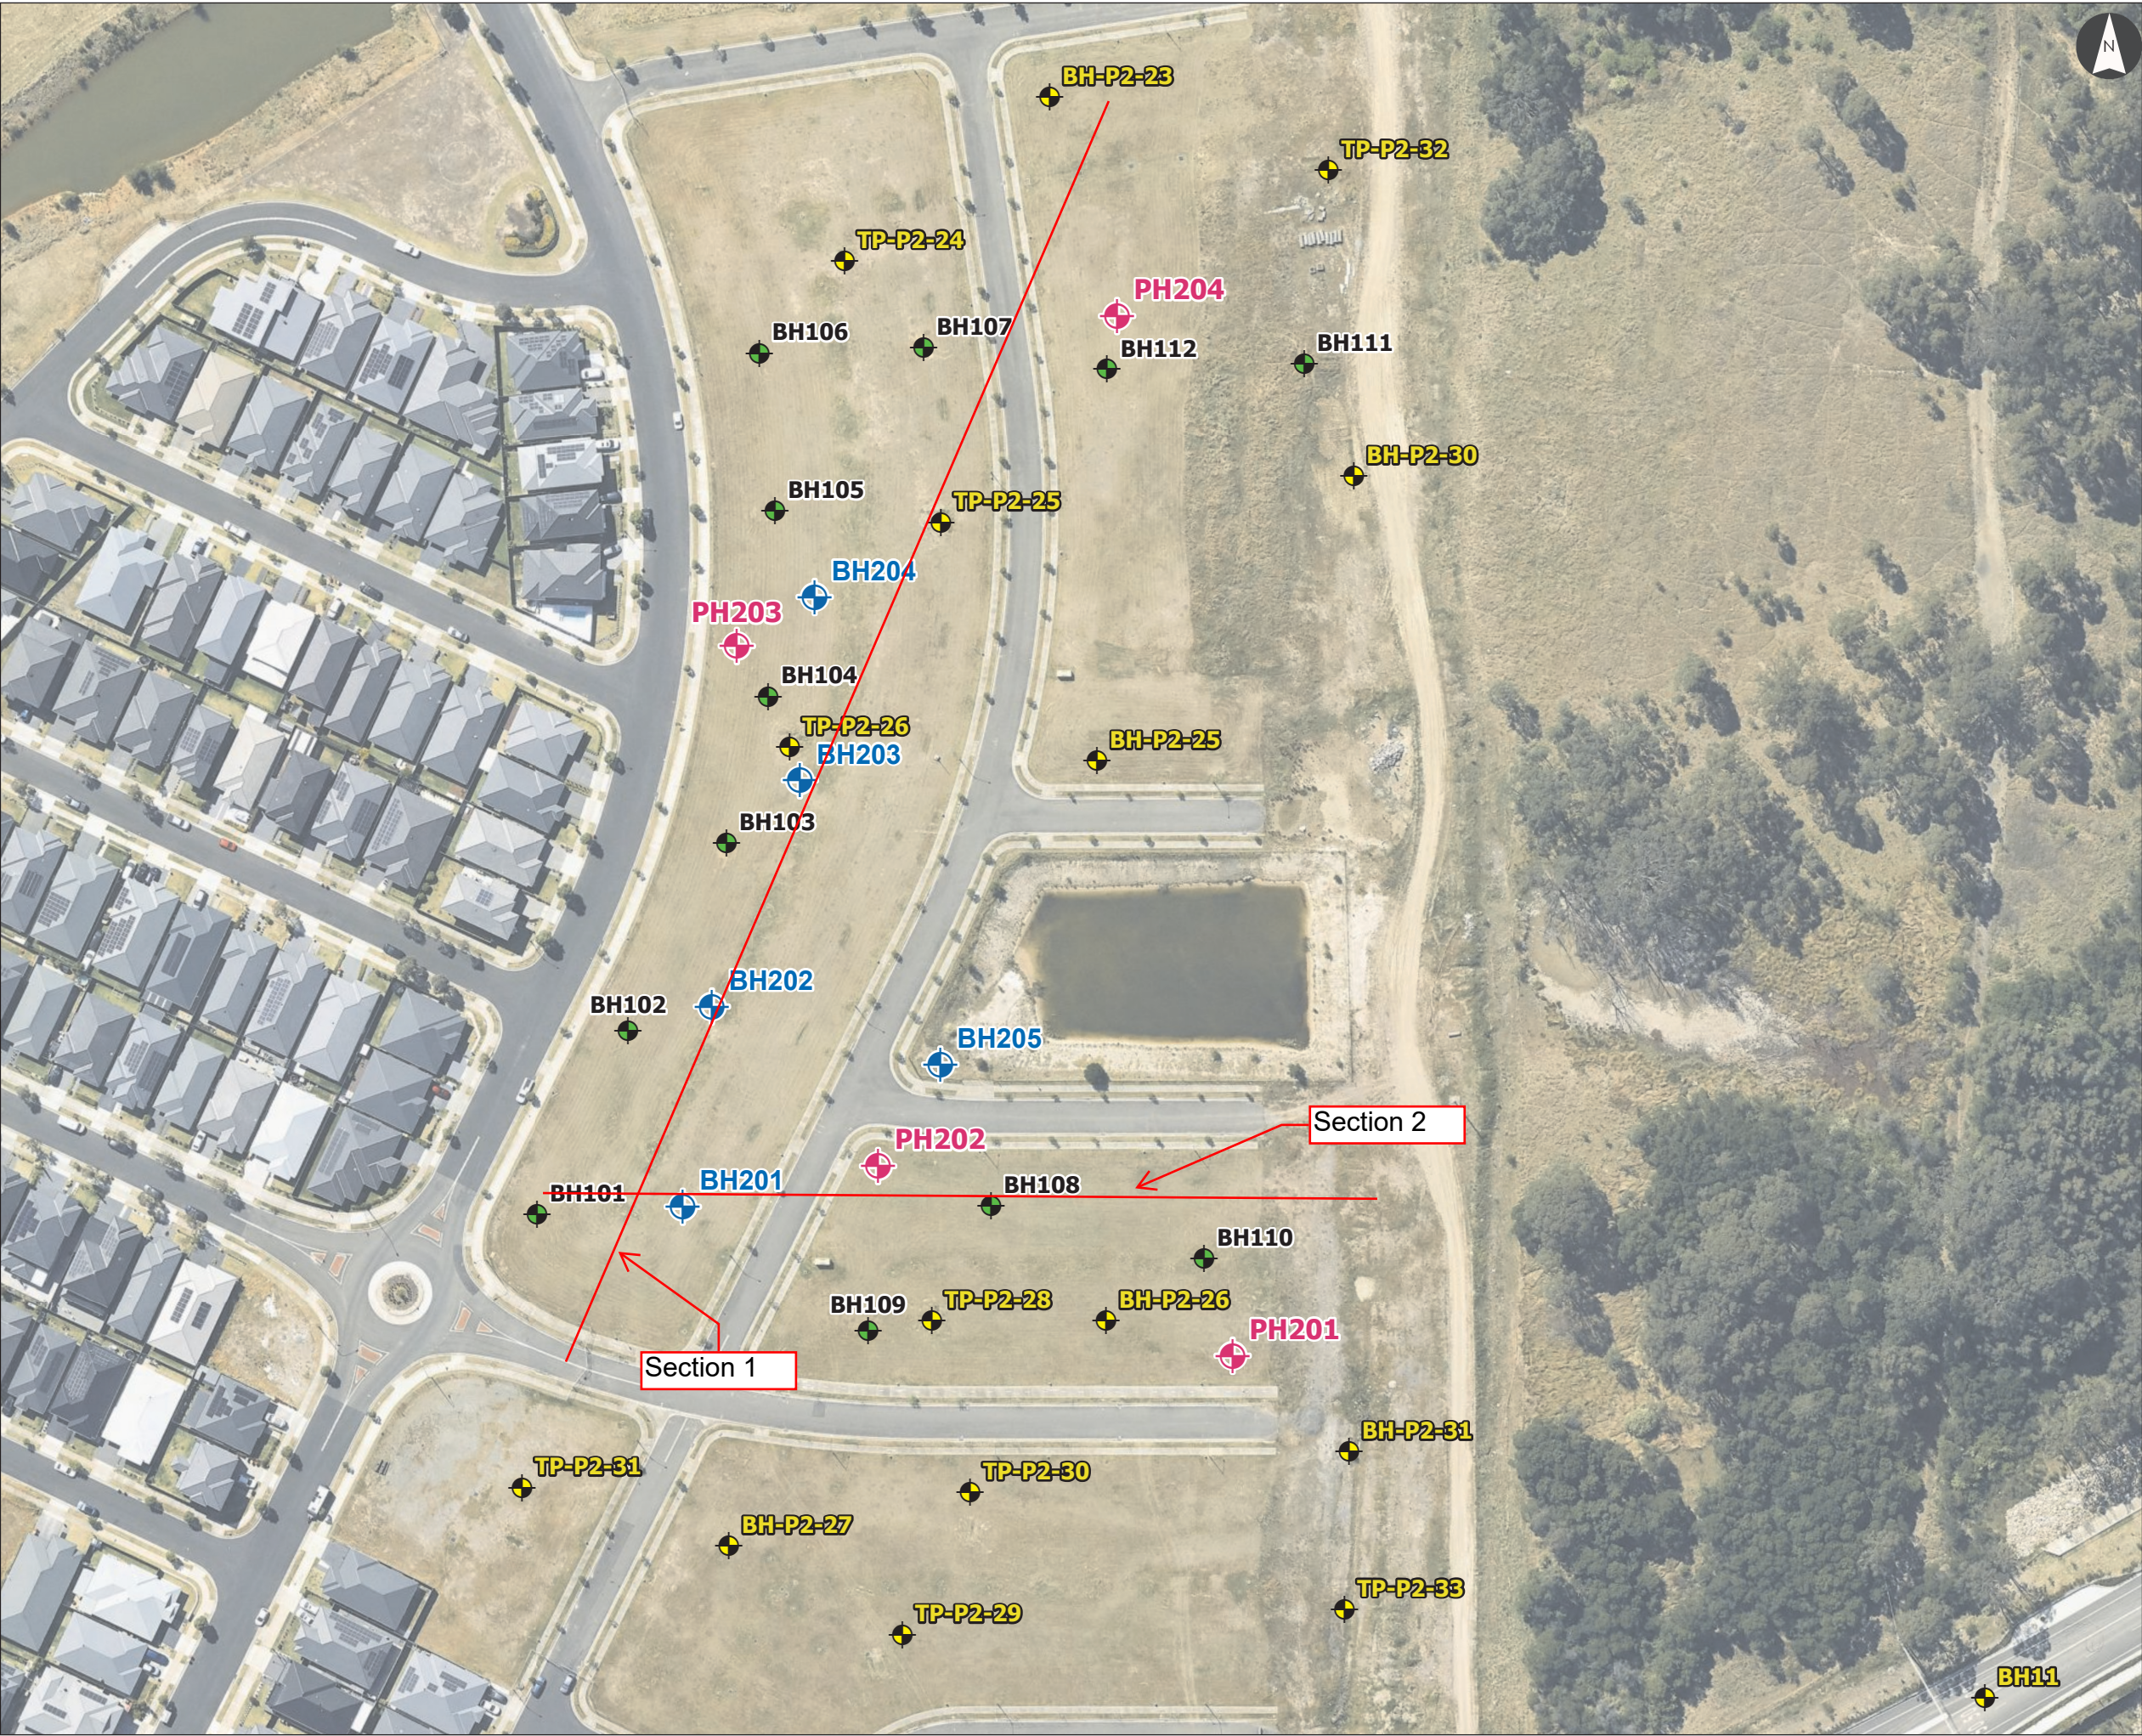
Site Plan

Jordan Springs Proposed new high school  
Site Investigation  
Jordan Spring, NSW

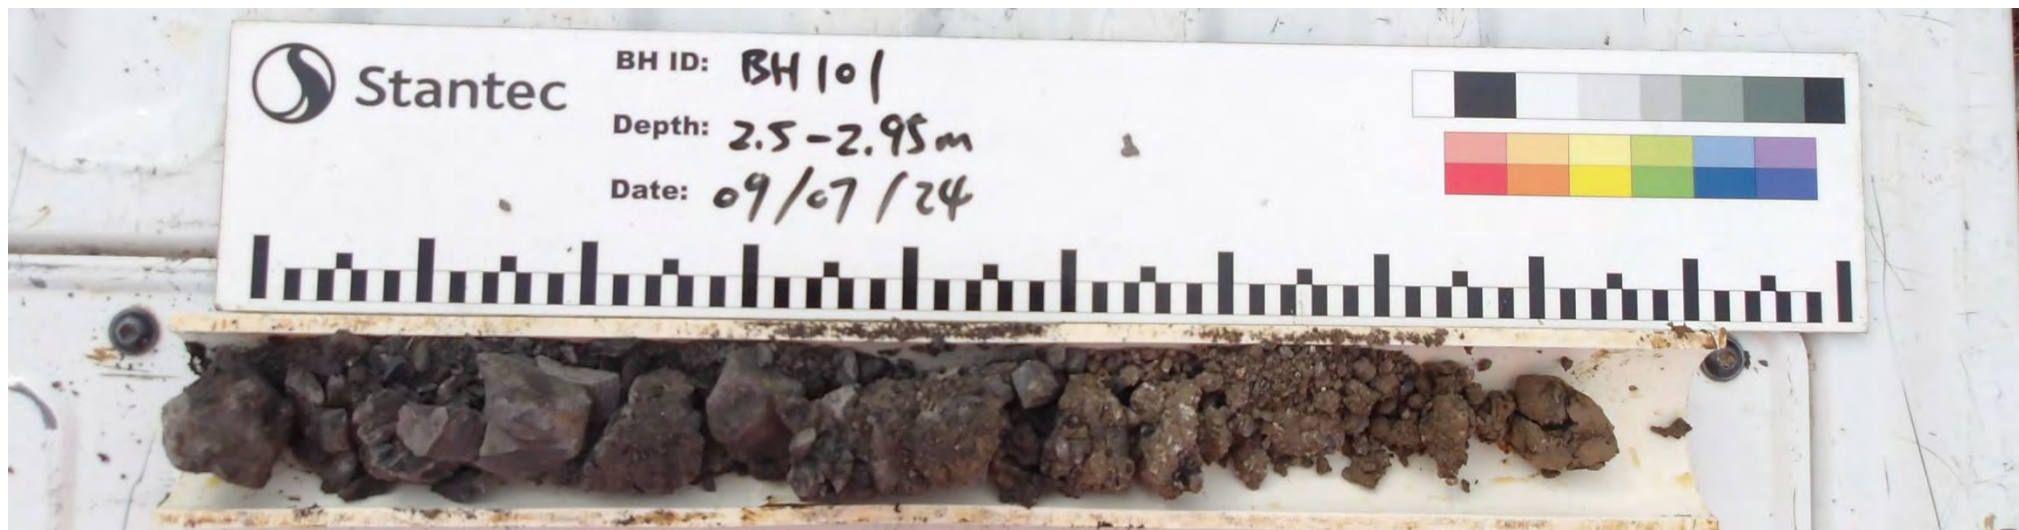
TITLE: Borehole Core Photographs – BH101 Proposed New High School in Jordan Springs			
	PROJECT NO: 304100928	TEST DATE: 09/07/2024	INCLINATION: -90 degree	CORED LENGTH: <b>BOX 1 OF 1</b> 2.5m to 2.95
	DRILL RIG: MD 300	CONTRACTOR: Traccess Drilling	LOGGED BY: AS	CHECKED BY: TH

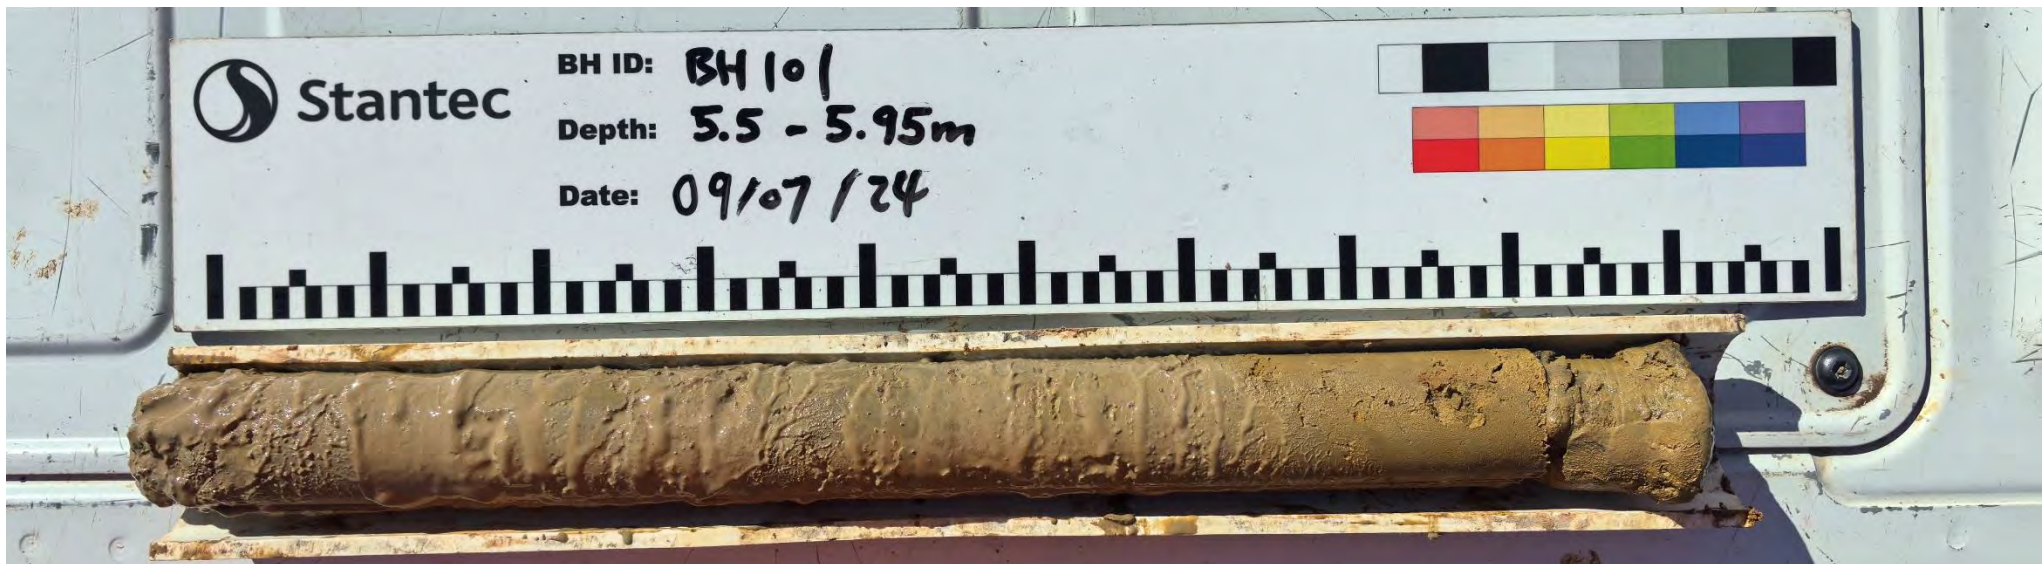
TITLE: Borehole Core Photographs – BH101 Proposed New High School in Jordan Springs			
	PROJECT NO: 304100928	TEST DATE: 09/07/2024	INCLINATION: -90 degree	CORED LENGTH: <b>BOX 1 OF 1</b> 5.5m to 5.95m
	DRILL RIG: MD 300	CONTRACTOR: Traccess Drilling	LOGGED BY: AS	CHECKED BY: TH

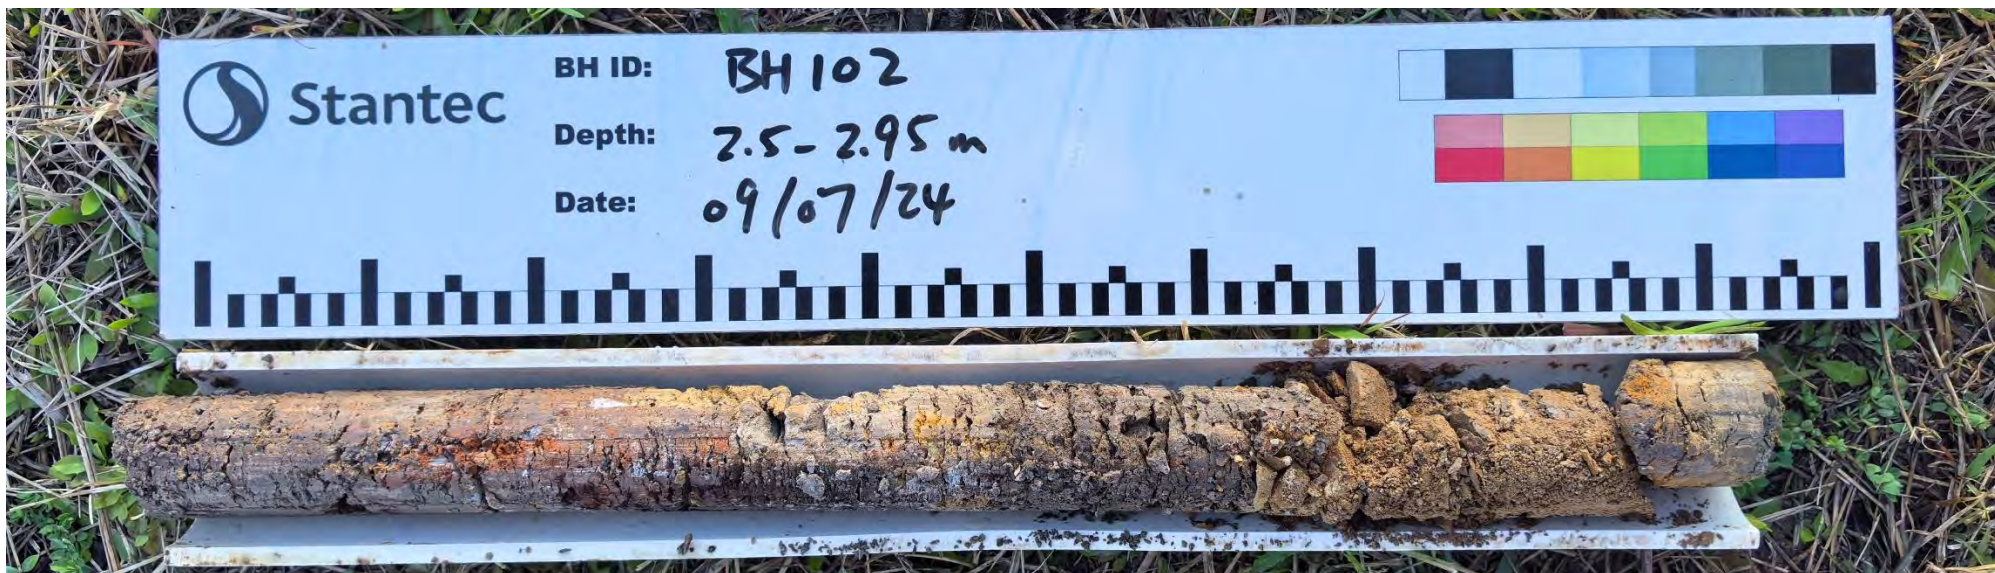
TITLE: Borehole Core Photographs – BH102 Proposed New High School in Jordan Springs			
	PROJECT NO: 304100928	TEST DATE: 09/07/2024	INCLINATION: -90 degree	CORED LENGTH: <b>BOX 1 OF 1</b> 2.5m to 2.95m
	DRILL RIG: MD 300	CONTRACTOR: Traccess Drilling	LOGGED BY: AS	CHECKED BY: TH

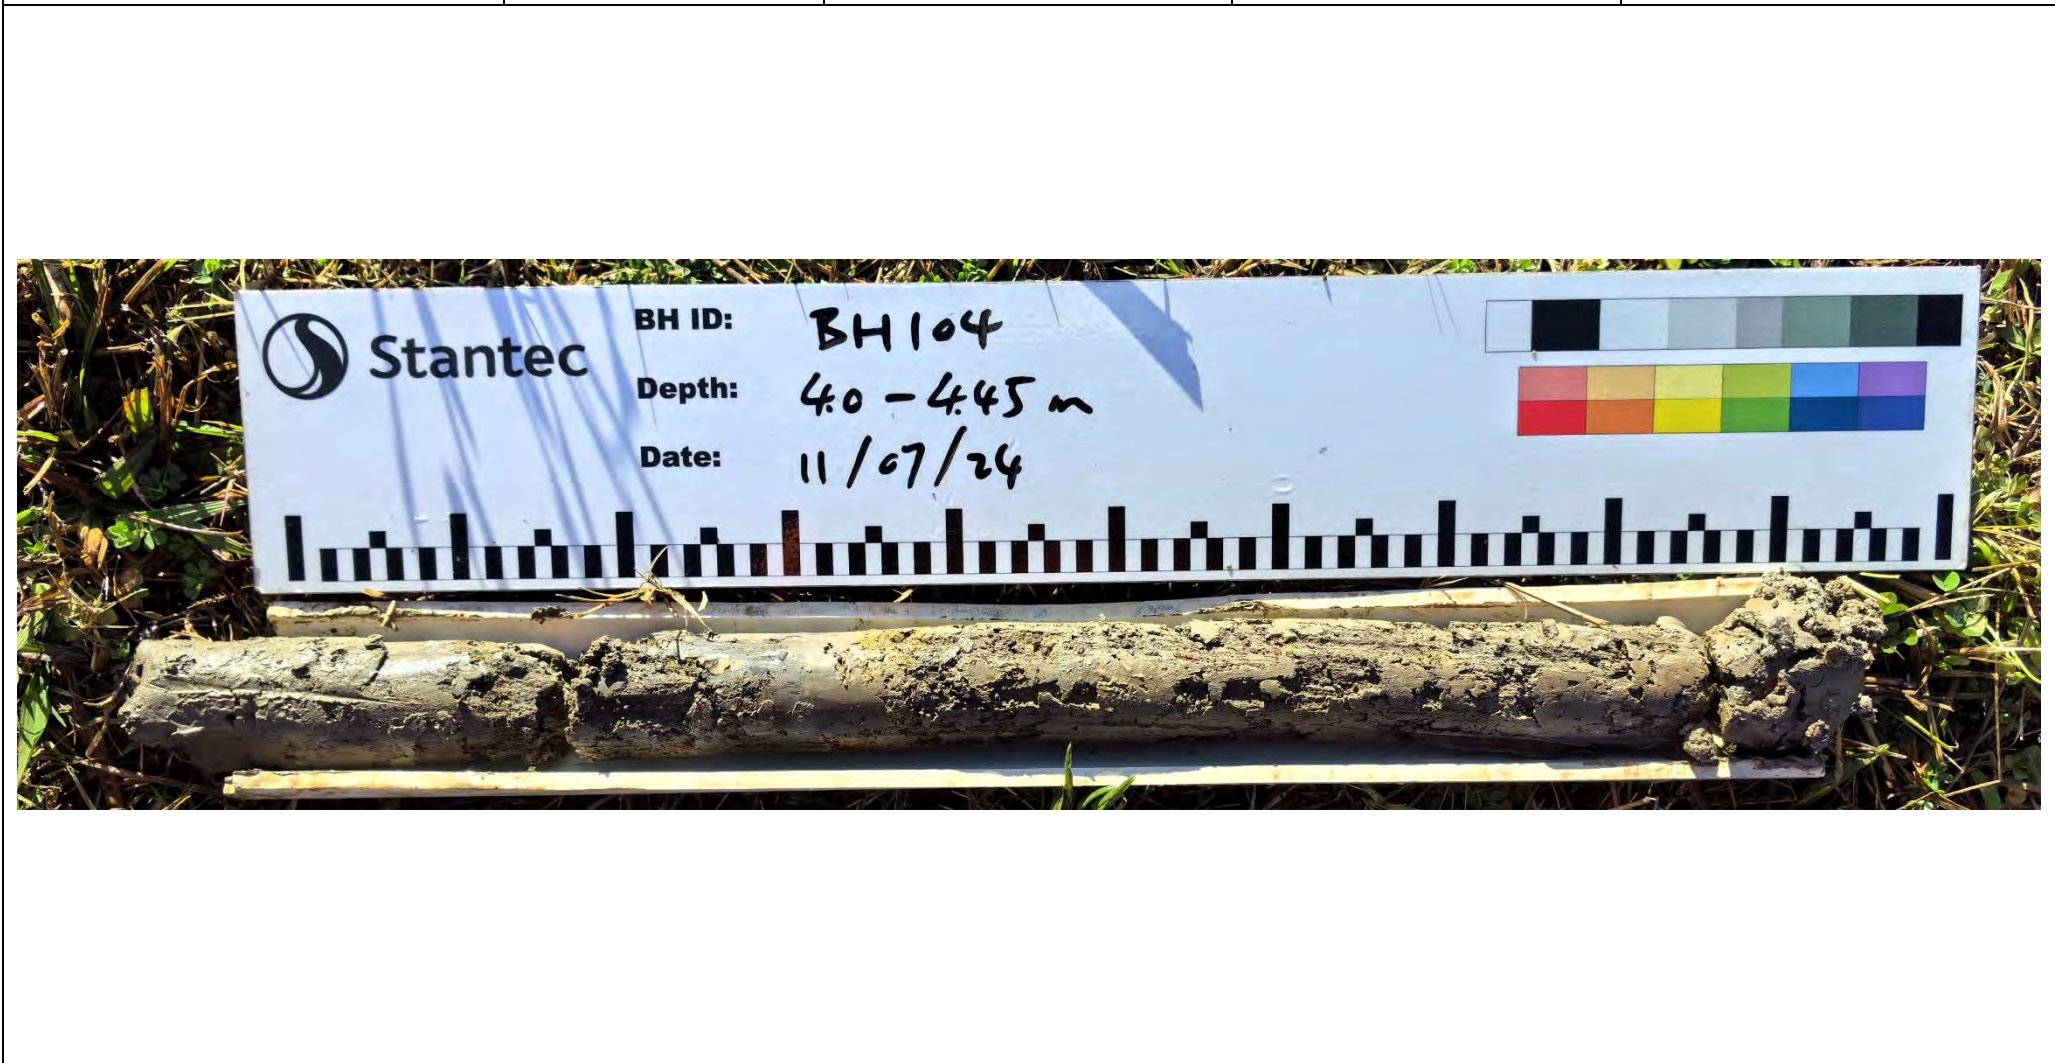
TITLE: Borehole Core Photographs – BH104 Proposed New High School in Jordan Springs			
	PROJECT NO: 304100928	TEST DATE: 11/07/2024	INCLINATION: -90 degree	CORED LENGTH: <b>BOX 1 OF 1</b> 4.0m to 4.45m
	DRILL RIG: MD 300	CONTRACTOR: Traccess Drilling	LOGGED BY: AS	CHECKED BY: TH

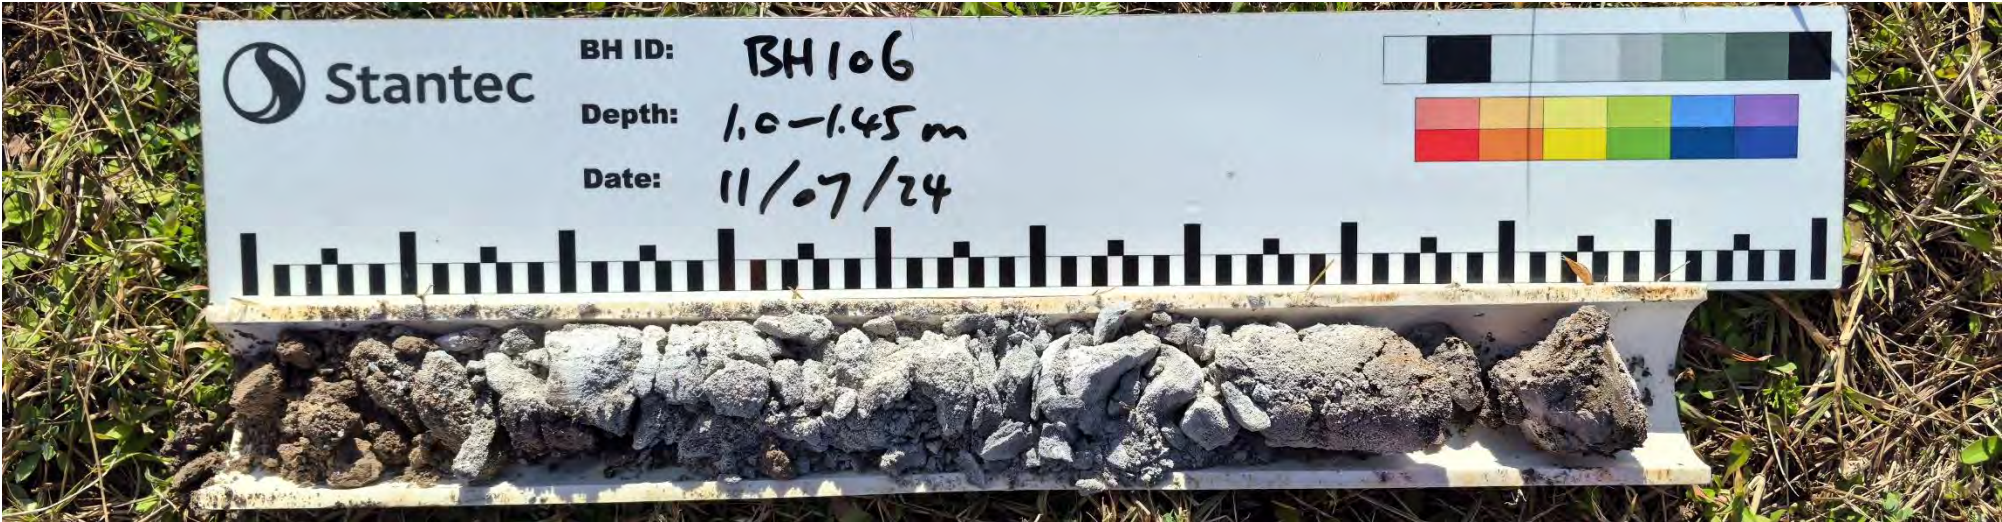
TITLE: Borehole Core Photographs – BH106 Proposed New High School in Jordan Springs			
	PROJECT NO: 304100928	TEST DATE: 11/07/2024	INCLINATION: -90 degree	CORED LENGTH: <b>BOX 1 OF 1</b> 1.0m to 1.45m
	DRILL RIG: MD 300	CONTRACTOR: Traccess Drilling	LOGGED BY: AS	CHECKED BY: TH

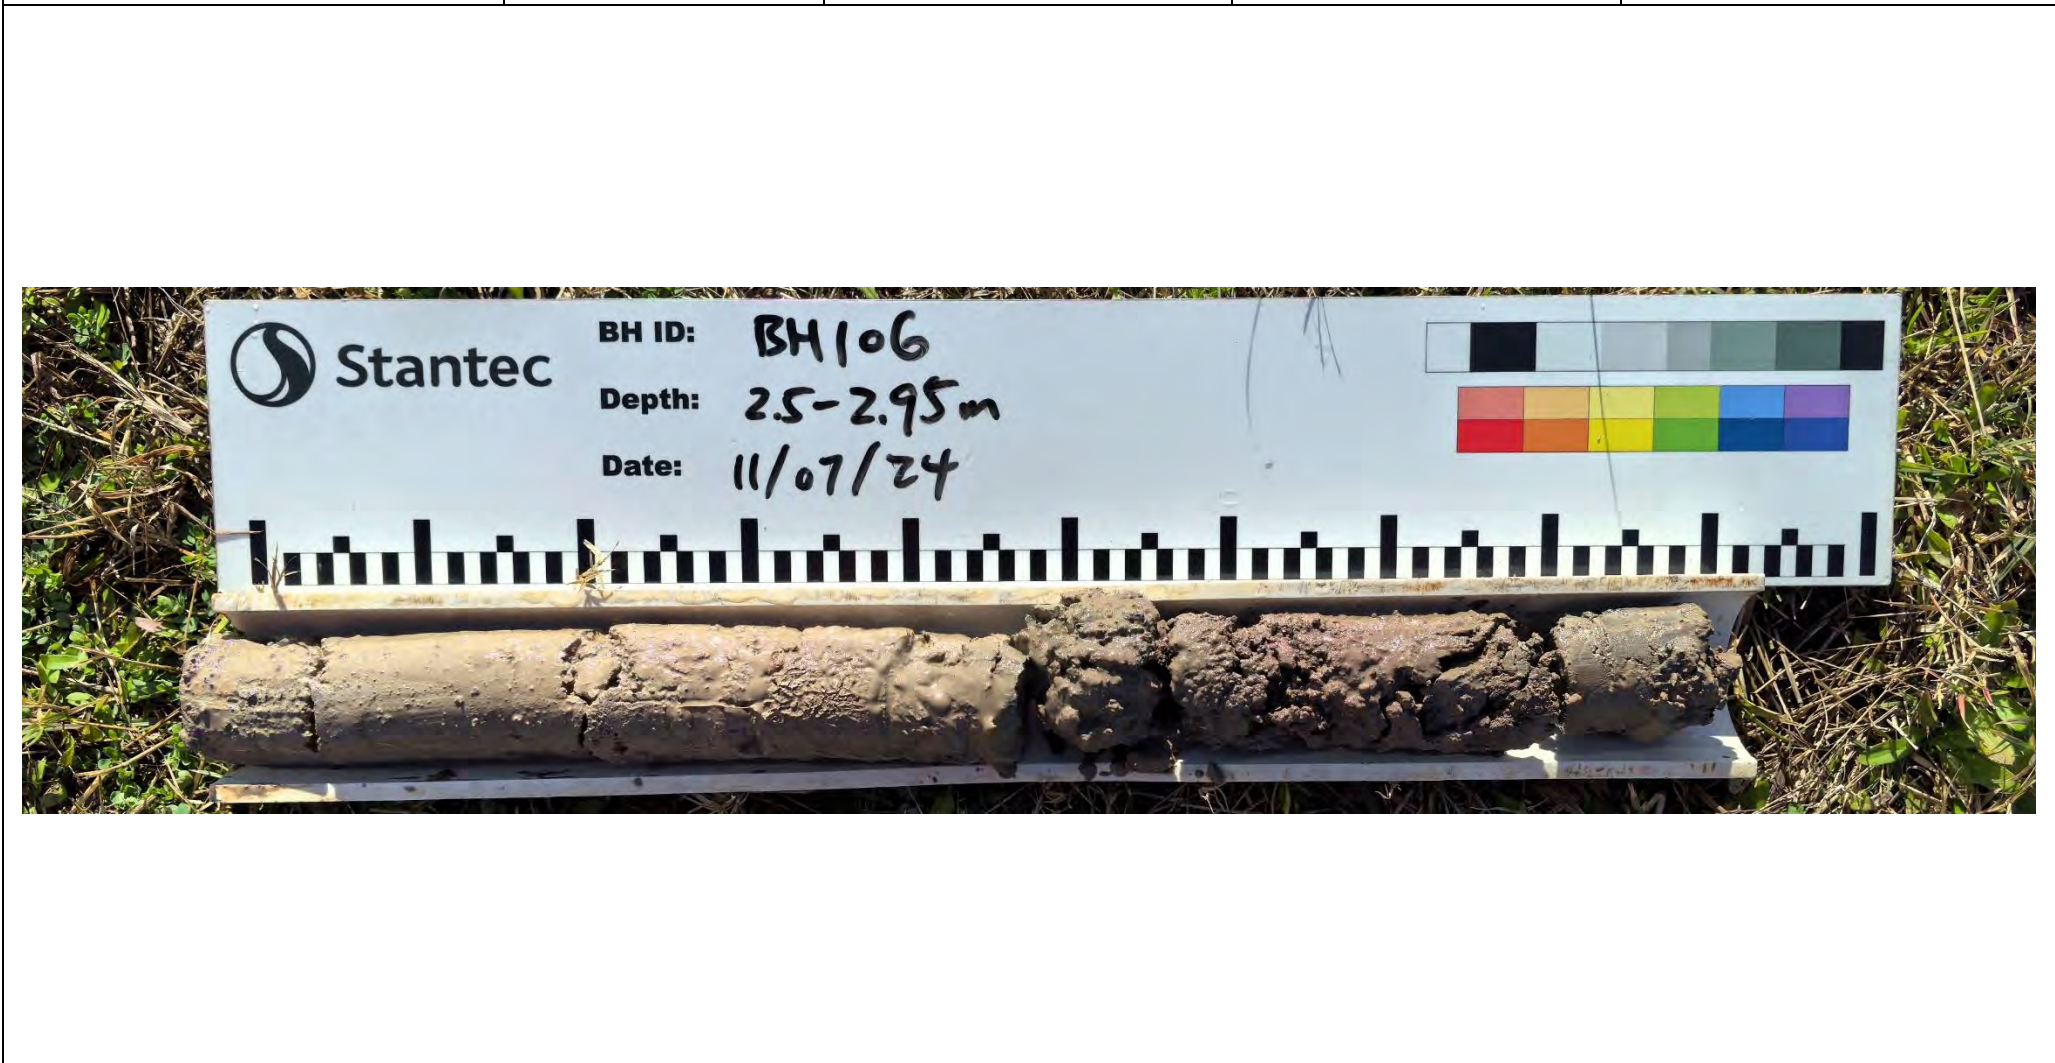
TITLE: Borehole Core Photographs – BH106 Proposed New High School in Jordan Springs			
	PROJECT NO: 304100928	TEST DATE: 11/07/2024	INCLINATION: -90 degree	CORED LENGTH: <b>BOX 1 OF 1</b> 2.5m to 2.95m
	DRILL RIG: MD 300	CONTRACTOR: Traccess Drilling	LOGGED BY: AS	CHECKED BY: TH

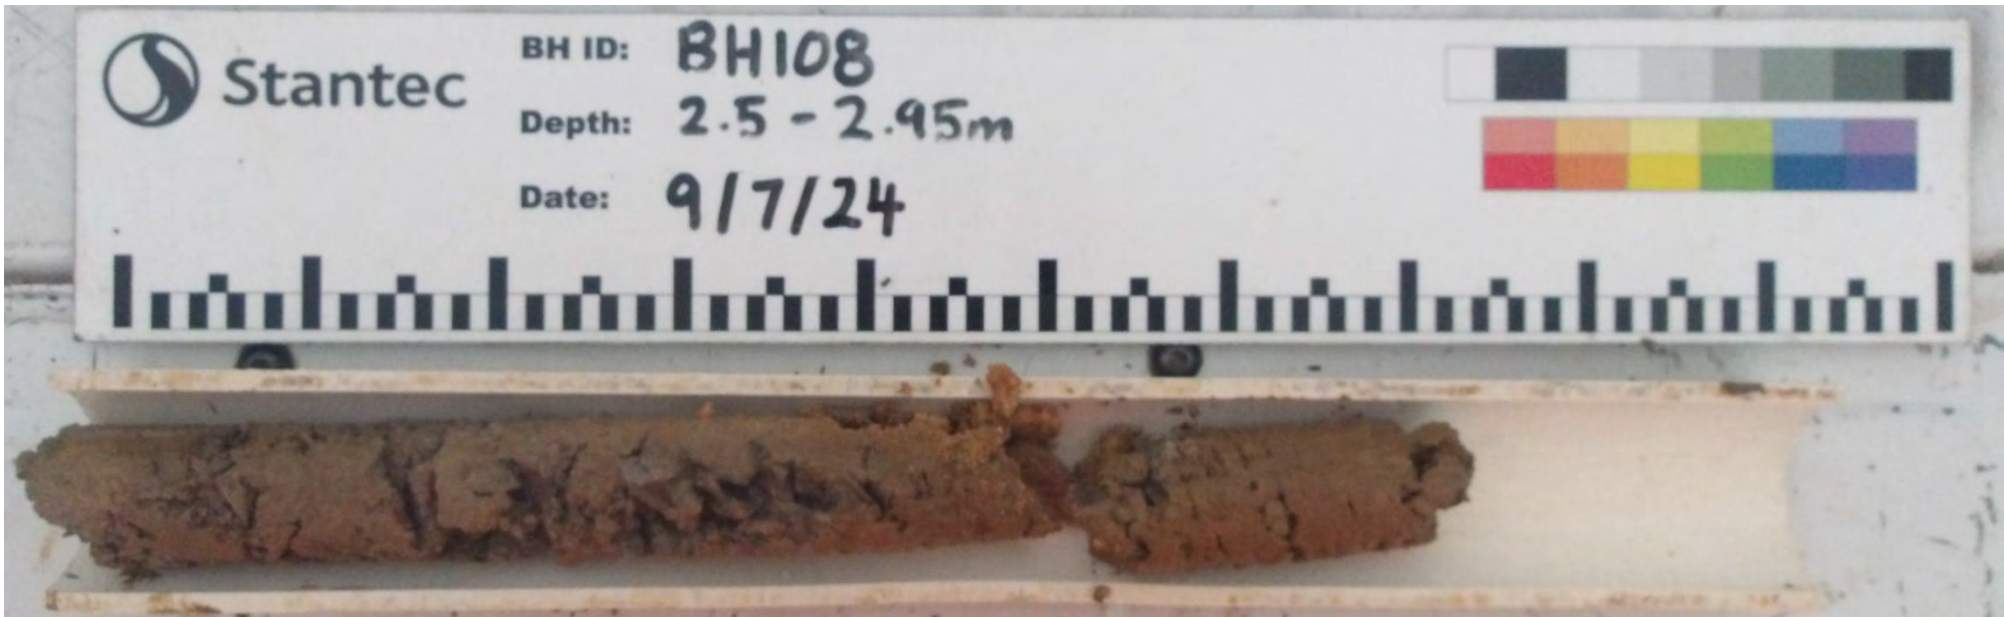
TITLE: Borehole Core Photographs – BH108 Proposed New High School in Jordan Springs			
	PROJECT NO: 304100928	TEST DATE: 09/07/2024	INCLINATION: -90 degree	CORED LENGTH: <b>BOX 1 OF 1</b> 2.5m to 2.95m
	DRILL RIG: MD 300	CONTRACTOR: Traccess Drilling	LOGGED BY: SL	CHECKED BY: TH

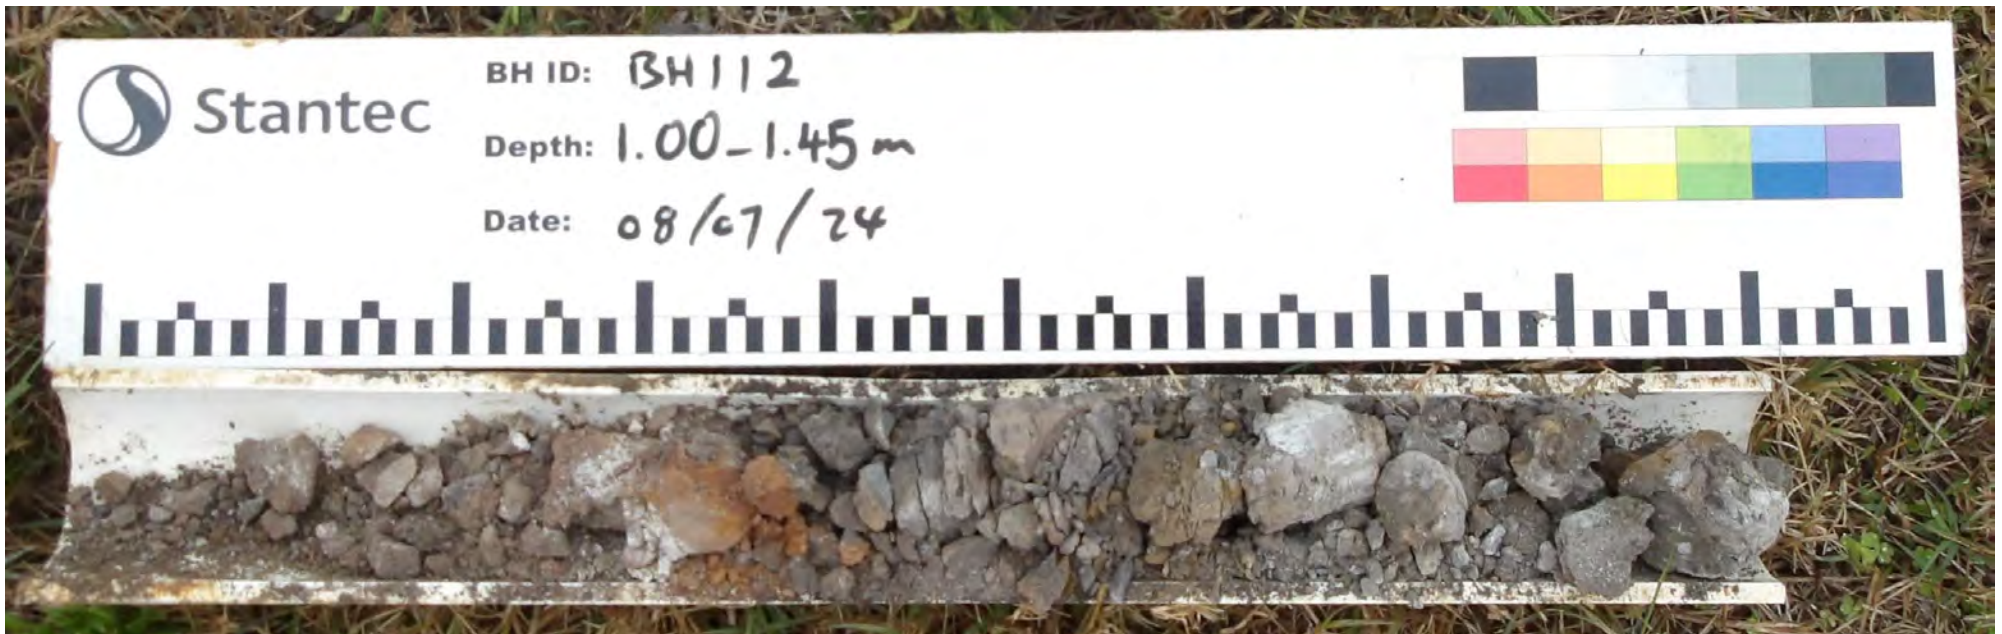
TITLE: Borehole Core Photographs – BH112 Proposed New High School in Jordan Springs			
	PROJECT NO: 304100928	TEST DATE: 08/07/2024	INCLINATION: -90 degree	CORED LENGTH: <b>BOX 1 OF 1</b> 2.5m to 2.95m
	DRILL RIG: MD 300	CONTRACTOR: Traccess Drilling	LOGGED BY: SL	CHECKED BY: TH

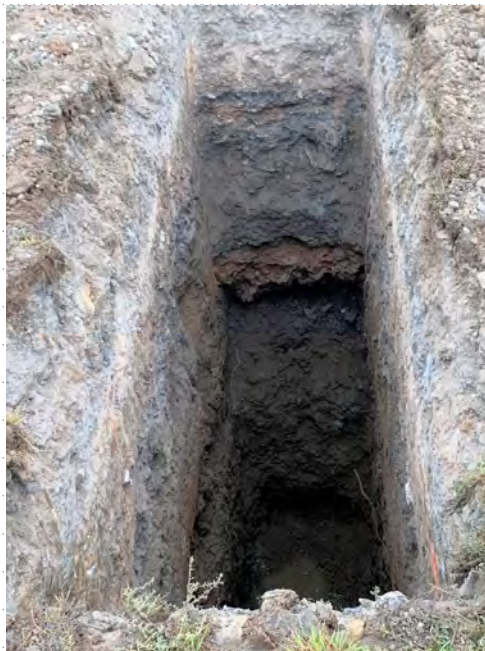
### Sketch & Other Observations

16.50					TEST PIT DISCONTINUED @ 5.20 m UNSTABLE TARGET DEPTH BACKFILLED WITH SPOIL			Groundwater slowly rising through base of pit, infilling pit to 5.10m
