GEOTECHNICAL INVESTIGATION

NSW LAND AND HOUSING CORPORATION

26 – 28, Stevenage & 53 Welwyn Roads, Canley Heights, NSW (BH273)

Report No: 23/1711

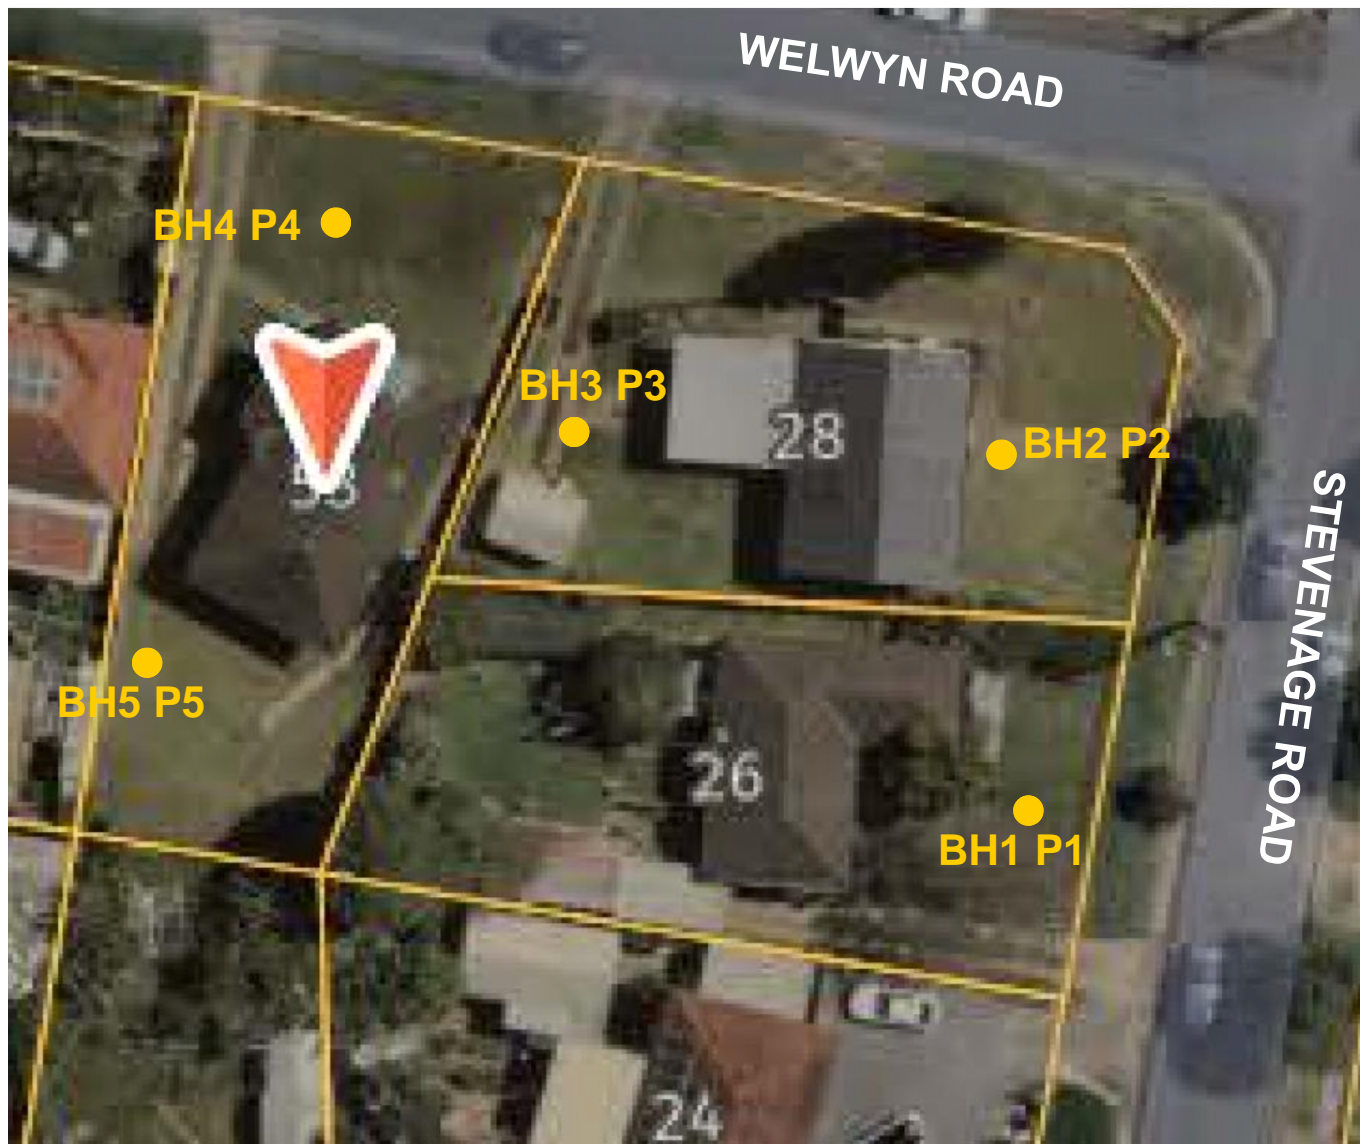
Drawing No: 23/1711

GEOTECHNICAL INVESTIGATION
26-28 STEVENAGE & 53 WELWYN ROADS, CANLEY HEIGHTS
BOREHOLE AND PENETROMETER LOCATIONS

The fieldwork consisted of drilling five (5) boreholes numbered BH1 to BH5, inclusive, at the locations shown on attached Drawing No. 23/1711. The boreholes were drilled using a utility mounted Christie drilling rig, owned, and operated by STS. Soil strengths were assessed by carrying out a Dynamic Cone Penetrometer (DCP) test adjacent to each borehole location.
