HISTORICAL HERITAGE ASSESSMENT

Maitland Mental Health Rehabilitation (MMHR)
Project

Prepared by
Umwelt (Australia) Pty Limited
on behalf of
Health Infrastructure

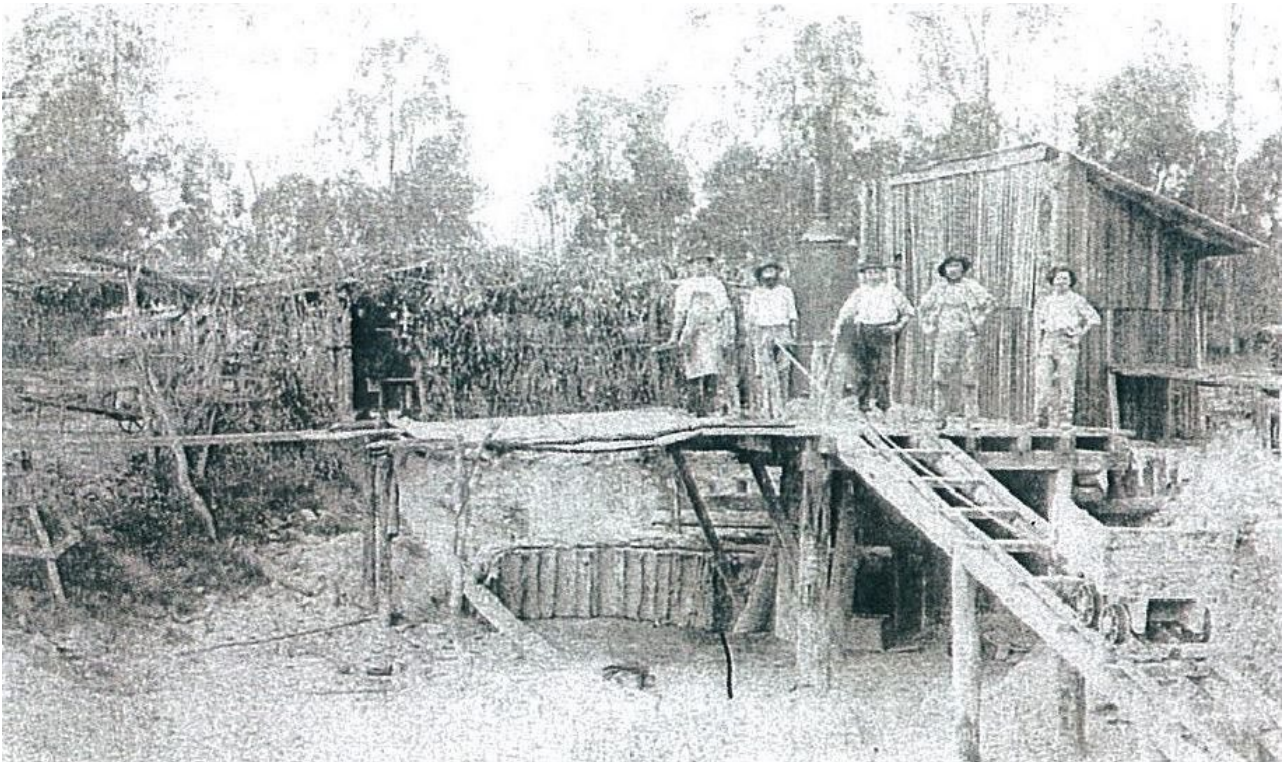
Figure 4.2 1882 photograph of the ‘Smith and Dawson East Maitland brickyard’

Frank Turton was the first to introduce the use of modern machinery to the East Maitland area, having made bricks by the extrusion method (Maitland City Council Library).

The photograph was taken at the time of the Turton purchase

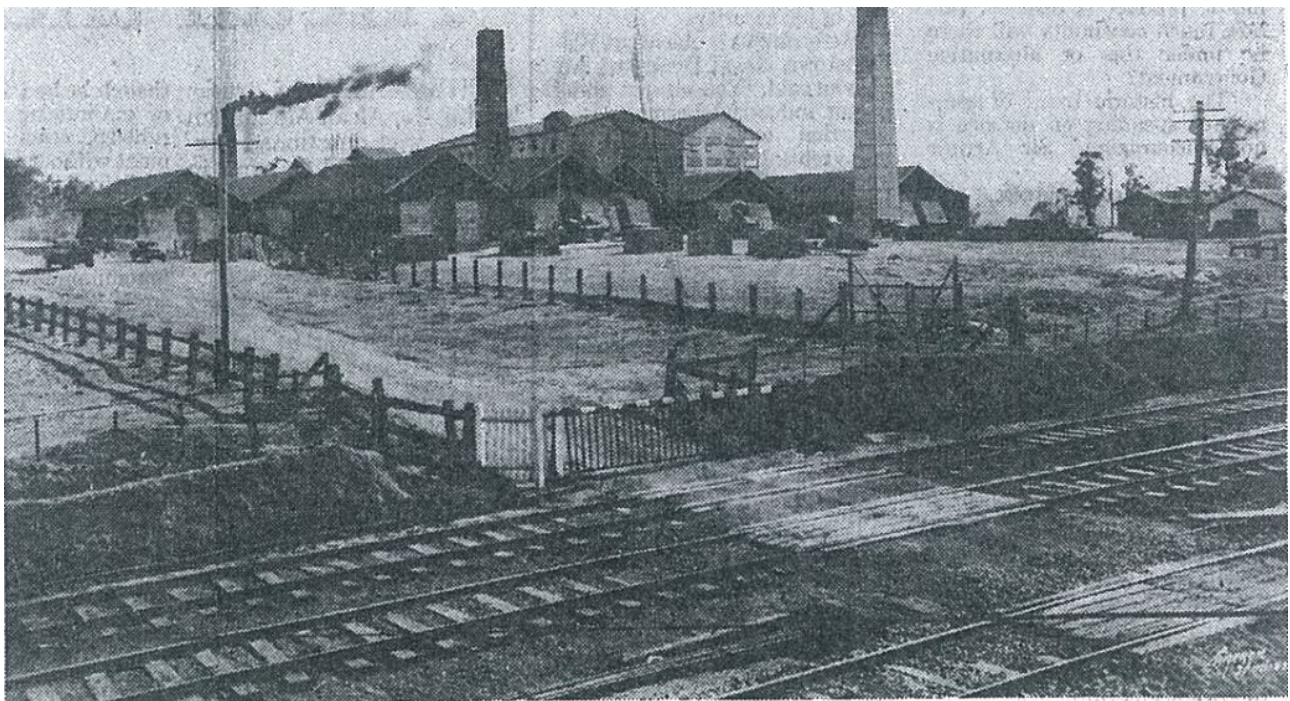
Figure 4.6 The western precinct of the brickworks in 1930

Maitland brickworks as they looked in 1930.

Behind these five buildings was a double-roofed structure with two chimneys that were smaller than the three chimneys visible in the 1932 photograph. To the south of the southernmost chimney, a new multi-storied structure had also been erected.

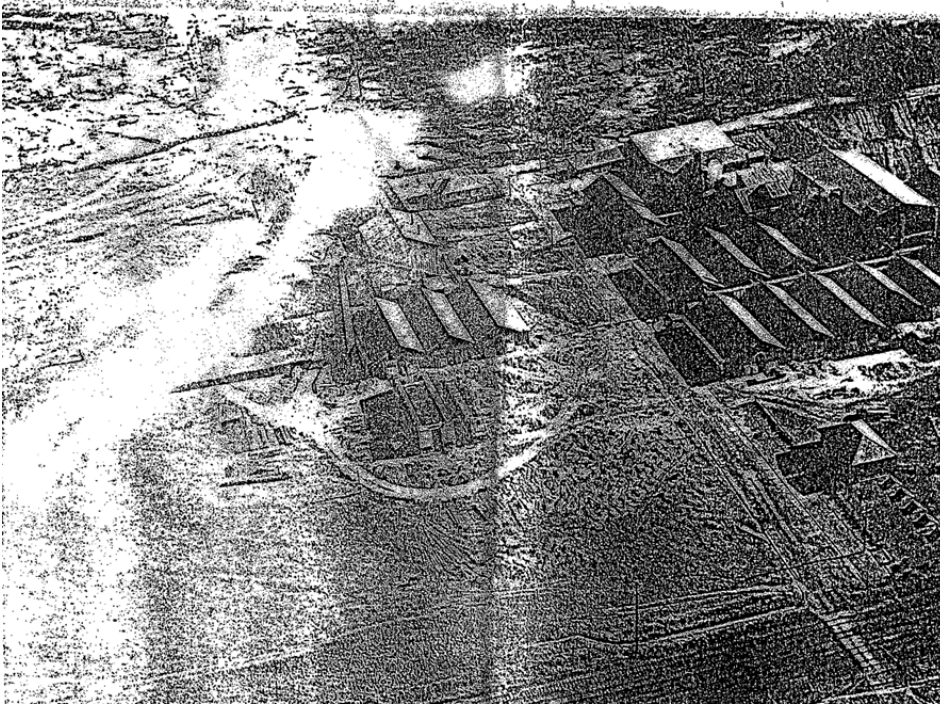
Figure 4.8 1939 view of the western and eastern precincts, facing south (rail line is visible at bottom of frame) *Source: HLA Envirosiences, 2003*

A second photo, also dated 1939 (**Figure 4.8**), provides information regarding the physical configuration of the expansion of the brickworks onto the eastern side of Metford Road, in what is herein referred to as the 'eastern precinct'. The date of this photograph establishes that the eastern expansion of the brickworks was undertaken during the 1930s, with construction works ongoing as late as 1939.

The brick press buildings are visible as completed structures in this photograph. Two rows of downdraft kilns and an associated chimney are shown as being in construction, and these kiln rows are located in alignment with the two rows of kilns on the western site. Also visible is a residence fronting Metford Road, as well as a clay hole.

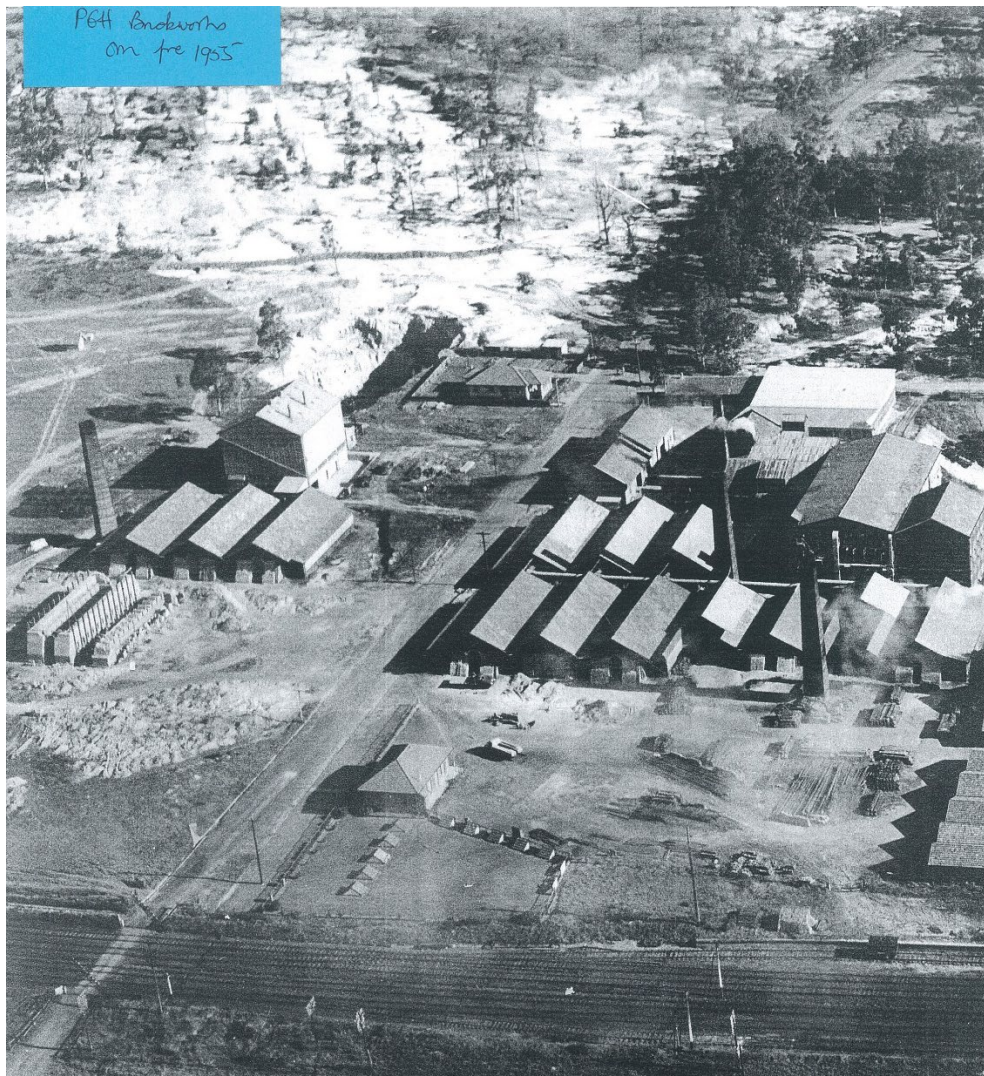
Figure 4.9 Pre 1955 photograph of the brickworks

The vacant area to the south of the main building complex of the eastern precinct, which forms the current Project site, is visible at the top/top left of frame.

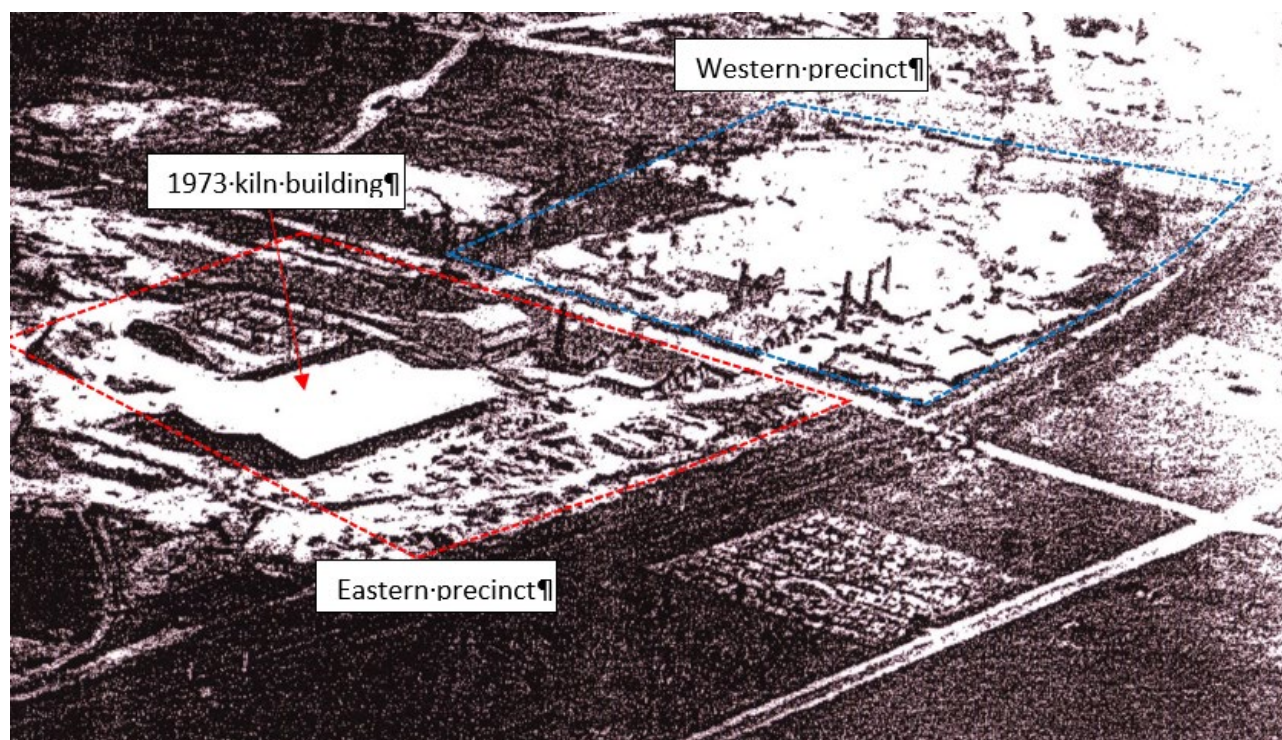
Figure 4.11 View facing southwest across the buildings of Turton's Brickworks, 16 April 1973

In 1972 PGH announced that a new brick and tile plant was to be constructed within and adjacent to the established eastern precinct, which would involve the substantial redevelopment of the existing buildings within this precinct in the following years. A large oil-fired kiln, which was to be opened by the then Premier of NSW in March 1974, was constructed to replace existing coal-fired kilns; this new larger building is visible in a 1973 aerial photograph (refer to **Figure 4.11**).

The current Project site is to the left of frame and not visible

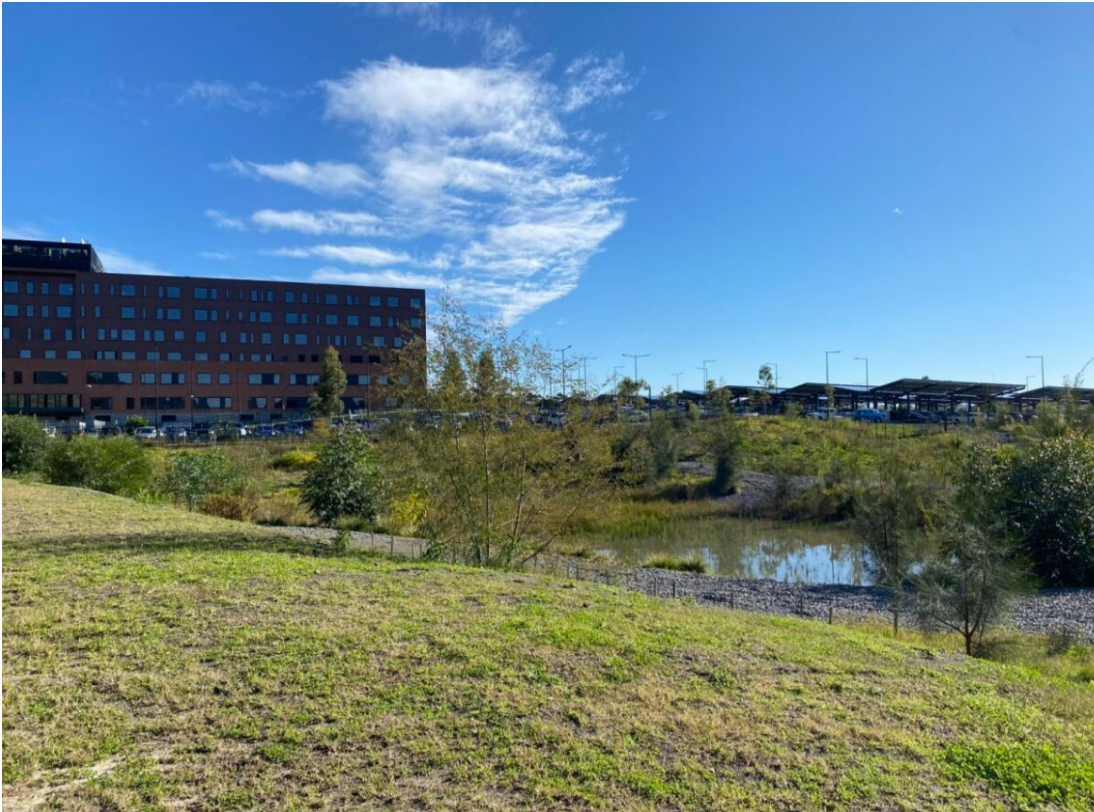
Photo 6.1 **General view of the Project site, facing northwest and showing the existing New Maitland Hospital**

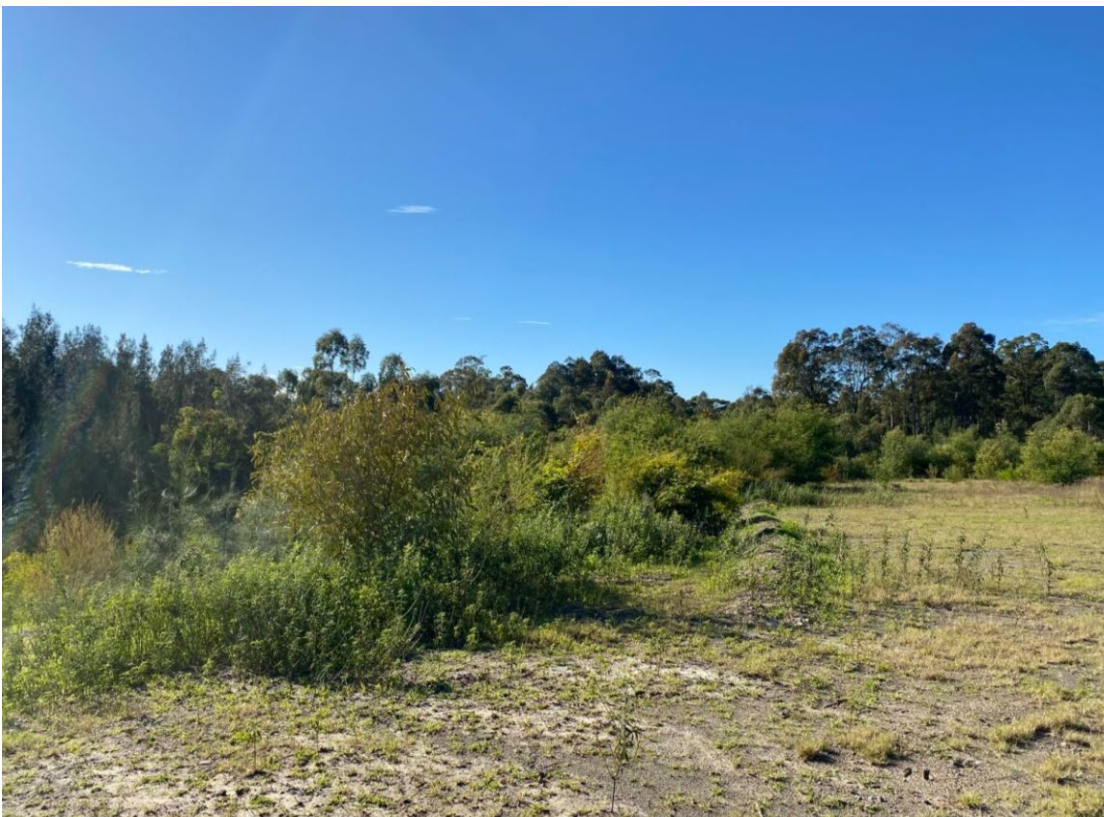
Photo 6.2 **View across the Project site, facing northeast**

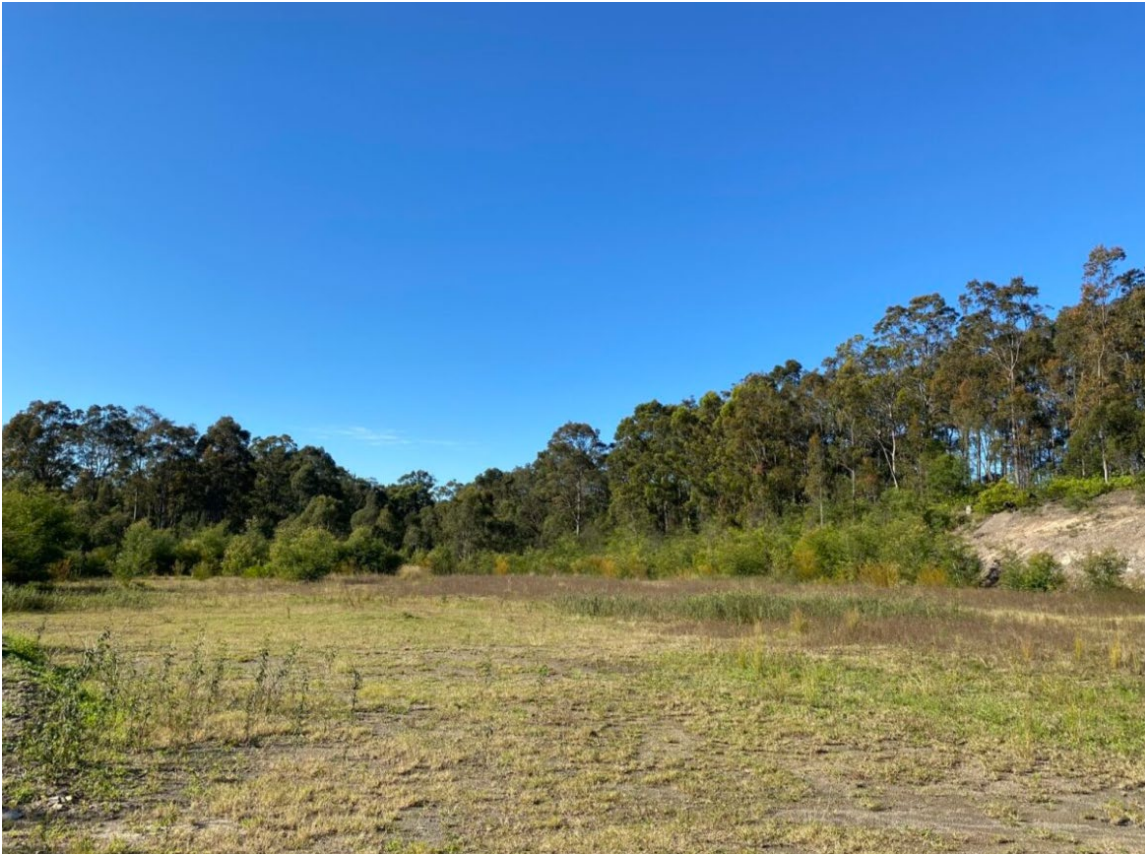
Photo 6.3 **View across the Project site, facing east**

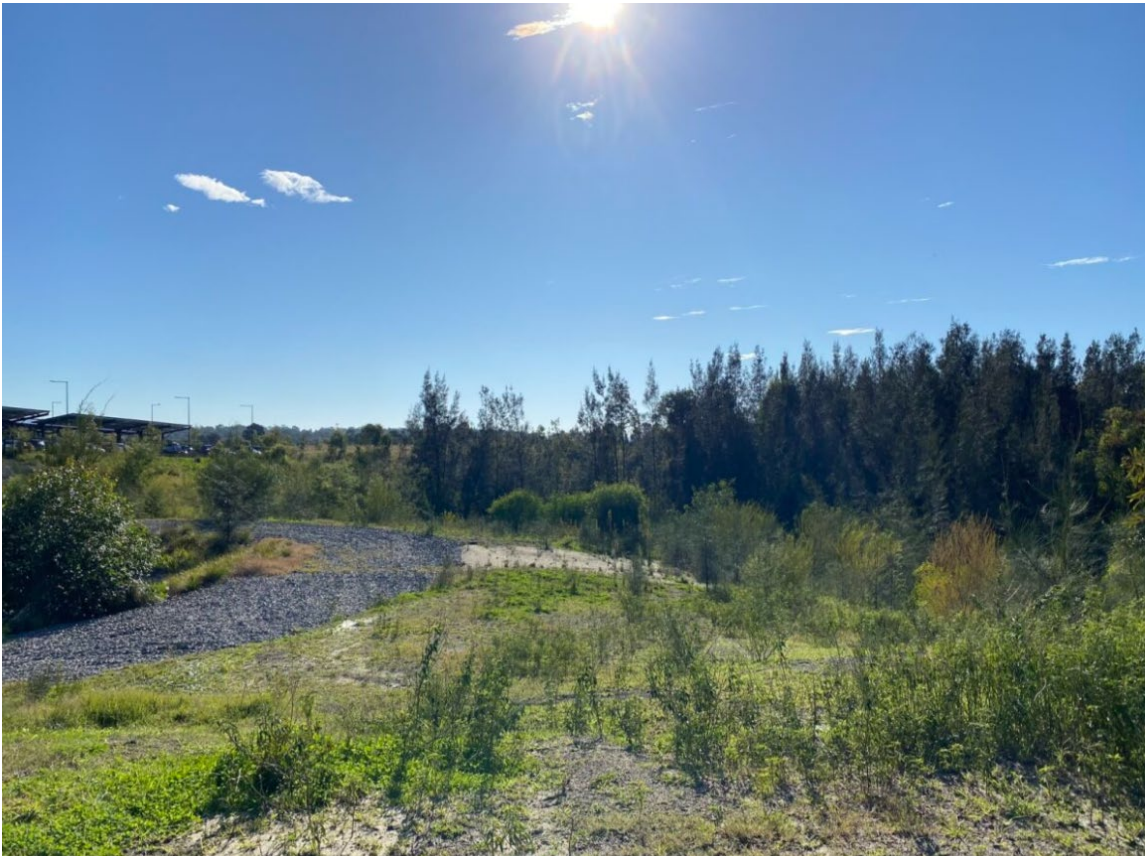
The portion of the railway line that extends across the width of the Project site was not observed to have any distinctive or defining features of particular visual significance; in this area, the railway line presents as a standard rail line comprising standardised rails and sleepers on a slightly elevated embankment or at-grade.

Photo 6.4 **View across the Project site, facing north towards the railway line**

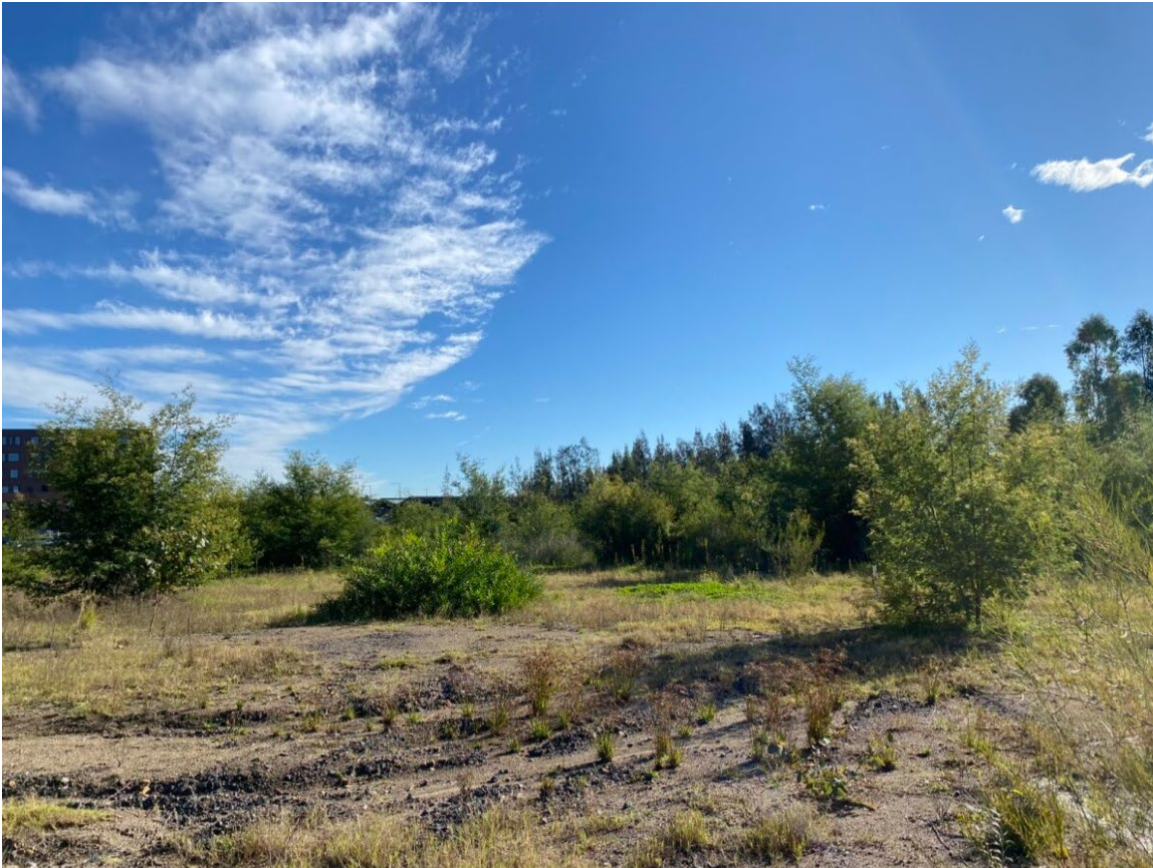
Photo 6.5 View across the Project site, facing west

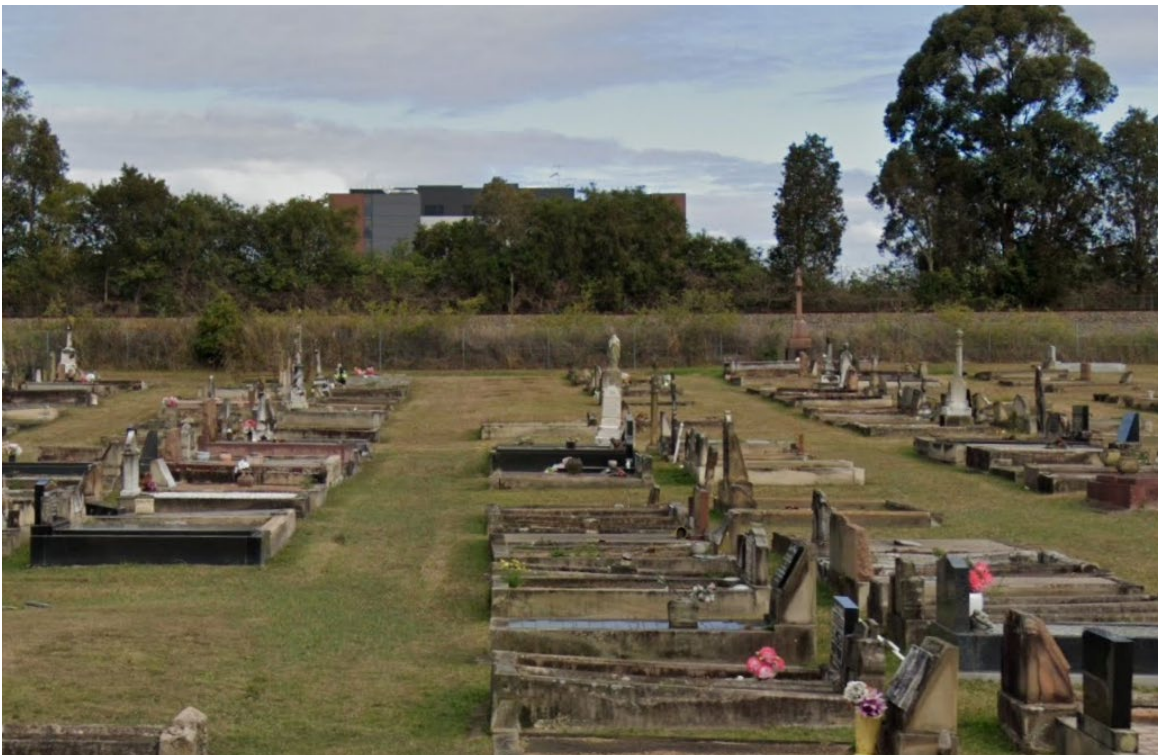
Photo 6.6 View of the new Maitland Hospital in relation to the railway line (indicated by embankment)

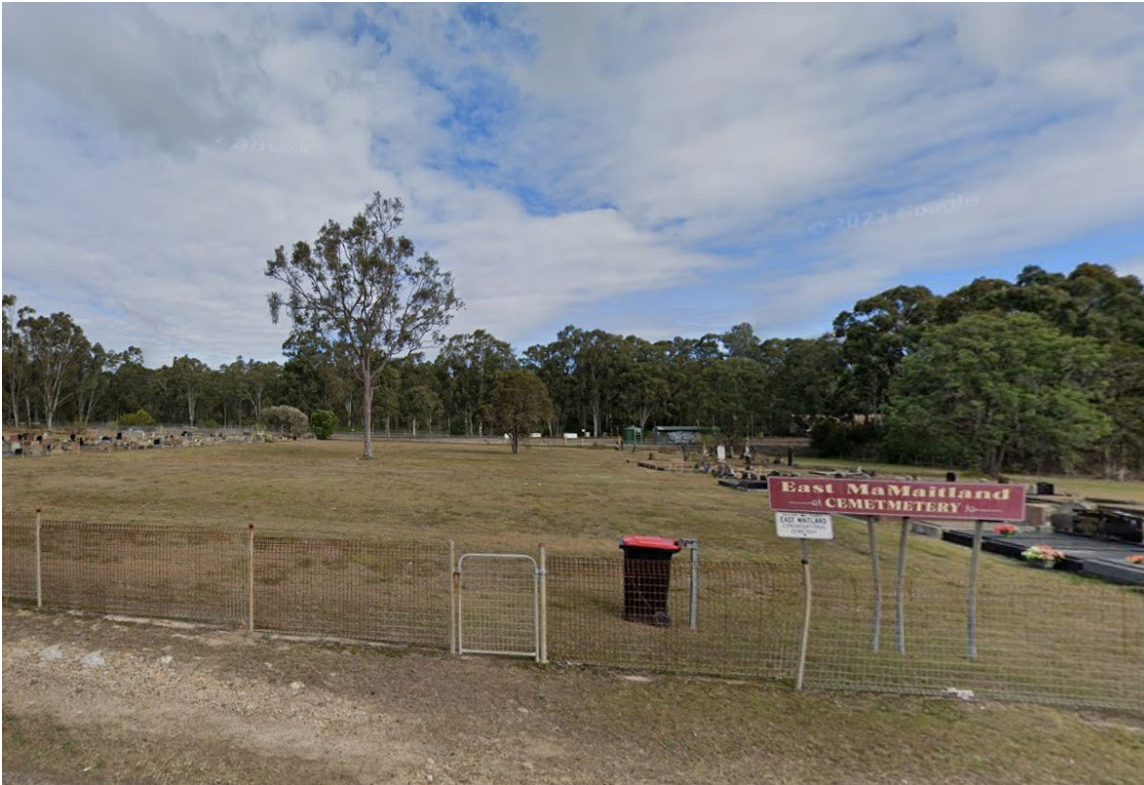
Photo 6.7 Comparative view looking towards the Project site with the railway line visible (at-grade in this area)
