REPORT TO
HEALTH INFRASTRUCTURE

ON
GEOTECHNICAL INVESTIGATION

FOR
LOT 73, MAITLAND HOSPITAL SITE

Date: 28 June 2023
Ref: 35924BFrpt

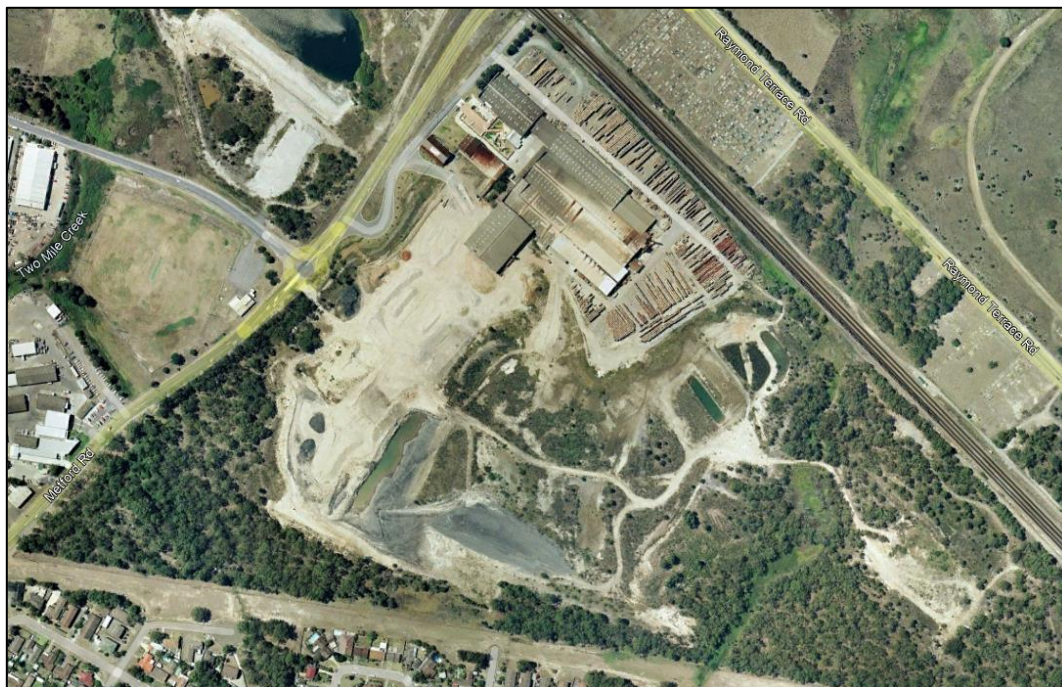
Plate 1 – Historical aerial imagery dated 12 November 2006 showing extent of clay mine (courtesy of Google Earth)

The site has historically been used as part of a quarry and brickworks, commonly known as the Metford Clay Mine, operated by CSR Buildings Products Ltd (CSR), which we understand occurred to some degree since the late 1800's. Based on a review of publicly available historical aerial imagery, evidence of mine works were observed in the 1944 image within the northern portion of the overall Maitland Hospital site, however not within the Eastern Area which is the subject of this report. However, by 1954 the mining works appear to have expanded to be within the subject site, although appears to be relatively minor. The mining then

gradually expanded over the following decades to cover an area shown in Plate 1 below based on the publicly available aerial imagery. The site then appears to undergo remediation in 2017 and then again in 2019 as part of the existing Maitland Hospital development.

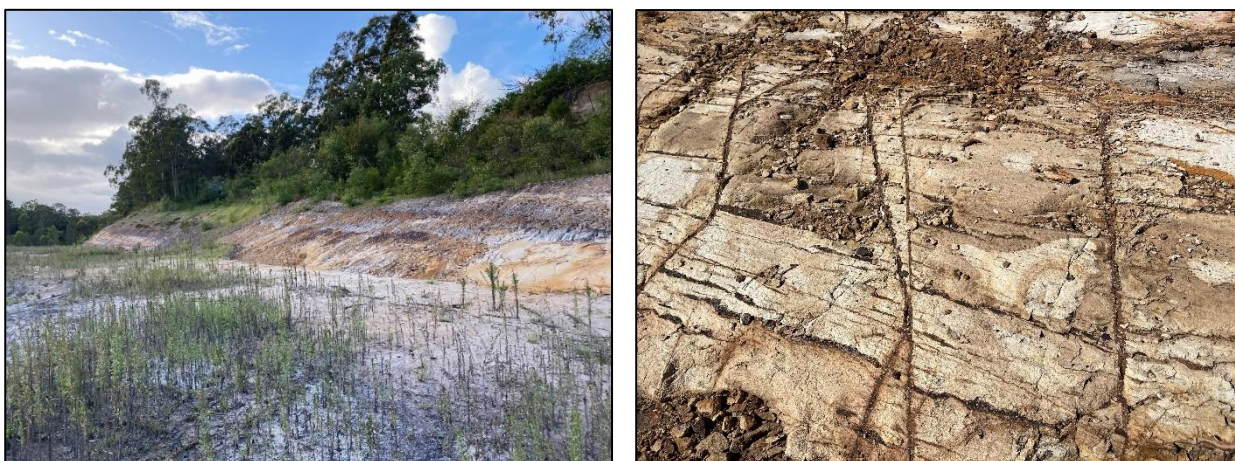
Plate 2 - Left: The exposed outcrop within the southern boundary; Right: Joints observed on the exposed cut face

The site itself appears to have been cut to level, evident by the presence of batter slopes along the north-western and southern boundaries. The excavations are associated with the historical use as a clay mine. The batter slope present along the north-western boundary is about 3m in height, slopes at about 10° to 12° down towards the subject site and is covered by loose gravel over the surface. Beyond the crest of the north-western batter slope is the on-grade car park. The southern batter slope is a maximum of approximately 6m in height and slopes down to the north at approximately 20° to 30°. The batter slope exposes weathered sandstone and siltstone estimated to be up to low strength, with bands of coal. The batter face appears eroded in parts, most likely due to surface run-off from beyond the batter crest. Small to large trees and vegetation are present atop the slope, however the majority of slope is unvegetated. Typically sub-vertical joints and sub-horizontal bedding partings are present in the cut face as shown in Plate 2 below.

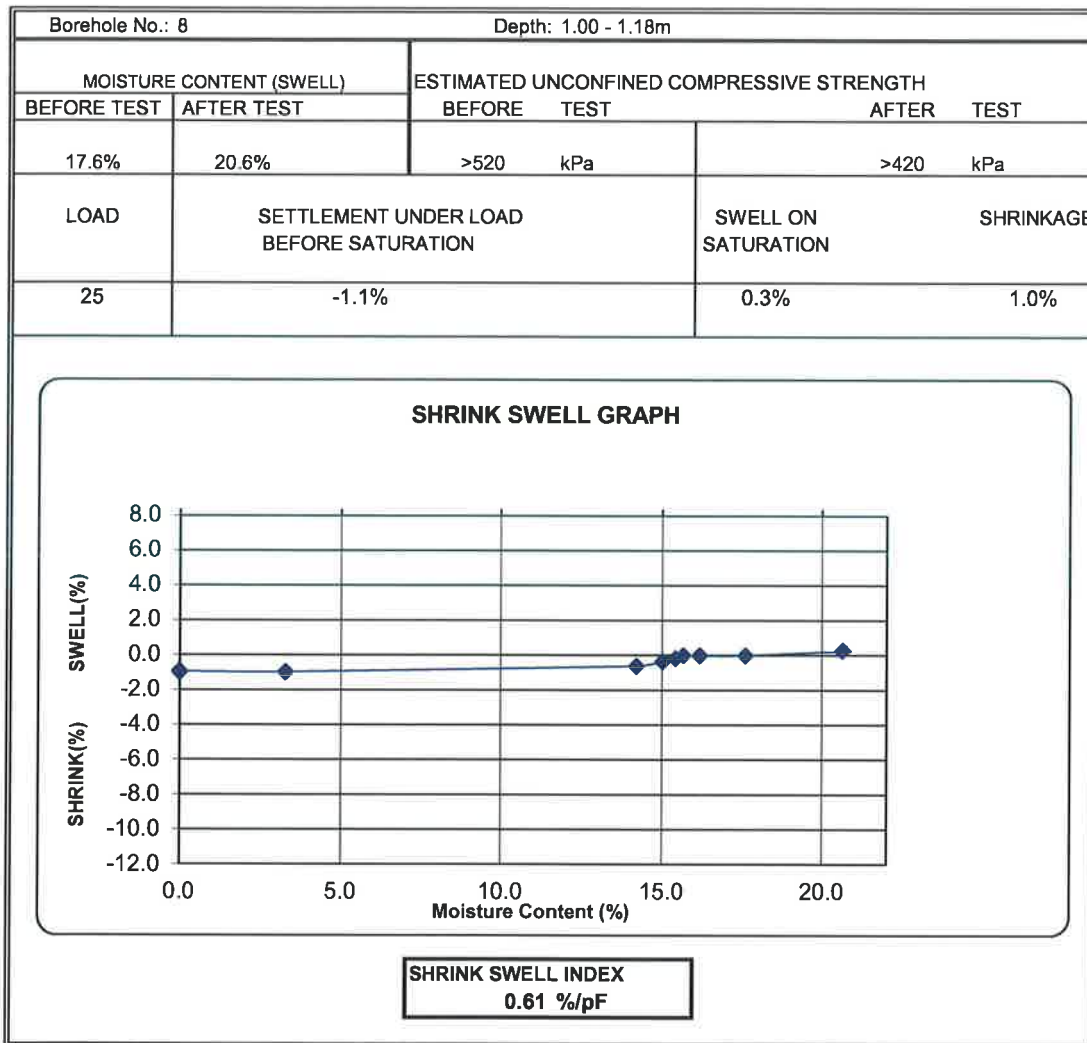
- Suction Value used in calculation = 1.8pF
- Volume Change Coefficient (α) was assumed = 2
- Visually estimated inclusions by volume = 0-5%
- Shrinkage Cracking = Moderate
- Soil Crumbling = none
- Date of receipt of sample: 17/04/2023.

Borehole No.: 14		Depth: 0.50 - 0.90m			
MOISTURE CONTENT (SWELL)		ESTIMATED UNCONFINED COMPRESSIVE STRENGTH			
BEFORE TEST	AFTER TEST	BEFORE	TEST	AFTER	TEST
13.8%	15.7%	360,520	kPa	>300	kPa
LOAD	SETTLEMENT UNDER LOAD BEFORE SATURATION		SWELL ON SATURATION		SHRINKAGE
25	-0.8%		0.1%		0.9%

The results of the shrink-swell testing from samples taken from BH8, BH14 and BH37 returned values of 0.61%/pF, 0.54%/pF and 1.53%/pF, respectively. This indicates the soils tested have a slight potential for shrink/swell reactivity with changes in moisture content. Reference should be made to the attached STS Table C for further details.

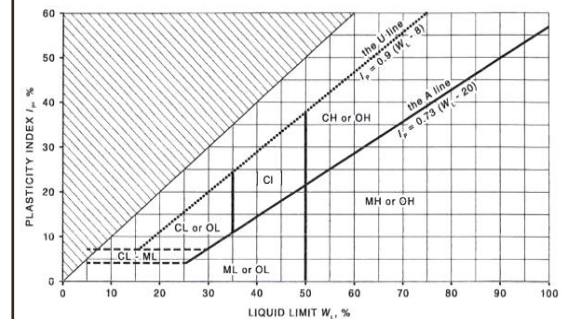
Modified Casagrande Chart for Classifying Silts and Clays according to their Behaviour
