**REMEDIATION ACTION PLAN**

**HOSPITAL REDEVELOPMENT**

TEMORA HOSPITAL, 169-189 LOFTUS STREET, TEMORA, NSW

Date: 13 November 2024 Ref: E35822PRrpt4-RAP

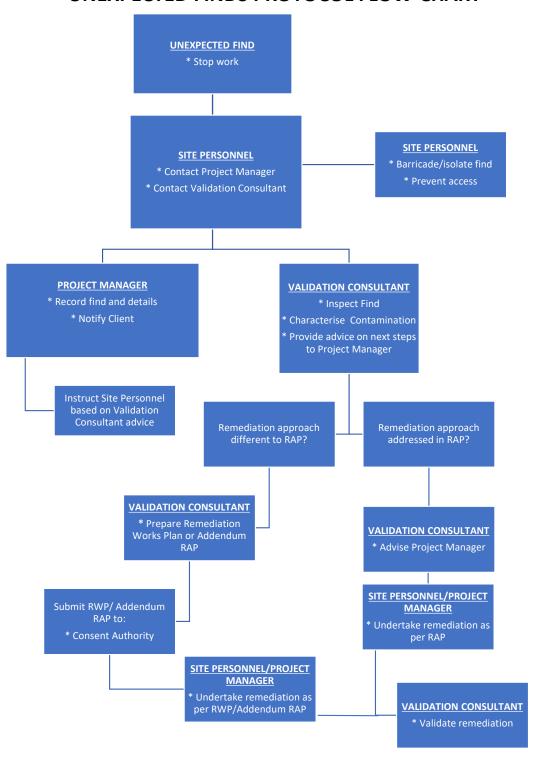
**Appendix F: Unexpected Finds Protocol**

## **UNEXPECTED FINDS PROTOCOL FLOW-CHART**

Residual hazards that may exist at the site would generally be expected to be detectable through visual or olfactory means. At this site, these types of hazards may include suspected friable types of asbestos such as rope or lagging, stained or odorous soils etc. The potential extent of the asbestos pipe identified in the northern section of the site is also unknown and there is a potential that the proposed works could disturb this pipe. The procedure to be followed in the event of an unexpected find is presented below:
