Milton Ulladulla Hospital - Statement of Heritage Impact

Health Infrastructure NSW

Project Name	Milton Ulladulla Hospital – Statement of Heritage Impact
Project Number	25SYD10412
Project Manager	Dr. Gary Marriner
Prepared by	Charlotte Bradshaw
Reviewed by	Karyn McLeod
Approved by	Karyn McLeod
Status	Final
Version Number	V1
Last saved on	10 April 2025

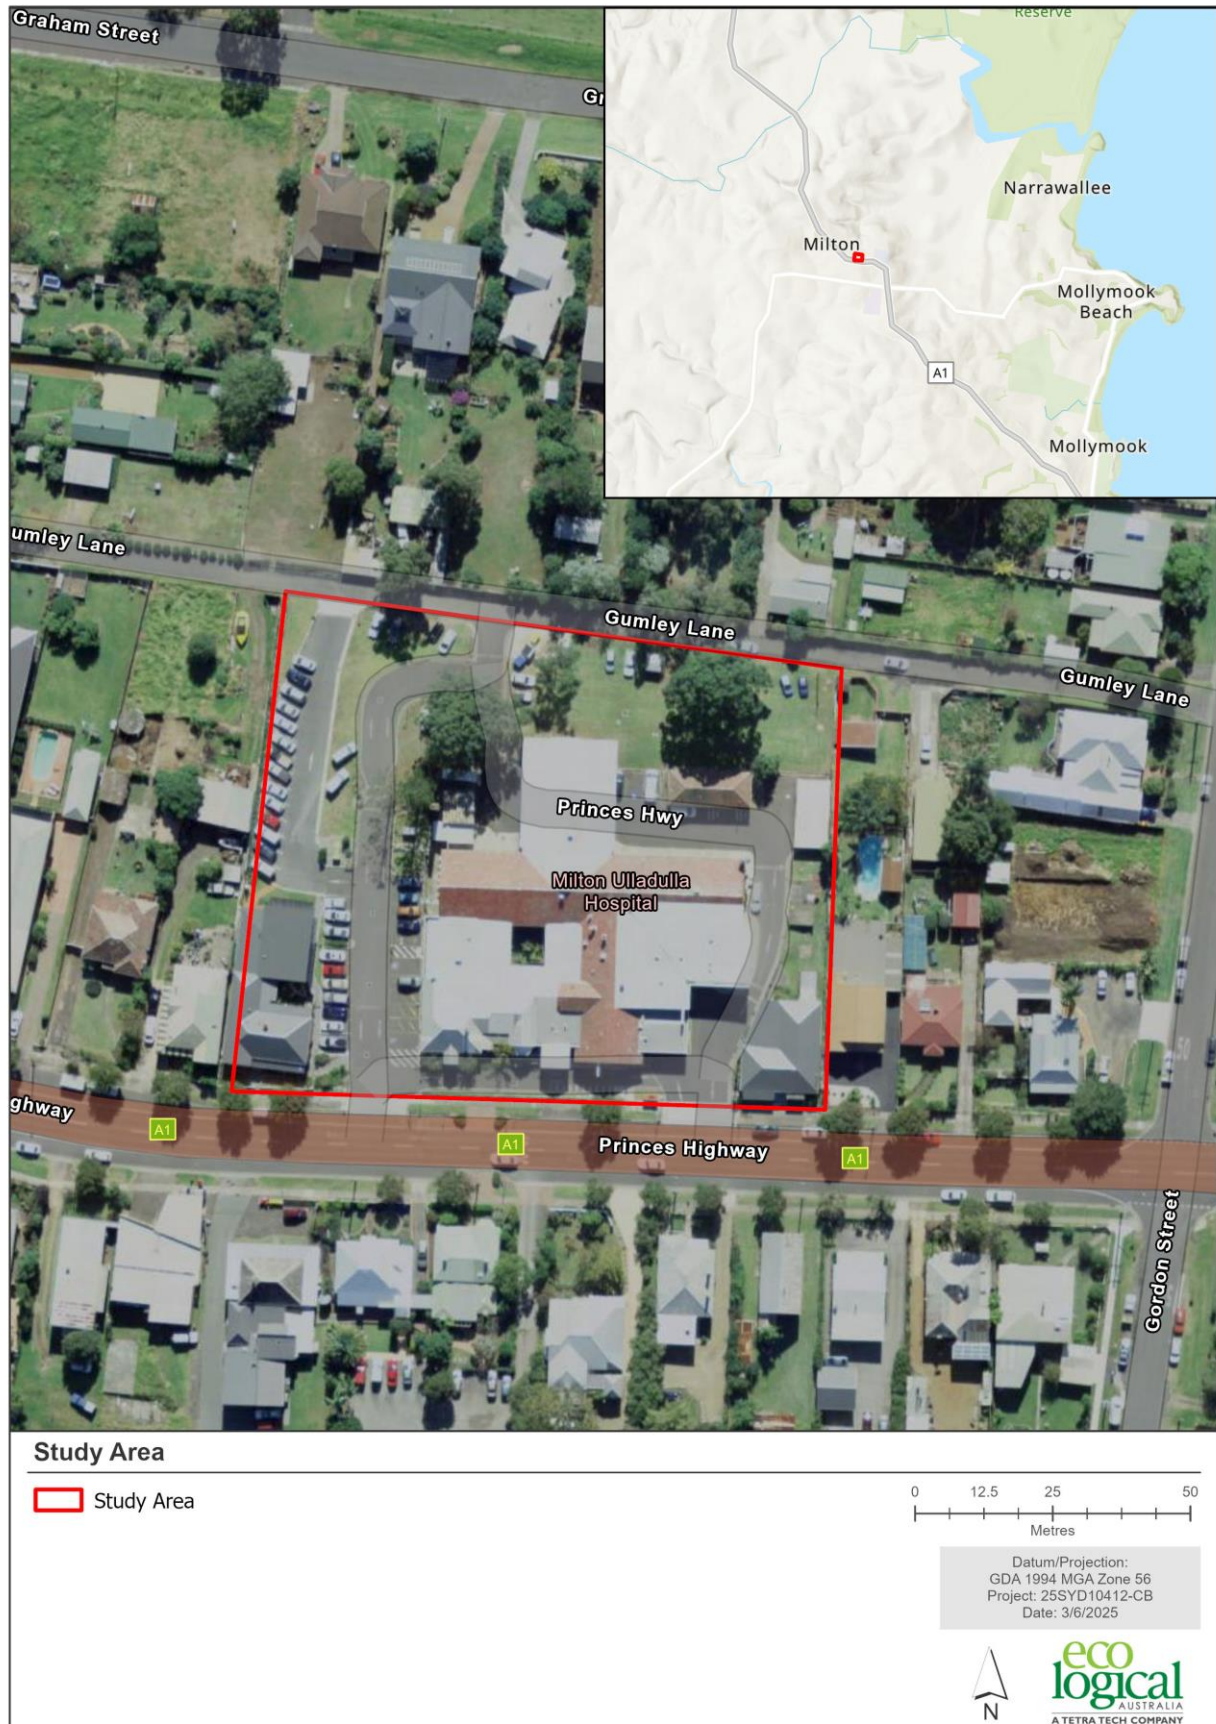
Figure 1: The study area

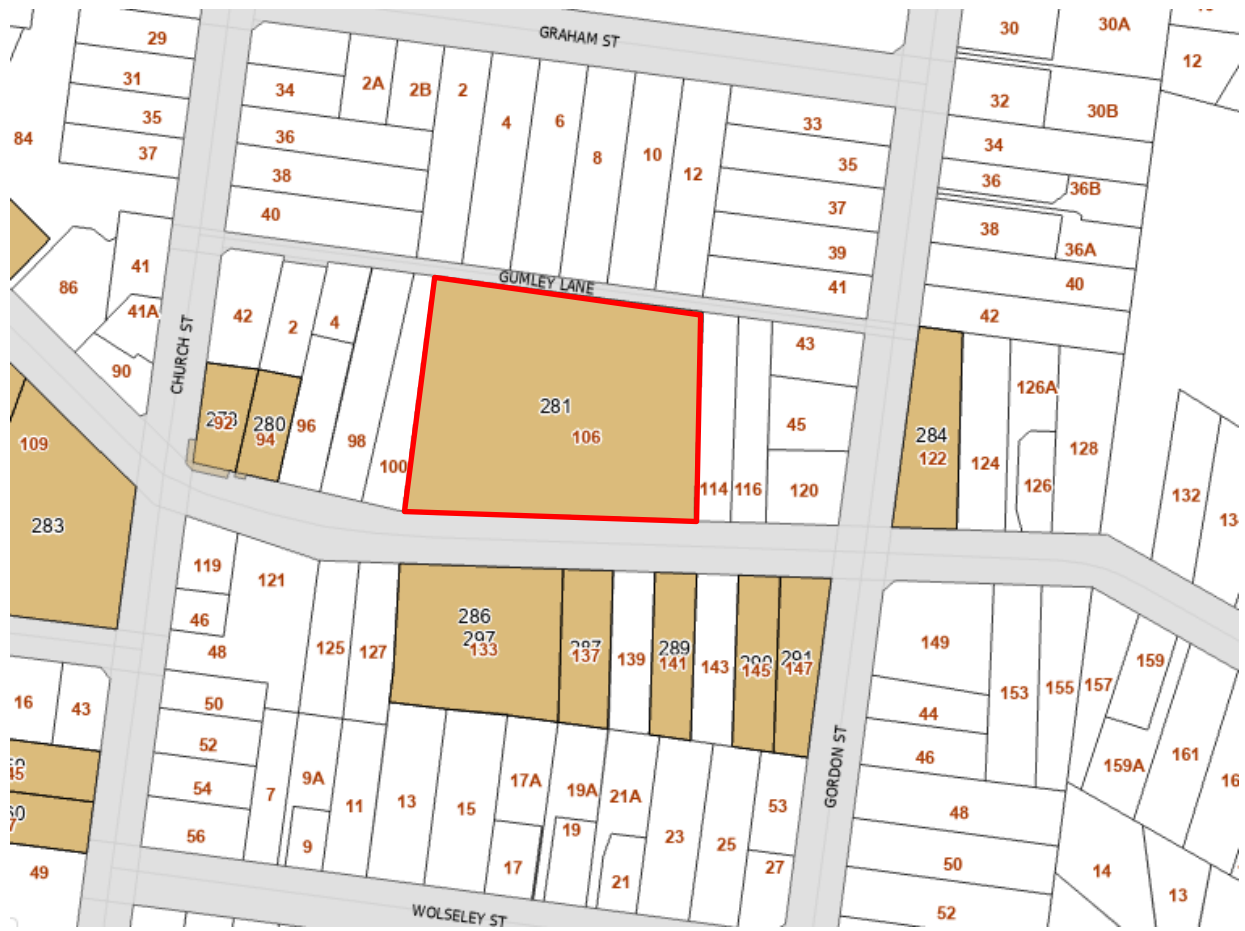
Figure 2: Heritage items within and in proximity to the study area (outlined in red) (Shoalhaven LEP 2014)

A search of all relevant statutory and non-statutory heritage registers identified one (1) heritage item within the study area, and seven (7) additional items within a 50 metre radius (Figure 2). The items identified are presented in Table 1.

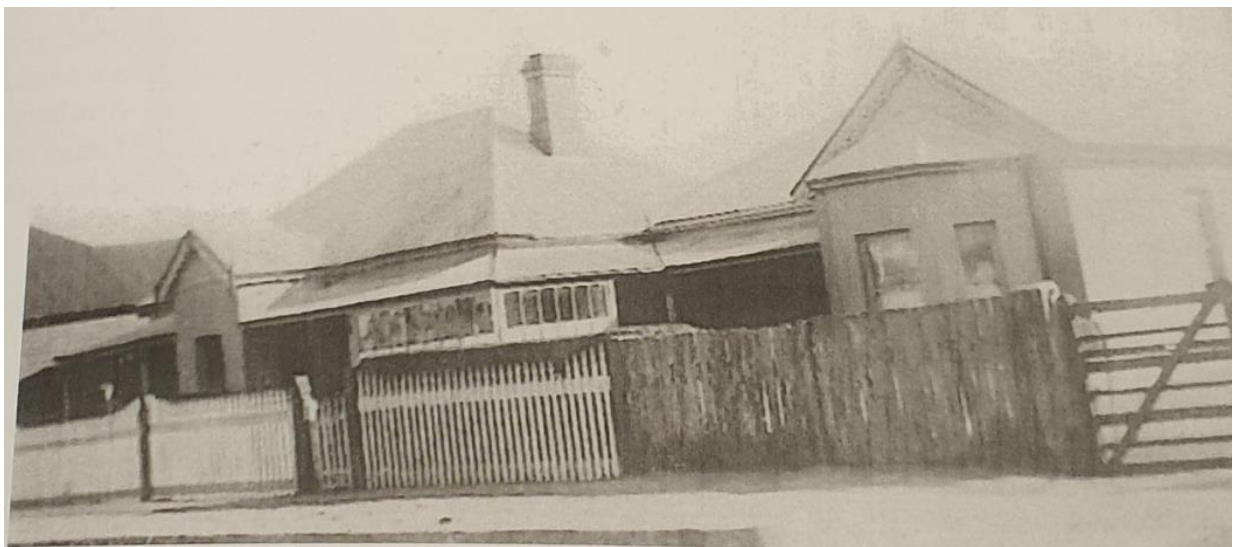
Figure 7: 'Garrad House before renovations' (unknown date) (*Boards, Beds, Babies: A History of Milton-Ulladulla Hospital* by Gregory, P. & Gregory, J., 2013, p. 57)

The phases of Garrad House have not been well documented, however changes can be inferred from photographic material. Garrad House, while a single L-Shaped structure, consists of two buildings linked together and was constructed in at least two phases as two distinct styles have been utilised. The western structure is a simple Federation weatherboard house, and the eastern structure is a rendered masonry building and Italianate in form. Figure 7 shows Garrad House prior to hospital refurbishments at an unknown date. The enclosed veranda, located in the front centre, and the wrap around veranda along the western side of the house have since been removed. The fencing has been removed. The ornate timber barge boards along the eastern gable have also been removed. The current corrugated iron roof is not original, however the chimney appears to be the original chimney. The aluminium window architraves were inserted in the weatherboard structure during the 1970s (SHI, 2020).

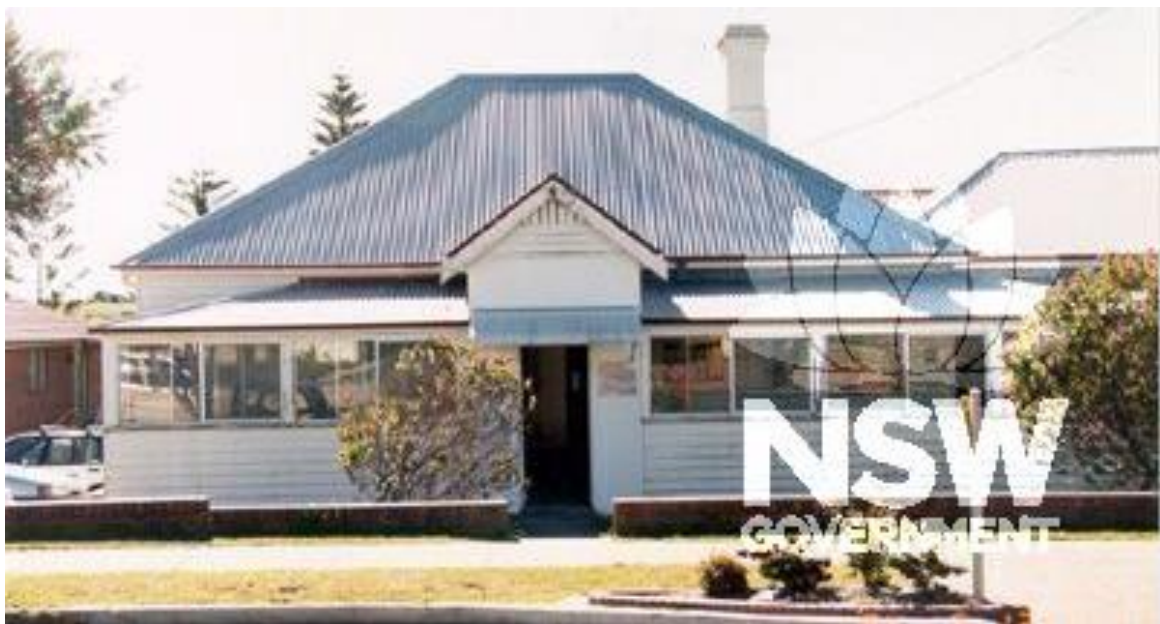
Figure 8: Front view of Garrad House (western structure) prior to removal of enclosed veranda (unknown date) (State Heritage Inventory, 2020)

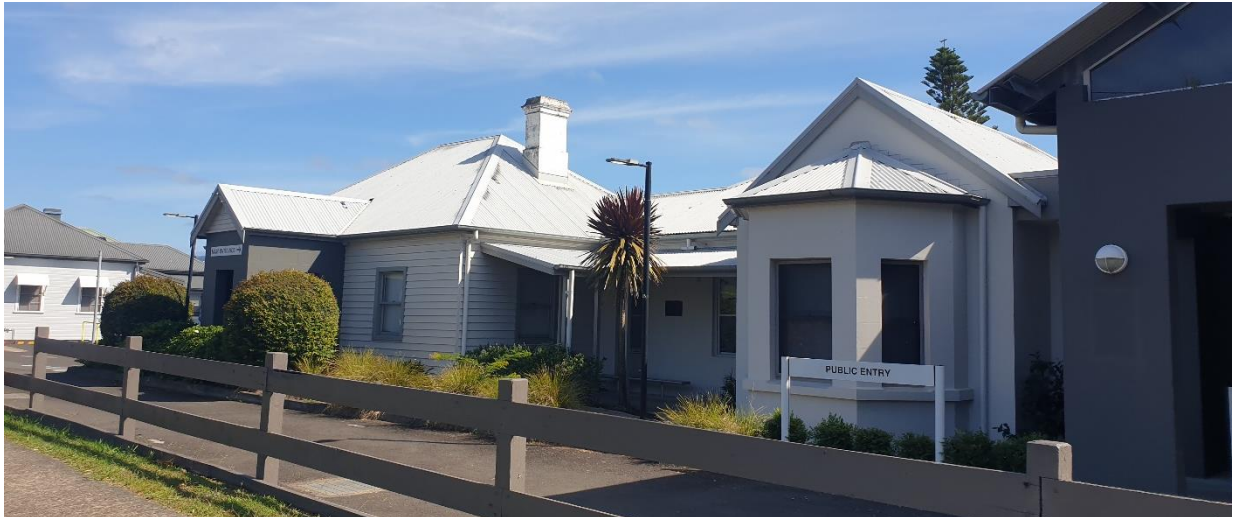
Figure 9: View of Garrad House on 10 March 2025

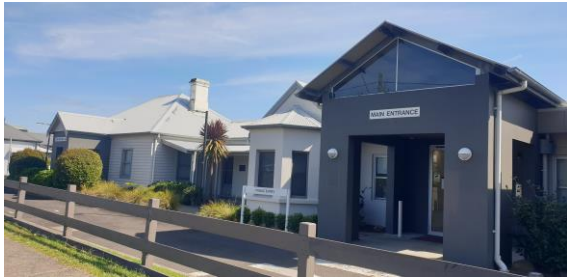
Figure 10: View north-west, showing the hospital main entrance, the weatherboard 'Garrad House' (left) and rendered masonry building (right)

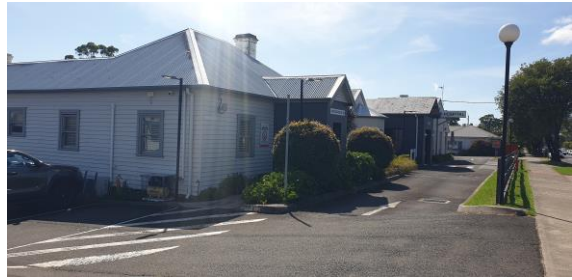
Figure 11: View east, showing weatherboard 'Garrad House' from hospital carpark entrance

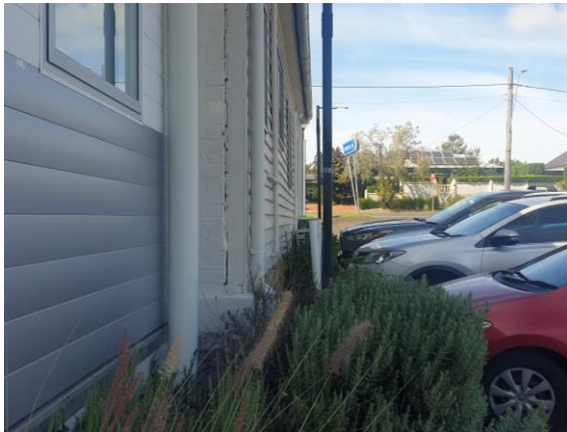
Externally, the weatherboard structure, including original weatherboard and rubblestone footings (Figure 13), are in good condition. From the exterior, the northern extent of Garrad House is distinct from the hospital extensions (Figure 12). The northern rendered masonry structure is also in good condition.

Figure 12: View south, showing original northern exterior wall of 'Garrad House' abutting newer hospital extension

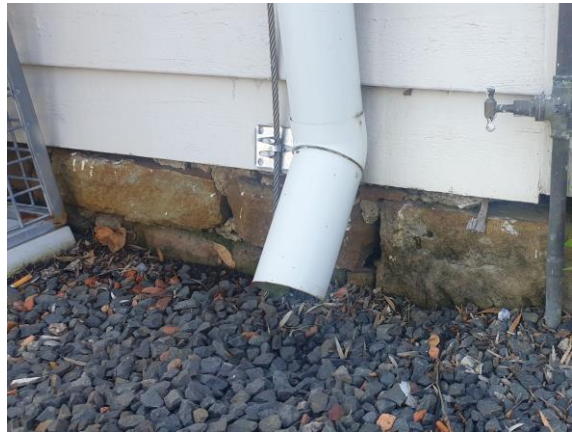
Figure 13: Rubblestone footings of 'Garrad House'

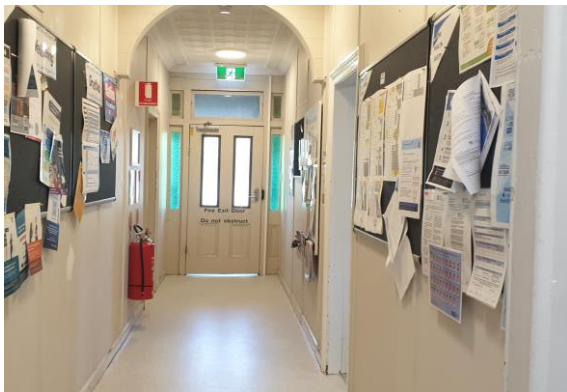
Internally, Garrad House has been highly modified to fit the use and purpose of the building as a hospital. There are some elements of the original building remaining, such as the entrance way including the front door, archway and decorative pressed tin ceiling features (Figure 14), and the original hall and room layout has been retained.

Figure 14: View north from the interior of 'Garrad House' showing altered front door, original fanlight and stained glass side lights, hall, arch, original architraves and decorative, pressed tin ceiling

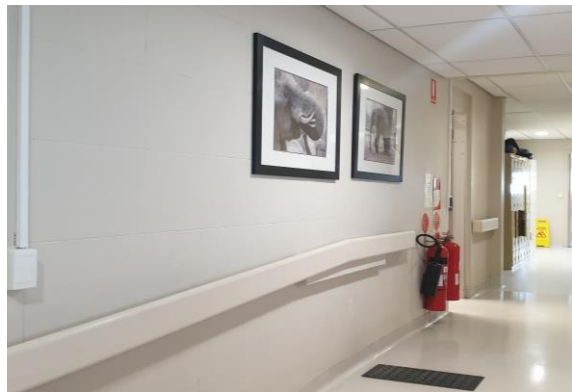
Figure 15: Hospital interior showing the original northern wall of Garrad House and extensions

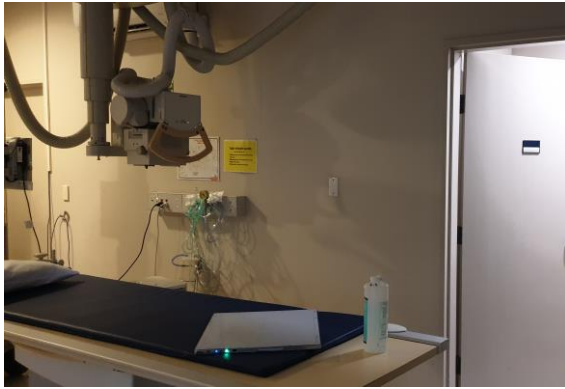
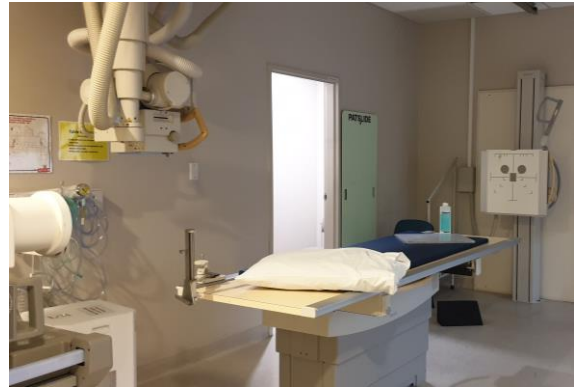
The CT Scanning/X-Ray Room was inspected to ensure that there is no impact to the original footprint of Garrad House and no shared walls would be impacted (Figure 16; Figure 17). The CT Scanning/X-Ray Room is located in the eastern wing of the hospital and well outside of the original Garrad House footprint and was a later extension

Figure 16: X- CT Scanning/X-Ray Room and wall proposed to be removed for room expansion

Figure 17: CT Scanning/X-Ray Room and wall proposed to be removed for room expansion

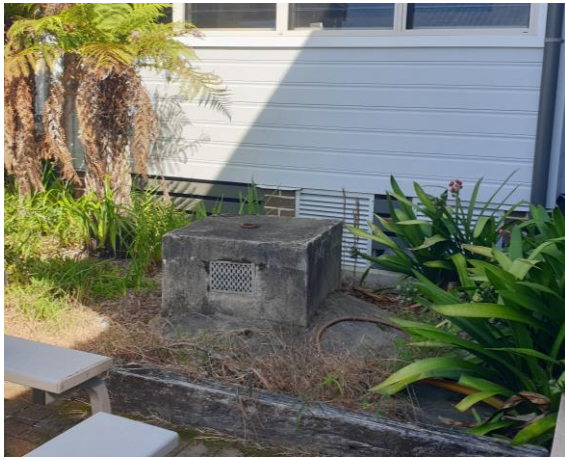
Figure 18: View of the domed water well to the east of the cancer care centre

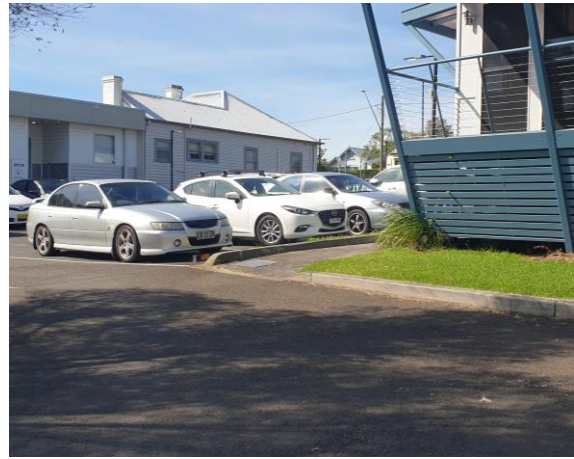
Figure 19: View south-west, showing the location of the proposed bed extension for the cancer care centre and the view to Garrad House and surrounding heritage items

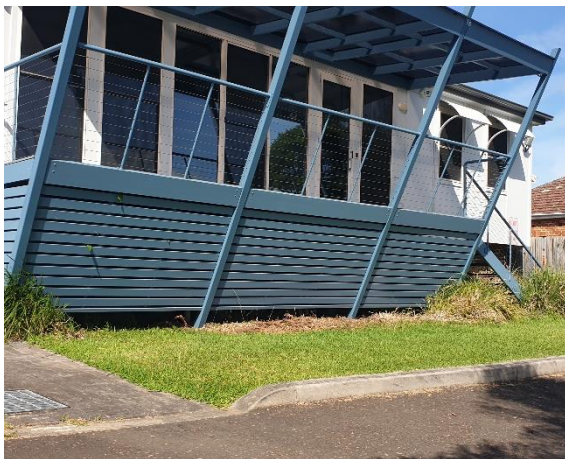
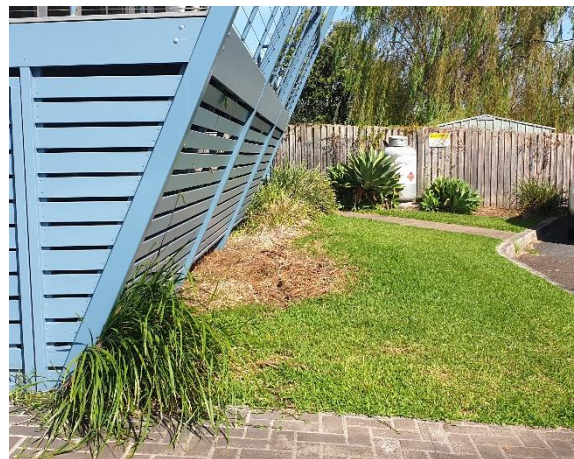
The Cancer Care Centre is a modern building, built within the last 20 years (Figure 20; Figure 21). The domed water well was inspected. The Cancer Care Centre has been constructed around the well (Figure 18). The proposed bed extension for the Cancer Care Centre is along the northern extent of the existing building, away from the well (Figure 20; Figure 21). The bed extension has a clear vantage point of Garrad House as well other heritage items opposite the hospital (Figure 20).

Figure 20: The location of the proposed bed extension for the cancer care centre

Figure 21: View west, showing the location of the proposed bed extension for the cancer care centre

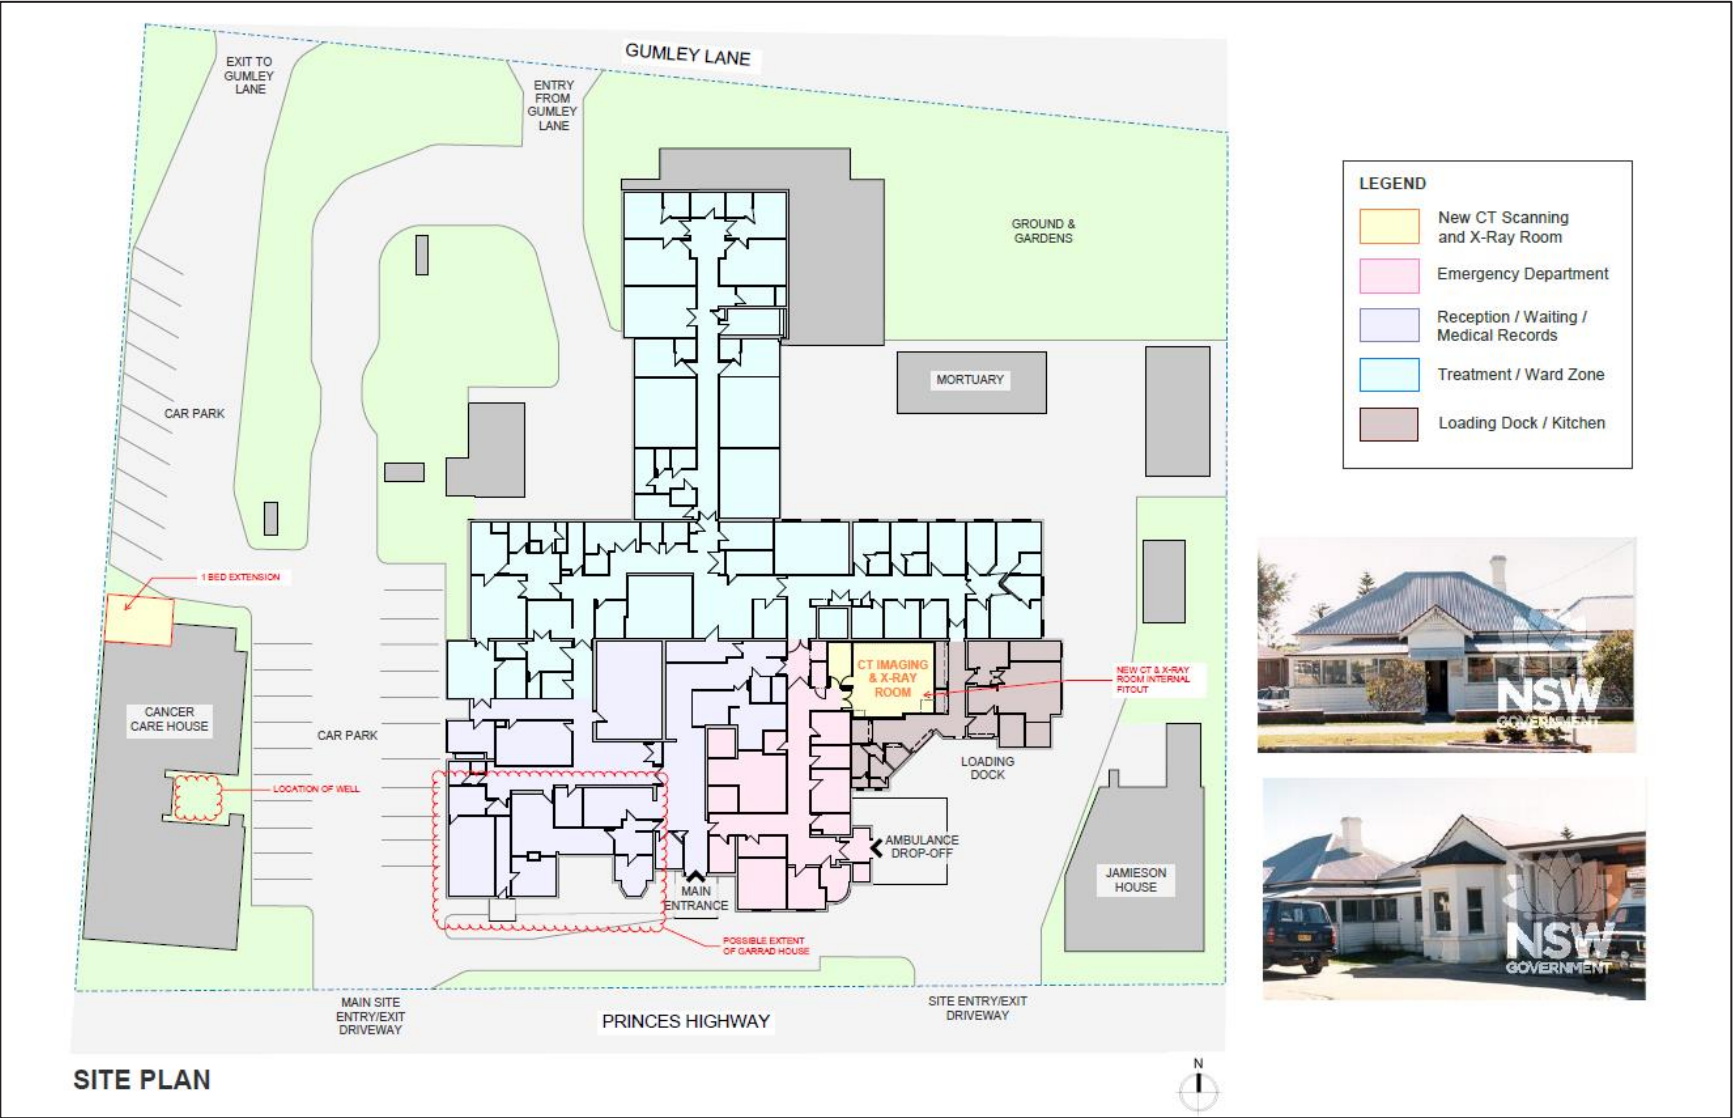
Figure 22: Site plan of works (Johnstaff, 2025)

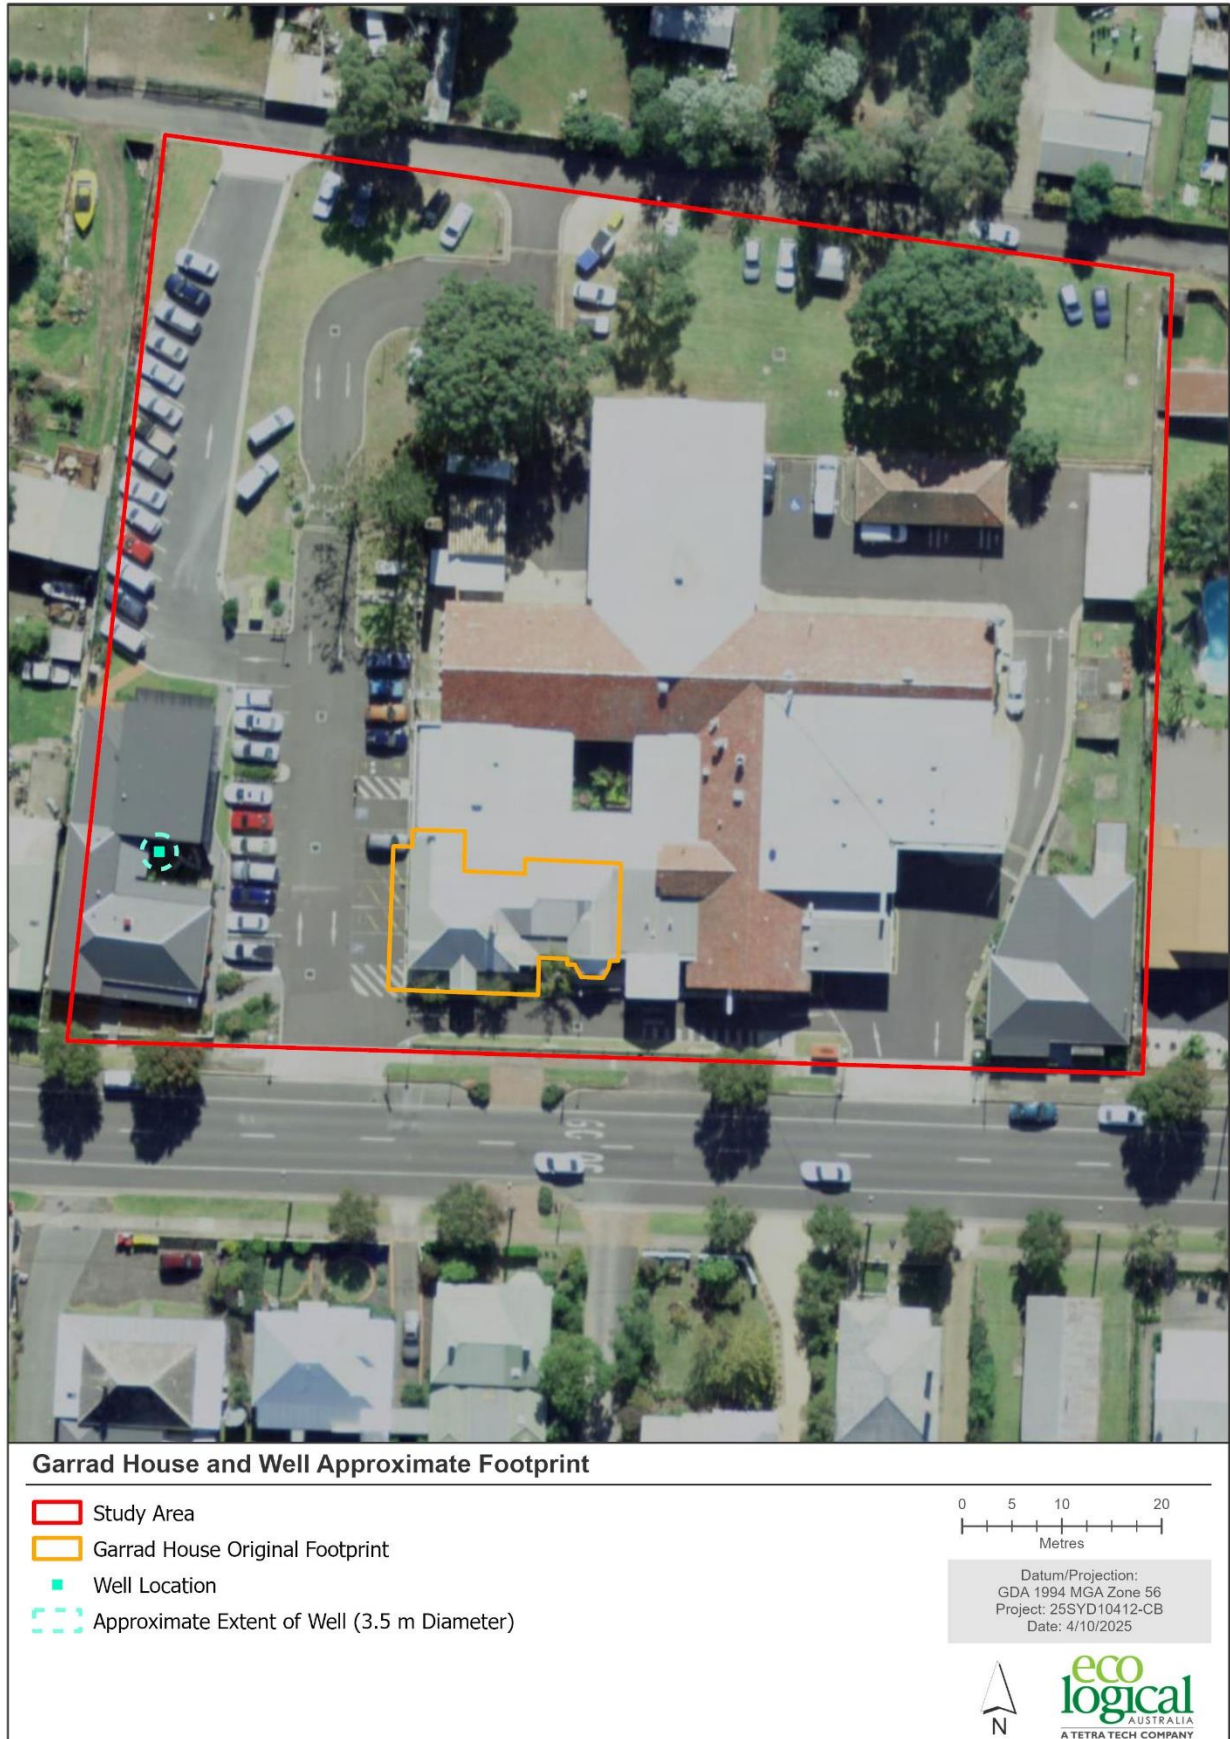
See Figure 23 for approximate original footprint of Garrad House and extent of subsurface domed water well. The well is assumed to be no greater than 3.5 m in diameter.

Figure 23: Approximate original footprint of Garrad House and approximate extent of well

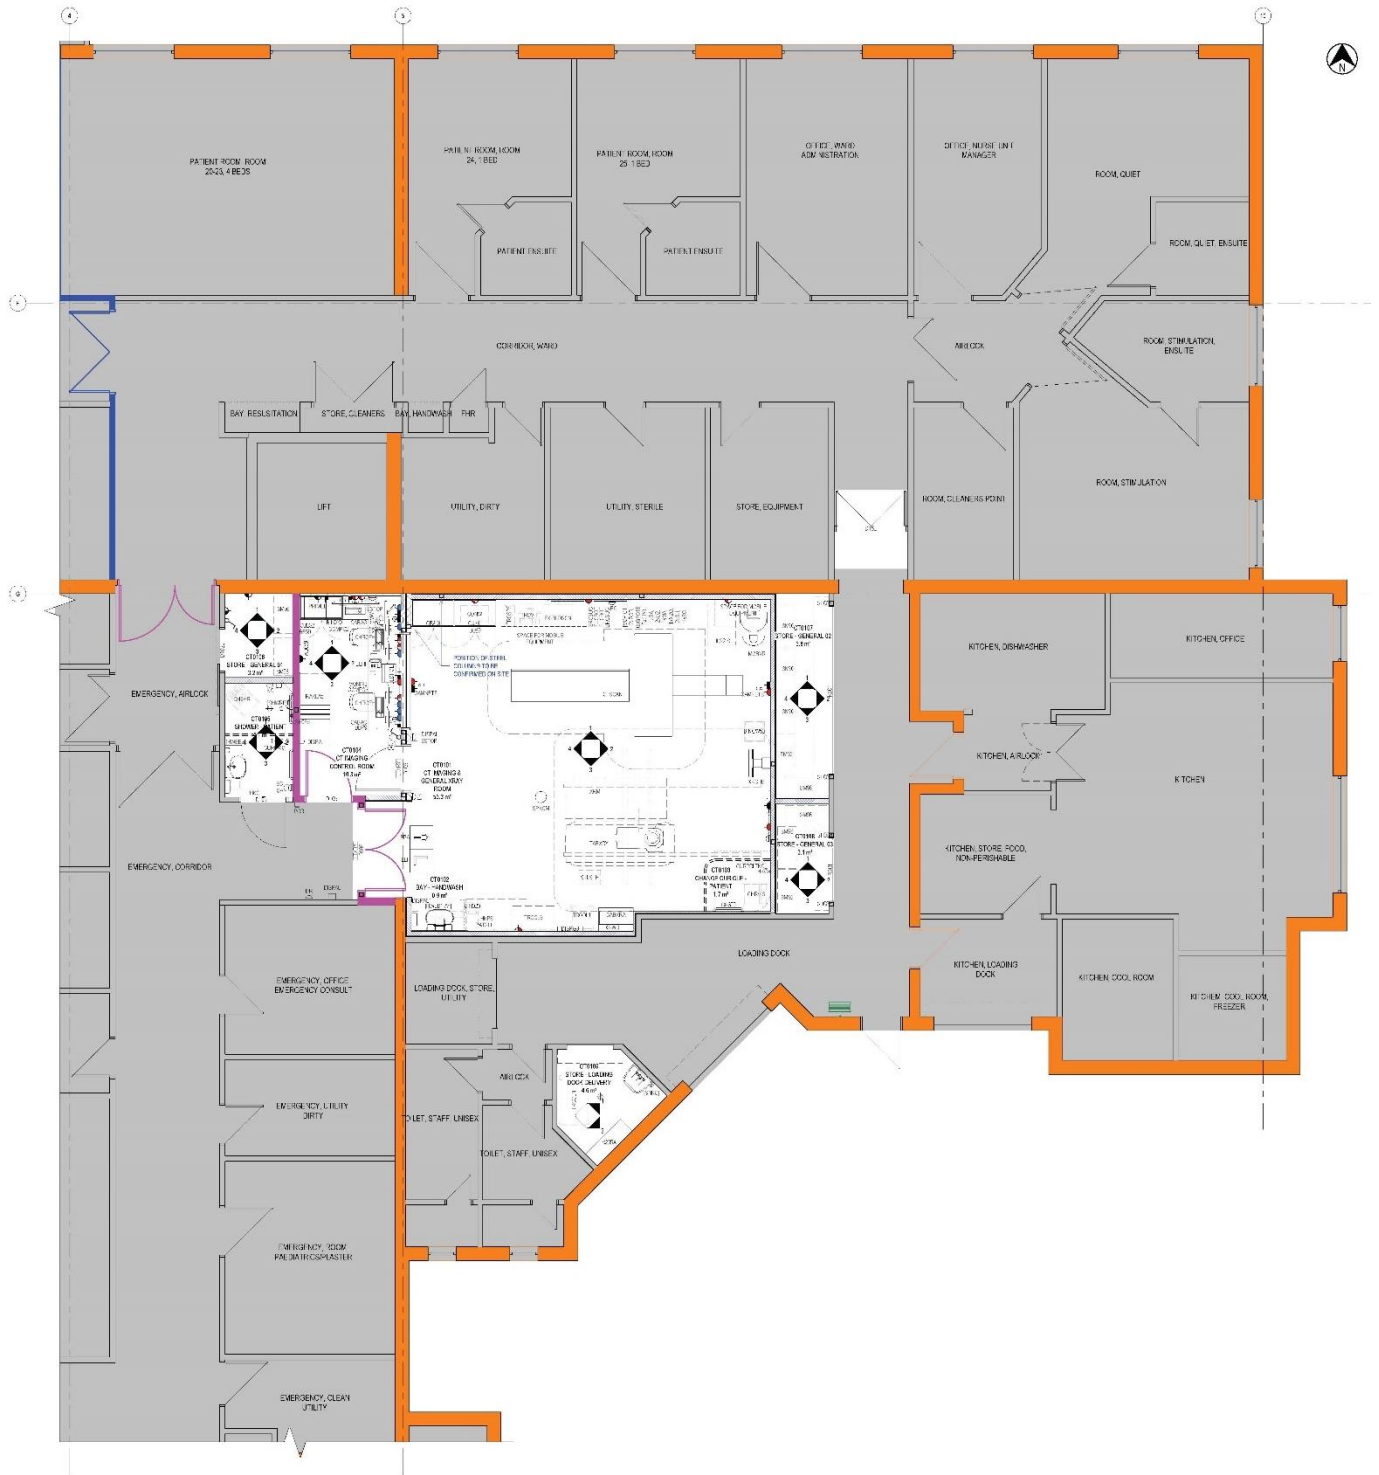
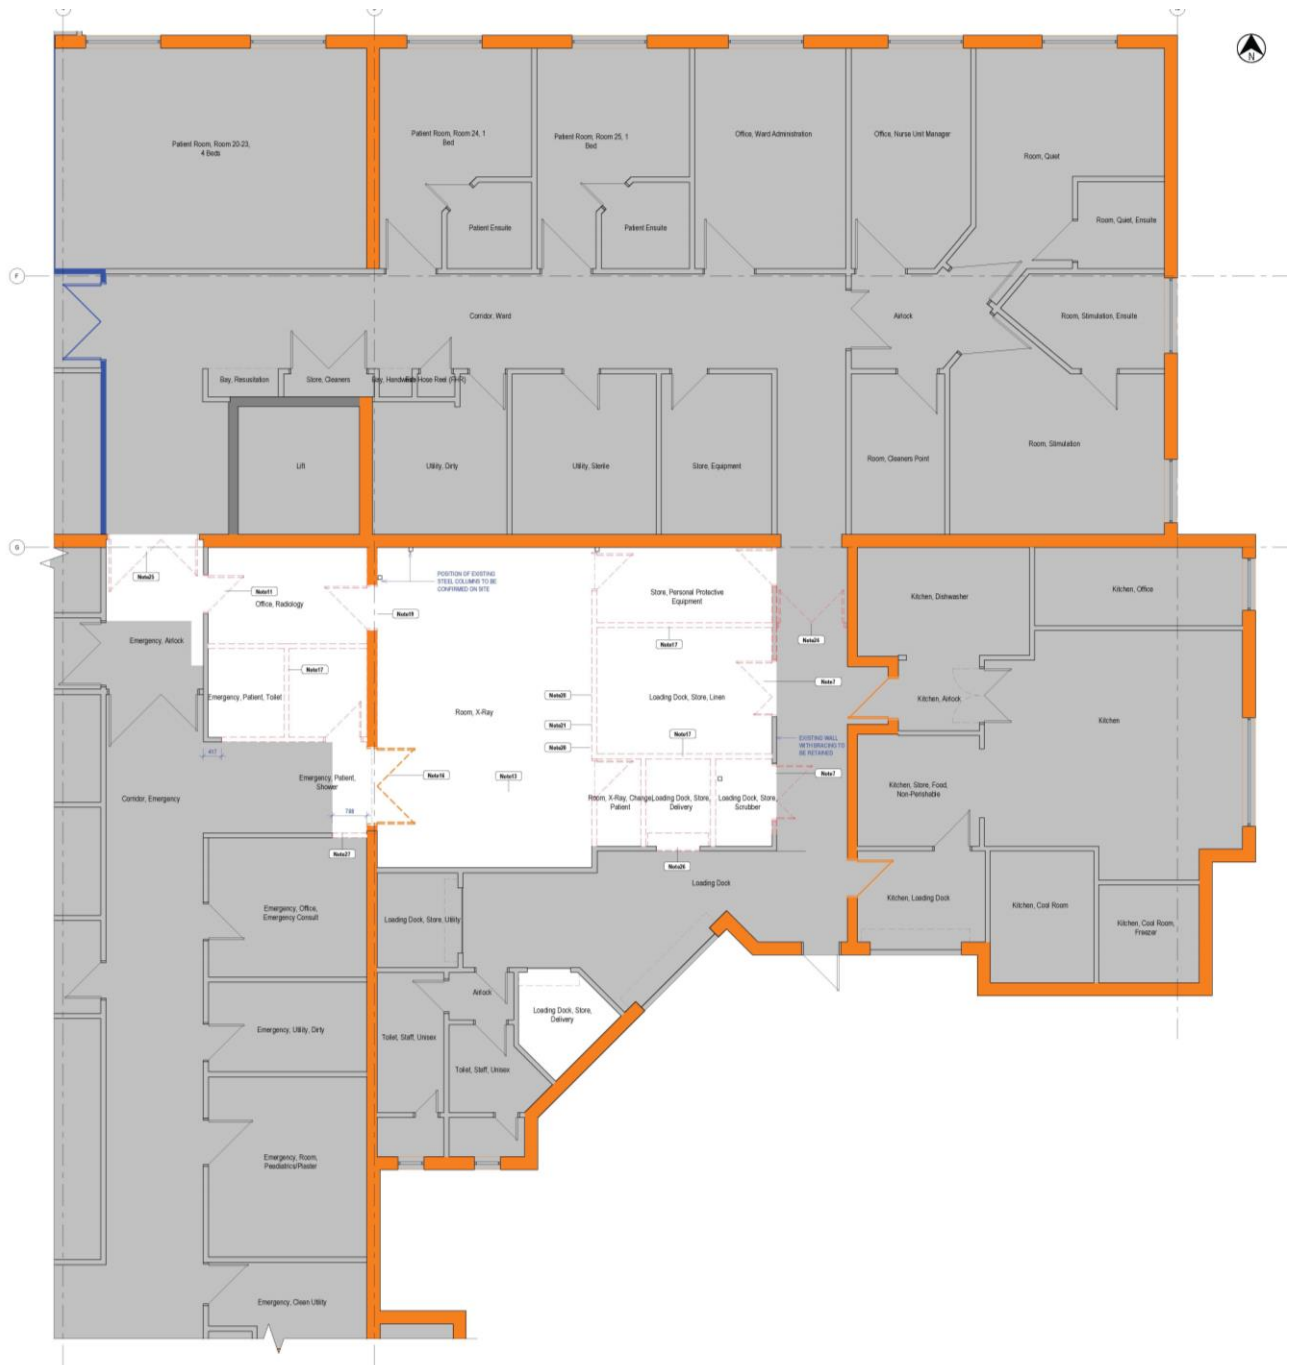
- Upgrade and expansion of CT Scanning/X-Ray Room, which would involve:
 - Demolition of internal walls
 - Removal of floor finish/underlay
 - Removal of ceiling and associated fittings
 - Construction of new fire rated walls
 - Replacement of doors
 - New internal walls for storage rooms
 - Subsurface excavation for structural reinforcement within the footprint of CT Scanning/X-Ray Room

Figure 24: CT Scanning/X-Ray Room Plan (Jacobs, 2025)

Figure 25: CT Scanning/X-Ray Room Demolition Plan (Jacobs, 2025)

Refer to Figure 24 and Figure 25 for proposed plan of works and demolition plan.

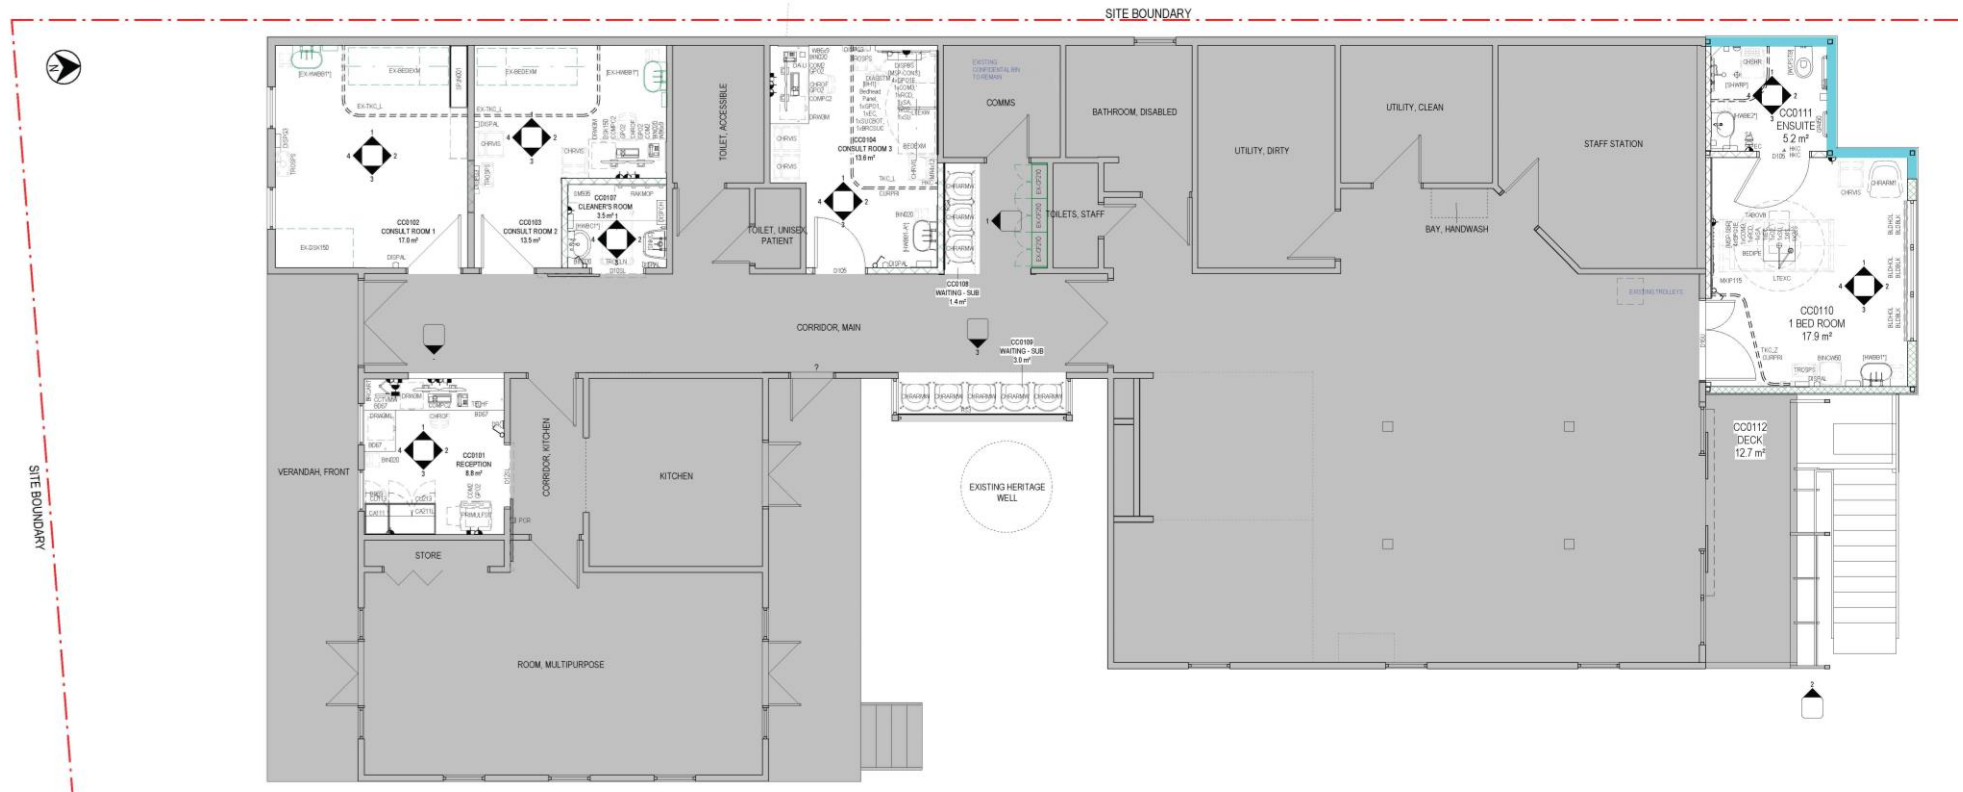
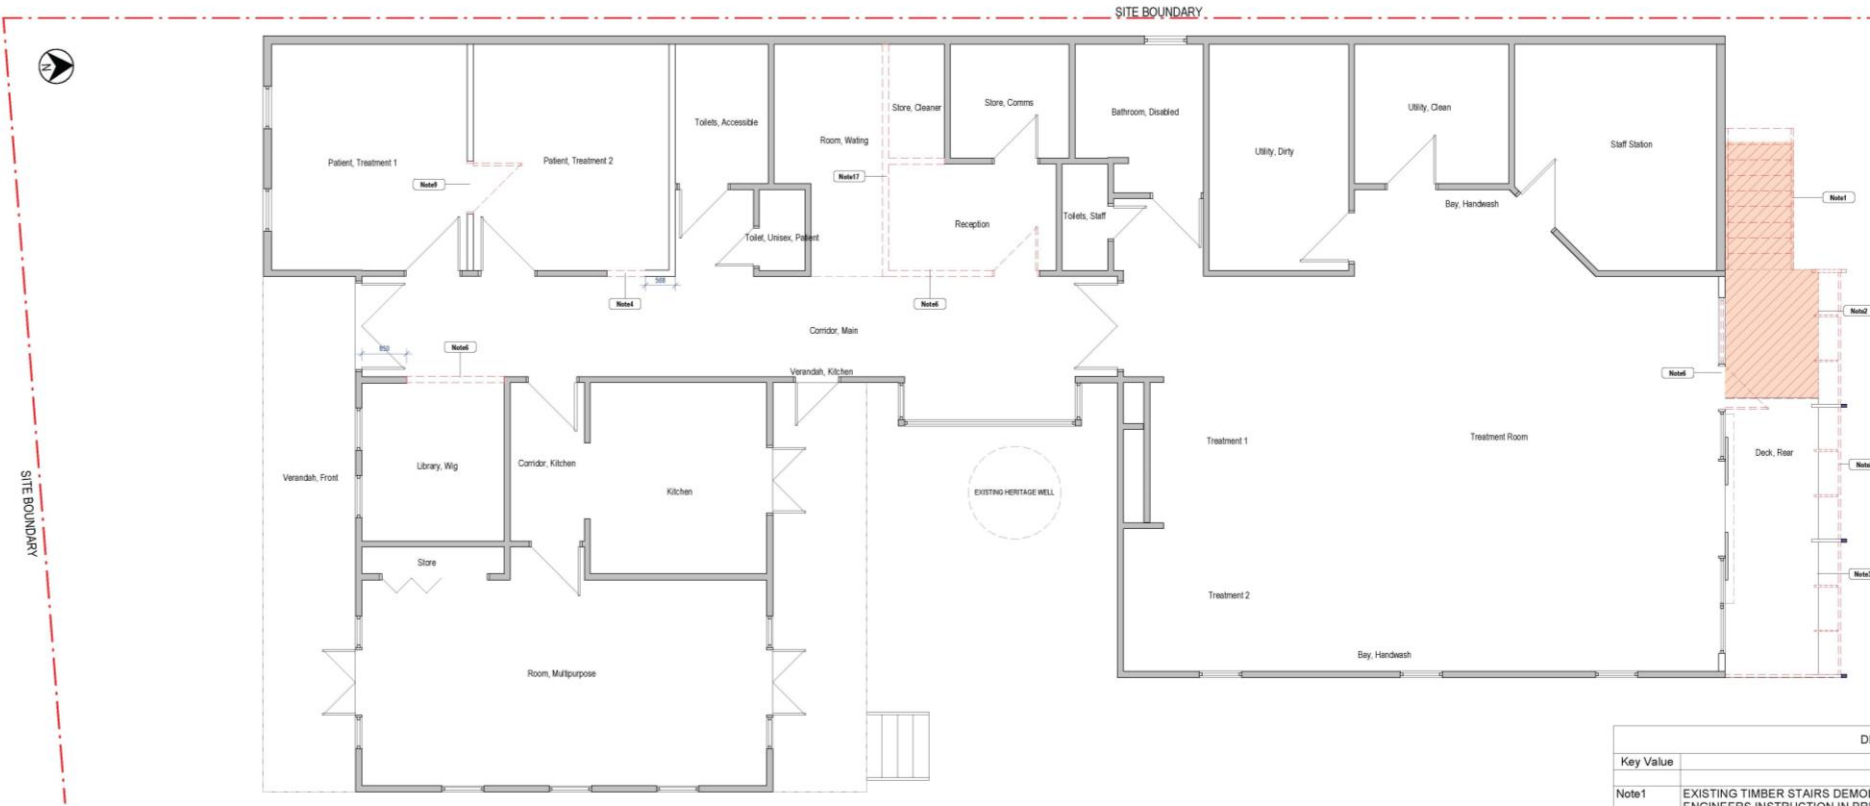
- Bed extension works within Cancer Care Centre, which would involve:
 - The demolition of a portion of the existing deck – to be saw cut and removed
 - The demolition of timber stairs leading to existing deck – to be saw cut and removed
 - Removal of deck wall
 - Building extension works for one new bedroom with ensuite
 - Construction of new fire rated walls
 - New internal doors in new bed extension area, consult room 3 and reception room
 - New stairway constructed parallel to deck

Figure 26: Cancer Care Centre Plan (Jacobs, 2025)

Figure 27: Cancer Care Centre Demolition Plan (Jacobs, 2025)

Refer to Figure 26 and Figure 27 for proposed plan of works and demolition plan.
