REPORT TO DEPARTMENT OF EDUCATION

ON FURTHER GEOTECHNICAL INVESTIGATION

FOR NORTHERN RIVERS FLOOD RECOVERY -RICHMOND RIVER HIGH CAMPUS REDEVELOPMENT

AT 163 – 170 ALEXANDRA PARADE, NORTH LISMORE, NSW

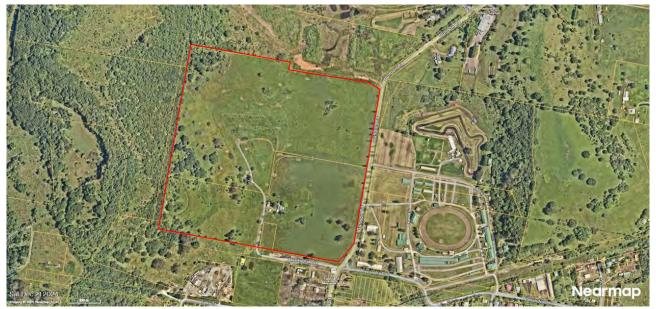
Plate 1 Aerial image of site (Source: Nearmap)

The site area is approximately 33.53 hectares, and is outlined in Plante 1. The proposed activity will be undertaken mainly within the southeastern portion of the site.

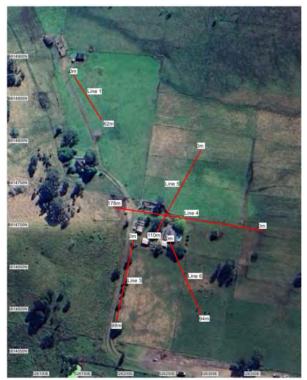
Plate 3 Location of SR Lines (Source: GBG Report dated June 2025, see Appendix A)

GBG completed a geophysical investigation at the site which used Seismic Refraction (SR) techniques. Six SR lines were completed at the locations indicated on Plate 3.

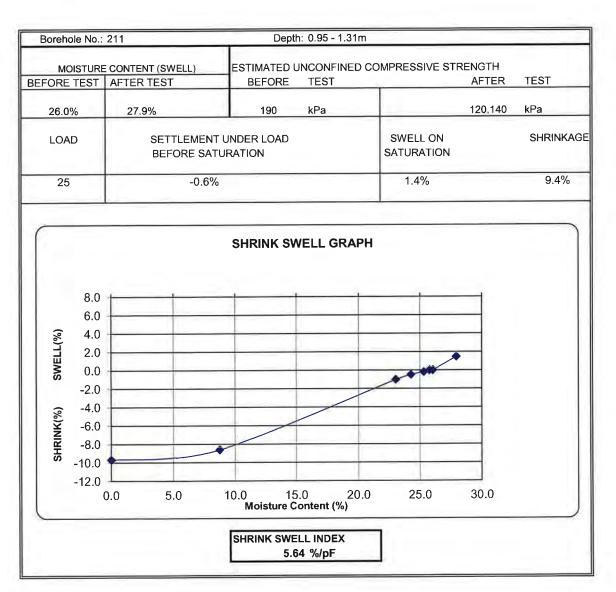
#### TABLE B SHRINK - SWELL TEST REPORT TEST METHOD: AS1289 7.1.1

- Suction Value used in calculation = 1.8pF
- Volume Change Coefficient (α) was assumed = 2
- Visually estimated inclusions by volume = 0-5%
- Shrinkage Cracking = Moderate
- Soil Crumbling = none
- Date of receipt of sample: 17/06/2025.

The moisture content and Atterberg Limits tests on the natural clay and weathered bedrock correlated reasonably well with our field assessments. Based on the Atterberg limits, linear shrinkage and shrink-swell index test results, the natural clays are of high plasticity and are assessed to have a high potential for shrink-swell movements with changes in moisture content.

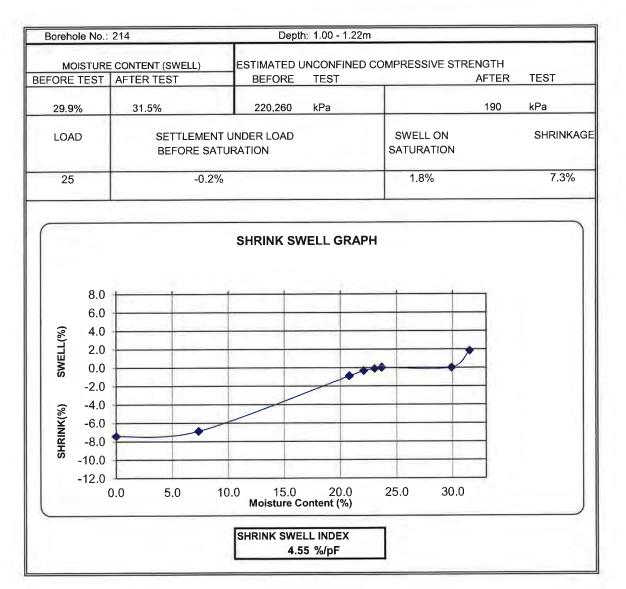
#### TABLE B SHRINK - SWELL TEST REPORT TEST METHOD: AS1289 7.1.1

- Suction Value used in calculation = 1.8pF
- Volume Change Coefficient (α) was assumed = 2
- Visually estimated inclusions by volume = 0-5%
- Shrinkage Cracking = Moderate
- Soil Crumbling = none
- Date of receipt of sample: 17/06/2025.

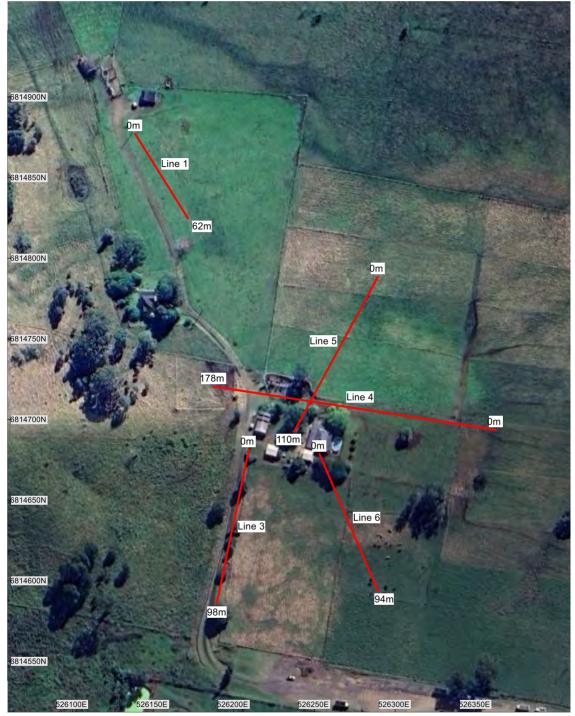
Figure 1: The survey area and locations of the acquired SR lines.

The location of the SR lines was agreed upon beforehand with some minor changes discussed on site with the clients representative due to obstacles along the original alignment (see Figure 1). Every effort was made to collect data as close to the original locations as possible.

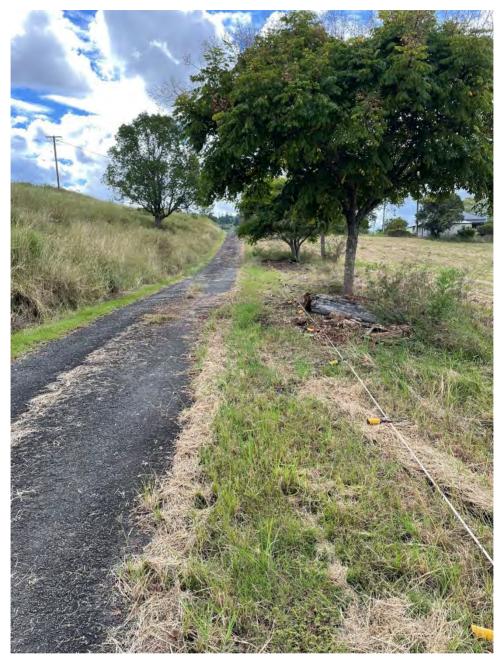
Figure 2: Data acquisition along Line 3.

Line	Number of geophones used
Line 1	32
Line 3	50
Line 4	90
Line 5	56
Line 6	48

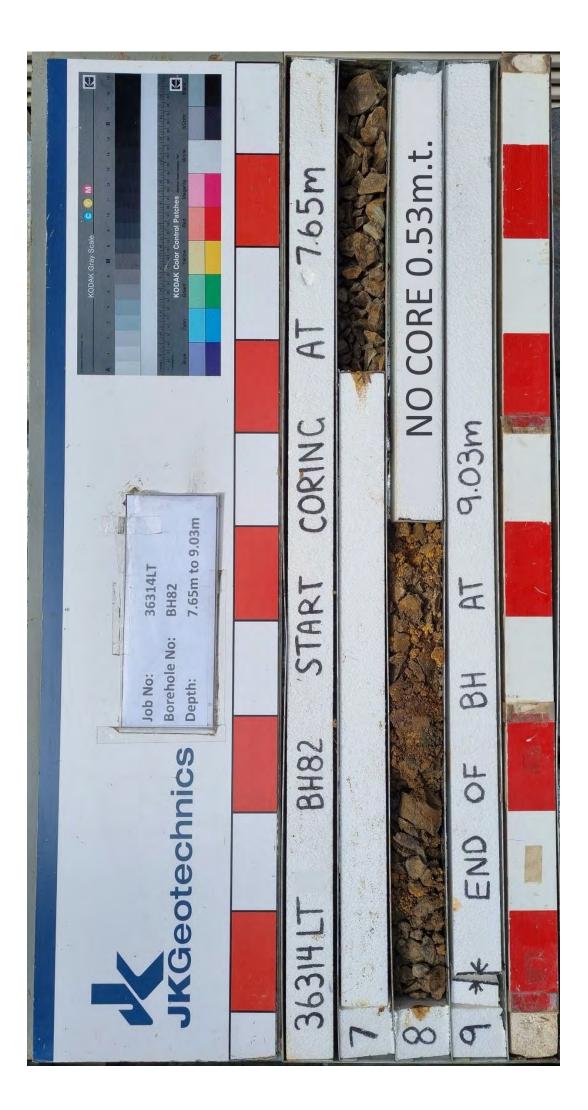
Borehole No. 85 1 / 2

RN		4			Extremely Weathered basalt: sandy silty CLAY, low plasticity, brown and yellow brown.	XW	(Hd)			- <sup>-</sup> - -	Lismo				
,	RETURN		-	- - - -	-	NO CORE 0.53m					-

- - - 2 - - - - - - - - - - 1	10												
				12						660  <						
			GHT		1						DERED TO BE DRILLING AND HANDLING BR
