# 05 Heritage Significance

## 5.1 Heritage Items in the Vicinity

# 06 The Proposal

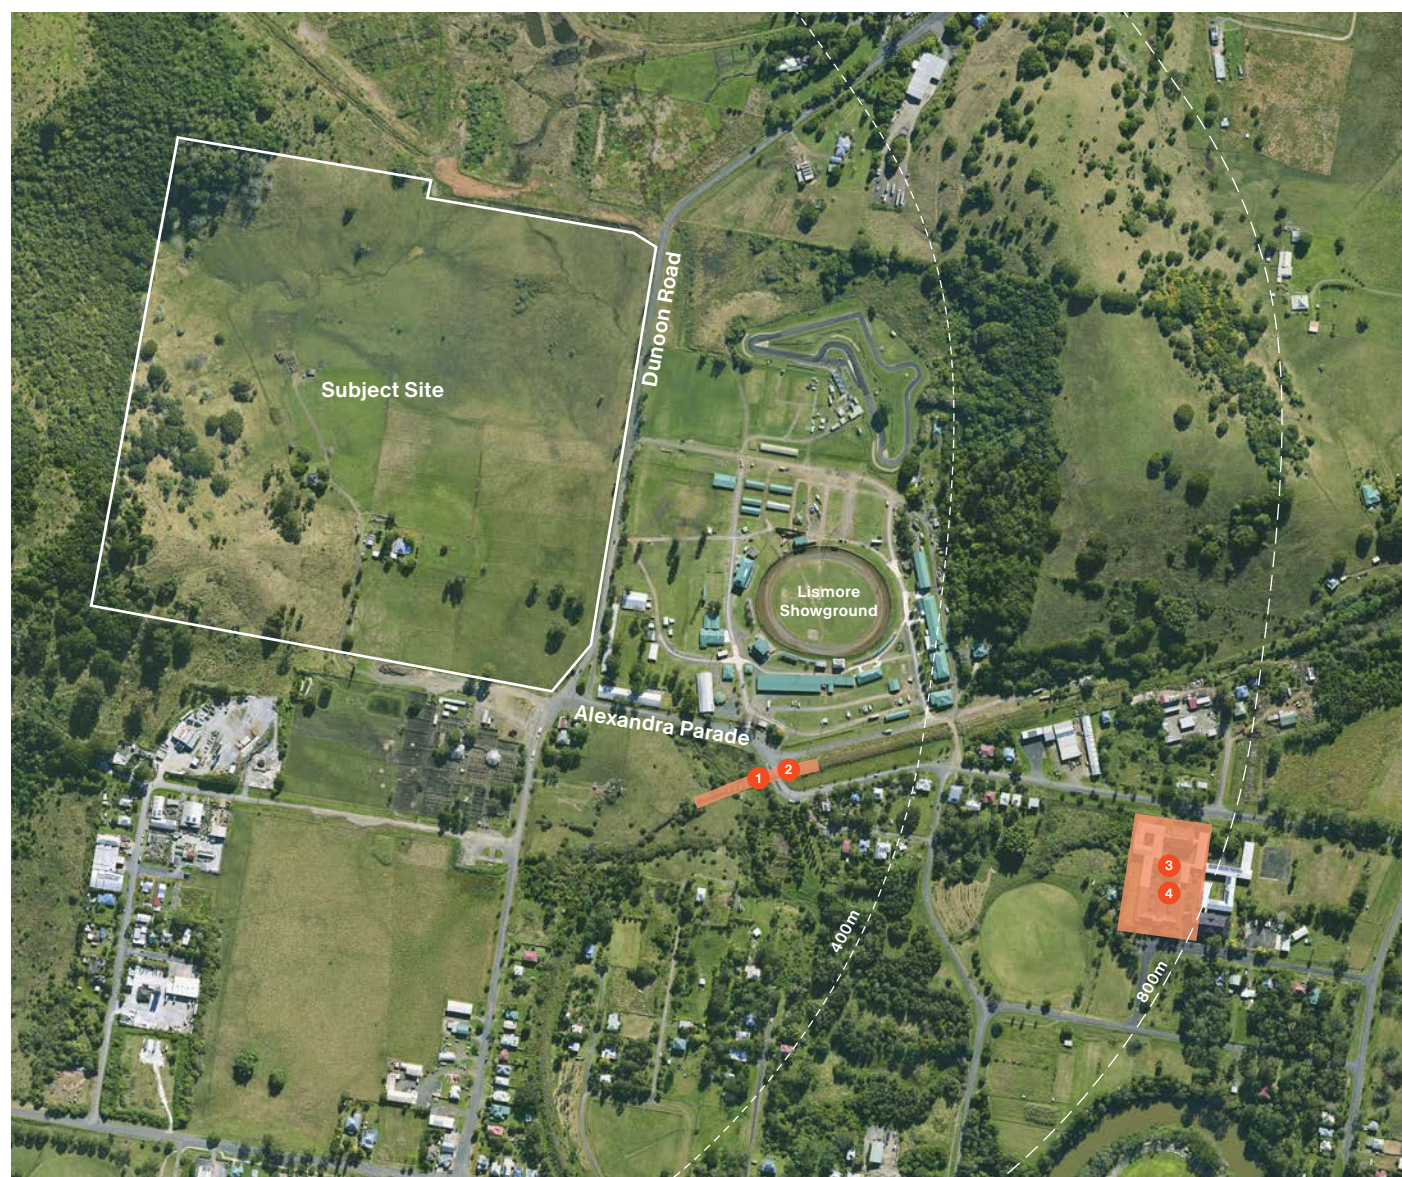
Figure 76: Subject site showing the existing structures and heritage items in the vicinity (shaded red).

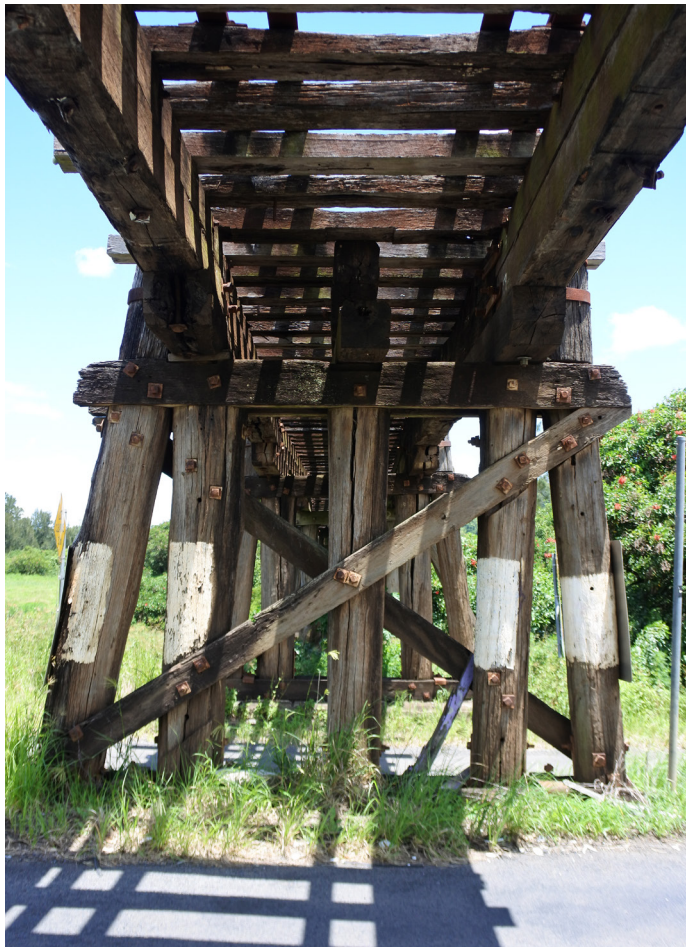
Figure 78: View below the underbridge and viaduct at Alexandra Parade.  
Source: TZG Heritage, 2024.

The Lismore Railway Underbridges is a group of three steel underbridges and timber viaducts along the North Coast Railway between Lismore and North Lismore. The underbridge and viaduct at Alexandra Parade is located 300m southeast of the subject site and can be seen from the southeast corner of the site and from the top of the knoll near Farmhouse 1.

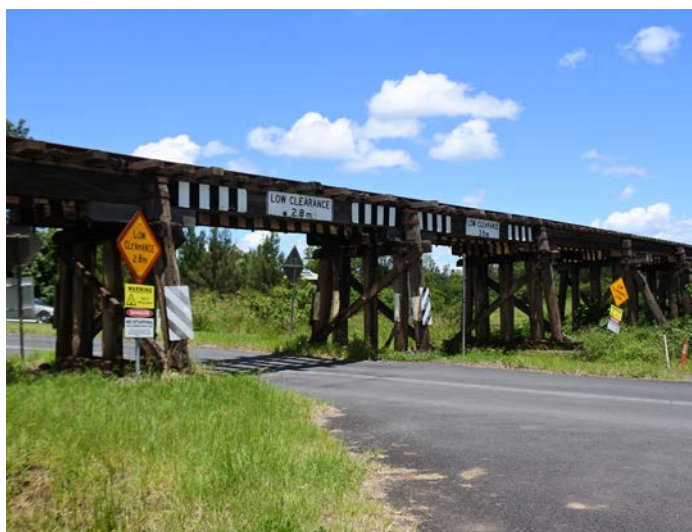
Figure 77: Railway underbridge and viaduct at Alexandra Parade.  
Source: TZG Heritage, 2024.

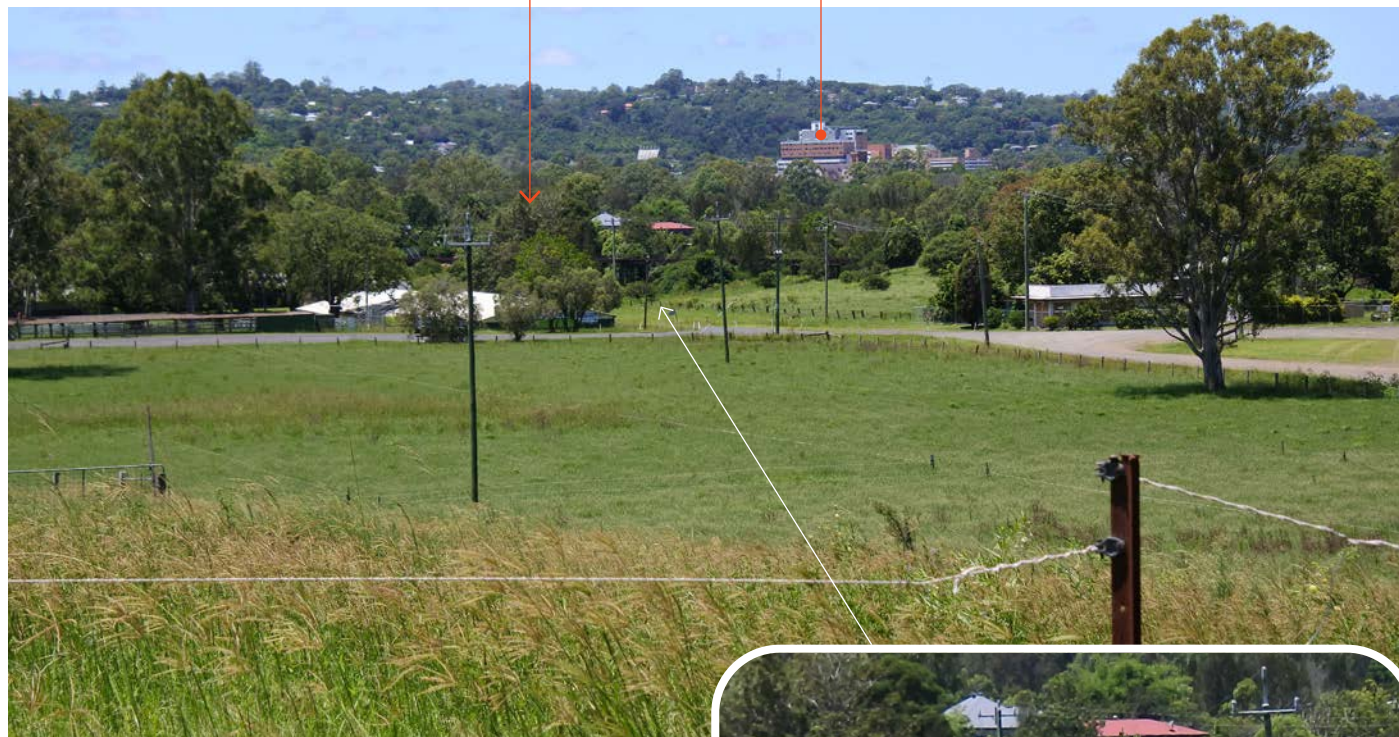
View of the Main Administration Building at Lake Street campus is screened by trees

Figure 84: View from the top of the knoll facing southeast. The heritage listed railway underbridge and viaduct on Alexandra Parade is visible but views of the Main Administration Building at Richmond River High Campus are screened by the trees along Bridge Street. INSET: Detail view of heritage item.

The Railway Underbridge and Viaduct on Alexandra Parade can be seen from these location whereas views of the Main Administration Building at Richmond River High Campus are screened by the trees along Bridge Street - see **Figure 84**.

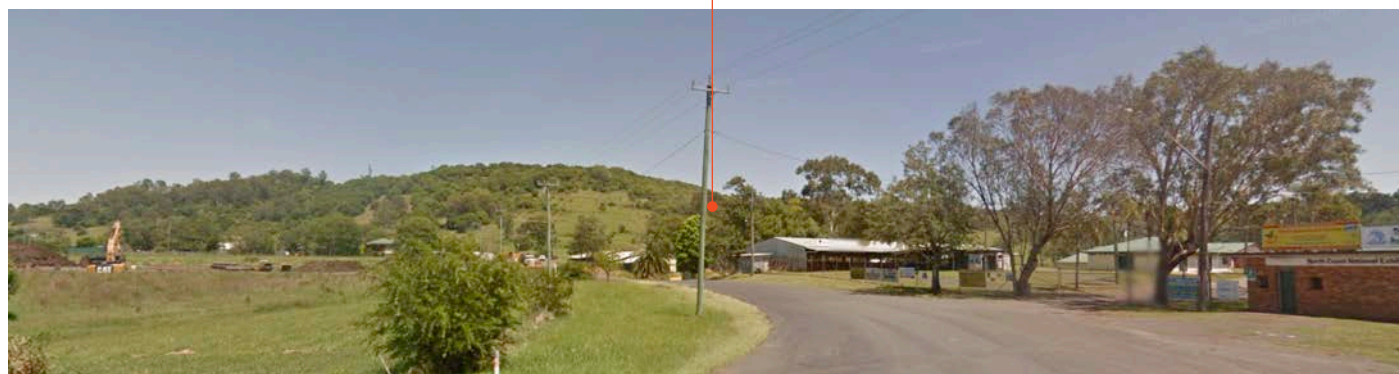
Views of the subject site from the railway underbridge and viaduct on Alexandra Parade are screened by the buildings and trees at Lismore Showground.

Figure 85: Views from the railway underbridge and viaduct facing west towards the subject site.

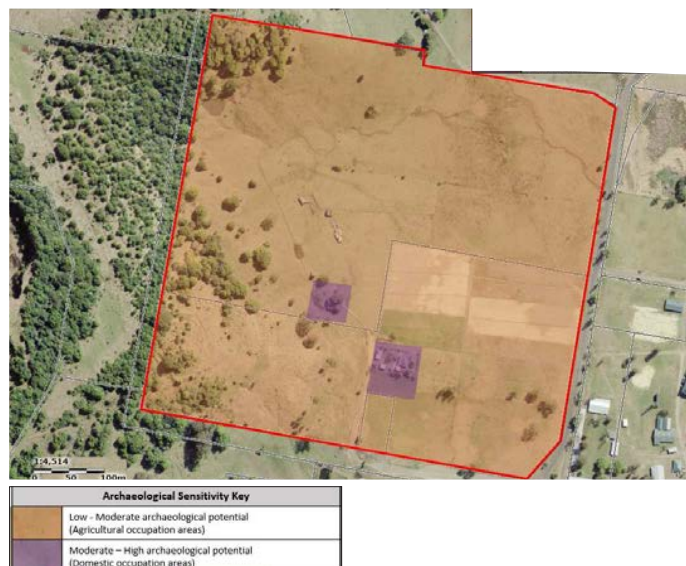
Figure 88: Historical Archaeology - Archaeological Sensitivity Map.  
Source: AMAC Group, October 2023.

The study site holds low to moderate potential for undocumented archaeological evidence of late 19th and 20th century agricultural activities in an intact to partly disturbed condition. Structural remains hold higher potential to remain intact, which are already known to survive in the centre of the site.<sup>17</sup>

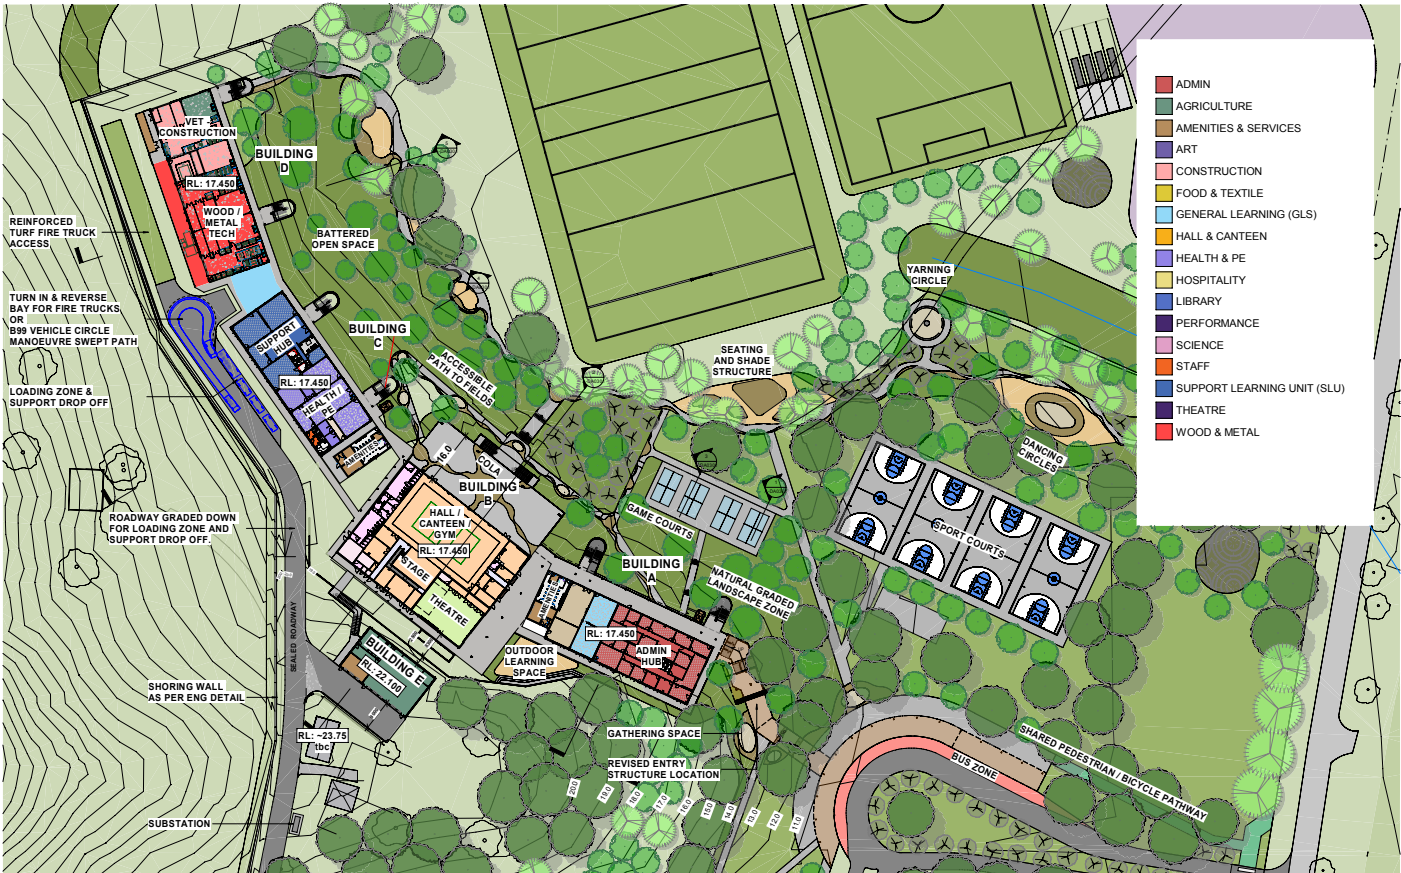
Figure 95: Overall Ground Floor Plan.  
Source: EJE Architects, 2025.

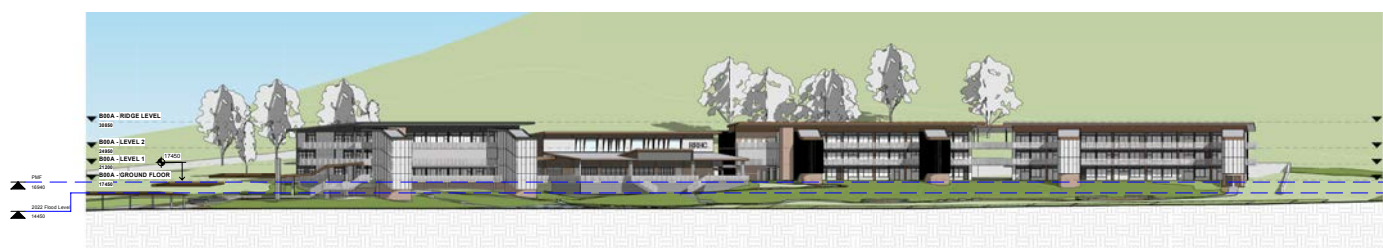
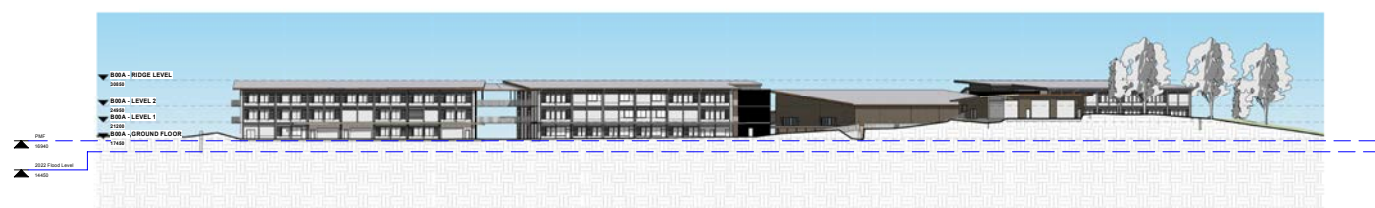
① SITE EASTERN ELEVATION - VIEW 1  
1 : 400

② SITE WESTERN ELEVATION - VIEW 2  
1 : 400

Figure 99: Site Elevations.  
Source: EJE Architects, 2025.

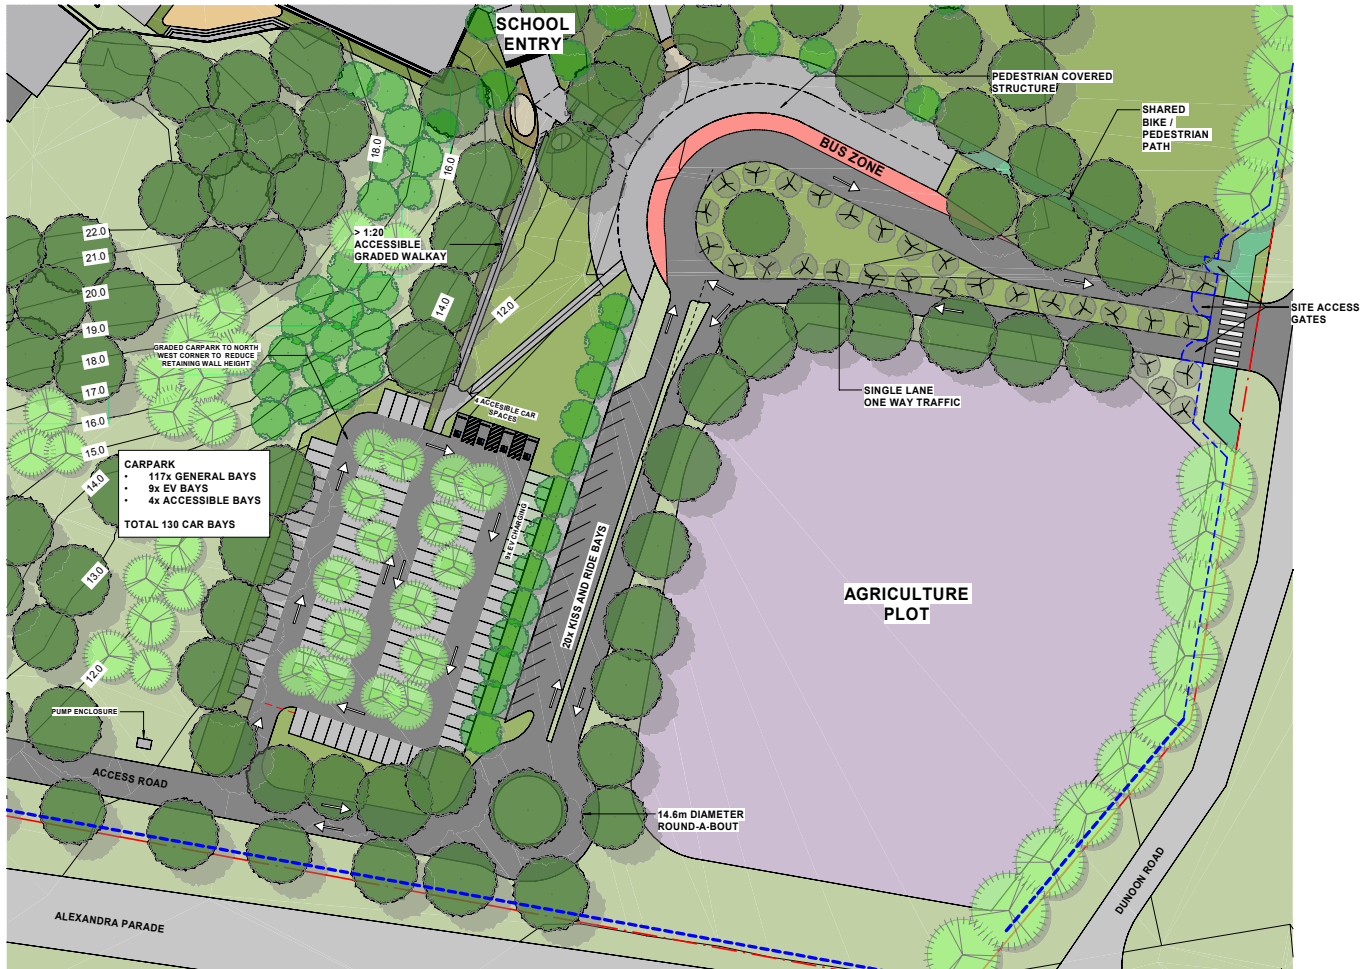
Figure 100: Zonal Car Parking and Entry Plan.

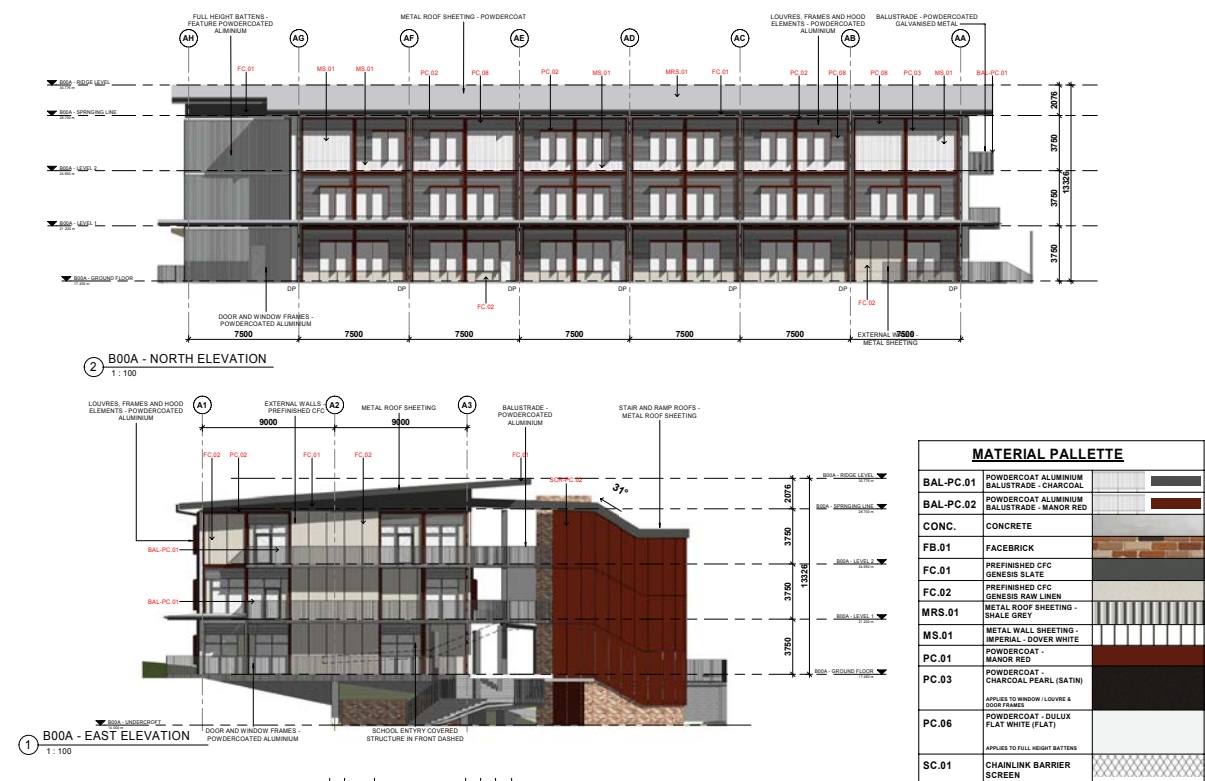
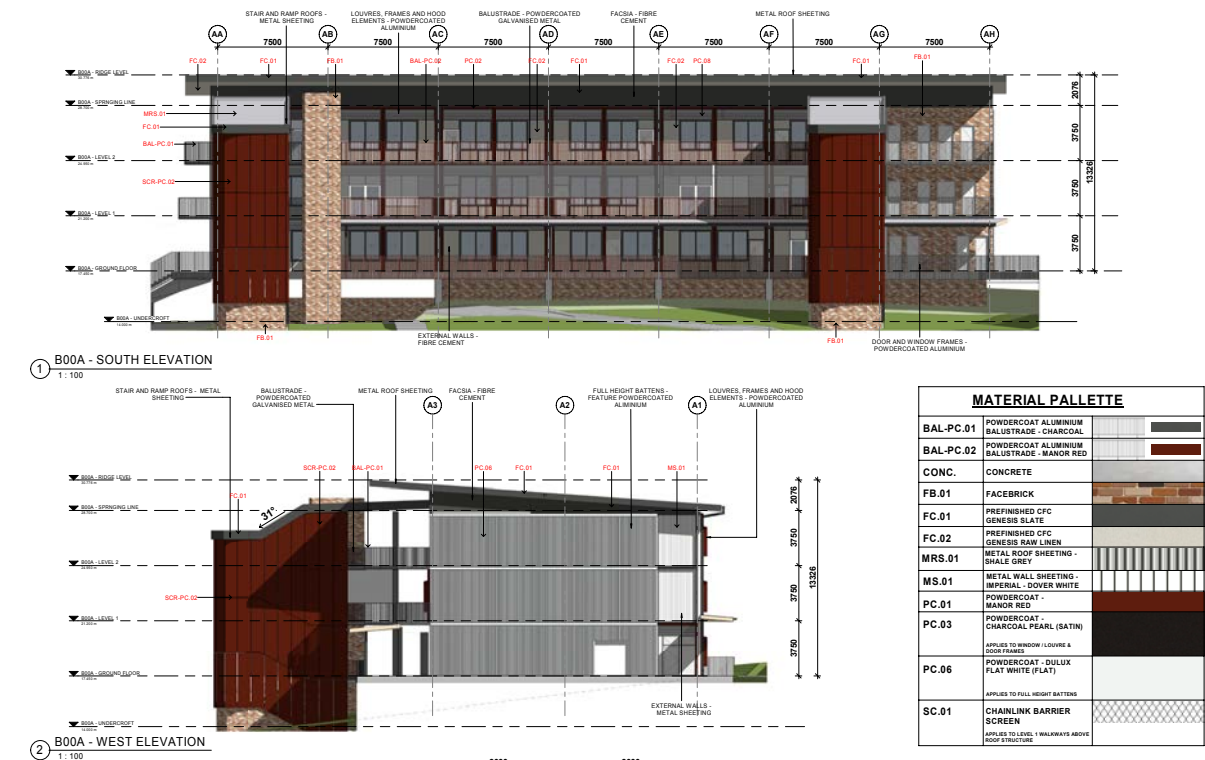
Figure 101: Typical Building Elevations.  
Source: EJE Architects, 2025.

Figure 102: Typical Building Elevations.  
Source: EJE Architects, 2025.

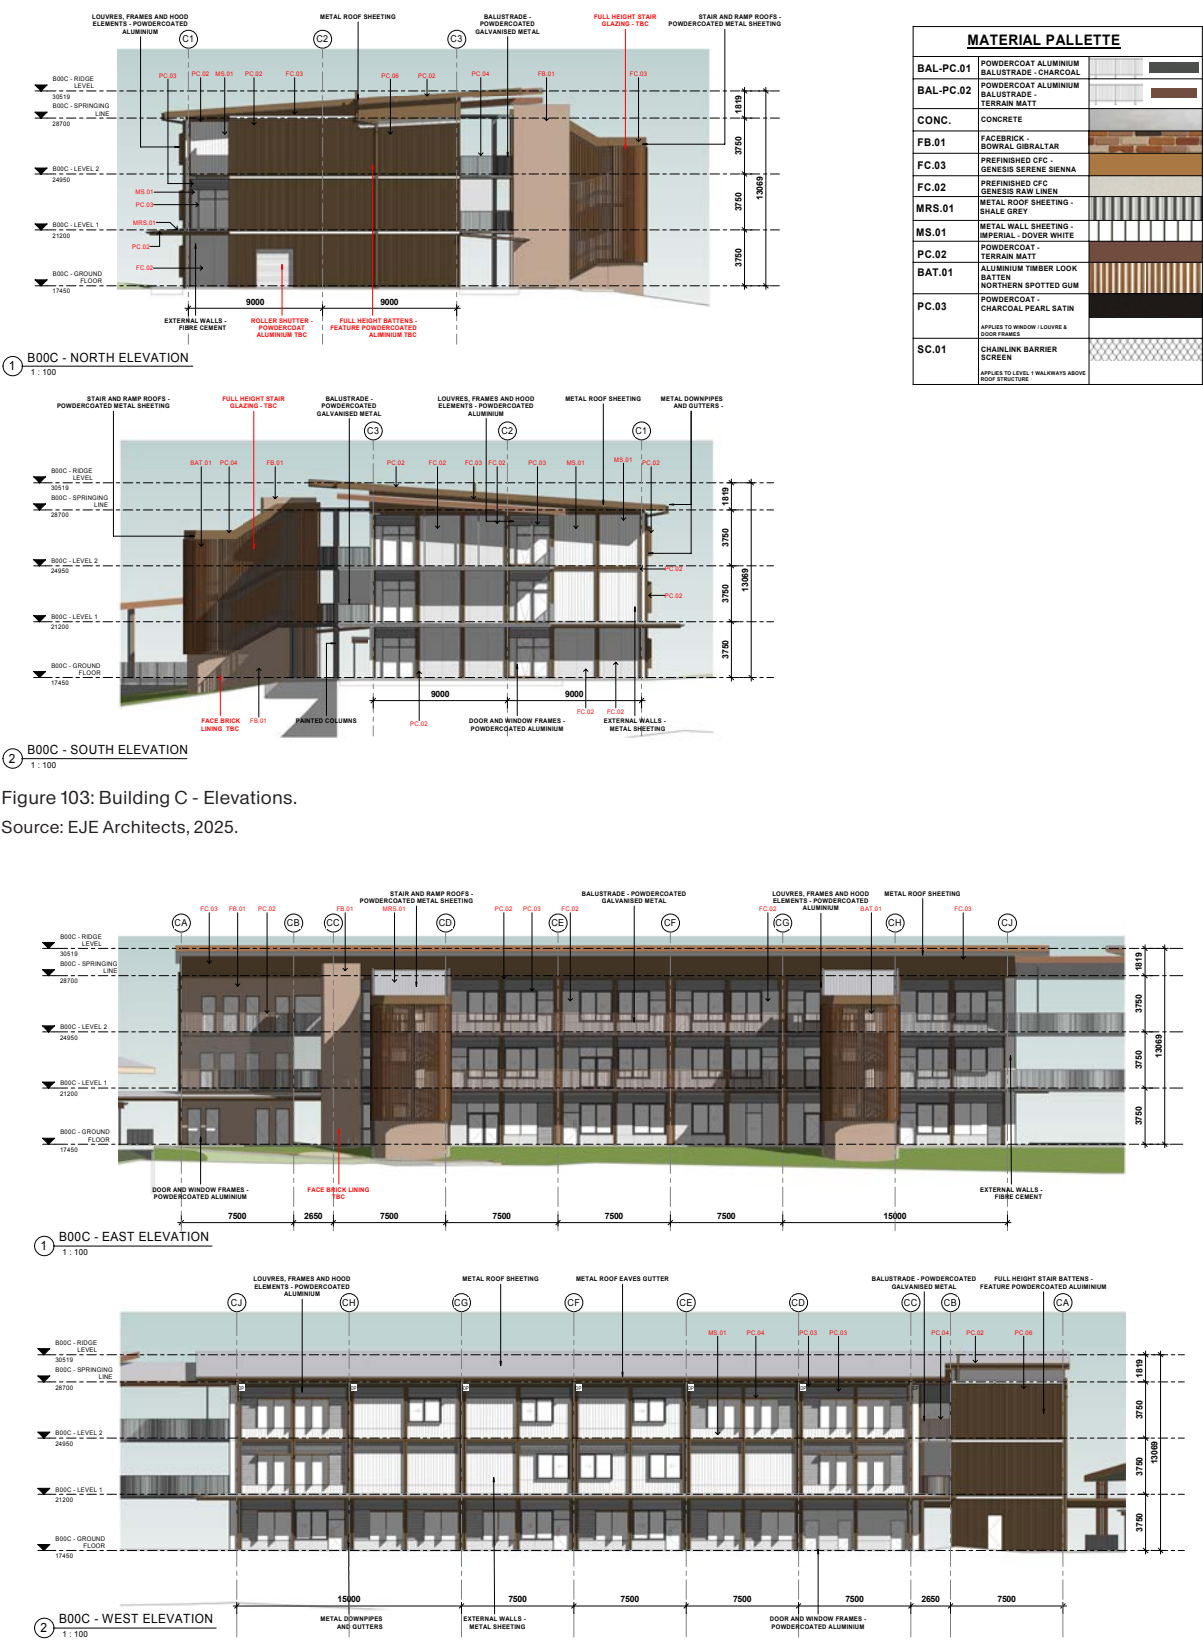
Figure 104: Building C - Elevations.
