**REPORT TO
DEPARTMENT OF EDUCATION**

**ON
SUPPLEMENTARY SURFACE AND
GROUNDWATER IMPACT ASSESSMENT**

**FOR
NORTHERN RIVERS FLOOD RECOVERY –
RICHMOND RIVER HIGH CAMPUS
REDEVELOPMENT**

**AT
163-170 ALEXANDRA PARADE, NORTH LISMORE,
NSW**

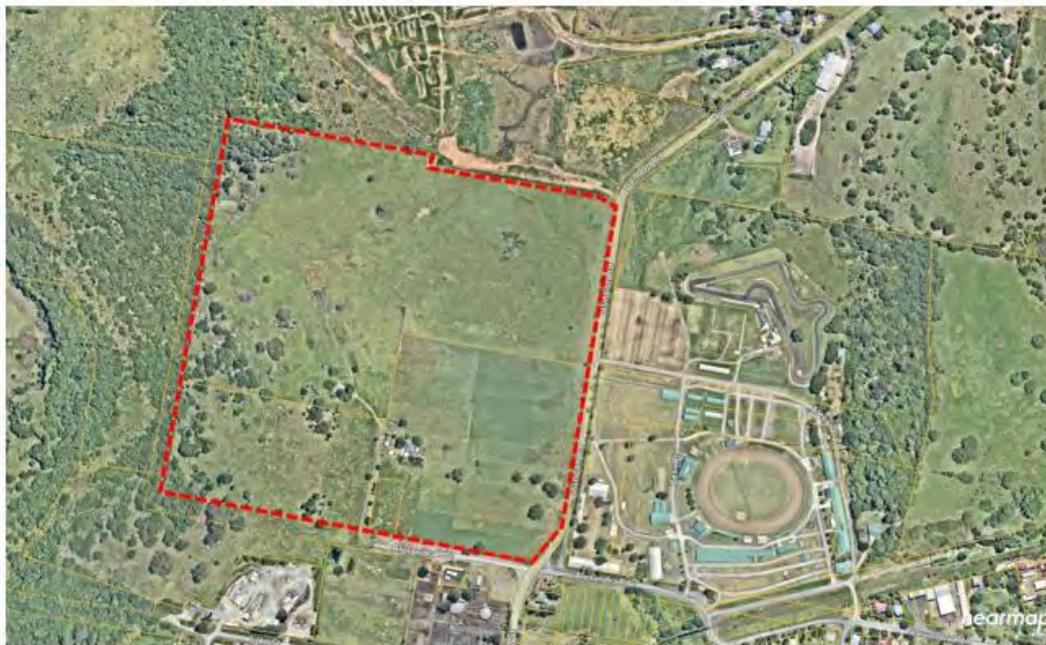
Figure 1 Aerial image of site (Source: Nearmap)

The site area is approximately 33.53 hectares. The proposed activity will be undertaken mainly within the south-eastern portion of the site. The site is outlined in Figure 1 below.

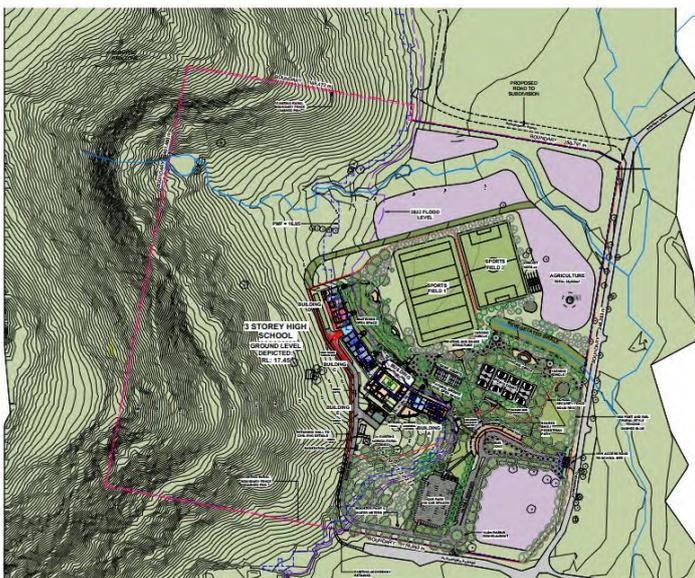
Figures 2 below shows the scope of works.

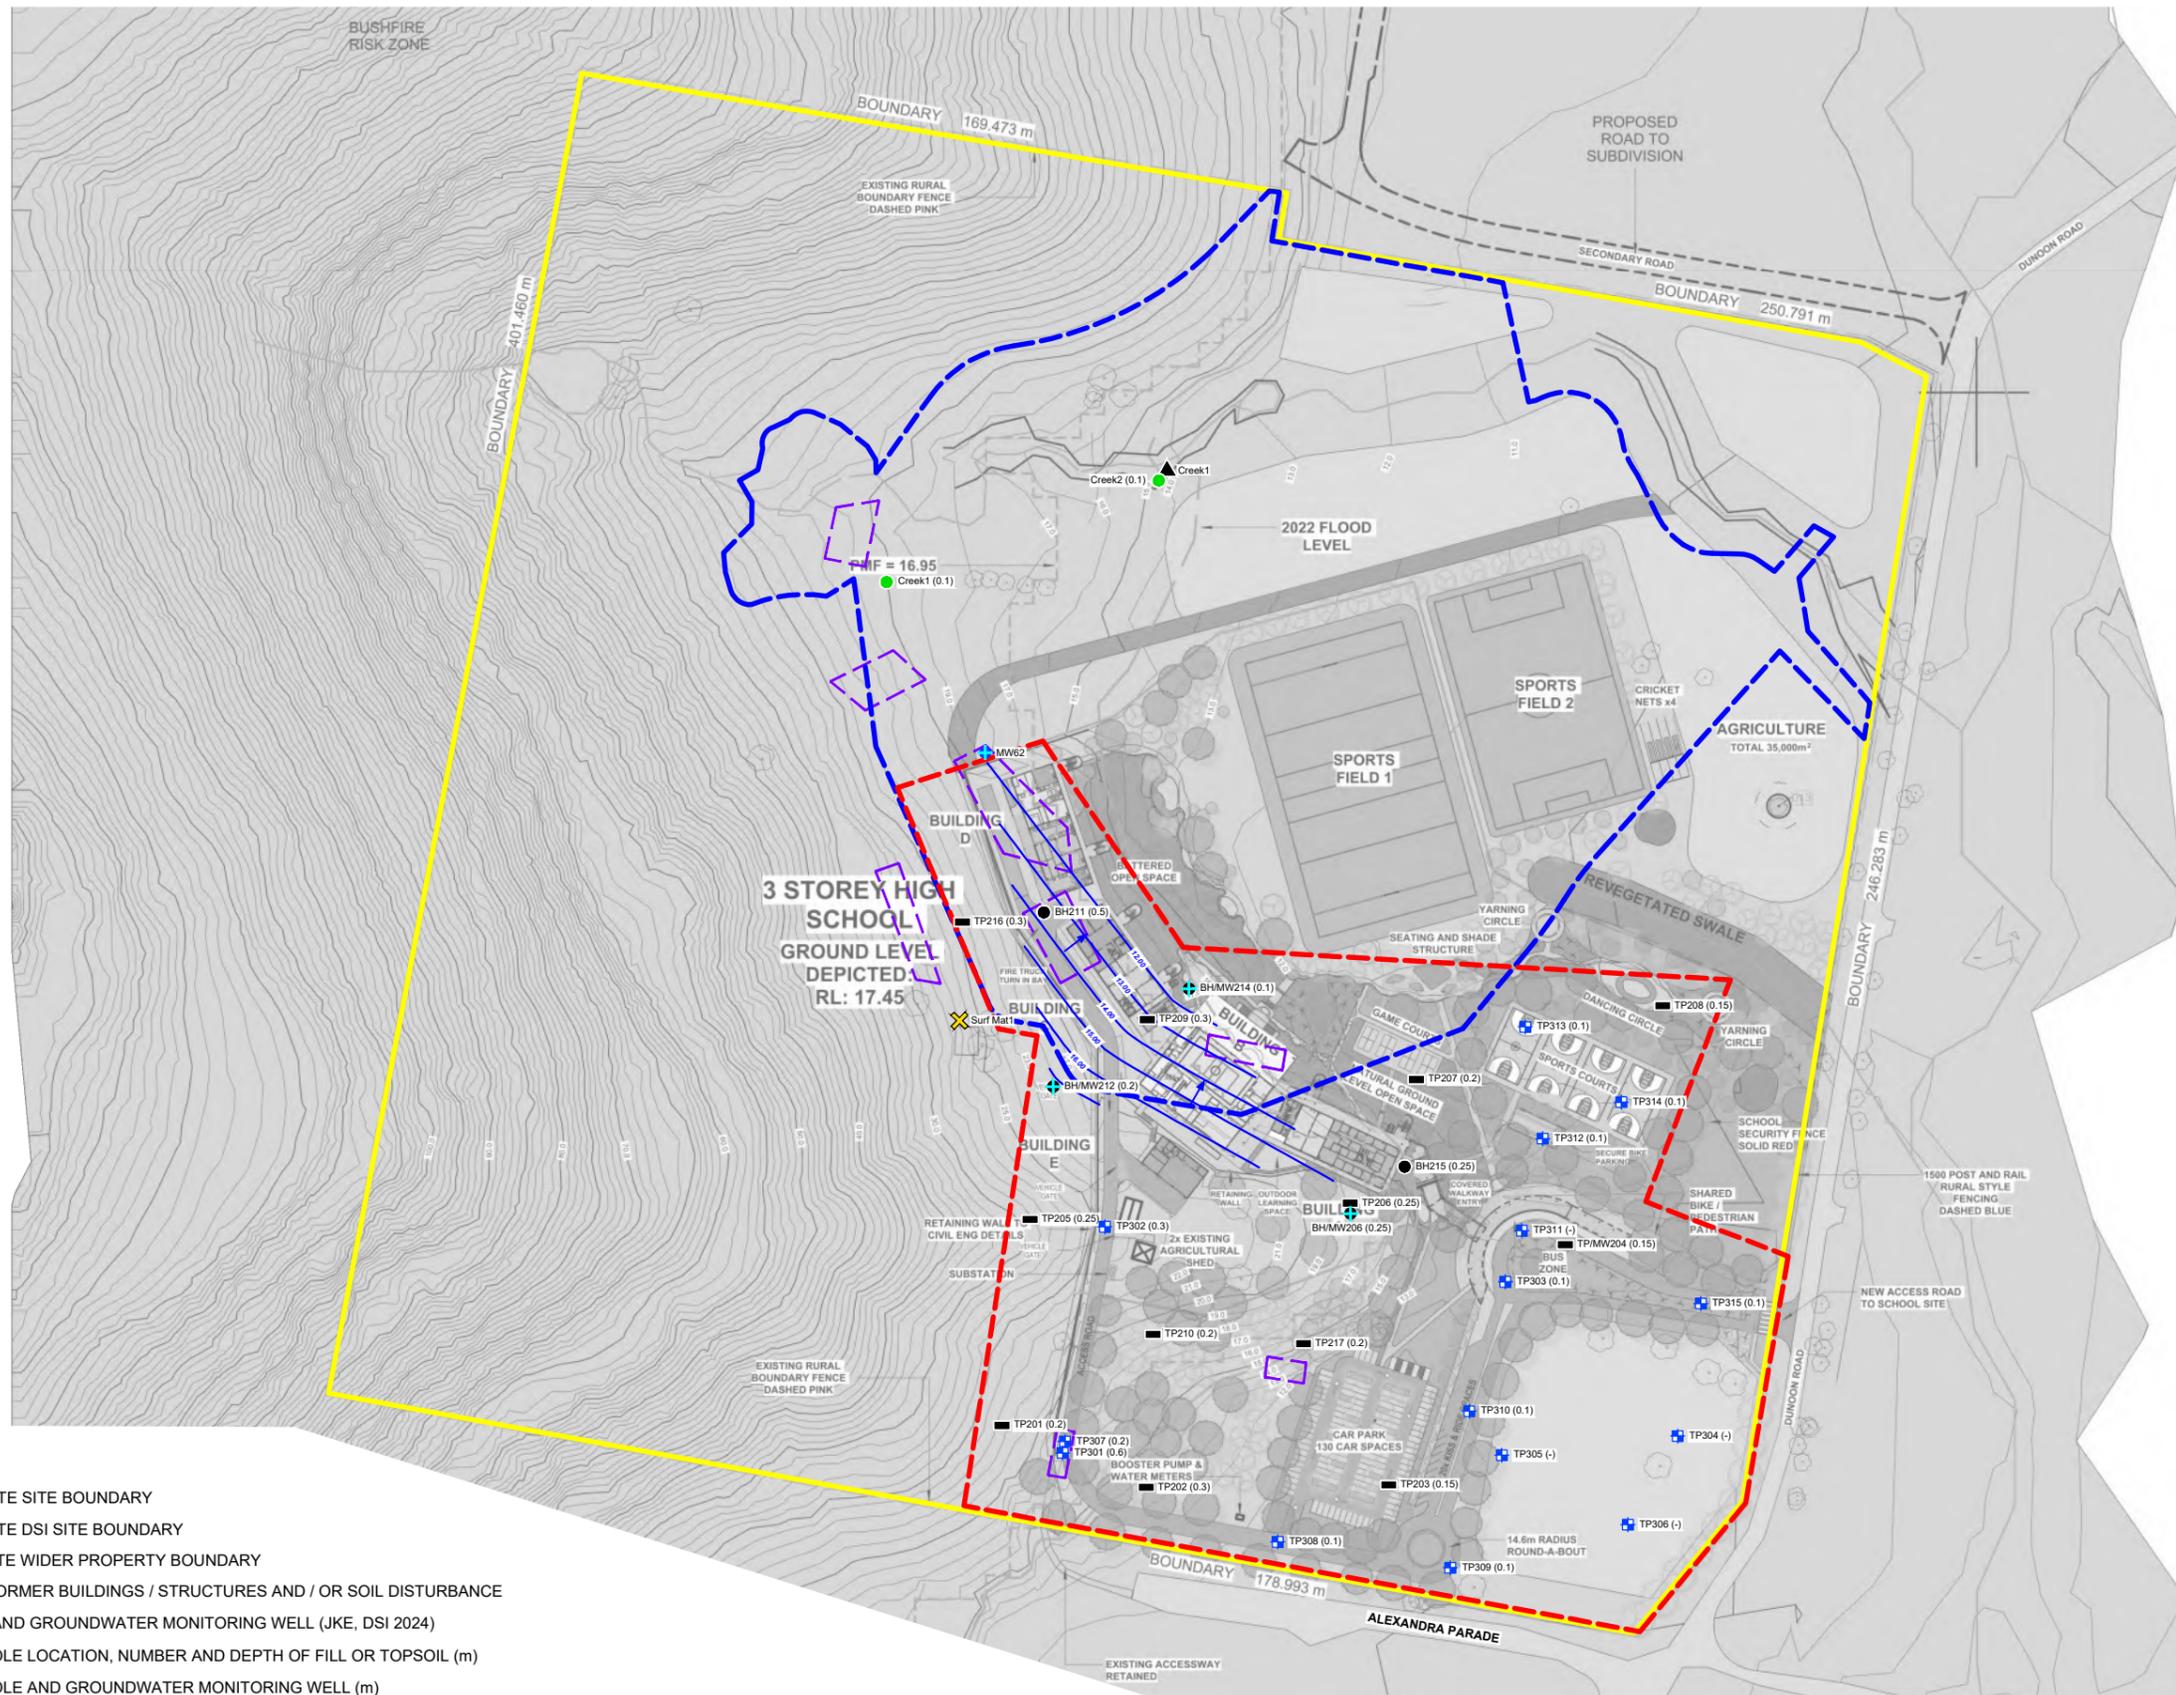
- APPROXIMATE SITE BOUNDARY
- APPROXIMATE DSI SITE BOUNDARY
- APPROXIMATE WIDER PROPERTY BOUNDARY
- AREAS OF FORMER BUILDINGS / STRUCTURES AND / OR SOIL DISTURBANCE
- + MW62 BOREHOLE AND GROUNDWATER MONITORING WELL (JKE, DSI 2024)
- BH211 JKG BOREHOLE LOCATION, NUMBER AND DEPTH OF FILL OR TOPSOIL (m)
- + BH/MW212 JKG BOREHOLE AND GROUNDWATER MONITORING WELL (m)
- TP201 JKG TEST PIT LOCATION, NUMBER AND DEPTH OF FILL OR TOPSOIL (m)
- + TP301 JKE TEST PIT LOCATION, NUMBER AND DEPTH OF FILL OR TOPSOIL (m)
- ▲ SURFACE WATER SAMPLE LOCATION
- X Surf Mat1 (SURFACE) FIBRE CEMENT SHEETING LOCATION, NUMBER AND DEPTH
- Creek1 SEDIMENT SAMPLE LOCATION (m)
- ~ 14.00 GROUNDWATER CONTOUR INTERVALS (m)
- INFERRED GROUNDWATER FLOW DIRECTION

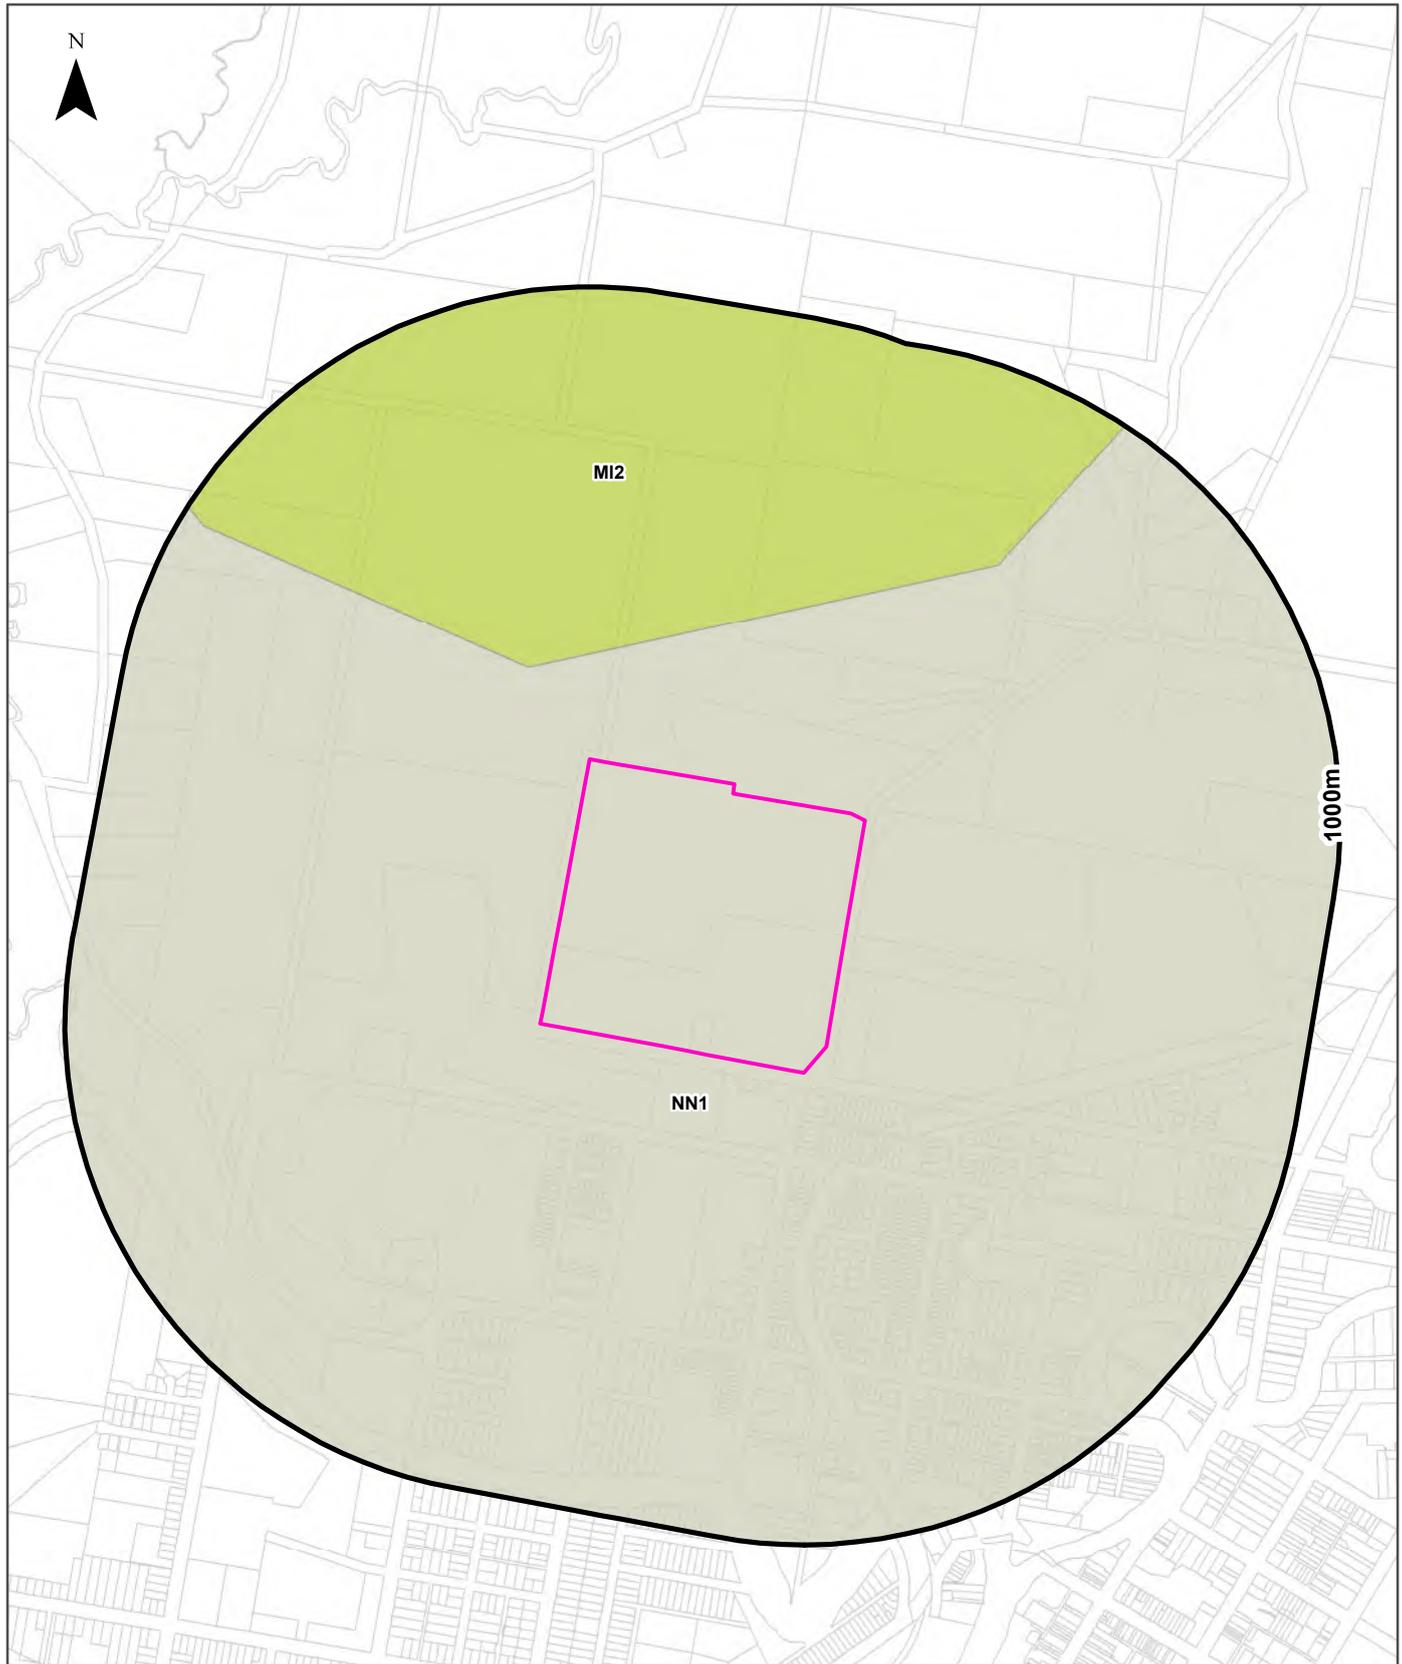
Atlas of Australian Soils

Map Unit Code	Soil Order	Map Unit Description	Distance	Direction
NN1	Vertosol	River flood-plains: relatively large and poorly drained, flat areas of deep dark cracking clays (Ug5.4) and (Ug5.16) with some melon-hole microrelief. Associated are friable yellow mottled soils (Dy5.1), and well-drained sandy levee soils (not described). As mapped, small islands of adjacent units are included.	0m	On-site
MI2	Dermosol		218m	North

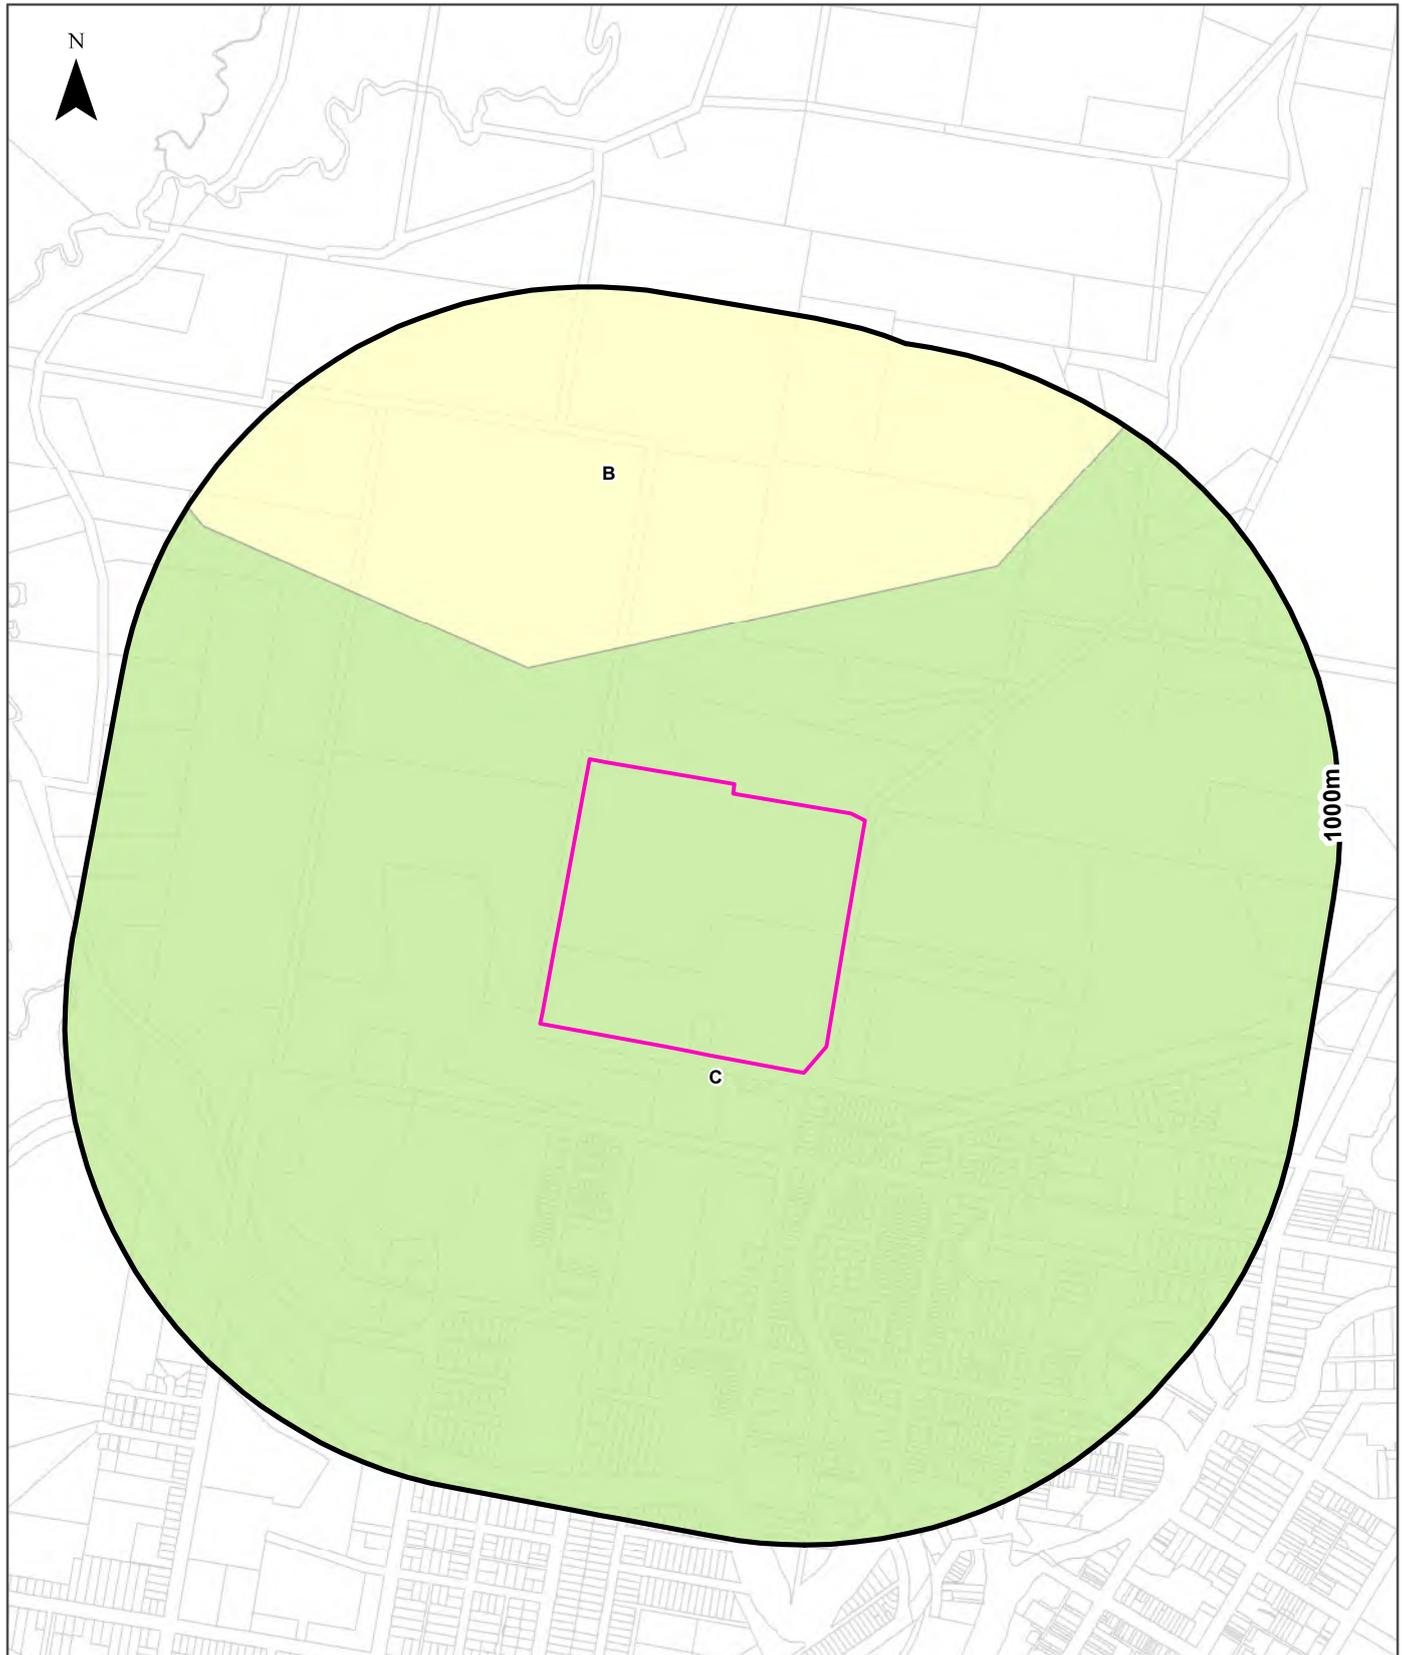
Legend			
Site Boundary	Probability of occurrence of Acid Sulfate Soils		
Buffer 1000m	A. High (>70%)	C. Extremely Low (1-5%)	No Data
Property Boundary	B. Low (6-70%)	D. No Chance (0%)	
Scale: 0 100 200 400 600 800 Meters	Data Sources: Property Boundaries & Topographic Data: © Department Finance, Services & Innovation 2023	Coordinate System: GDA 1994 MGA Zone 56	Date: 06October 2023

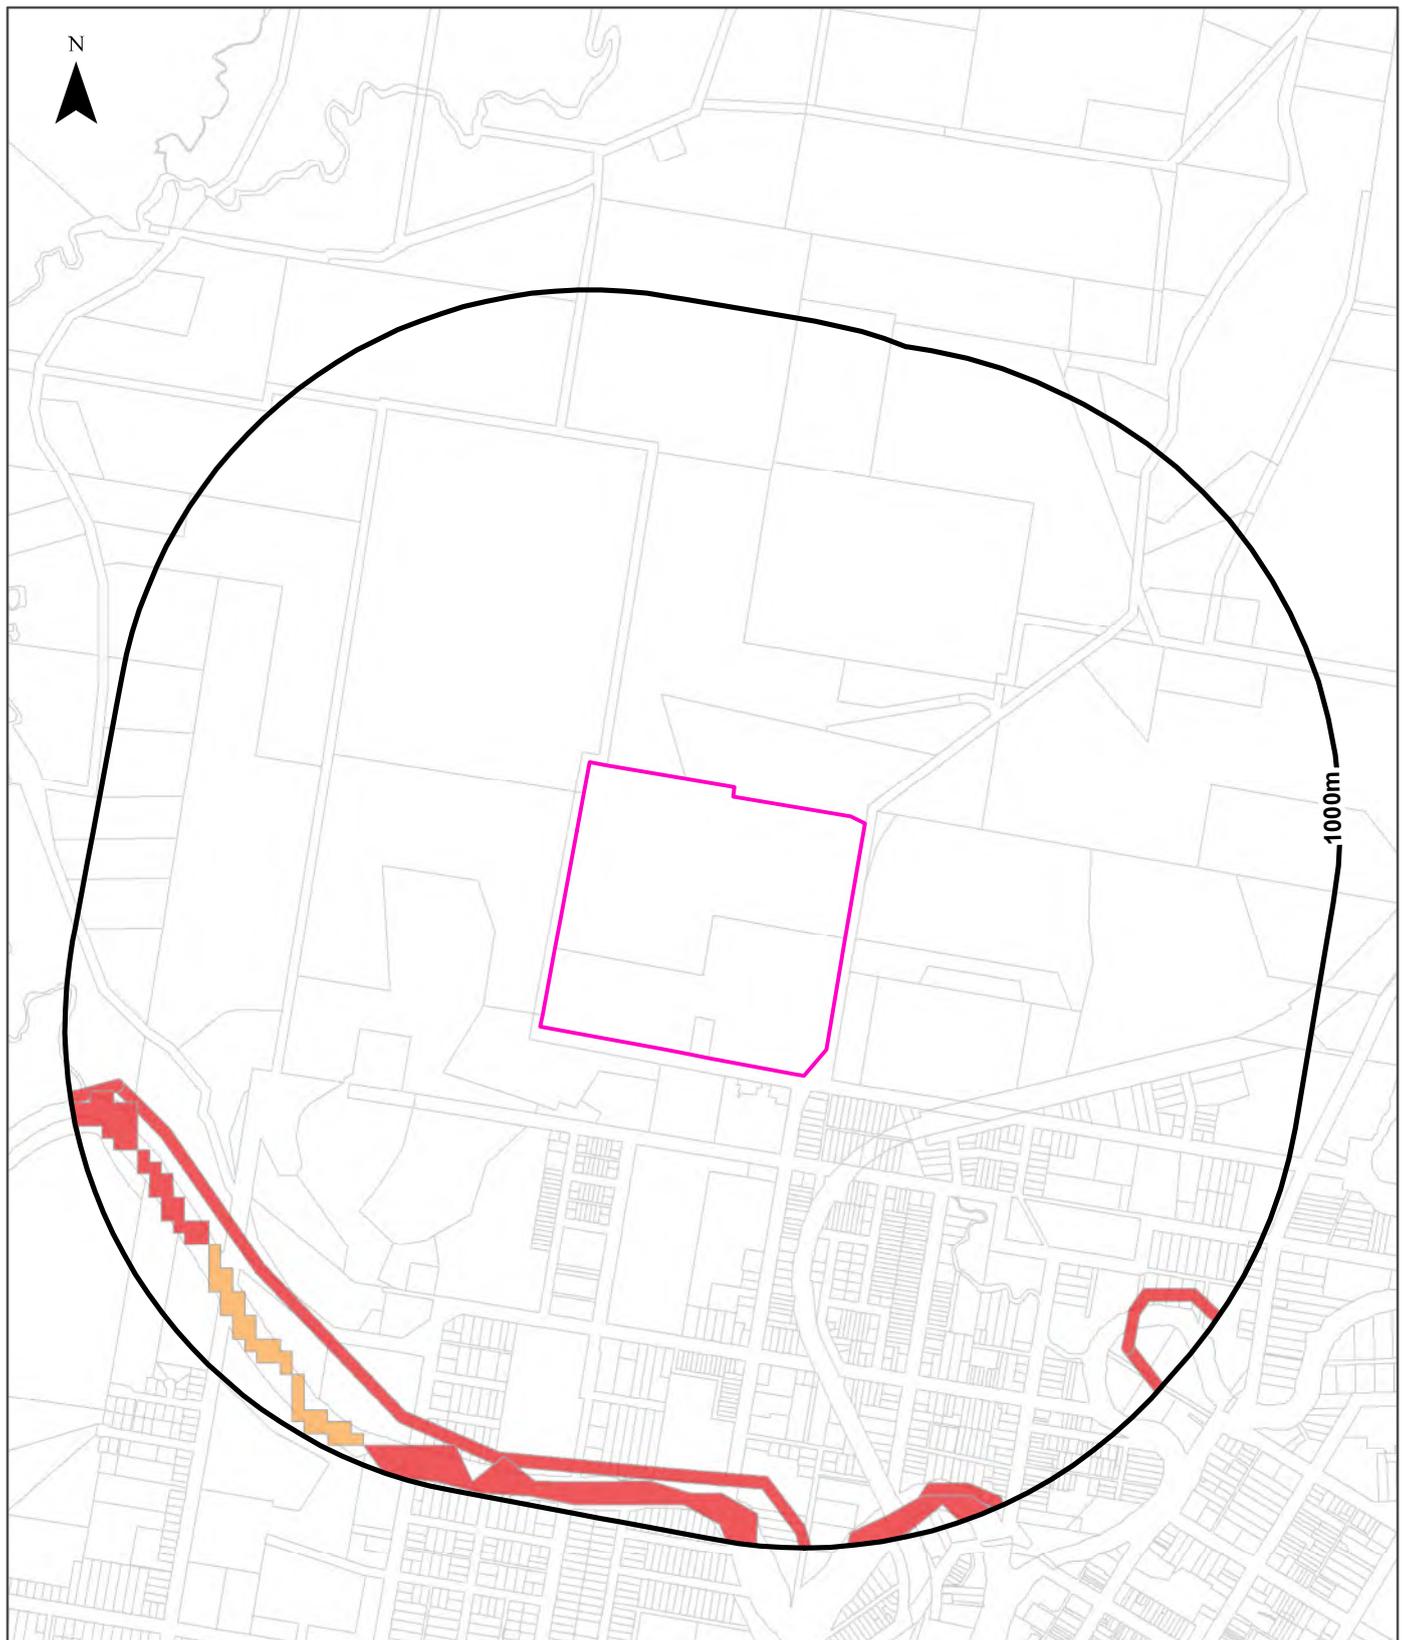
Ecological Constraints - Groundwater Dependent Ecosystems Atlas

Site Boundary	High potential GDE - from national assessment	Low potential GDE - from national assessment
Buffer 1000m	High potential GDE - from regional studies	Low potential GDE - from regional studies
Property Boundaries	Moderate potential GDE - from national assessment	Known GDE - from regional studies
	Moderate potential GDE - from regional studies	Unclassified potential GDE - from national assessment
		Unclassified potential GDE - from regional studies
