Geotechnical Investigation Report

Farnell Street, Forbes NSW

Prepared for: Land and Housing Corporation c/- ADW Johnson Pty Ltd
EP3269.003v1 15 May 2025

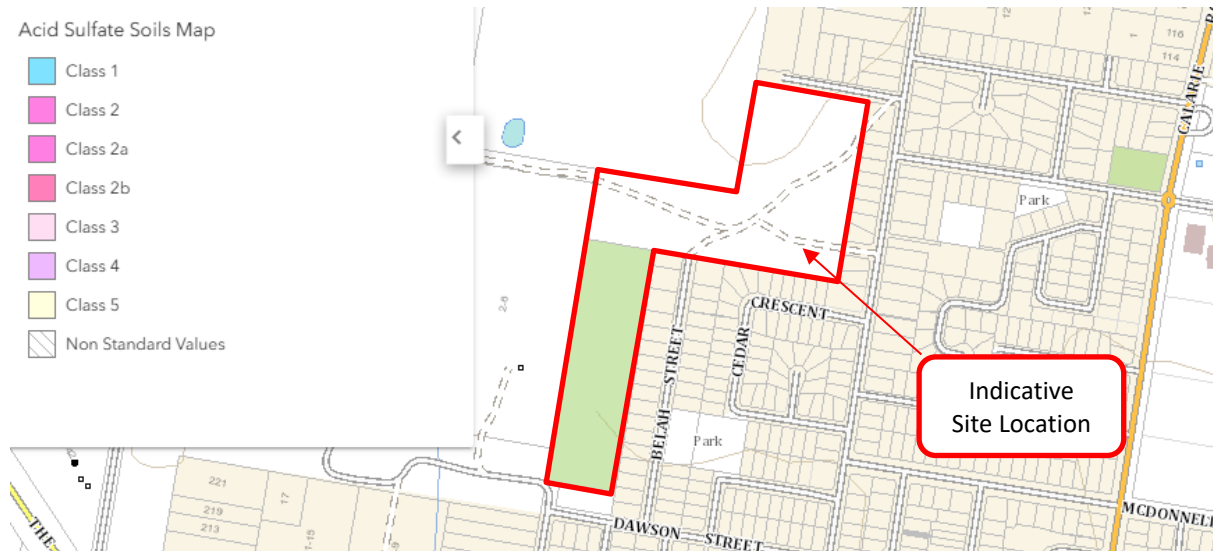
Figure 3 - ASS Map Excerpt

The NSW Government data available on NSW Planning Portal indicates the site is located in an area with no known acid sulphate soils. An extract of the acid sulphate soil map is shown in Figure 3.

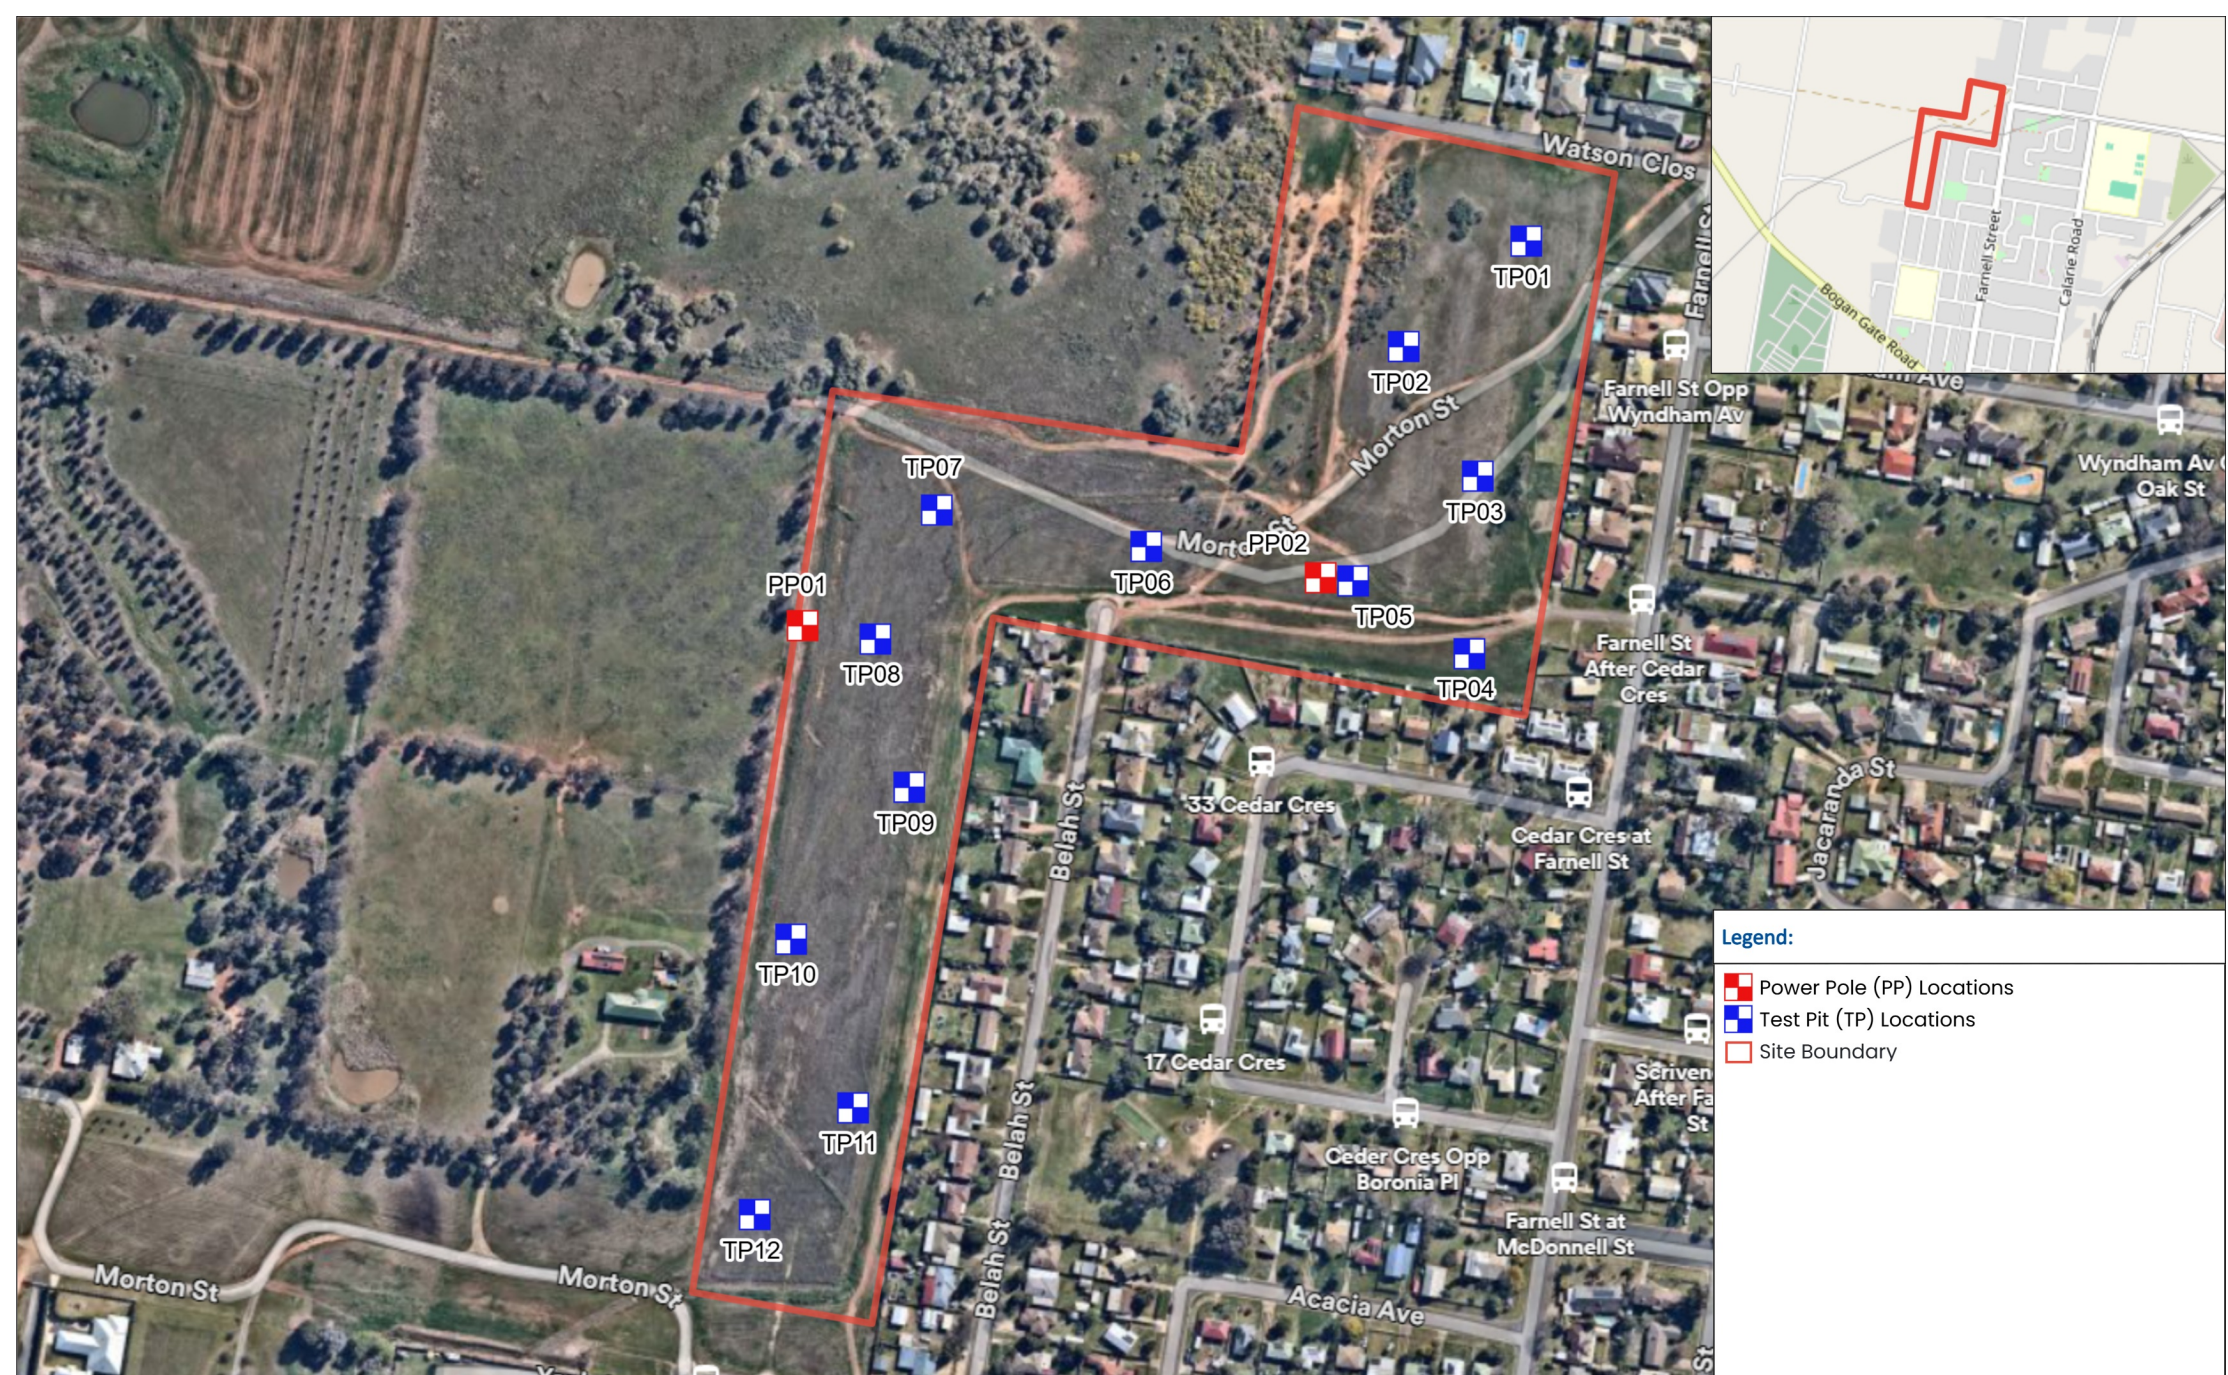
Appendix C - Geotechnical Investigation Locations

Geotechnical Investigation Farnell St, Forbes NSW, Australia

- Prepared all the work health and safety documentation and procured Before You Dig Australia plans for the site.
- Advanced twelve (12) test pits (TP) across the site to a maximum depth of 3.0m below ground level (BGL), or prior bedrock refusal to assess the subgrade conditions.
- Advanced an additional two (2) test pits at proposed locations for lightning poles.
- Dynamic Cone Penetrometer (DCP) was conducted adjacent to test pits to assess the consistency of the subsurface.
- Collected representative soil/rock core samples for further laboratory testing. Upon completion the test pits were filled with spoil and light compaction by excavator bucket, mounded and tracked over.
- Preparation of a Geotechnical Investigation report including investigation findings, laboratory test results, pavement design and site classification.

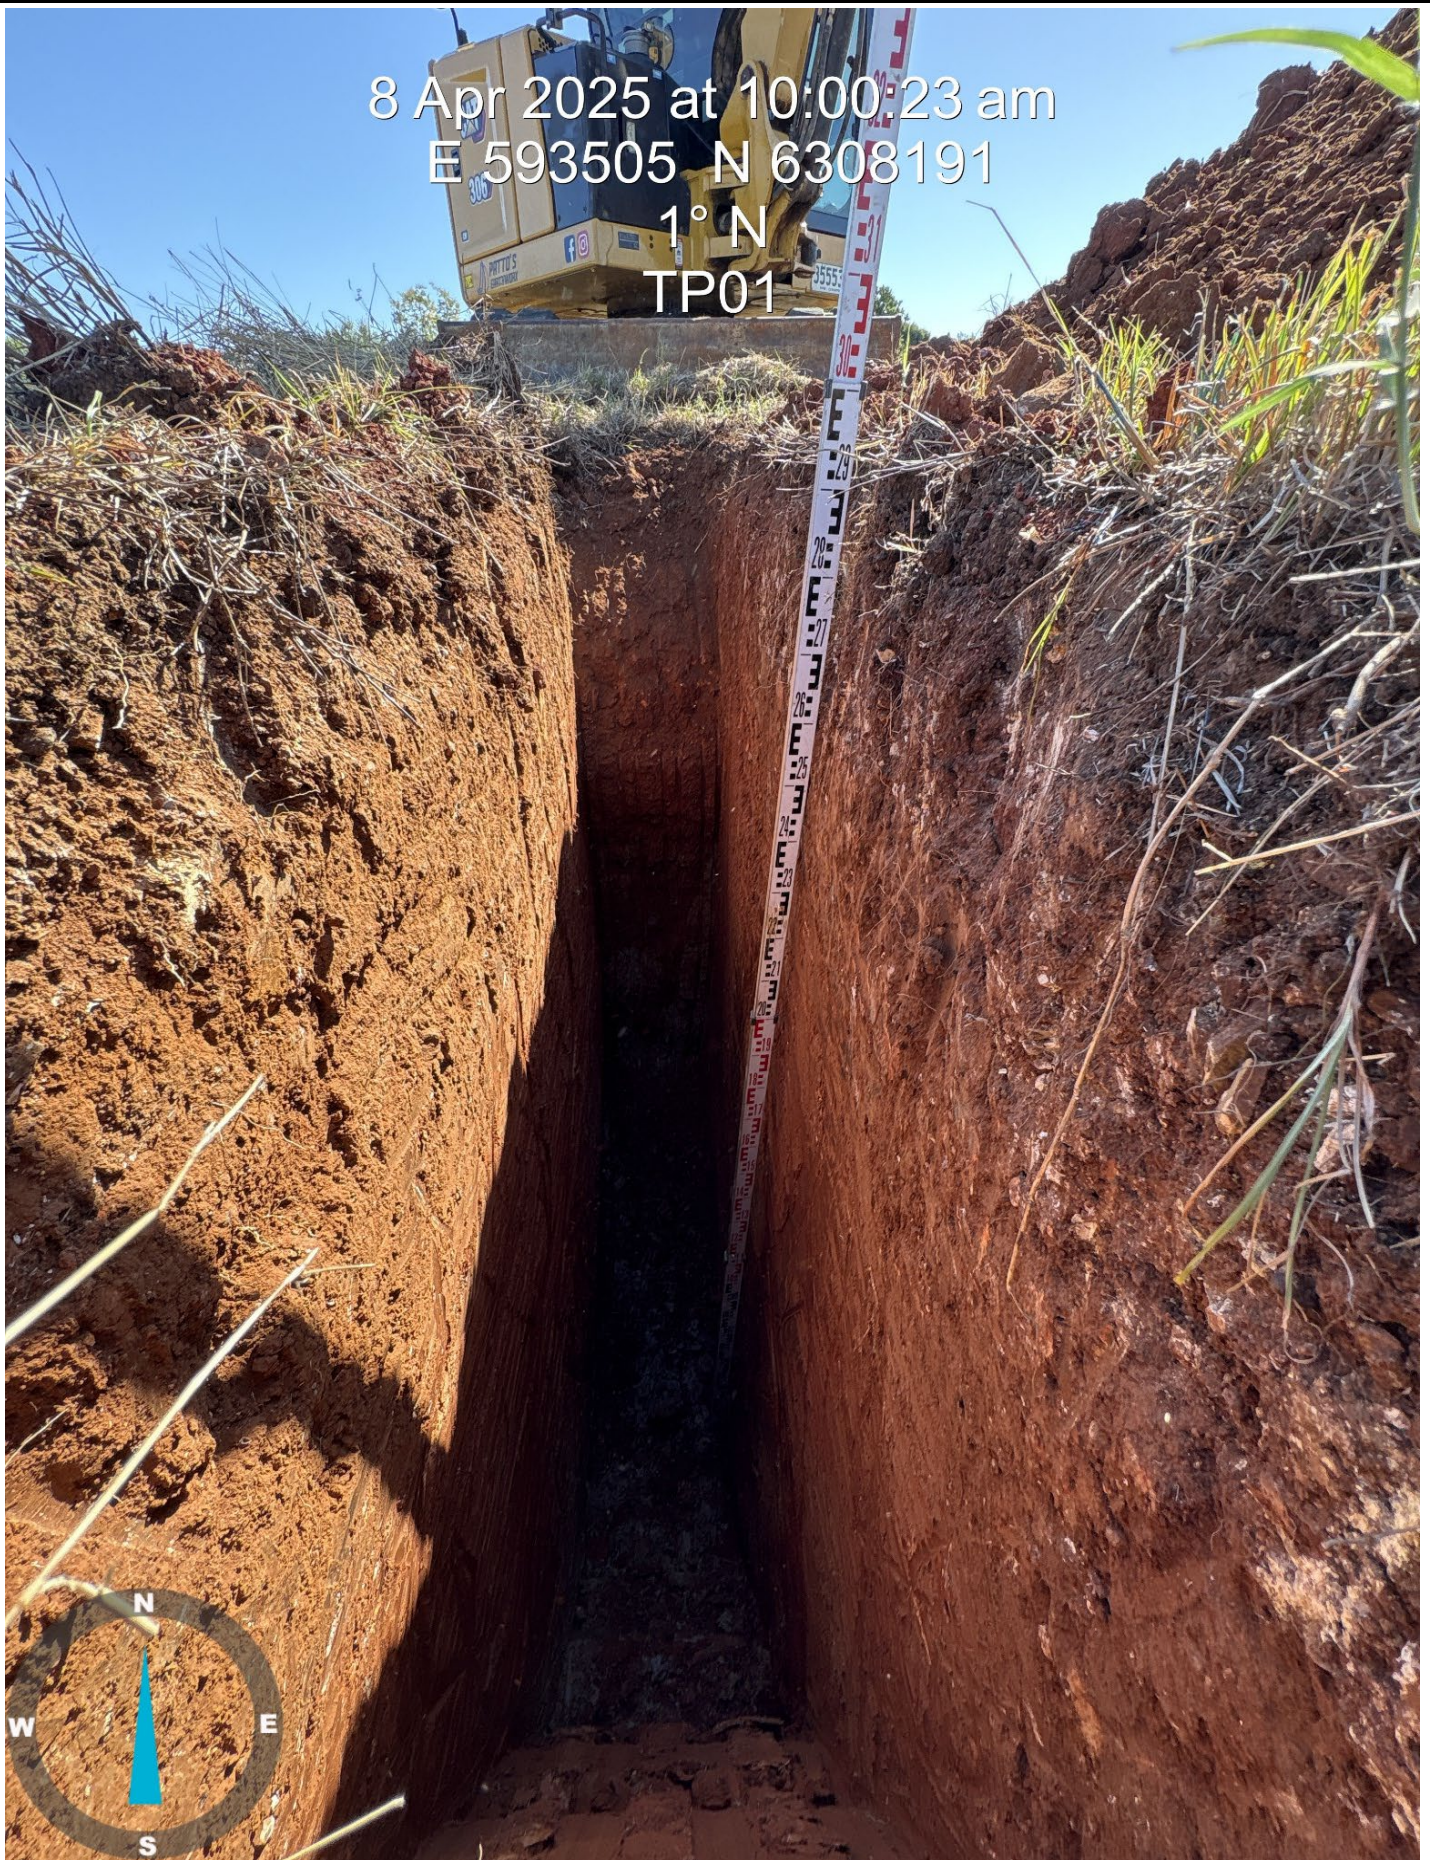
TP01

EP3269.003
Geotechnical Investigation

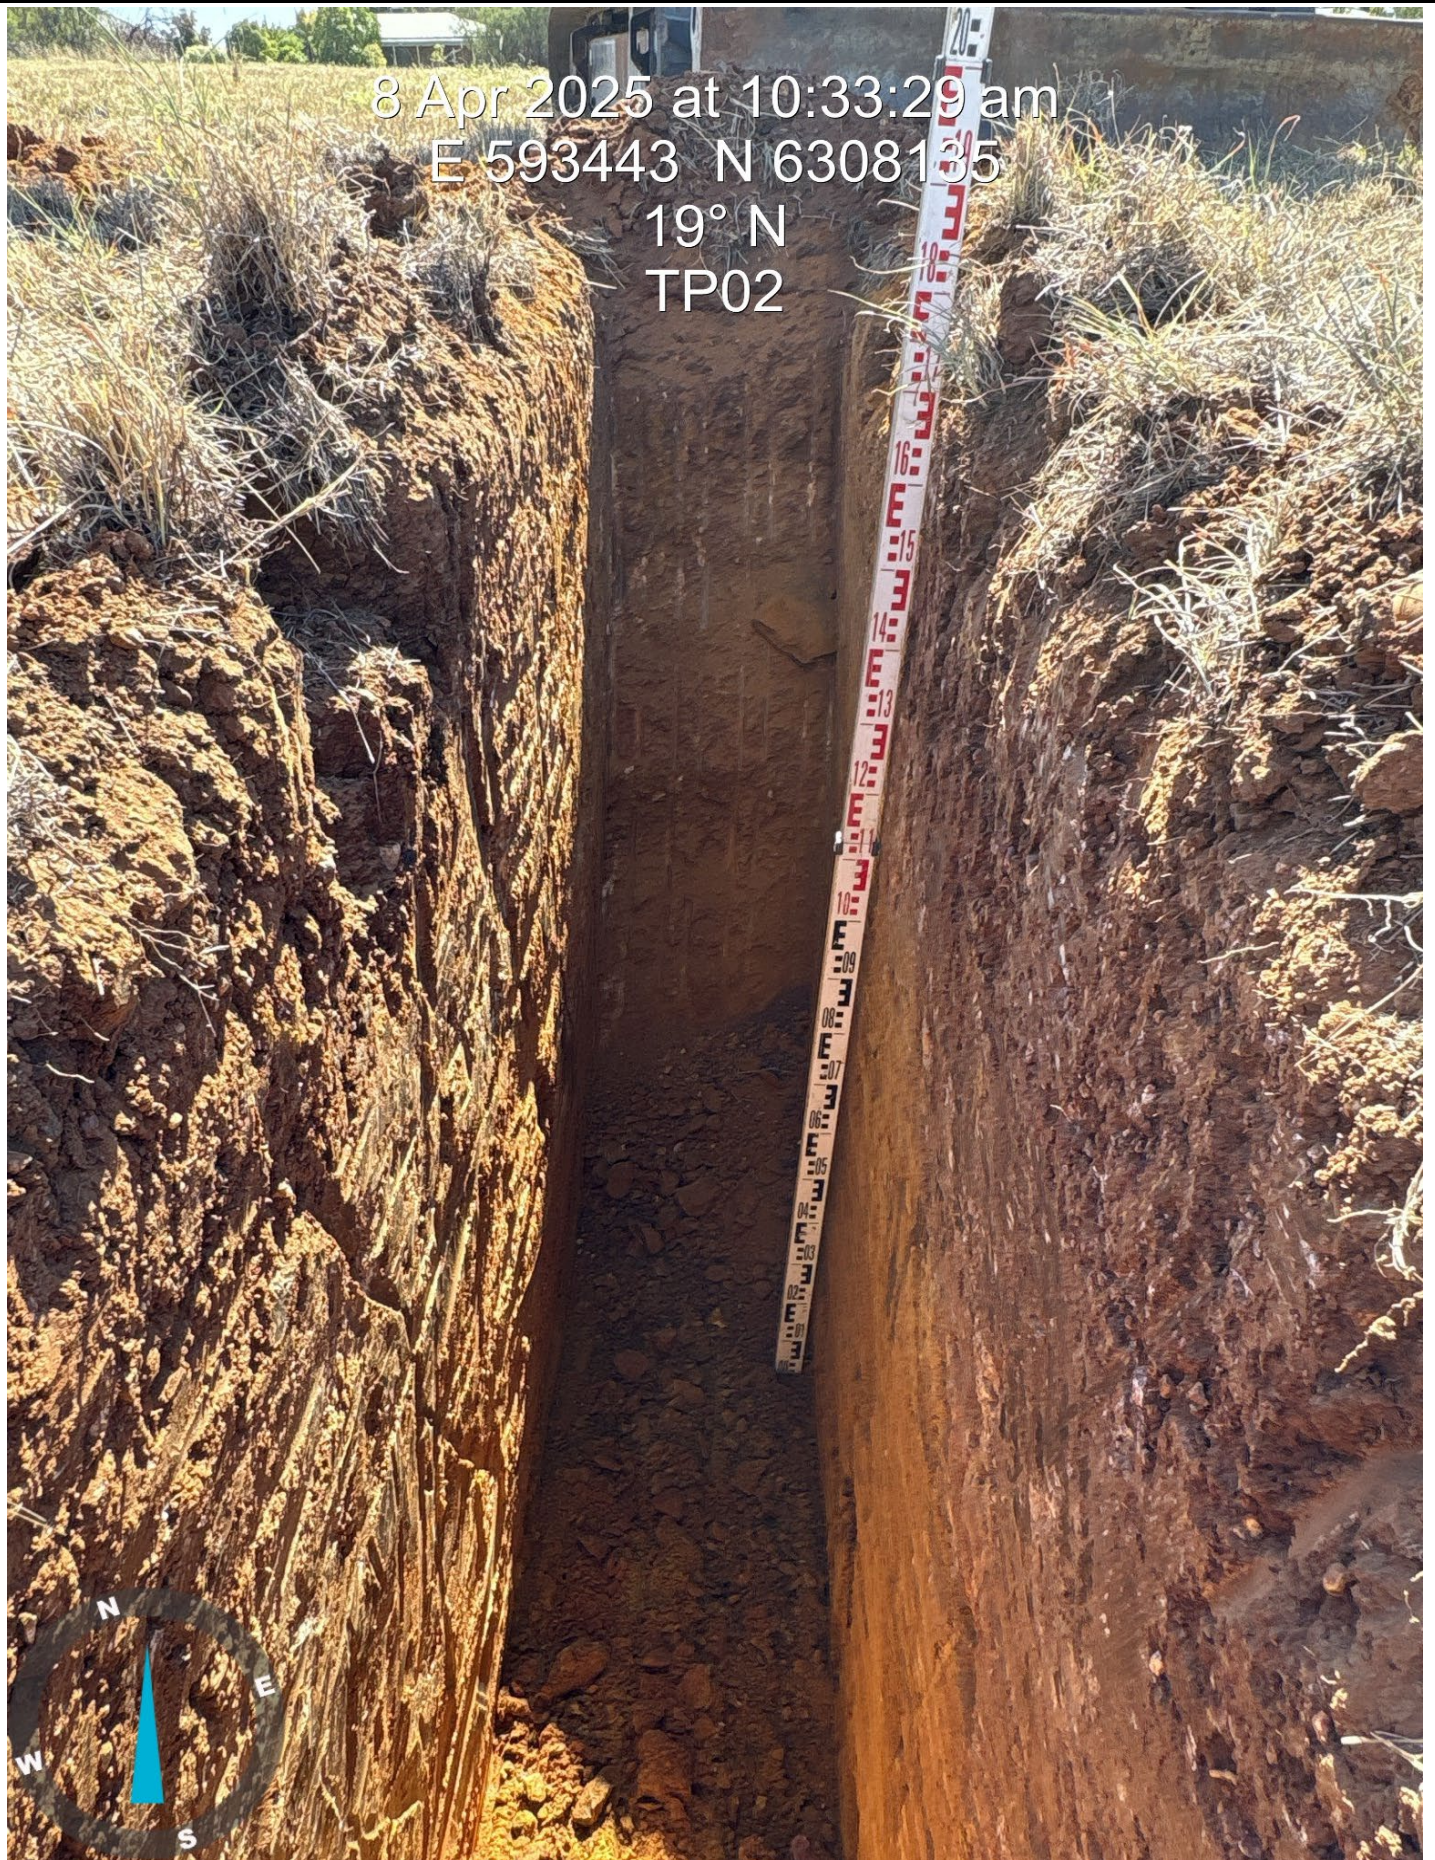
TP02

EP3269.003
Geotechnical Investigation

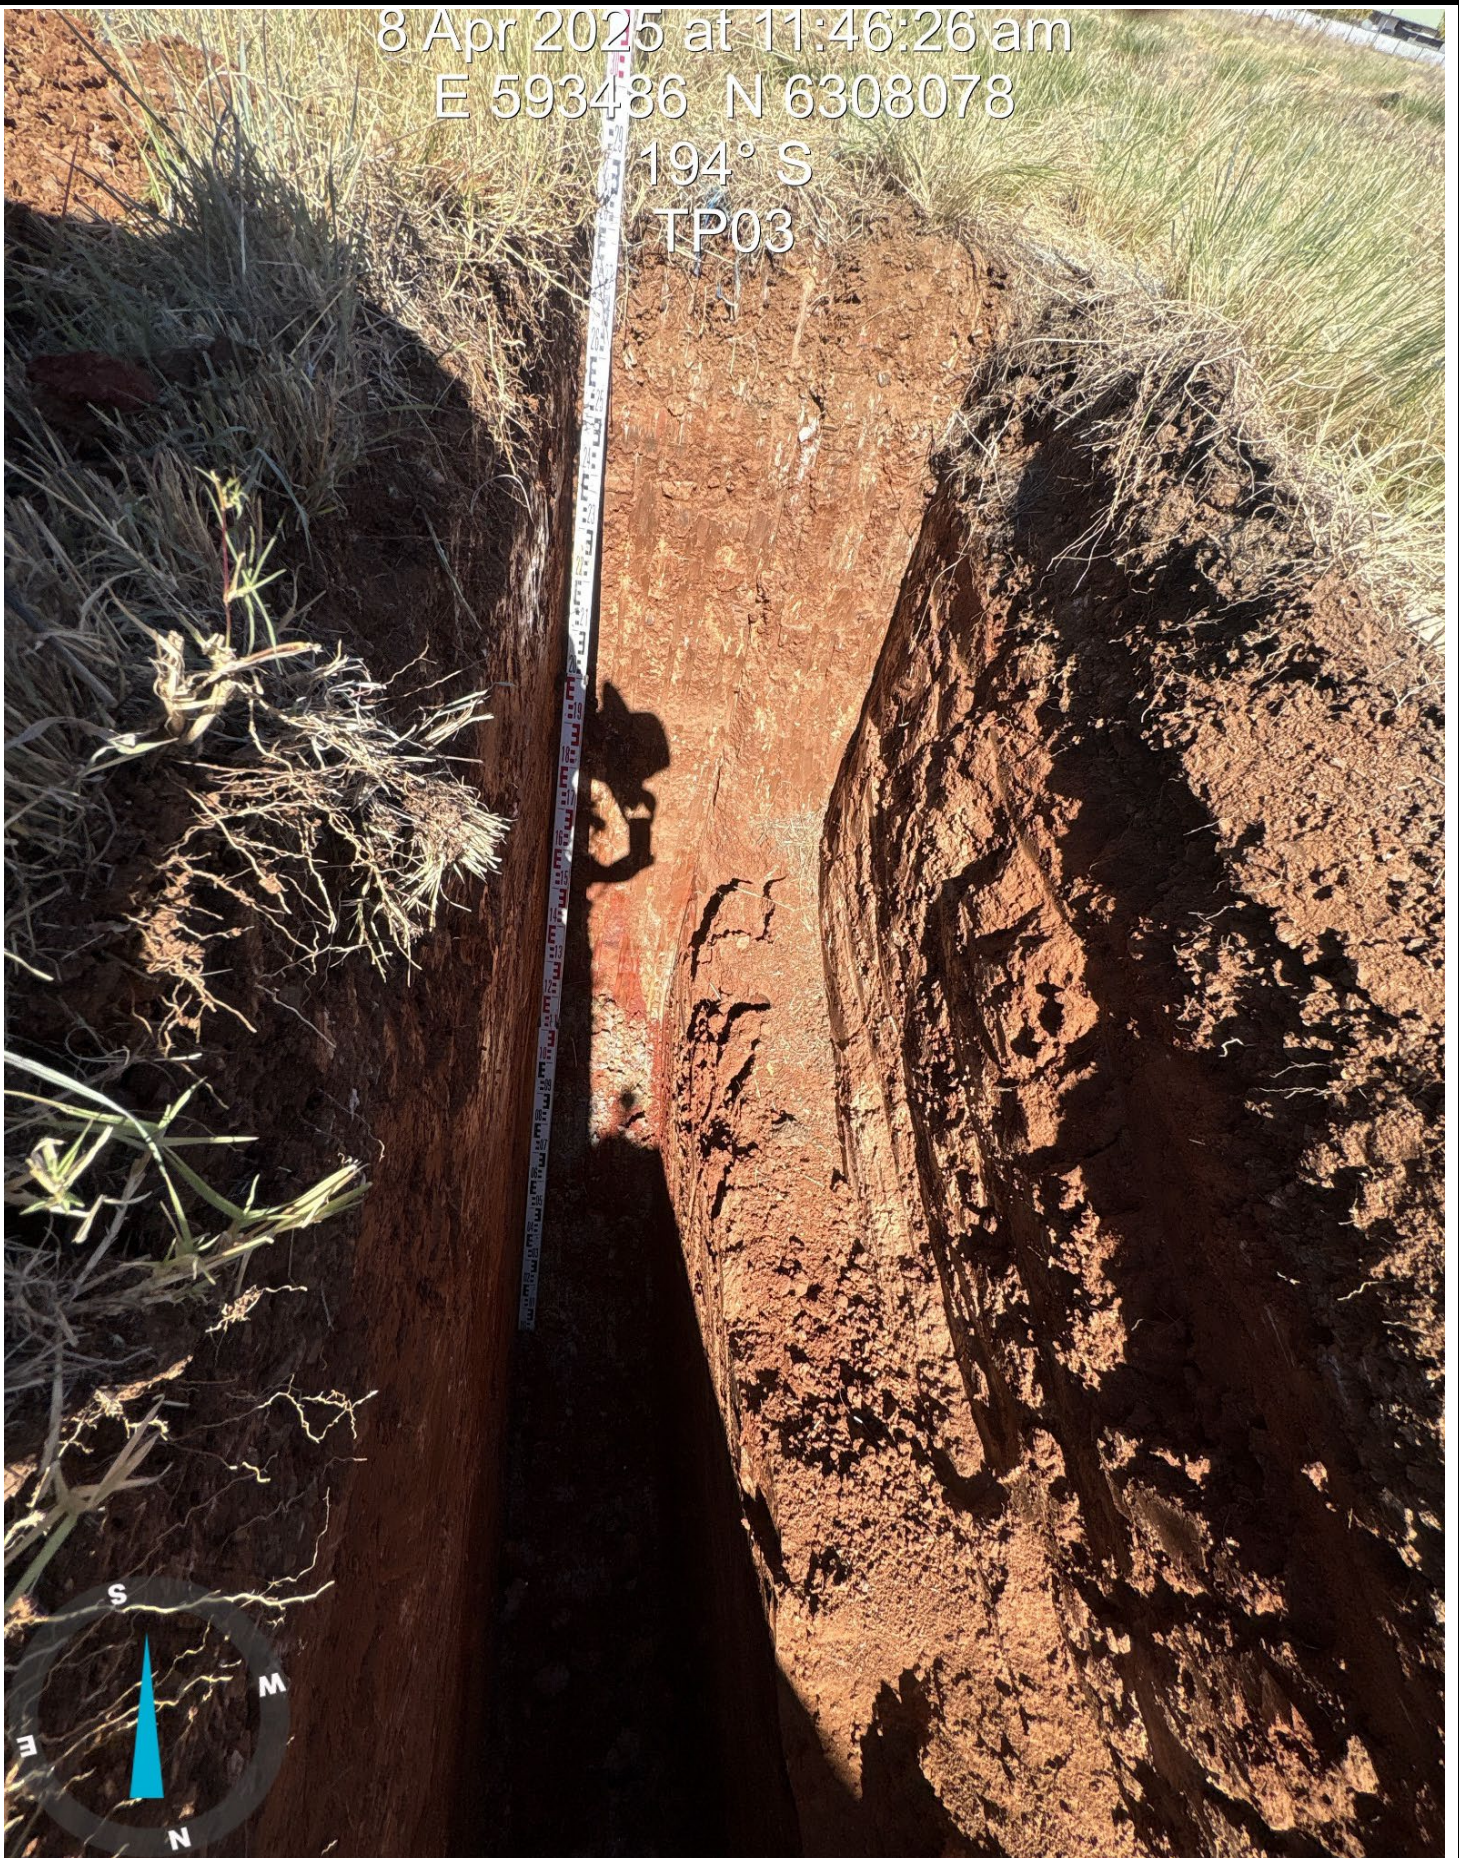
TP03

EP3269.003

Geotechnical Investigation

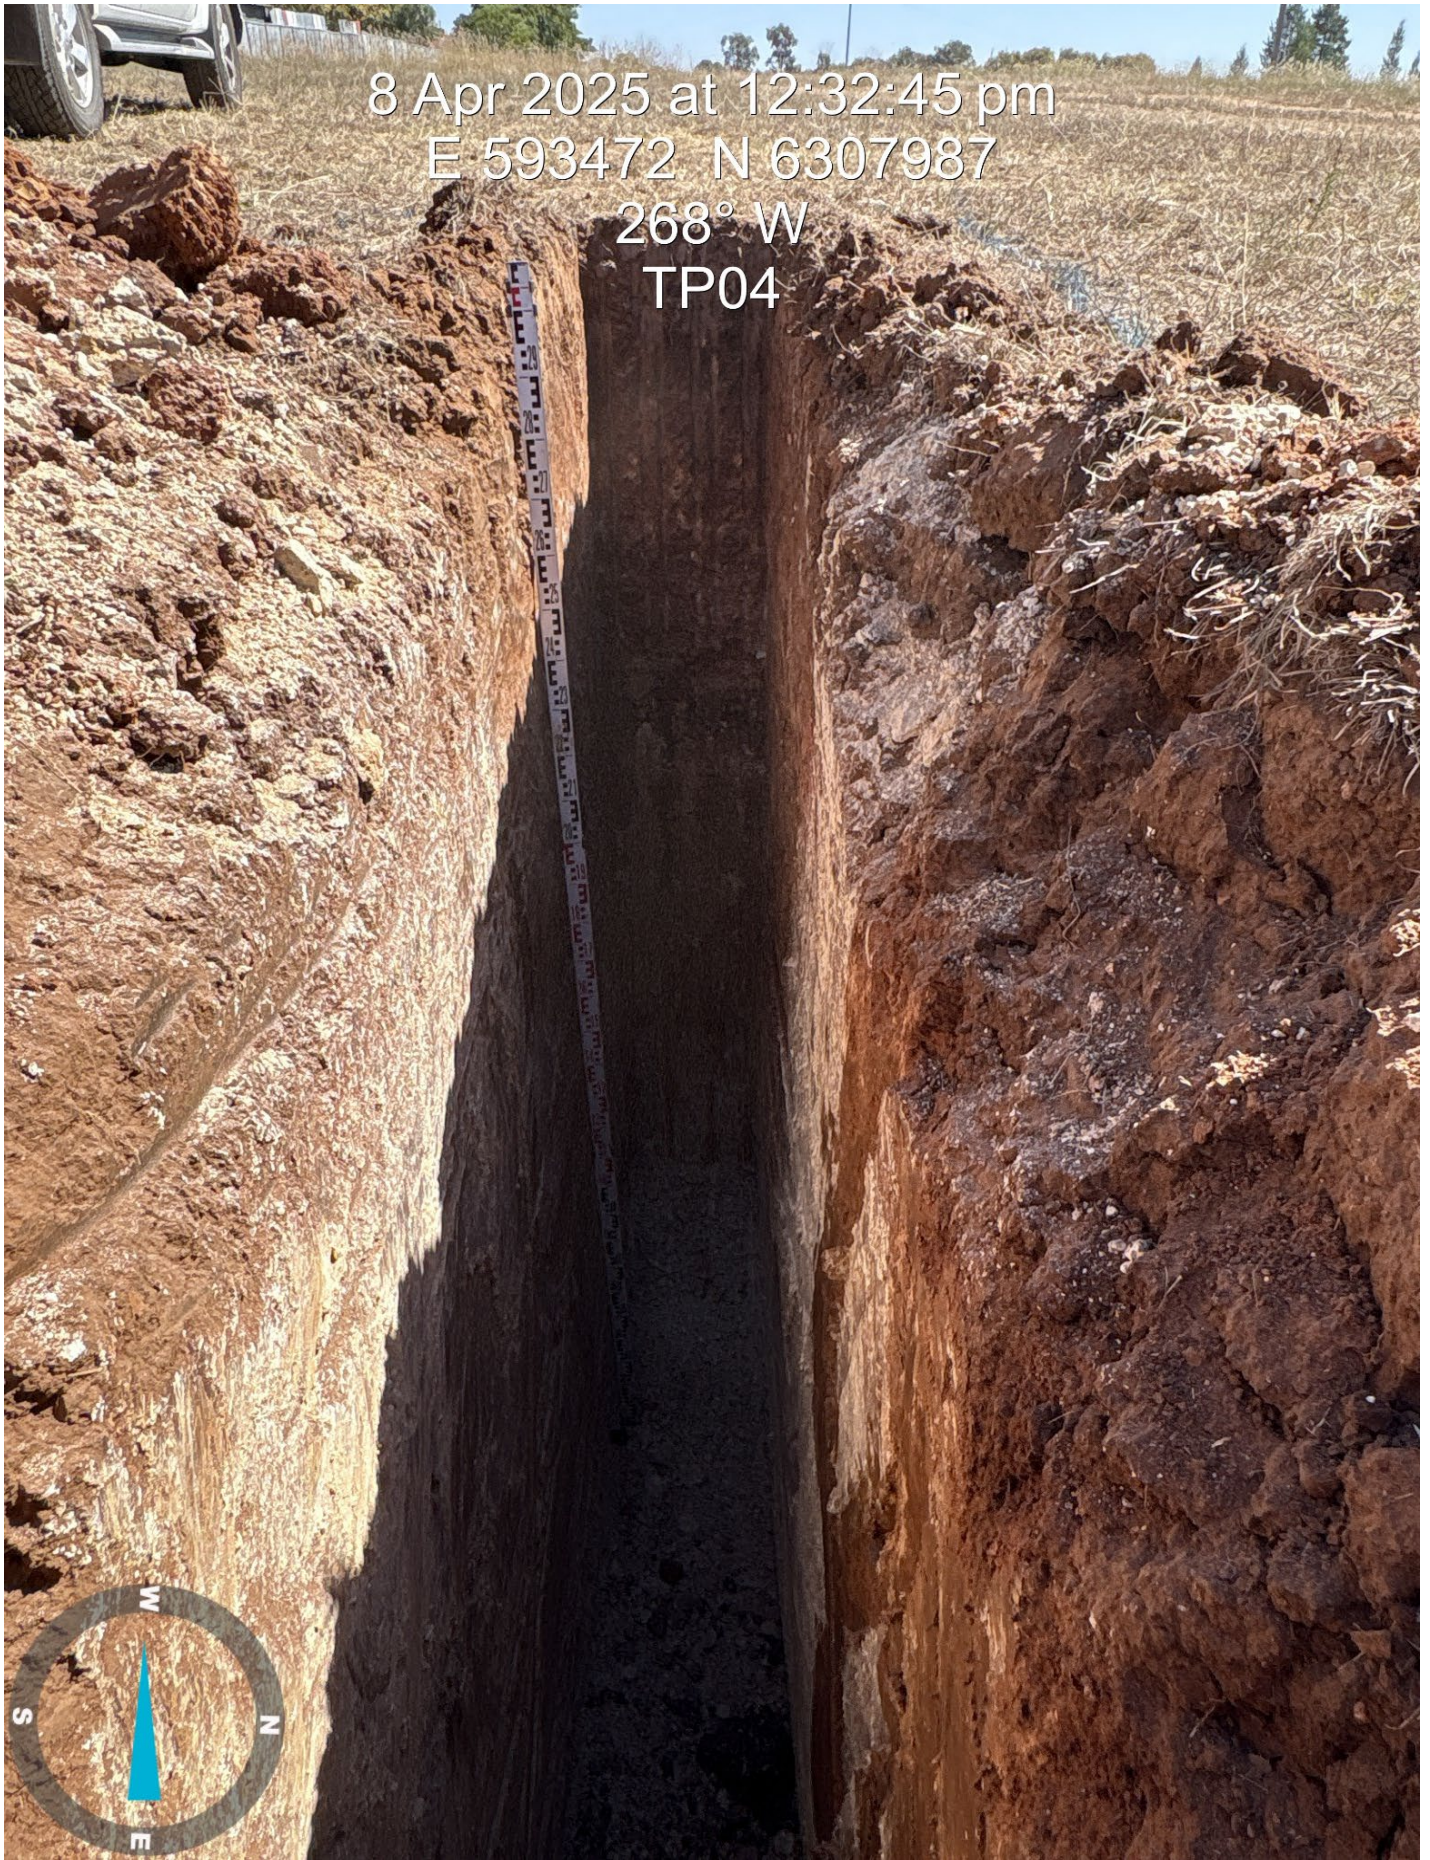
TP04

EP3269.003
Geotechnical Investigation

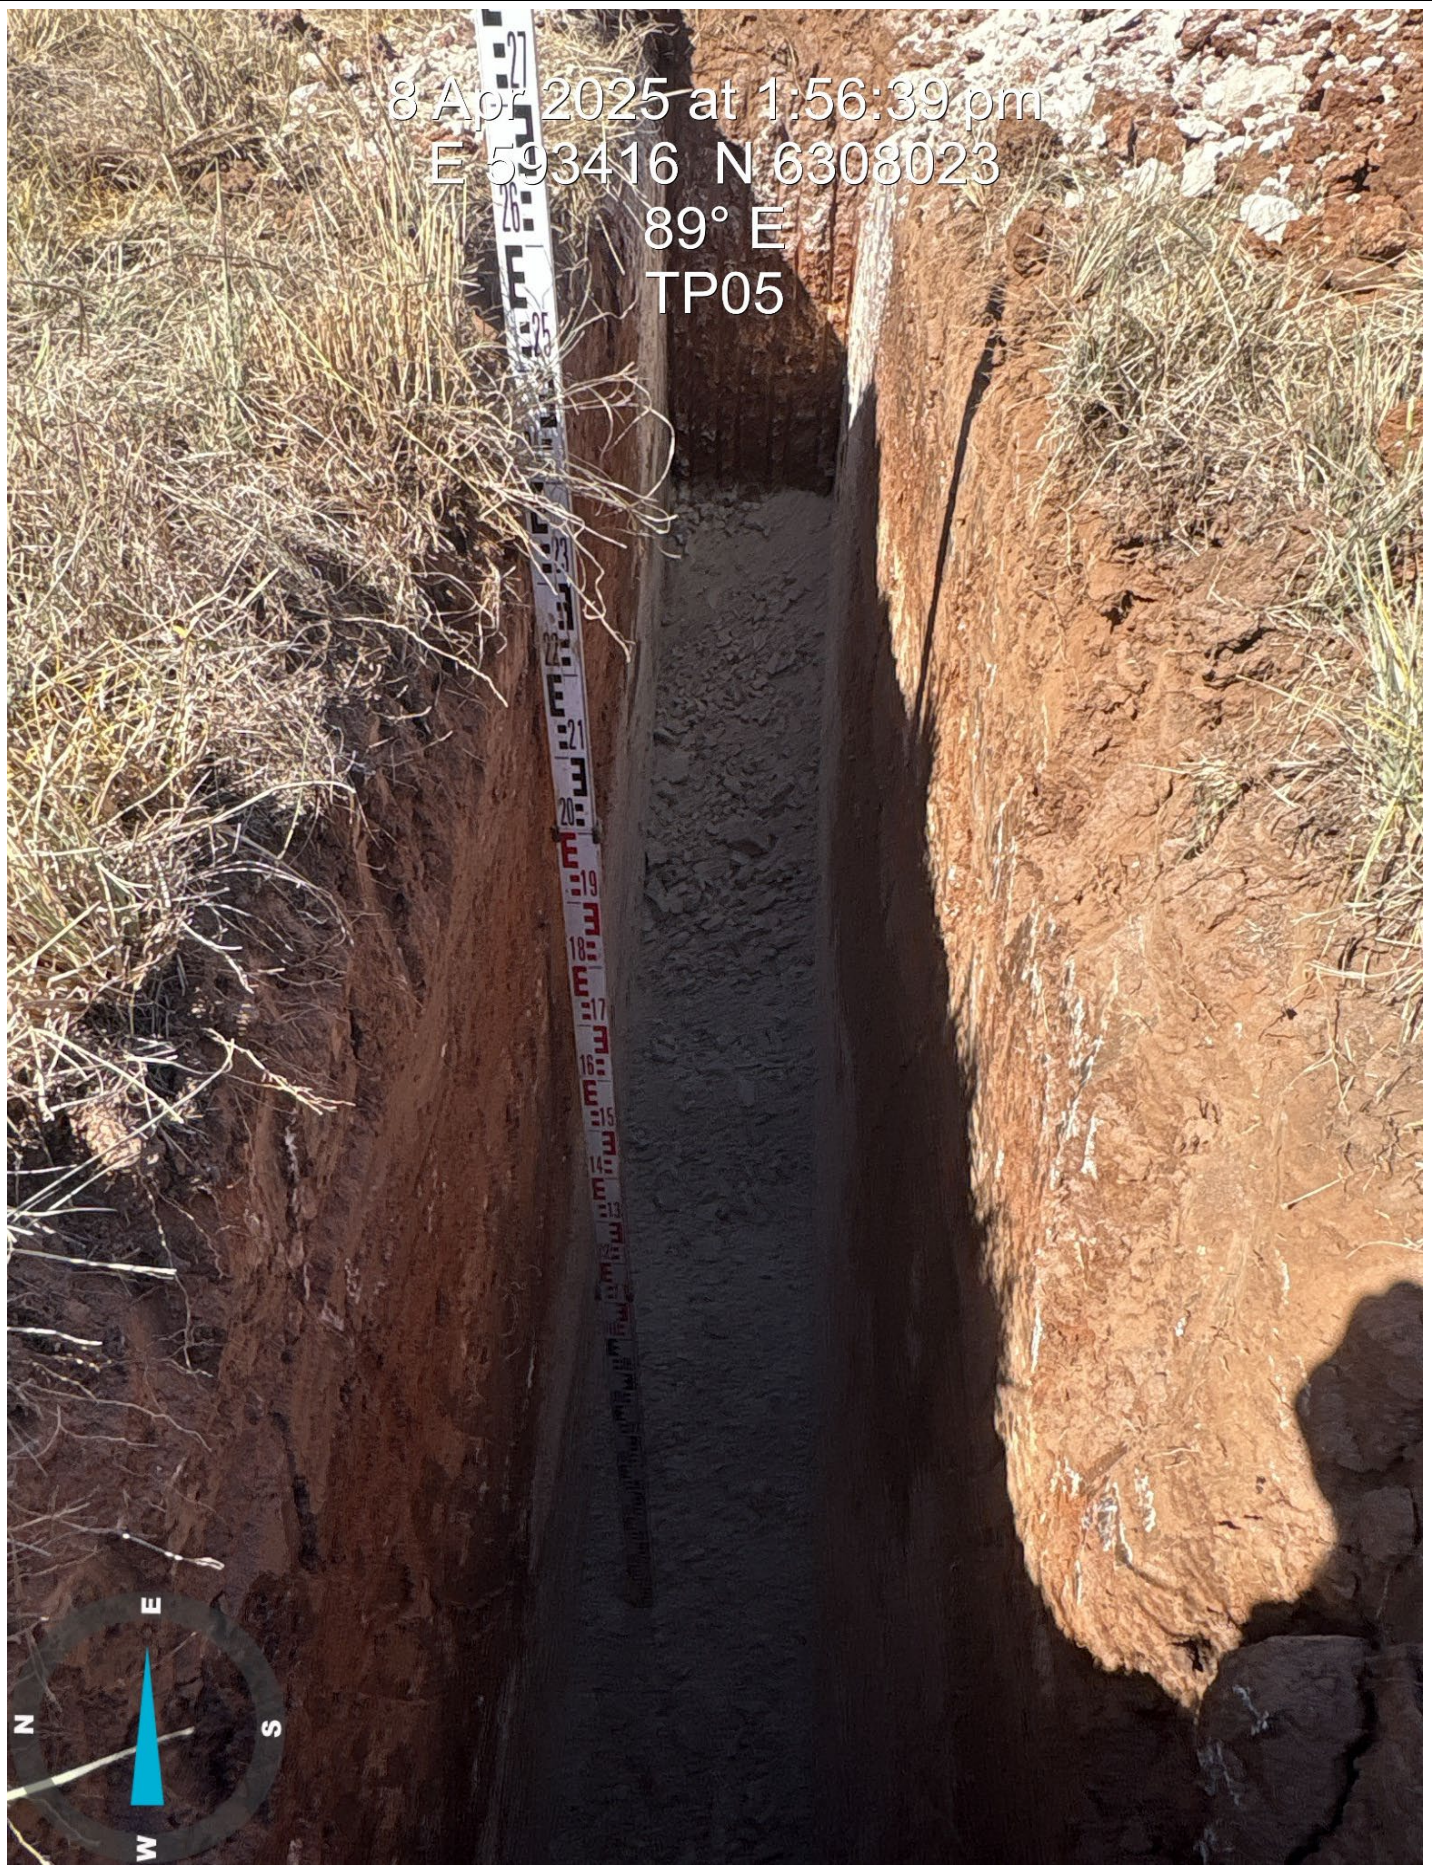
EP3269.003
Geotechnical Investigation
TP05/PP05

Engineering Log - Test Pit

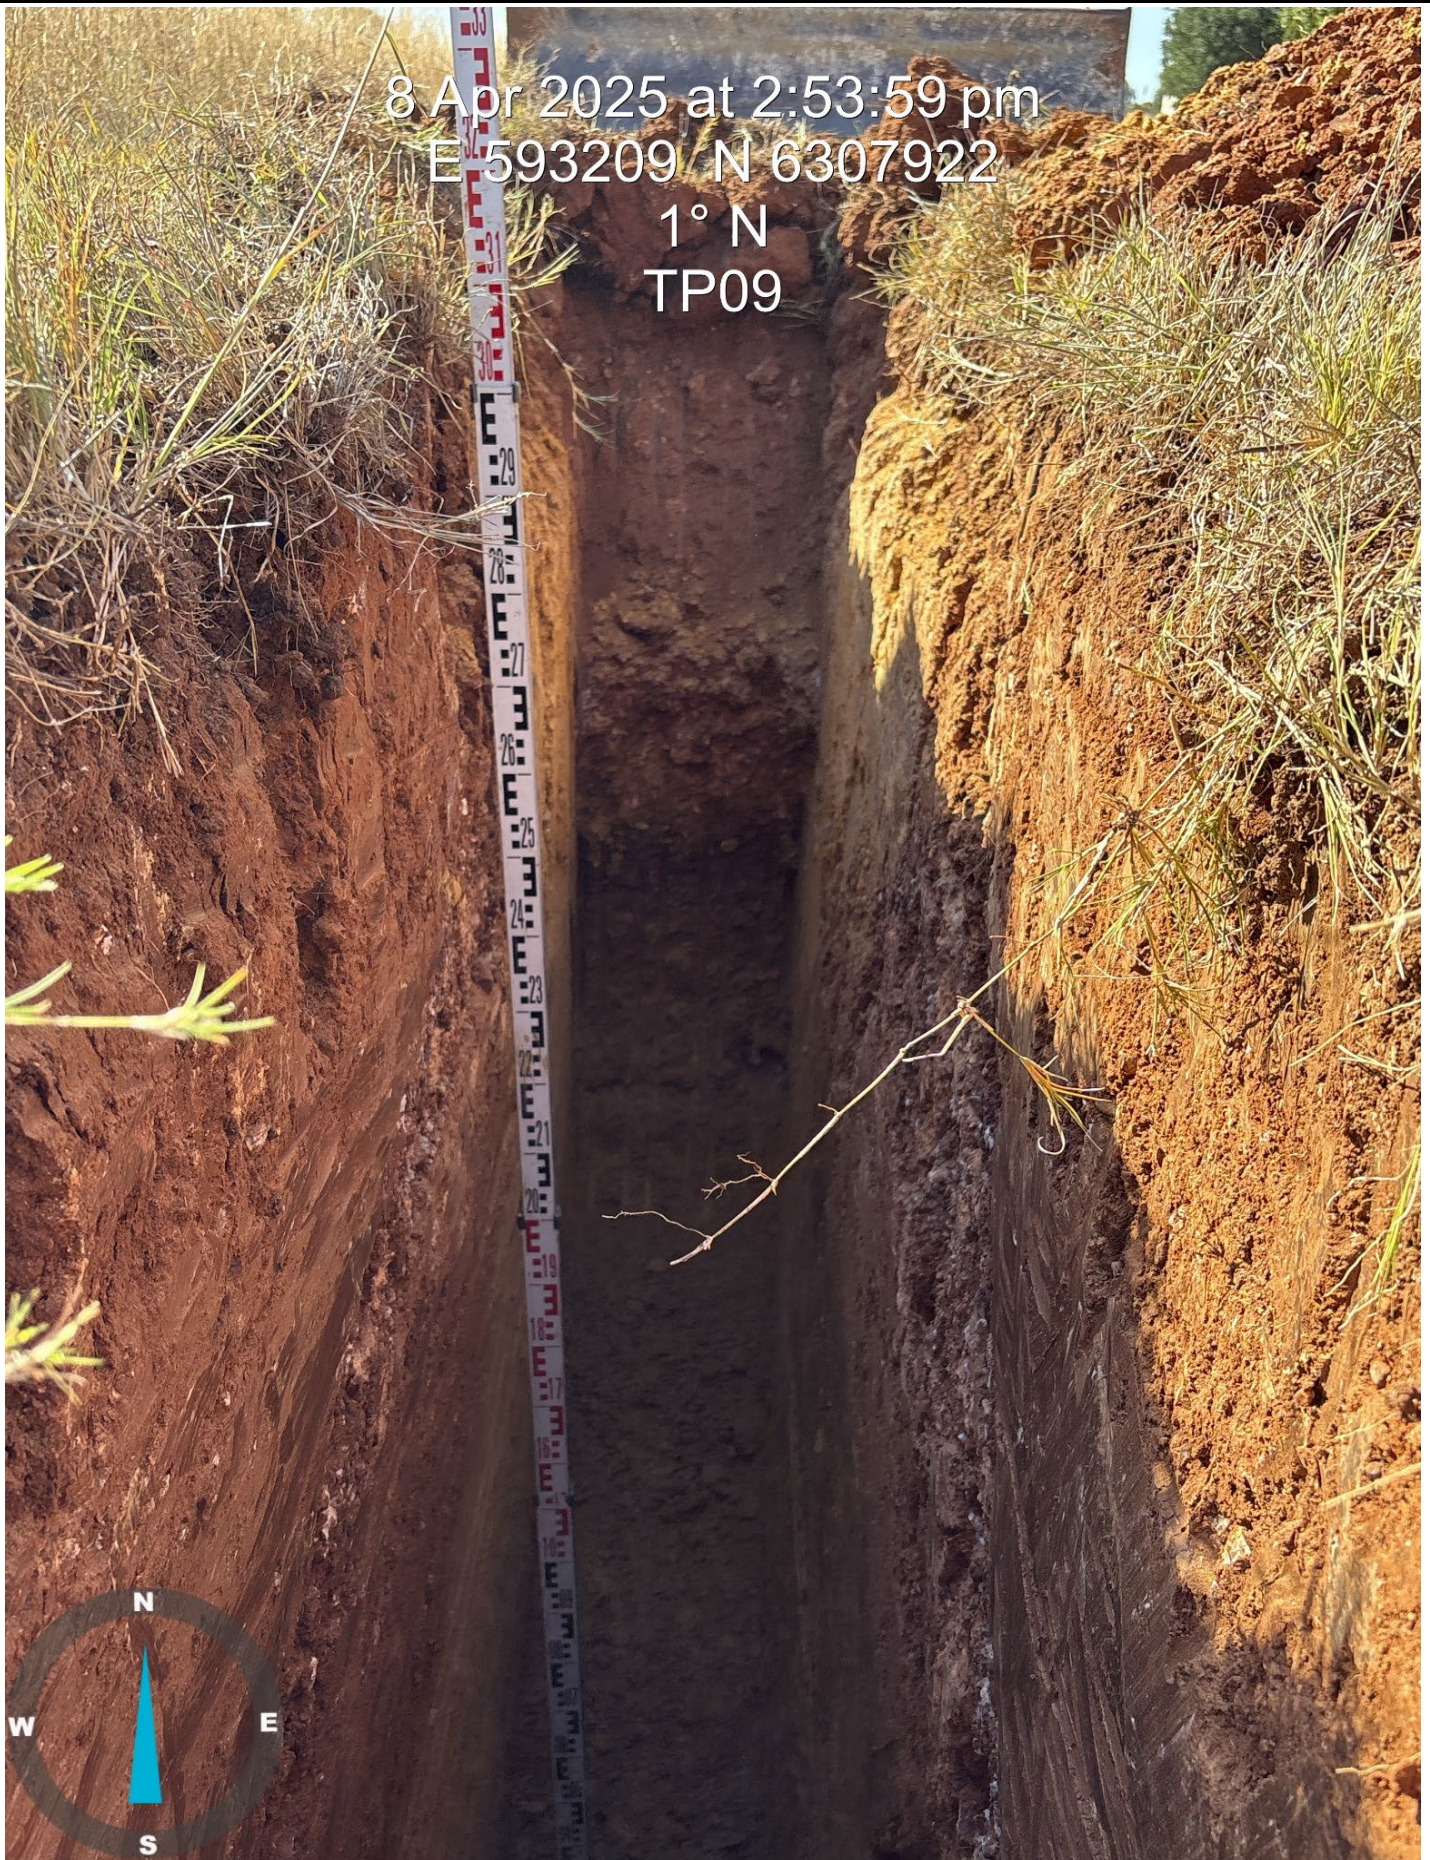
TP09

EP3269.003
Geotechnical Investigation

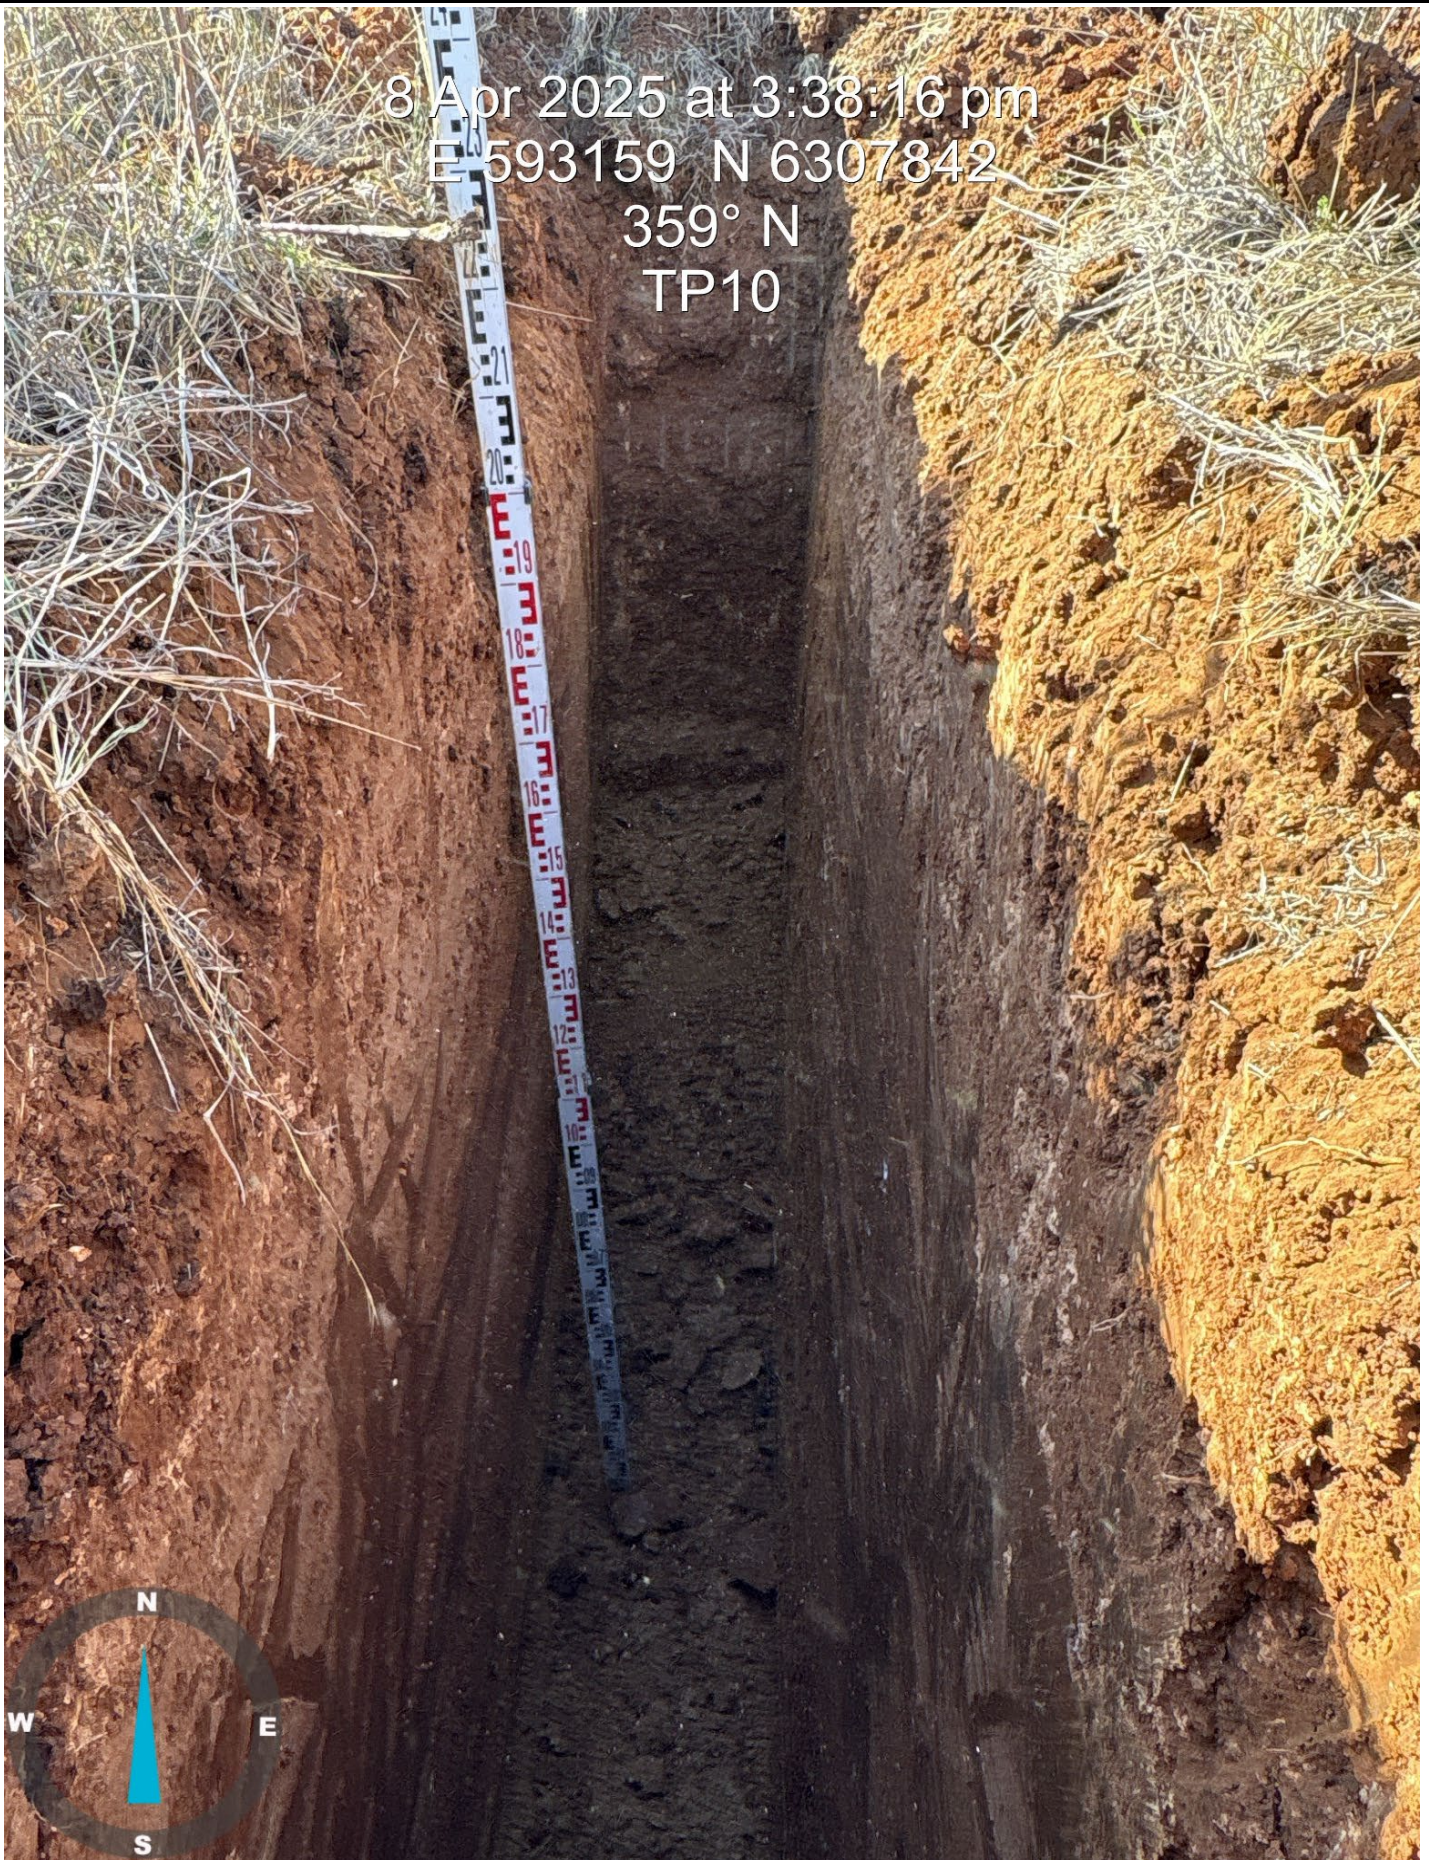
TP10

EP3269.003
Geotechnical Investigation
