Geotechnical Investigation Report

Farnell Street, Forbes NSW

Prepared for: Land and Housing Corporation c/- ADW Johnson Pty Ltd
EP3269.003v1 15 May 2025

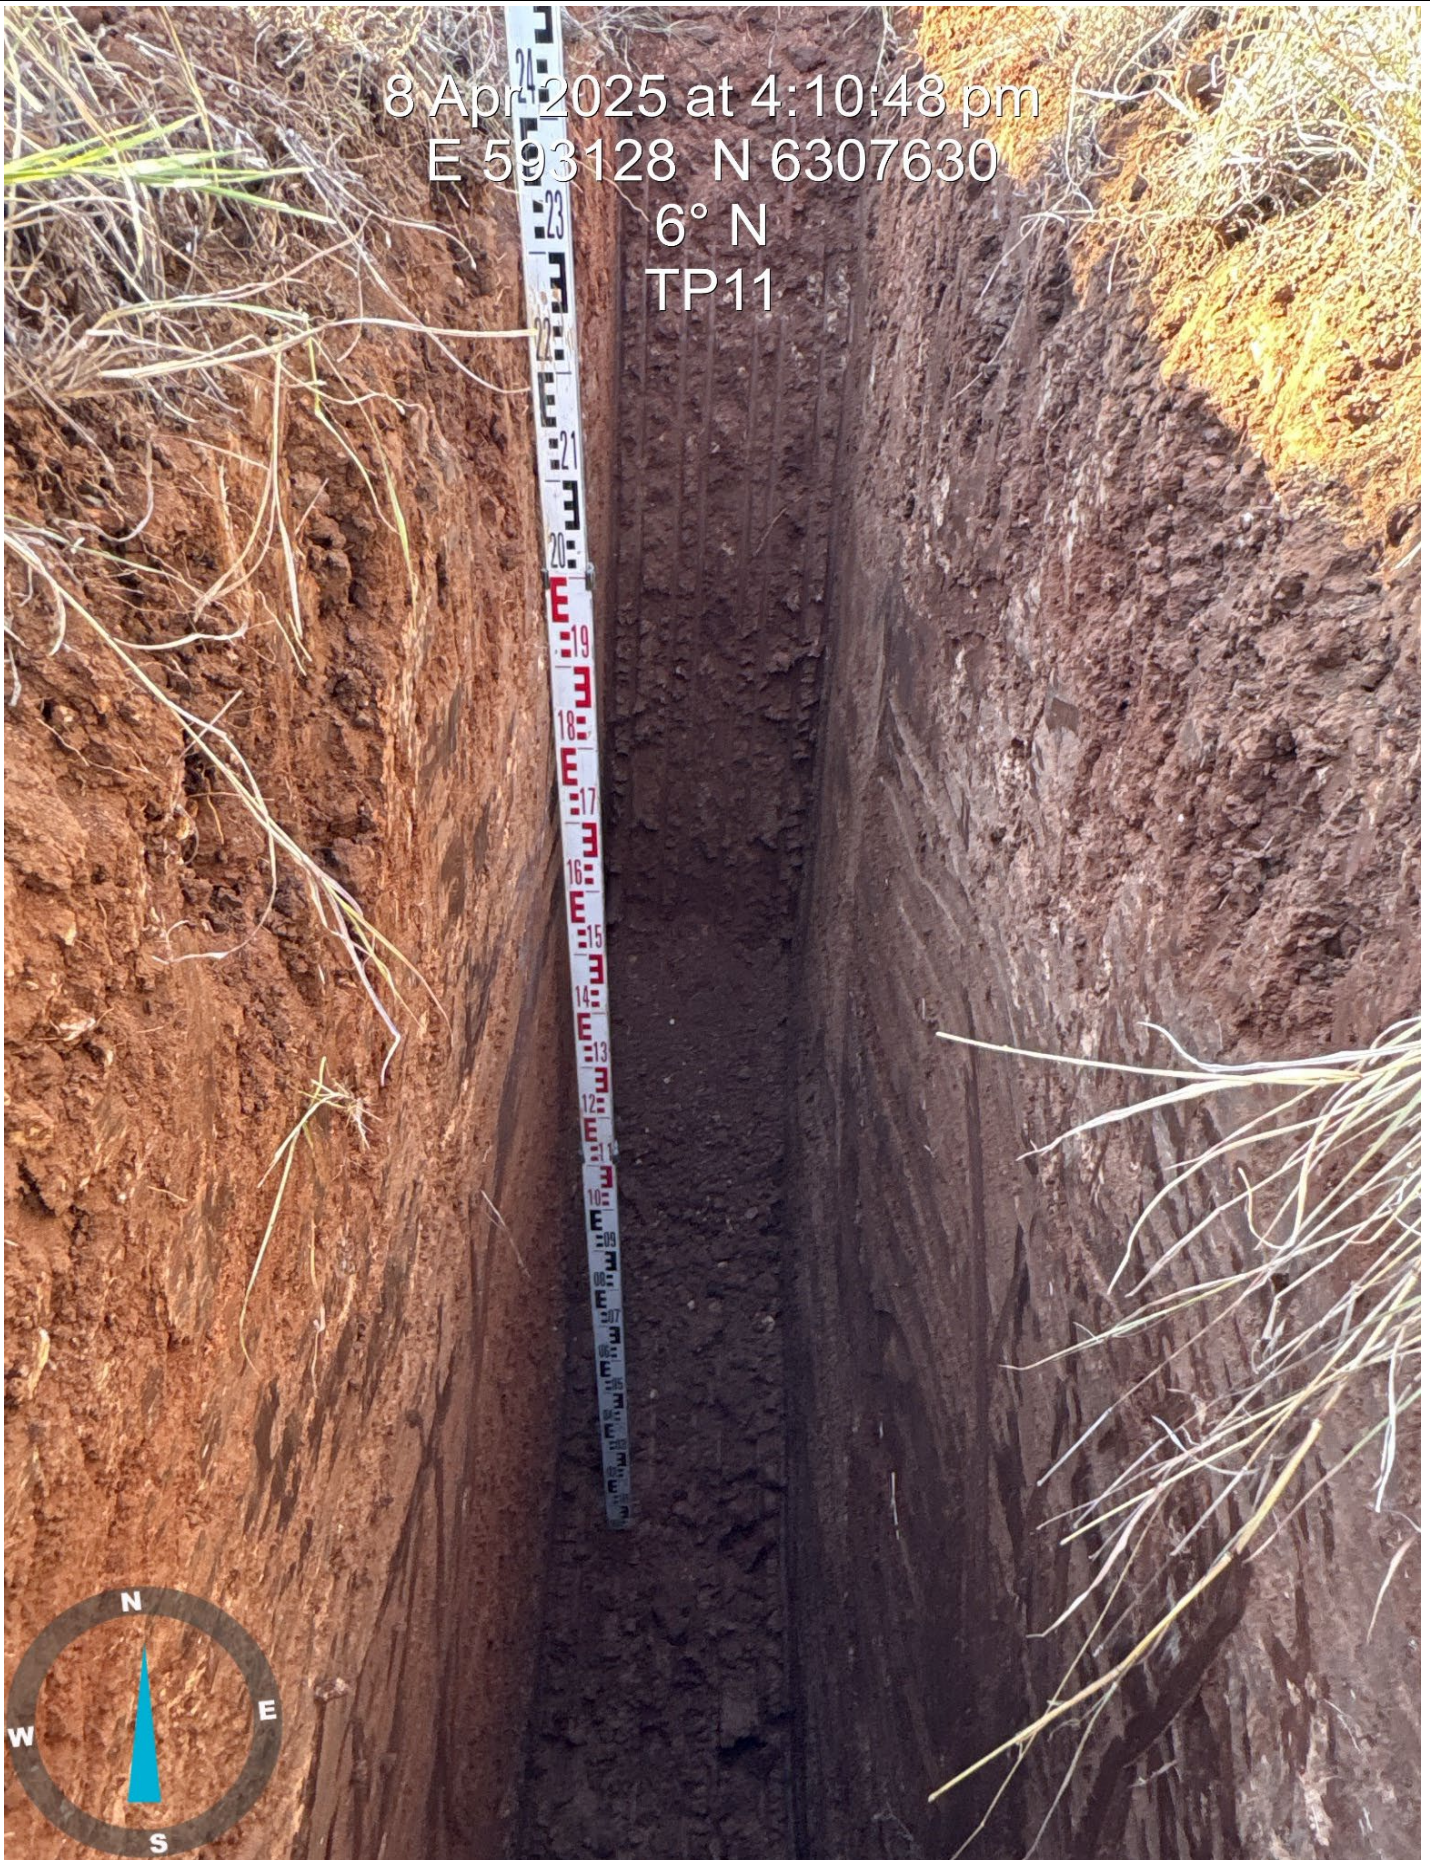
TP11

EP3269.003
Geotechnical Investigation

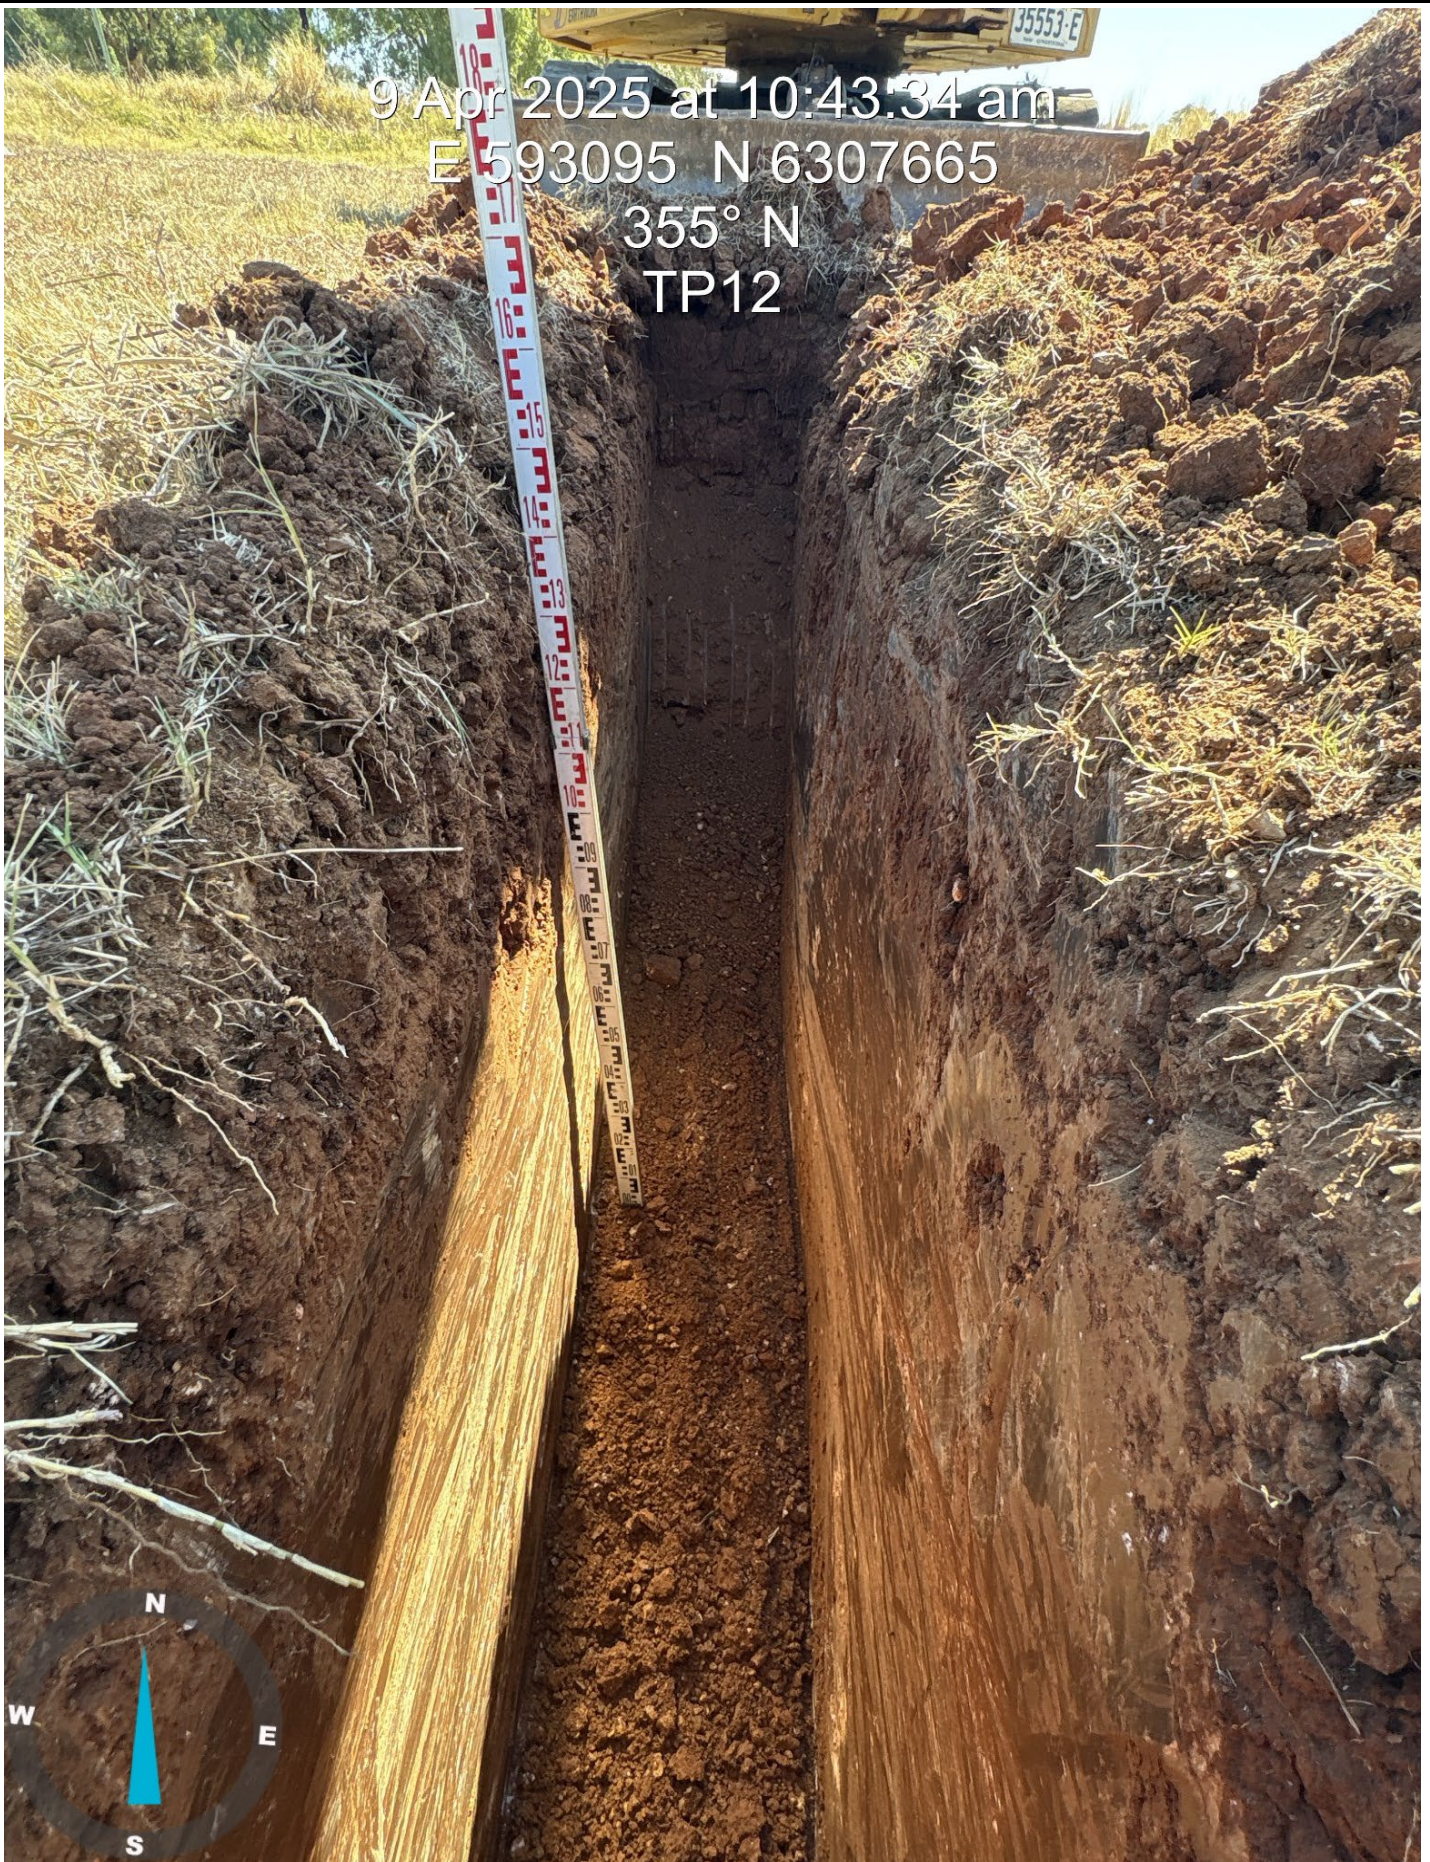
TP12

EP3269.003
Geotechnical Investigation
