REVIEW OF ENVIRONMENTAL FACTORS (REF) FORESHORE PROTECTION AND ENHANCEMENT SUSSEX INLET WATERWAY LOT 7028 DP1052695, ADJACENT UNIDENTIFIED CROWN LAND, AND WATERWAY

Item	Details	
Project Foreshore Protection and Enhancement Works – Sussex Inlet Foresh		
Client/Proponent Environmental Services, Shoalhaven City Council		
Prepared By City Services, Shoalhaven City Council

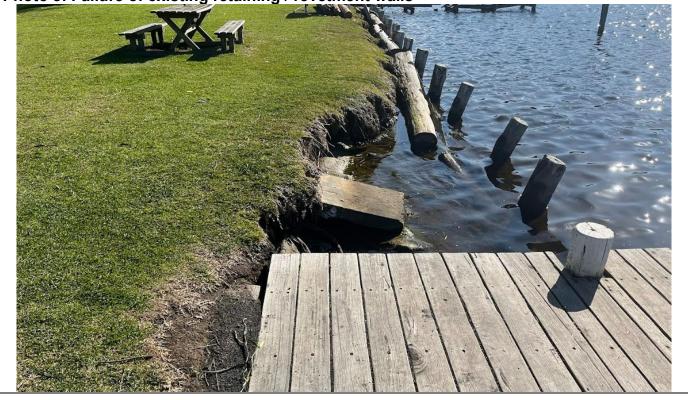
Photo 8: Failure of existing retaining / revetment walls

blocks, bricks, gravel and geotextile and they all appear to be ineffective in mitigating erosion. Many of these have failed or are failing. Scouring is evident behind some of these structures with further informal remediation treatment added to them, such as adding bricks behind the log revetment. (Water Technology 2025)

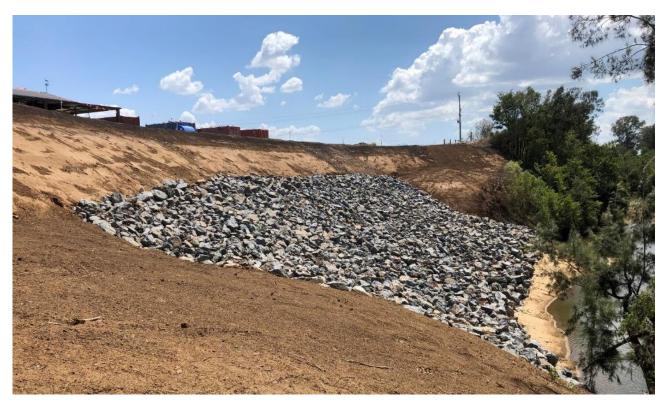
Figure 2-4 Rock Beaching, Logan River, Beaudesert.

Angular quarry rock is often preferred for rock rip rap due to its shape and stability. The angular edges of quarry rock allow the stones to interlock effectively, creating a stable and durable structure that resists movement and can withstand strong water currents and wave action. The relative stability of rock riprap (against the force of gravity) is indicated by its 'angle of repose'. Simons and Senturk (1979) show that the angle of repose for rock riprap increases with rock mean diameter (D_{50}) but is significantly greater for angular rock, compared to rounded rock (Figure 2-5). Additionally, quarry rock is often graded and sized specifically for rip rap applications, ensuring consistency and reliability in its performance, and is often supplied with specifications such as specific gravity. In contrast, other stone, such as river stones, can be rounded and smooth, which makes them more prone to shifting and rolling under pressure. This not to say that only angular graded quarry rock can be used for rock riprap applications, rather that, if using other rock, the following should apply:

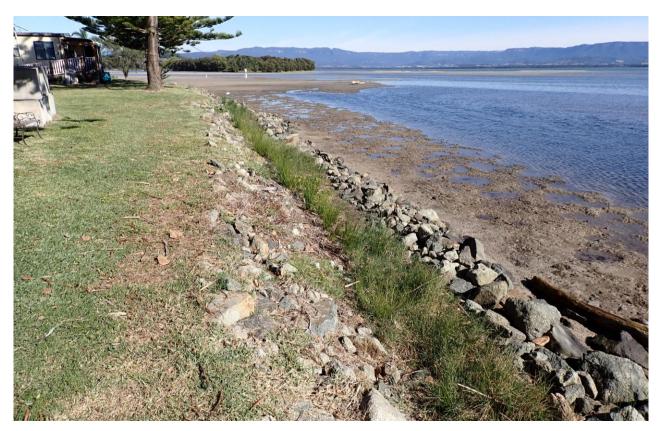
Figure 2-6 Rock fillet work allowing saltmarsh to establish at Lake Illawarra

These structures are particularly effective in areas with erosion caused by natural forces like tides and floods, as well as human activities such as boating. They are, however, limited as they may fail in areas with highly dynamic flood flows or extreme wave energy.

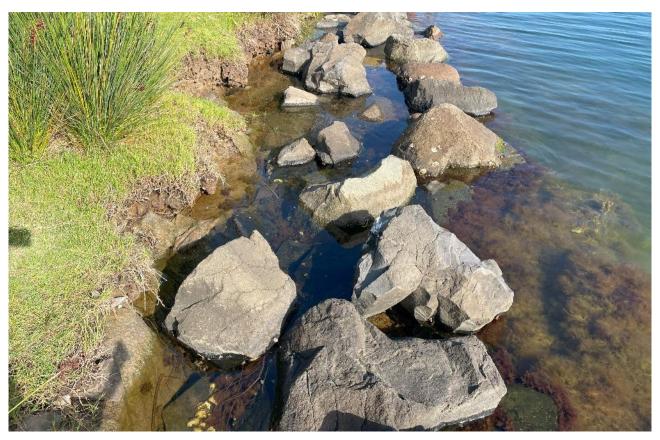
Figure 3-4 Ineffective Foreshore Rock Protection

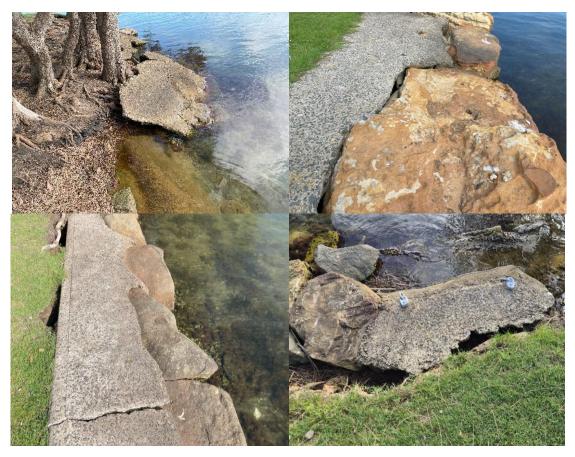
Figure 3-6 Examples of concrete reinforcement in poor conditions

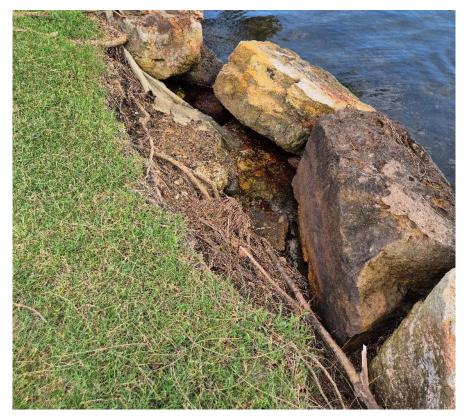
Figure 3-7 Rocks collapsed into the lake

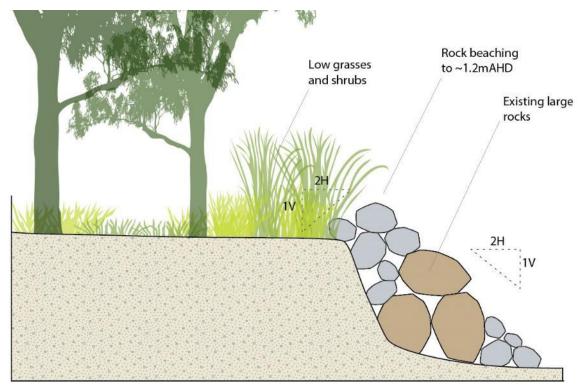
Figure 3-10 Rock beaching

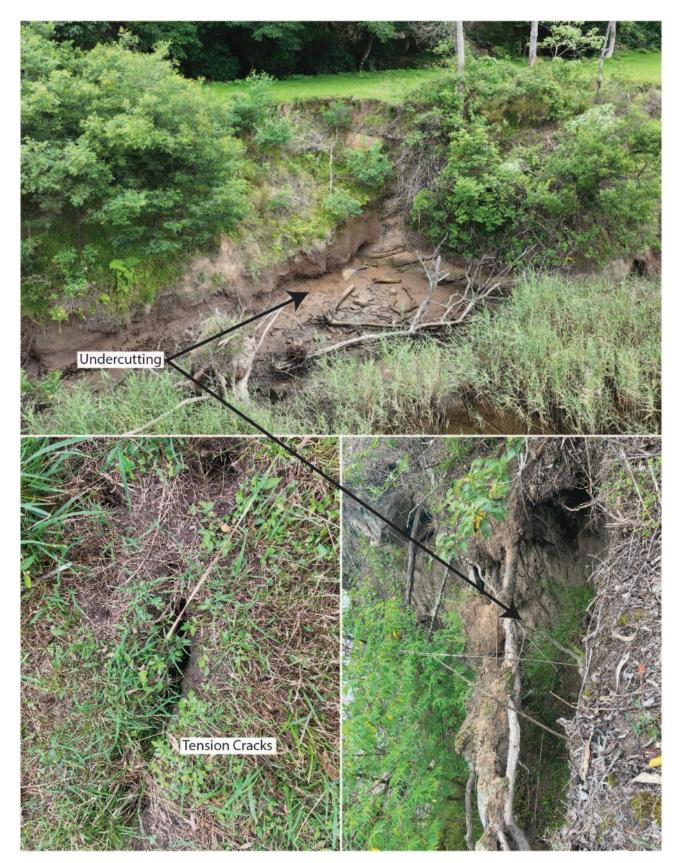
The riverbank in this location is approximately 5–6 meters high and the reach of concern, approximately 160 meters in length. Active bank erosion is progressing towards the bedrock cliffs. The erosion is occurring in sections, with other sections stabilised by a combination of exposed bedrock outcrops, individual large rocks and large trees (Figure 4-1). The primary erosion mechanism appears to be slumping and undercutting of the bank. The bank is undercut in some areas, and tension cracks are visible on the surface at the top of the bank (Figure 4-2).

Figure 4-2 Undercutting of the bank captured by the drone and from the bank. Tension cracks in the top of the bank viewed from above.

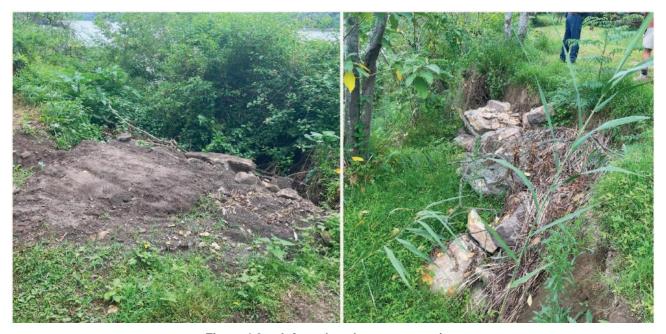
Rocks have been informally placed by the landholder on the upper bank face, but this measure is unlikely to address the identified erosion mechanism. Overland flow is concentrating in low points on the terrace and discharging down the bank face, likely contributing to the erosion. Informal repairs have also been made to address this process by backfilling the erosion extent. Similarly, this is not likely to address the erosion mechanism.

Figure 4-3 Informal works to treat erosion.

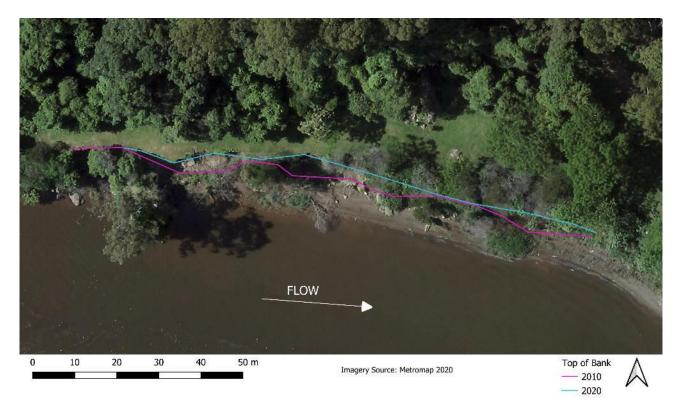
Multi temporal topographic datasets are not available to measure the extent of erosion over time. Measuring the top of bank alignment from the 2010 LiDAR and the 2020 aerial imagery indicates bank retreat in the order of 5m over this time (Figure 4-4).

Figure 4-4 Indication of bank movement based on 2010 LiDAR and 2020 aerial imagery.

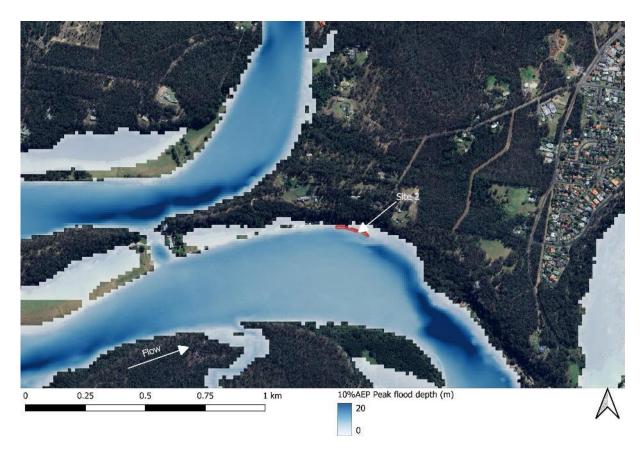
Figure 4-5 10%AEP flood extent and depth (Cardno, 2022)

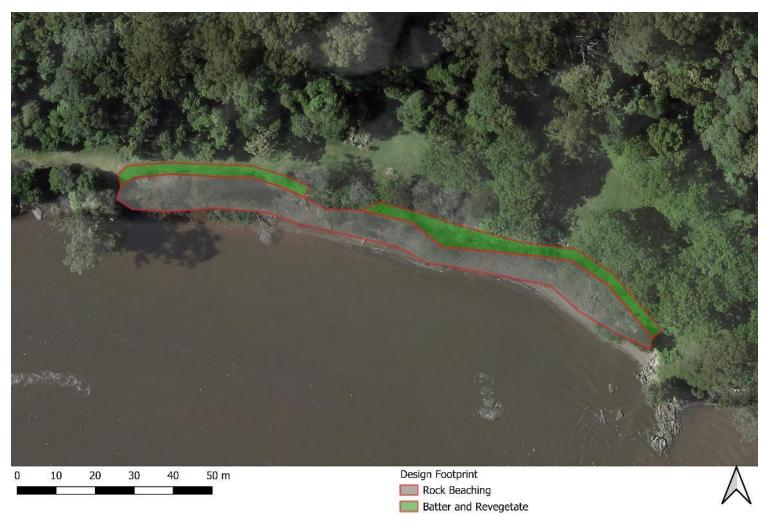
Figure 4-6 Plan view of rock beaching concept

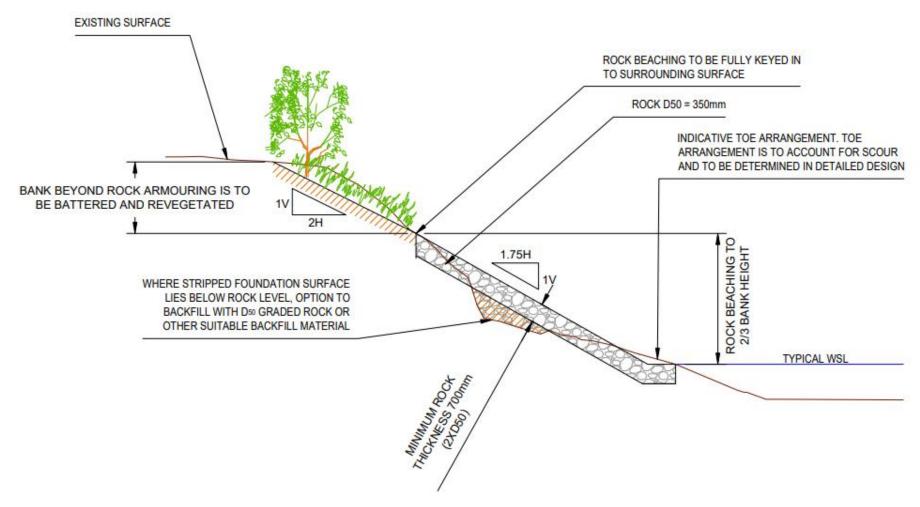
Figure 4-7 Section view of rock beaching concept

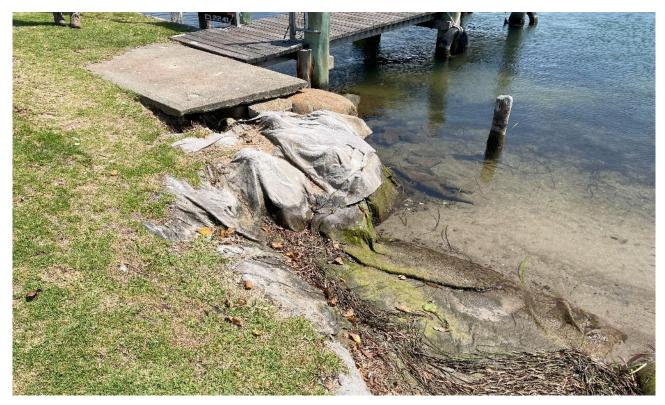
Figure 5-3 Undermined concrete slab and failed geotextiles on an eroding bank

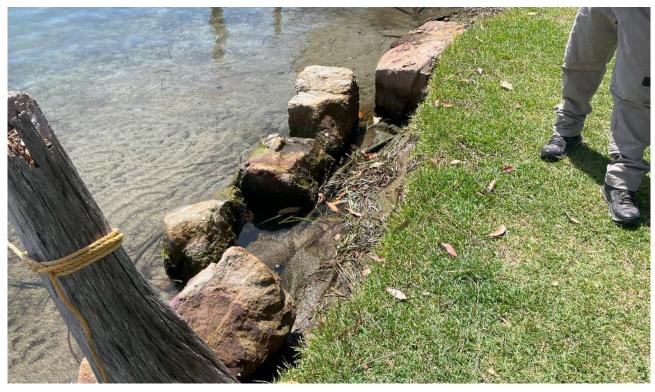
Figure 5-4 Rock beaching undermined and collapsed into the water

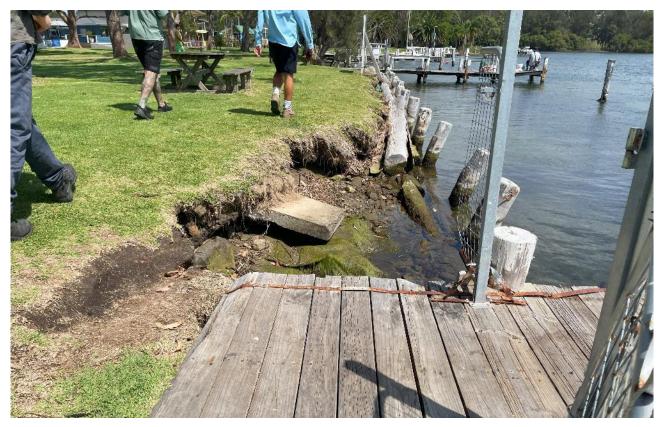
Figure 5-5 Foreshore erosion and failed log revetment

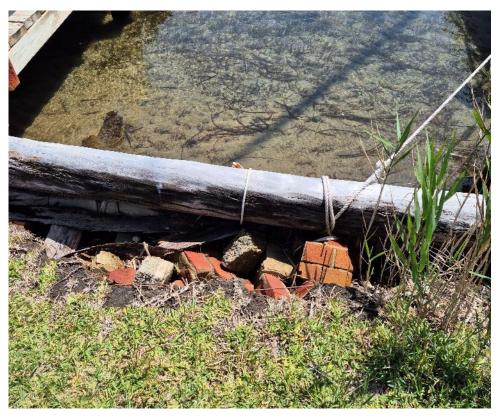
Figure 5-6 Bricks added to fill the scour hole behind the log revetment

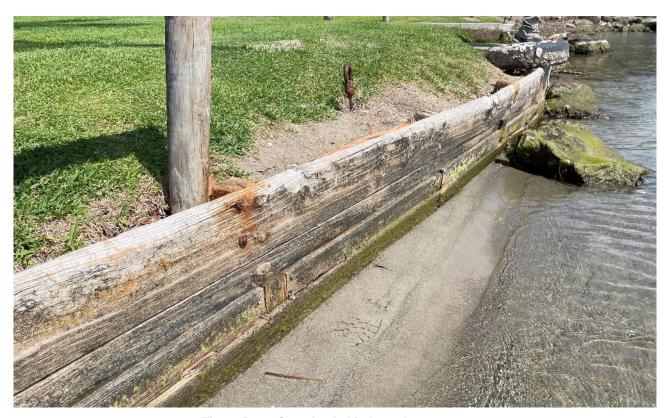
Figure 5-7 Scouring behind wood revetment

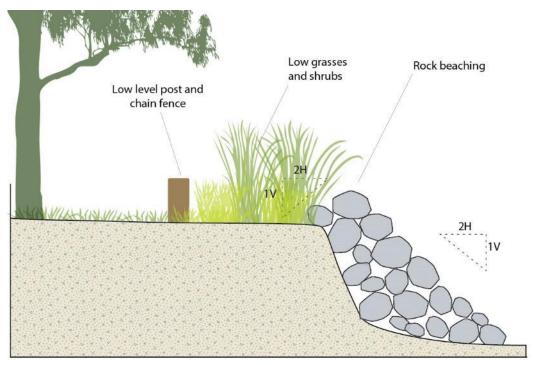
It is recommended that, where possible, the foreshore bank is treated with rock beaching. Rock beaching should consist of graded quarry rock with a d_{50} of approximately 350mm to form an interlocking rock riprap. The intent of the rock is to provide protection to the foreshore bank in such a way that is flexible enough to accommodate minor changes in the foreshore geometry that are expected to occur over time. A key physical constraint at the Sussex Inlet site is the presence of many private pontoons and jetties. The most effective rock beaching arrangement would consist of rock beaching applied consistently along a continuous reach of the foreshore. It is recognised that the presence of jetties and pontons will not allow for this to be the case. As such, rock beaching should tie in as close as practicable to the jetty infrastructure. It may also be beneficial to attempt to install rock on the bank underneath the jetties. A profile view of the recommended arrangement is shown in Figure 5-9.

Figure 5-9 Rock beaching

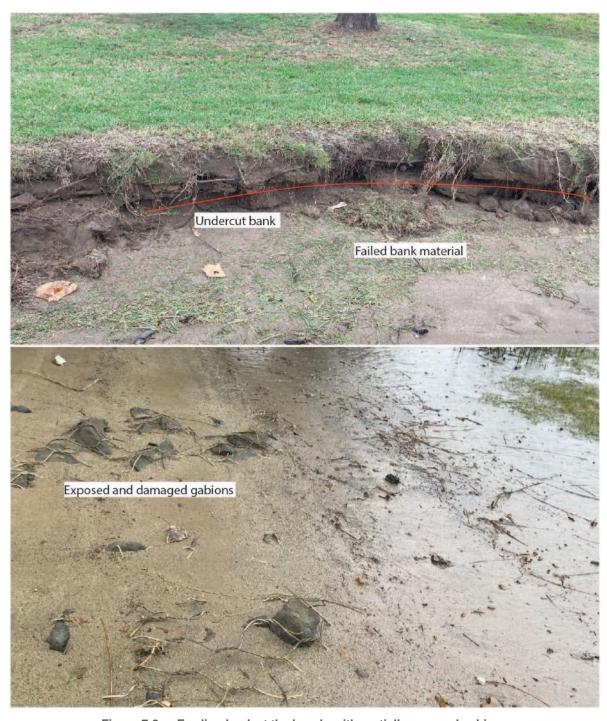
Figure 7-2 Eroding bank at the beach, with partially exposed gabions

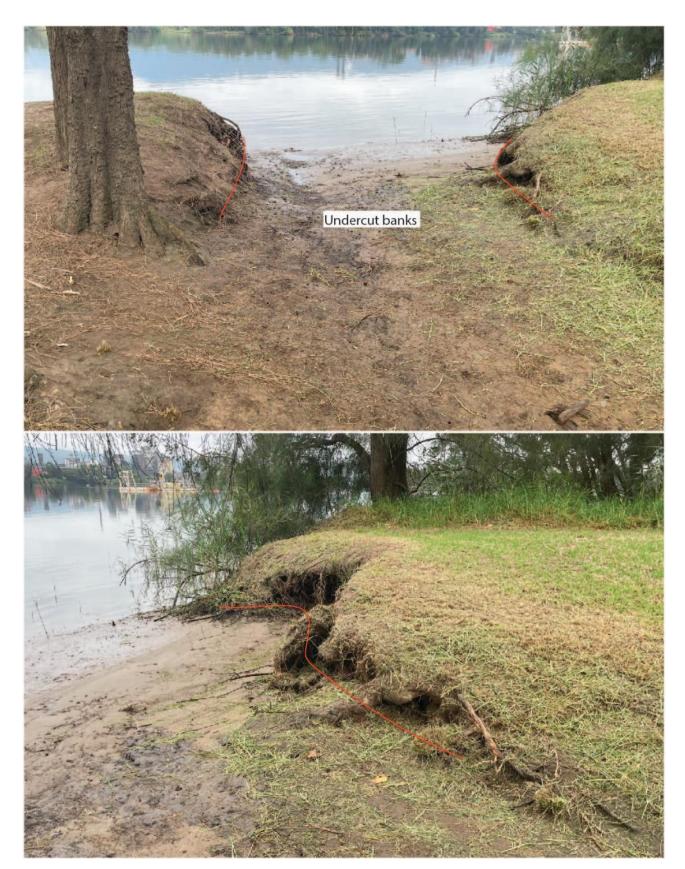
Figure 7-3 Stormwater outlet eroding at riverbank

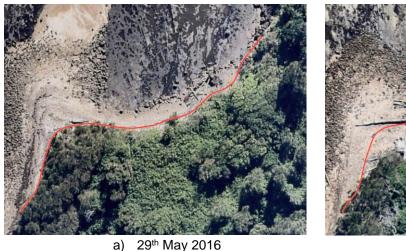
Figure 8-2 Visualization of coastal retreat between May 2016 (a, left) and April 2025 (b, right). The red line in both images represent the coastline position in May 2016.

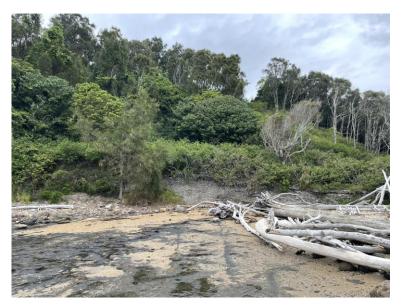
Figure 8-3 shows a front view of the site, highlighting its current state facing ongoing coastal erosion. The wide rock platform contains a scattering of natural headland reef-rocks of various dimensions, and wooden debris trees are present in the area. At the time of writing there is no confirmation regarding the origin of those fallen trees. It is unlikely that the woody debris or scattered rocks are providing partial coastal protection to the site – as this material is not fixed in places and would be readily mobilised under storm conditions. Nevertheless, the coastal protection provided by those fallen trees are not quantifiable by any standard coastal engineering methodology, nor reliable.

Figure 8-3 Site 5A front view

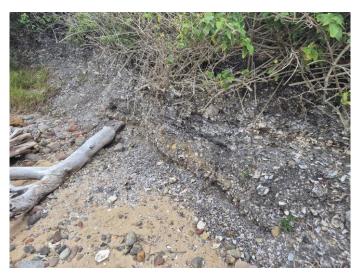
The middens at this site (see Figure 8-4), are subsequently directly exposed to the incident wave energy during periods of high spring tides and during storm events, causing accelerated erosion that threatens their fragile structure.

Figure 8-4 Middens exposed to coastal erosion in Site 5A

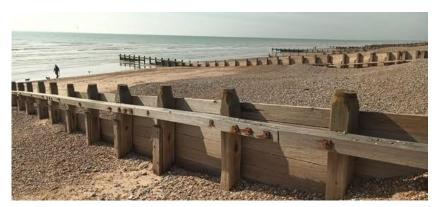
- Biological degradation, such as marine borer or fungal attack on timber elements.
- Mechanical wear, particularly from wave-driven debris and abrasion against the rock platform.
- Saltwater corrosion, if steel fixings or reinforcements are used.
- UV exposure, which can accelerate timber weathering and reduce structural integrity over time.
- Maintenance demands, as ongoing inspections and repairs would be required to maintain performance over the life of the structure.

Figure 8-7 Example of timber groyne, similar to the proposed timber low crest wave barrier.

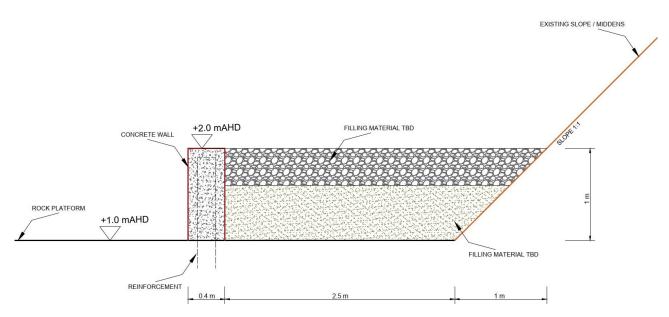
Figure 8-9 Proposed concrete low crest wave barrier

Further details of the proposed concept design, including summarized technical specifications and proposed geometry, are included Appendix D for review. This annex provides additional information on the solution, recommended for its long-term durability, constructability advantages and the opportunity to use the solid foundation provided by the rocky platform.
