ARBORICULTURAL IMPACT ASSESSMENT

Gledswood Hills High School

9 Gregory Hills Drive, Gledswood Hills NSW 2557

Project No: G860 Date: 11 December 2024 Revision: B

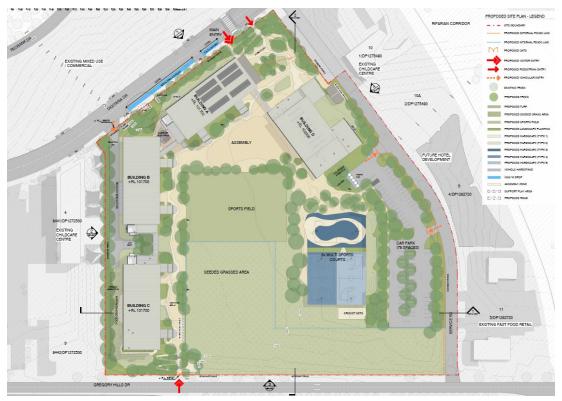
Figure 2 – Site Plan extract showing the proposed layout of the development. Source: DJRD Architects, November 2024.

An extract of the overall ground floor plan is shown at **Figure 2** below.

Specifically, those works considered likely to impact the existing trees adjoining the subject site include the vehicular access requirements and services infrastructure.

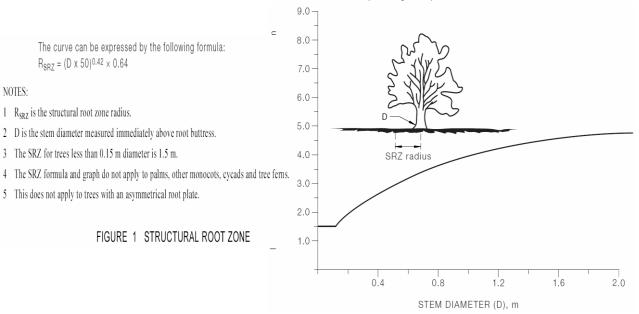
D = trunk diameter, in metres, measured above the root buttress.

Note: The SRZ for trees with trunk diameters less than 0.15 m will be 1.5 m (see Figure 1).

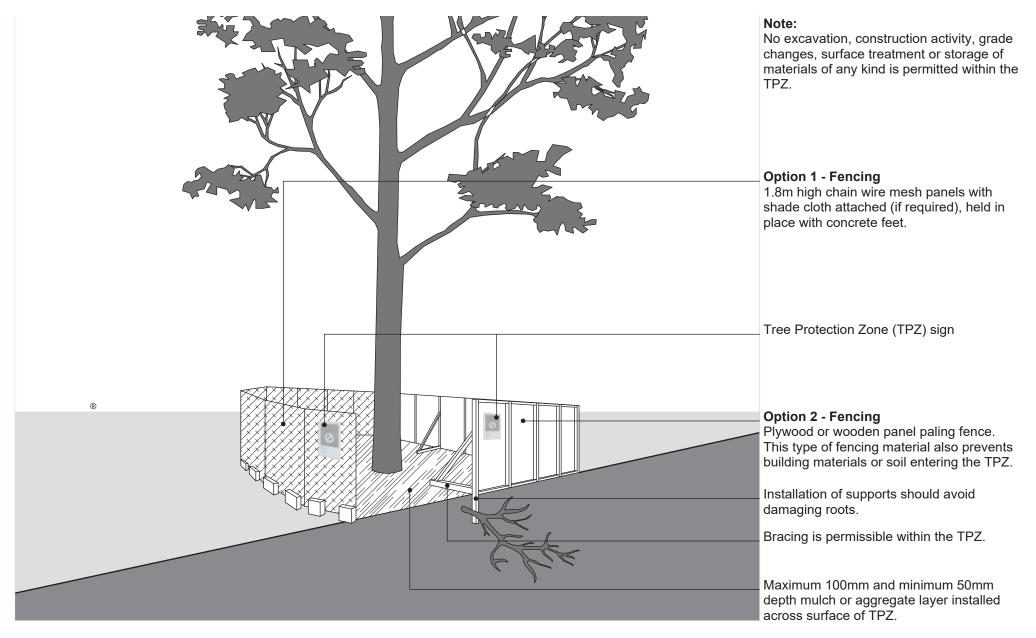
01

Tree Protection Fencing

As a minimum, the Tree Protection Fence shall consist of 1.8m high wire mesh panels supported by concrete feet. Panels shall be fastened together and supported to prevent sideways movement. The tree shall not be damaged during the installation of the Tree Protection Fencing. Refer to Typical Tree Protection Details (*Appendix 3*).

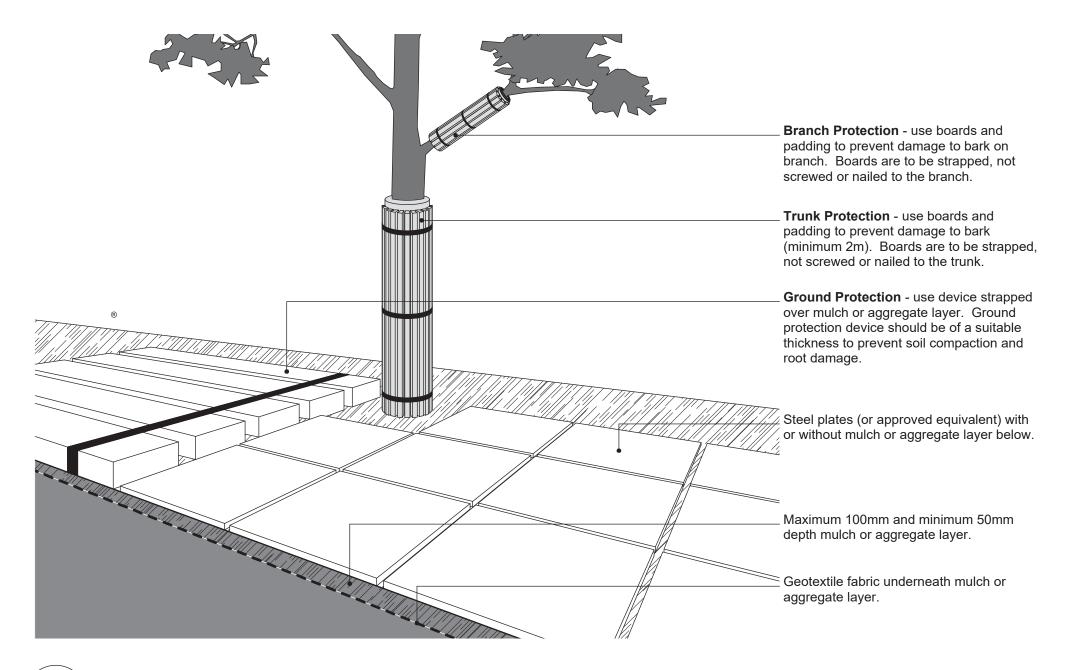
02

Examples of Branch, Trunk and Ground Protection

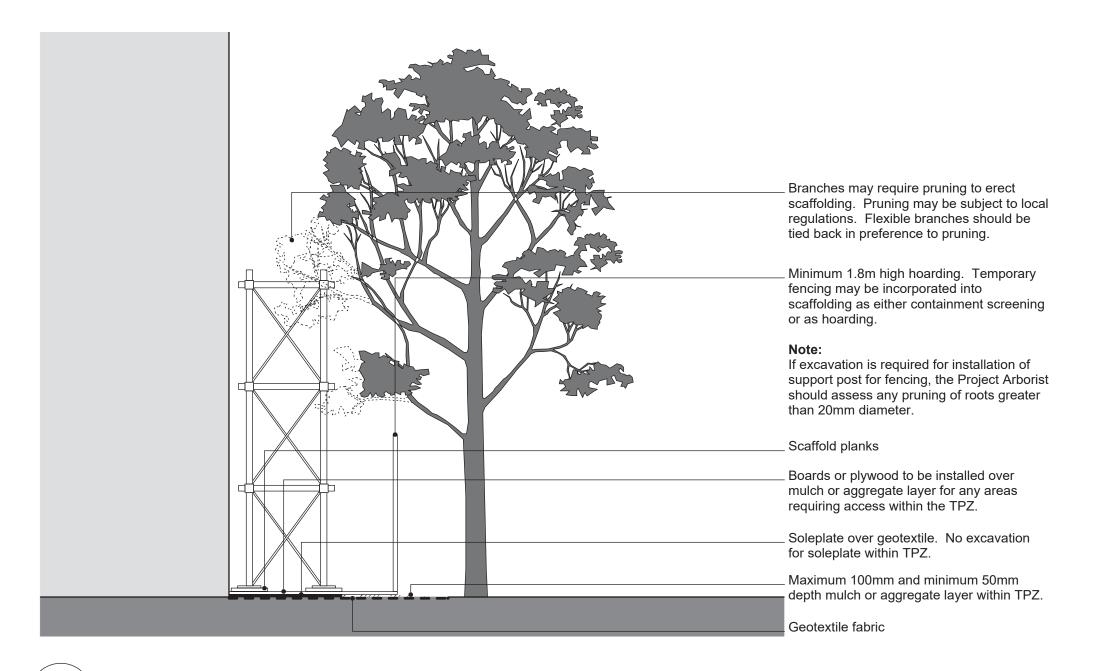
03

Indicative Scaffolding within a Tree Protection Zone (TPZ)
