GILLIESTON PUBLIC SCHOOL  
REDEVELOPMENT AND NEW PUBLIC  
PRESCHOOL

Statement of Heritage Impact

REF SUBMISSION

Prepared by  
**Umwelt (Australia) Pty Limited**  
on behalf of  
**NSW Department of Education**

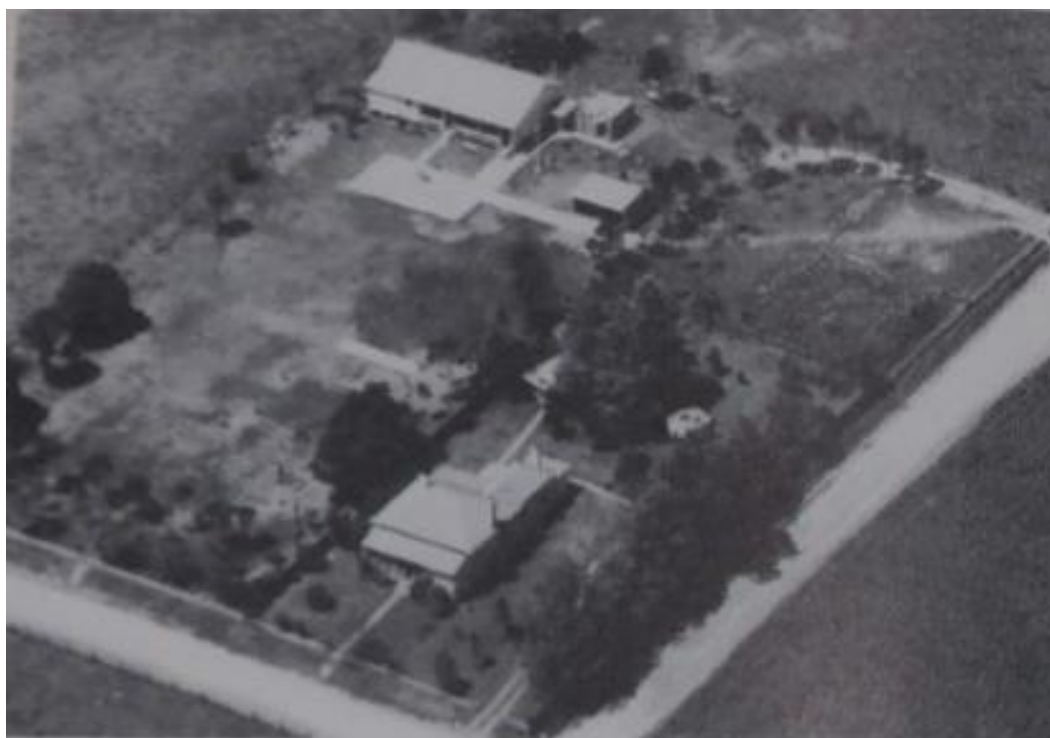
**Figure 2.9** Gillieston Public School, c 1978, looking south-east. The 1894 school building was to the left (east) of the brick cottage.

Building B00A in its original form is shown in **Figure 2.9** and **Figure 2.10**. The north-facing verandah was infilled after 2010. The fenestration in the northern façade is now aluminium-framed. The brick and concrete steps were built in 1959, though the steel handrail is more recent. The verandah on the south side is more recent than 2010.

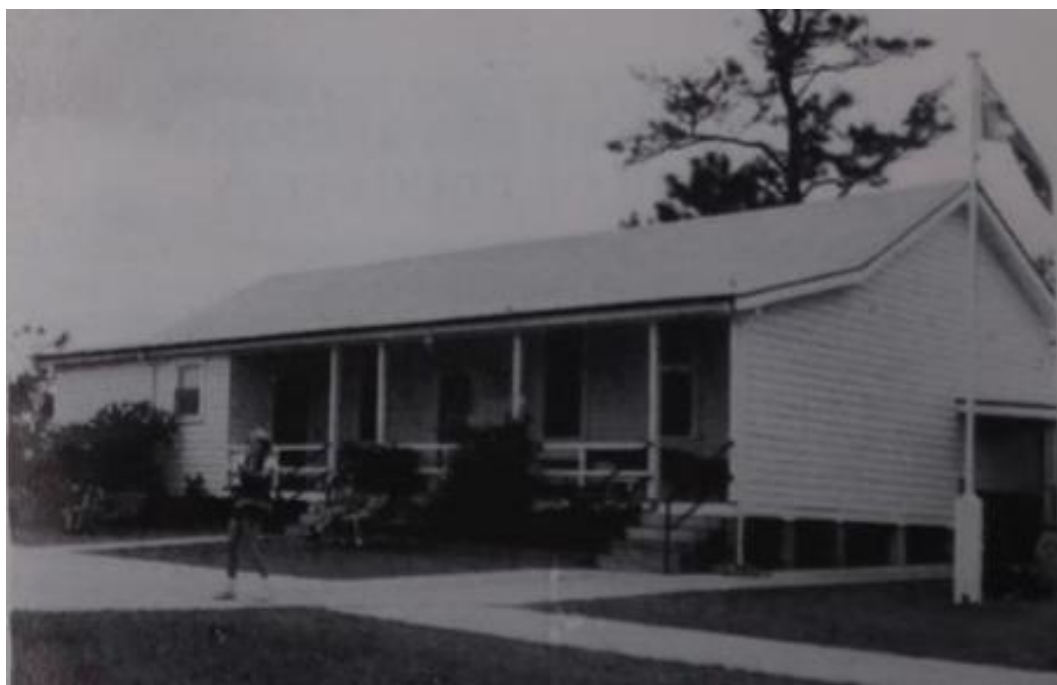
**Figure 2.10** The relocated school building seen c1978. The front verandah and attached façade have been removed.

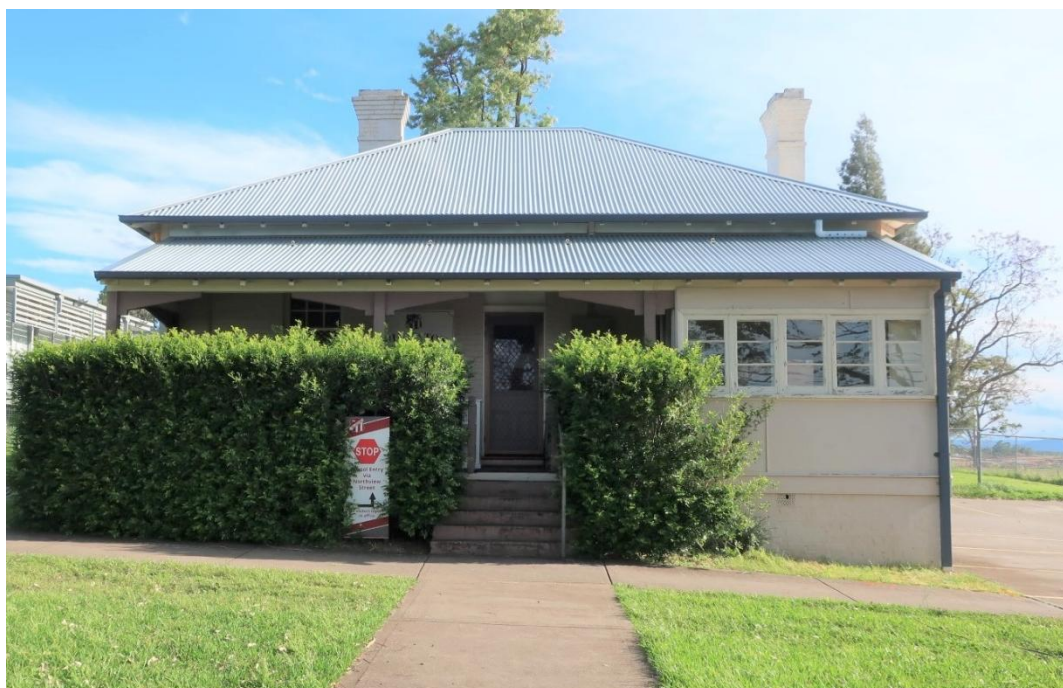
**Photo 3.5** The north elevation of the cottage, Building B00D

Building B00D is constructed with brick walls, and timber framing to the floor, whole of the verandah and the roof. The roof is clad with corrugated steel sheet. The main front section of the cottage has a hip roof, with a skillion roof over the verandah and a large skillion over the original service wing at the rear. The carpenter's craft is demonstrated in the simple timber framing of the verandah and the exposed rafters under the eaves, with some decorative chamfering work. The rear service wing has no eaves. The western end of the verandah appears to have been enclosed in the c1930s, with windows have a characteristic horizontal emphasis in their transoms. The original sliding sash windows are in Federation Queen Anne style with two panes in the lower sashes and nine in the upper sashes. The front door is in the same style richly profiled timber mouldings. The top light has had its glazing replaced with an opaque panel.

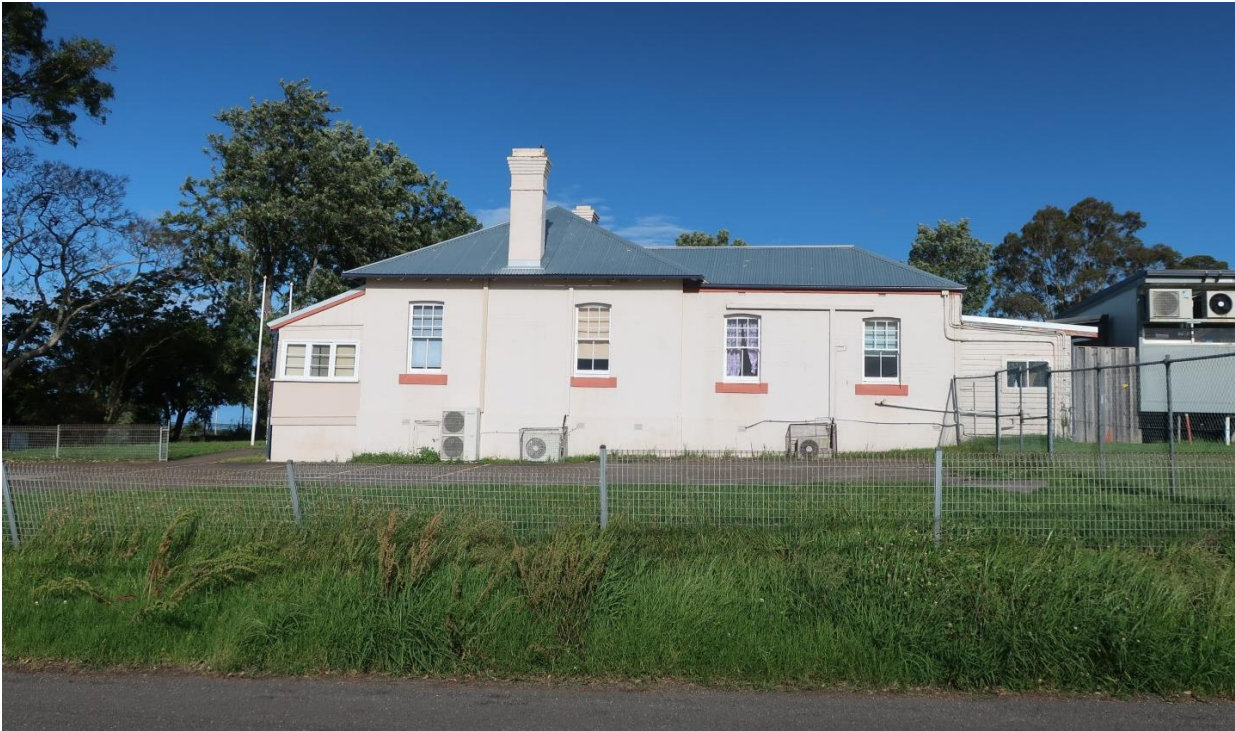
**Photo 3.6**      **The west elevation of Building B00D**

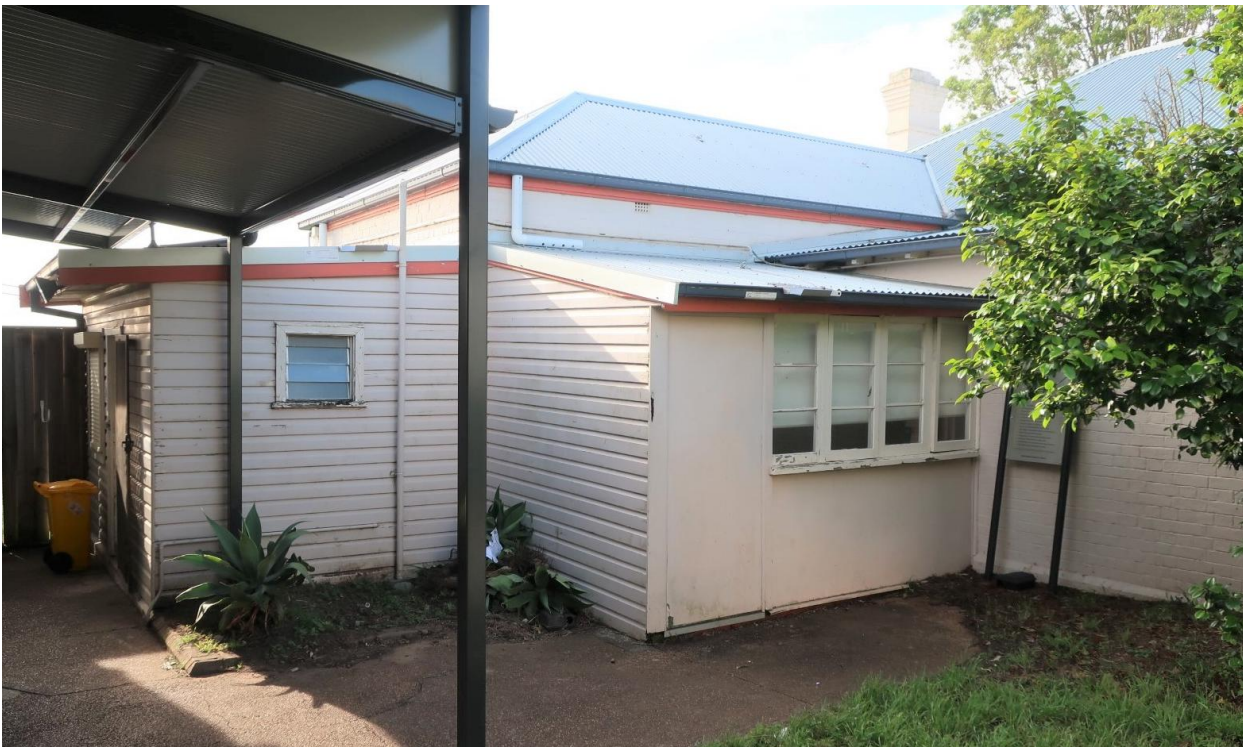
**Photo 3.7**      **The rear wing of Building B00D, seen looking north-west.**

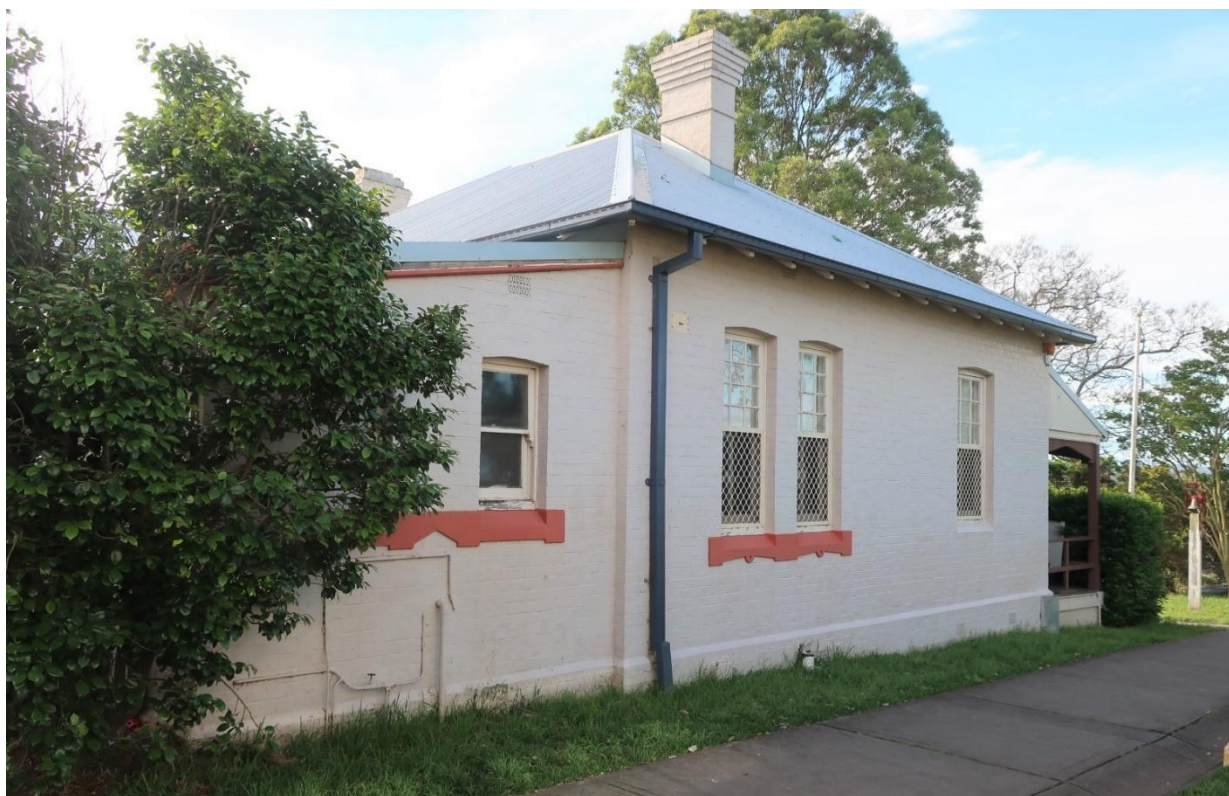
**Photo 3.8 The east elevation of Building B00D**

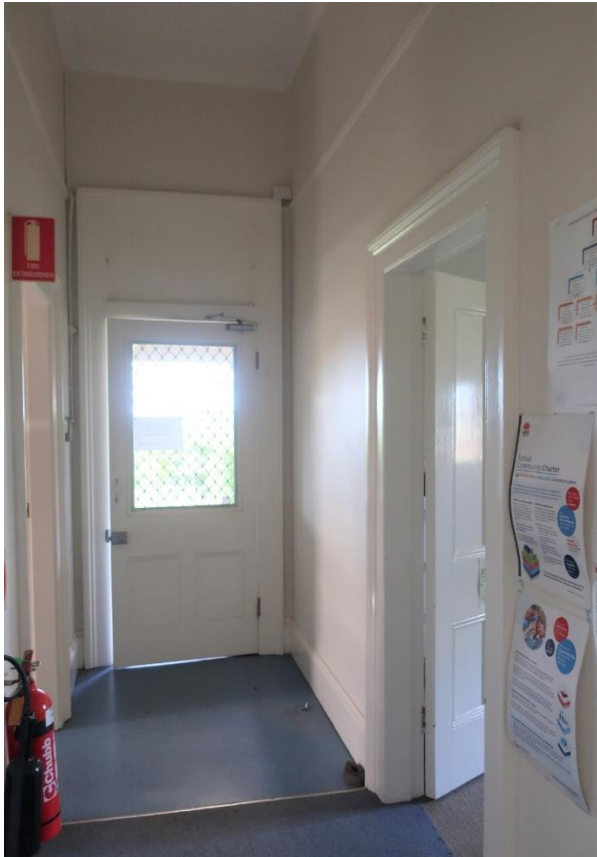
**Photo 3.10** The hallway looking towards the front door, showing original joinery.

The interior is largely intact and fitted with many original fixtures of a high quality, including four marble mantelpieces, all in off-white marble with red marble in the decorative astragals. The floors are finished with modern carpet and linoleum that hide the floorboards. All the original internal walls are plastered. There are staff moulds on the projecting wall corners on each side of the fireplaces. The joinery is of a good quality with wide architraves and regular profiles of the period for middle-class housing. The four-panelled interior doors are original and typical of the period. The original ceilings are lined with V-jointed timber boards and profiled timber cornices. The former kitchen retains its original hearth and mantle shelf. All the fire places have had their void covered over with a panel or converted to cupboard space, so it is not clear if cast iron grates remain with the marble mantelpieces, as would be typical.

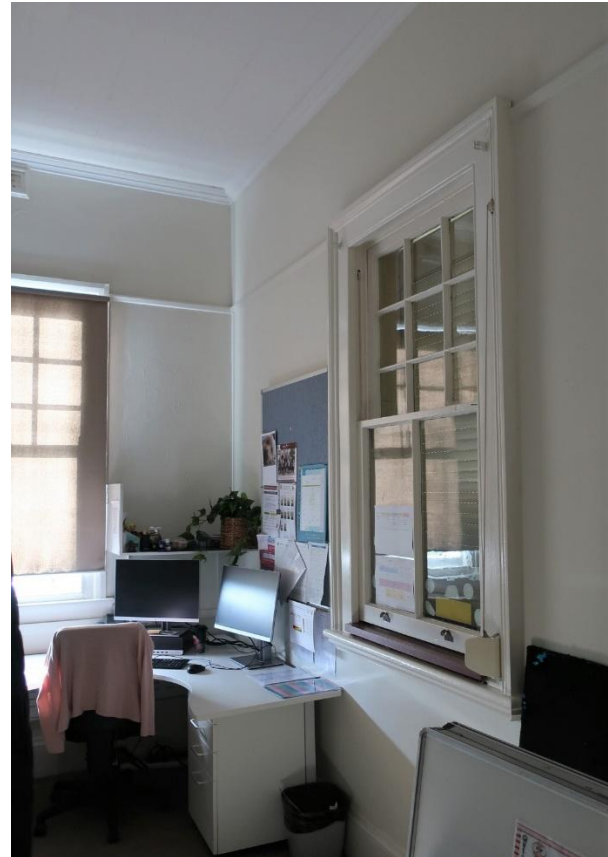
**Photo 3.11** Typical windows in the north-west room.

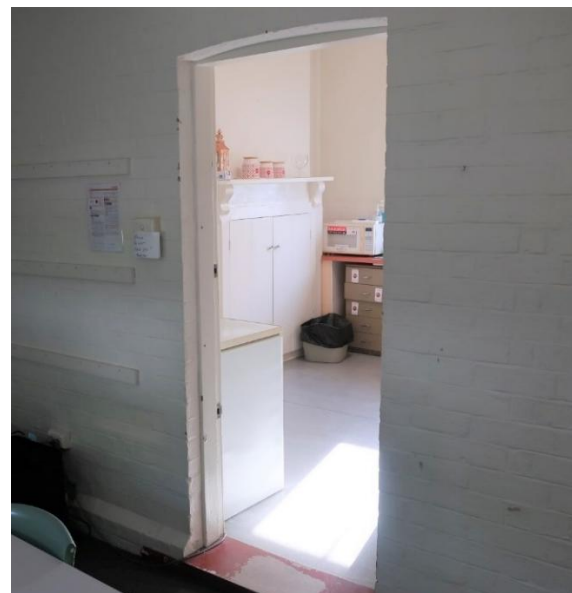
**Photo 3.13** south-west view into the former kitchen, showing the hearth adapted with a cupboard.

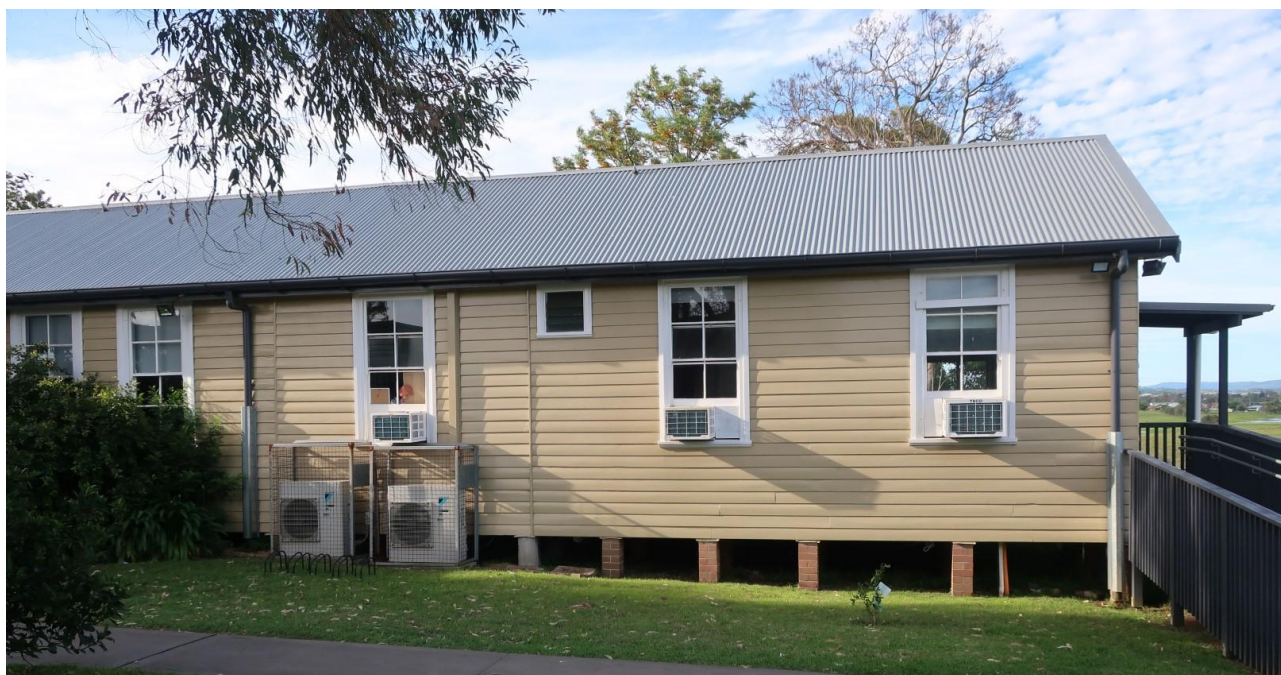
**Photo 3.14** The eastern end of the southern elevation of Building B00A

Building B00A has a long gable form, formerly enclosing three classrooms, but is now used as the school library. The long facades have vertical joins that demonstrate where the building was cut to move it here from Kurri Kurri.

Building B00A is constructed on brick piers at the ends and precast concrete piers at the centre, supporting timber bearers and conventional timber balloon framing with joists and wall studs. The walls are clad with timber weatherboards, lacking any decorative profile. The original windows are timber-framed sliding sashes with four panes to each sash. The architraves have some decoration in the mouldings and quadrant-shaped sash horns typical of the inter-war period. The doors appear to be modern replacements. The roof has been re-clad with grey corrugated steel sheet.

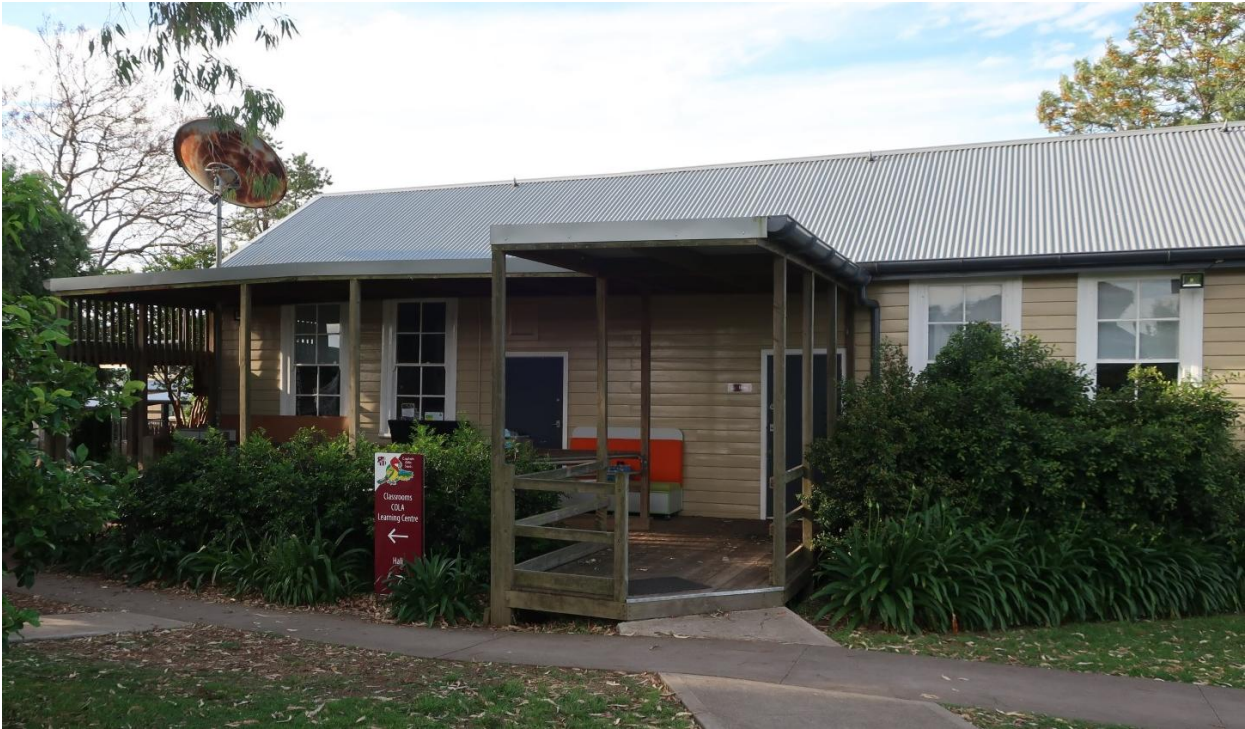
**Photo 3.15** The western end of the southern elevation of Building B00A

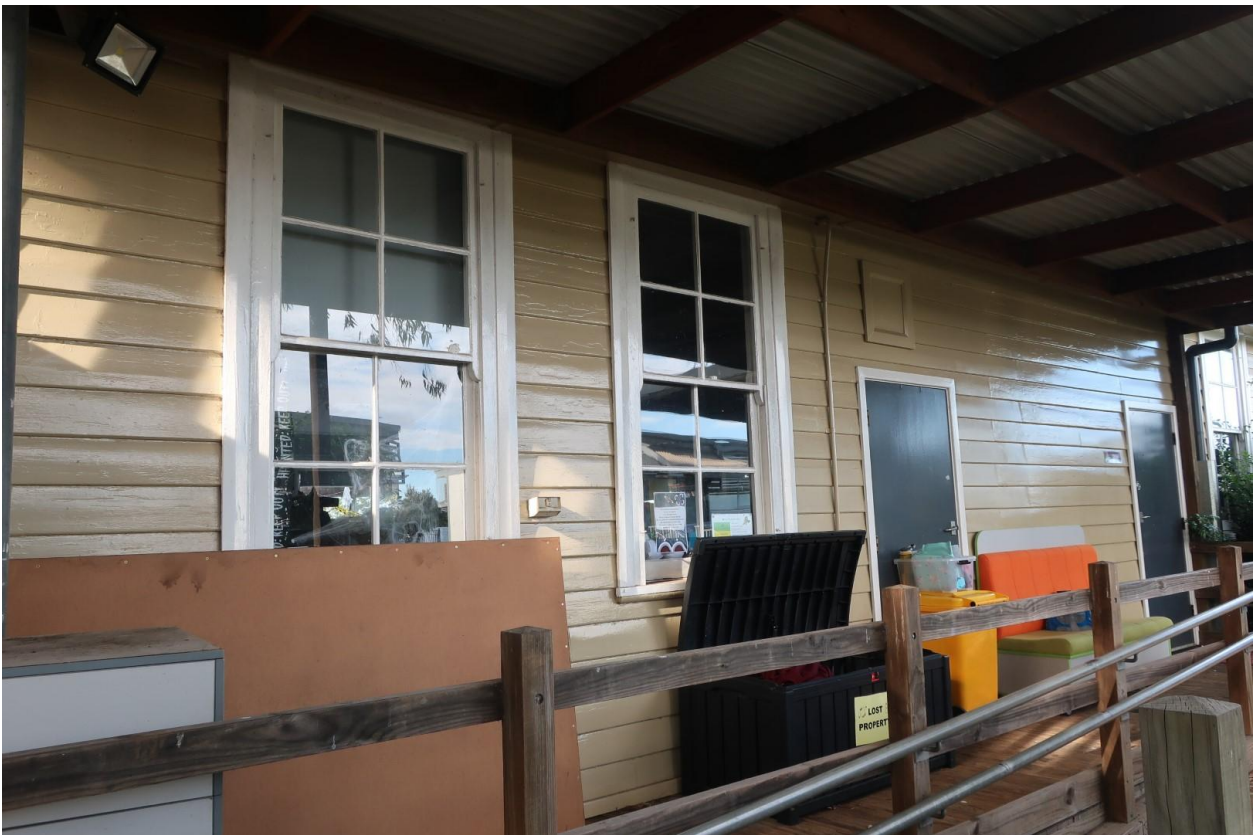
**Photo 3.16** The south verandah of the inter-war Building B00A

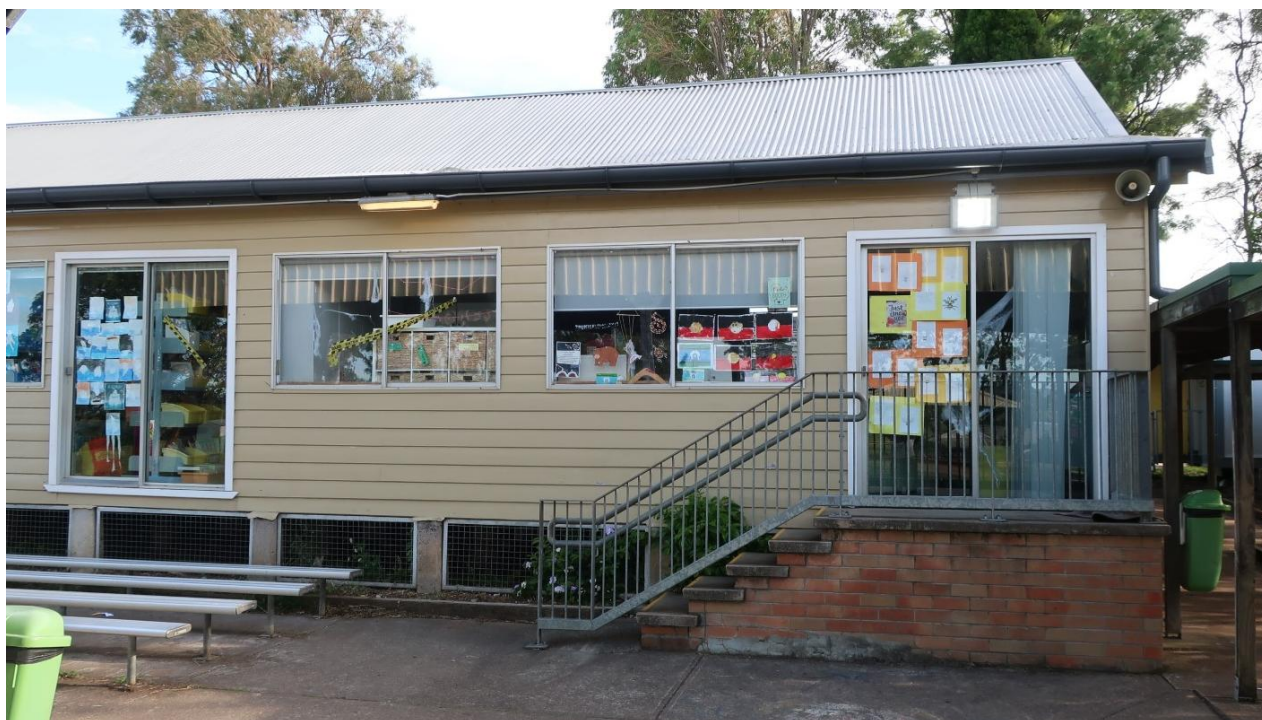
**Photo 3.17** The western end of the northern elevation of Building B00A showing the infilled verandah.

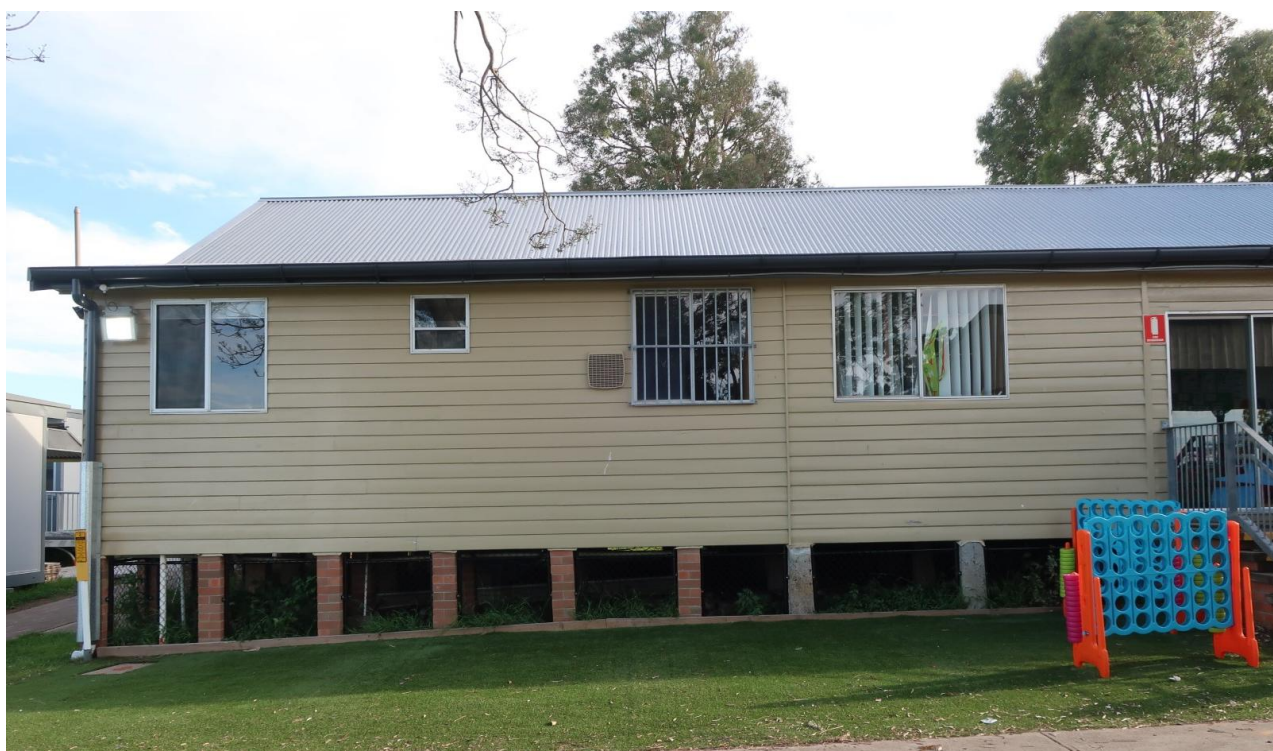
**Photo 3.18** The eastern end of the northern elevation of Building B00A
